Benton County National Bank Building, CORVALLIS, Oregon.

Benton County State Bank  
Building  
Corvallis, Benton County,  
Oregon

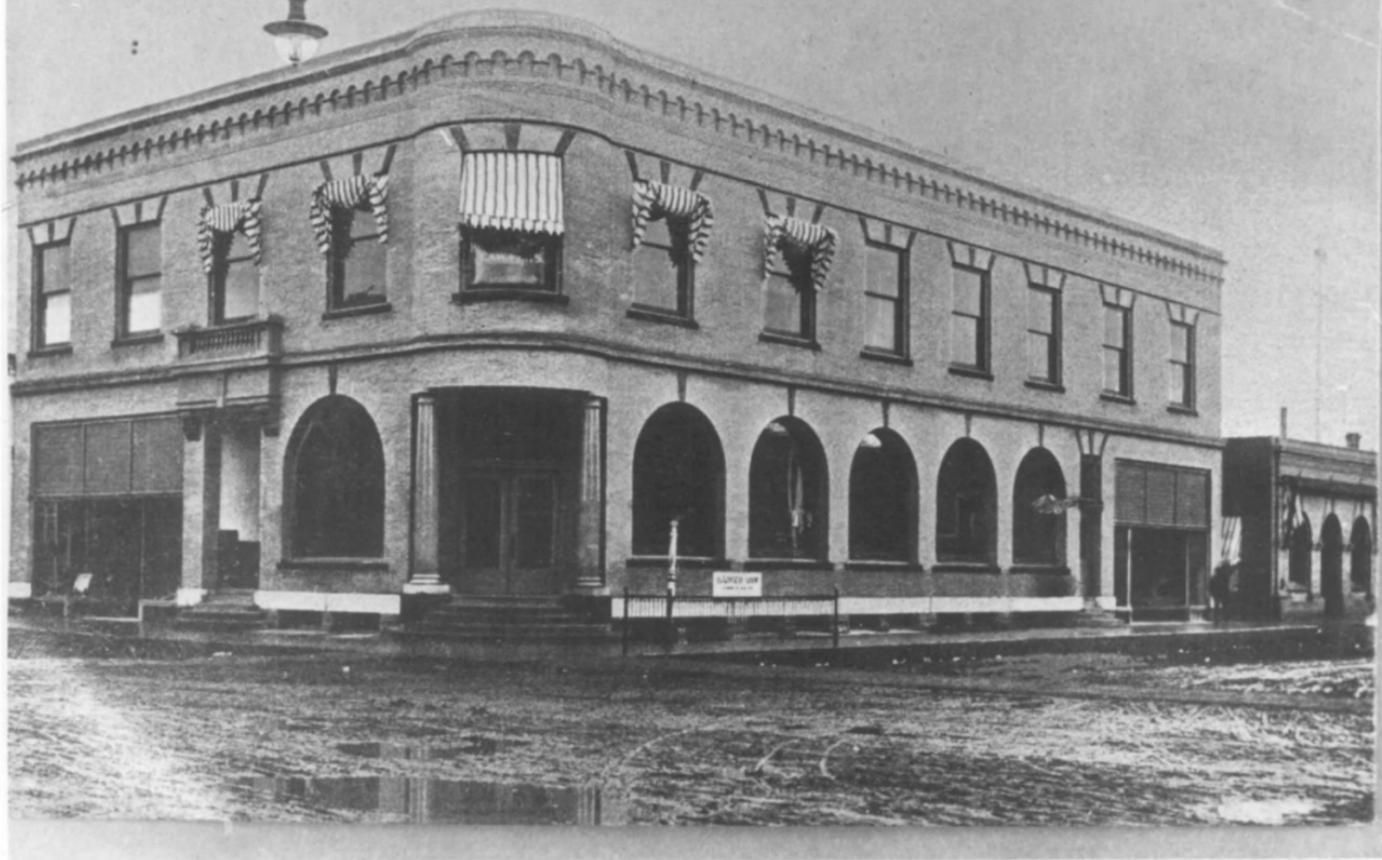
1 of 12  
Historic postal card, view  
ca. 1909  
West and South faces showing

original ground story outer  
end bay treatment and corner  
bay entry.

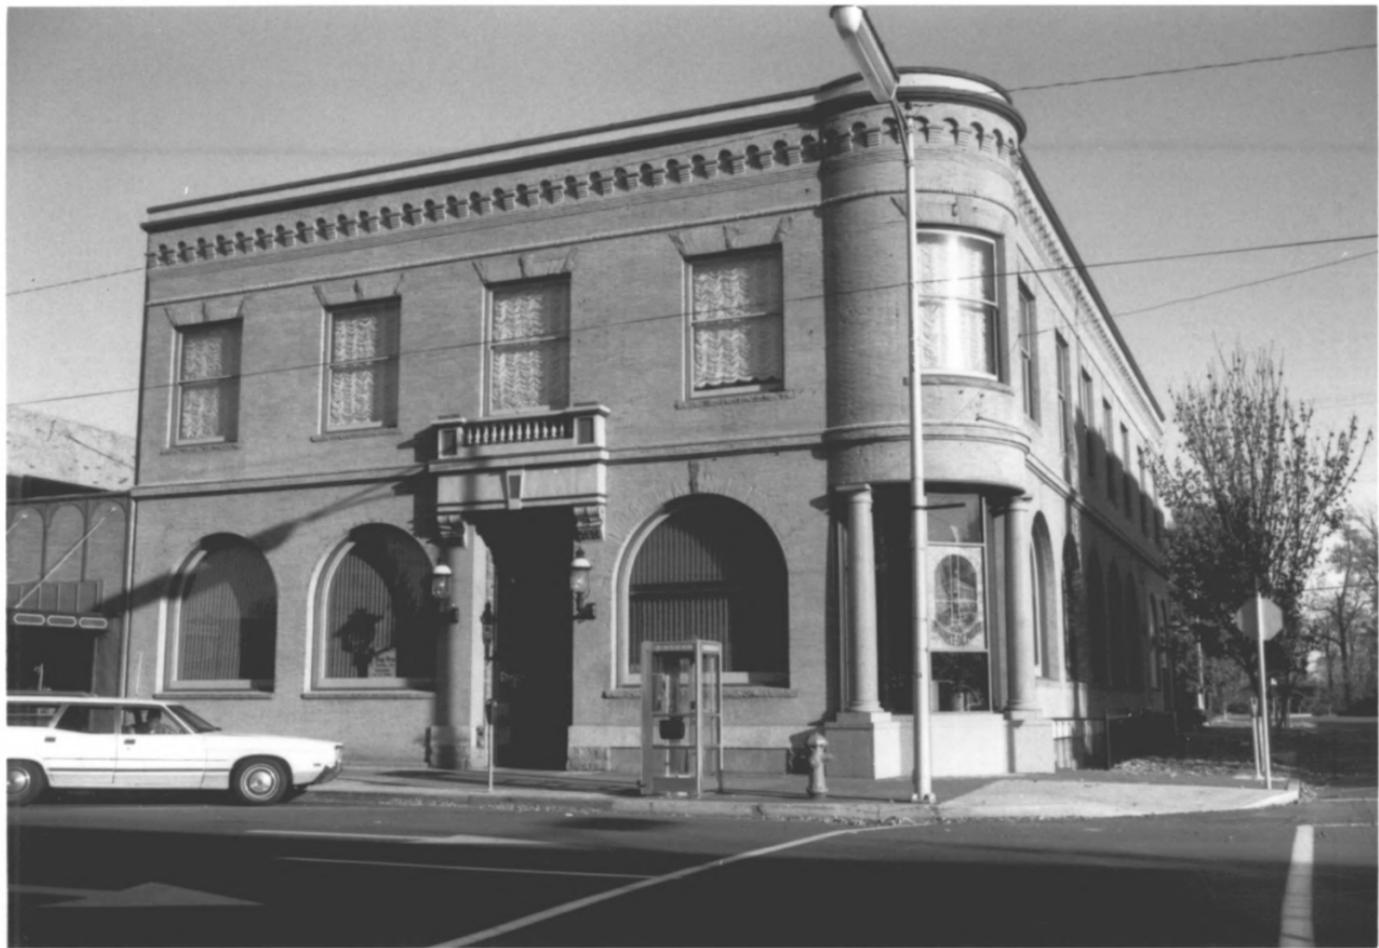
2 of 12

West elevation, showing re-  
modeled outer end bay treat-  
ment and conversion of corner  
bay entry to window.

(Steps were removed from  
corner ca. 1920-1925.)

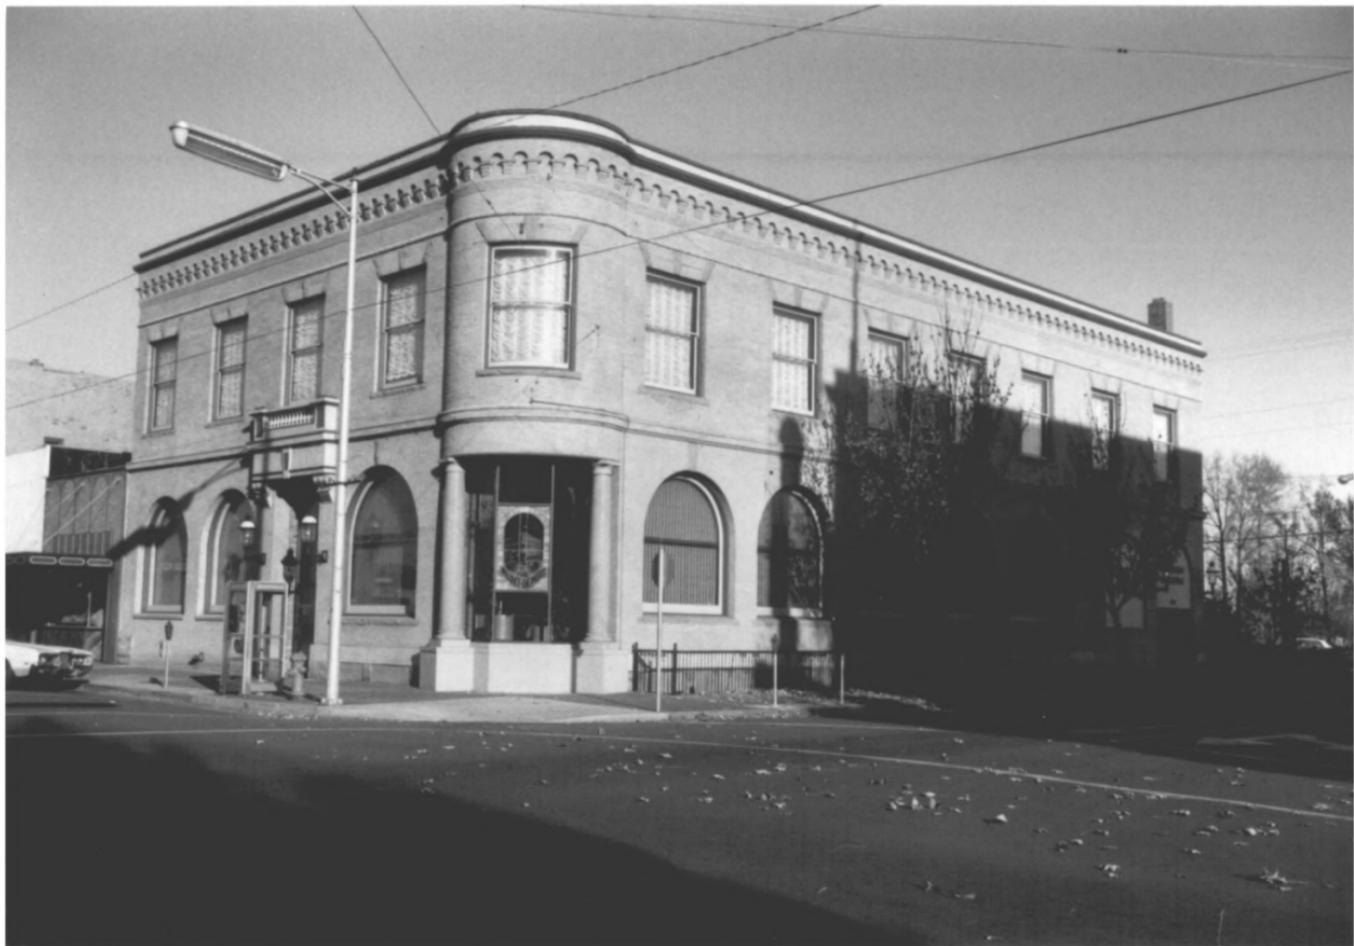
3 of 12

West and south elevations,  
showing remodeled outer end  
bays and corner bay  
treatment.

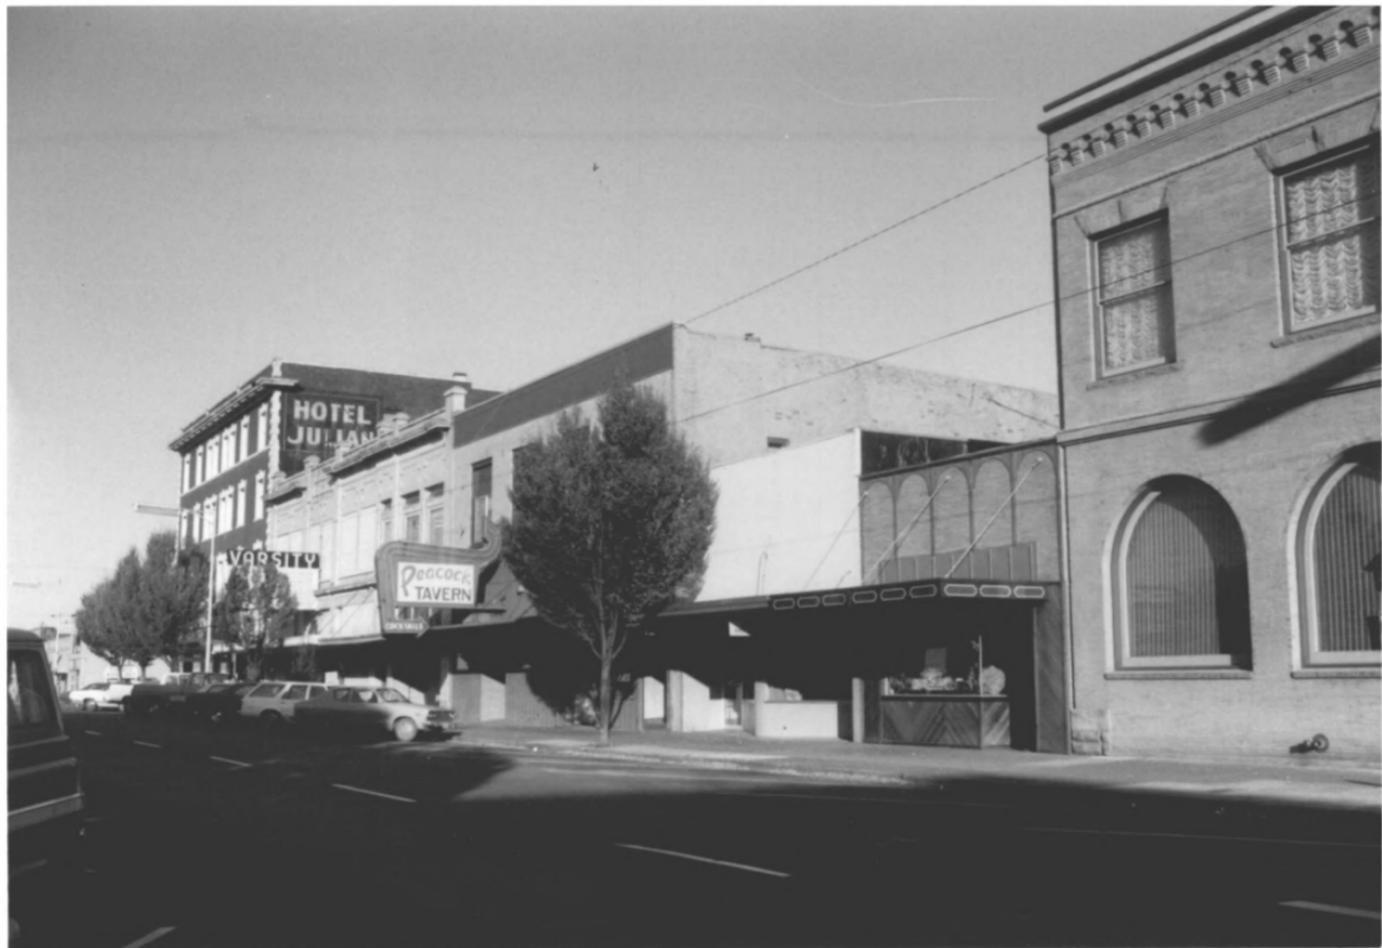
4 of 12 **MAR 7 1979**

Looking northeast along 2nd  
Street, showing bank building  
in relation to other struc-  
tures on the block.

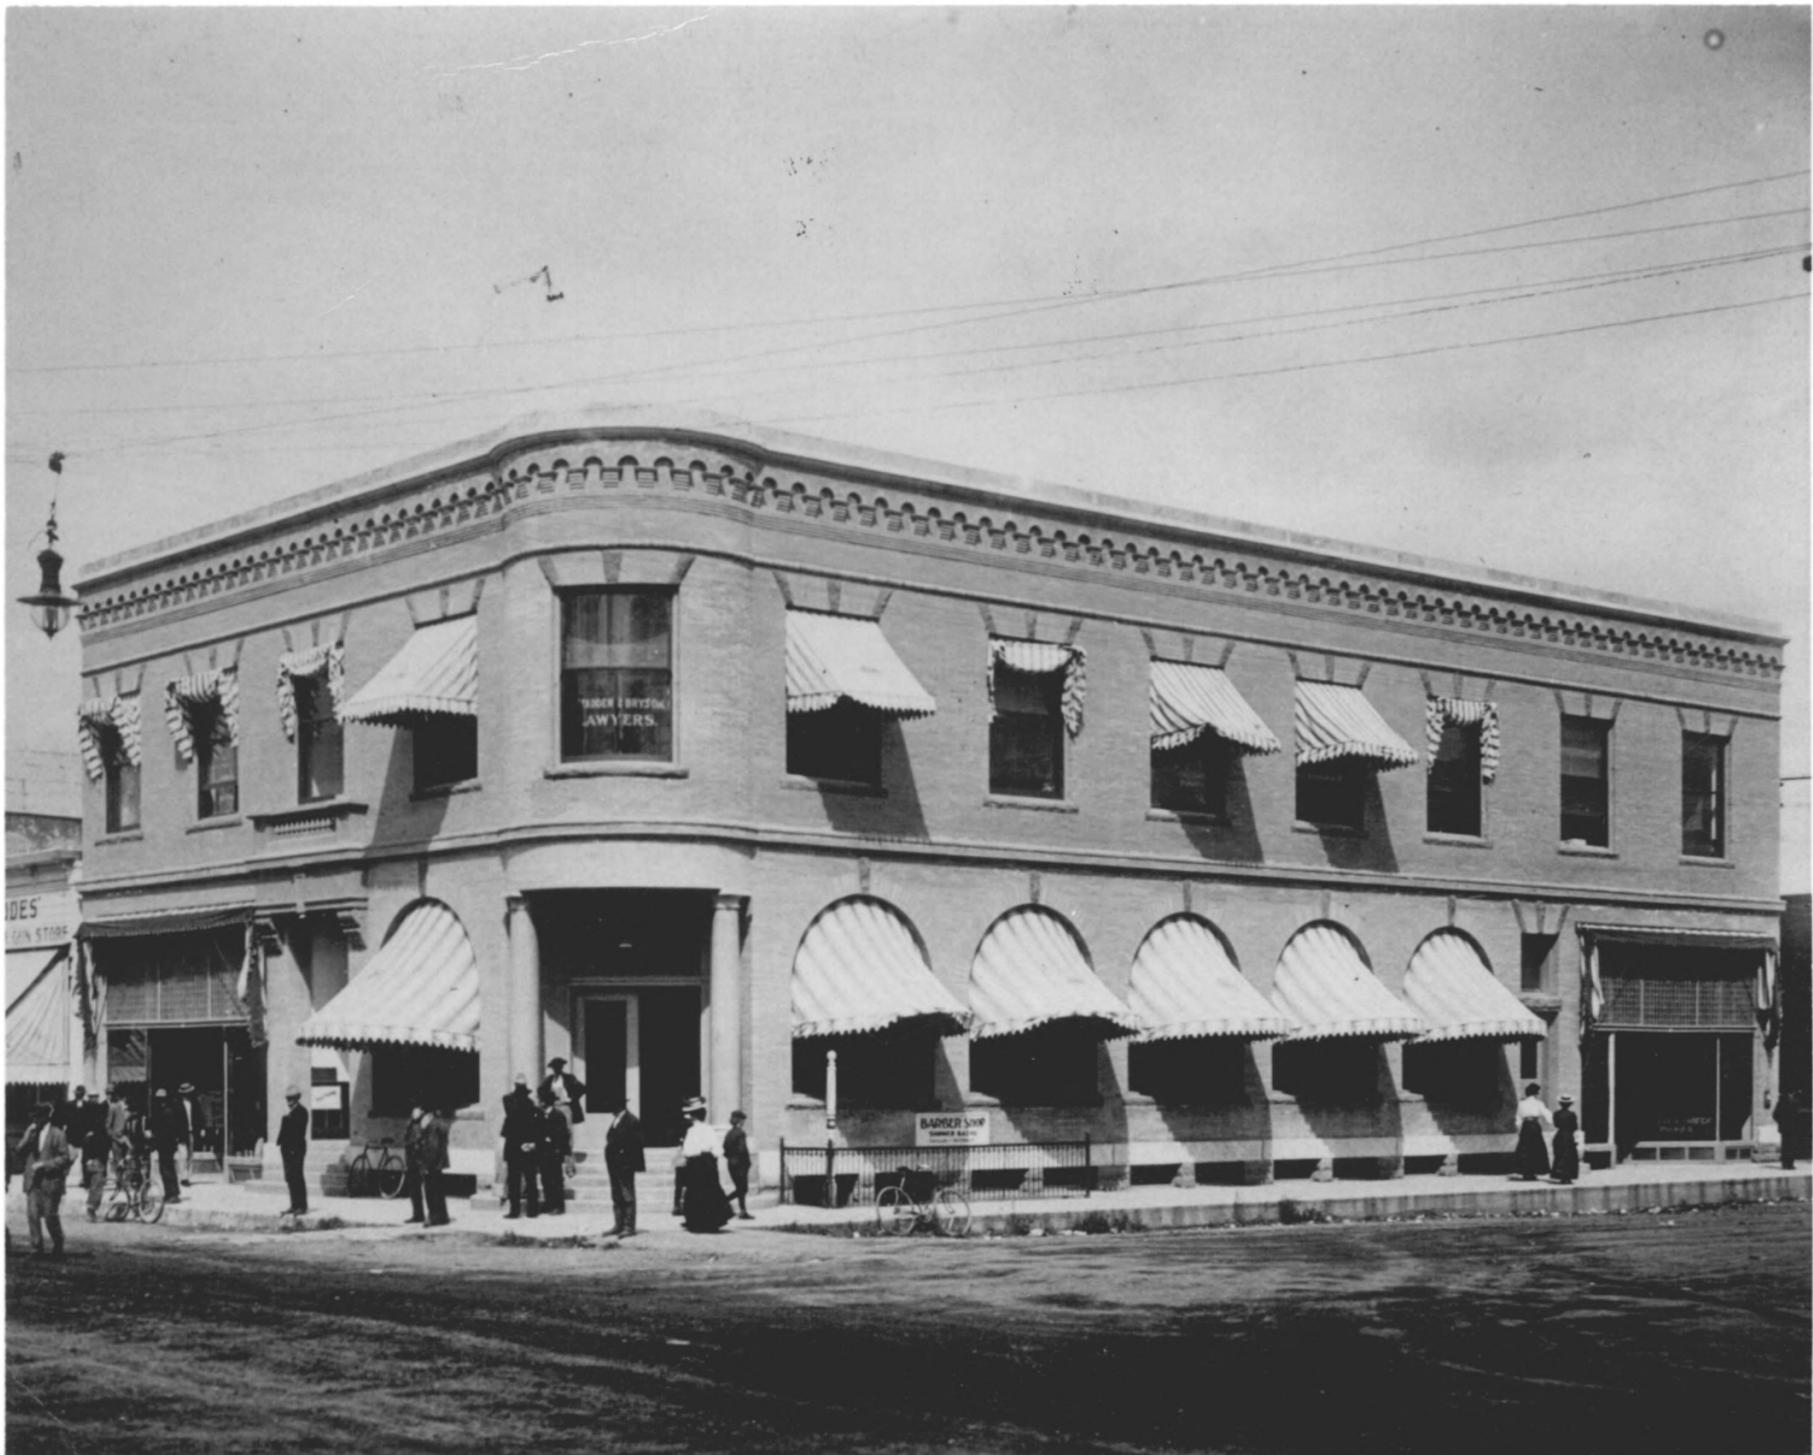
5 of 12  
Historic view, ca. 1910  
Note basement openings.  
Main floor was lowered  
between 1920 and 1925.

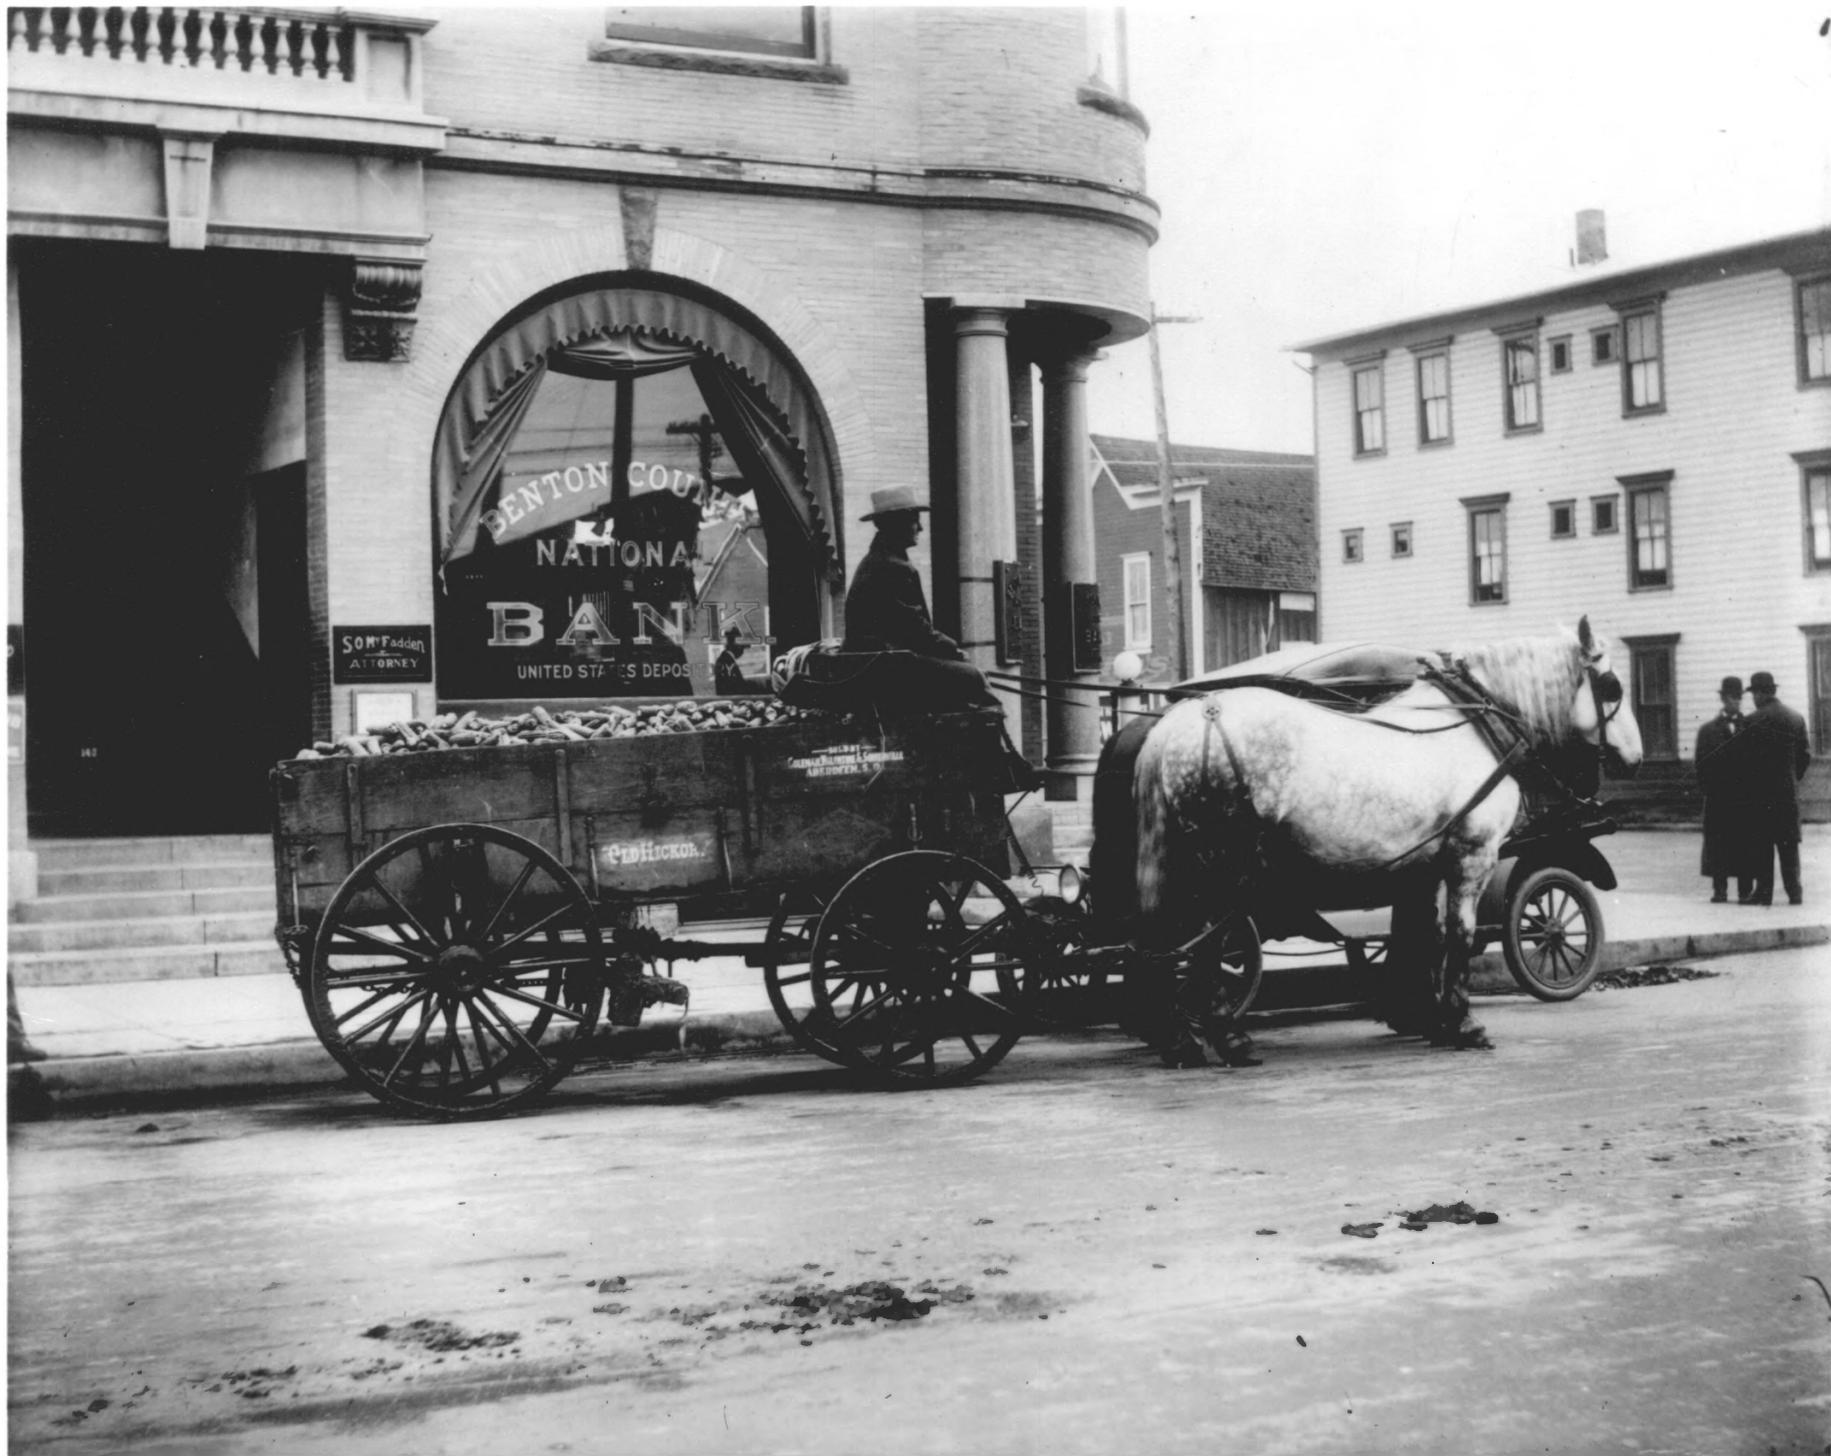
6 of 12  
Sidney Trask photo, ca. 1916  
West face, showing window  
treatment and cast metal name  
plates strapped to porch  
columns. Wood frame building  
on opposite side of Madison  
Street is Occidental Hotel,  
predecessor of existing  
Corvallis Hotel.

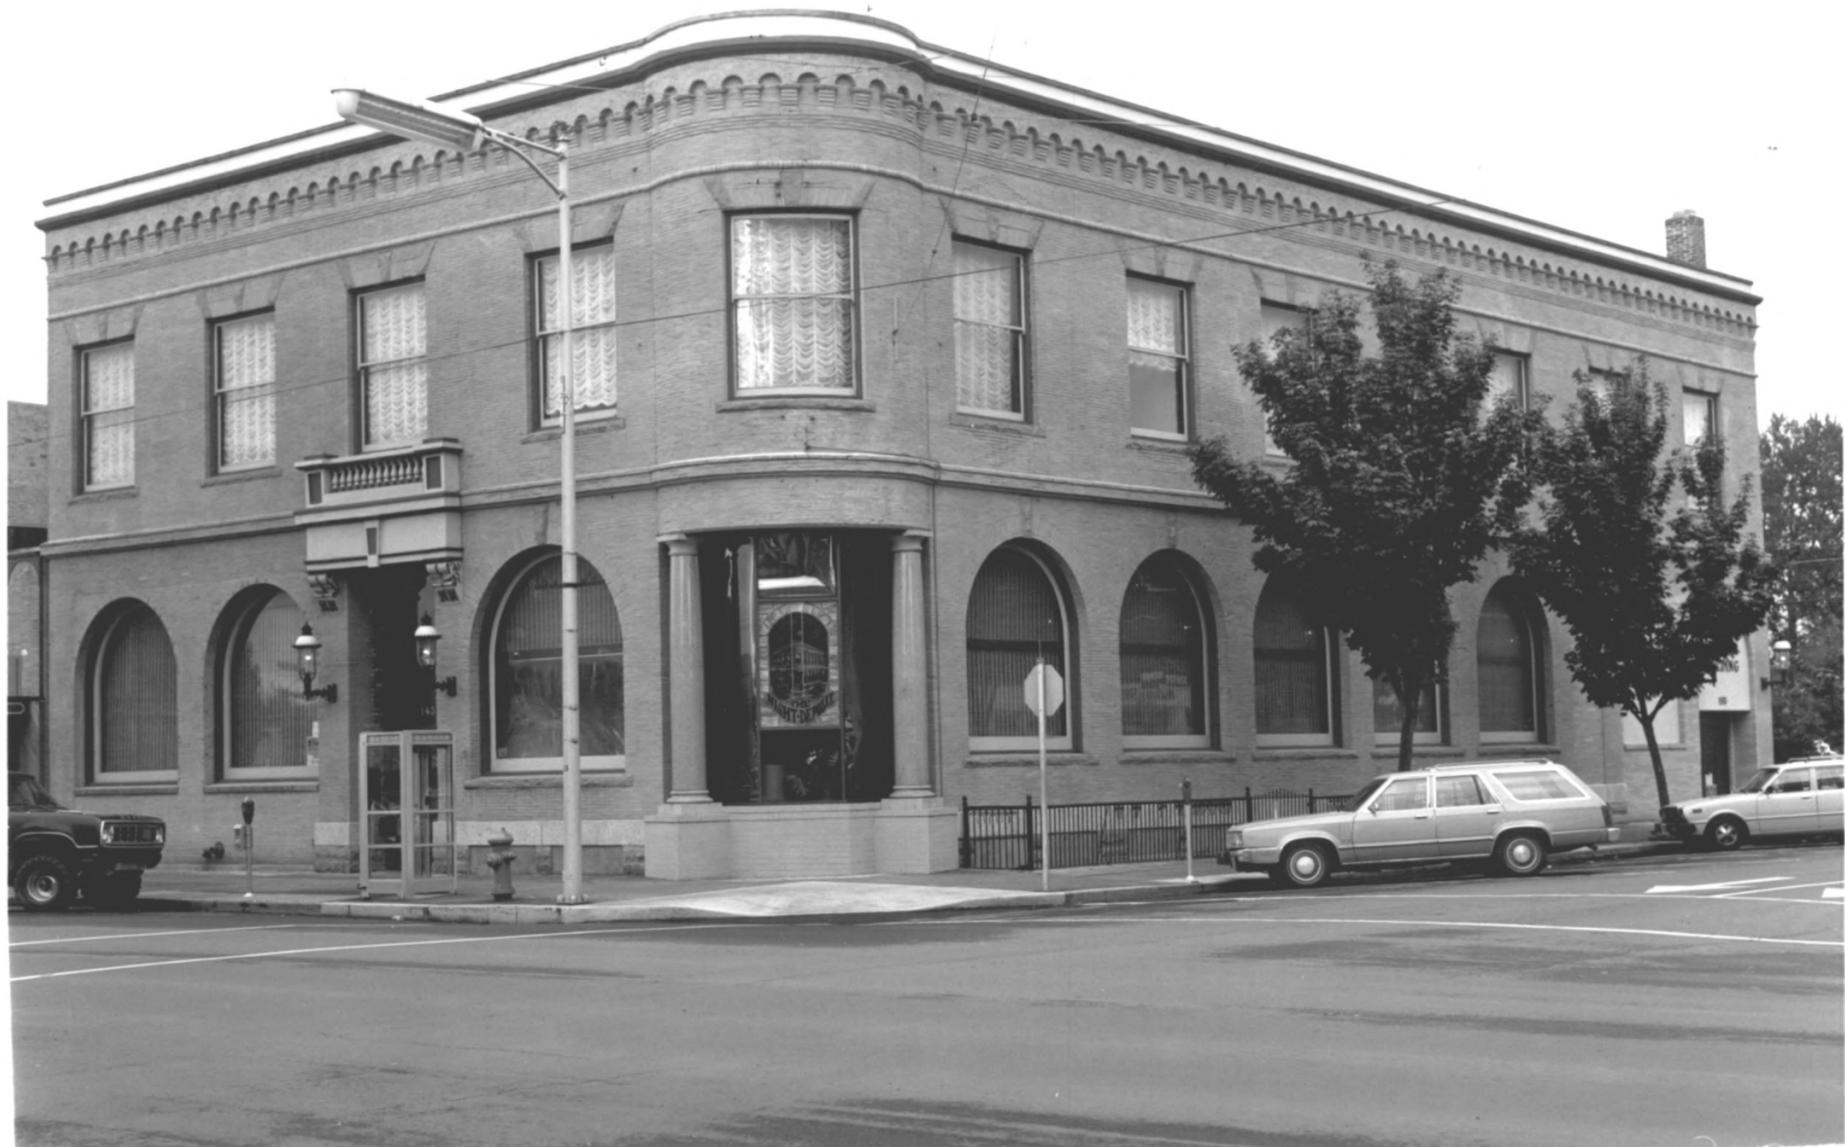
7 of 12  
West and south elevations

- 1) Benton County State Bank Building
- 2) Corvallis, Oregon
- 3) Jeff Goldner, Sun Star photographers.
- 4) September, 1978
- 5) MAR 7 1979
- 6) from Southwest corner of 2 nd & Madison Avenue
- 7)

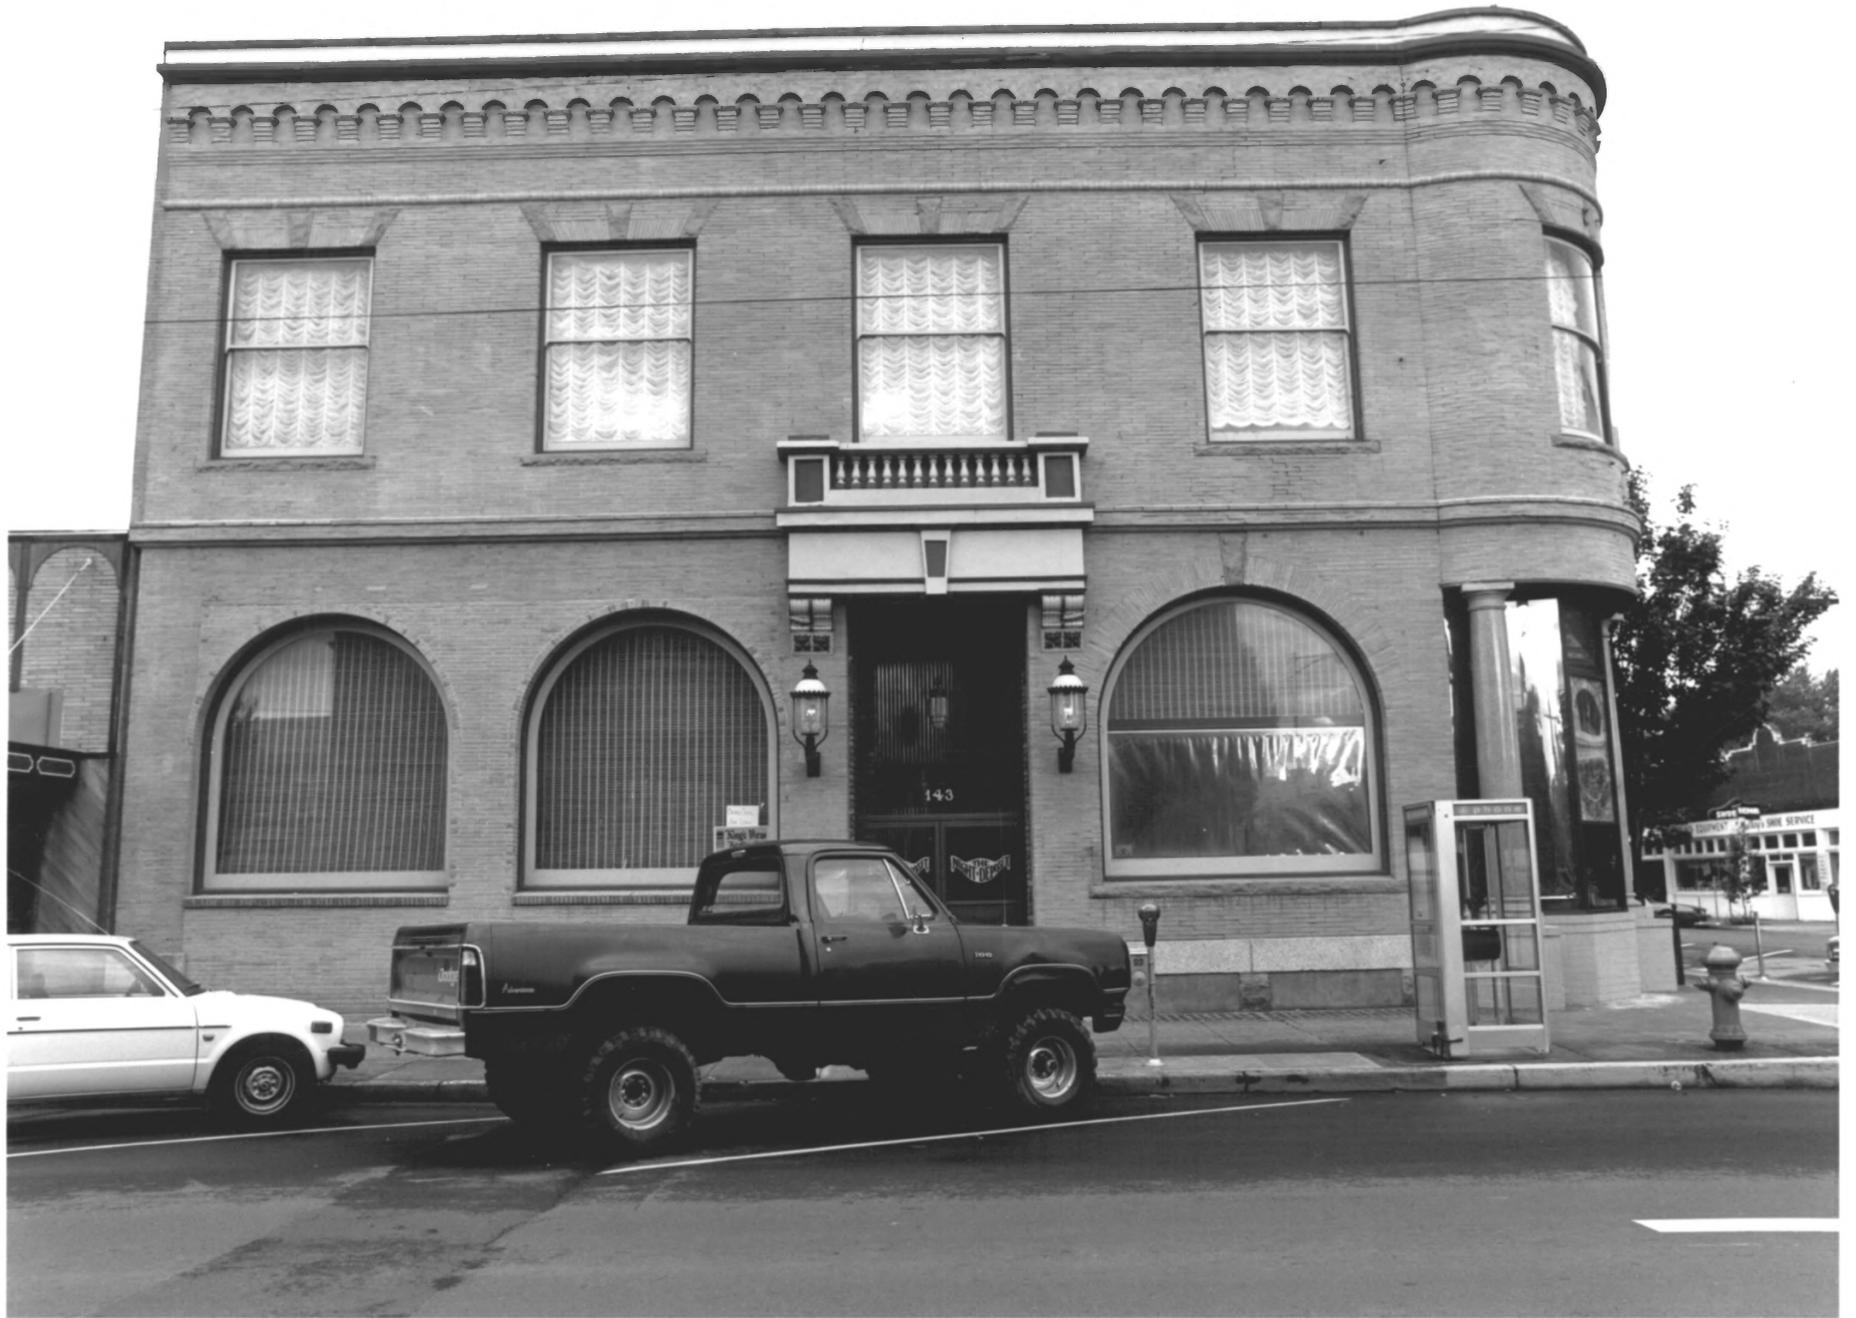
8 of 12  
West elevation

- 1) Benton County State Bank Building
- 2) Corvallis, Oregon
- 3) Jeff Goldner, Sun Star Photography
- 4) September 1978
- 5)
- 6) from the Northwest side of 2 nd Street
- 7)

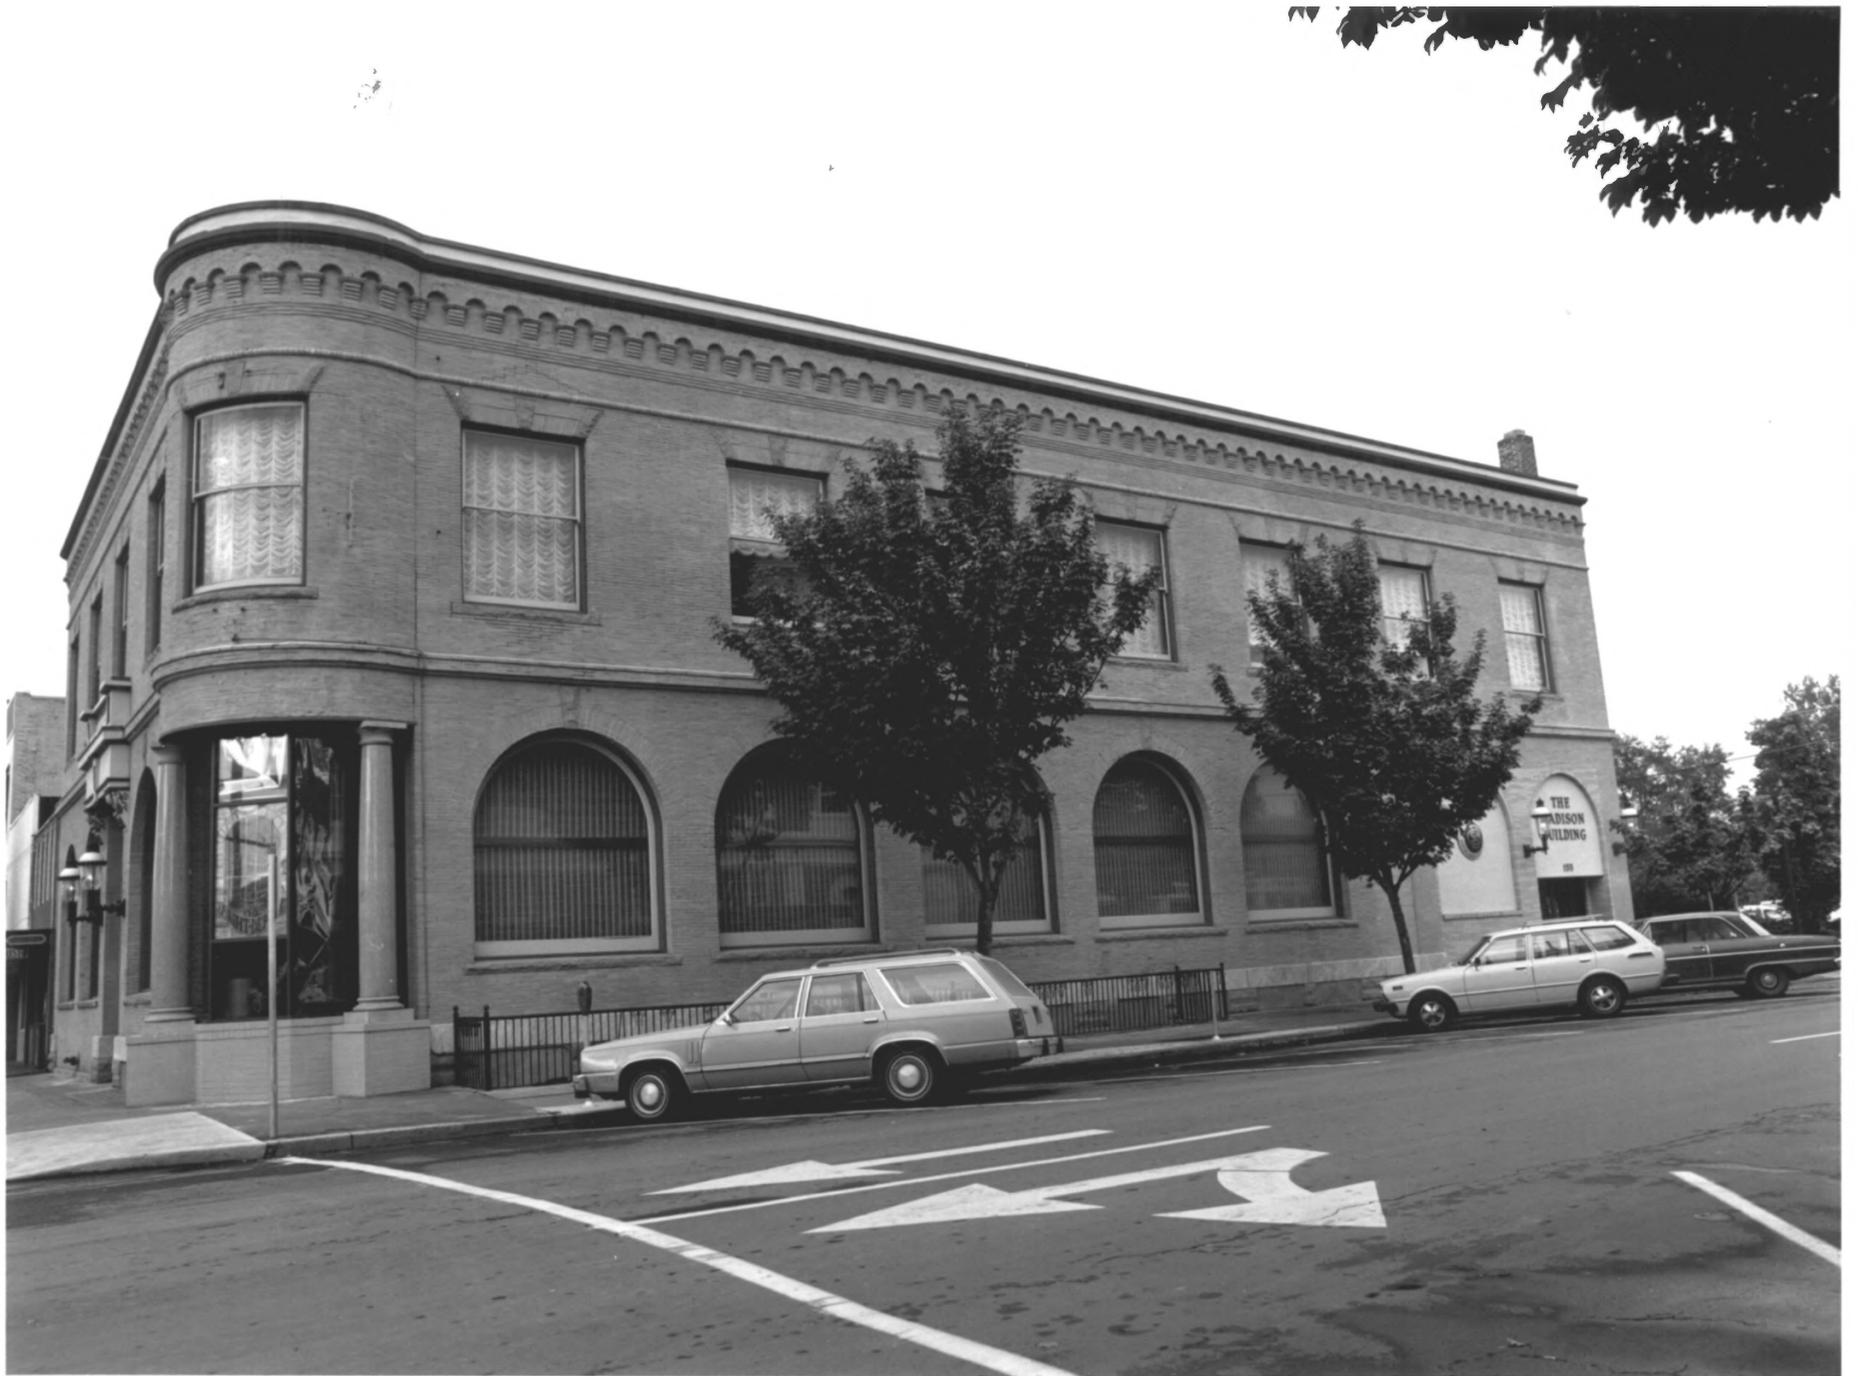
9 of 12  
South elevation

- 1) Benton County State Bank Building
- 2) Corvallis, Oregon
- 3) Jeff Goldner, Sun Star photographers
- 4) September, 1978

5)  
6) from the south

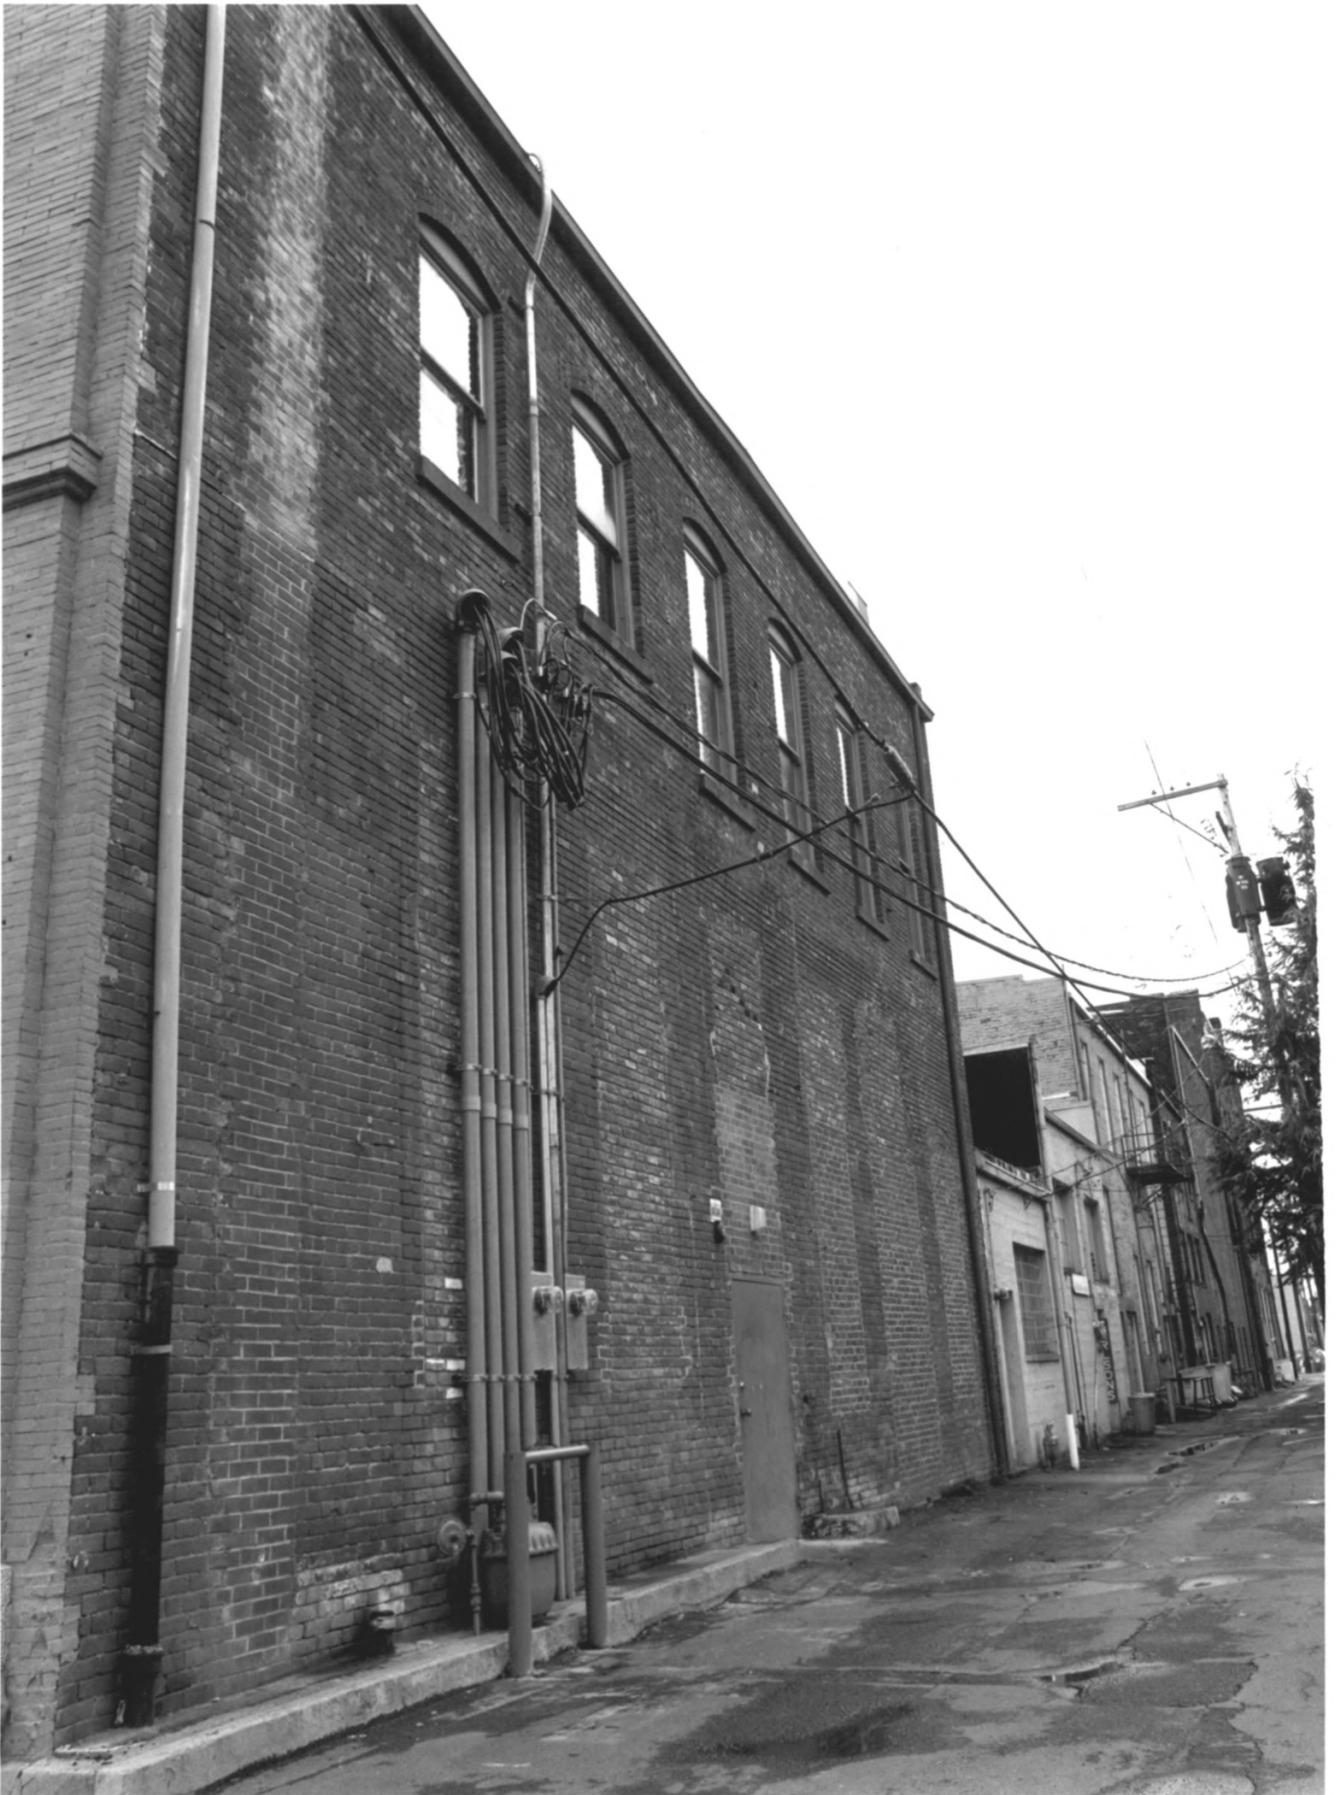
- 1) Benton County State Bank Building
- 2) Corvallis, Oregon
- 3) Jeff Goldner, Sun Star Photography
- 4) September, 1978
- 5)
- 6) from the south showing east side Alley
- 7)

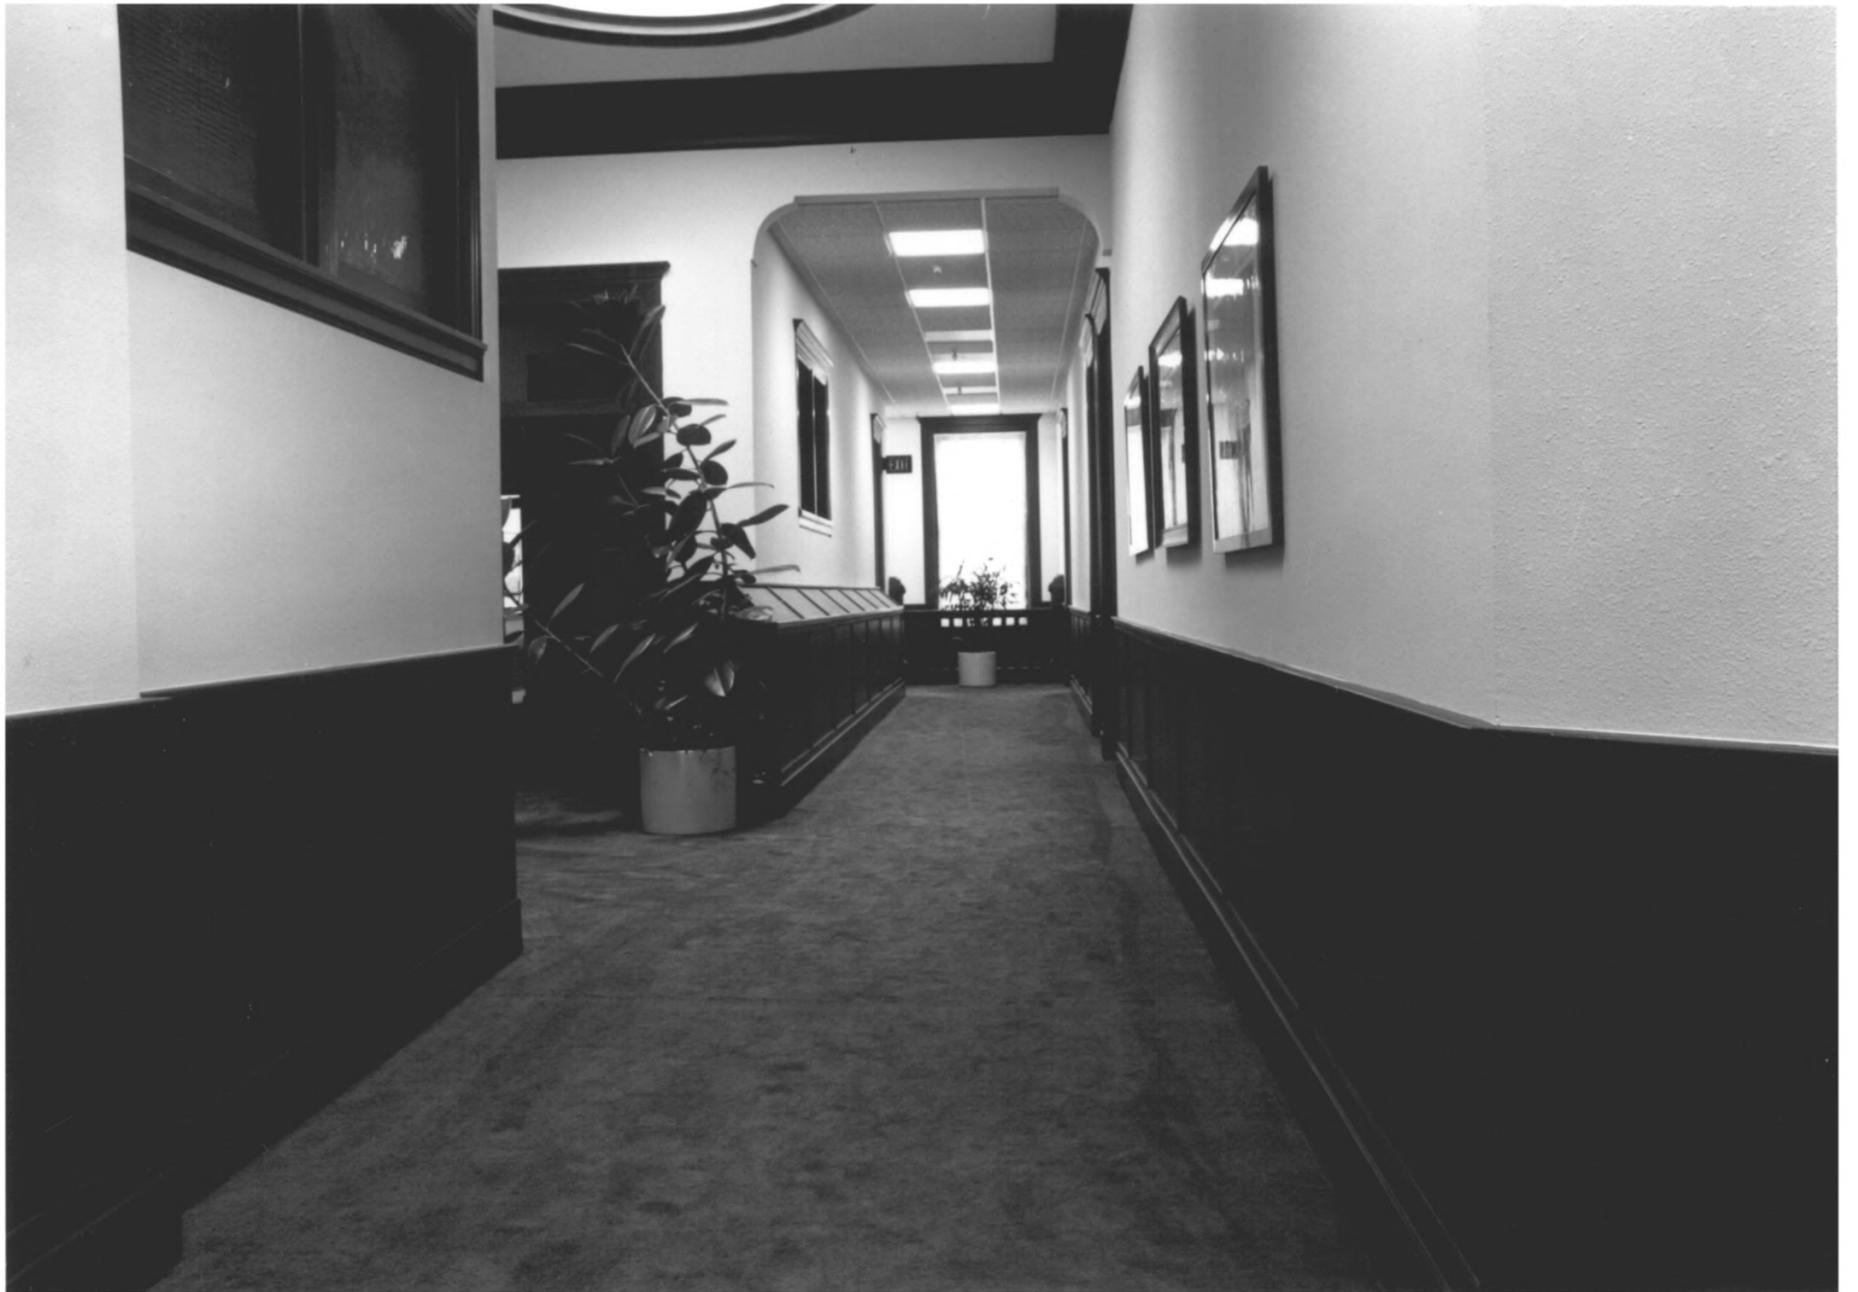
11 of 12  
Rehabilitated second story  
hallway (looking West) showing  
restoration of wainscoting,  
ceiling and skylight molding;  
preservation of existing window  
and door trim.
