Benton County National Bank Building, CORVALLIS, Oregon.

Benton County State Bank  
Building  
Corvallis, Benton County,  
Oregon

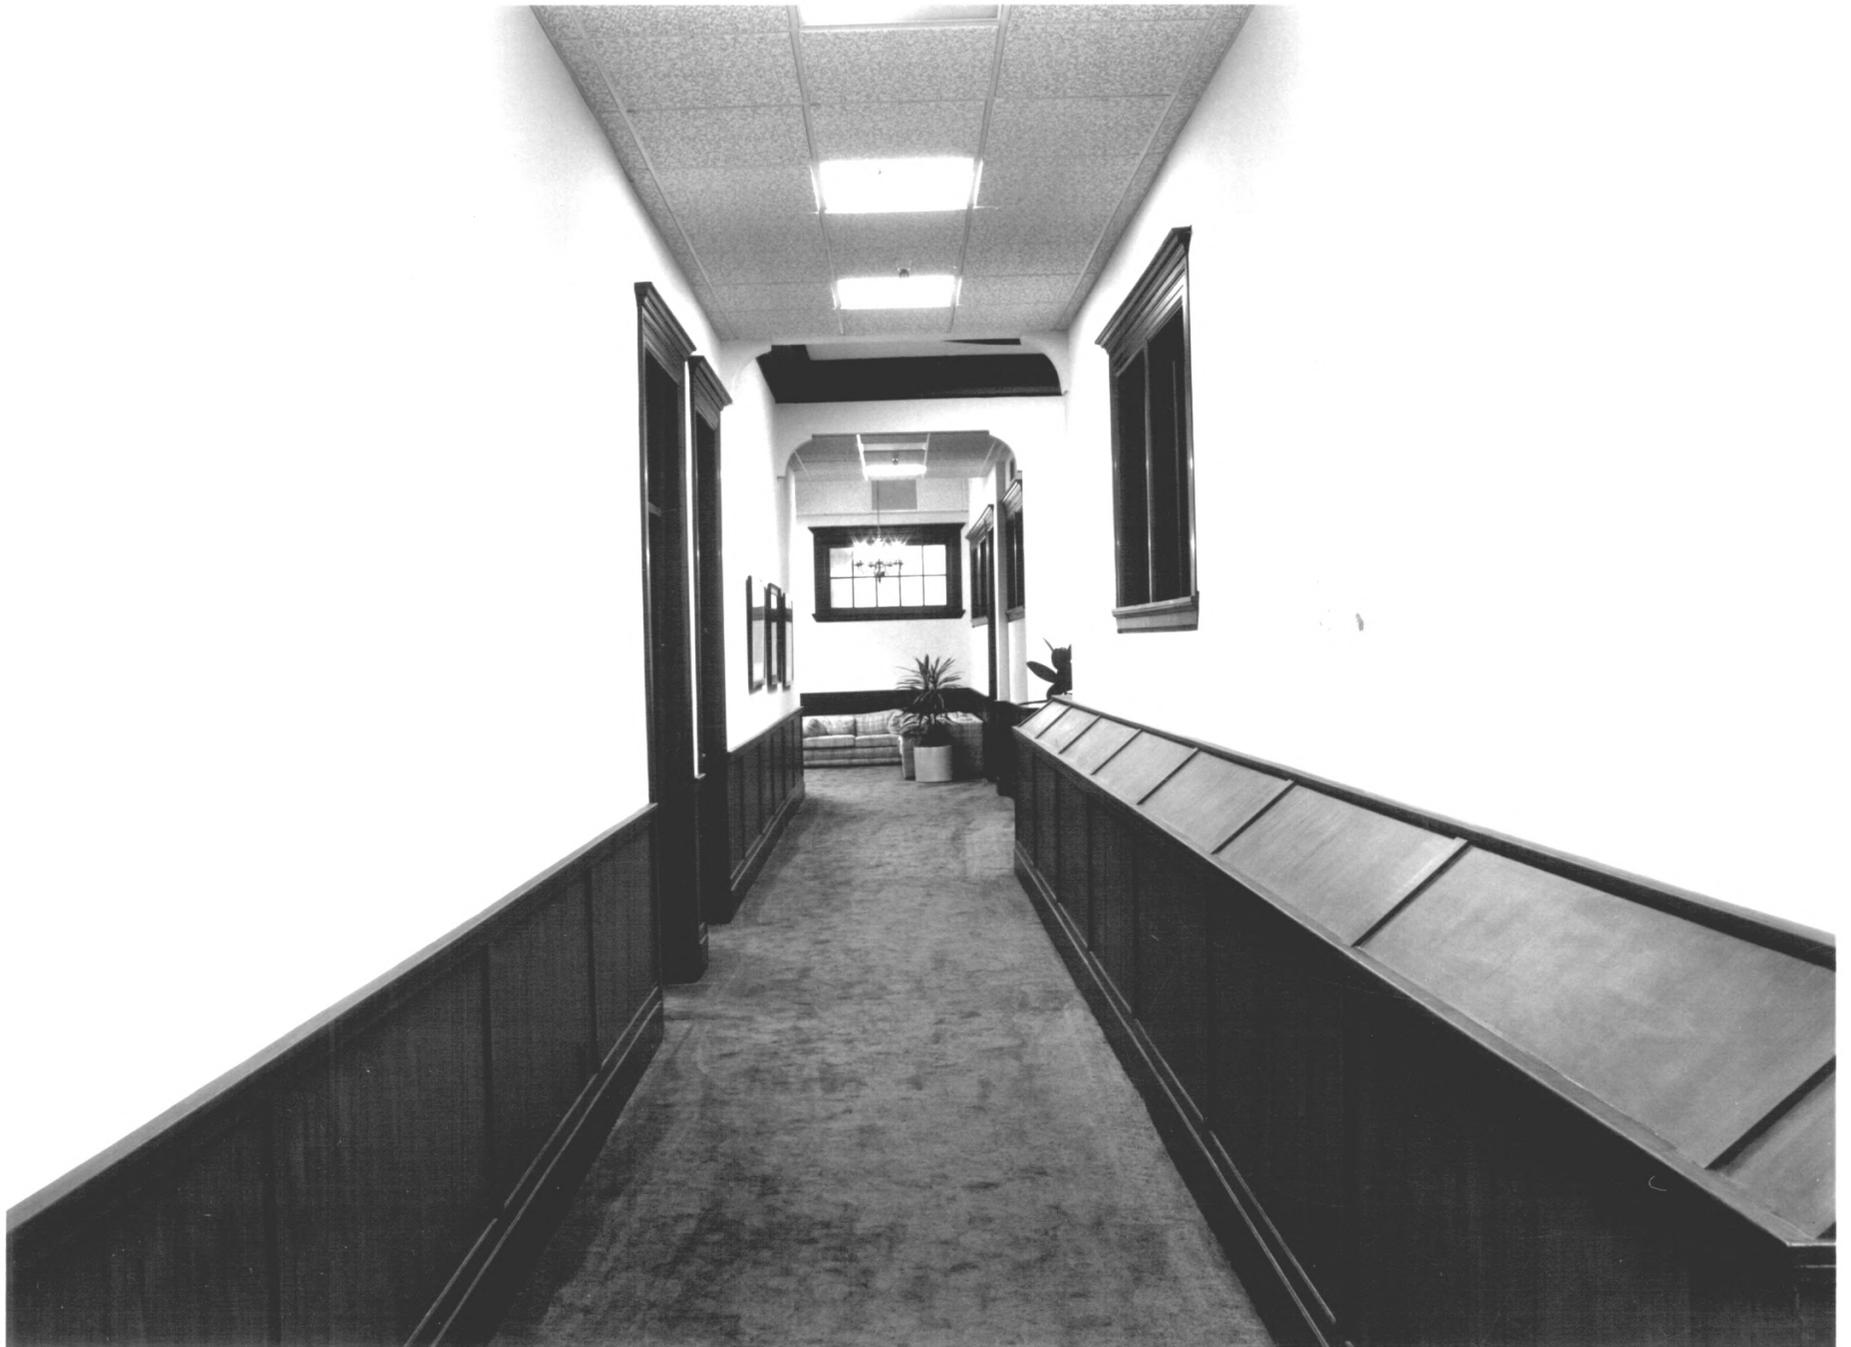
12 of 12  
Rehabilitated second story  
hallway (looking east), showing  
restoration of wainscoting  
and moldings; preservation of  
existing window and door trim.
