NEW JERSEY TRANSIT RAILROAD STATION SURVEY

- ✓ A. Name: Common Newark (Broad St) ^{Station} Historic Line: Hoboken Division
Morristown Line
(Delaware, Lackawanna, and Western)
- B. Address or location:
 ✓ Broad and University ^{Sts.}
 ✓ Newark, N.J. 07102
 ✓ County: Essex
 Municipality: Newark City
 Block & lot: part of 165/111
- C. Owner's name: N.J. Transit
Address: Trenton, N.J.
- D. Location of legal description: Recorder of Deeds, Essex County
Courthouse, Raymond Boulevard, Newark, N.J.
- E. Representation in existing surveys: (give number, category, etc.,
as appropriate)

FACILITY NAME: Newark (Broad St.)

Survey # RR 0714-2-2

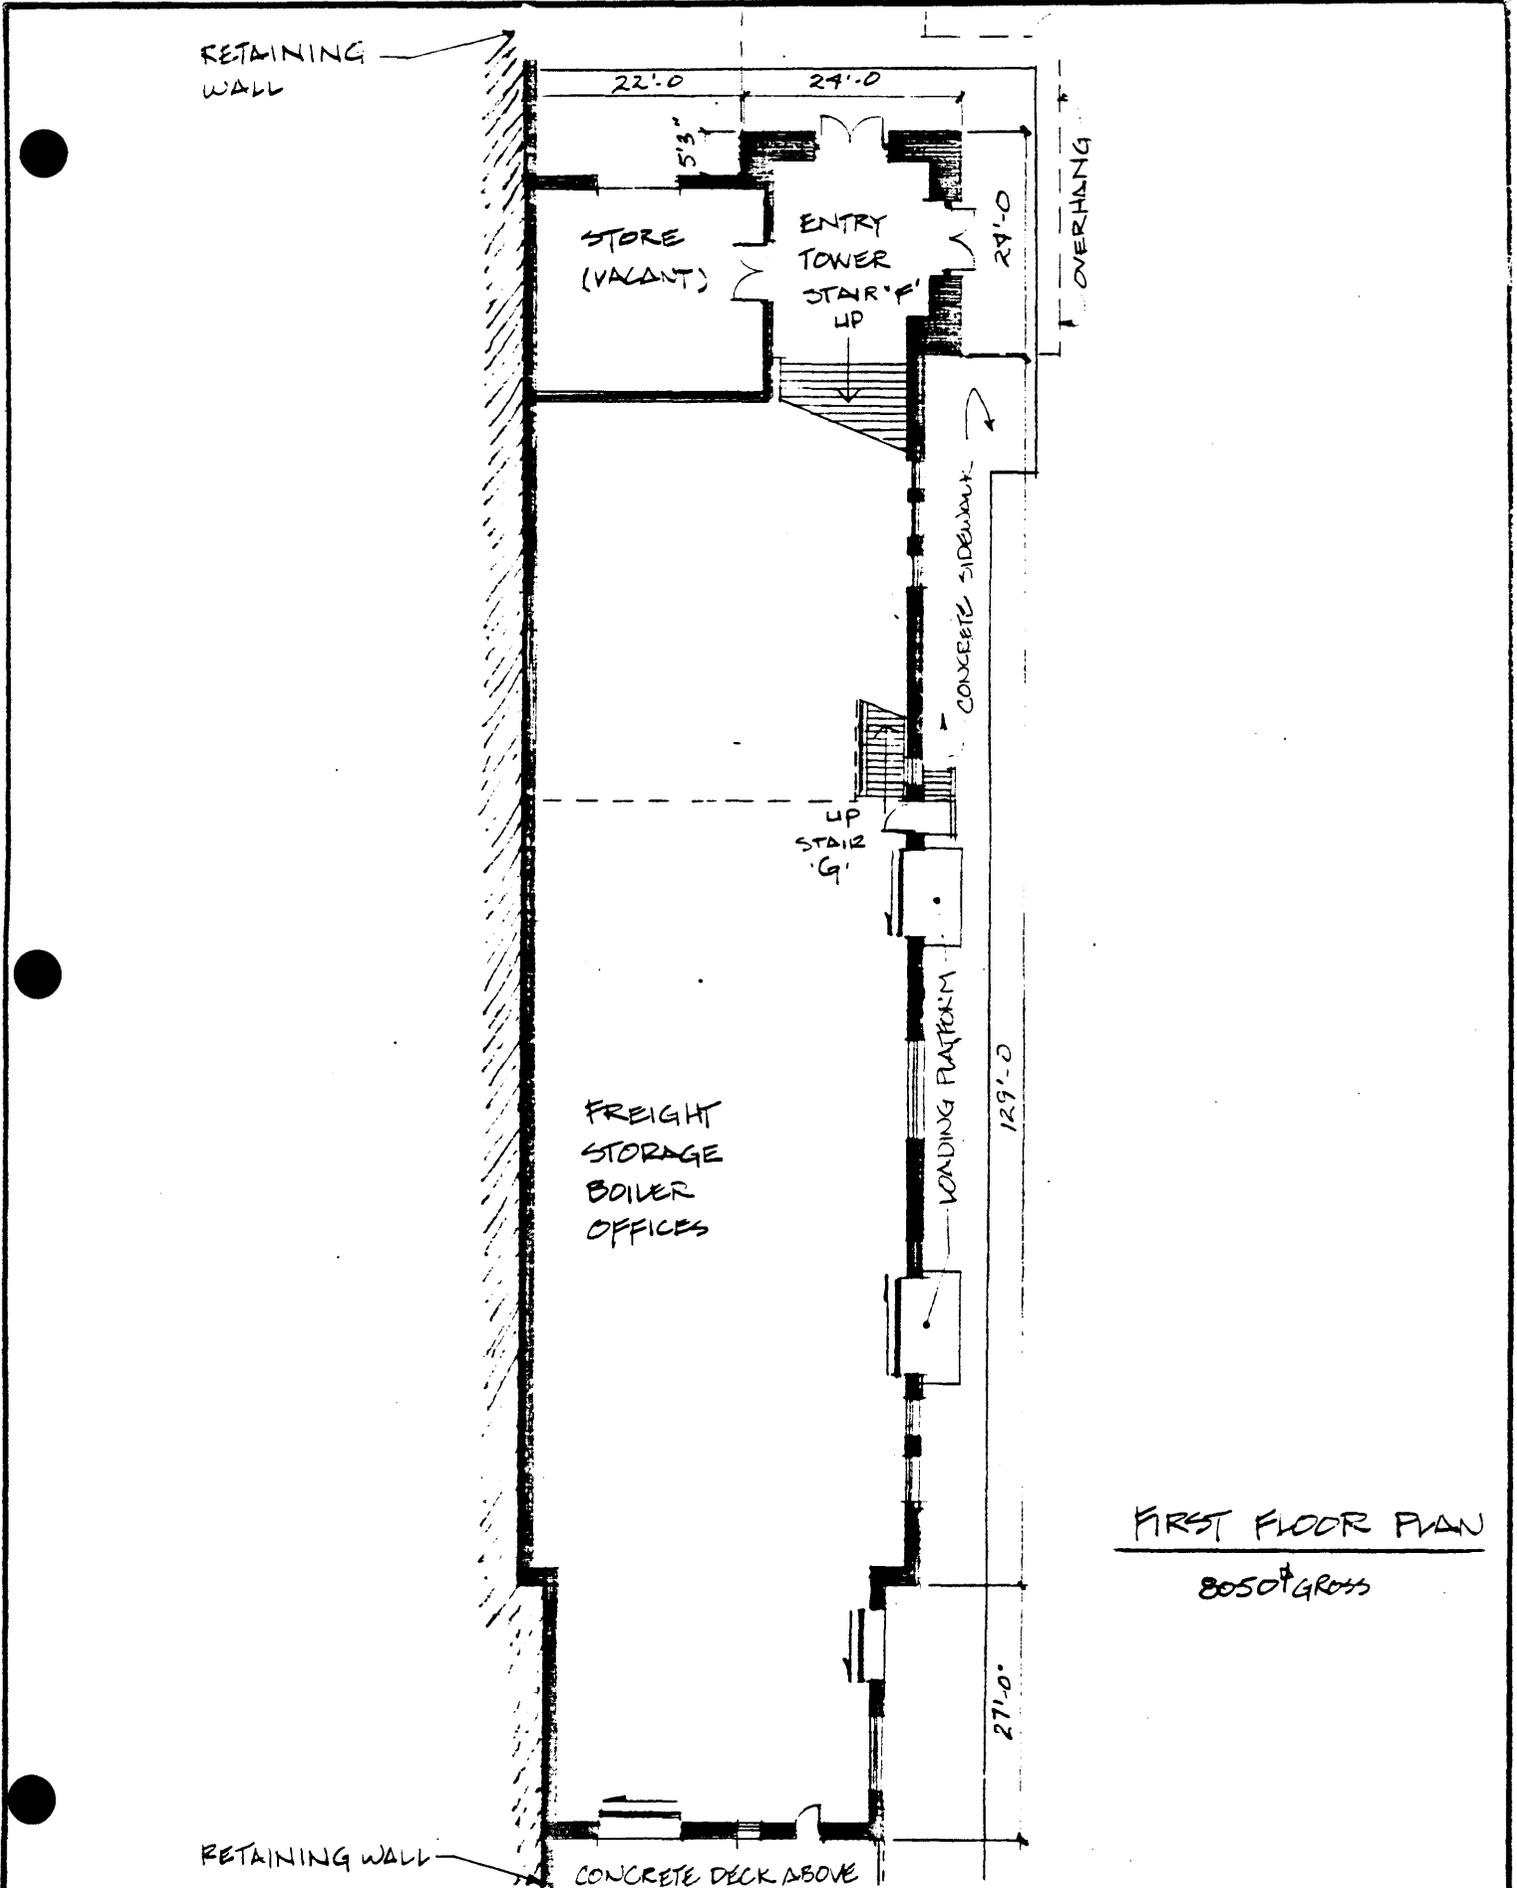
FIRST FLOOR PLAN
 8050[±]GROSS

The spaces of the Newark Station are on three levels. The first floor at street level comprises a huge two-story freight and storage area (soon to be converted to offices) and at the E end, a Foyer, leading to the lobby, and a small store (soon to be converted to a police station). The second floor, at tunnel level, comprises the lobby with access to both the westbound shelter and the waiting room. East of the Lobby is the Ticket Office and to the W, a newsstand. The west half of this level comprises the upper portion of the freight and storage area. The third floor at track level comprises a large Waiting Room, flanked on the E by offices, and on the W by offices and a Freight Room. (The original use of the office spaces is uncertain). The most distinguished spaces are the foyer and lobby where original classical detailing remains intact (see schedules). Much of the rest of the building is being partitioned into small offices.

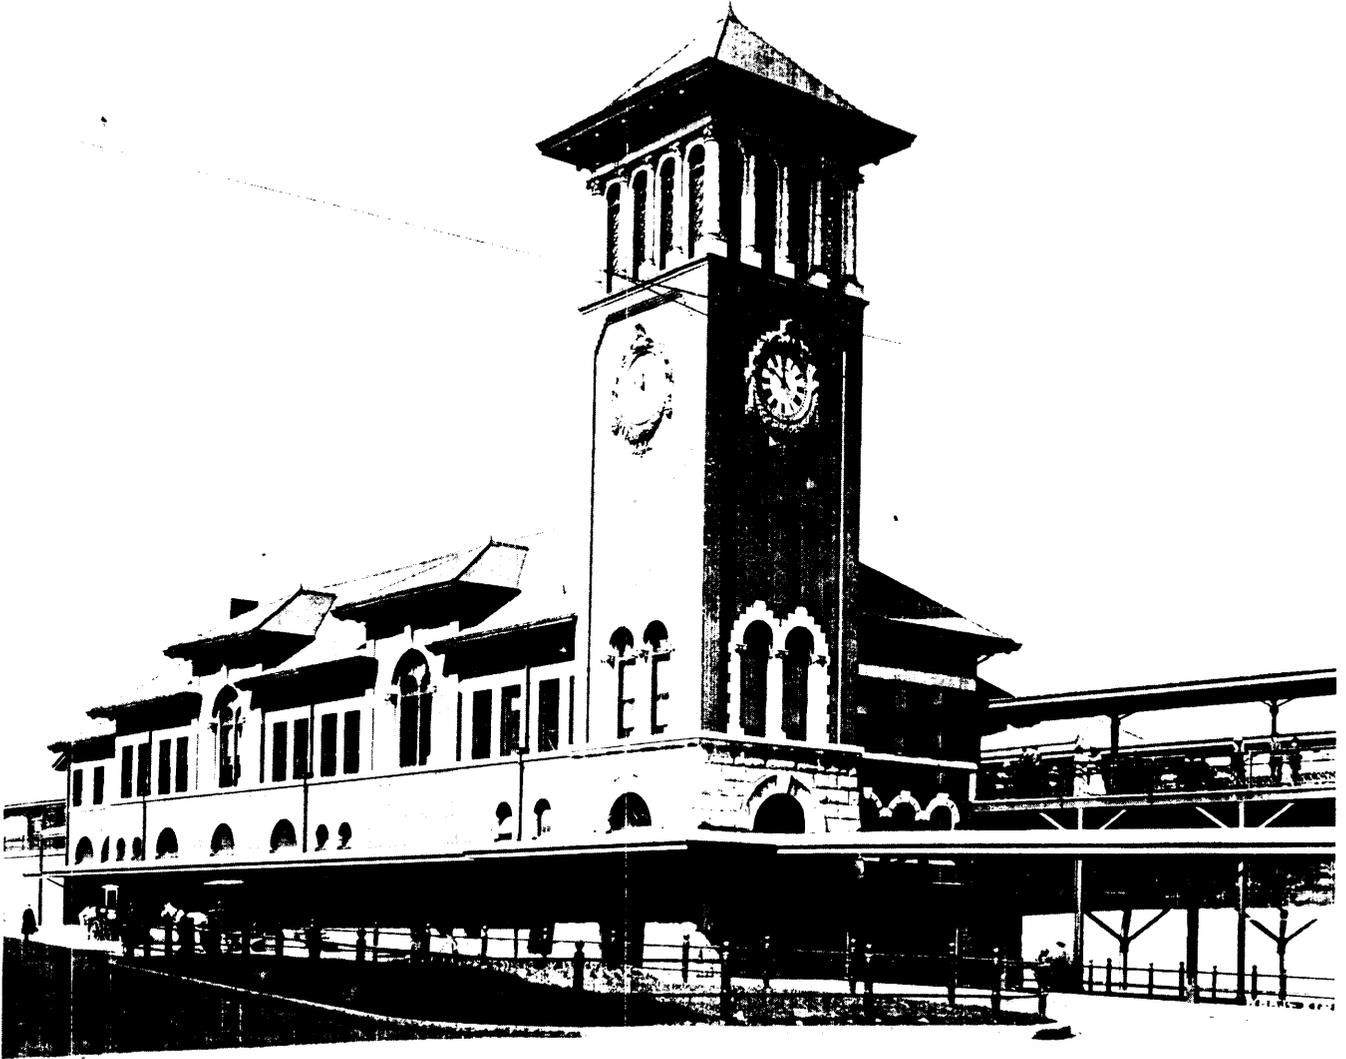
⁸ 2-2 Newark (Broad Street) Railroad Station (Taber, 20th, p. 8)

Newark. The station was completed in 1903 as part of the track elevation project.

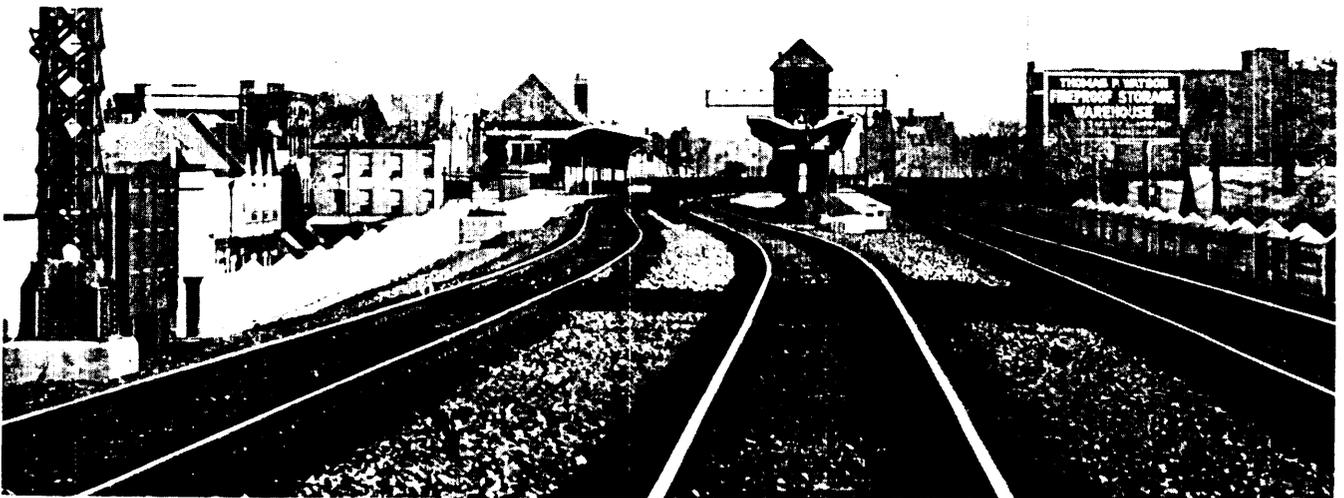
2-2 Newark(Broad Street) Railroad Station (Taber, 20th, p. 69)

All main line passenger trains stopped at Brick Church for Orange area passengers. This view is looking eastbound shortly after the elevation work was completed in 1923.

Newark station looking west. The station is located a half block north of the old one. The Passaic River bridge was double tracked with the third track starting at the west end of the bridge. East of the river, the third track terminated at the Harrison station. The Newark project was estimated to cost three million dollars with the City of Newark contributing 20%. Five grade crossings in Harrison and twenty-two in Newark were eliminated — each one of them having been protected by crossing gates and watchman. A half mile west of the station the rising terrain caused the tracks to enter an open cut to Roseville Avenue. By raising the tracks at Newark 24 feet and lowering them 22 feet at Roseville, the grade was reduced from 2.8% to 1.2%, which eliminated the need for helper engines. The importance of the dangerous grade crossing situation was emphasized after the project was underway when on February 19, 1903, a Clifton Avenue trolley slid down the hill out of control, crashed through the crossing gates, and struck a passing train. Nine persons on the street car were killed. The separation project had two major problems. The first was where to place a temporary track while the depression work was in progress; the second was an engineering and legal problem for the Morris Canal crossing over the tracks. This delayed the work for more than a year. The first trains used the elevated portion of the project on December 21, 1903.

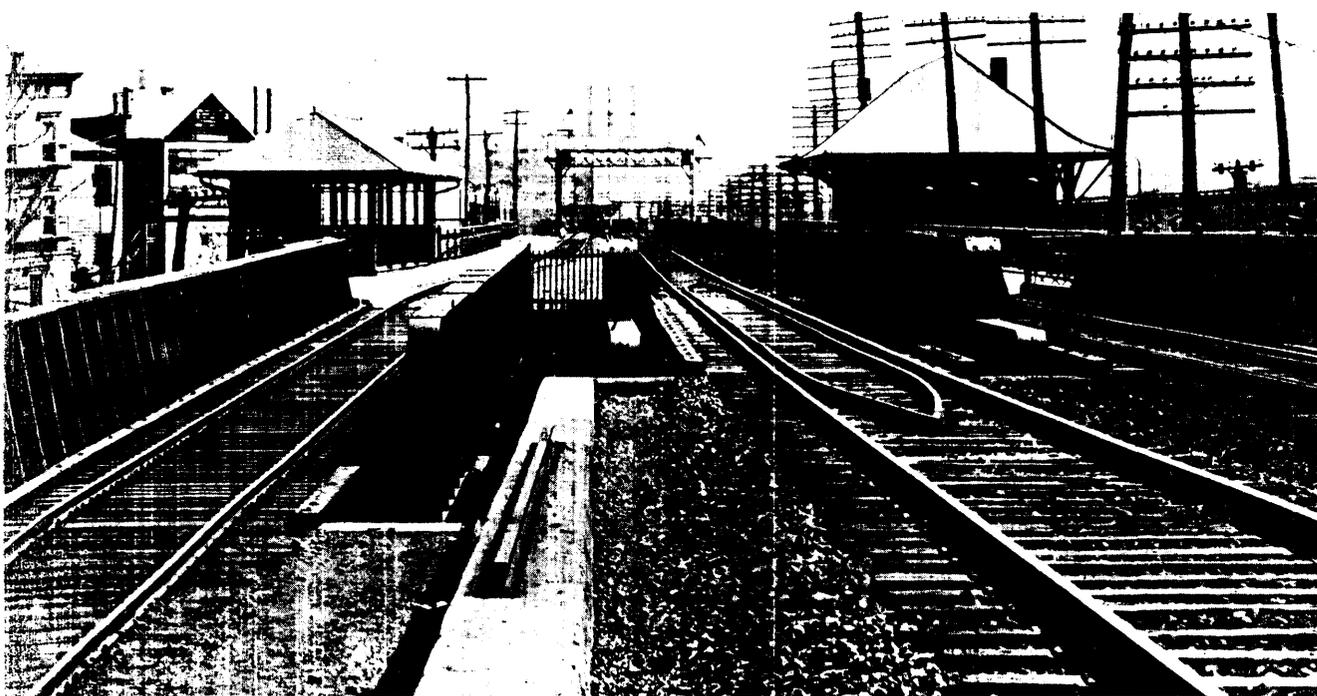
The Newark elevation work also included track elevation in Harrison to eliminate grade crossings and raise it to the proper height for Newark. Work started in 1902 on this, the first track elevation project for the railroad. This view looks east at Harrison. The track to the left descends to the lower level of the bridge.
