NEW JERSEY TRANSIT RAILROAD STATION SURVEY

- ✓ A. Name: Common Murray Hill Historic Line: Hoboken Division--Gladstone Branch (DL&W)
- B. Address or location:
 - ✓ The Circle
 - ✓ Murray Hill, NJ 07974
 - County: Union
 - Municipality: New Providence Borough
 - Block & lot:
- C. Owner's name: NJ Transit
Address: Trenton, NJ
- D. Location of legal description: Recorder of Deeds, Union County
Courthouse, Broad St., Elizabeth, N.J. 07207
- E. Representation in existing surveys: (give number, category, etc., as appropriate)

FACILITY NAME: Murray Hill

- 1. Site Base at 1" = 100'
- 2. Floor Plan at 1" = 20'
- 3. Platform and Canopies
- 4. Station Building Structural Mech. & Elec.
- 5. Track Crossings and Barriers
- 6. Parking Access and Circulation
- 7. Information System
- 8. Notes on Community & Security Aspects
- 9. Record Photograph of Station X Detailed Field Photographs

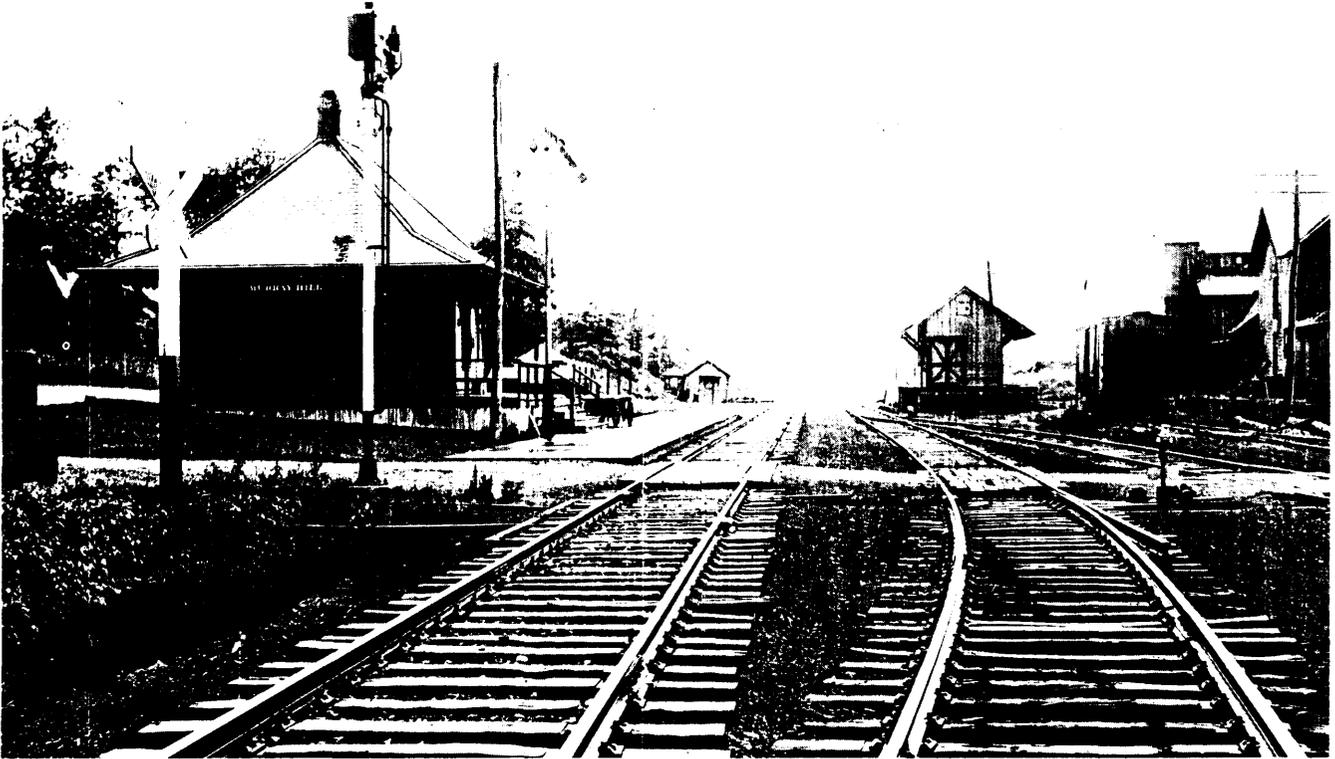
190 3-2 Murray Hill Railroad Station (Taber, 20th, p. 190)

The Murray Hill passenger station and freight house at about 1915. This station is actually located in New Providence. Note the chewed ties in the foreground where a car ran off the track when the derail was open.
