City, Village or Town: City of Wauwatosa		County: Milwaukee	Surveyor: Virginia A. Palmer	Date: May 27, 1985	Street Cedar Street
Street Address: 6839 Cedar Street, originally noted as 233 Cedar Street		USGS Quad and UTM Reference: 16/418820/4765600		Acreage: less than 1	
Current Name & Use: private residence		Current Owner: Janet M. Jelinek			Number 6839
Film Roll No.	Affix Contact Prints	Current Owner's Address: 6839 Cedar Street			
Negative No.		Legal Description: Lot 6, Block 2, Aetna Park Subdivision of the N.W. 1/4 of S 27, T 7 N, R 21 E, City of Wauwatosa,			
Facade Orient.

Original Name & Use:	Source	Previous Owners	Dates	Uses	Source	Town
2 H.R. Davis home	A					7 N
Dates of Construction/Alteration 1924	A					21 E
Architect and/or Builder: Arnold F. Meyer & Company, Inc.	A					27

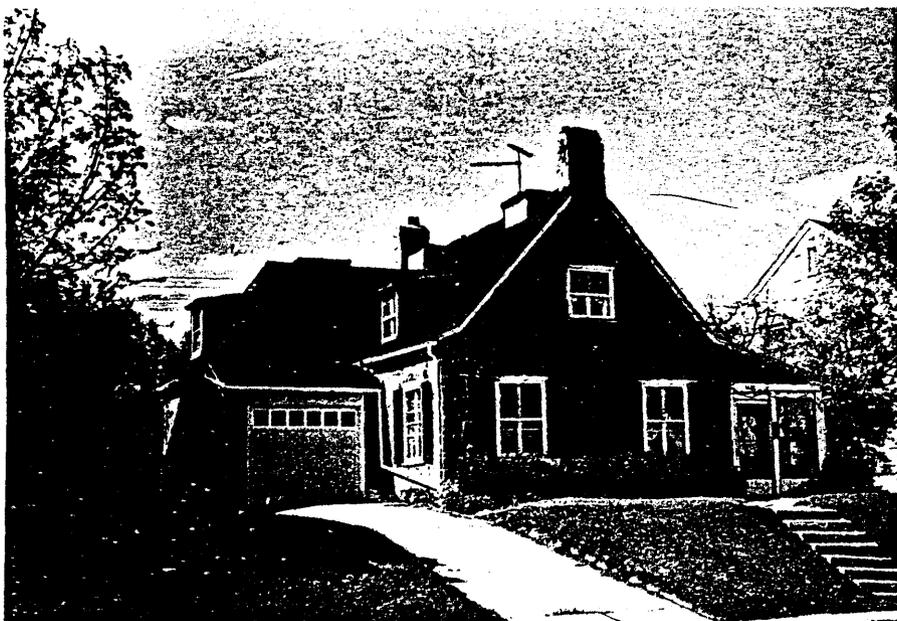
Architectural Description and Significance: This 1 1/2 story Flagg System house has exterior walls of Tennessee quartzite. It is L shaped and faces north. Window and door openings are symmetrical. There is a steep gable composition roof. There are 3 1/2 pairs of ridge dormers, four shed dormers, and two chimneys with distinctive round openings. The glassed-in porch at the front entrance has a shed roof. The original garage with hip roof is attached to the house but a larger garage was built later which is not a significant part of this nomination. There is a stone fireplace in the living room Interior visited? <input checked="" type="radio"/> Yes <input type="radio"/> No (over)	Historical Background and Significance: 	Map Name Milwaukee Quadrangle
---	---	---

B	7 Condition <input checked="" type="radio"/> excellent <input type="radio"/> good <input type="radio"/> fair <input type="radio"/> poor <input type="radio"/> ruins
----------	---

and casement windows open inward. There is a partial basement and laundry room on the first floor. The bathroom floor is one step above the level of the hallway on the second floor. Storage space is in a walk-in attic on the second floor.

This house is architecturally significant because it is one of a group of stone masonry houses built by Arnold F. Meyer & Company, Inc. according to the construction methods of Ernest Flagg. It is also significant because it resembles the house illustrated on plate 20B in Flagg's book on small houses and the house at 1913 E. Olive Street.
