William Pinto-Eli Whitney House  
275 Orange Street, New Haven, Connecticut.

NHPT Photo: 8-19-1984  
Negative filed with Connecticut Historical  
Commission, Hartford, CT.

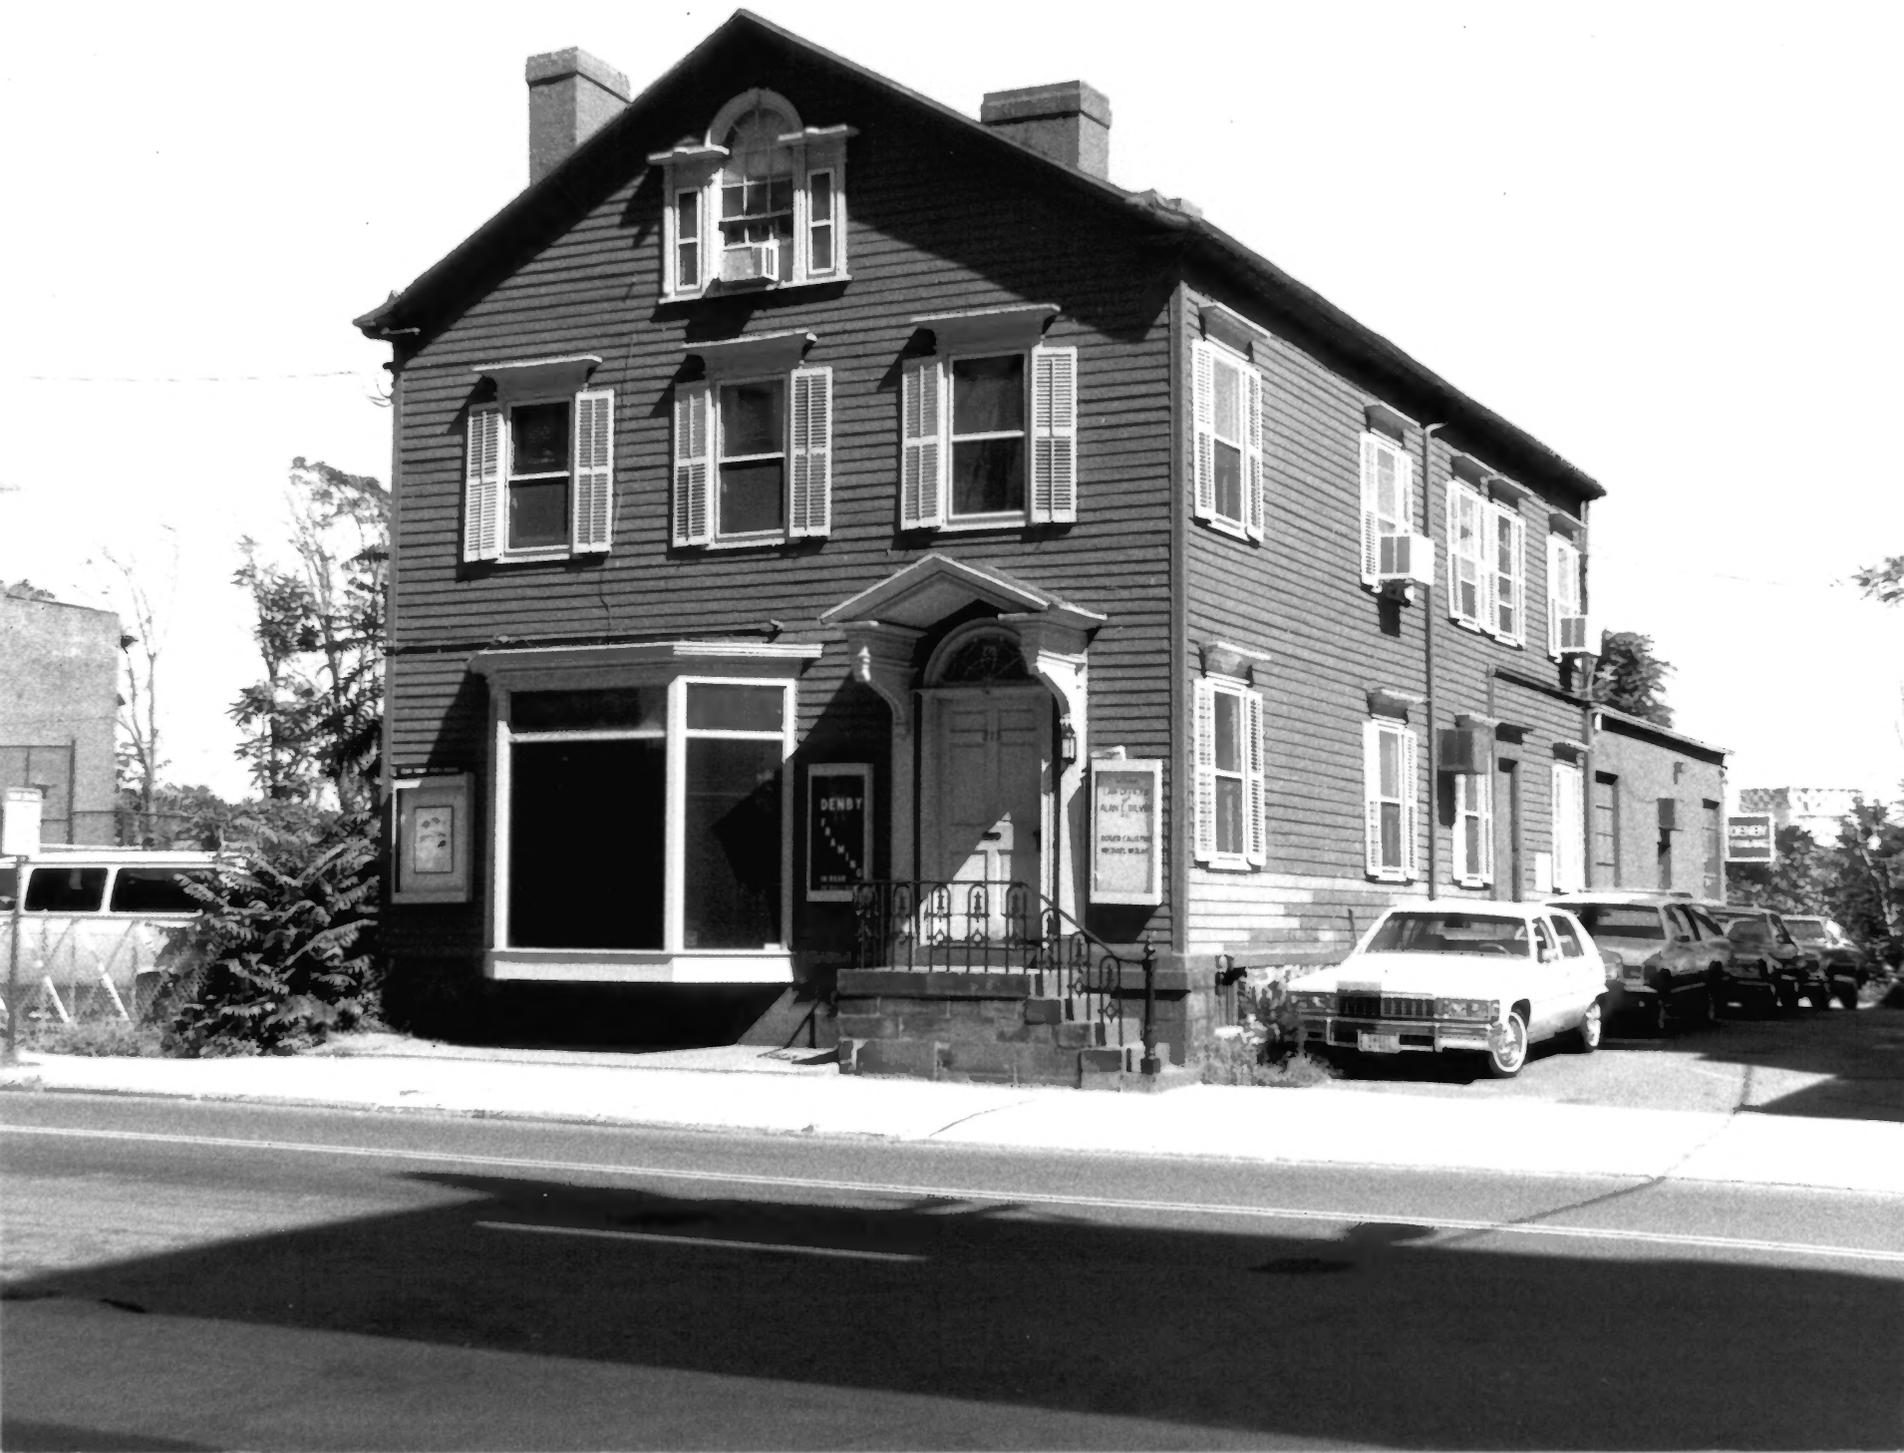
Photograph 1.

Front (western) and southern elevations as  
viewed from the west.

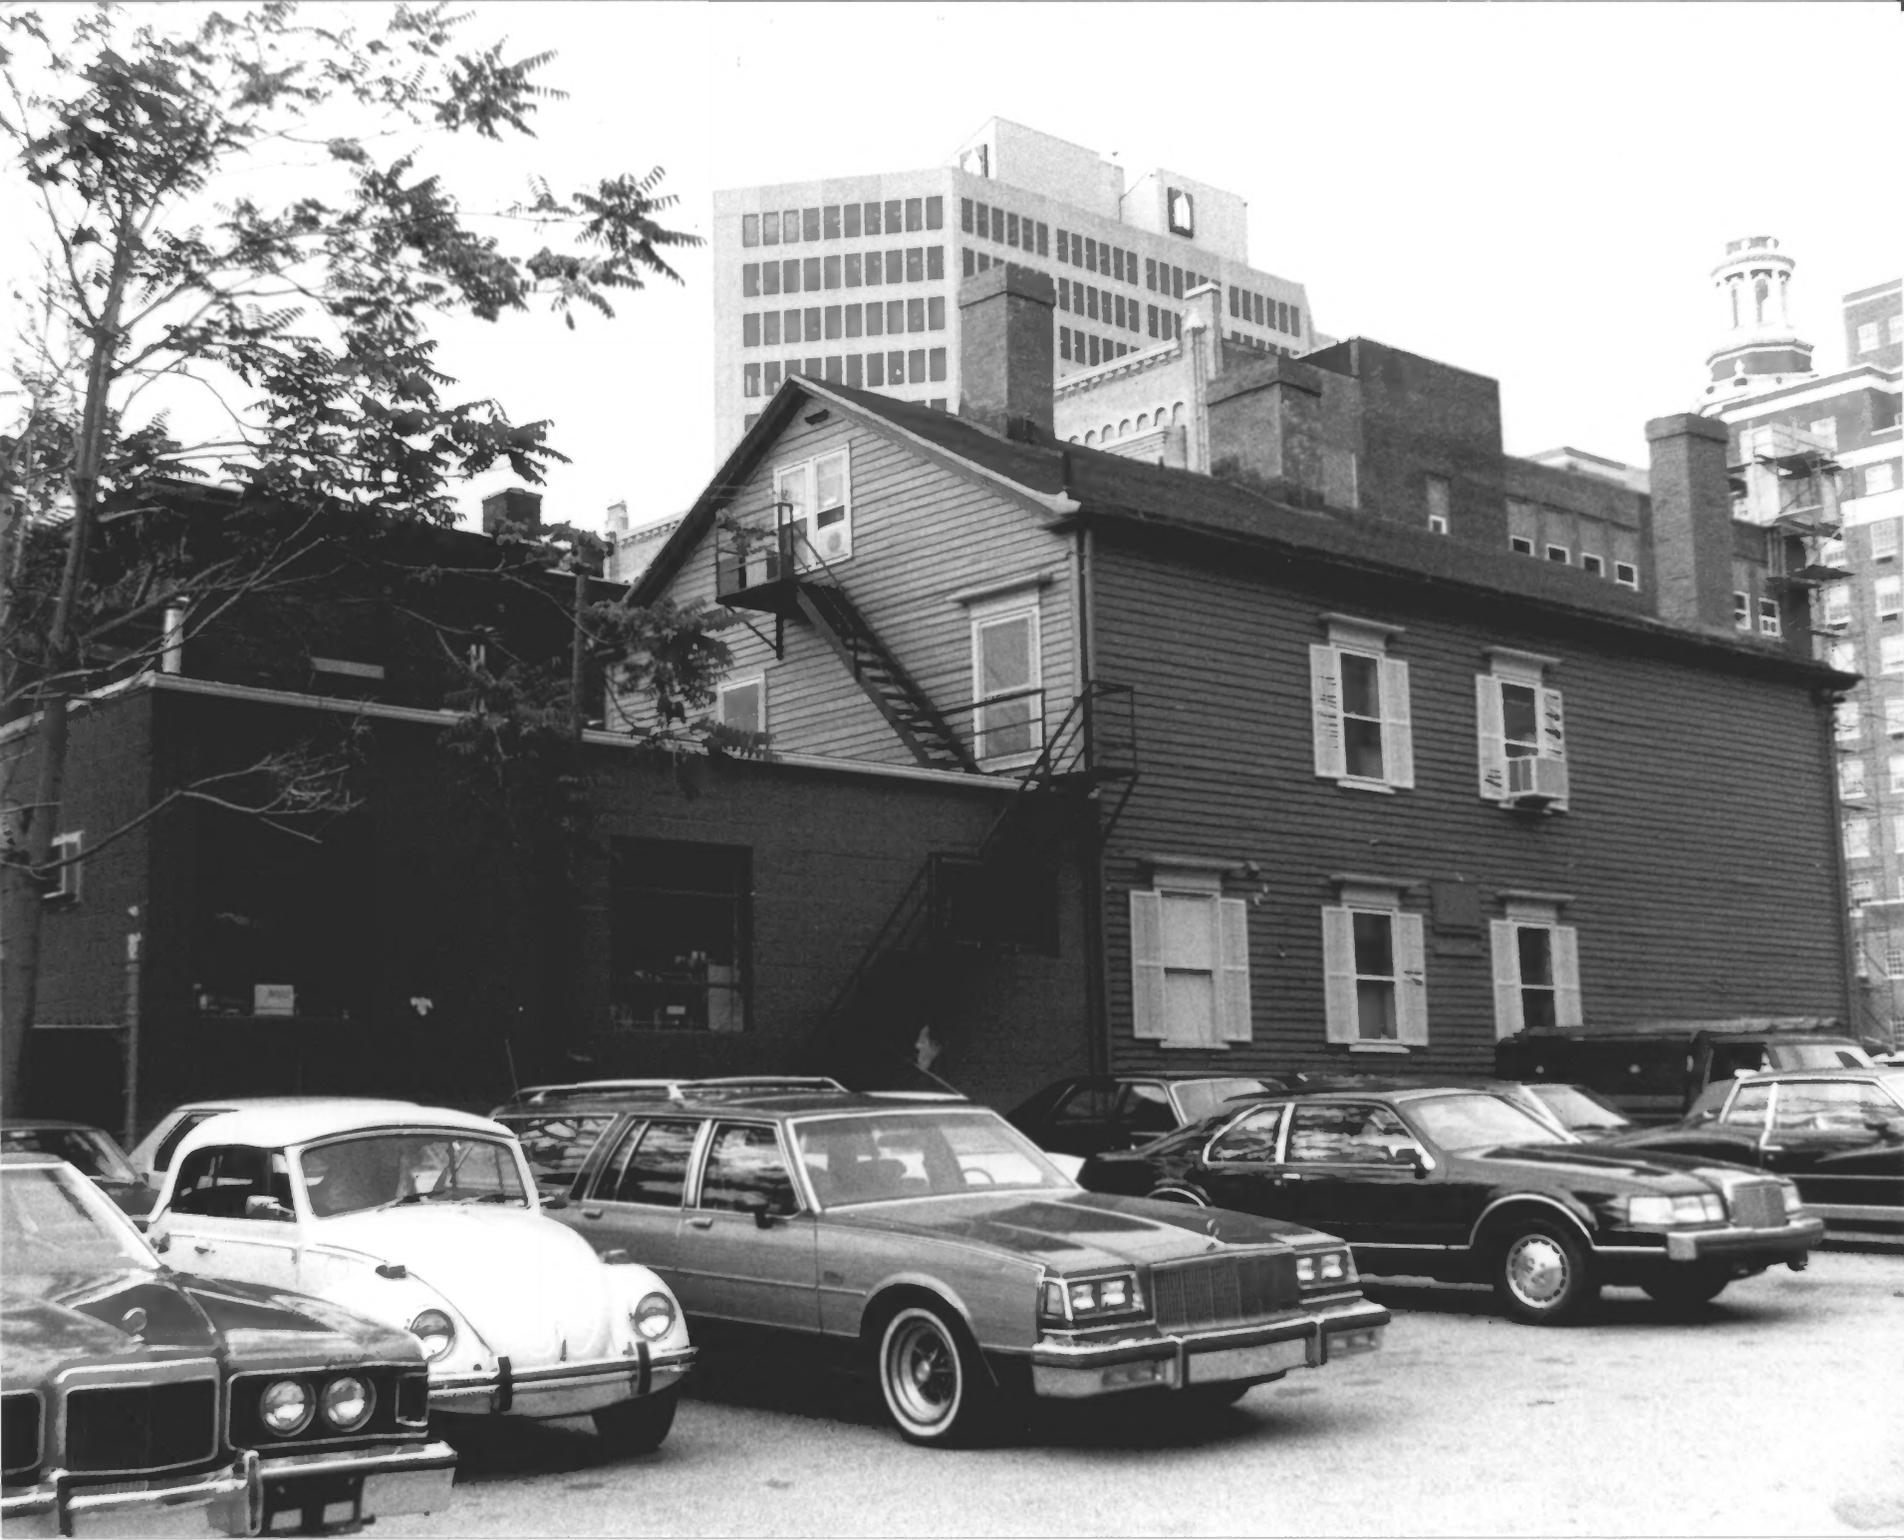
Photograph 2.

Rear (eastern) and northern elevations as  
viewed from the northeast.

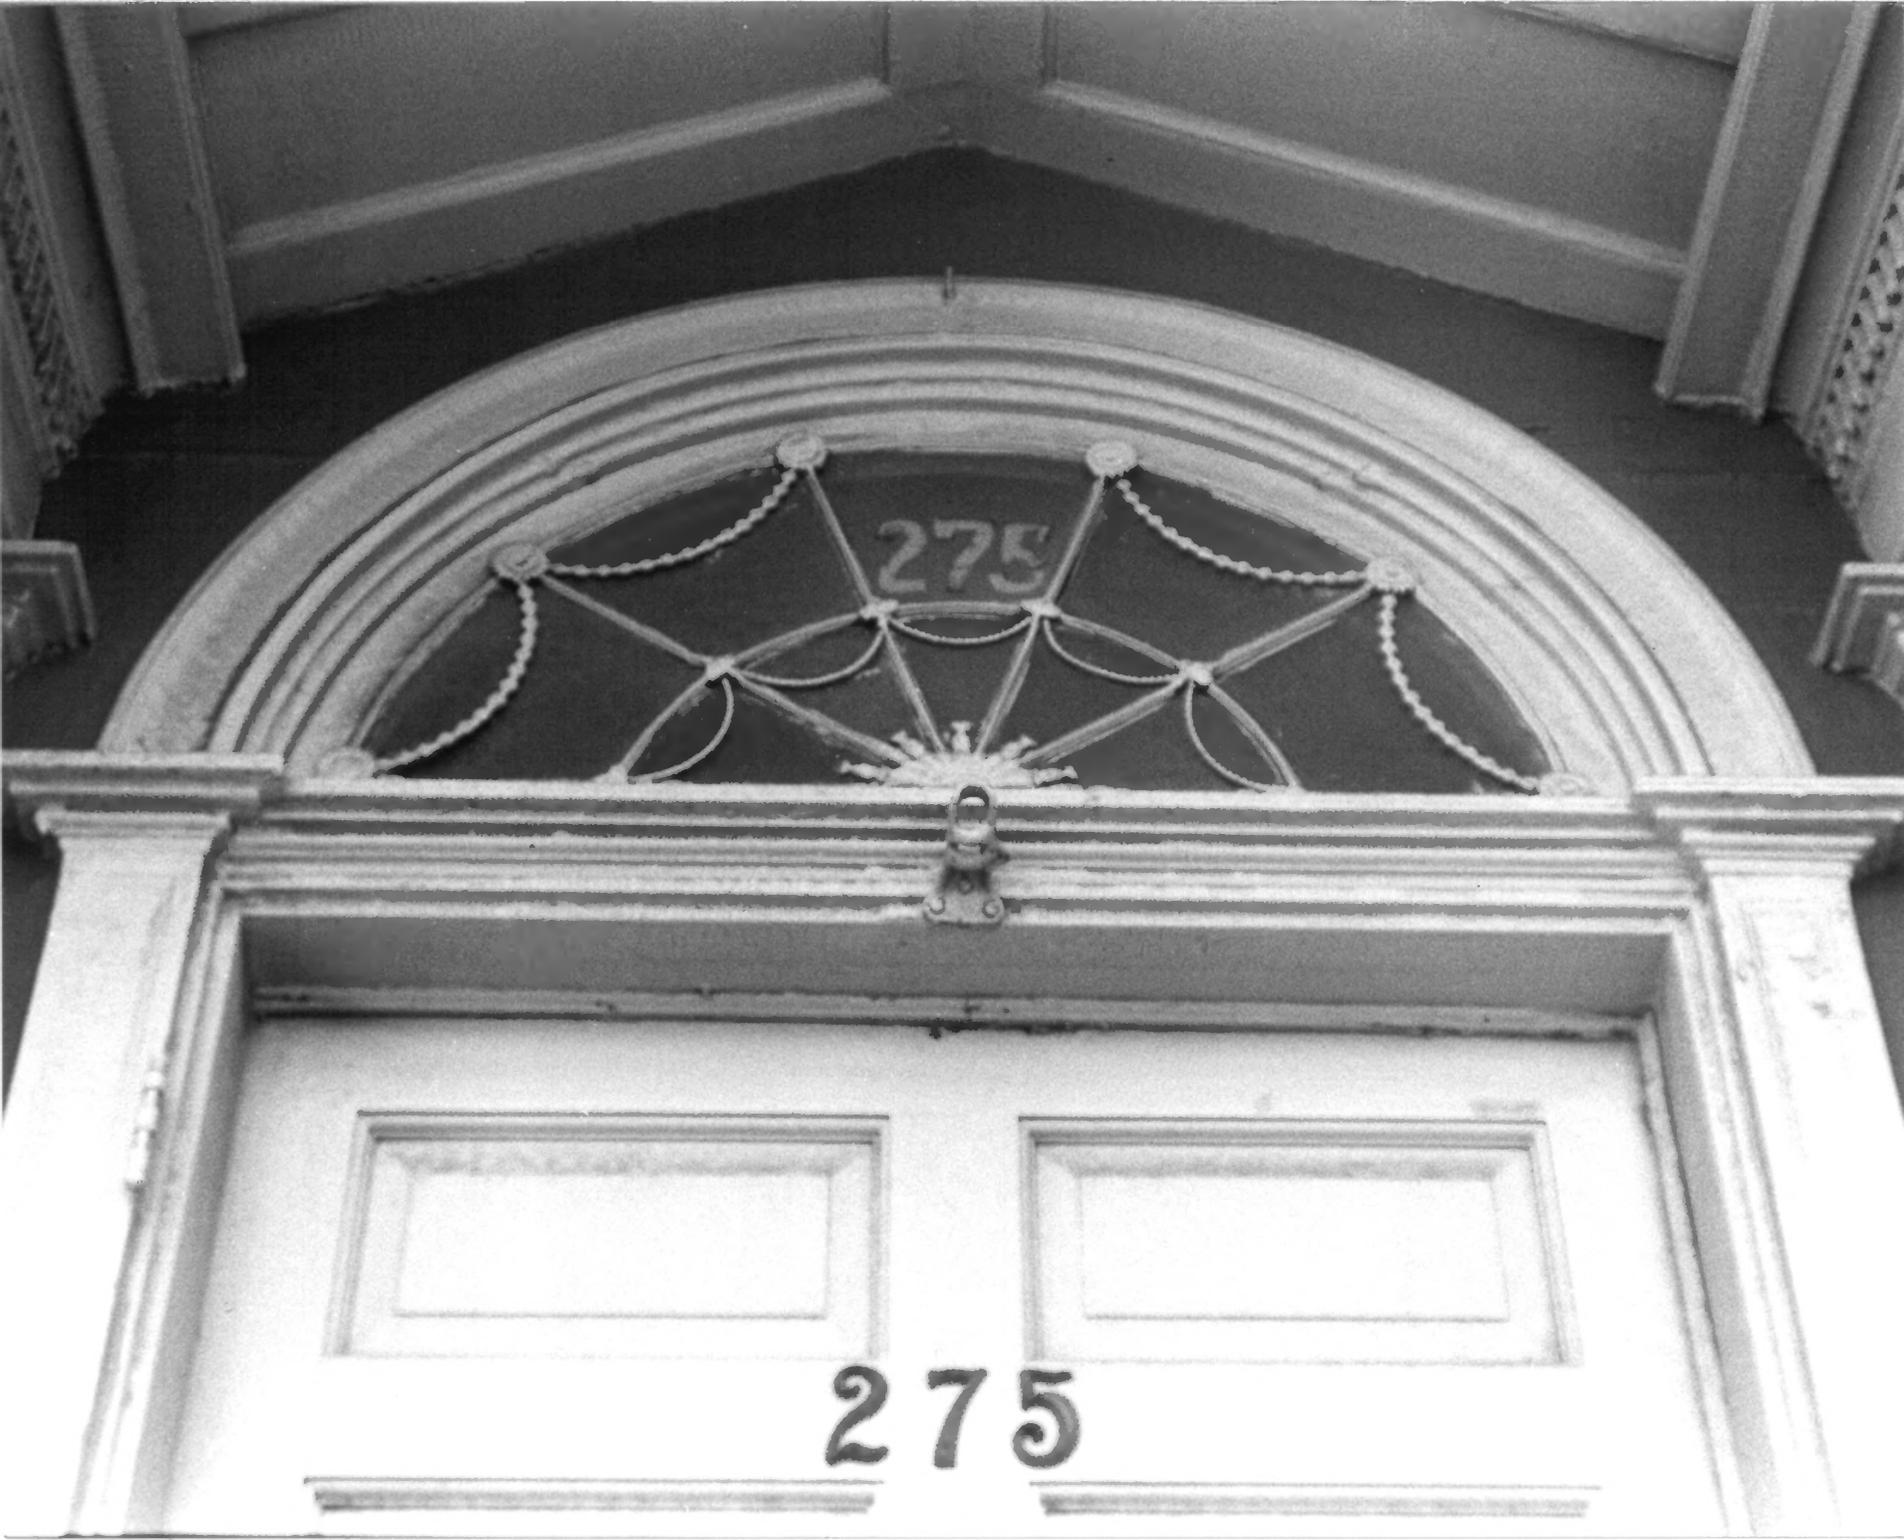
Photograph 4.

Close-up view of front entry fanlight  
transom.

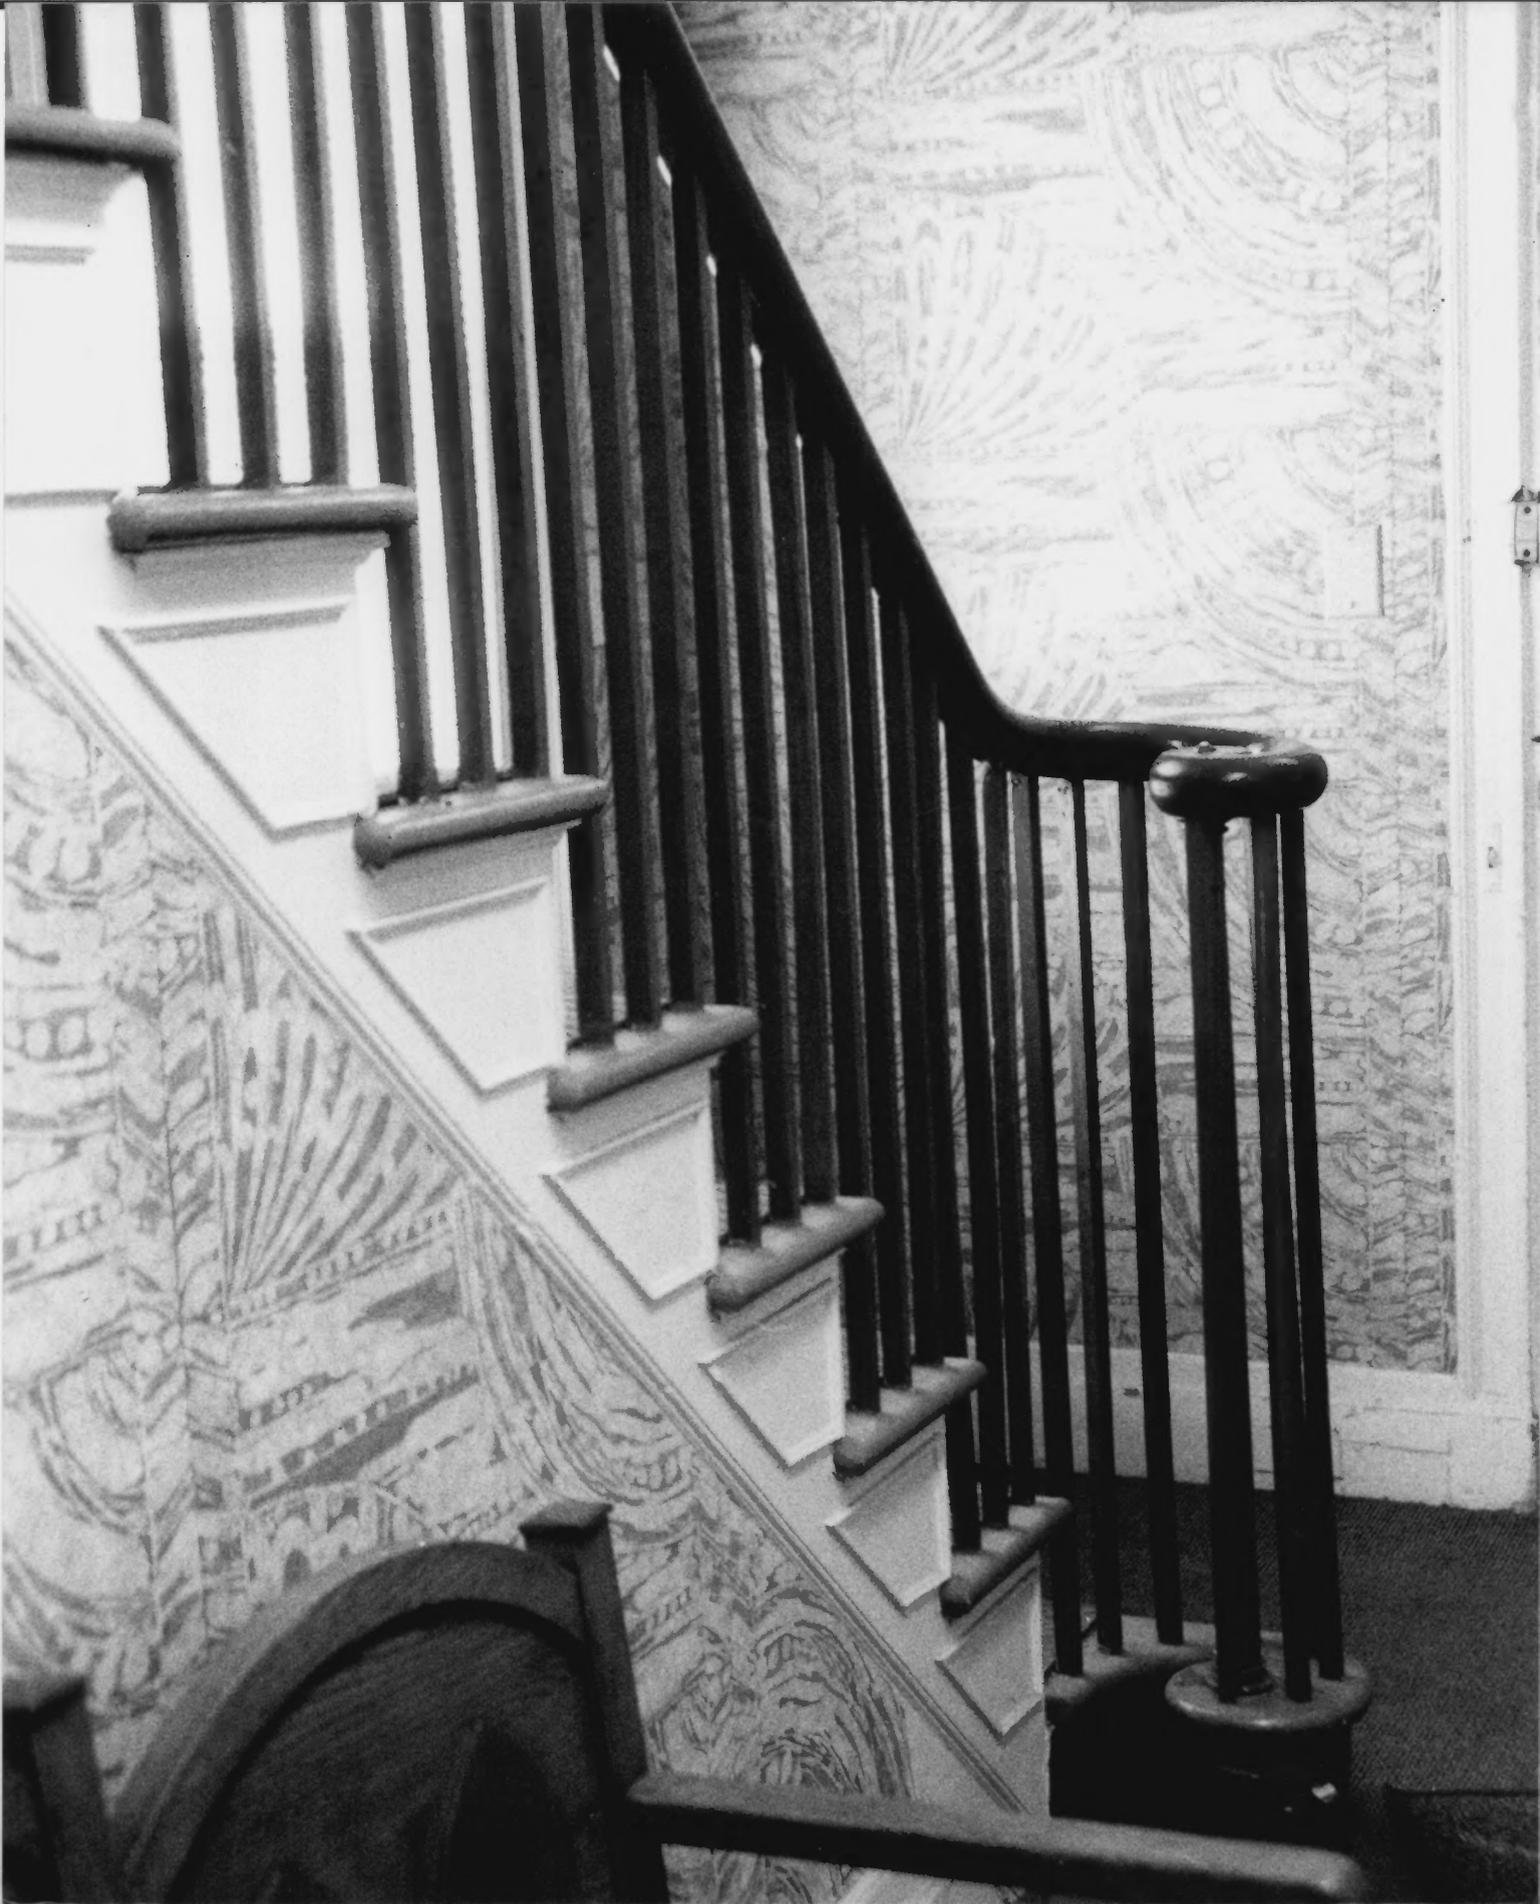
Photograph 5.

Front stairway as viewed from the first floor  
hallway.

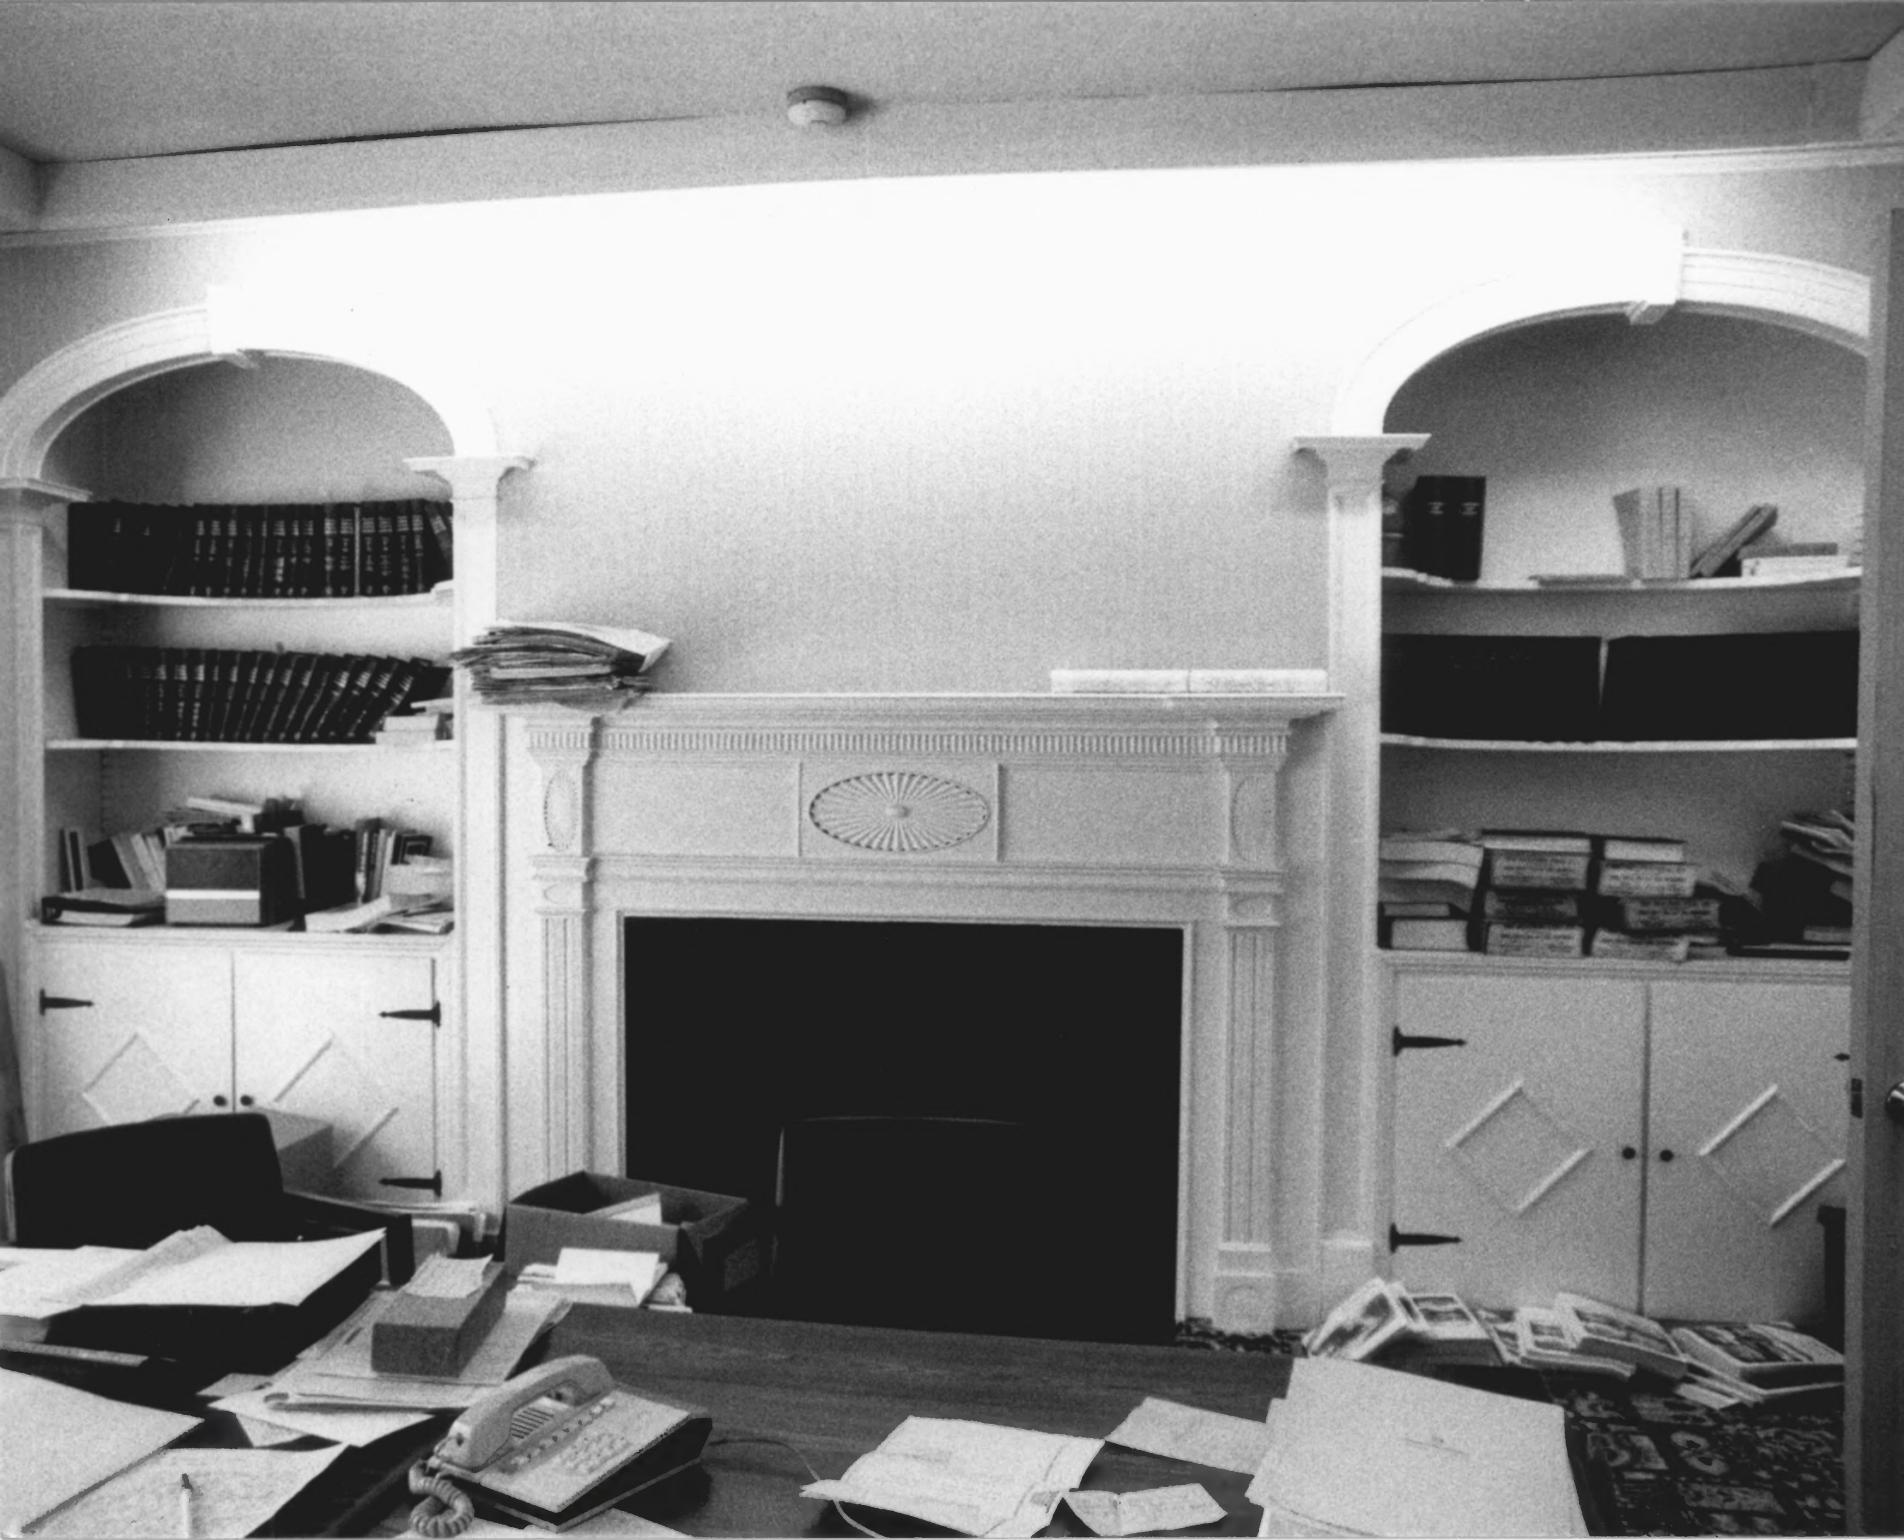
Photograph 6.

Interior elevation of north wall, first-story  
front room

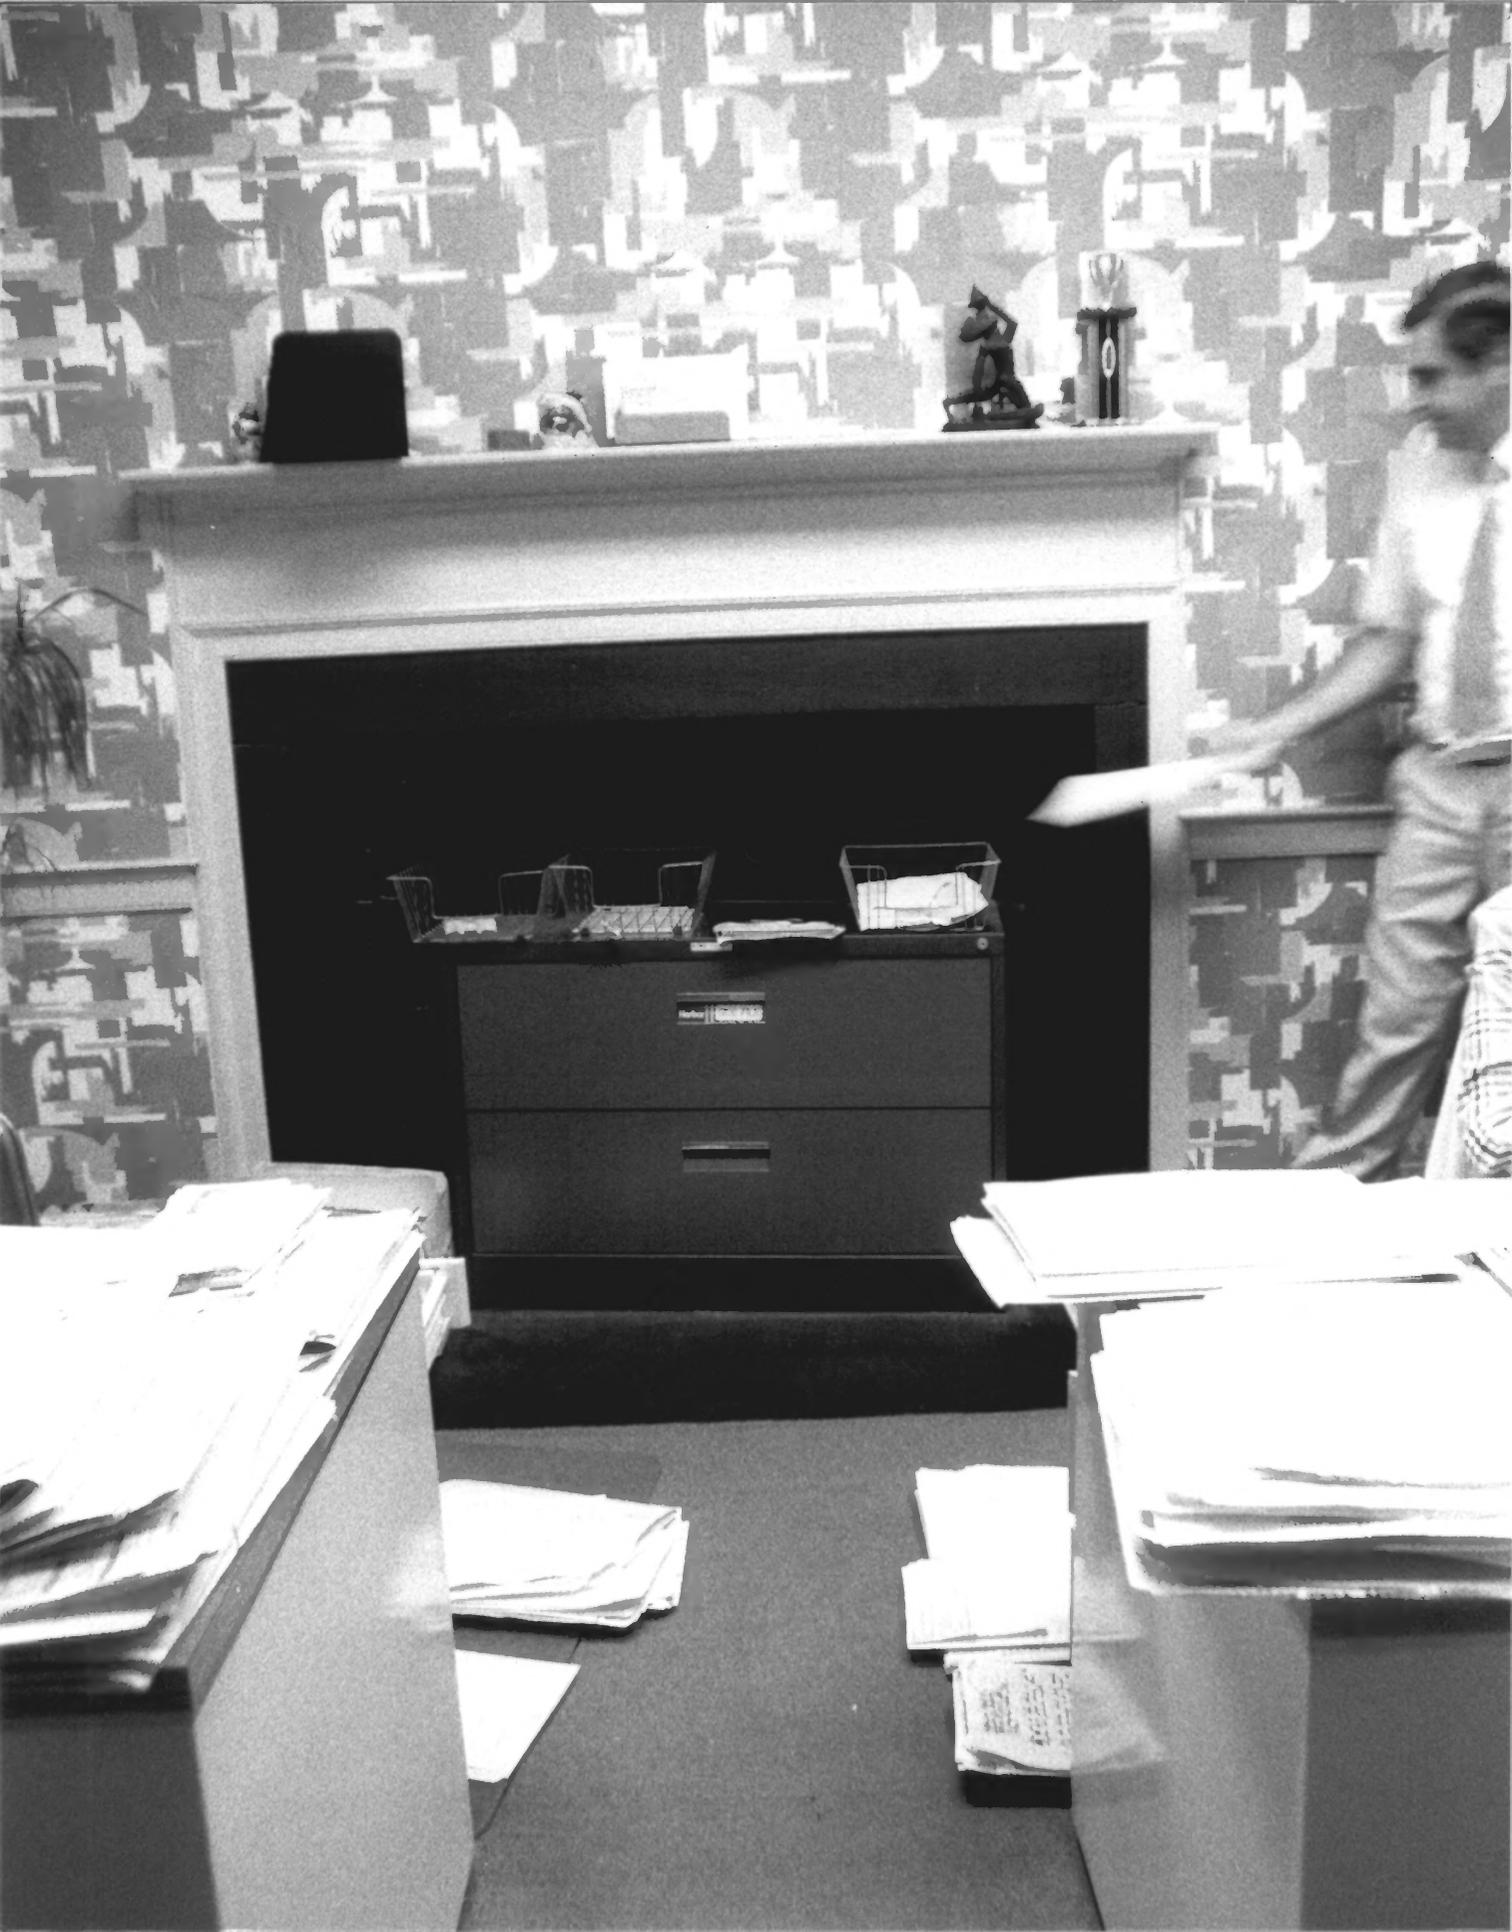
Photograph 7.

Fireplace in southeasternmost room of original portion of building, first floor (original kitchen north wall).

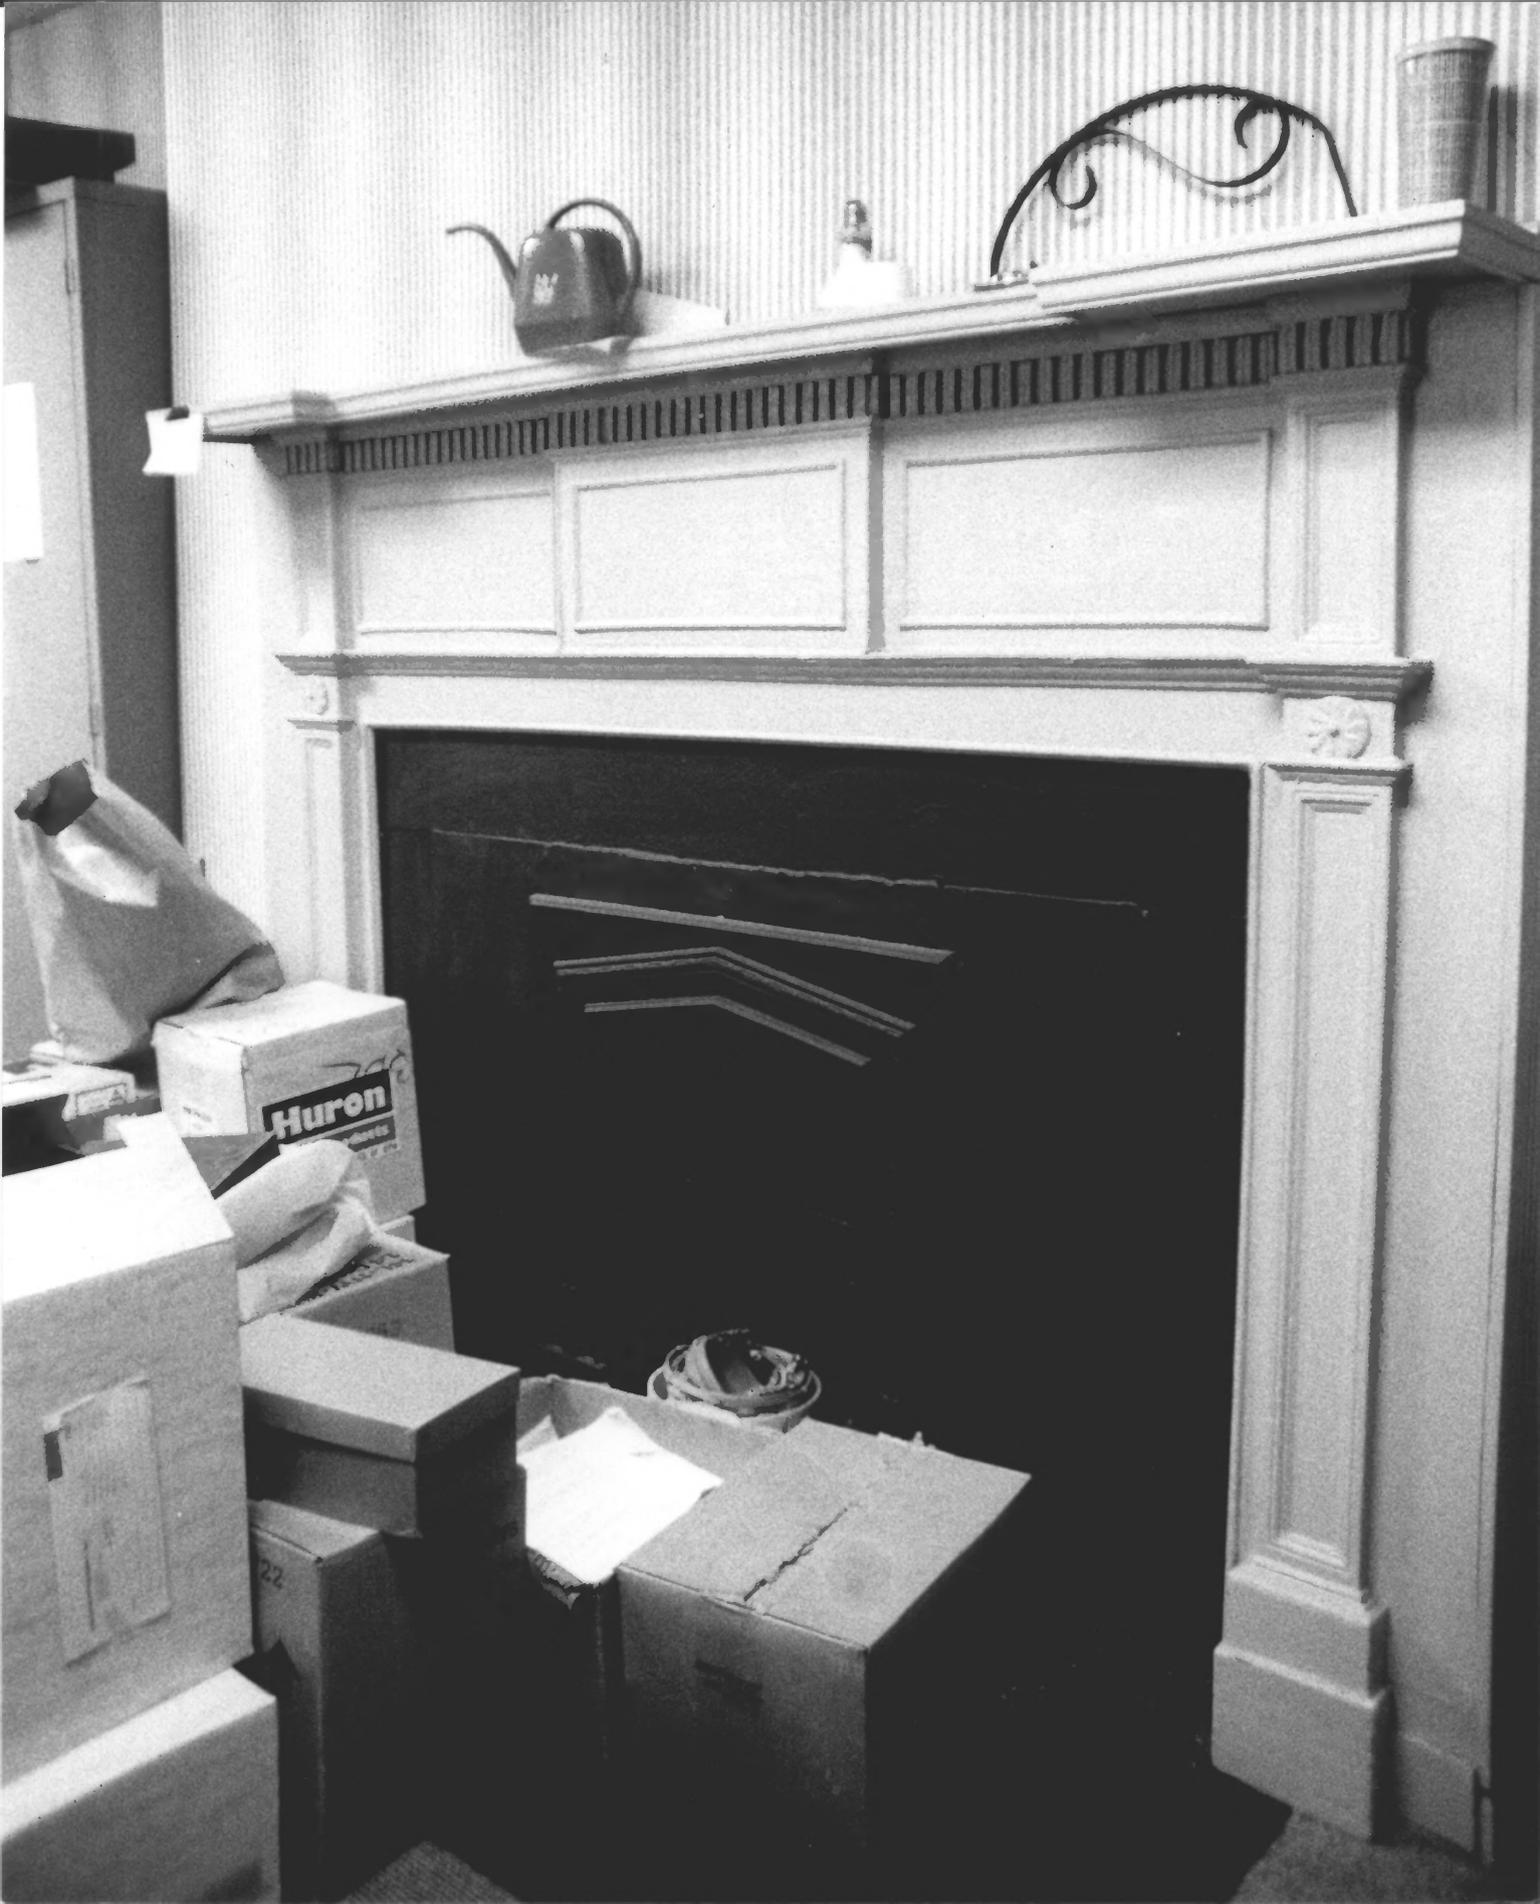
Photograph 8.

Fireplace (south) wall in central room, north side of first floor in original main block.
