William Pinto-Eli Whitney House  
275 Orange Street, New Haven, Connecticut.

NHPT Photo: 8-19-1984  
Negative filed with Connecticut Historical  
Commission, Hartford, CT.

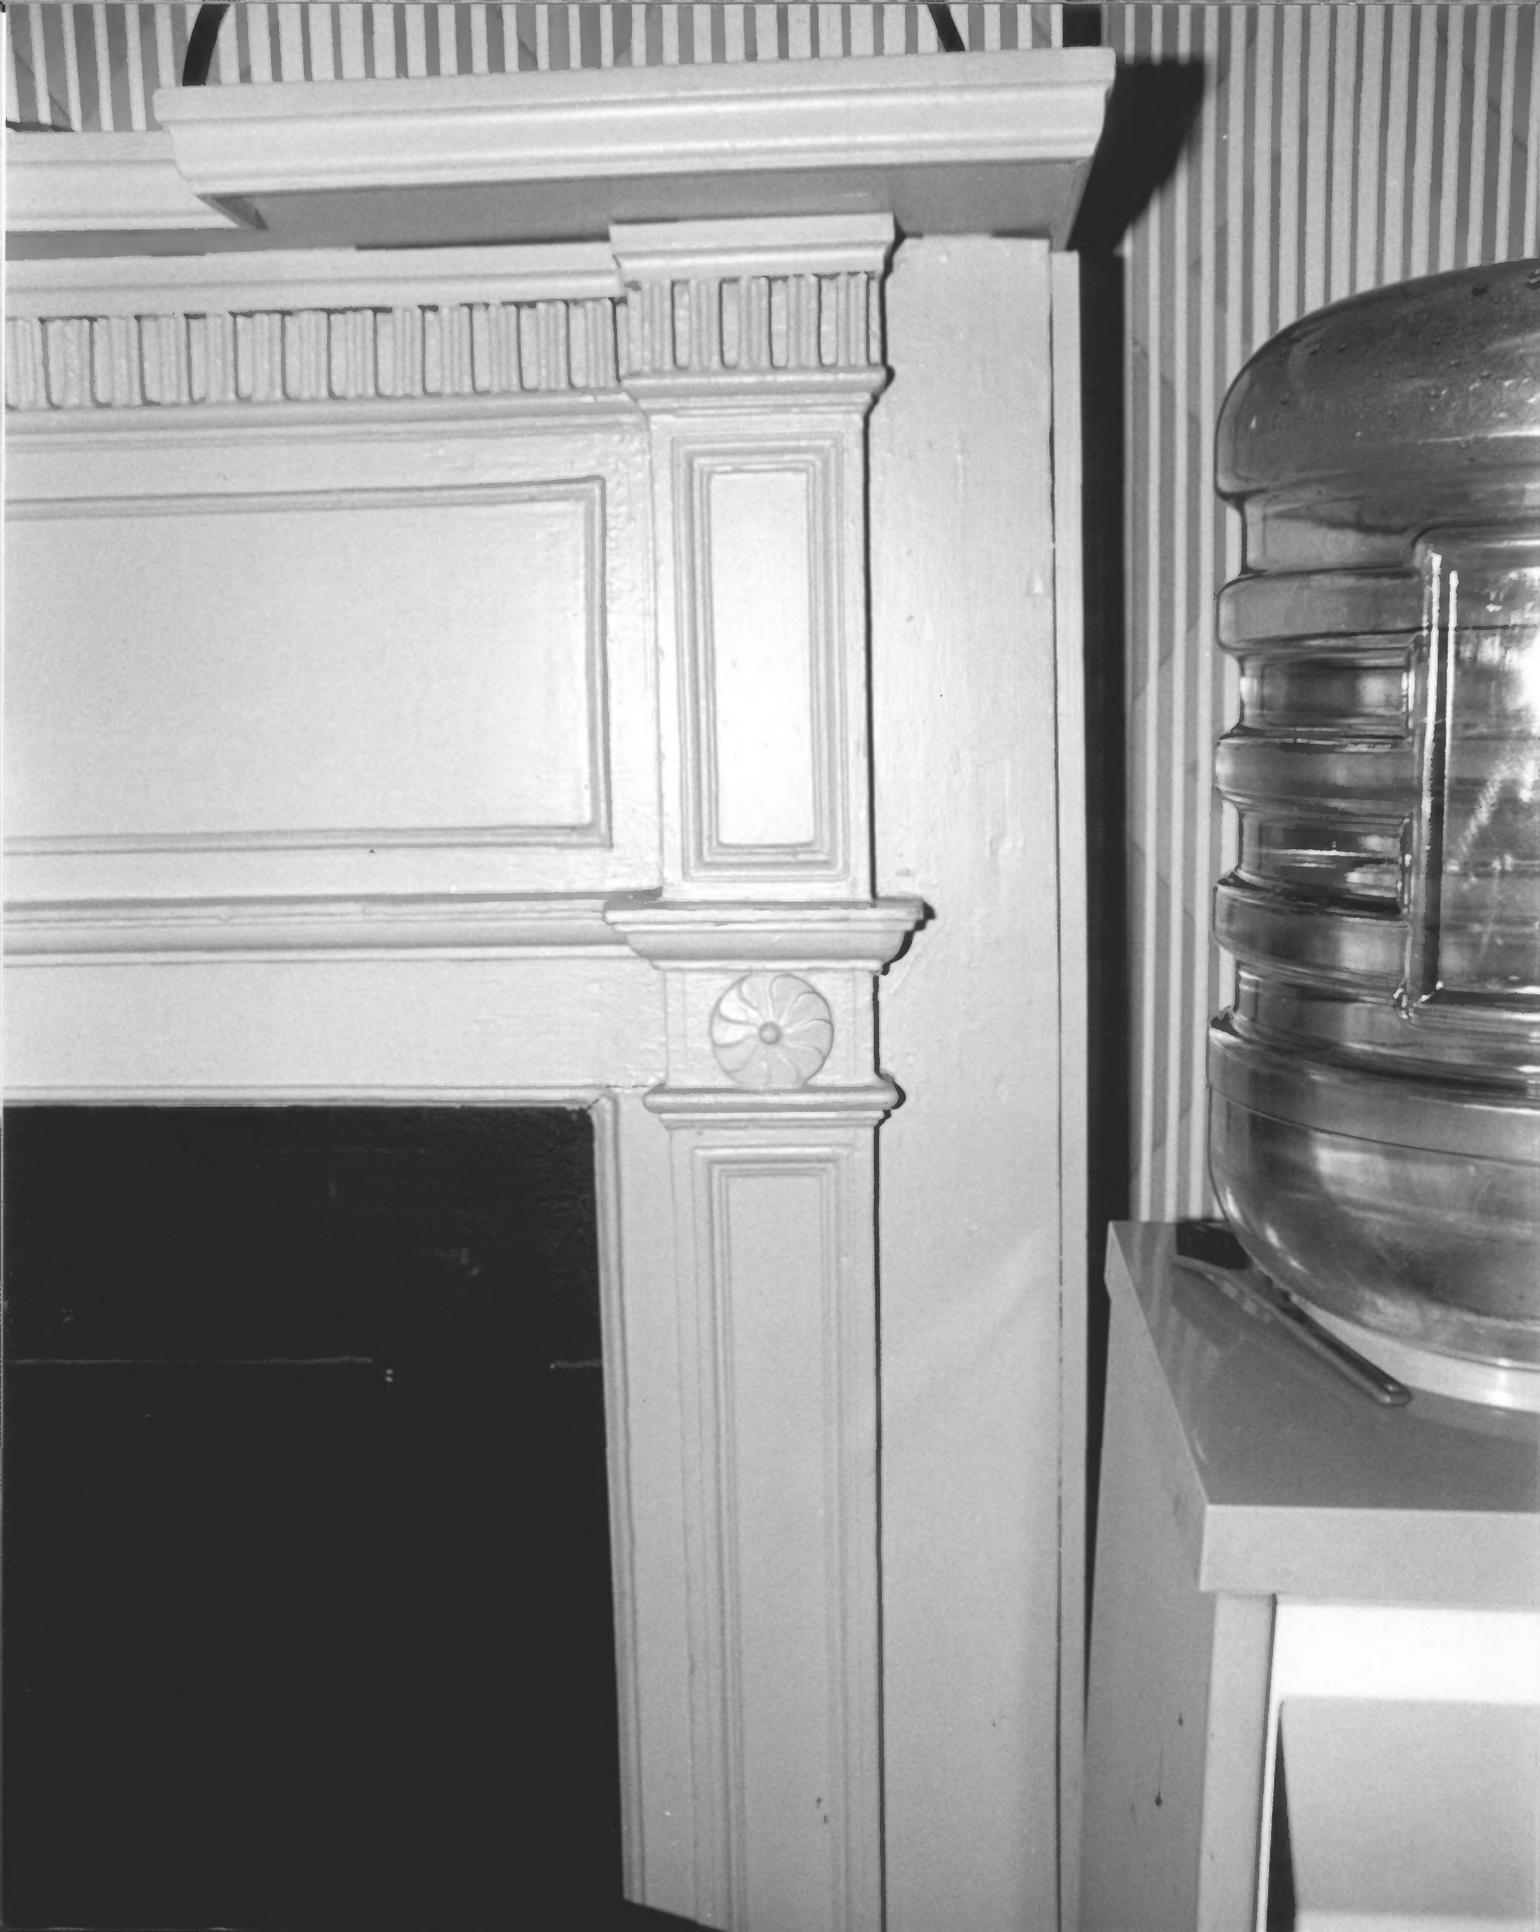
Photograph 9.

Close-up view of mantelpiece detailing in first-story central room, south wall, north side of building.

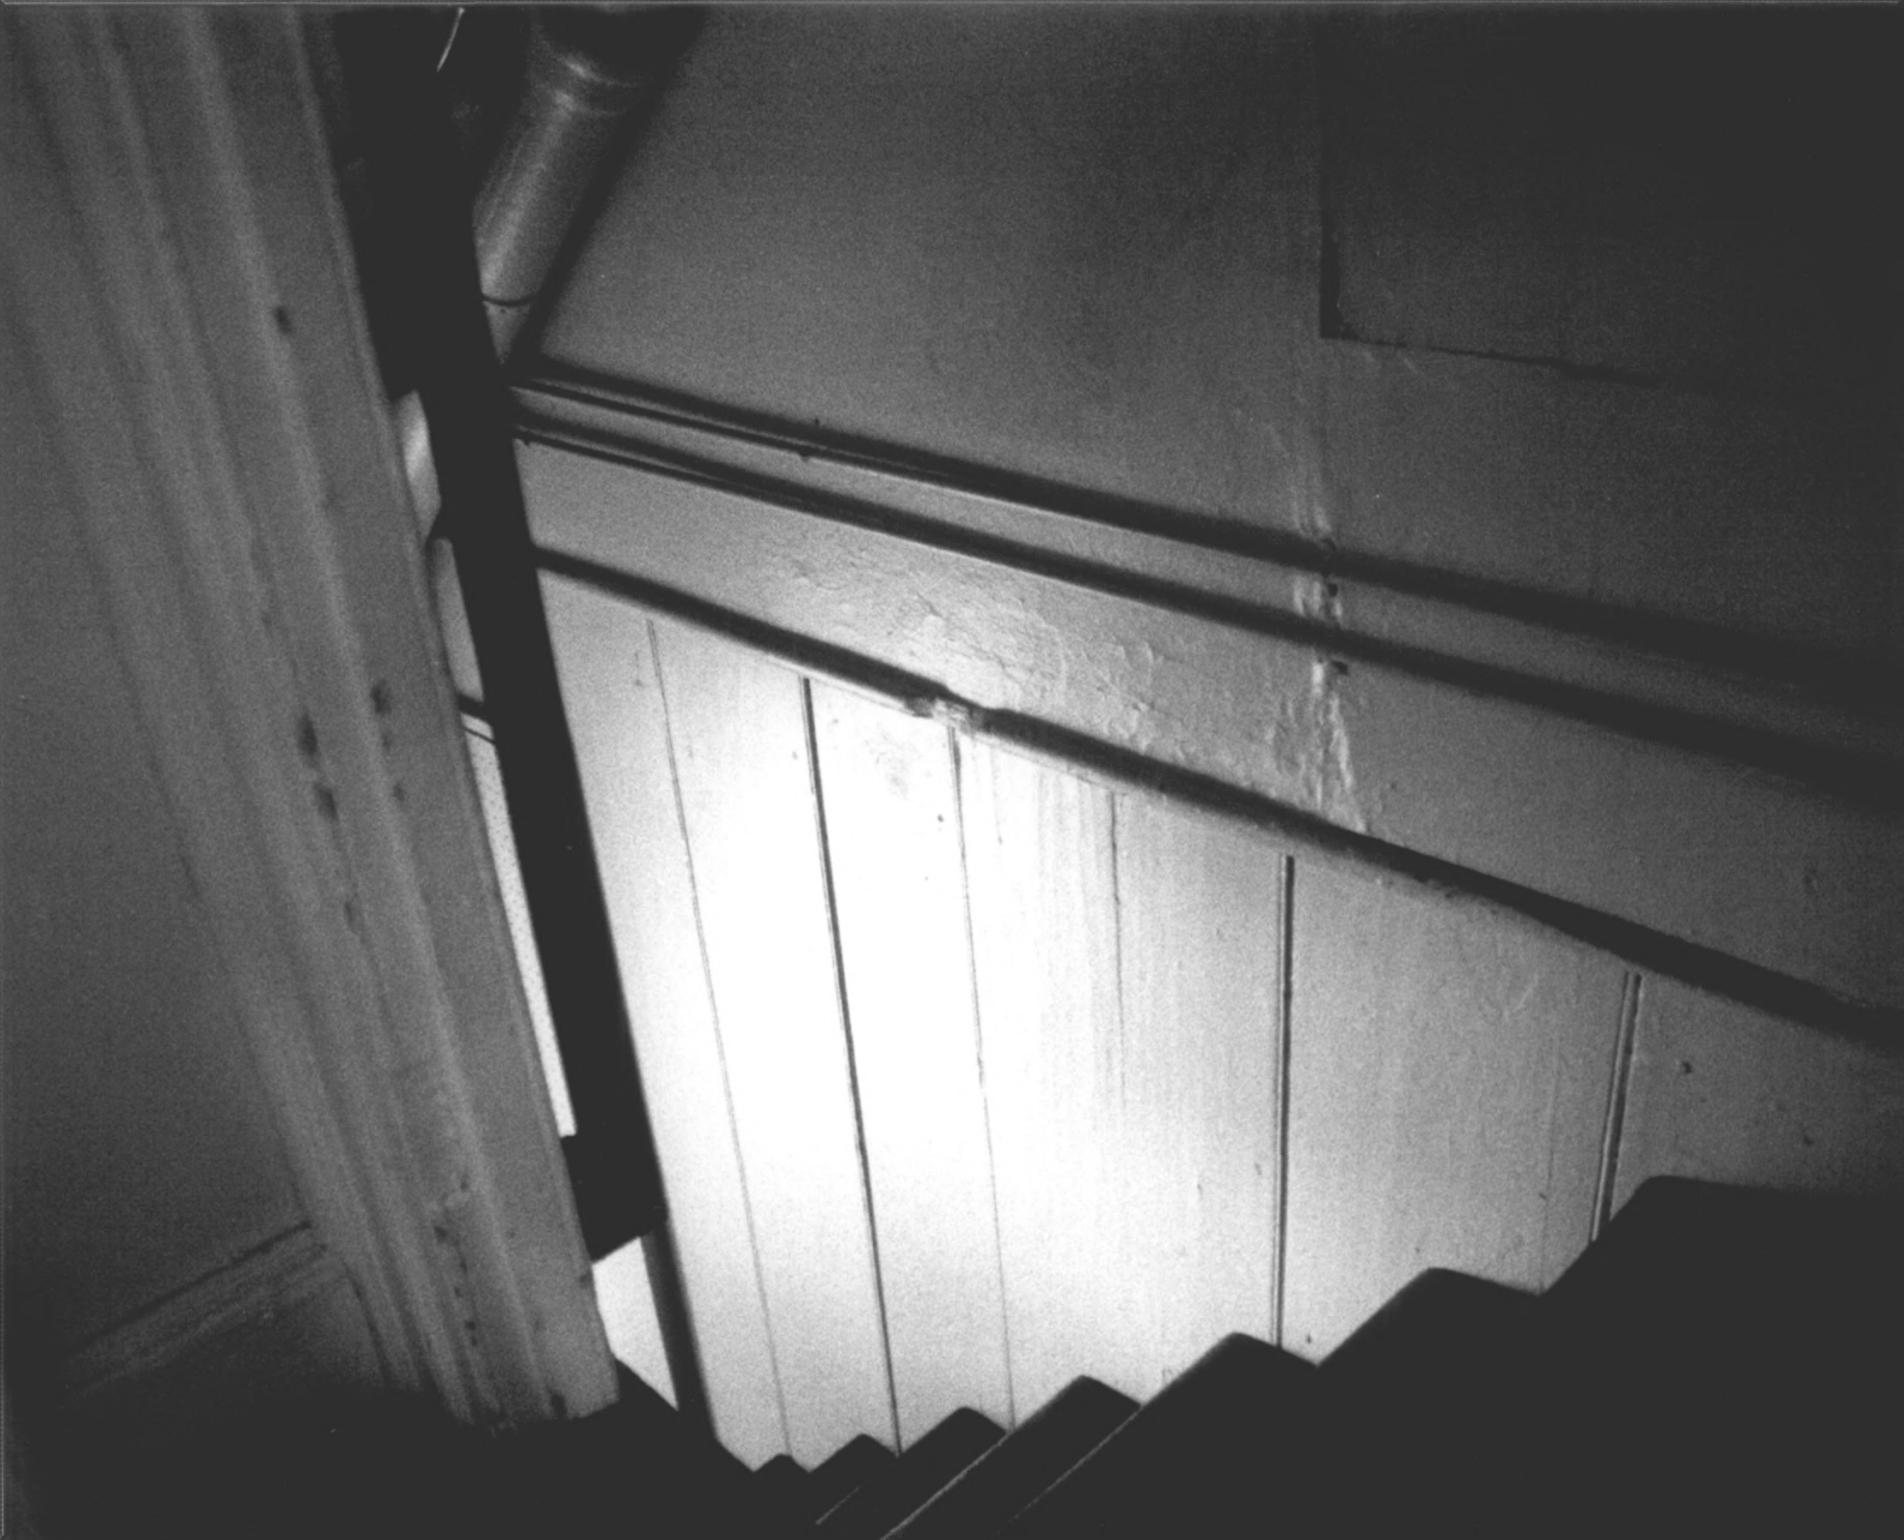
Photograph 10.

Central stairwell on southern side of building as viewed from second-story landing.

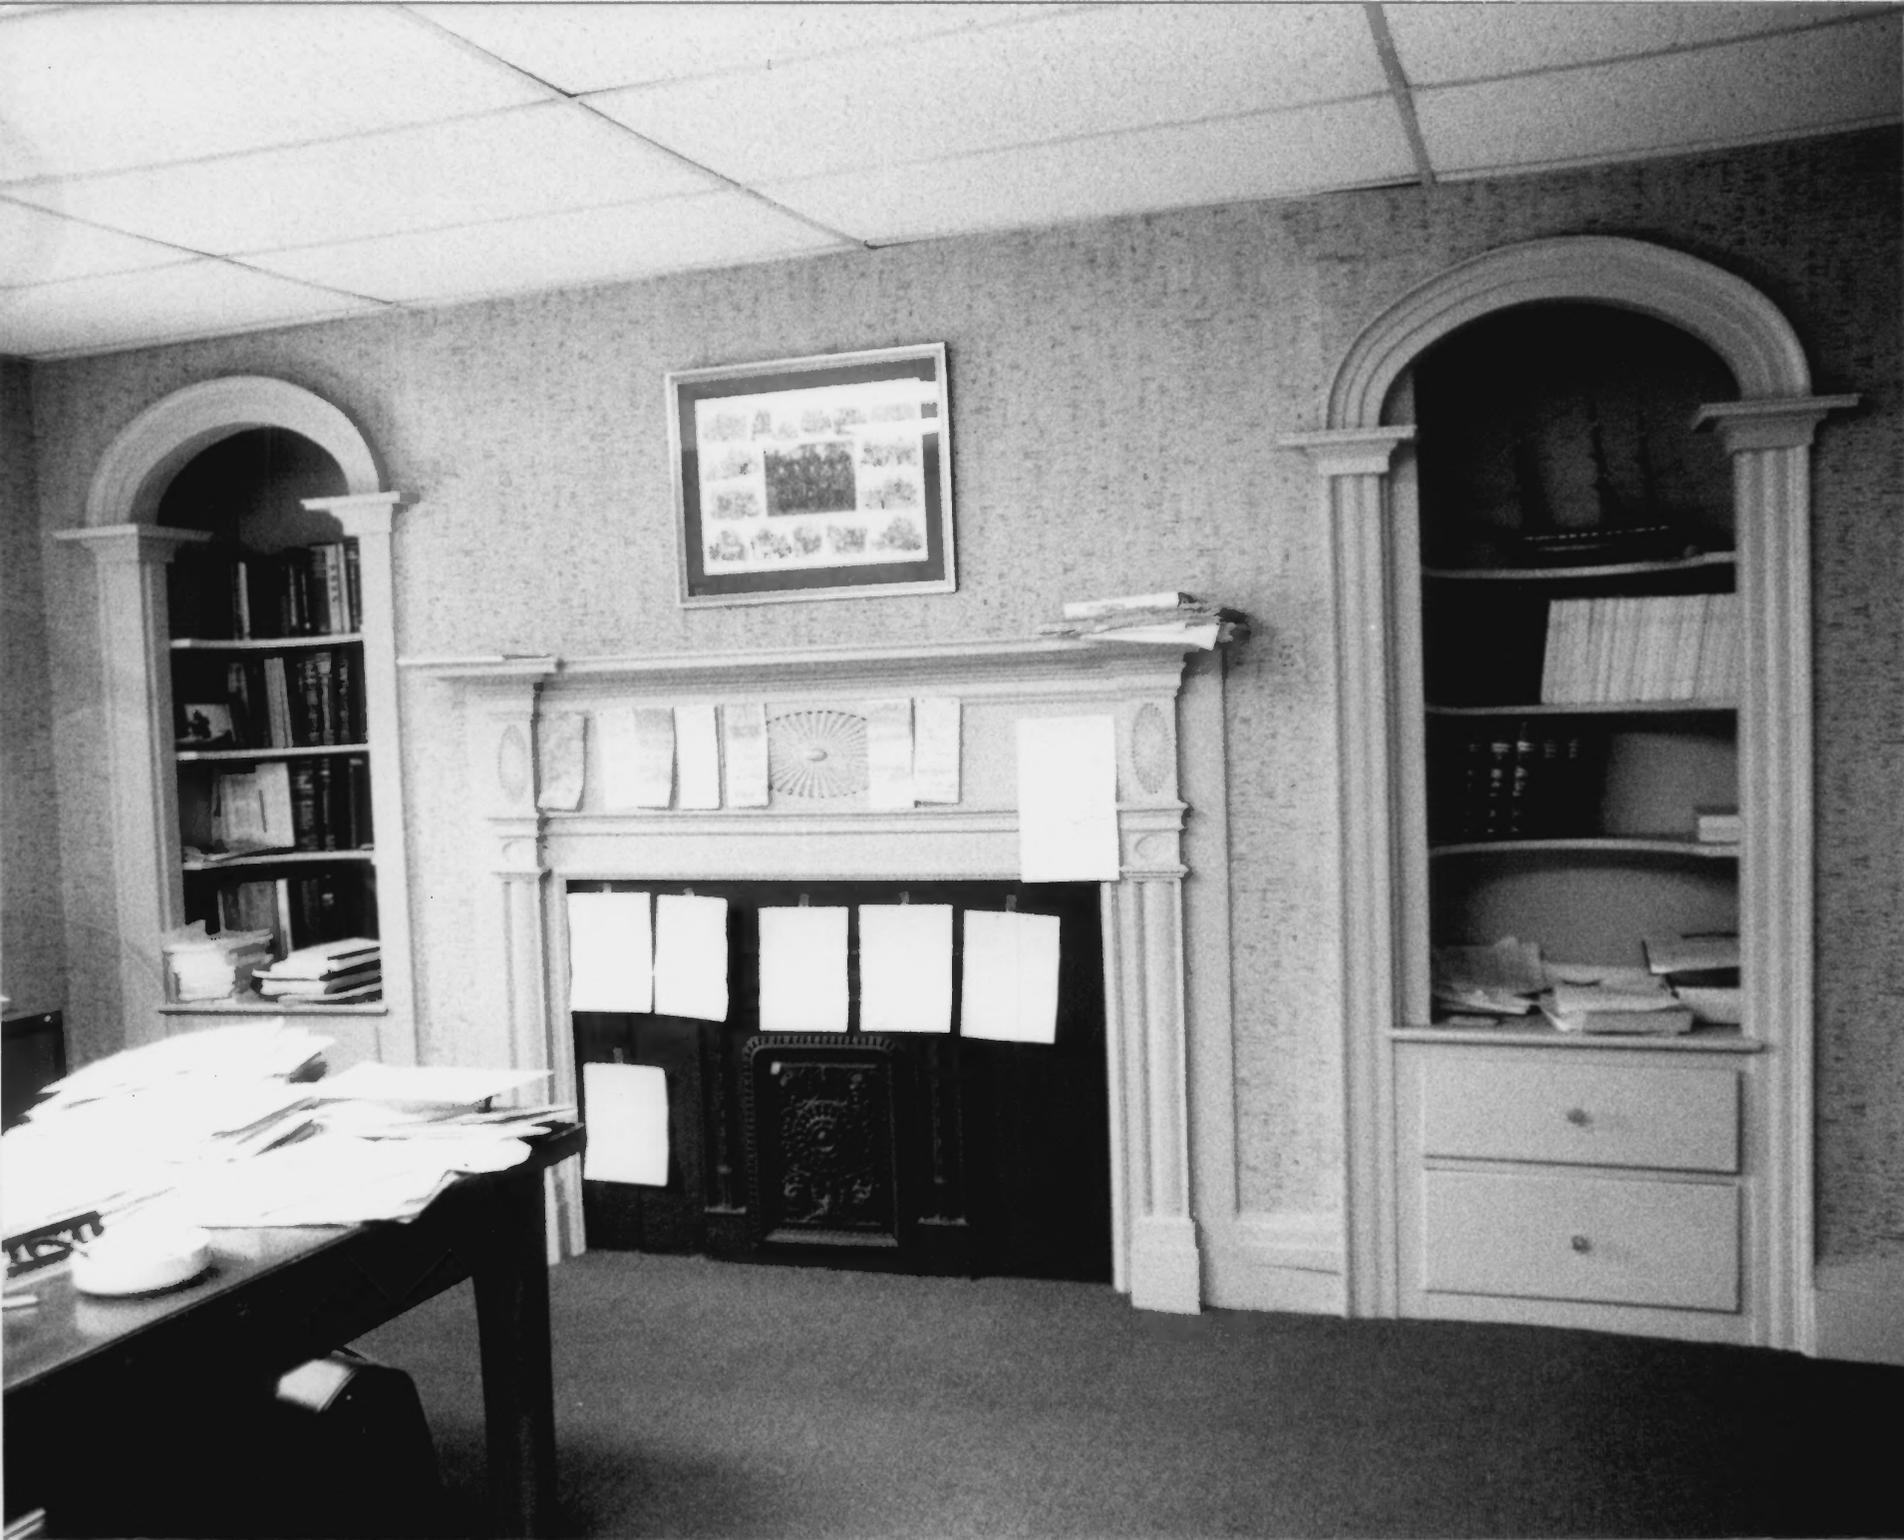
Photograph 11.

Interior elevation, second-story westernmost  
front room, north wall.

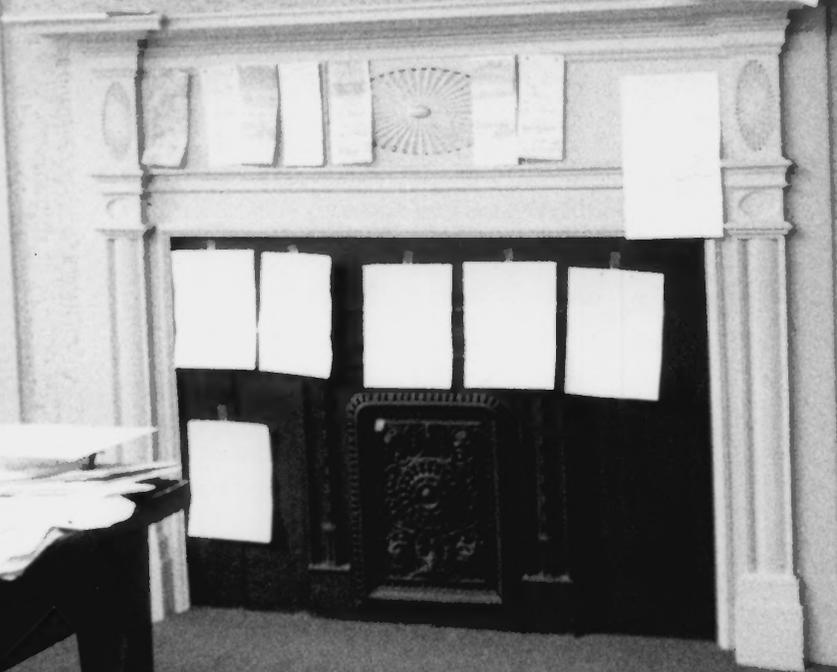
Photograph 12.

Close-up view of mantelpiece details in  
second-story, westernmost front room, north  
wall.

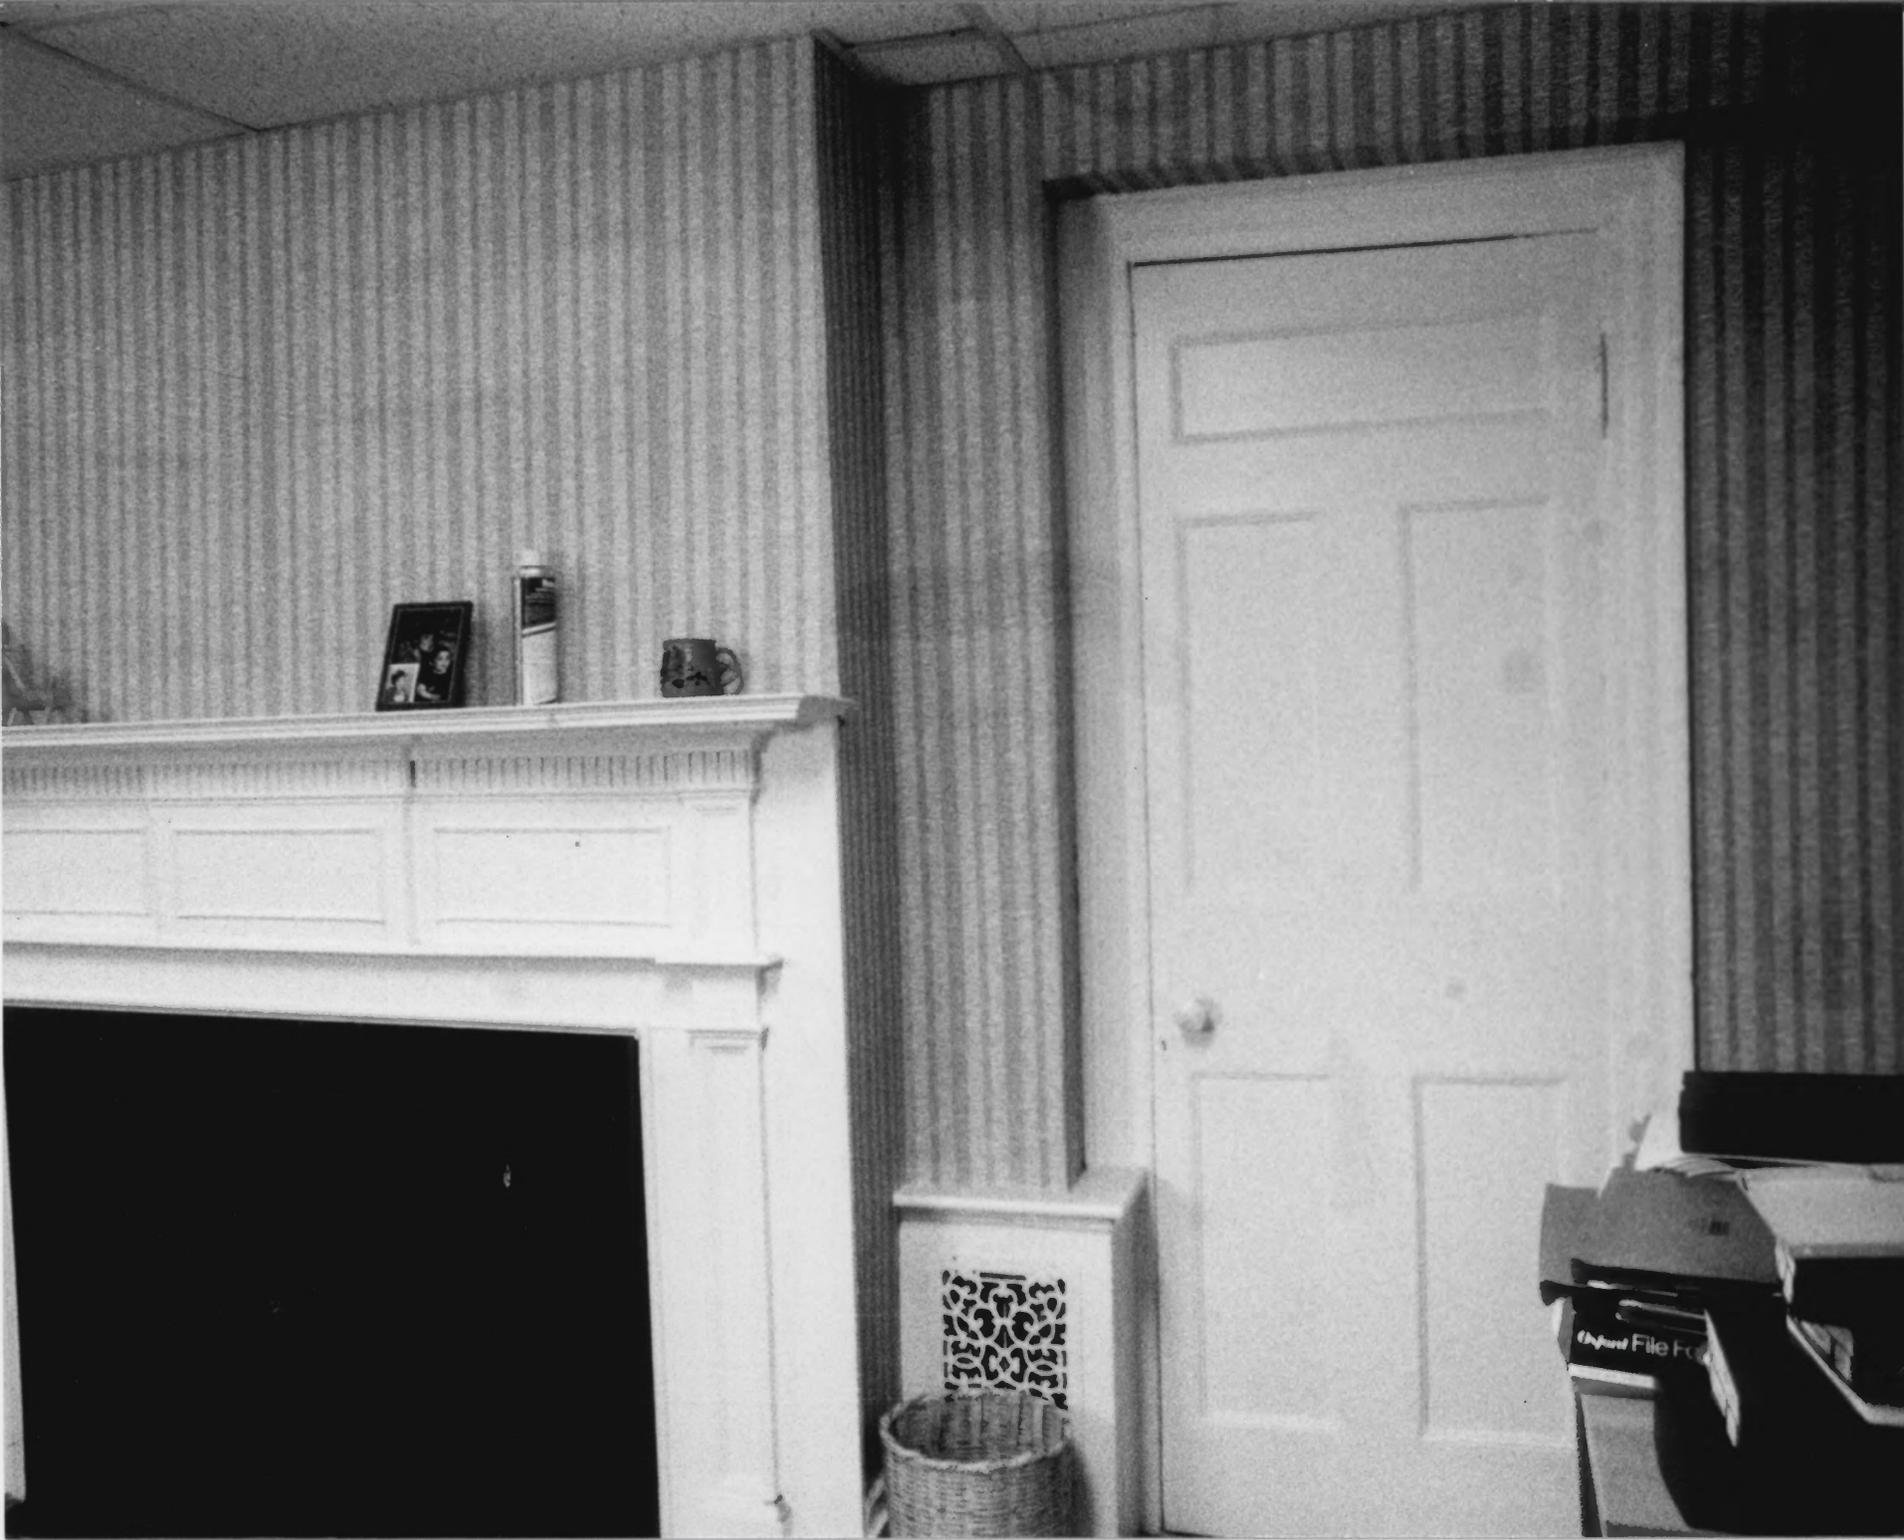
Photograph 13.

Interior elevation, west wall central second-story southern room.

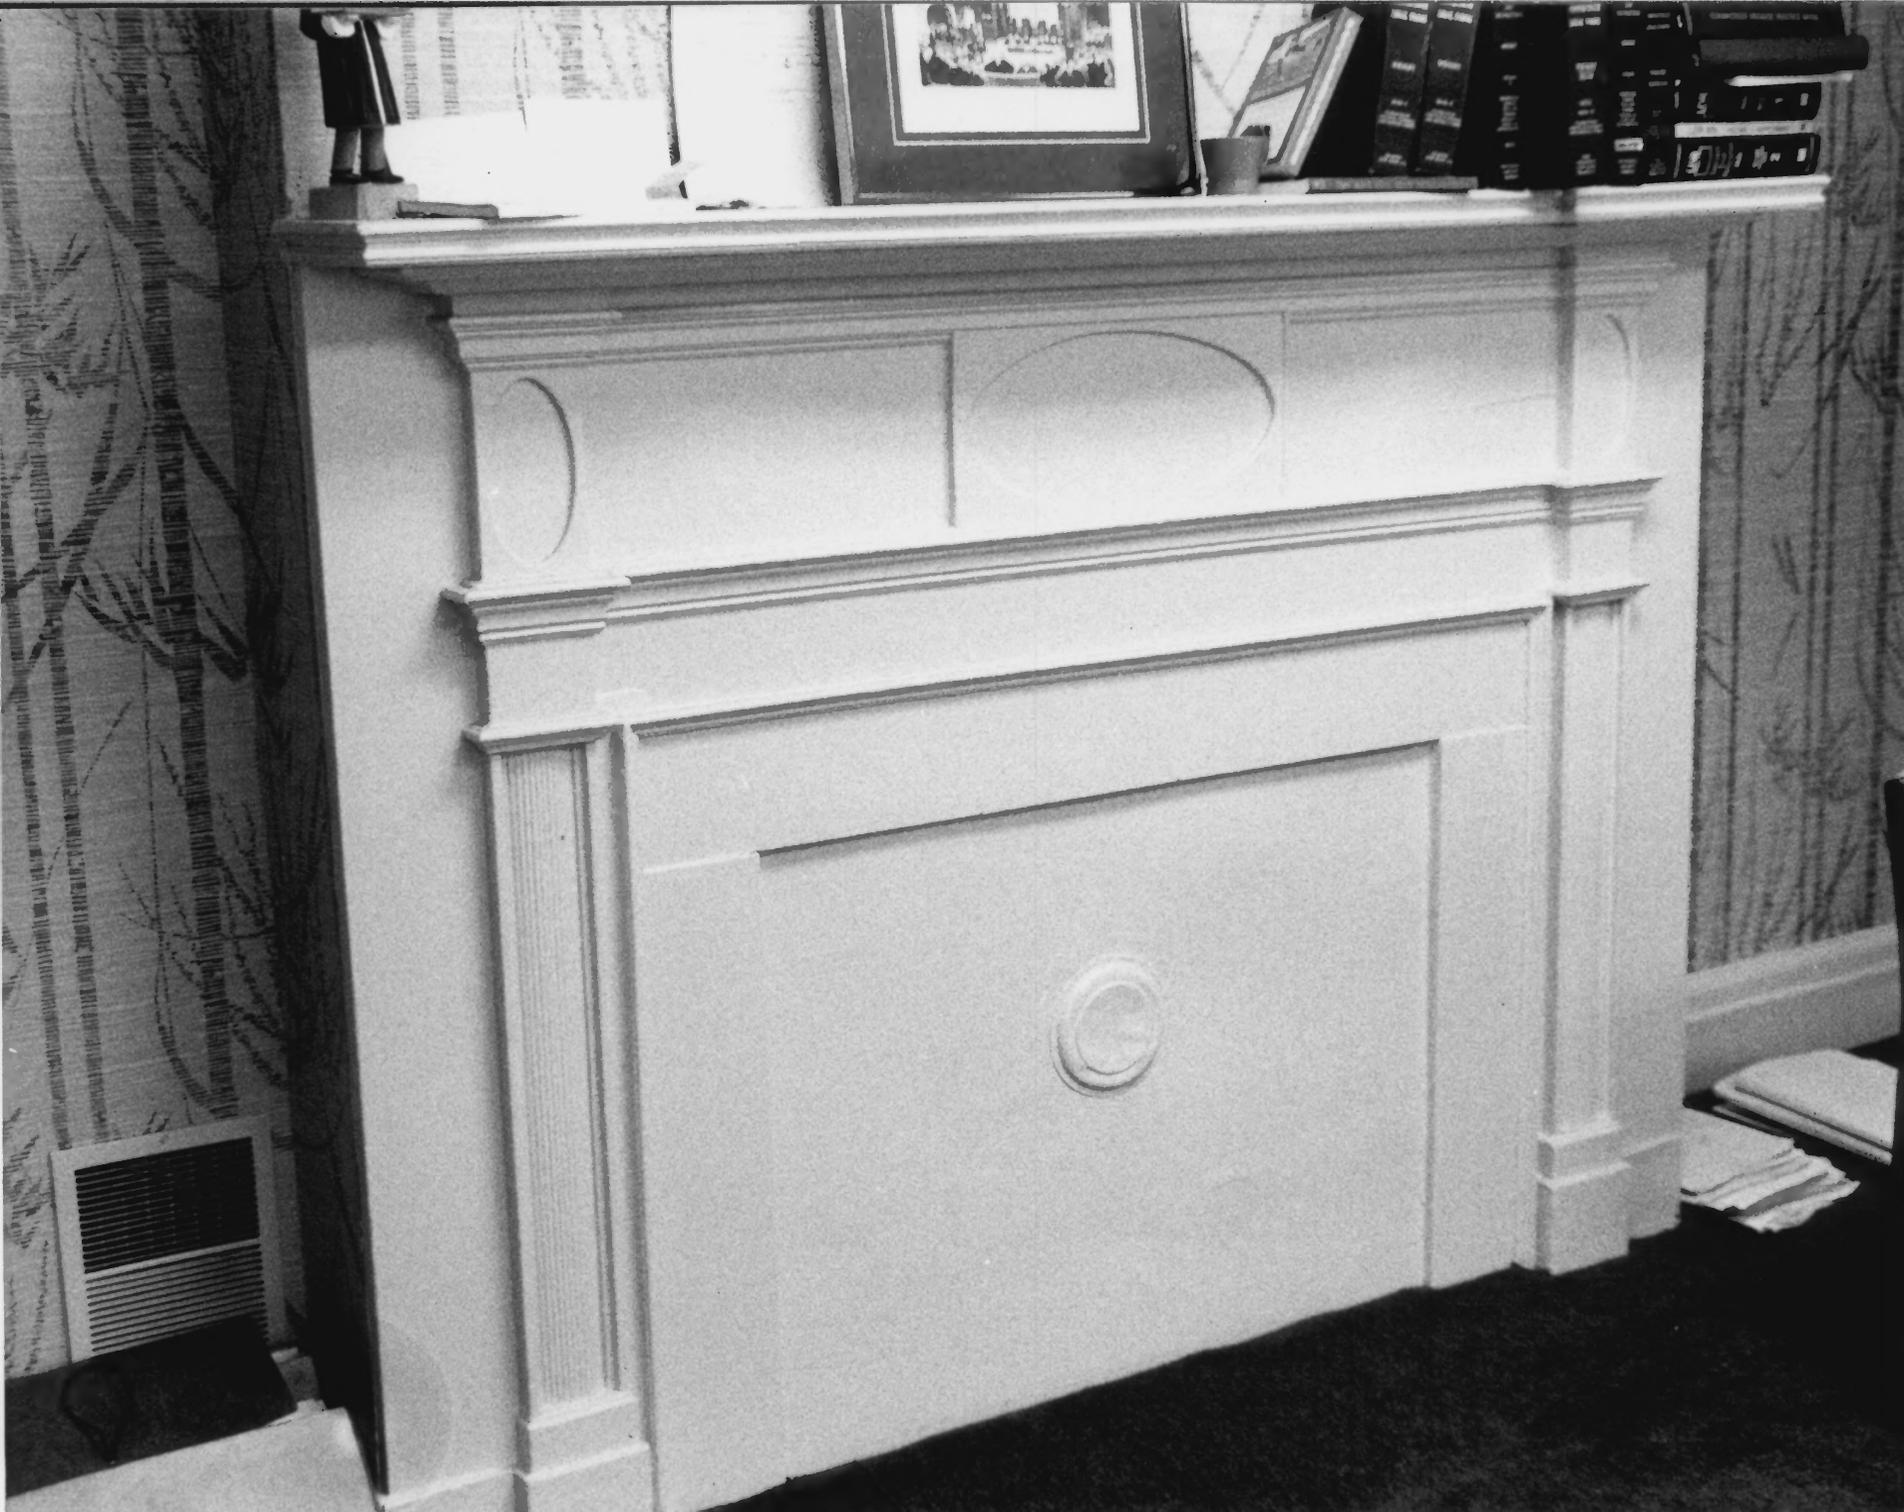
Photograph 14.

Mantelpiece on south wall of central second-story northern room.

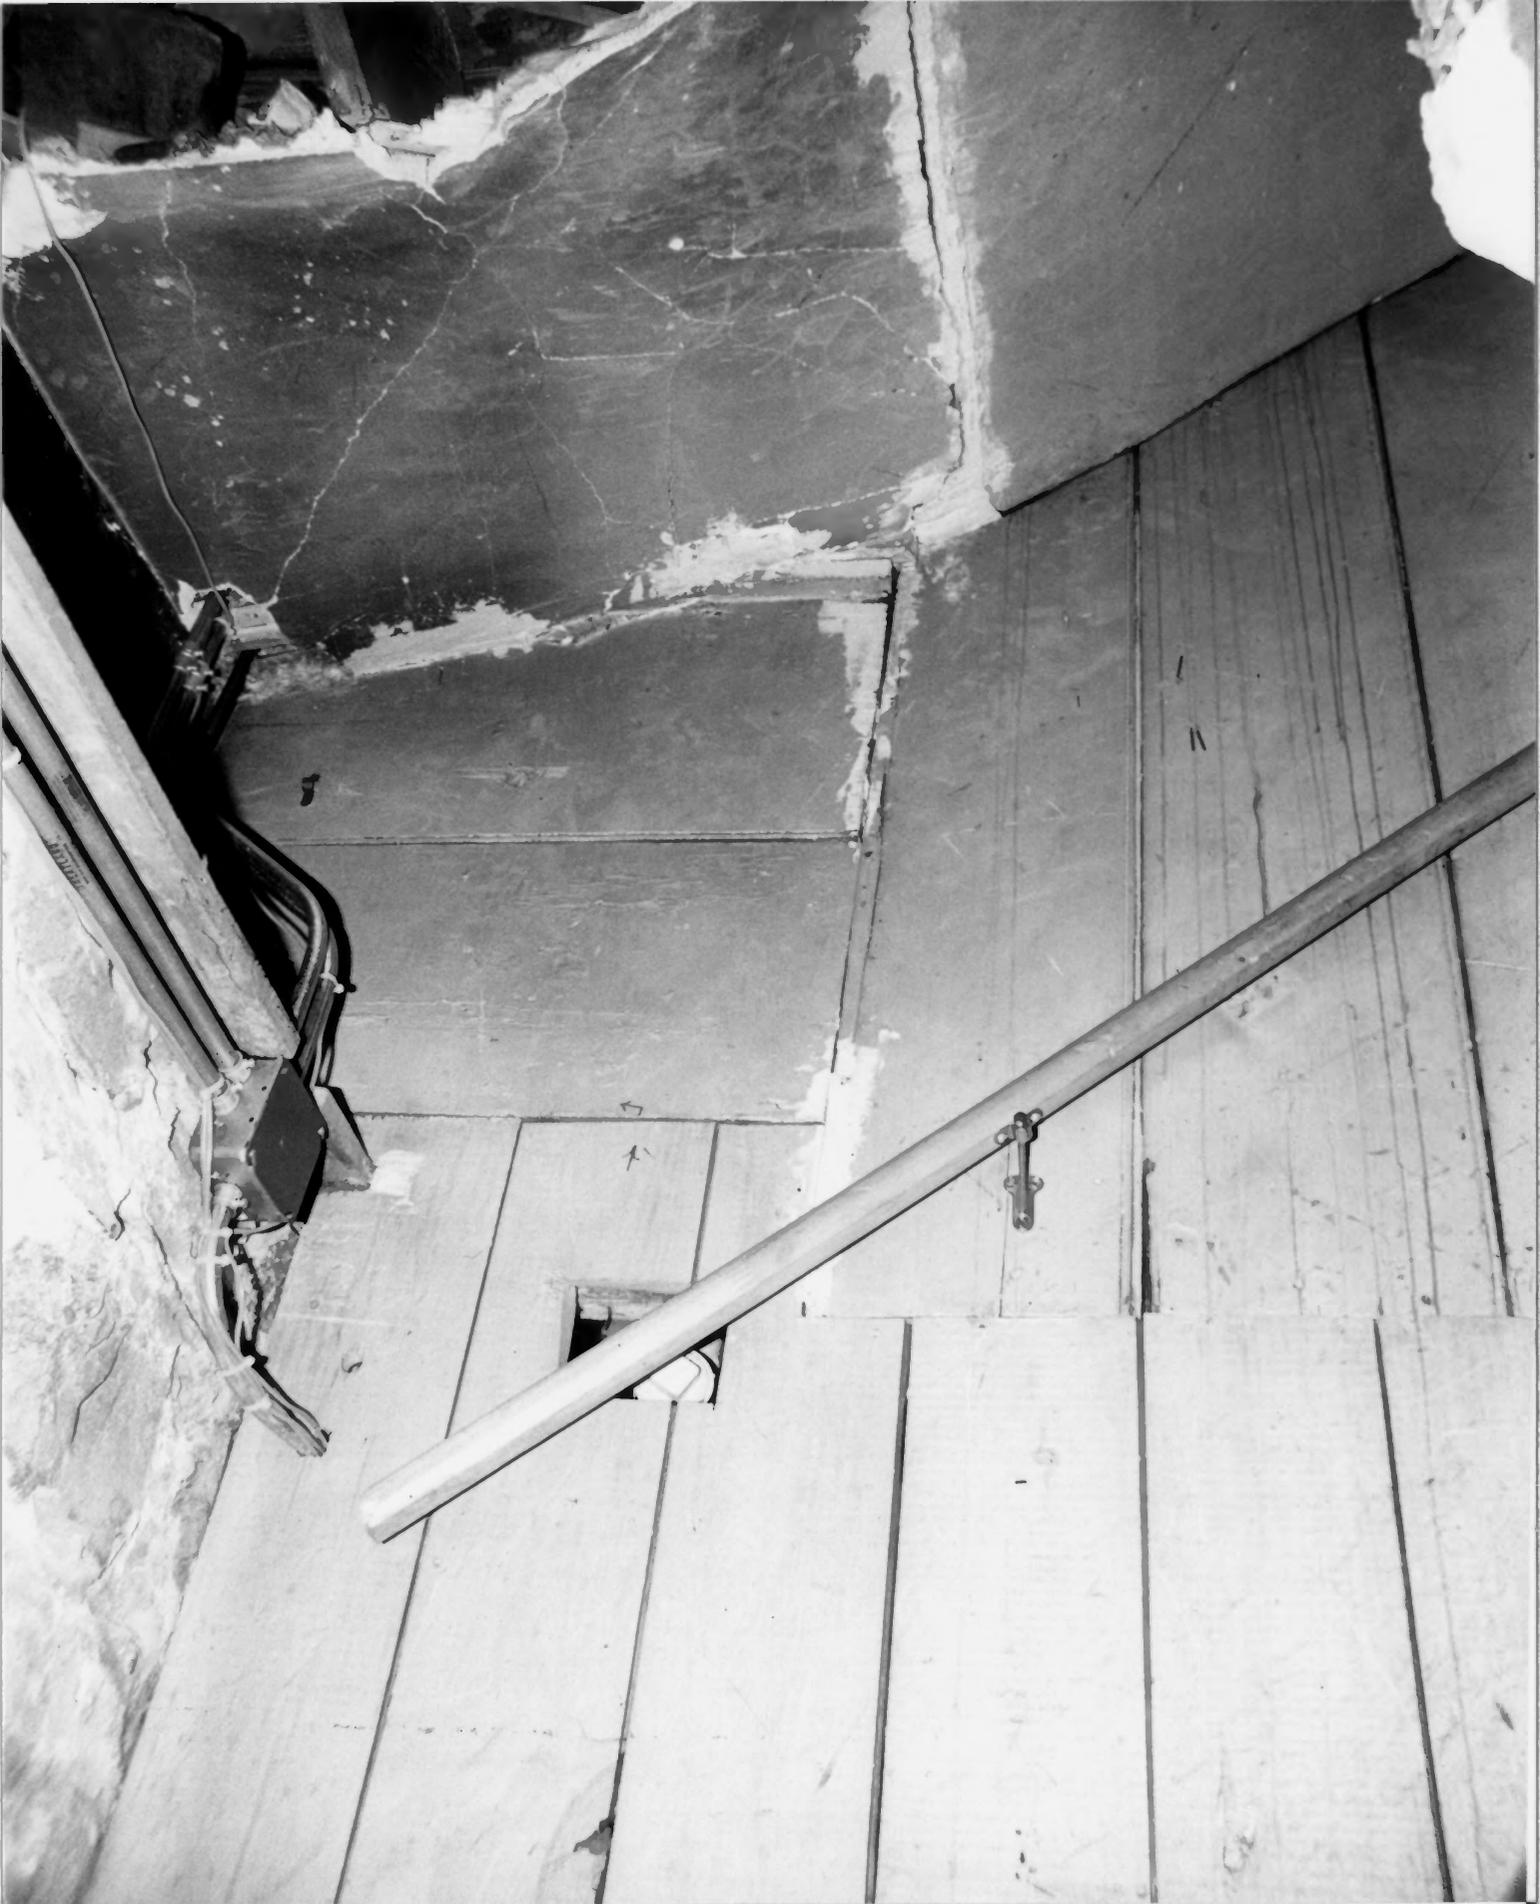
Photograph 15.

Basement stairwell in central portion, north side of building as viewed from the basement floor level.

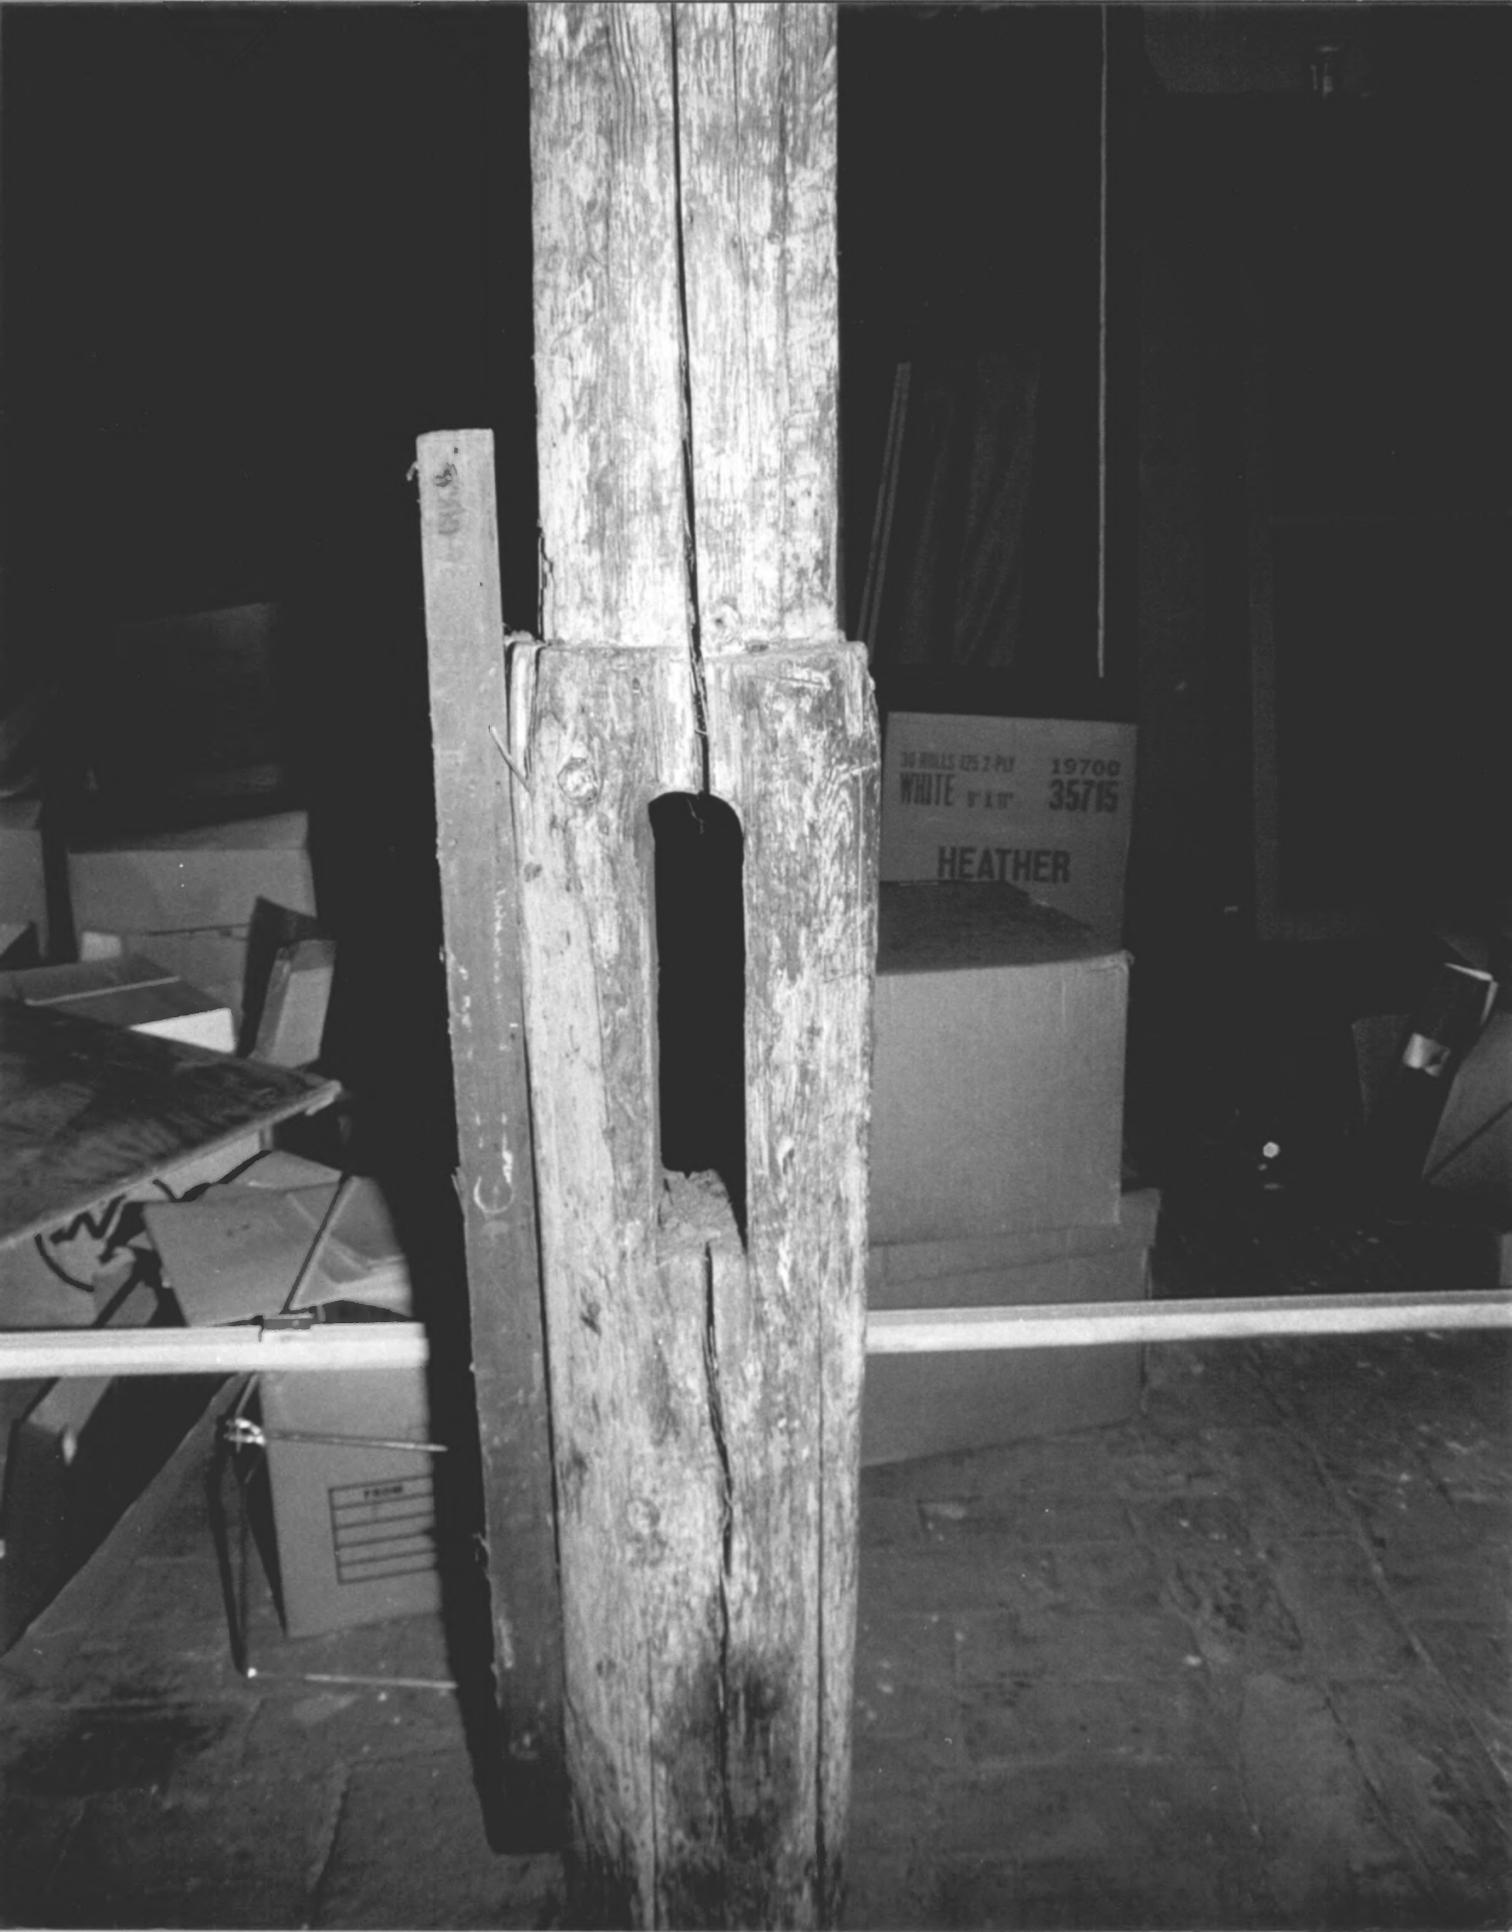
Photograph 16.

Reused structural post in basement level.

Note octagonal shape of upper portion of post  
and chamfered edges of lower portion of post.
