William Pinto-Eli Whitney House  
275 Orange Street, New Haven, Connecticut.

NHPT Photo: 8-19-1984  
Negative filed with Connecticut Historical  
Commission, Hartford, CT.

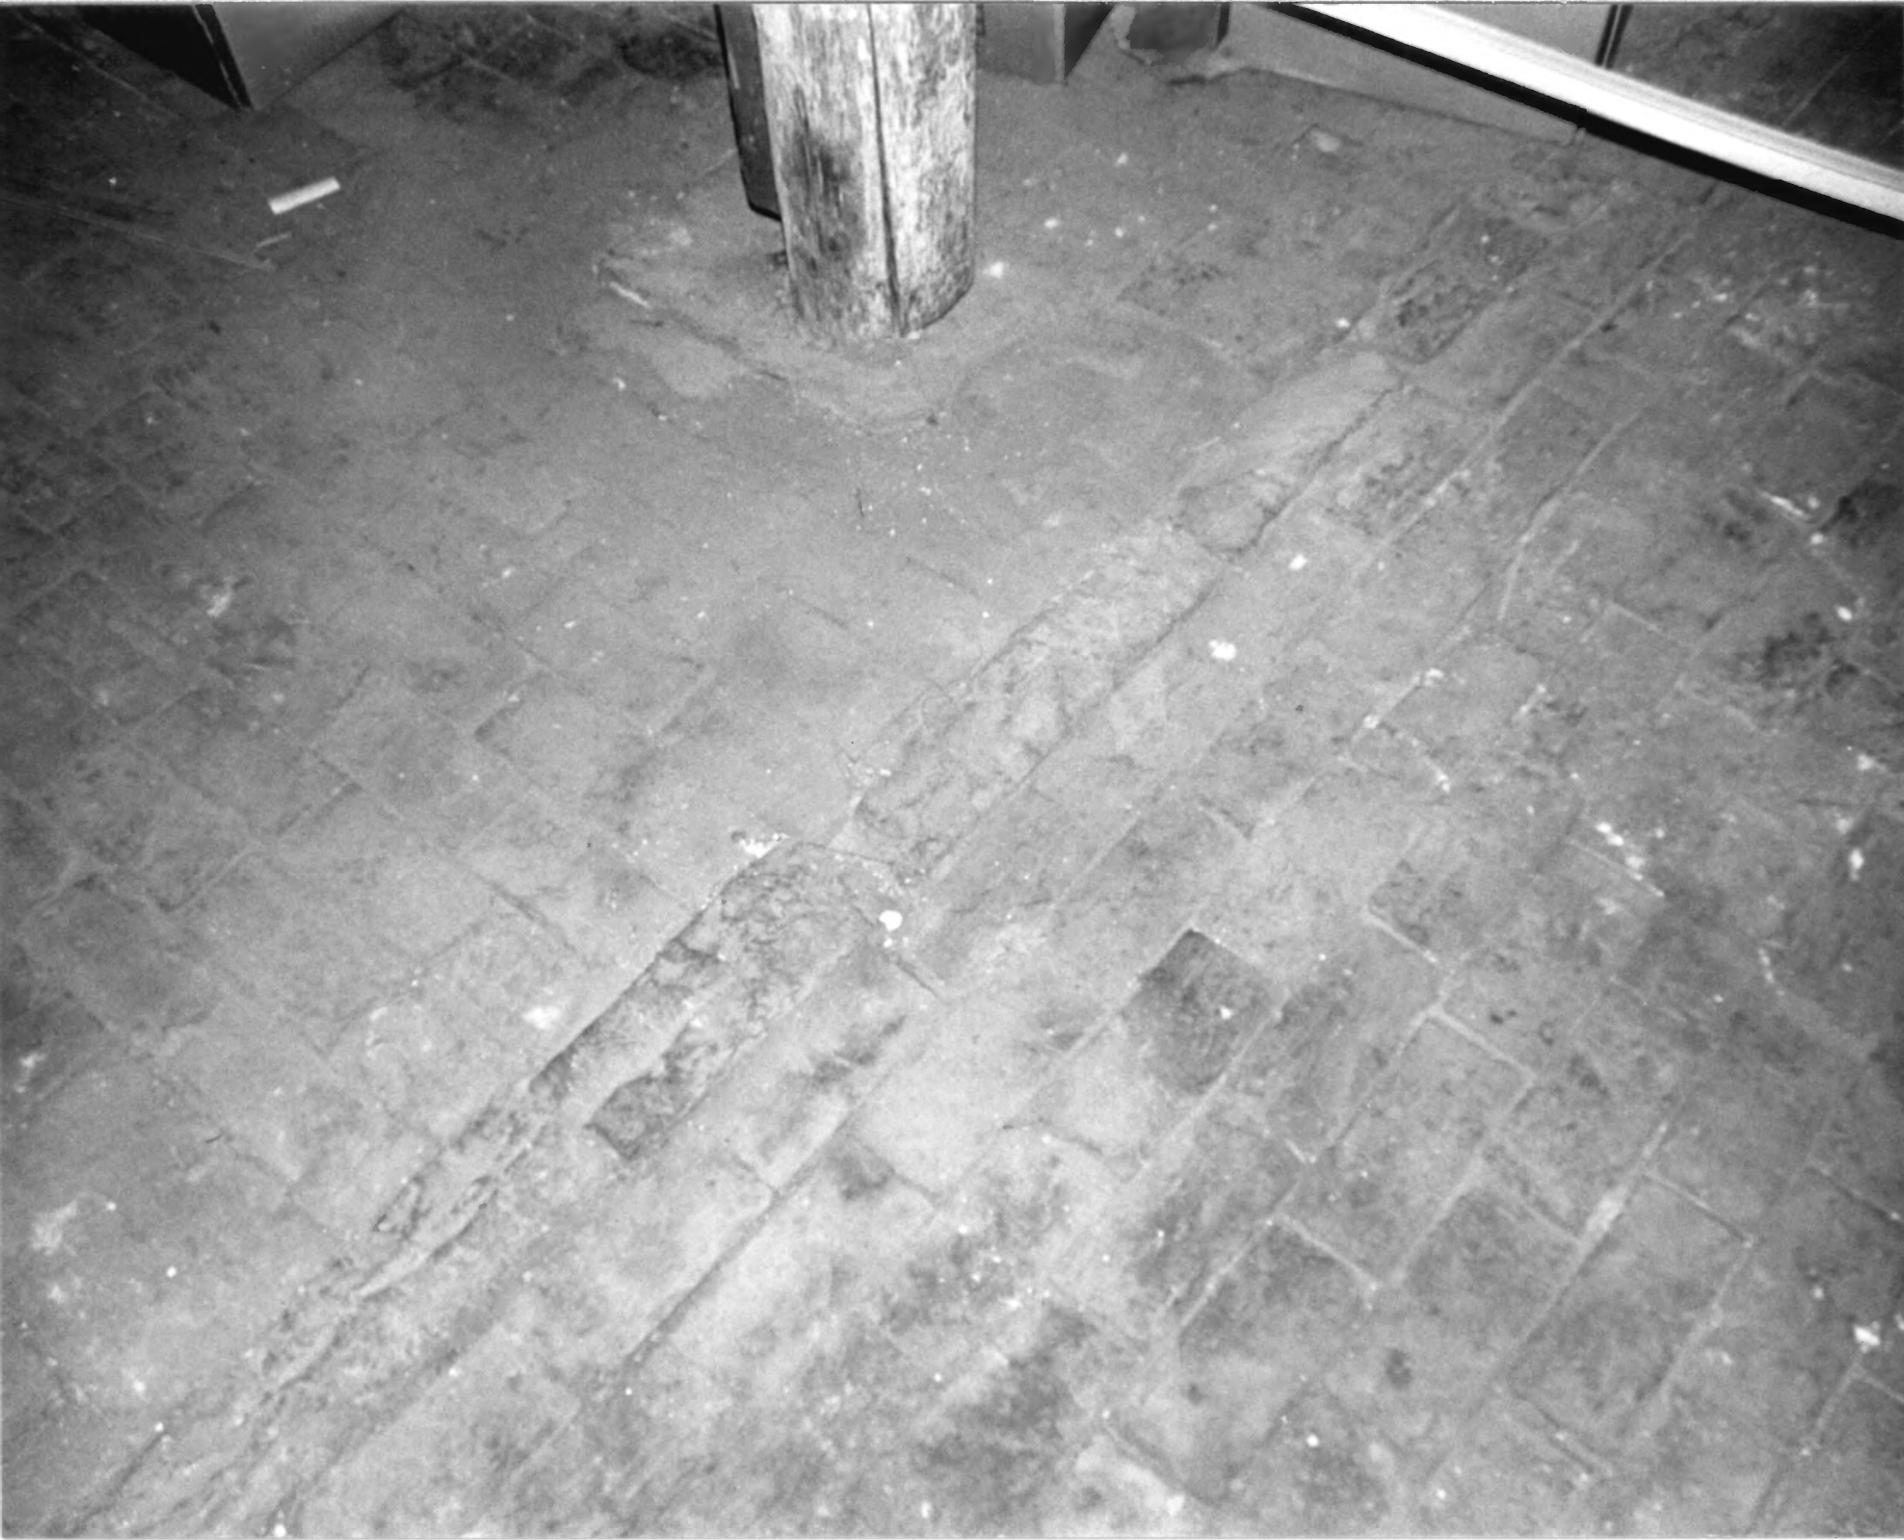
Photograph 17.

Typical view of brick floor in basement level

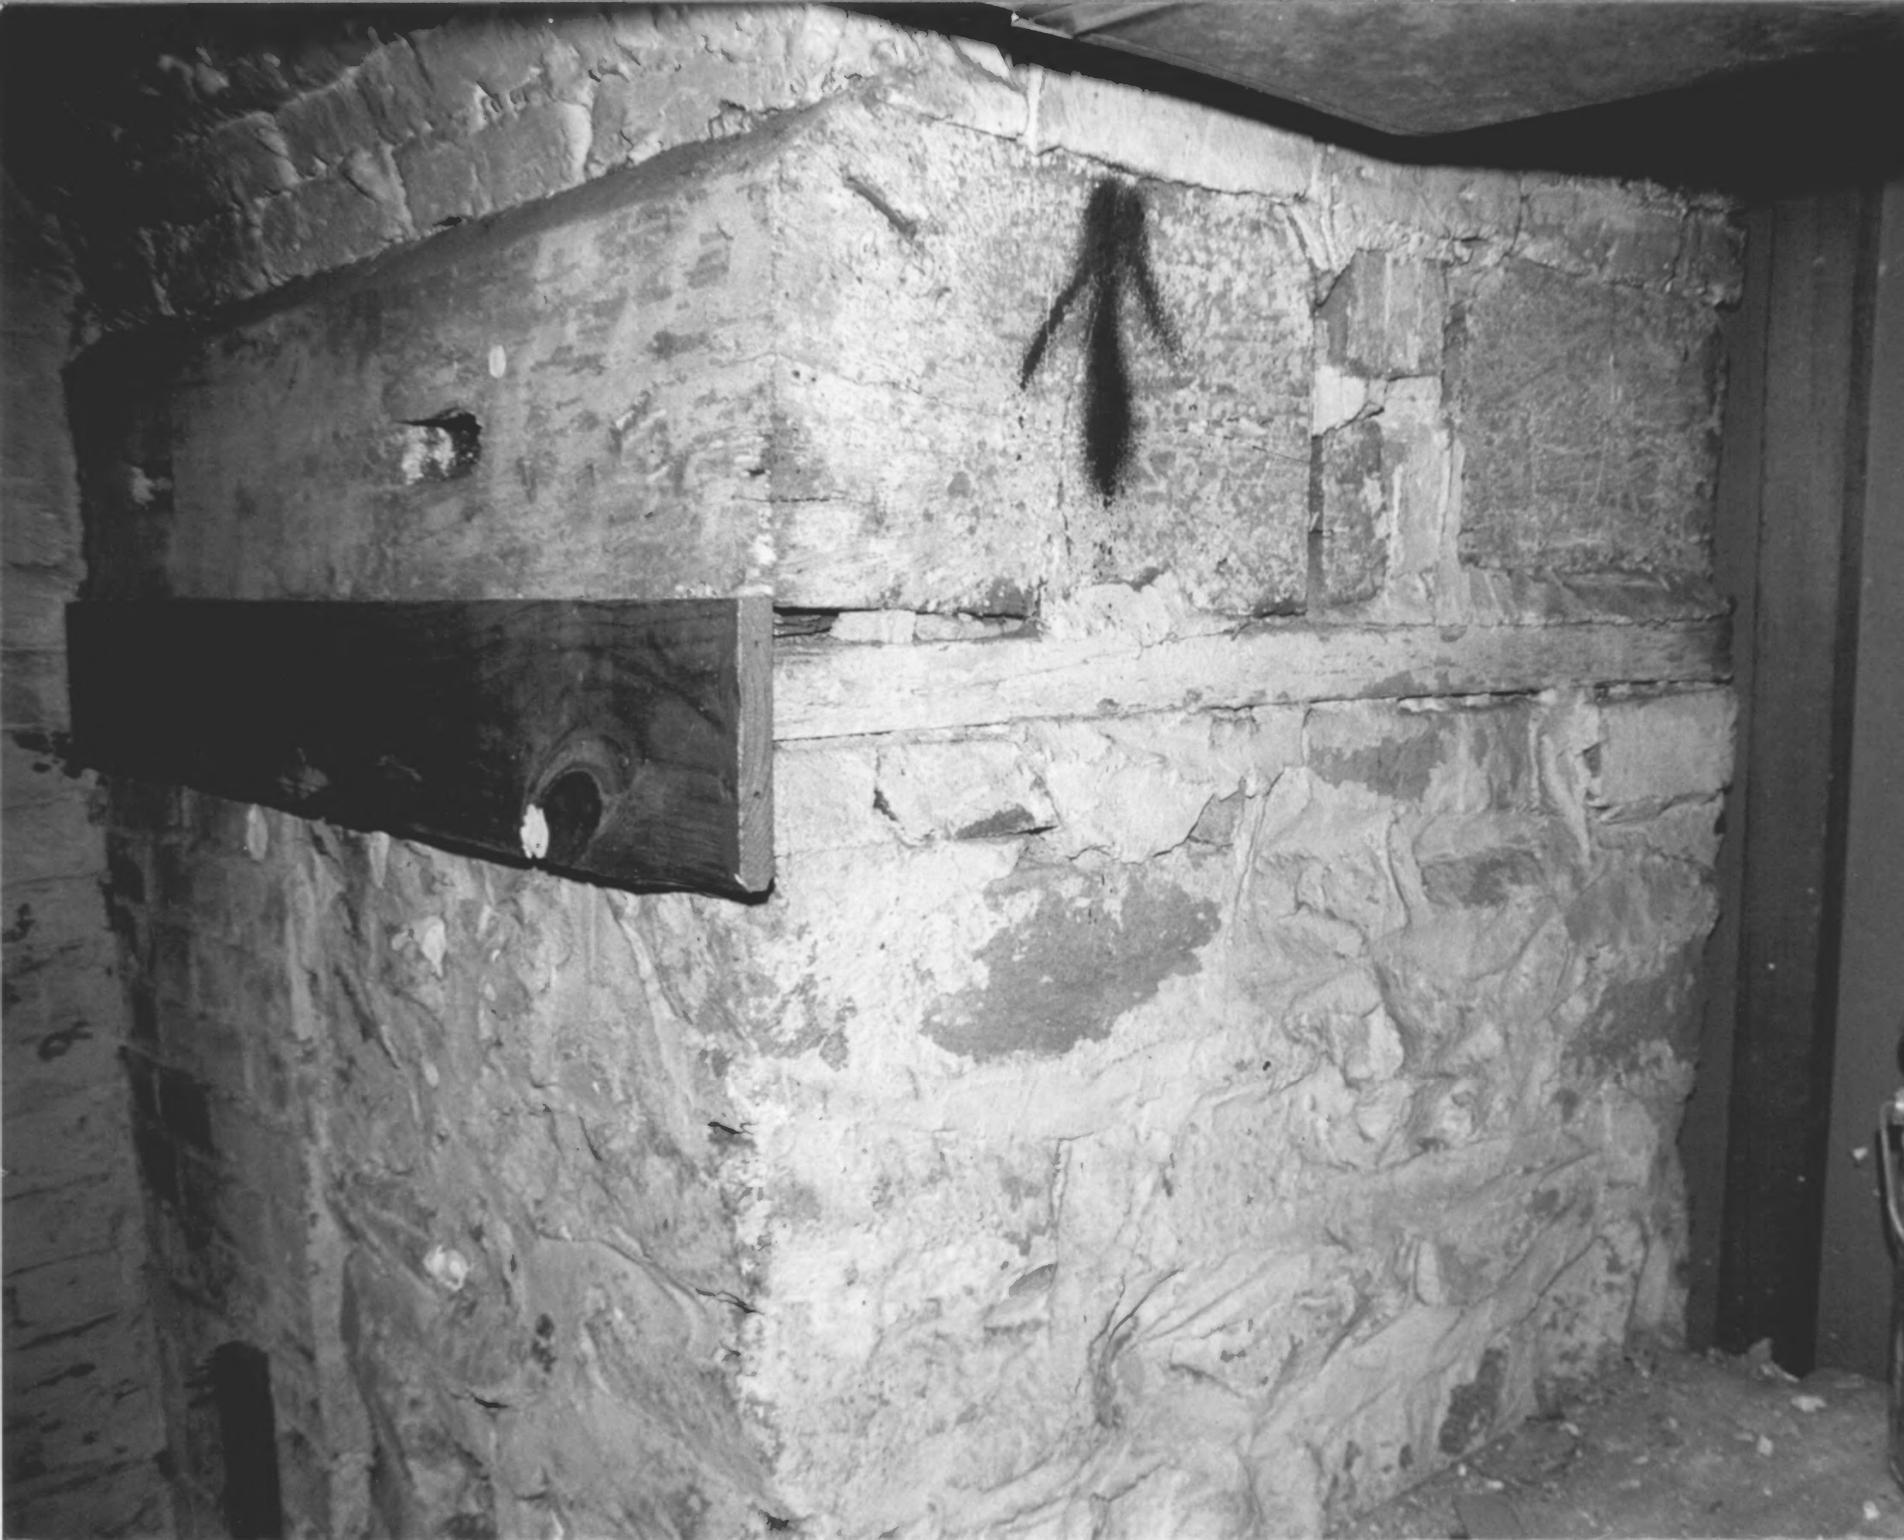
Photograph 18.

Typical chimney-stack base in basement level.
