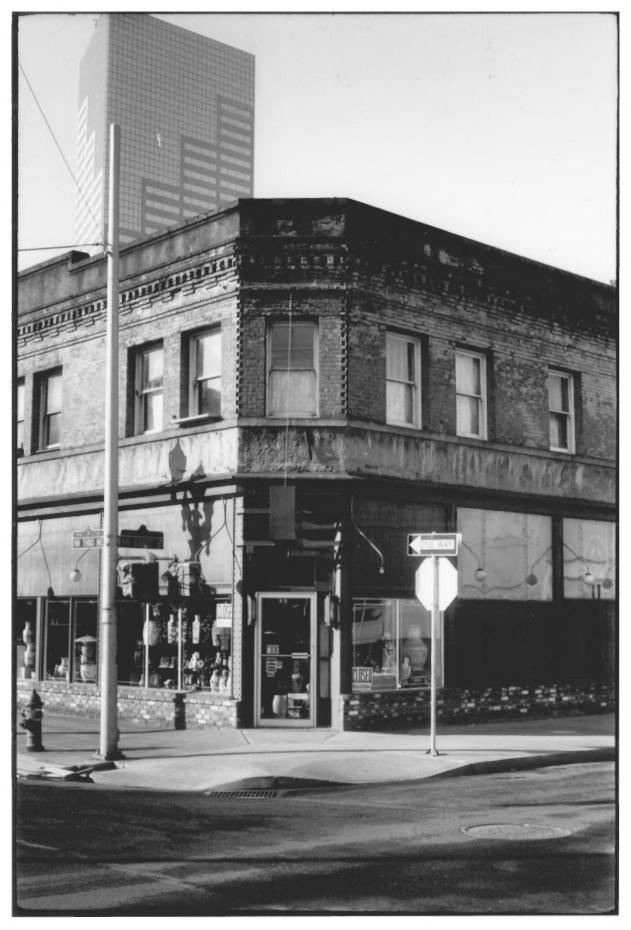
Photograph 1 of 6
Detail of the east side of the corner entrance, showing decorative brick work, stuccoed belt cornice and wood sash windows. Looking west.

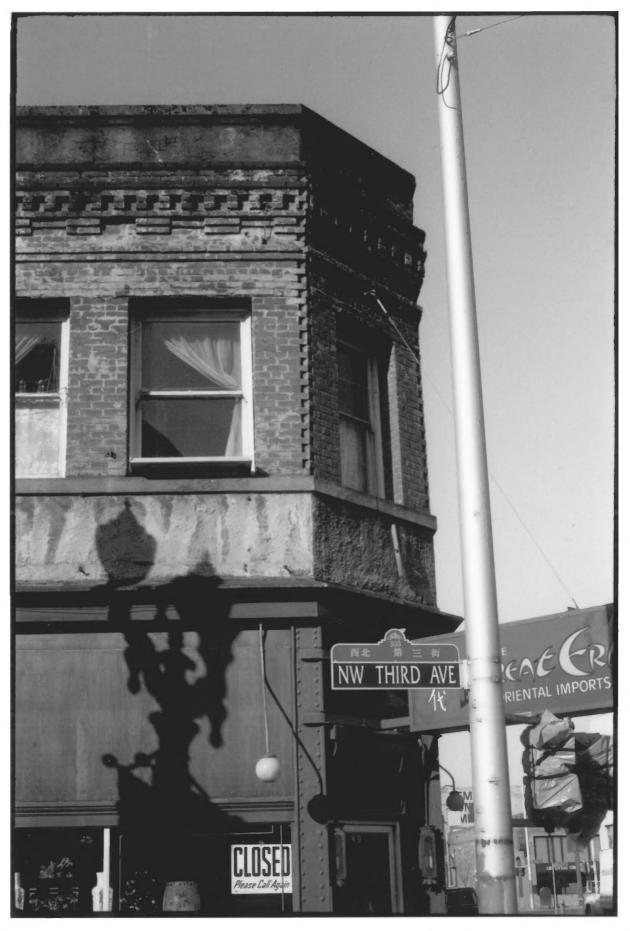
Photograph 2 of 6 Close up of corner entrance and relationship of the steel I-beam ground floor store fronts and the upper floor brick. Looking south.

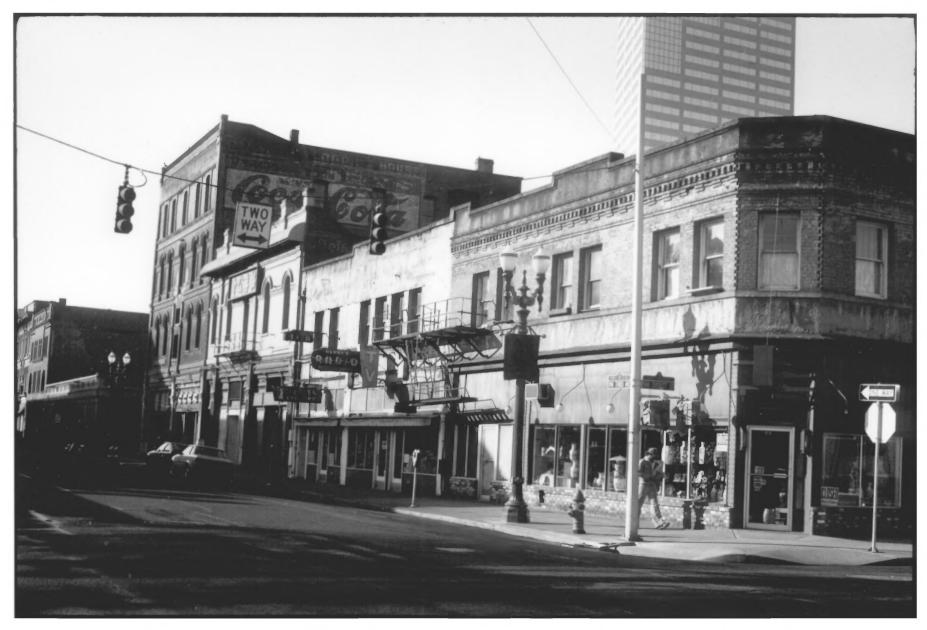
Photograph 3 of 6 Looking south at the north (Everett Street) and east (3rd Avenue) elevations, showing the two story air rights development mid-block on 3rd Avenue, and the window pattern and general building compatibility with remainder of block.

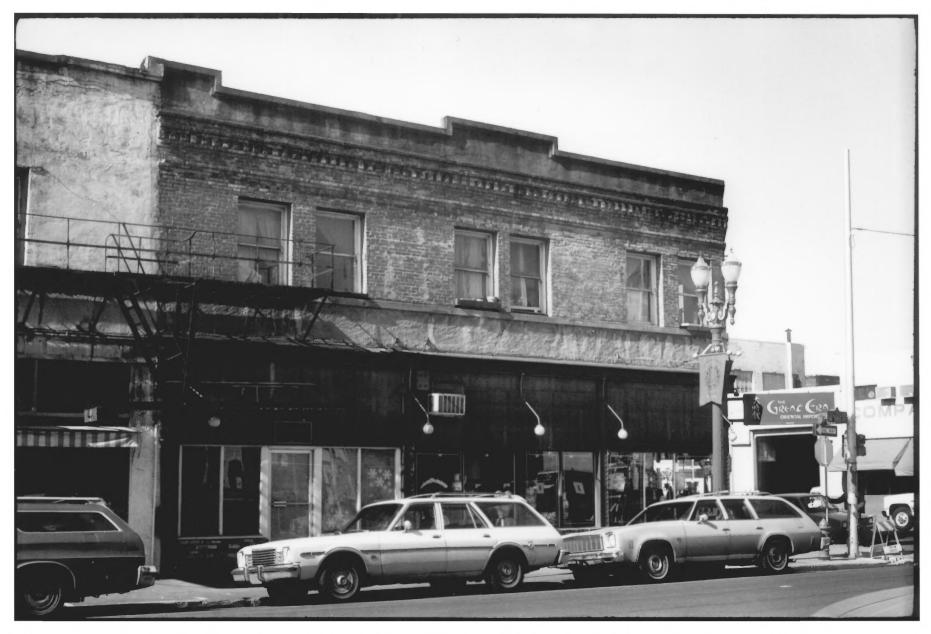
Photograph 4 of 6 The east elevation on 3rd Avenue, looking west, showing the two story air rights development; articulated parapet wall, stone coping and decorative brick work, stringcourse.

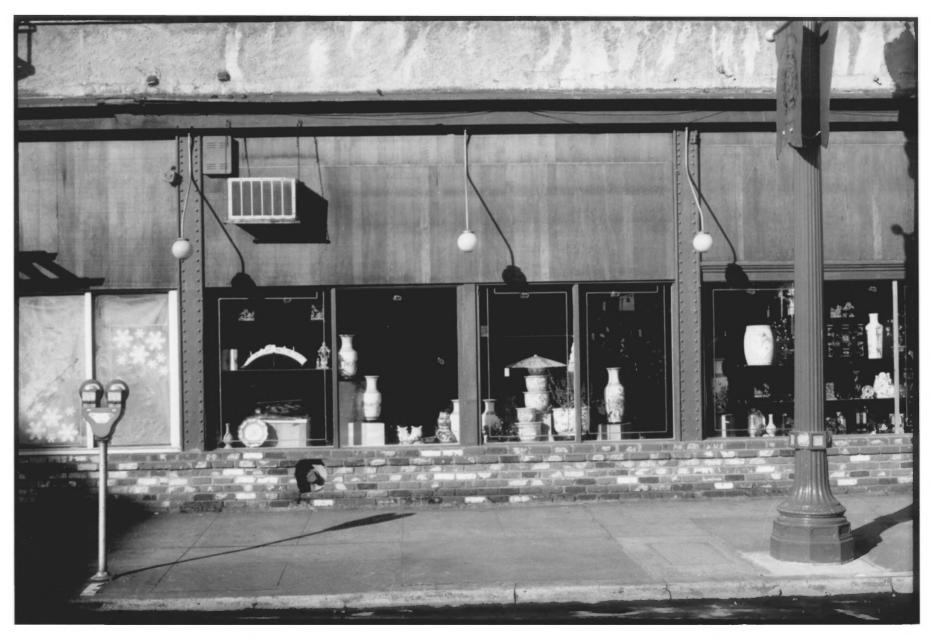
Photograph 5 of 6 View of the 3rd Avenue storefront, showing the structural I-beam columns, with the display window infill; plywood and brick veneer covering original storefront material still existing.

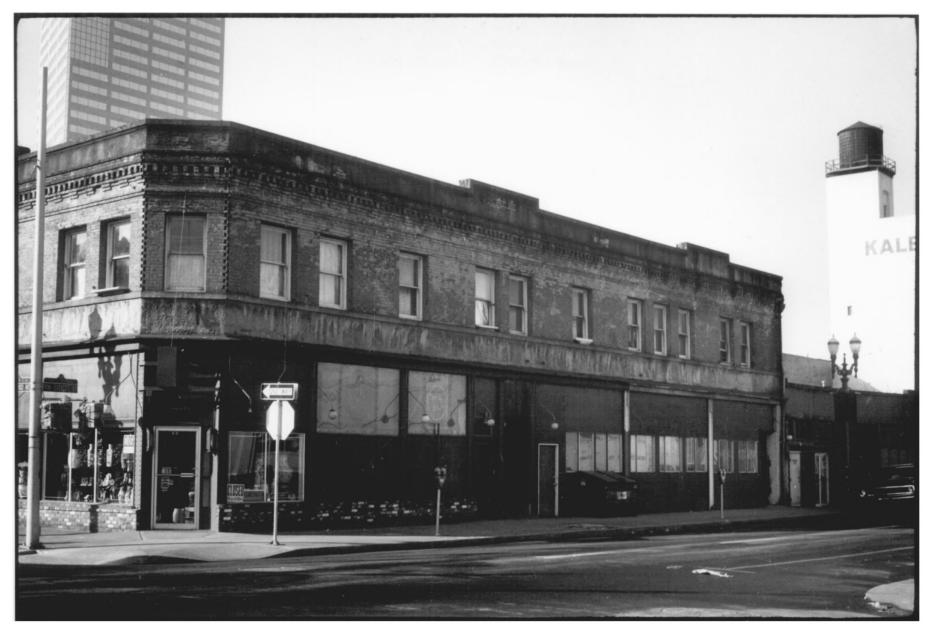
Photograph 6 of 6
The north elevation (Everett Street) looking south, showing the articulated parapet wall, original entrances including the exterior basement entrance location at mid point of the elevation.
