NATIONAL REGISTER OF HISTORIC PLACES
REGISTRATION FORM

historic name: SAN VITORES BEACH FORTIFICATION (66-04-1200)

Name of related multiple property listing: JAPANESE DEFENSE FORTIFICATIONS

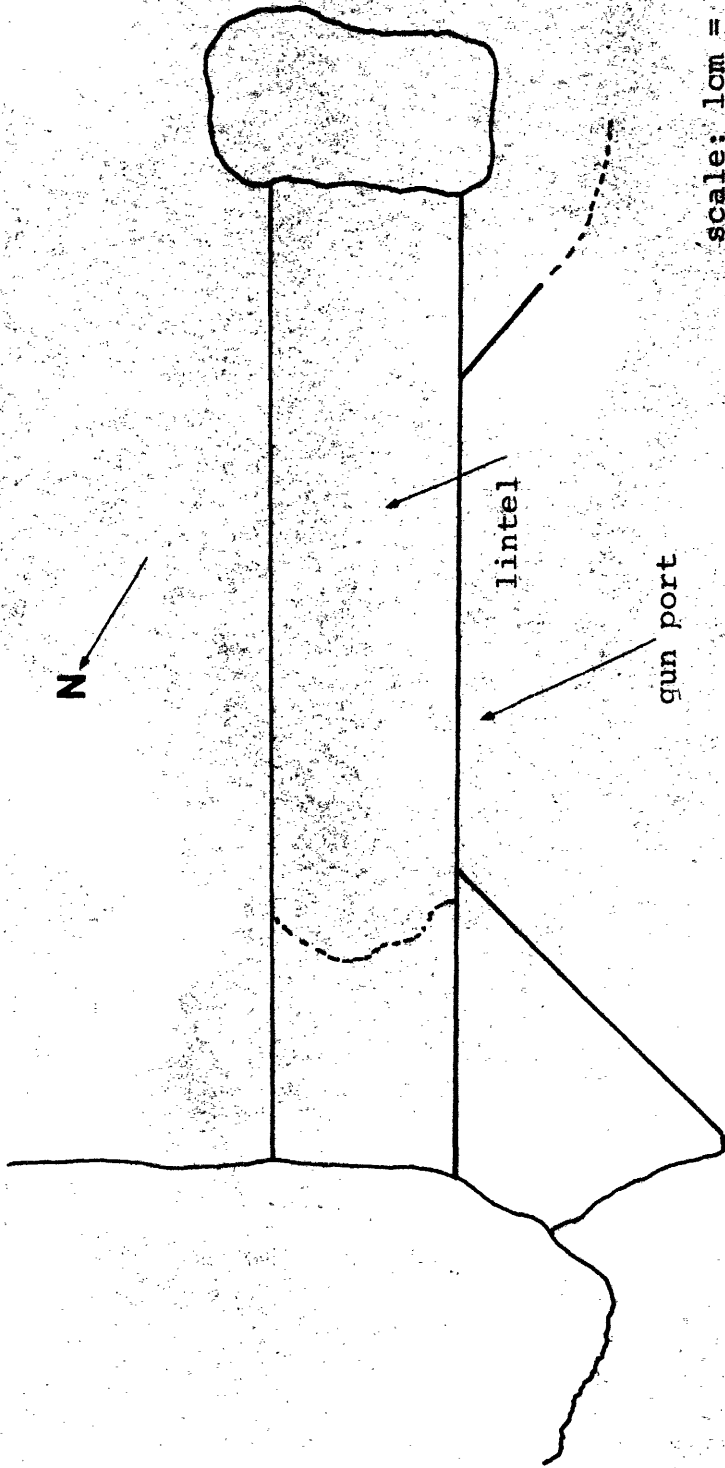
Plan view
Sanvitores Beach ruins, Tumon Bay, Guam

The remains of a pillbox are located on the west side of the limestone cliff of the headland where the Reef Hotel is located. The remains occur next to the stairs leading from the beach to the hotel. The pillbox is situated behind the beach about 10.0m from the high tide line. Built of steel-reinforced concrete, the original shape of the structure is not reconstructable. Only a portion of the gun port remains. The embrasure faces west with a view of the west part of Tumon Bay. The opening of the gun port measures 1.50m wide and 1.36m high. The cement cross beam above the port is .54m thick and .75m wide.

A second cement structure is located about 10.0m to the south of the first. It is 18.0m inland from the high tide line. This feature is built into a niche in the the limestone cliff. Constructed of reinforced concrete, it is also in poor condition. Only a portion of the roof slab, two cement supporting posts, and a secton of the rock-faced wall remain. The original shape of the structure cannot be reconstructed. Steel rebars extrude from the broken edge of the roof which is .31m thick. The sdupporting posts, which are .30m by .30m, extend above present ground surface .63m. the rock wall appears to enclose the north side of the strucutre. The wall is .90m high.
