**HISTORIC RESOURCES INVENTORY  
BUILDING AND STRUCTURES**

1. BUILDING NAME (Common) *Private Residence* (Historic) *Orrin Hoadley House*

3. STREET AND NUMBER (and/or location) *15 Sunset Hill Road Map G7, Block 2, Lot 8; 1 acre*

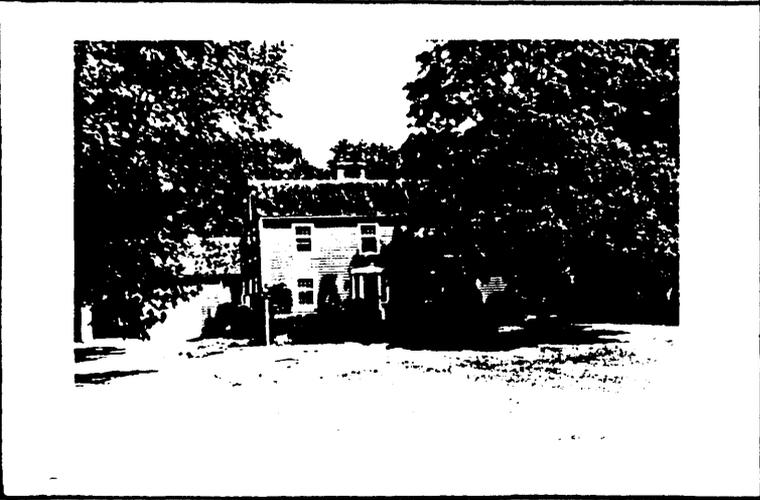
VIEW: South Elevation  
 NEGATIVE ON FILE: CHC-File 2 Neg 11A

Constructed on a square plan with its ridge parallel to its facade, this structure has a steeply-pitched roof (45° or 12:12) with a brick-faced, center chimney set back of the ridge. The house has a three-bay, five-window facade with eight-over-twelve sash. The entry has a paneled door flanked by sidelights; its cornice appears to have been altered. The gable ends have five windows, the east end has received a large one-story addition. The house has several additions constructed during the mid-twentieth century. Its exterior appears to have been restored during the same time.
