**HISTORIC RESOURCES INVENTORY
BUILDING AND STRUCTURES**

1. BUILDING NAME (Common) <i>(Historic)</i> Ezekiel Woodruff House	
2. TOWN/CITY Southington	VILLAGE Southington 06489
3. STREET AND NUMBER (and/or location) 1152 East Street (map 88, parcel 7) 0.8 acre	
4. OWNER(S) Hamilton, Sheila E. (vol.286,p.760) <input type="checkbox"/> Public <input checked="" type="checkbox"/> Private	
5. USE (Present) Residential	<i>(Historic)</i> Residential
6. ACCESSIBILITY TO PUBLIC: <input checked="" type="checkbox"/> Yes <input type="checkbox"/> No	EXTERIOR VISIBLE FROM PUBLIC ROAD <input type="checkbox"/> Yes <input checked="" type="checkbox"/> No
INTERIOR ACCESSIBLE <input type="checkbox"/> Yes <input checked="" type="checkbox"/> No	
IF YES, EXPLAIN N.A.

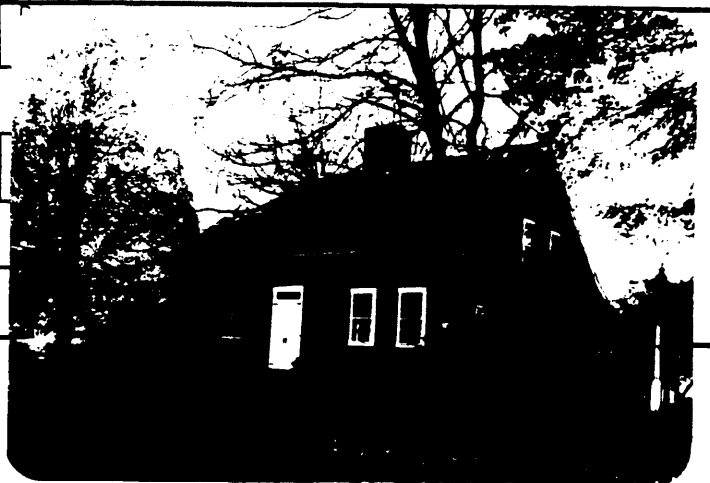
X-29

11. NUMBER OF STORIES 1	APPROXIMATE DIMENSIONS 38 x 35'	
12. CONDITION (Structural) <i>(Exterior)</i>		
<input type="checkbox"/> Excellent	<input checked="" type="checkbox"/> Good	<input type="checkbox"/> Fair
<input type="checkbox"/> Deteriorated	<input type="checkbox"/> Excellent	<input checked="" type="checkbox"/> Good
<input type="checkbox"/> Fair	<input type="checkbox"/> Fair	<input type="checkbox"/> Deteriorated

The 5-bay front elevation has central door flanked by 6/6 windows in plain frames. The door has six transom lights. There is a central brick chimney, and a large brownstone slab in front of the front door.
