## NORTH CASCADES NATIONAL PARK

NAME(S) OF STRUCTURE/SITE BRIDGE CREEK SHELTER			DATE OF CONSTRUCTION	SITE ID. NO.					
SITE ADDRESS/LOCATION	Bridge Creek Campground, off Stehekin Valley Road		<i>c. 1938</i> Addition(s)	SCALE 1:24000 UTM ZONE	EASTIN	QUAD NAME McGregor Mour		HING	00
DISTRICT Stehekin OWNER/ADMIN ADDRESS	COUNTY <u>Chelan</u> National Park Service	STATE Washington		CROSS REF DANGER OF (SPECIFY 1	ERENCE DEMOLI	TION?			IV- 11
DESCRIPTION AND BACKGROUND HISTORY INCLUDING CONSTRUCTION DATE(S), PHYSICAL DIMENSIONS, MATERIALS, MAJOR ALTERATIONS, IMPORTANT BUILDERS, ARCHITECTS, ENGINEERS, ETC. Shelter. Wood frame set on log and rock foundation; square			CURRENT USE Shelter	ORIGINAL USE Shelter

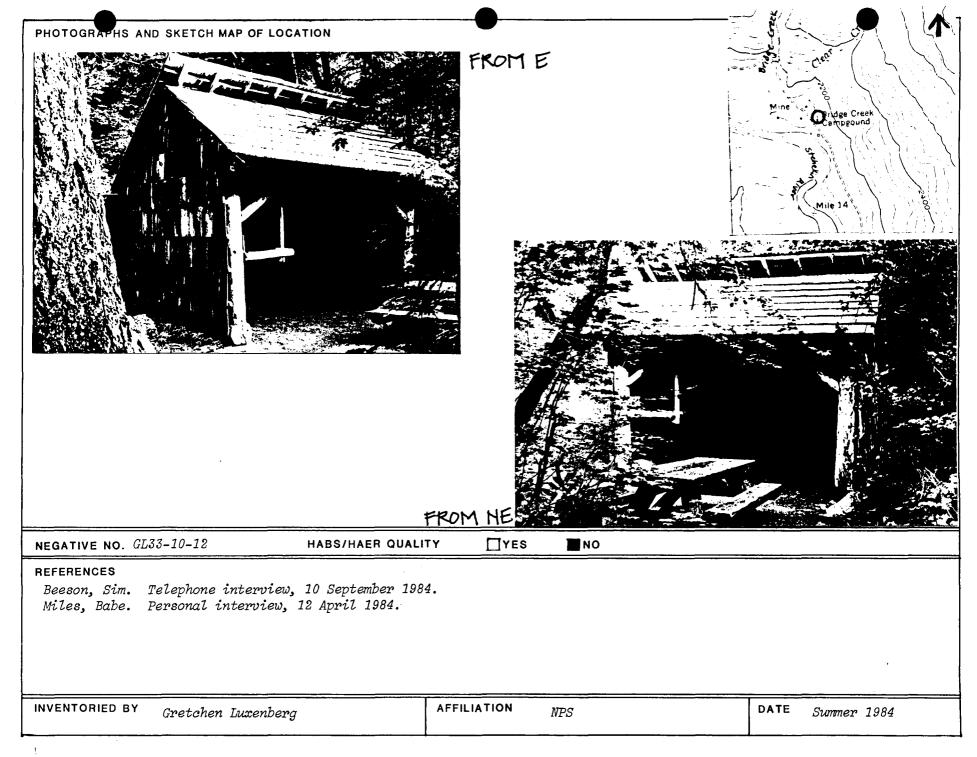
(14' x 14'); 1-story; wood shake siding (on 3 sides) over round log construction; wood-shaked saltbox roof with slightly extended eaves and extended ridgeline; entrance opening on northeast. Exterior features include exposed log purlins and rafters.

PUBLIC VES, LIMITED		EXISTING SURVEYS		HABS D'NHL	□LCS □NPS	□,STATE □county	DLOCAL Dother
LOCATED IN AN YES HISTORIC DISTRICT? NAME	NO	<u> </u>	CONDITION	C EXCELL	ENT [	FAIR DETERIORATED
