National Register of Historic Places Registration Form

historic name Herring, Donald Grant Estate
other names/site number _____

Donald Grant Herring Estate, Princeton
Township, Mercer County, NJ

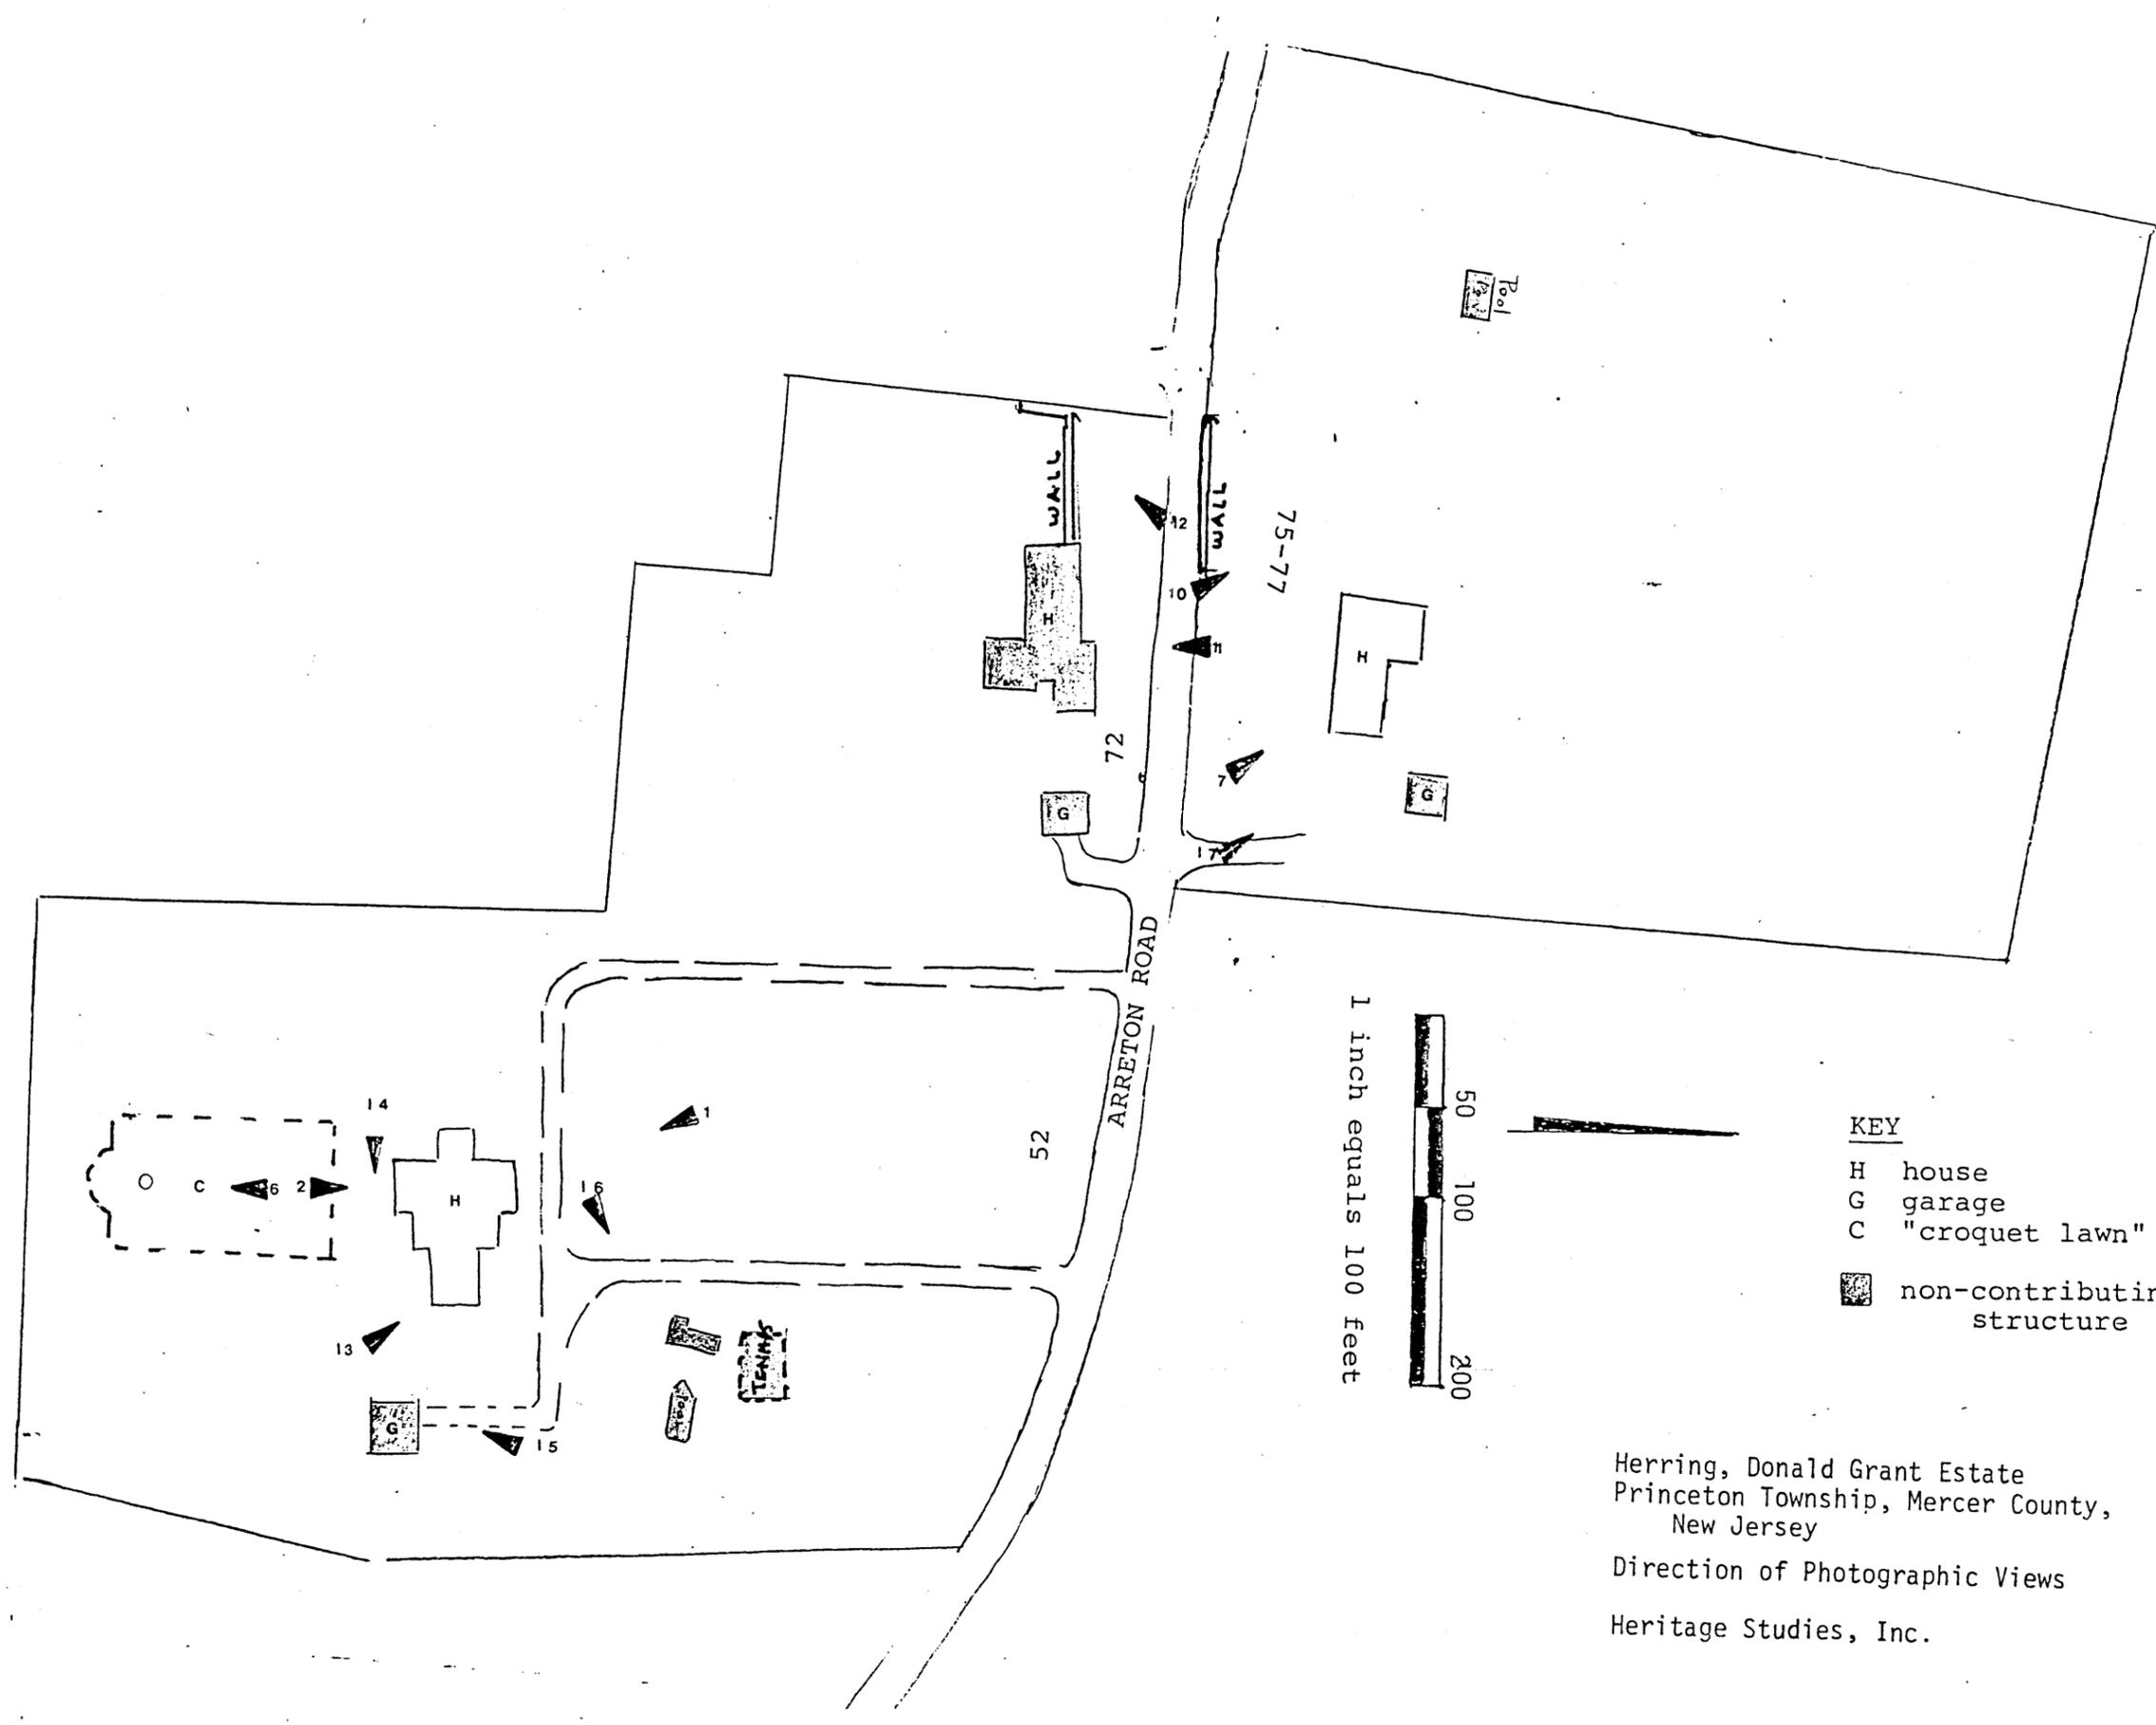
Direction of Photographic Views

- H house
- G garage
- C "croquet lawn"
- non-contributing building or structure
