# National Register of Historic Places Registration Form

1. Name of Property
historic nameJACOBUS VANDERVEER HOUSE
other names/site number KNOX HOUSE
2. Location
street & number U.S. Routes 202 and 206, n. of River Road NA not for publication
city or town Pluckemin, Bedminster Township
state New Jersey code 034 county Somerset code 035 zip code 07978

J	acobus	Vanderveer	House
	Name of Pro

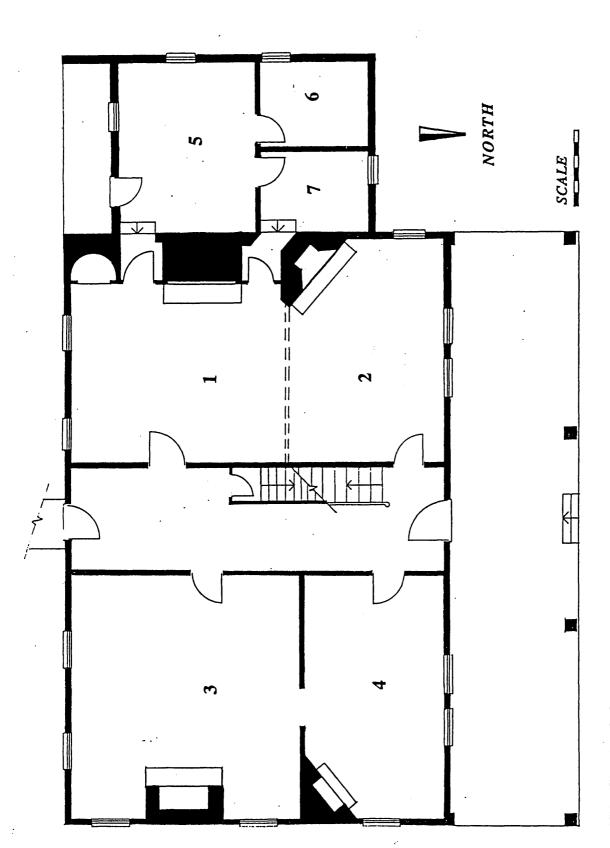
FIRST FLOOR PLAN

JACOBUS VANDERVEER HOUSE, BEDMINSTER TOWNSHIP, SOMERSET COUNTY, N.J.

The southern room (Room 1) is entered from the hallway through an original five-panel door. (Photo 6) A few massive beams, finished and meant to be exposed, span from front to back. (Photo 7) These suggest that the framing of the building is Dutch, although further investigative probing of the garret and roof framing would be necessary to establish its character with certainty. Like the rest of the first floor, the flooring of wide pine boards is original. A hefty chair rail marks the east and south walls and forms the sills of the windows. (A plate rail, which also runs along these walls is a late 19th or early 20th century addition.) The west wall, with fireplace at the center, is fully paneled. (Photos 8 and 9) The firebox has been bricked up to accommodate a stove flue. The style of the mantel, framed with unusual attenuated colonnettes and a frieze with center panel, suggests that it is an early 19th century addition. To the left of the fireplace are a five-panel door and fine arched, barrel-backed cupboard with curved shelves. A similar arched opening to the right of the fireplace now holds a 19th century door. (Photo 10)

investigation. Because there is no indication of cooking facilities elsewhere, some form of kitchen probably always occupied this space. The shed is now occupied by a kitchen and two pantries or store rooms. (Rooms 5, 6 and 7.)

A partition has been removed between the southern and northern rooms, creating one large space. The treatment of the Room 2 is simpler than that of the larger Room 1. While the exposed beams, chair rail and later plate rail are the same, there is no fully paneled wall. The fireplace is in the southwest corner. Although the form of the mantel, with its frieze in the form of a flattened bolection molding, is widely found in central New Jersey in the 18th century, the delicate and slender proportions again suggest that this mantel was added in the early 19th century. (Photo 11) Room 2 has been somewhat more affected by alterations than Room 1. The change in the north windows obviously affects the interior as well as the exterior. In addition, the original doorway opening from the hall was closed up when the stairway was added, and a new, late 19th or early 20th century door was inserted at the north end of the wall dividing this room from the hallway.

The remaining two rooms on the first floor differ markedly in character from those to the west side of the hall. For one thing, their ceilings are about a foot higher, giving a sense of greater amplitude. Elements, such as the six-panel doors, tend to be more vertical. (Photo 12) These rooms also have chair rails, although again these are more delicate in profile than their counterparts across the hall. The southeast room (Room 3) is dominated by the fireplace centered on the east wall. Its mantel, in vernacular Federal style, has a frieze richly embellished with carved and gouged fans, circles and ovals. (Photo 13) Some ornament appears to have been added to this room in Greek Revival style, perhaps in the 1830s. This includes somewhat heavy fluting along the sides of the mantel and overdoor moldings incorporating a Greek fret.

Like the north room across the hall, the northeast room (Room 4) has a corner fireplace ornamented with circles, ovals, diamonds and fans. The treatment is, however, not as elaborate, with far less carving. (Photo 14) This fireplace has been bricked up to enclose a woodburning heater. Also, at some time in the 20th century, a toilet was installed in the northwest corner of the room; presently the room is used for storage.

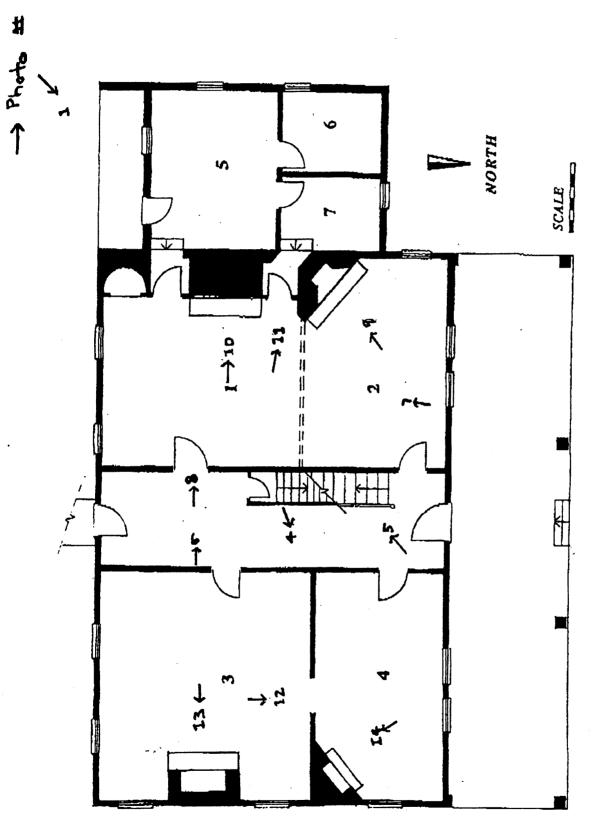
FIRST FLOOR PLAN

JACOBUS VANDERVEER HOUSE, BEDMINSTER TOWNSHIP, SOMERSET COUNTY, N.J. DRAWN 11.18.94 BY ART
