historic name Bordentown Historic District (Boundary Increase)

street & number 1 Spring Street not for publication

city or town Bordentown City vicinity

This boundary increase proposes to add the Eagle Shirt Factory to the Bordentown Historic District, in Bordentown City, Burlington County, New Jersey. The Eagle Shirt Factory is a late-19th-century clothing mill located at 1 Spring Street, which abuts the east side of the district (see district map). The factory is a 3-story, red-brick building, one of several older industrial properties along a Pennsylvania Railroad line that extends northeasterly through Bordentown toward Hightstown, trackage that historically reached South Amboy on the Raritan River. The factory consists of three principal sections: an original building built about 1882, an addition to the south built in 1890, and an addition to the north built between 1924 and 1950. (Sanborn 1886, 1892, 1924, 1950) The building has been vacant since 1980 and parts of the building have deteriorated due to age and deferred maintenance.

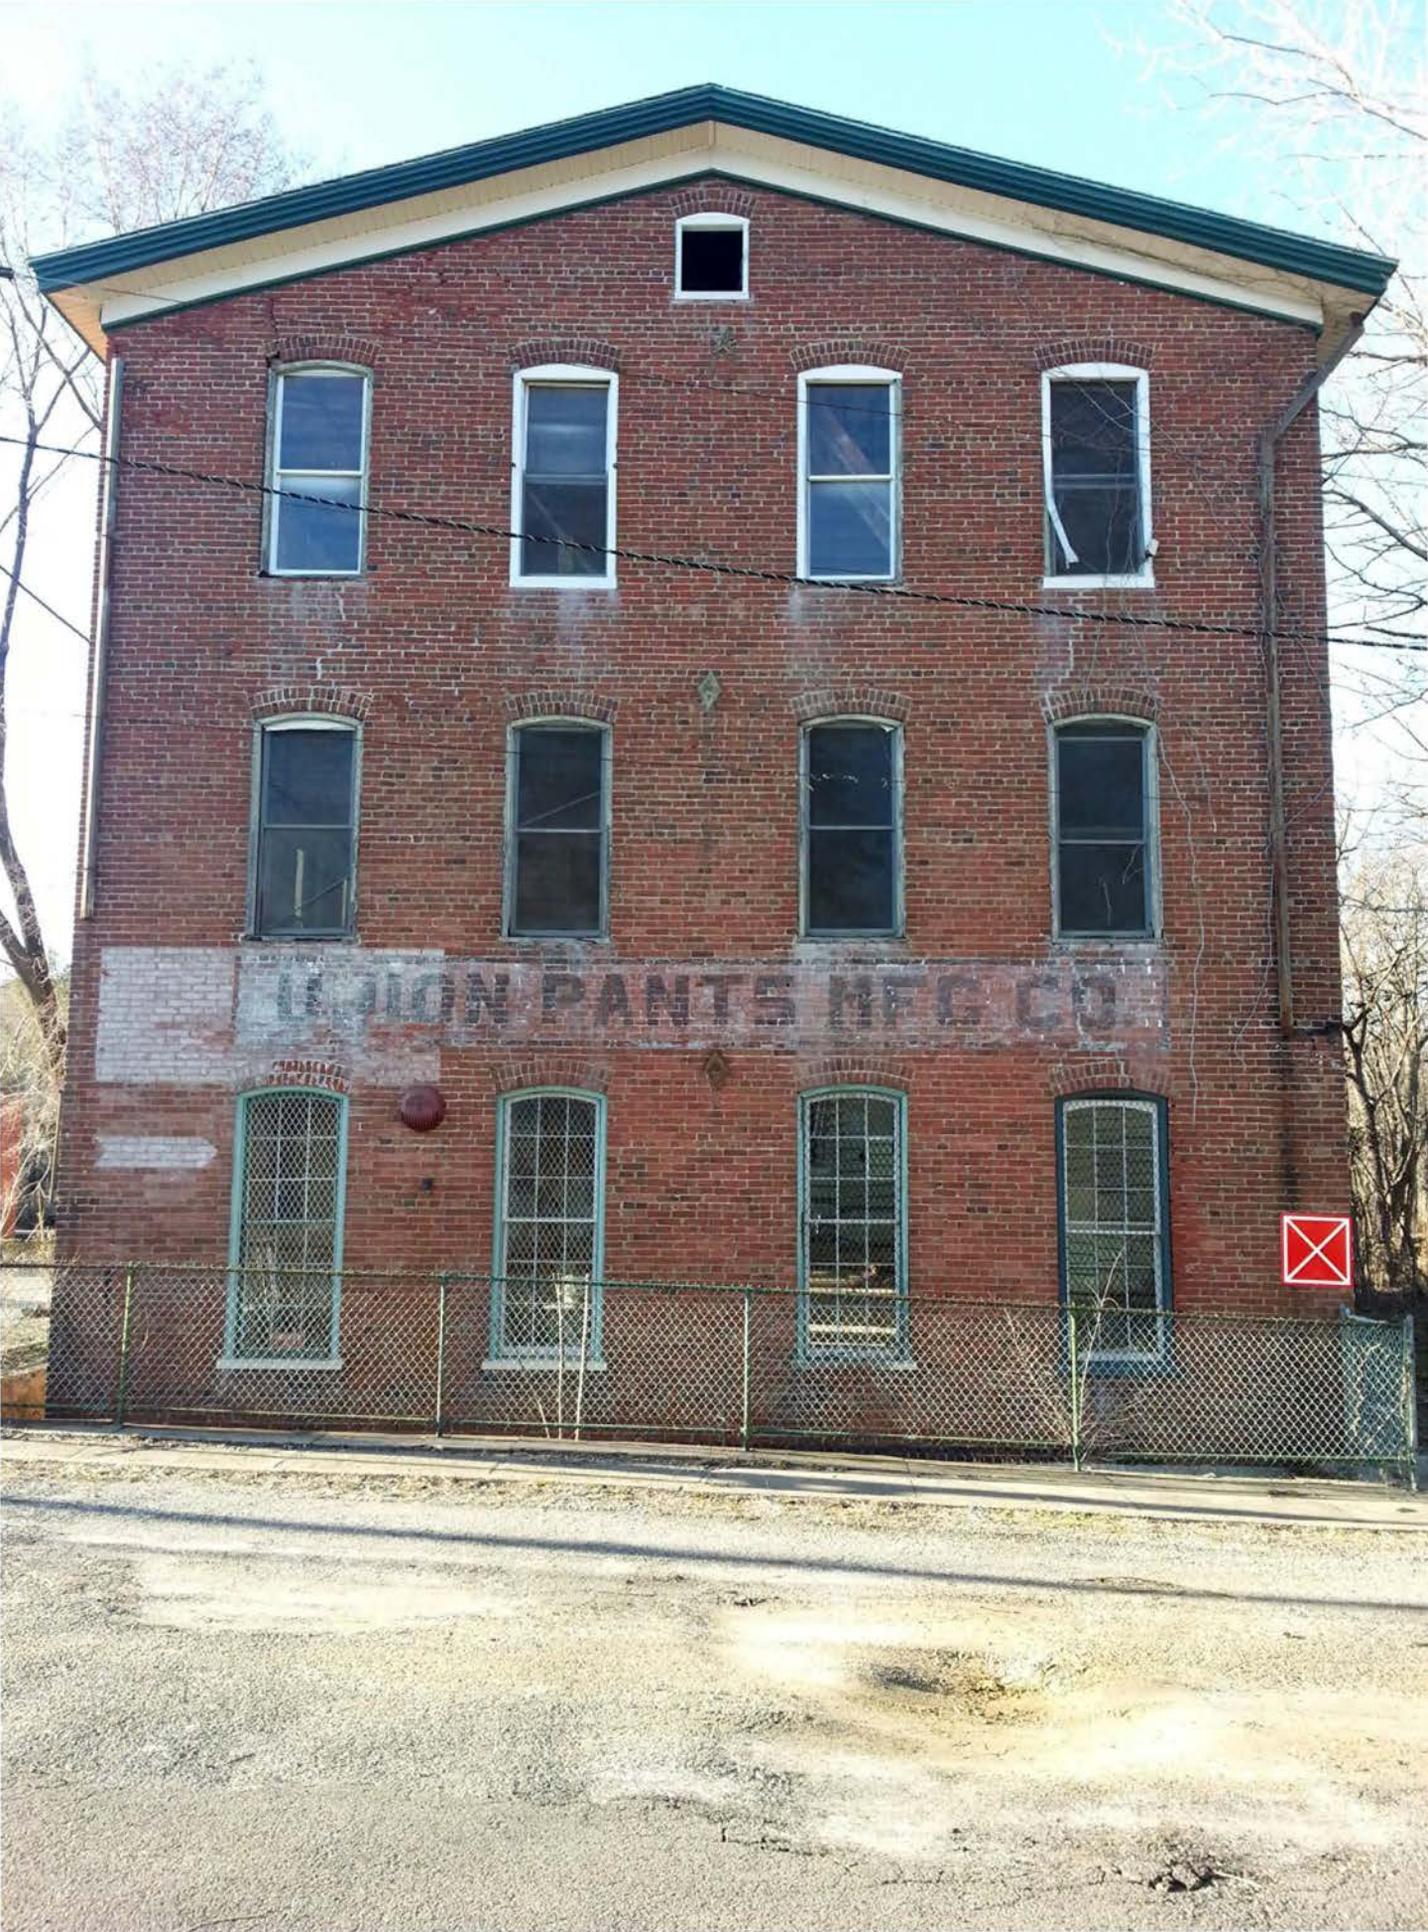
- Photo #1 (NJ_Burlington County_Bordentown Historic District (Boundary Increase)_0001)
South elevation of 1890 addition, camera facing north from Ann Street.

Despite many similarities, no two exterior elevations are alike. The southern elevation along Ann Street is the lower end of the 1890 addition. The elevation is 38' wide and divided into four window bays. (*Photos 1, 9*) The western elevation along Spring Street is 140' in length, and the three sections of the building are discernible. Together they encompass eighteen window bays. The middle section built in 1882 is two bays wide, each bay being considerably wider than those of the additions. The southernmost section, the 1890 addition, is 10 bays wide; the northern addition, built between 1924 and 1950, is 6 bays wide. (*Photo 2, 4*) The northern elevation, nearest the railroad track, is 51' wide and divided into five window bays. (*Photo 4, 5*) The eastern elevation is more differentiated, because the unity that was maintained along the Spring Street (western) side could not also be maintained along the eastern side with each section being a different width. This elevation faces the middle of the block and ranges from 3+1/2 stories above grade at the northern end to three stories above grade at the southern end. (*Photos 6,7,9*) The eastern elevation of the northern addition mirrors the western elevation of this addition along Spring Street. The grade around the building is lower on the eastern side and the eastern elevation has steel panels within masonry openings at the basement level. These steel panels are the same width as windows above, but are 48" high. The central portion of the eastern elevation is the 1882 original building. The openings at the 1st floor level have been infilled with brick. There is a metal door in this portion adjacent to the northern addition set between the 1st floor and basement levels. The 1890 portion varies in width. The portion adjacent to the 1882 original building is the same width as the original building, but steps back at the southern end. The portion that is stepped back has a similar window pattern to

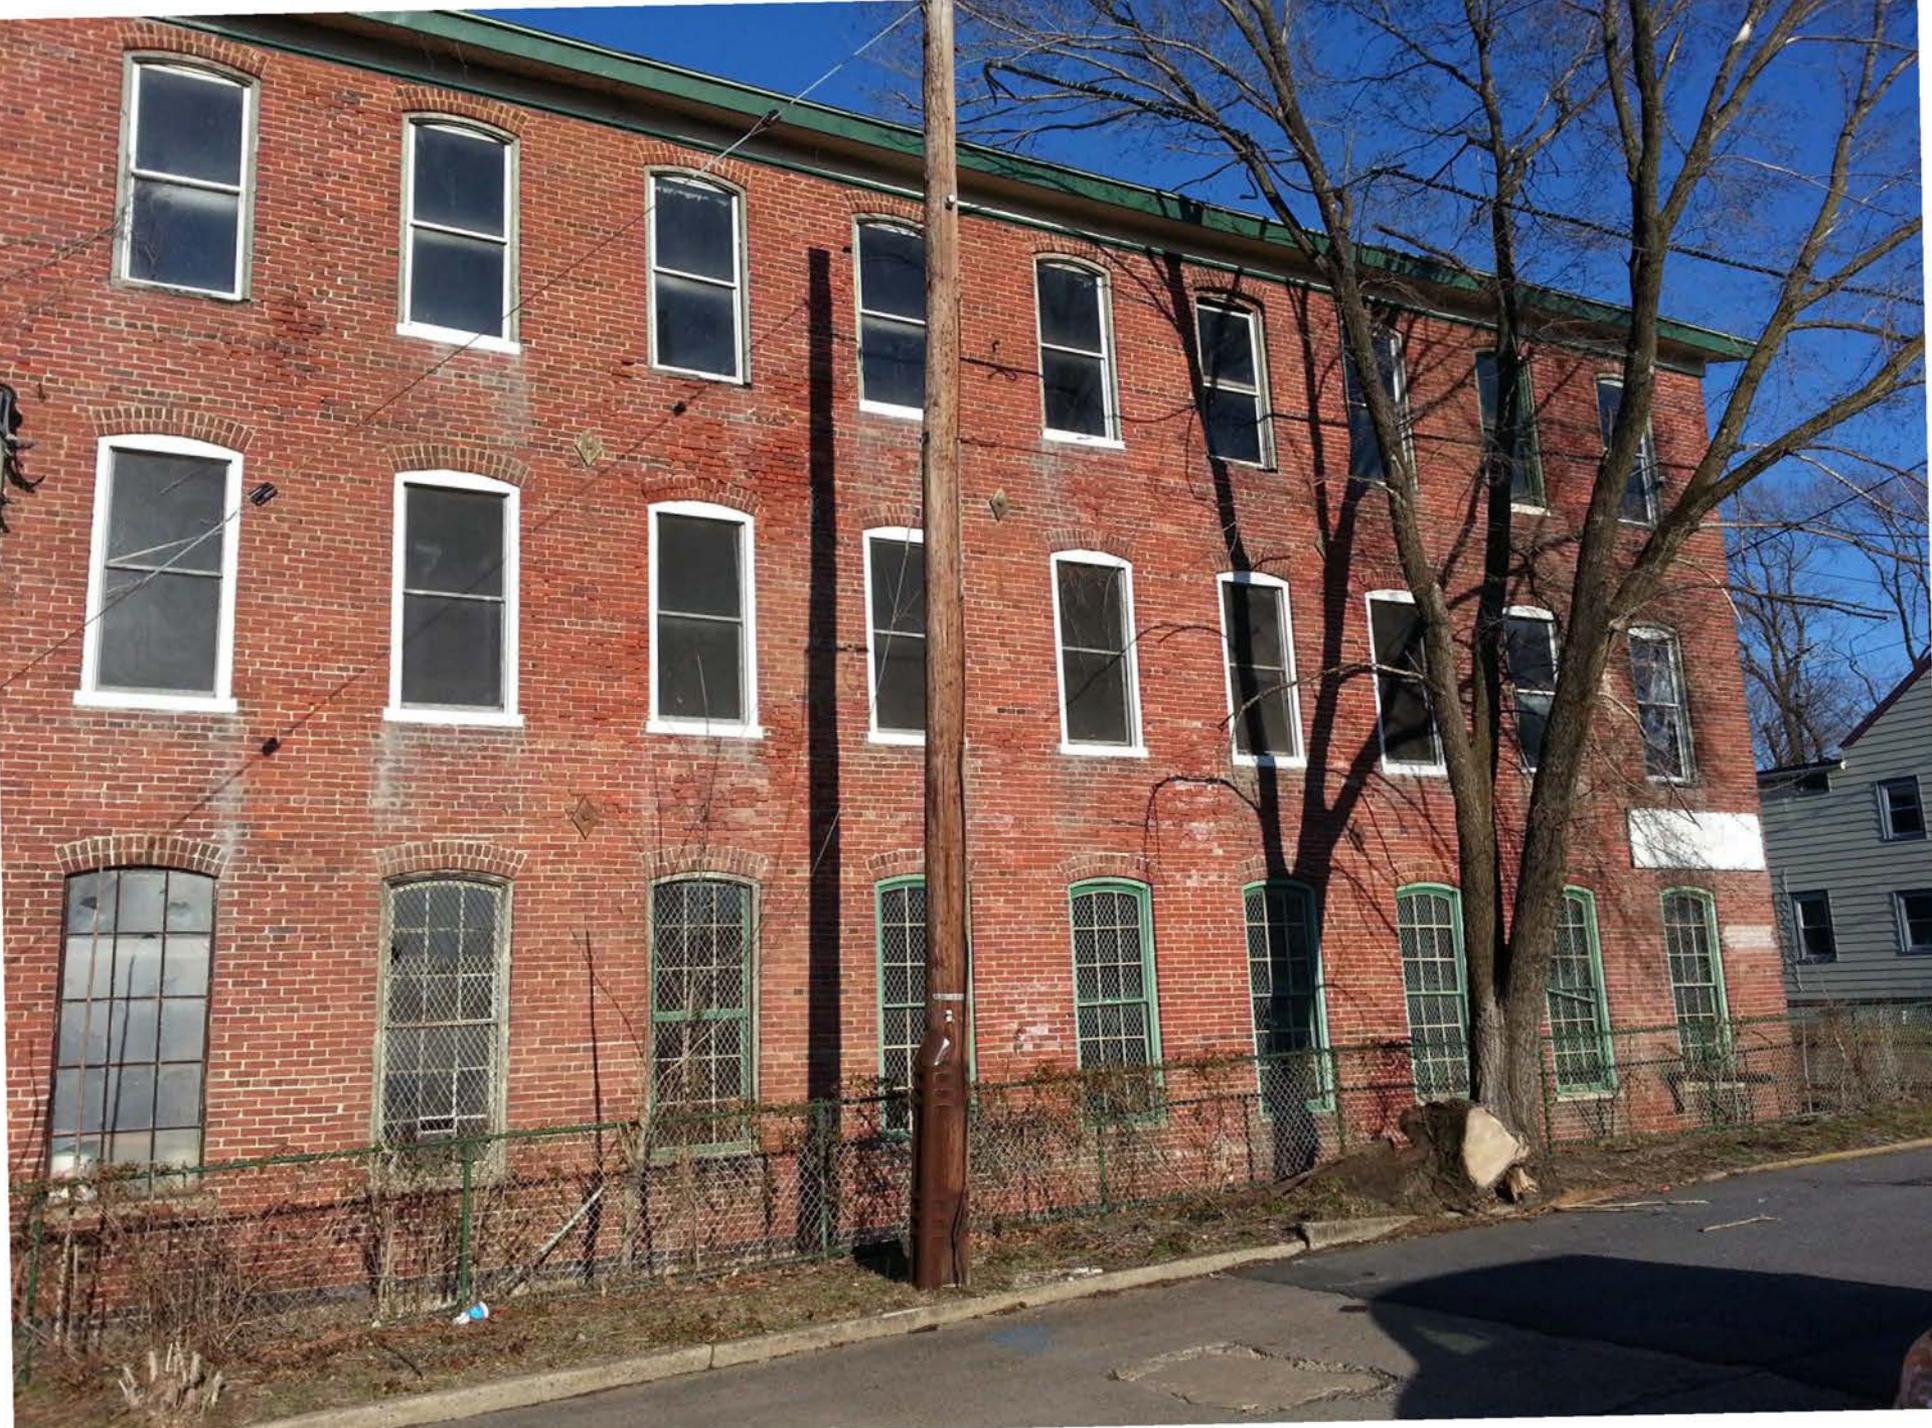
- Photo #3 (NJ_Burlington County_Bordentown Historic District (Boundary Increase)_0003)
West elevation of 1890 building, camera facing east from Spring Street.

In total, the building has 136 window openings. There are wood, double-casement basement windows in a 2-over-4 configuration. Each opening above the basement level maintains a similar size and features a segmented arch header of row-lock brick and a brick row-lock sill. (*Photos 1, 3, 6*) Window openings vary from 37"-43" wide, but have a common sill height of 26½" above the finished-floor level. Windows vary in height from 97½" on the first floor to 80½" on the upper floors. (*Photo 1*) The stiles and rails of the original window frames are of wood, 4¼" wide, with a 1½" wood sill. The original windows feature arched glazing implemented in wood sash with lites in a nine-over-nine configuration. (*Photos 1, 3*) Many have iron security grates with a dia-grid pattern, occurring along the first floor and at the basement (*Photo 1*). The vinyl replacement windows, mostly on the upper floors, lack the arched glazing but otherwise maintain the dimensions of the original windows. (*Photo 3*)

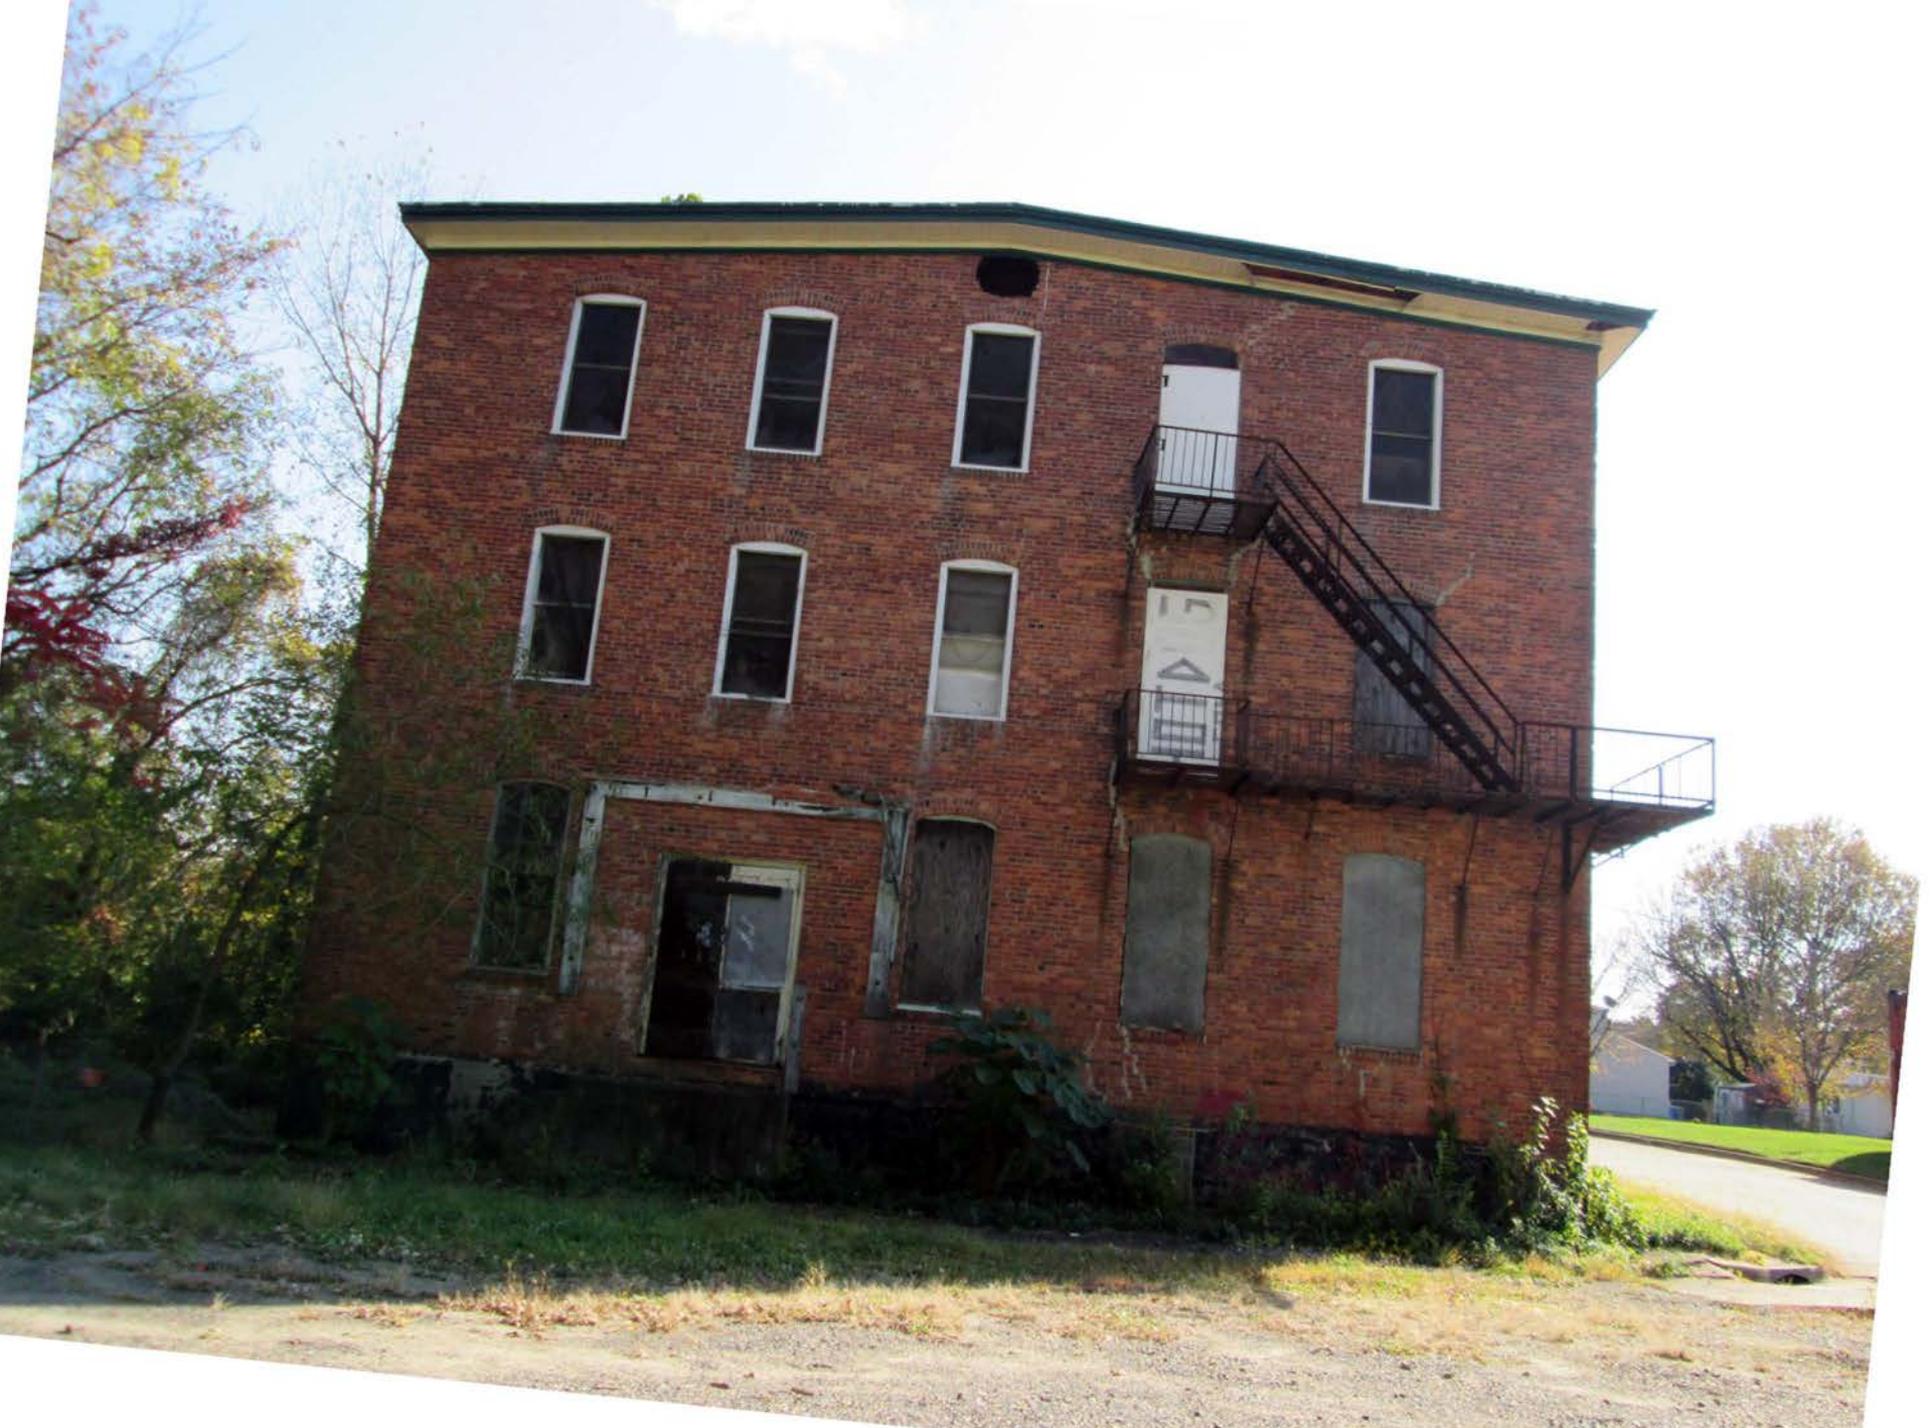
- Photo #5 (NJ_Burlington County_Bordentown Historic District (Boundary Increase)_0005)
North elevation of 1924-1950 addition, camera facing south from railroad.

Seventeen cast-iron masonry anchor plates are incorporated into the brick of the 1882 and 1890 sections of the building, expressed as 5- or 8-pointed stars and diamonds. (*Photo 1-3, 7-9*) Pieces of gutters and leaders are found on both sides of these two sections—all in disrepair and missing large pieces. (*Photo 1, 2, 7, 9*) A defunct metal fire alarm is affixed to the brick on the southern elevation, where, painted on the brick between the first and second floor windows a faded rectangular sign reads "UNION PANTS MFG.," representing the fifth operator to occupy the factory. (*Photo 1*) Other painted signage has faded past legibility. A brick protrusion belonging to the 1924-1950 addition is found at the transition between said addition and the original 1882 building on the eastern and western elevations, extending approximately 13" out from the rest of the brick. (*Photo 4, 6-8*) On the northern elevation, five concrete steps and a stoop lead from grade level to a doorway on the first floor above which a ruined wooden hoist is affixed to the brick. (*Photo 5*)

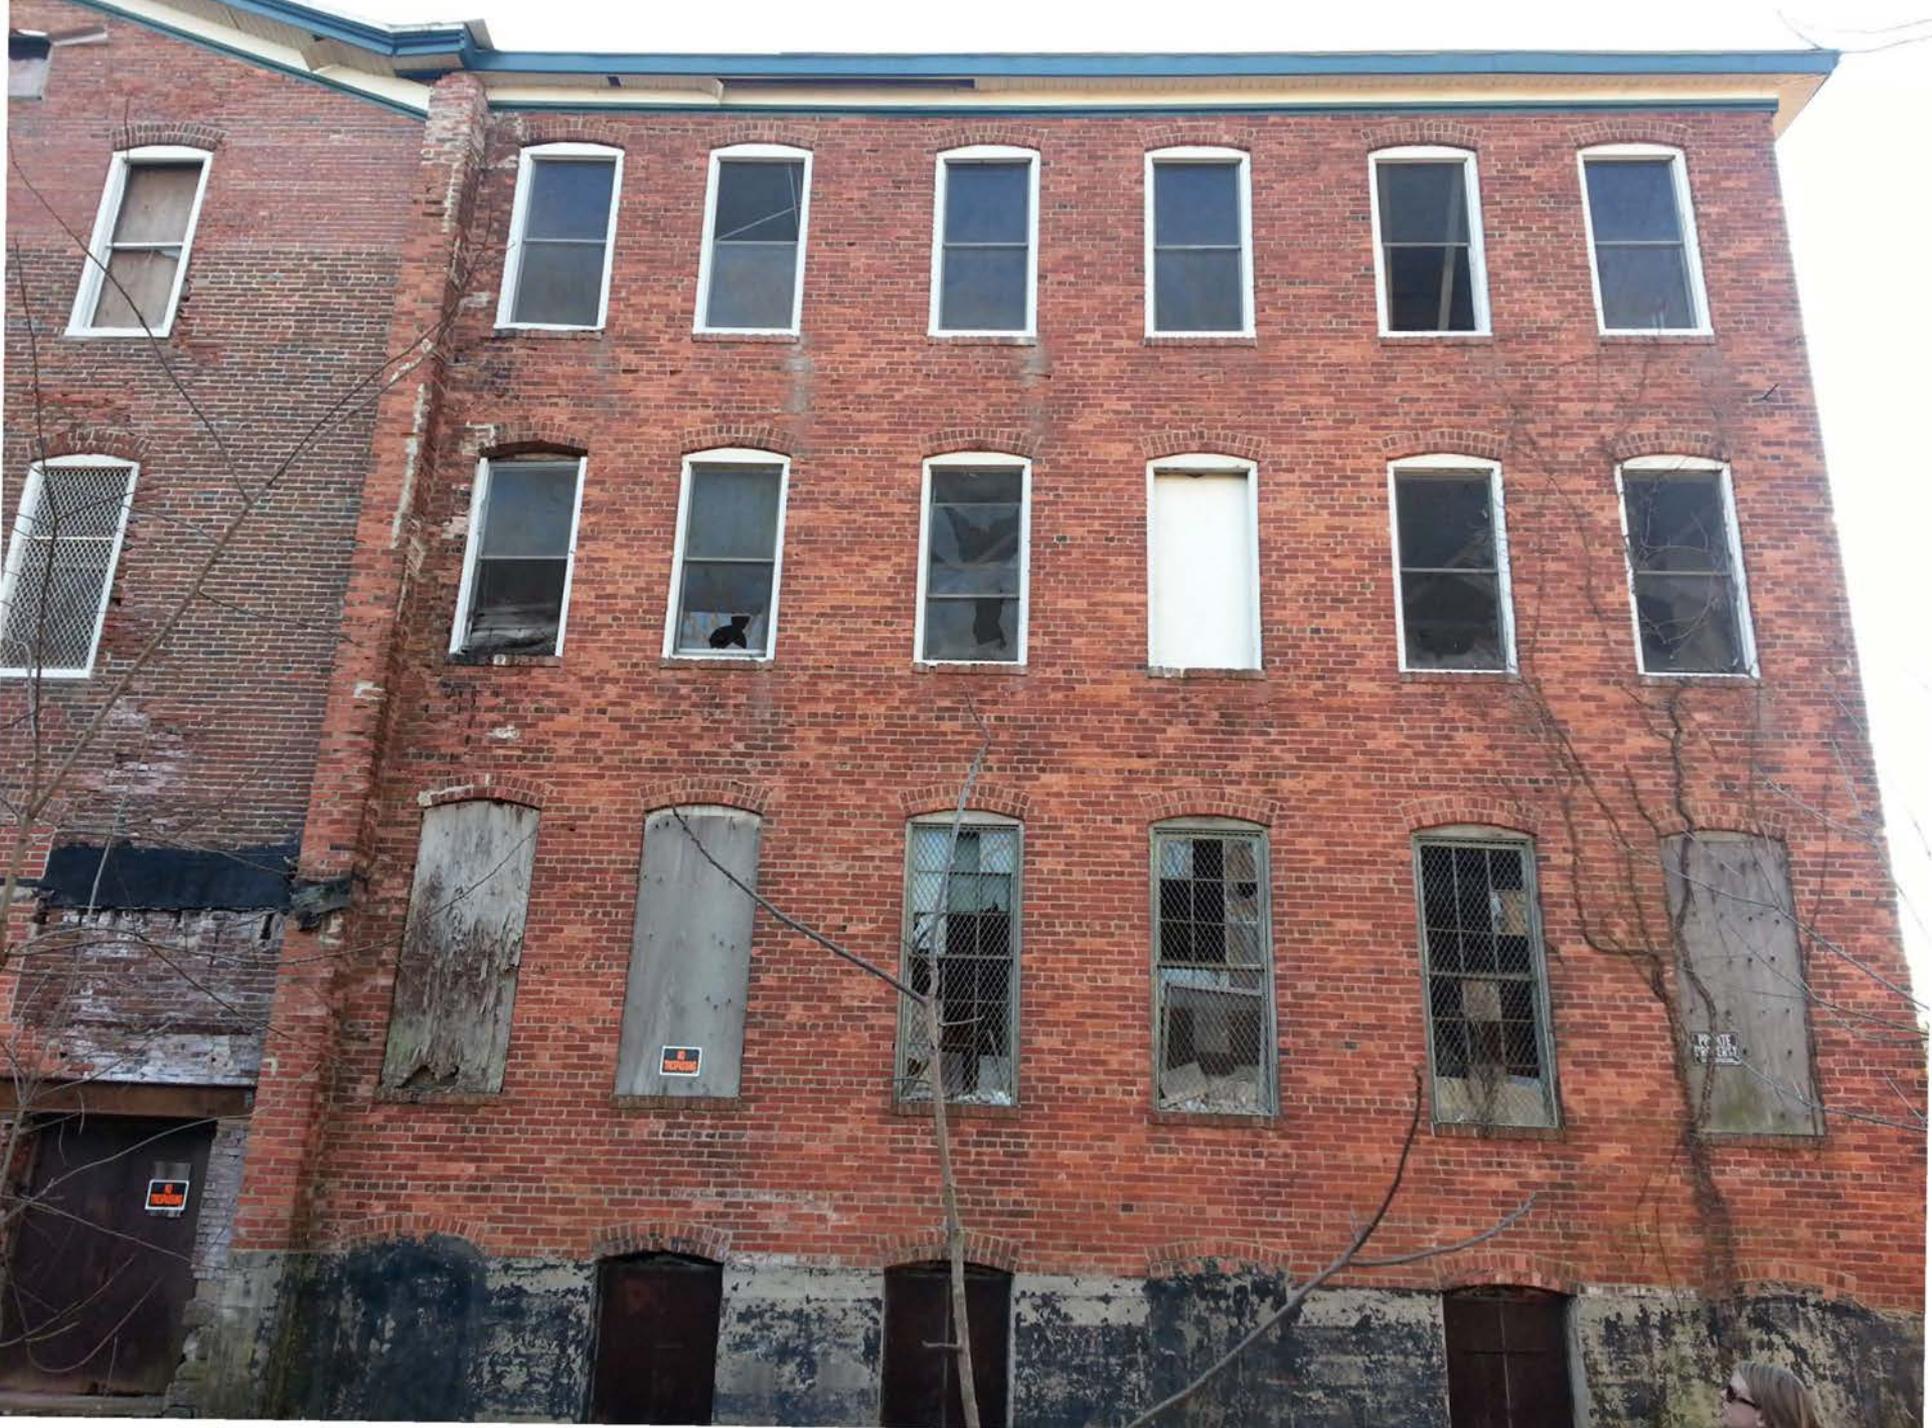
- Photo #6 (NJ_Burlington County_Bordentown Historic District (Boundary Increase)_0006)
East elevation of 1924-1950 addition, camera facing west.
- Photo #7 (NJ_Burlington County_Bordentown Historic District (Boundary Increase)_0007)
East elevation of 1882 building with portions of additions (left and right), camera facing southwest.

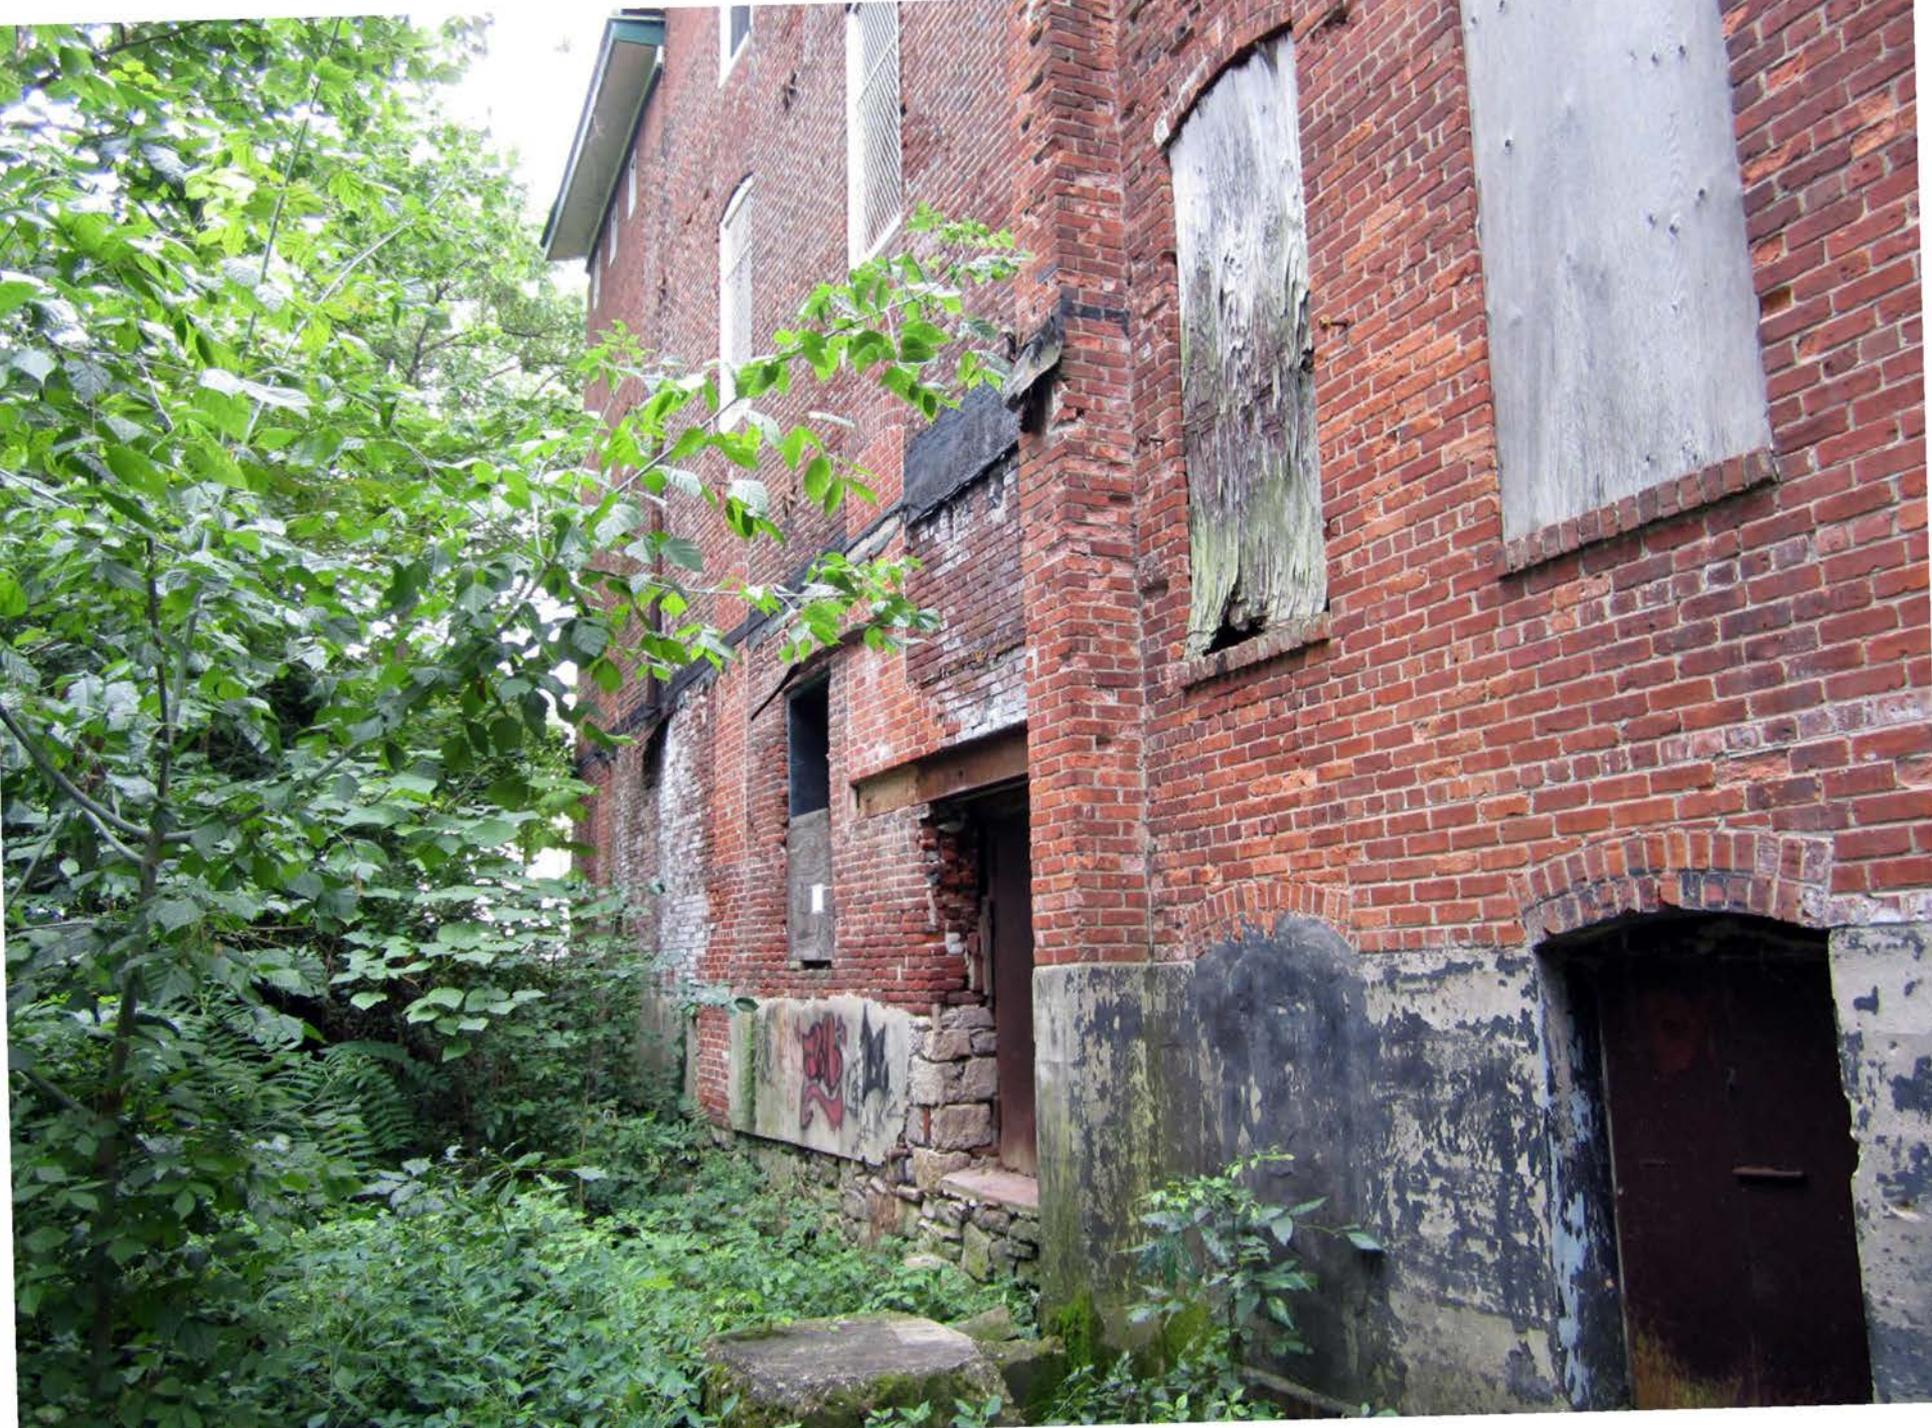
- Photo #8 (NJ_Burlington County_Bordentown Historic District (Boundary Increase)_0008)
Transition from 1924-1950 addition to 1882 original portion, east elevation at grade level.

The building is currently accessed through the door in the 4th bay from the south on the eastern elevation, into the 1890 addition. (*Photo 9*) The basement is reached by an enclosed staircase accessible by a door directly to the left of this entry. The floor in the basement is of compacted earth, and the walls are covered in a layer of bituminous material to the sill height of the basement windows. (*Photo 10*) The cellar walls above that height are whitewashed, but the coating has faded and the brick has significantly deteriorated in some areas. The ceilings are exposed throughout the building, revealing existing building systems. (*Photo 10*) The space is divided by the foundation walls of the 1882 middle section, with some portions removed to provide access between the spaces. The basement of the 1890 addition is mostly open; the portion belonging to the original 1882 section has a storage area and contains some original factory equipment; the basement of the northern addition is organized in ranges of storage shelves. Six original metal columns, believed to be cast iron* in the 1890 portion are exposed and painted black; three columns in the 1882 portion are encased in brick. (*Photo 10*) (*When tapped with a hammer, these columns emit a dull thud rather than the ringing sound associated with cast steel.) The northern addition has two concrete columns at its mid-span, plus two more incorporated into the northern side of the basement wall of the 1882 middle section. The floor structure is slow-burning wood construction in the 1882 and 1890 sections, and wood joists supported by steel beams and concrete-encased columns in the northern addition. The joists and exposed subfloor in the northern and middle sections are charred or fallen in places. Along the eastern side of these sections are doors through which coal was brought into the basement. (*Photo 6-8*)

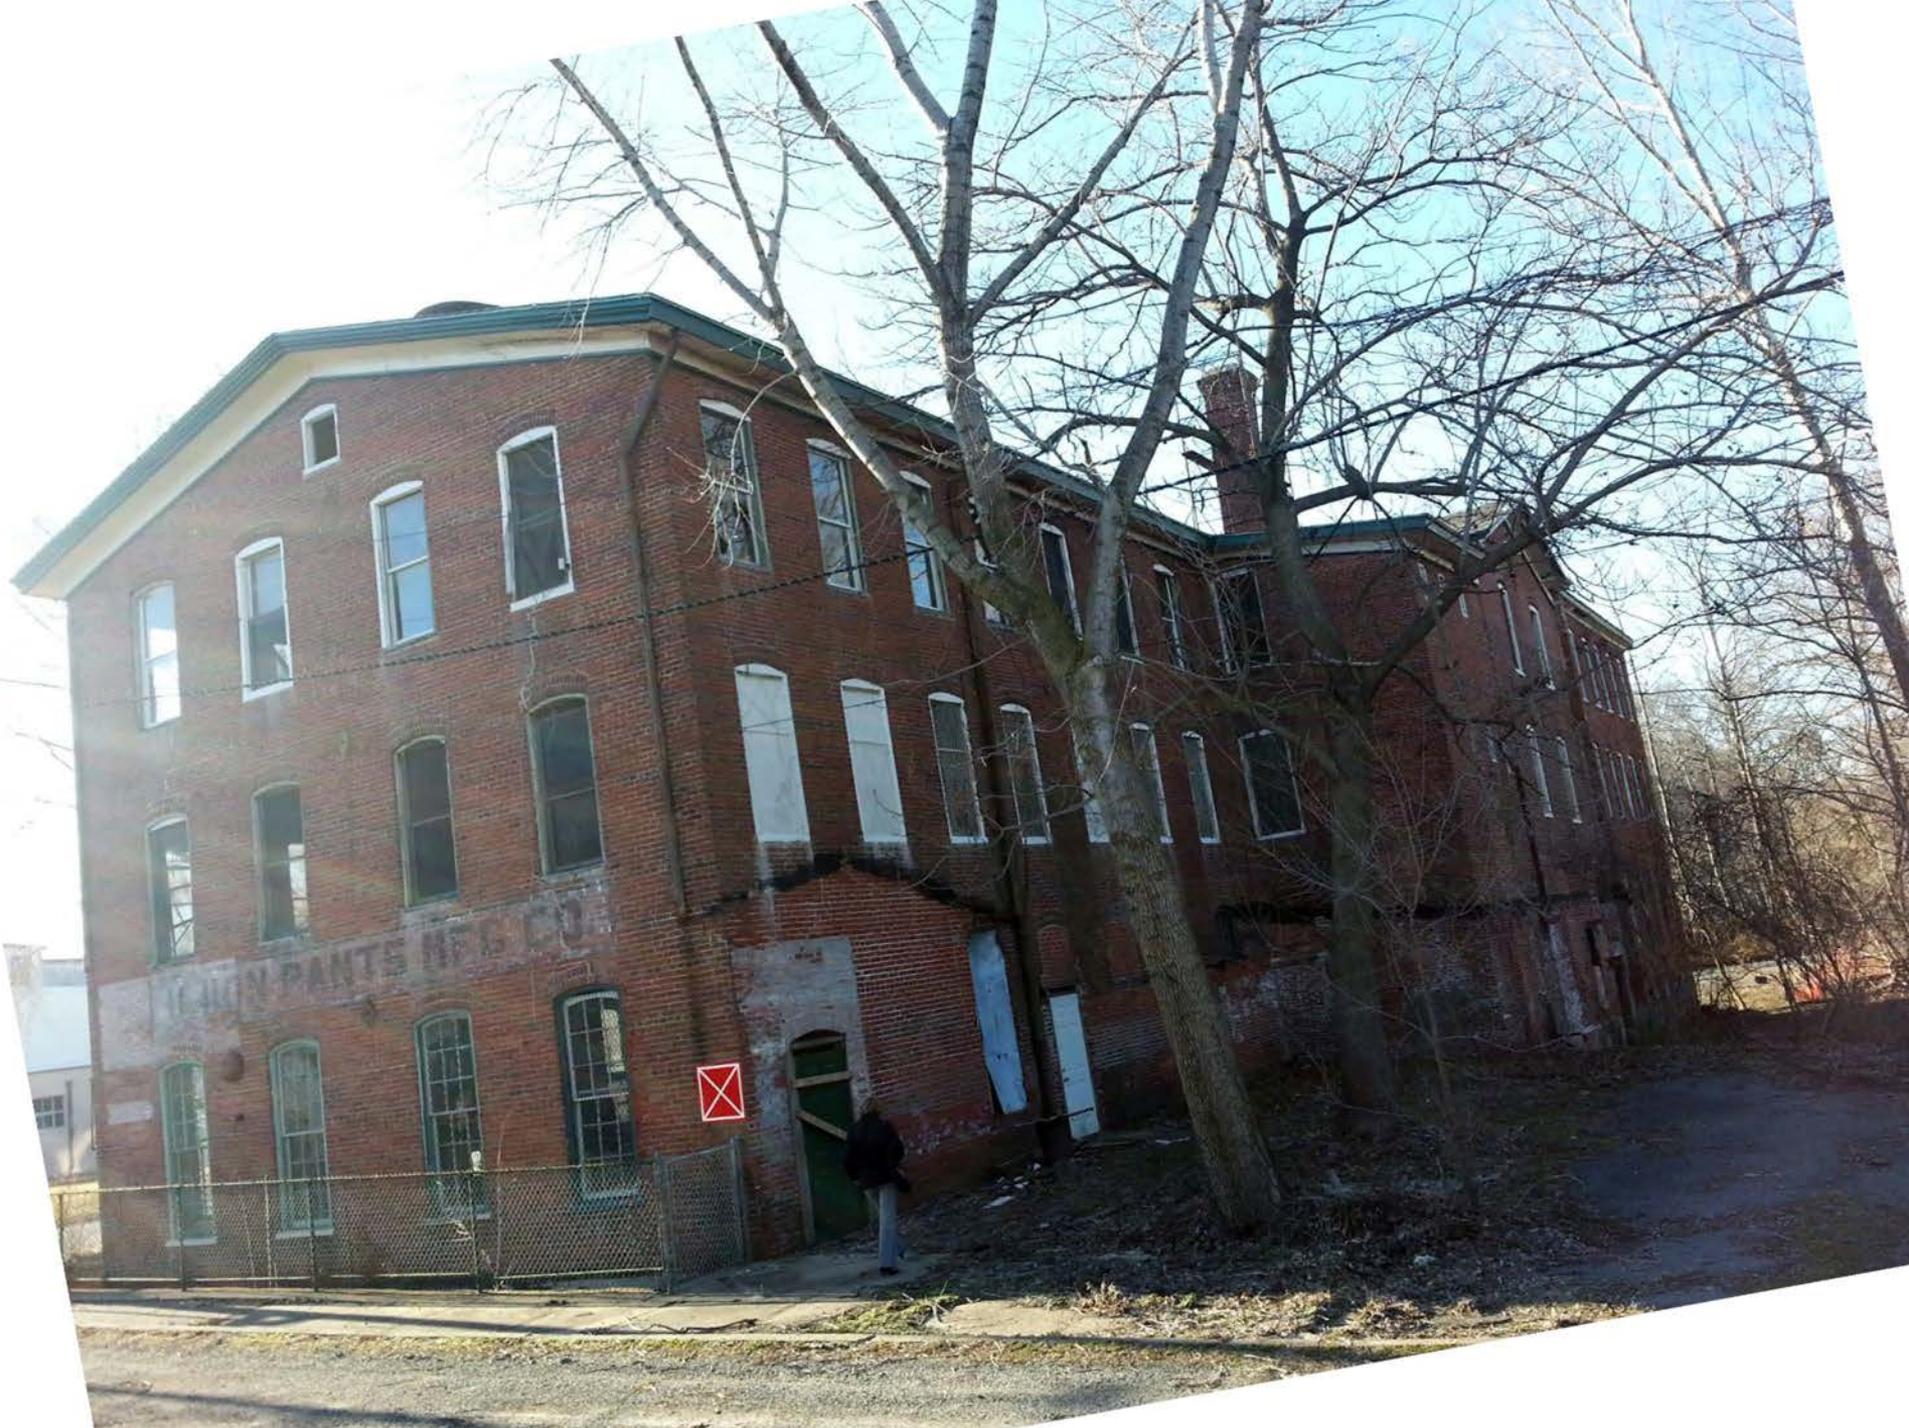
- Photo #9 (NJ_Burlington County_Bordentown Historic District (Boundary Increase)_0009)
South elevation of 1890 addition (left), east elevation of whole building (right), camera facing northwest.

Additional wood sheds/structures were built around the same time as the 1890 addition and were used as a wood shed/coal house and office/shipping shed. These additional structures were removed, but their existence is evidenced by empty rafter pockets and bituminous flashing remnants on the eastern elevation. (*Photo 6-9*) Also added in the 1890 addition was a Coben low-speed dynamo, a direct current electrical generator placed in the basement. Electricity was carried from the dynamo to the upper floors through an exposed wiring system. Central electrical service was provided to the building at some point after Bordentown was electrified with alternating current, and the dynamo was removed. The utility connection is evidenced by electrical panels and wiring in the basement. (*Photo 10*) Several changes to the fenestration were made throughout the building's history; openings were in-filled with masonry or boarded up, some windows were replaced with doors, and large scale window replacements took place at least twice, although it is unknown when. (*Photos 5-7*) The roof structure was replaced in 1902 when a storm blew off the roof. In 1980, a large fire occurred in the northern addition, causing the factory to close for good and remain abandoned for more than three decades (*Photo 9*).

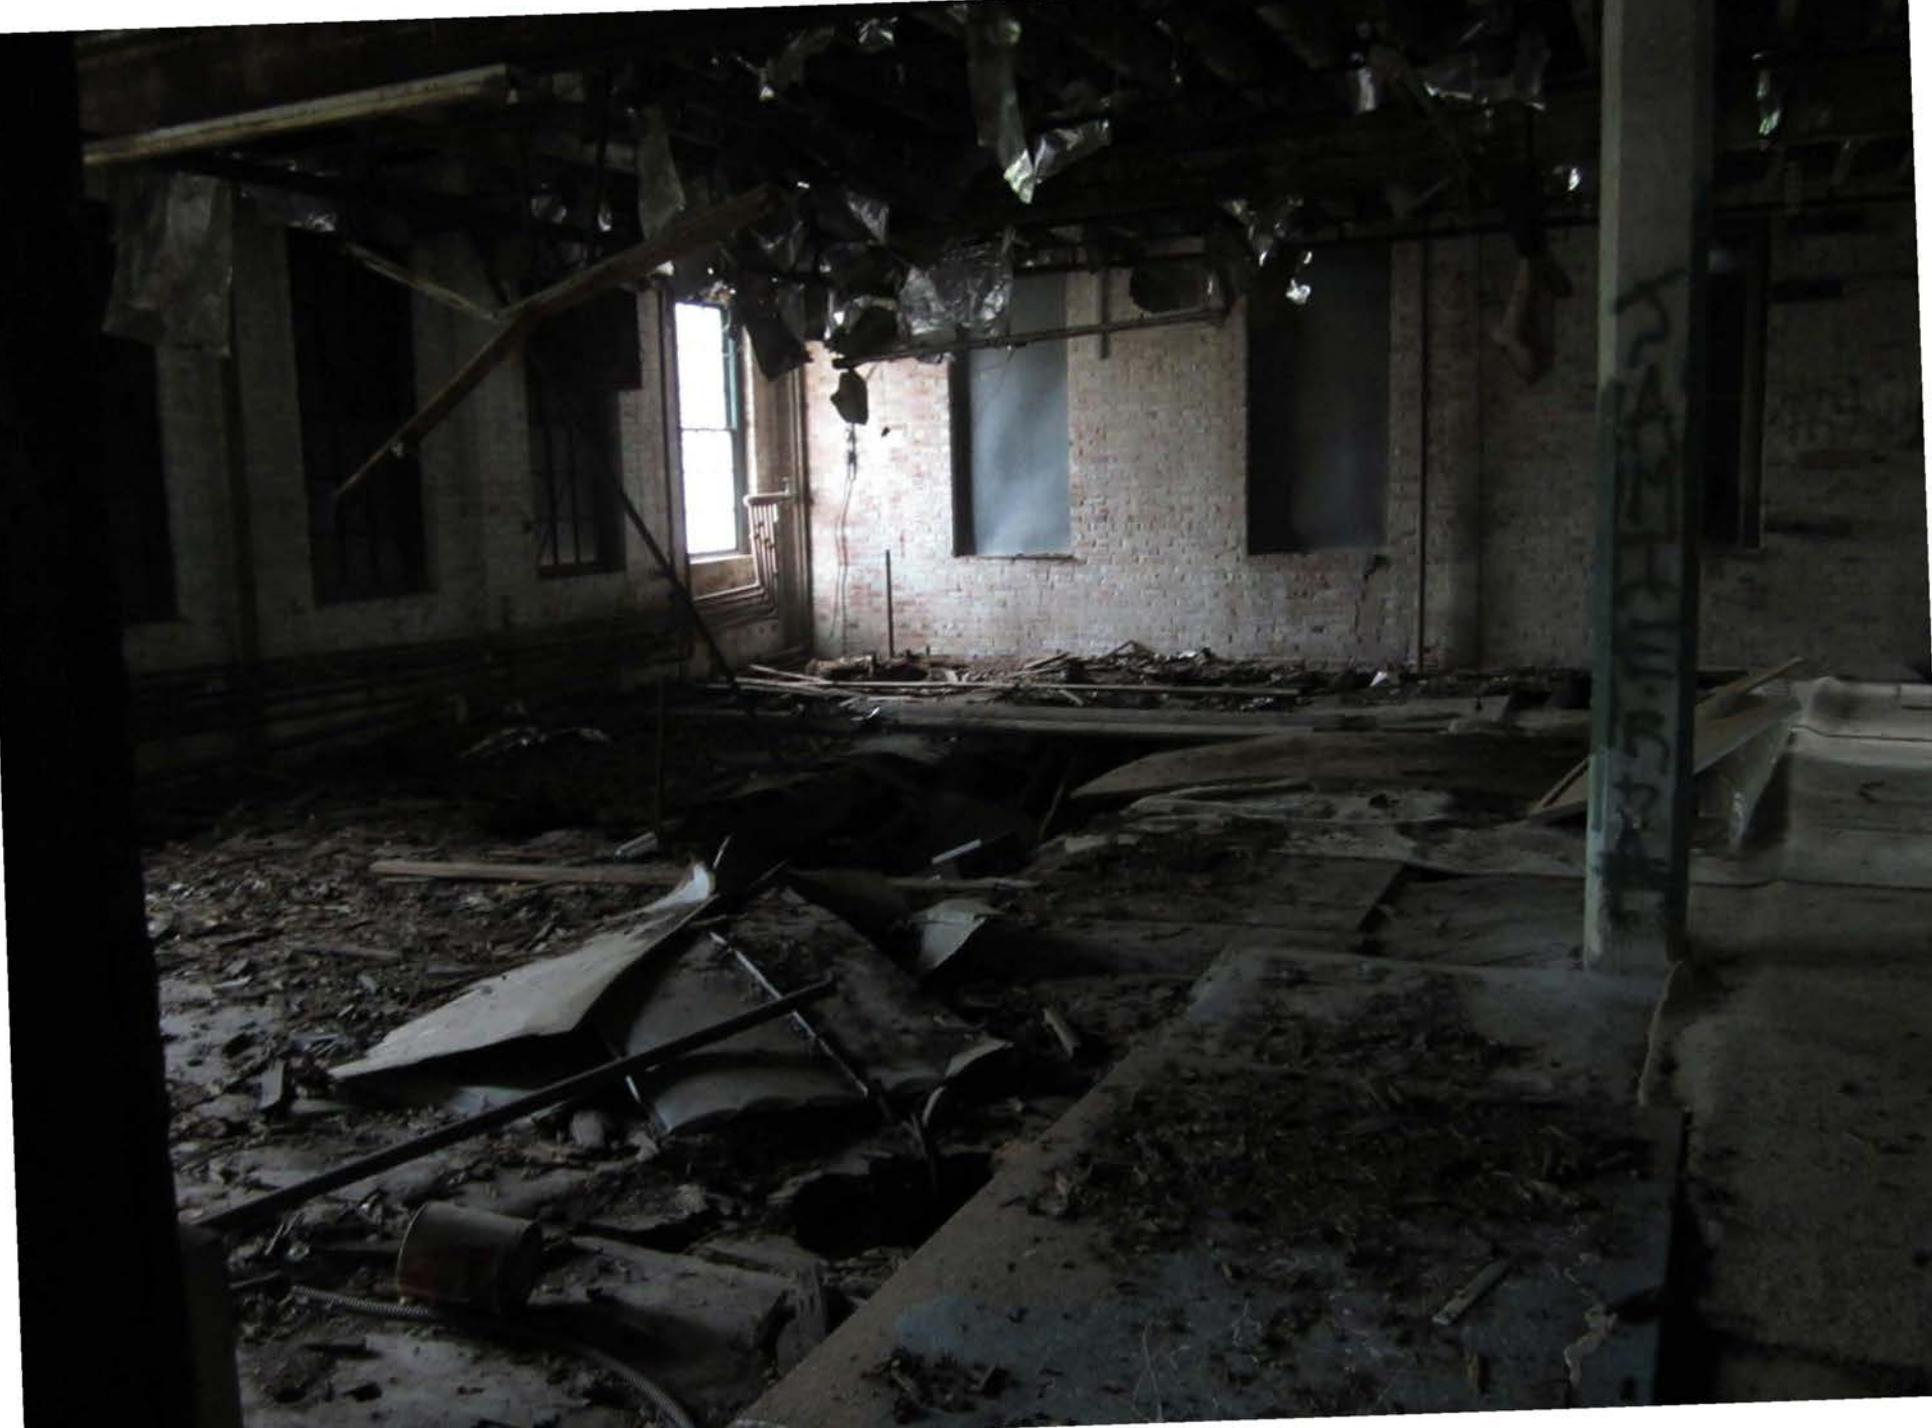
- Photo #12 (NJ_Burlington County_Bordentown Historic District (Boundary Increase)_0012)
First floor interior of 1924-1950 addition, camera facing northwest.

All three floors above grade are separated into two primary spaces by the original northern brick exterior wall of the 1882 building, but the 1882 and 1890 sections were integrated into one space when the 1890 section was constructed. An 8' section of the wall was removed at the center, and the gap permits access between the two spaces. The original arched transom window located above the original entrance to the 1882 building on the north side remains in the wall. (*Photo 11*) The finished floor is a strip oak wood floor laid at a 45° angle to the floor joists, although it has deteriorated on every floor and some areas of flooring are missing altogether. (*Photo 13, 14*) Large sections of the floors in the northern portion are missing or damaged by fire. (*Photo 12*) The walls are whitewashed brick, with some portions having been painted light green. (*Photo 11-15*) Each window opening is supported at the top with a wood lintel painted to match the wall. All original window openings that have been enclosed by later additions were in-filled with brick. (*Photo 11*) An exposed, ruined freight elevator occupies the northeast corner of the 1882 portion of the building. An area enclosed with brick walls located in the northeast corner of the 1890 addition is open to the basement below on the first floor and contains bathrooms on the second and third floors. The ceiling is exposed and painted white, revealing all existing sprinklers, wiring, and other building systems. (*Photos 12-15*)
