historic name Bordentown Historic District (Boundary Increase)

street & number 1 Spring Street not for publication

city or town Bordentown City vicinity

This boundary increase proposes to add the Eagle Shirt Factory to the Bordentown Historic District, in Bordentown City, Burlington County, New Jersey. The Eagle Shirt Factory is a late-19th-century clothing mill located at 1 Spring Street, which abuts the east side of the district (see district map). The factory is a 3-story, red-brick building, one of several older industrial properties along a Pennsylvania Railroad line that extends northeasterly through Bordentown toward Hightstown, trackage that historically reached South Amboy on the Raritan River. The factory consists of three principal sections: an original building built about 1882, an addition to the south built in 1890, and an addition to the north built between 1924 and 1950. (Sanborn 1886, 1892, 1924, 1950) The building has been vacant since 1980 and parts of the building have deteriorated due to age and deferred maintenance.

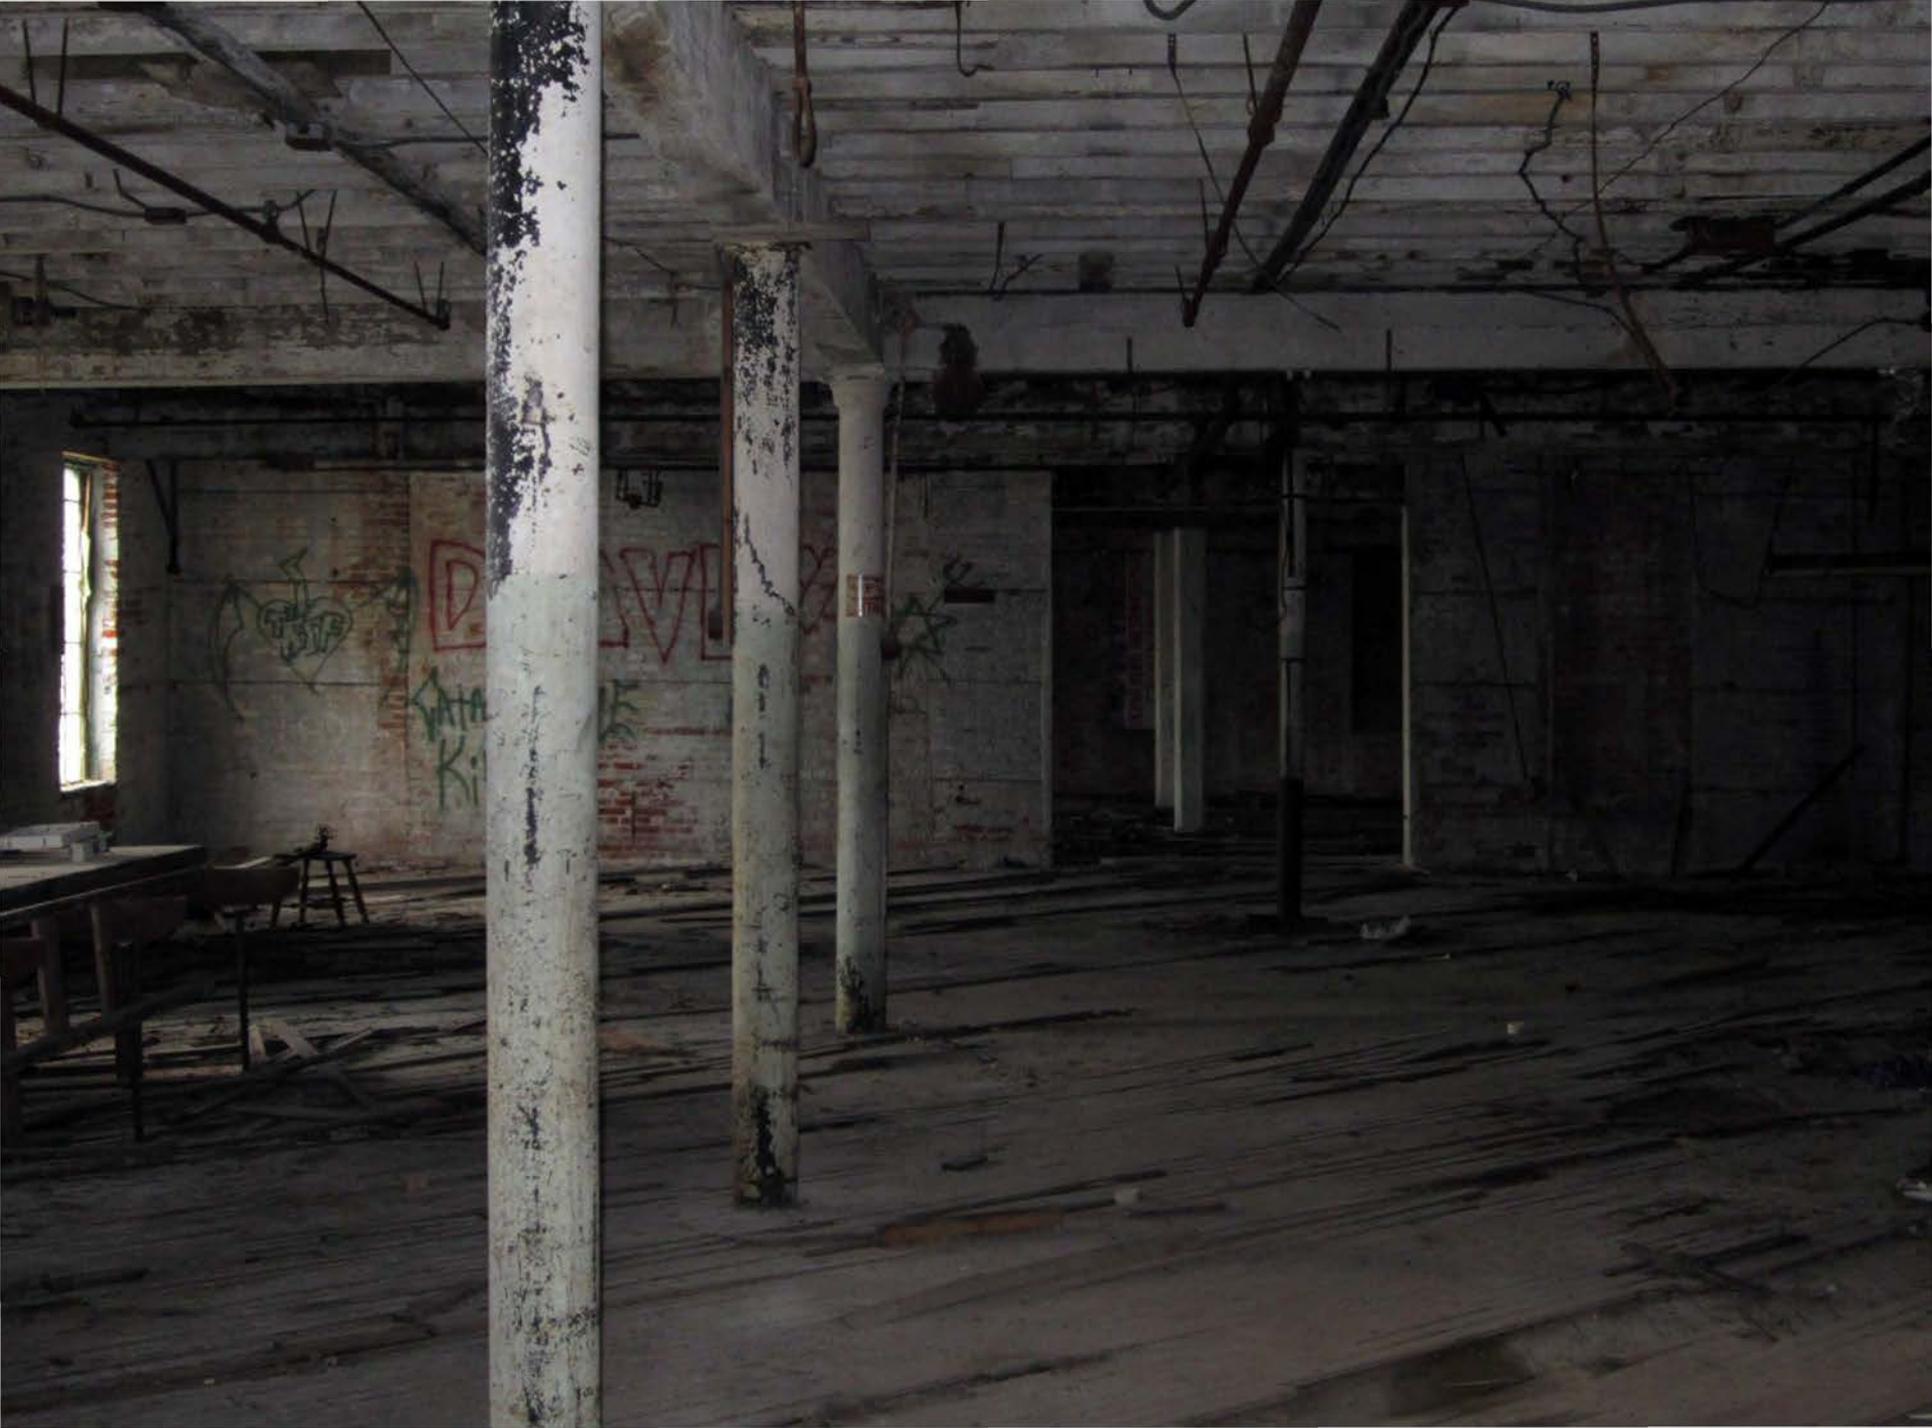
- Photo #13 (NJ_Burlington County_Bordentown Historic District (Boundary Increase)_0013)
Second floor interior of 1882/1890 portion, camera facing north.

the second floor, painted light green on the bottom and white on the top; the four concrete columns in the northern addition are exposed and show faded paint. (*Photo 13*) A 15'-10"x17'-2" space is framed out in the southeast corner of the 1890 addition on the second floor. Workbenches occupy the western half of the 1890 portion.

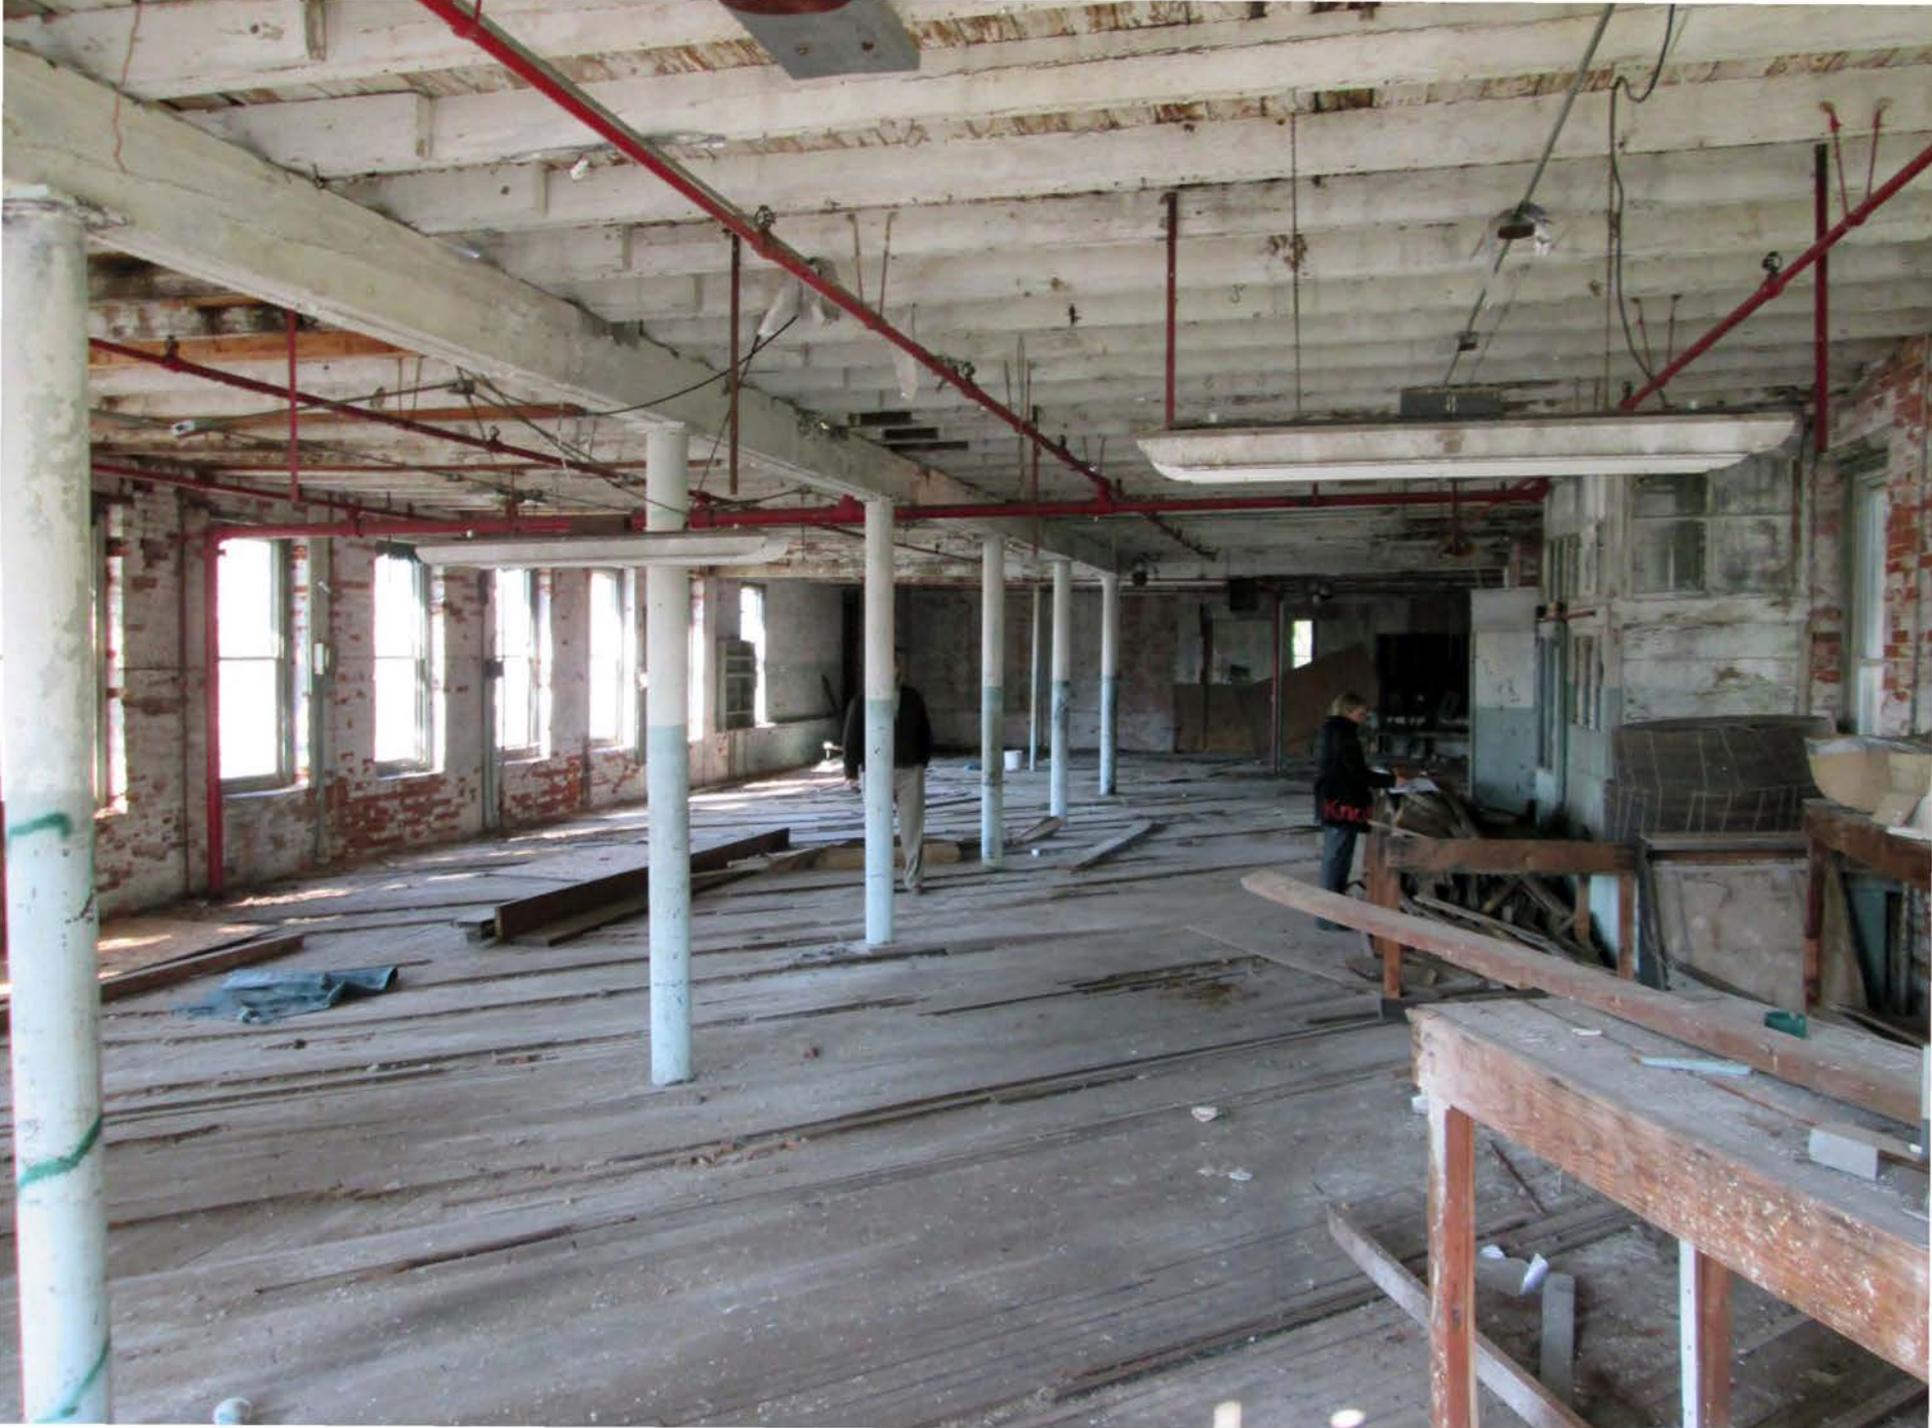
- Photo #14 (NJ_Burlington County_Bordentown Historic District (Boundary Increase)_0014)
Third floor interior of 1882/1890 portion, camera facing north.

The staircase continues to the third floor and remains enclosed on the third floor by a wall with a transom above. (*Photo 14*) In the 1882 portion of the third floor, the brick is inset one wythe, starting 10 courses above the finished floor. The columns in both spaces are painted the same as on the second floor. (*Photo 14, 15*) The wood trusses are visible in the attic, which has sprinklers but no insulation. In the northern addition, the entire roof system is exposed, showing the steel wide flange beams and wood rafters that form the gable of the northern end of the building. (*Photo 15*)
