United States Department of the Interior National Park Service National Register of Historic Places Registration Form

1. Name of Property		
historic name Woodland Baptist Chu	urch	
other names/site number N/A		
2. Location		
2. Location		
street & number 885 Woodland Church	h Road	N/A not for publication
city or town Woodland		NA vicinity
state Tennessee code T	TN county <u>Haywood</u> code	<u>075</u> zip code <u>38012</u>

Woodland Baptist Church

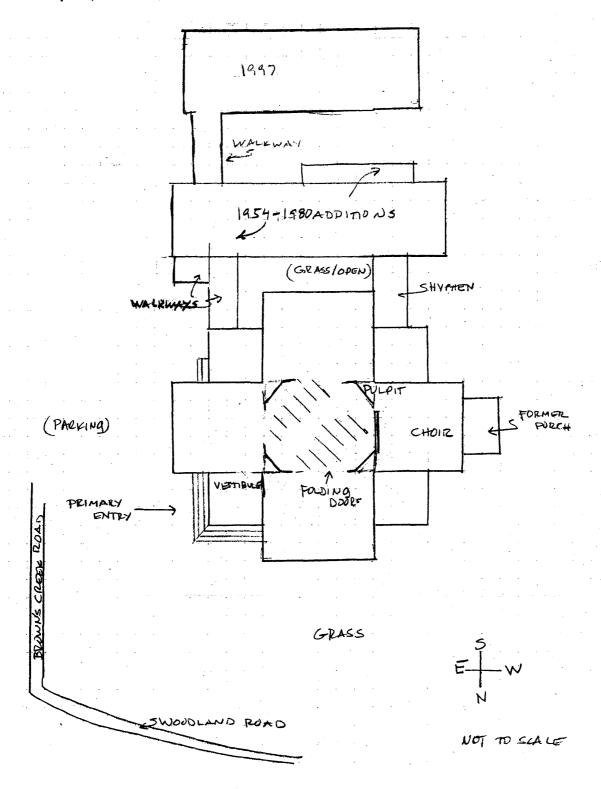
Sketch plan, not to scale

The sanctuary itself, which includes, the chancel, the area where the pastor conducts his service, and the nave, where the congregation sits, is connected to the four classrooms that protrude out to form the cross of the building. This configuration was popular in the late nineteenth to early twentieth centuries, especially as the Sunday School Movement gained popularity, and is referred to as the Akron Plan. The interior of the building is laid out on a southwestern access. The lectern and pulpit or ambo is built upon a small stage. The ambo is situated at an angle, and is positioned between two rooms. The two sets of the three windows illuminate this area. Curtains now are draped down from the shelf behind the pulpit to define the space and hide the baptistery. Located behind the ambo is the baptismal.

The four rooms were designed to serve as classrooms and also to open onto the sanctuary by opening folding wood doors (extant). Three of the rooms now act as extensions of the sanctuary, when they are not in use as classrooms. The fourth room is for the choir and is positioned to the northwest of the pulpit. Each room gains light from the four symmetrical placed windows located on the façade of the protruding walls. The corners all contain smaller rooms similar to the entry, but each has a different purpose. The east and north corners contain access to the side parking lot. The corner located behind the baptistery in the southwest contains the hallway to the annex, a small door to the mechanical system space, and a small room now used for storage. The corner to the northwest contains access to the front elevation, mechanical area, and houses the old pews no longer in use.
