National Register of Historic Places
Registration Form

historic name Pisgah Rural Historic District
other names/site number NA

Name of related multiple property listing:
Pisgah Area of Woodford County, Kentucky

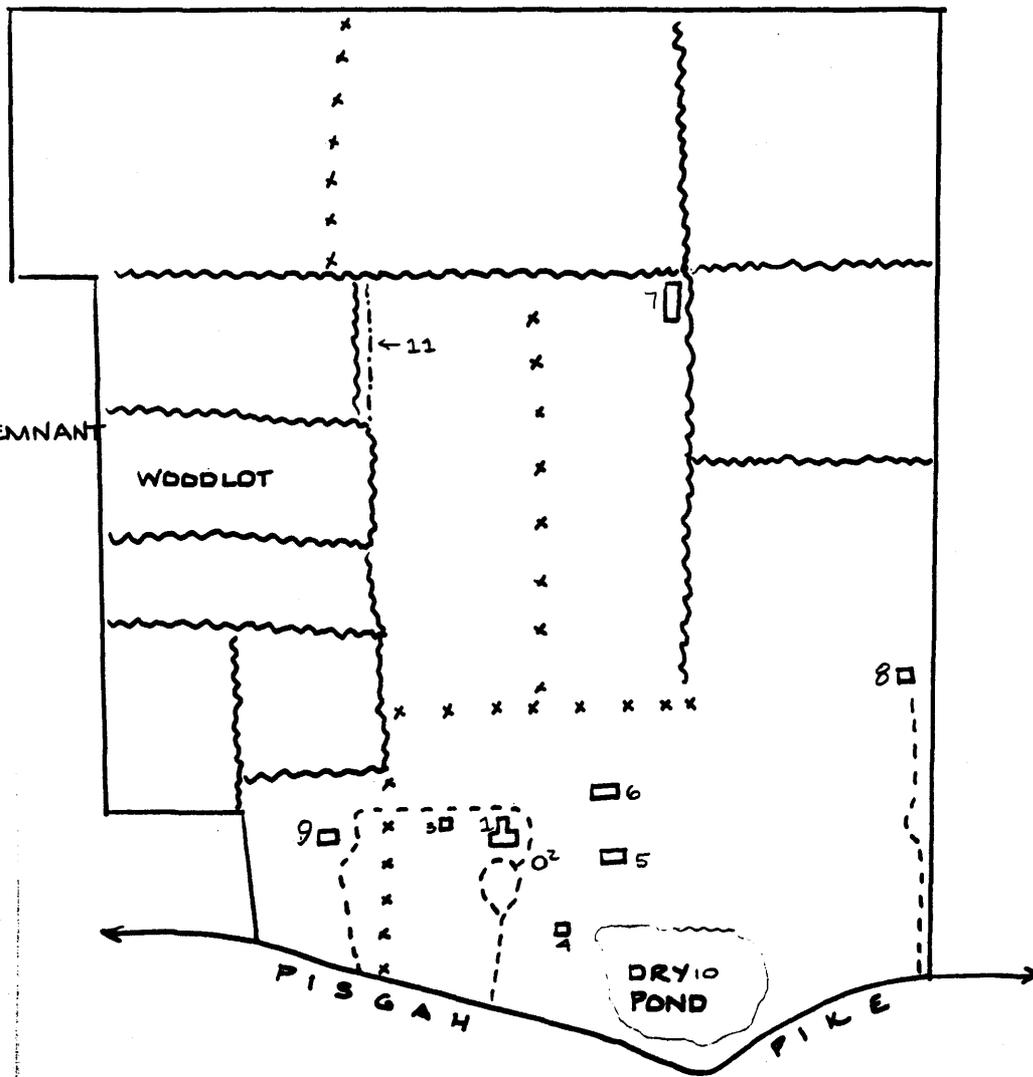
GLENLAKE FARM WD 90

- 1- MAIN HOUSE
- 2- ICE PIT
- 3- MEAT HOUSE
- 4- SPRING HOUSE
- 5- STOCK BARN
- 6- TOBACCO BARN
- 7- TOBACCO BARN
- 8- TENANT HOUSE
- 9- TENANT HOUSE
- 10- POND SITE
- 11- HISTORIC ROAD REMNANT

1" = 660'
SITE PLAN

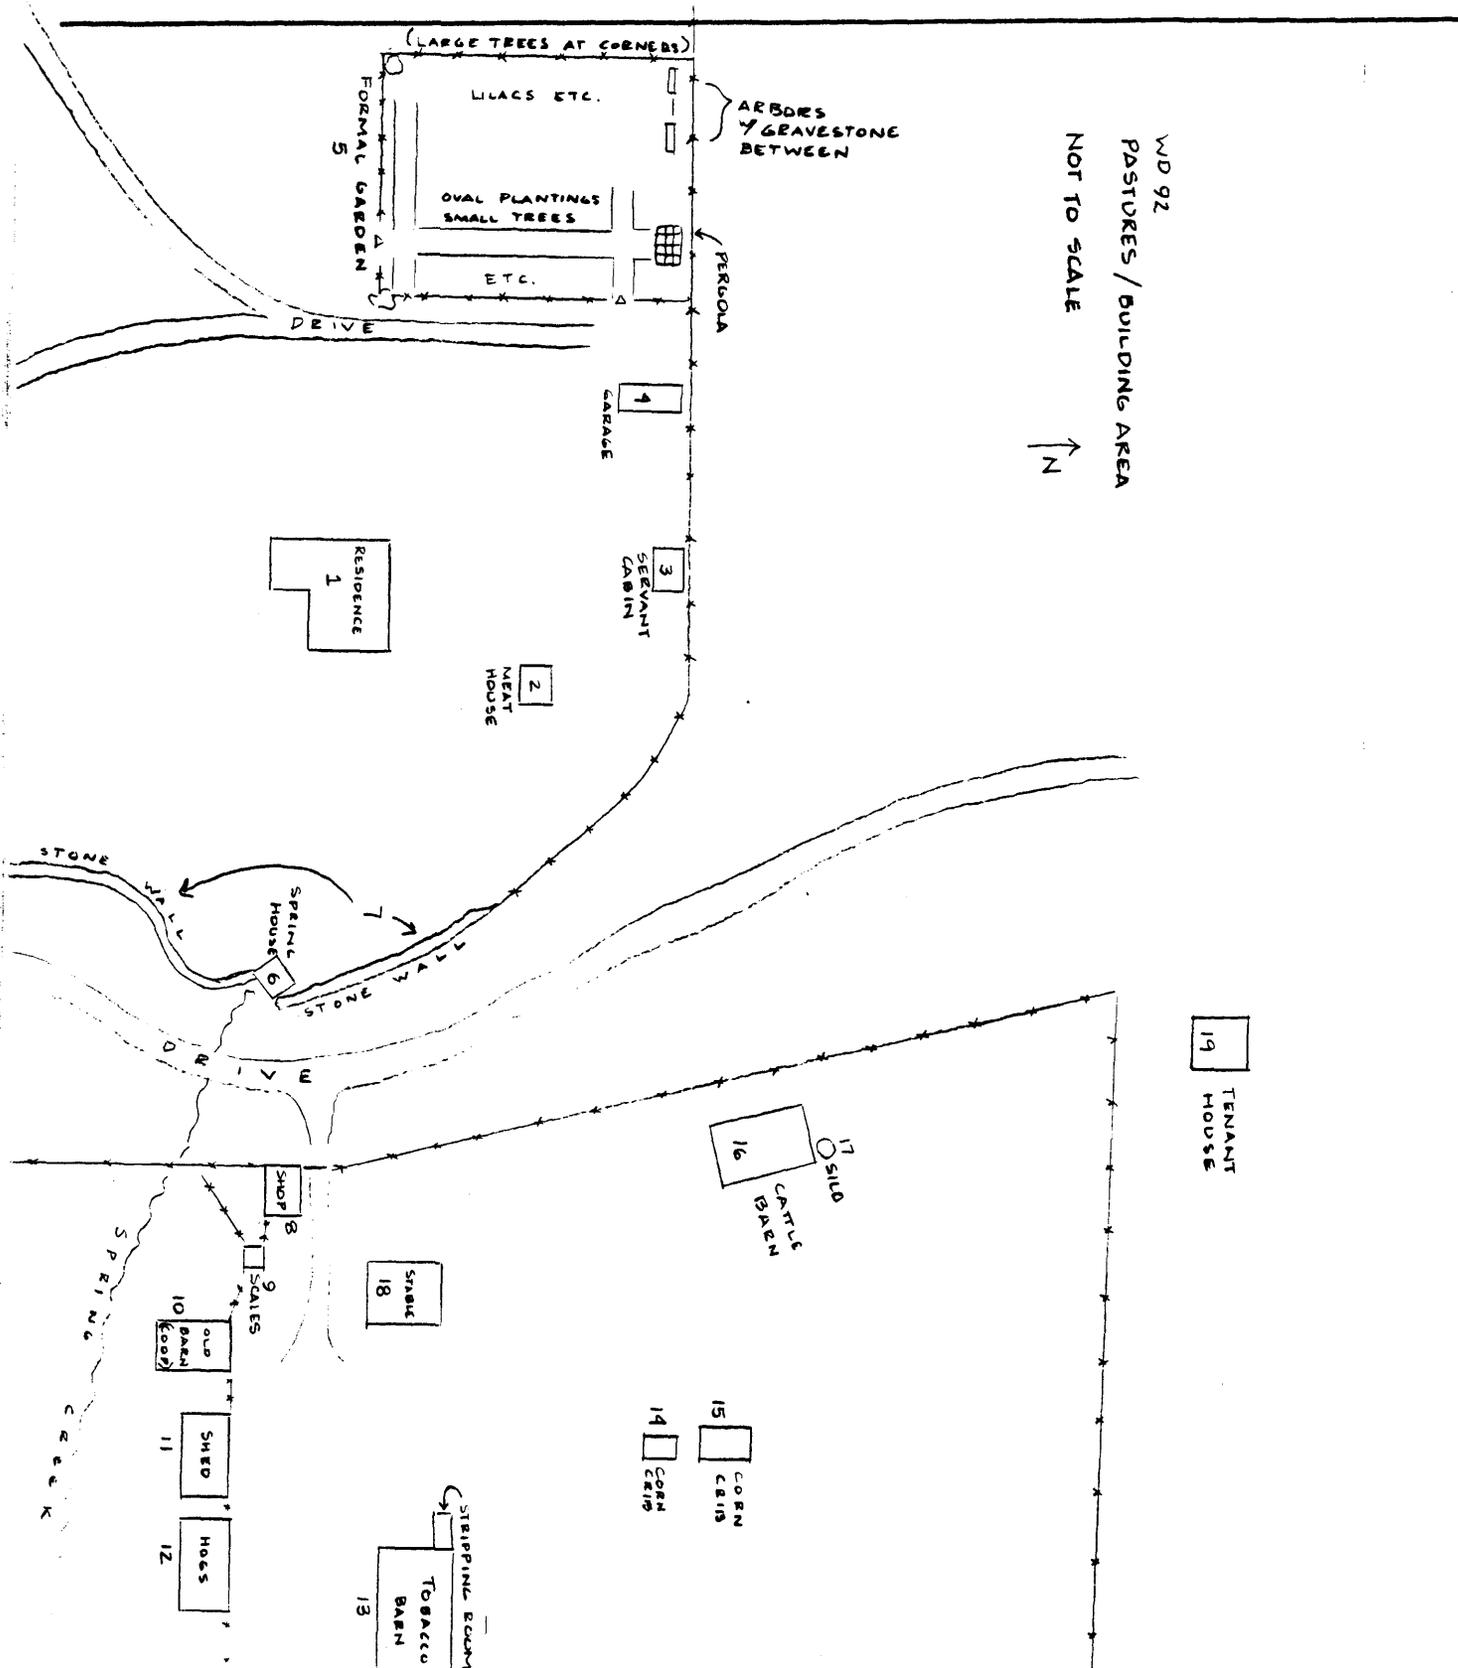
WD 92
PASTURES / BUILDING AREA
NOT TO SCALE
N

19
TENANT
HOUSE

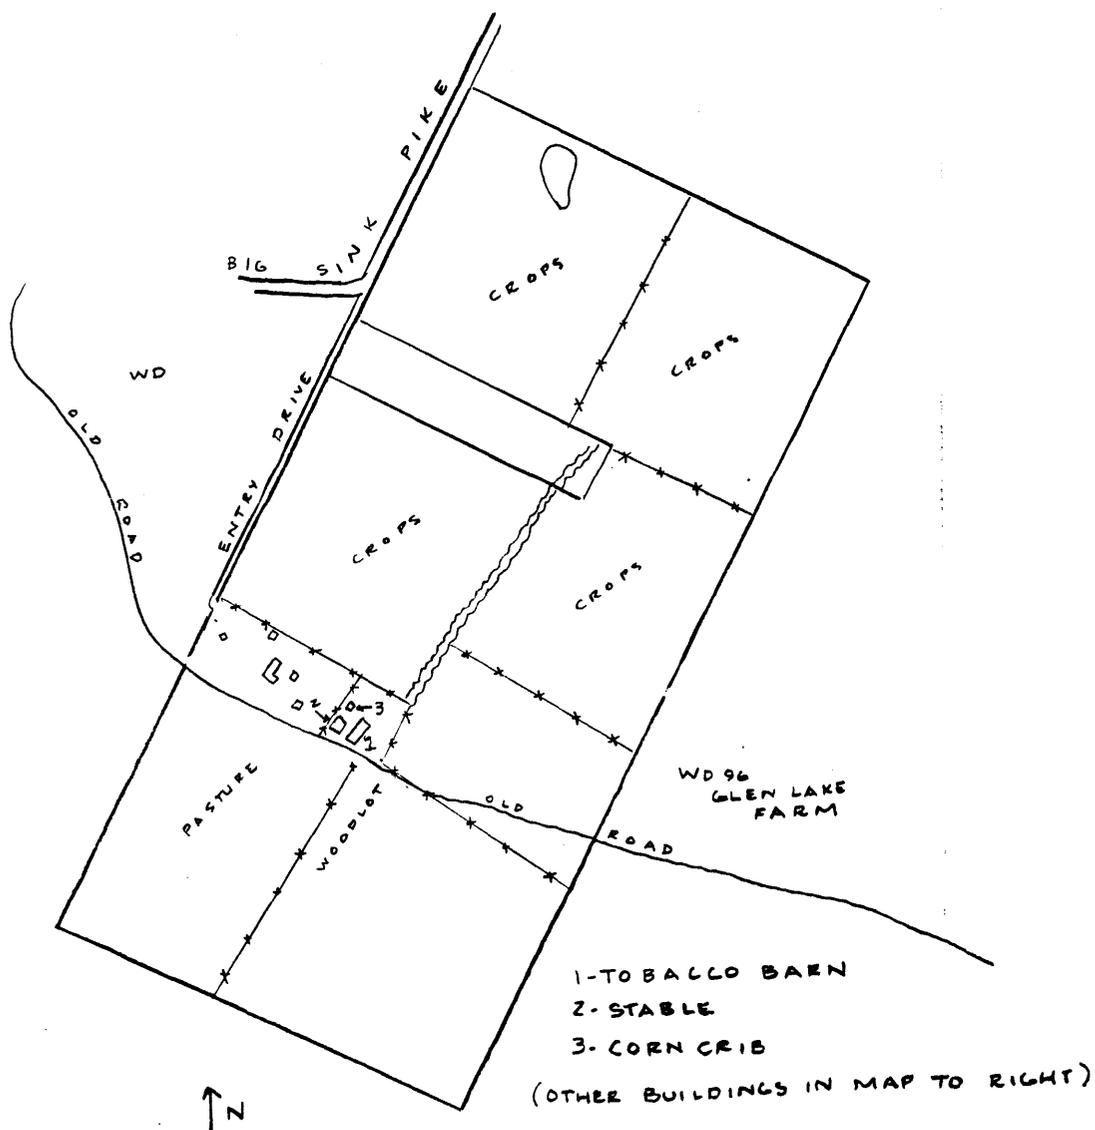
WD 102 AMOS STOUT FARM

SITE MAP 1" = 660'

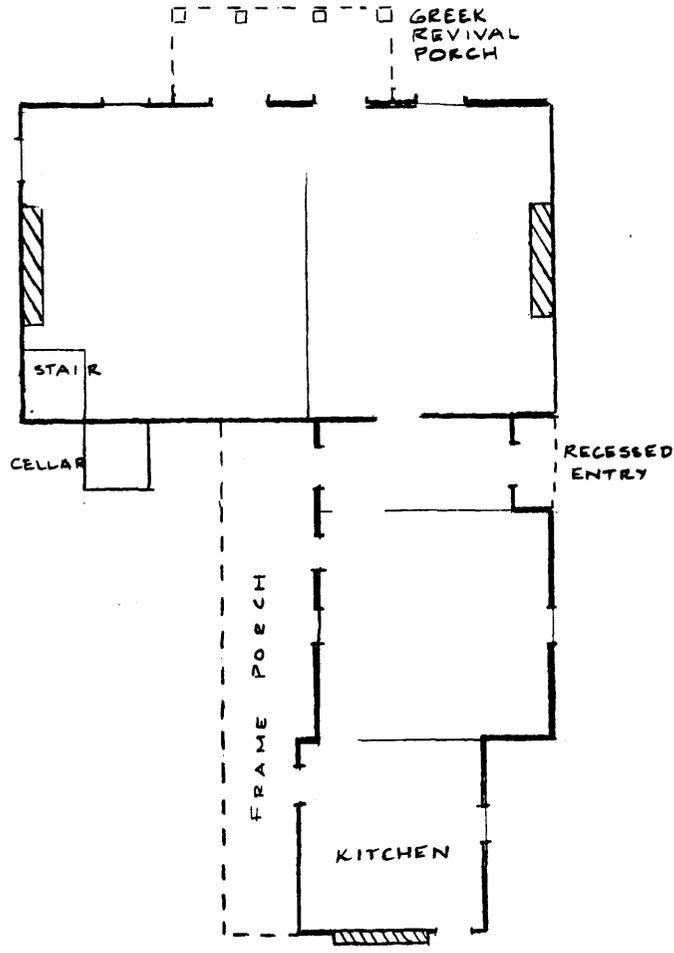
AMOS STOUT FARM
RESIDENCE

□ CISTERN

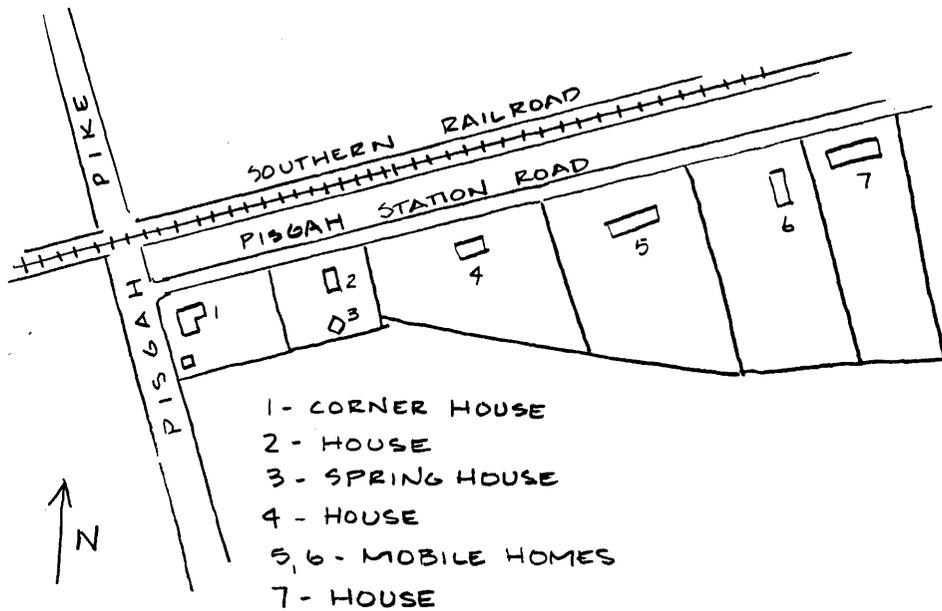
PIGHE STATION WD 160

1" = 200'

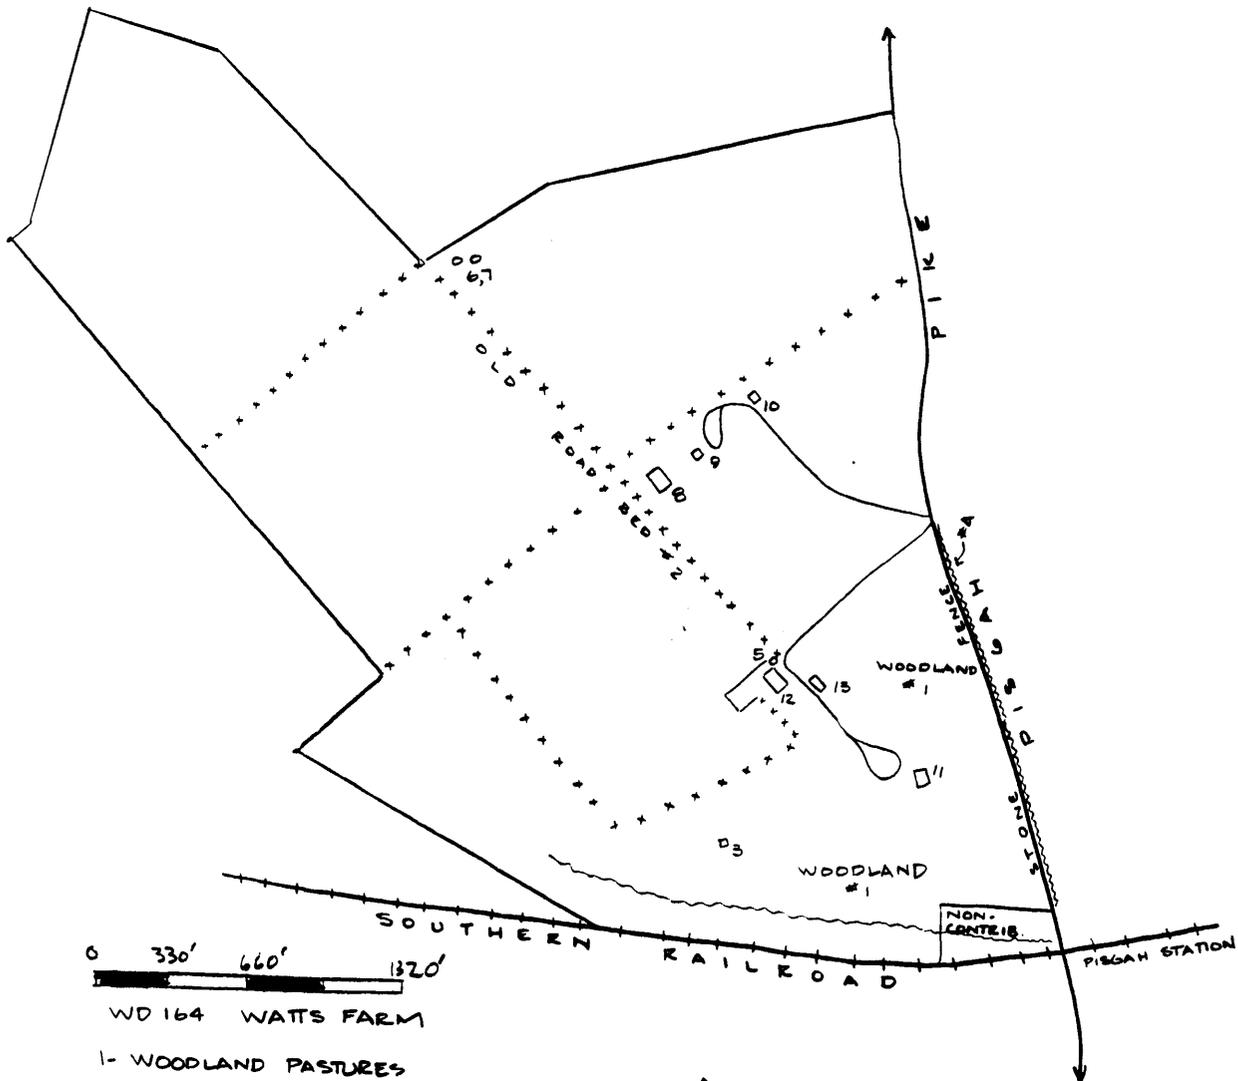
- WD 164 WATTS FARM
- 1- WOODLAND PASTURES
 - 2- OLD ROAD ALIGNMENT
 - 3- SPRING HOUSE FOUNDATION
 - 4- STONE FENCE
 - 5-6-7 SILO, GRAIN BINS
 - 8- TOBACCO BARN
 - 9-10-11 TWO TENANT HOUSES
TWO- STORY HOUSE (NEW)
 - 12- TOBACCO BARN
 - 13- MACHINE SHED

Examples of characteristic stone fences in the District include alignments at FA 307, WD 91, 92, 108, 162, 164, 174, 176, 196, and 199. One example, found at WD 164, the Watts farm, aligns the west edge of the Pisgah Pike. The stone fence fronts the farm's woodland pasture remnant which is located on sloping ground surrounding a meandering creek bed. An additional example, along the Old Frankfort Pike at WD 176, contains a flared opening marking an historic entry. The stone walls flanking the old road to the saw and grist mills near Faywood, WD 91, remain one of the most evocative stone wall structures in the area. District examples indicate variety in construction method and quality of workmanship.

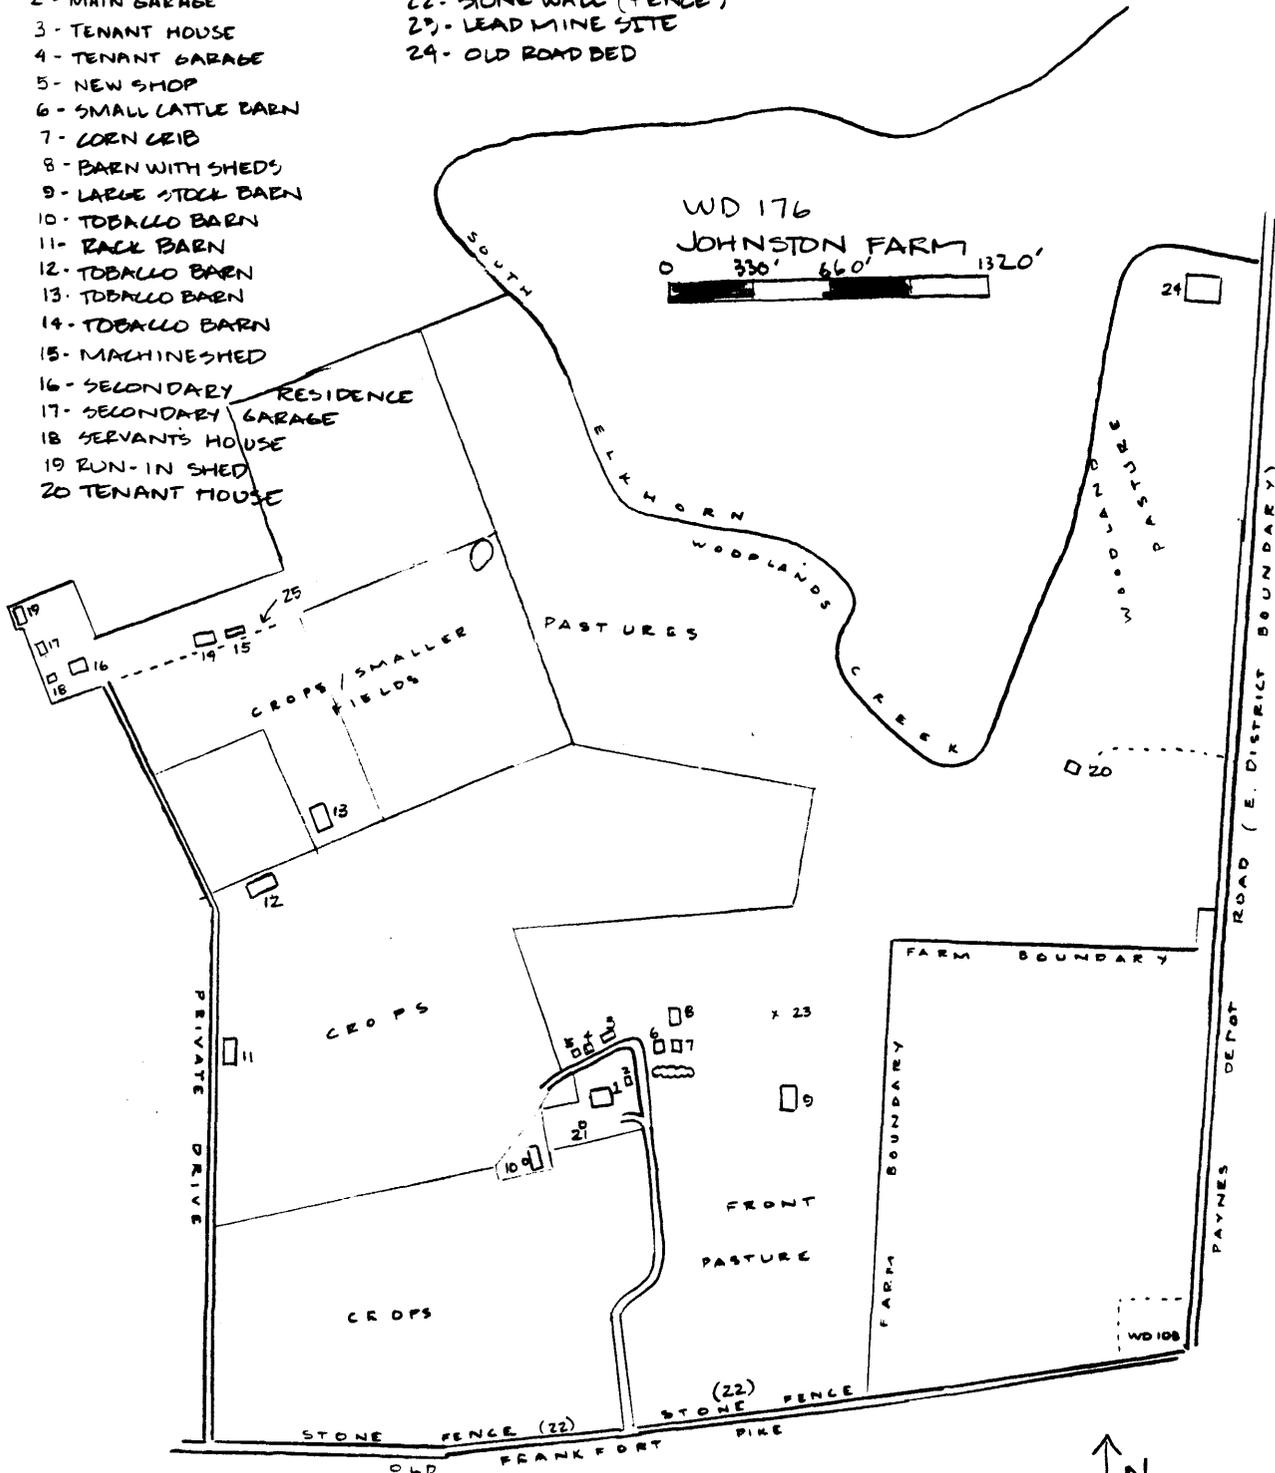
- 1- MAIN RESIDENCE
- 2- MAIN GARAGE
- 3- TENANT HOUSE
- 4- TENANT GARAGE
- 5- NEW SHOP
- 6- SMALL CATTLE BARN
- 7- CORN CRIB
- 8- BARN WITH SHEDS
- 9- LARGE STOCK BARN
- 10- TOBALLO BARN
- 11- RACK BARN
- 12- TOBALLO BARN
- 13- TOBALLO BARN
- 14- TOBALLO BARN
- 15- MACHINESHED
- 16- SECONDARY RESIDENCE
- 17- SECONDARY GARAGE
- 18 SERVANT'S HOUSE
- 19 RUN-IN SHED
- 20 TENANT HOUSE

- 21- ROOT CELLAR
- 22- STONE WALL (FENCE)
- 23- LEAD MINE SITE
- 24- OLD ROAD BED

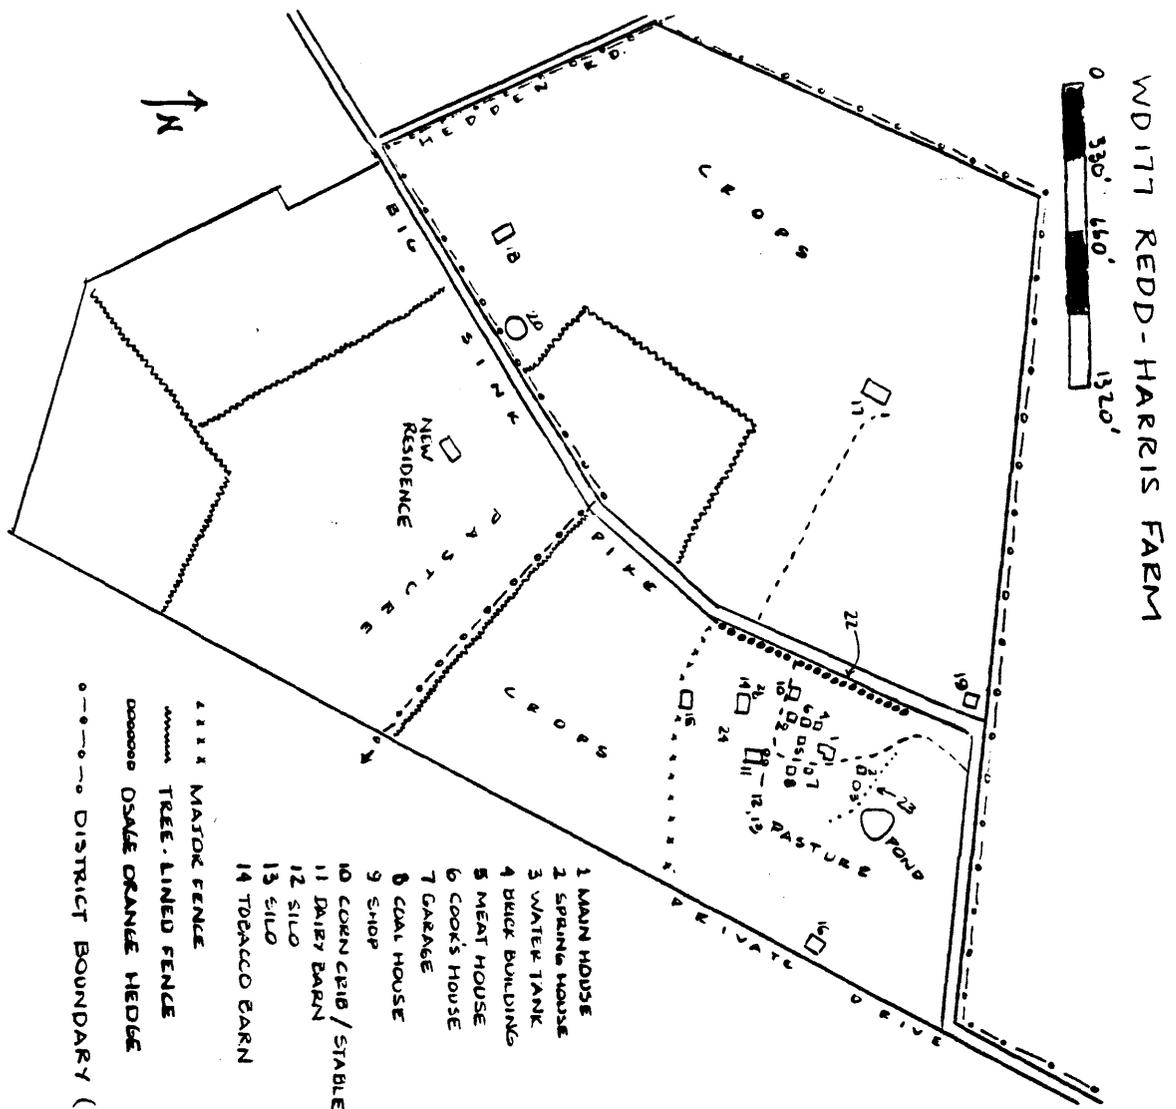
- 1 MAIN HOUSE
- 2 SPRING HOUSE
- 3 WATER TANK
- 4 BRICK BUILDING
- 5 MEAT HOUSE
- 6 COOK'S HOUSE
- 7 GARAGE
- 8 COAL HOUSE
- 9 SHOP
- 10 CORN CRIB / STABLE
- 11 DAIRY BARN
- 12 SILO
- 13 SILO
- 14 TOBACCO BARN
- 15 BANK BARN
- 16 TENANT HOUSE
- 17 TOBACCO BARN
- 18 TOBACCO BARN
- 19 SMALL BANK BARN
- 20 QUARRY SITE
- 21 STOCK CISTERN
- 22 OSAGE ORANGE HED
- 23 ABANDONED ROAD
- 24 GRAVEYARD

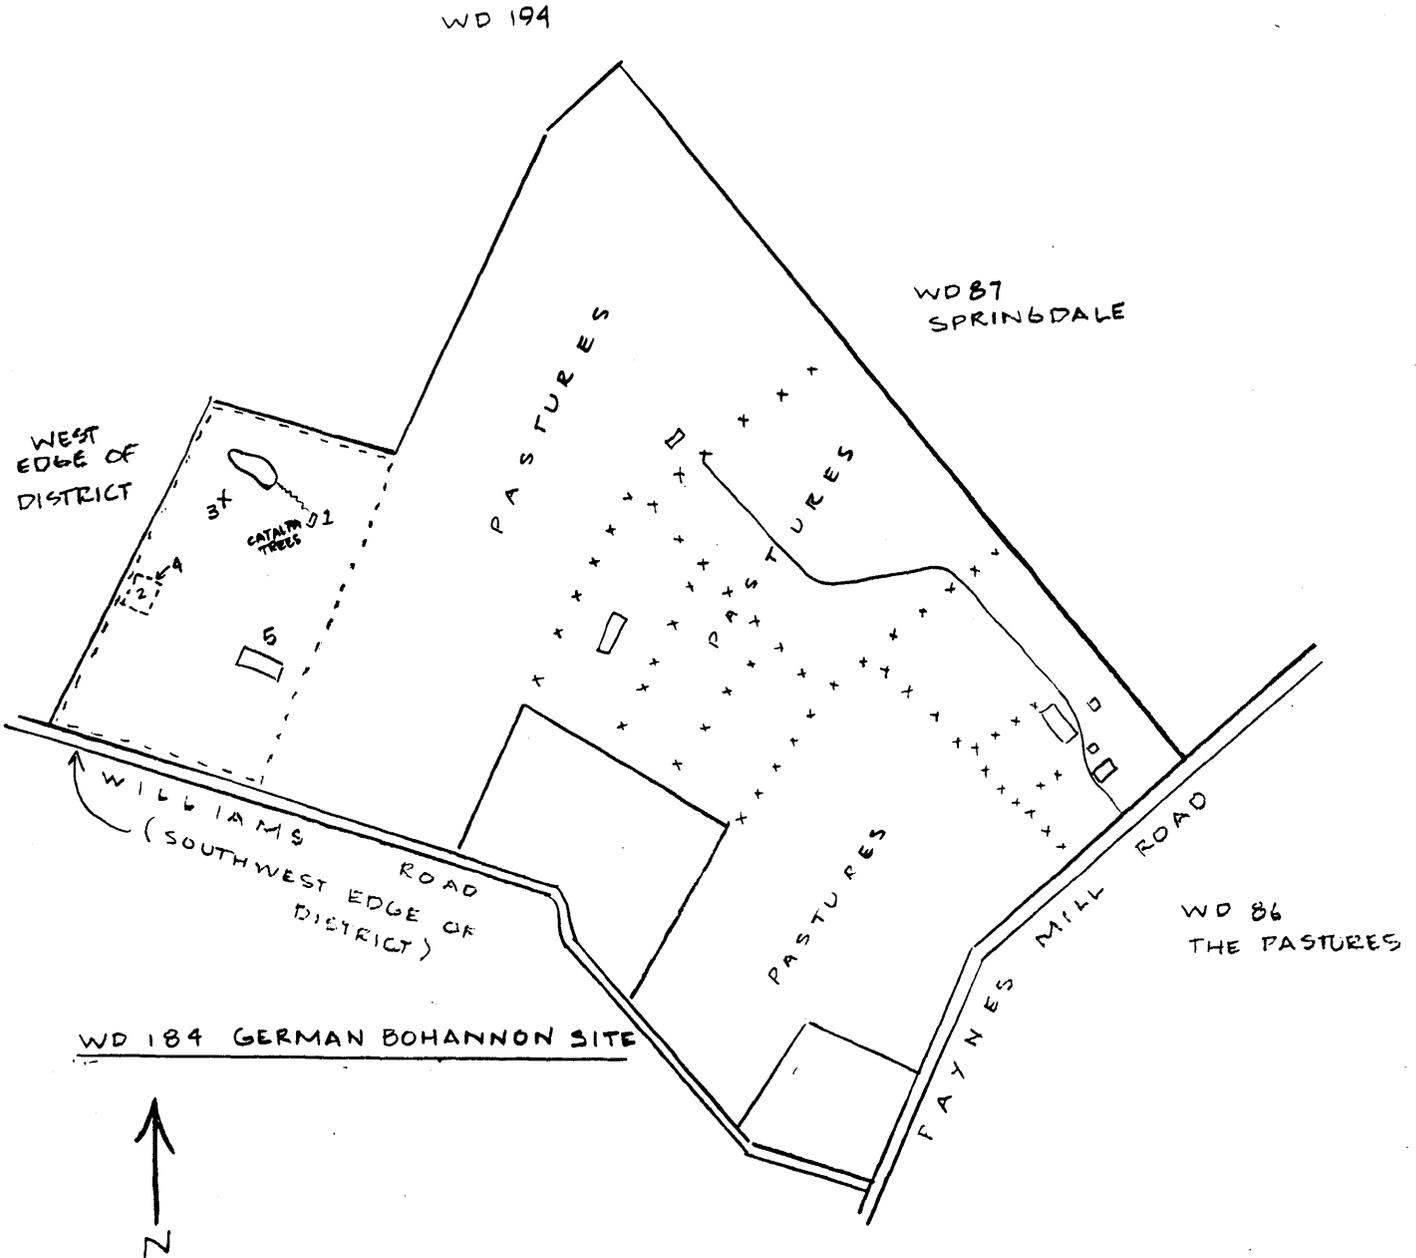
--- BOUNDARY OF SITE AREA IN DISTRICT
REMAINDER OF FARM AND BUILDINGS ARE
NOT INCLUDED IN PISGAH RURAL HISTORIC DISTRICT
