NATIONAL REGISTER OF HISTORIC PLACES  
REGISTRATION FORM

Historic name Mohnike Adobe

Street & number 12115 Black Mountain Road not for publication   
City or town San Diego vicinity \_\_\_\_\_  
State California code CA county San Diego County code 073 zip code 92126

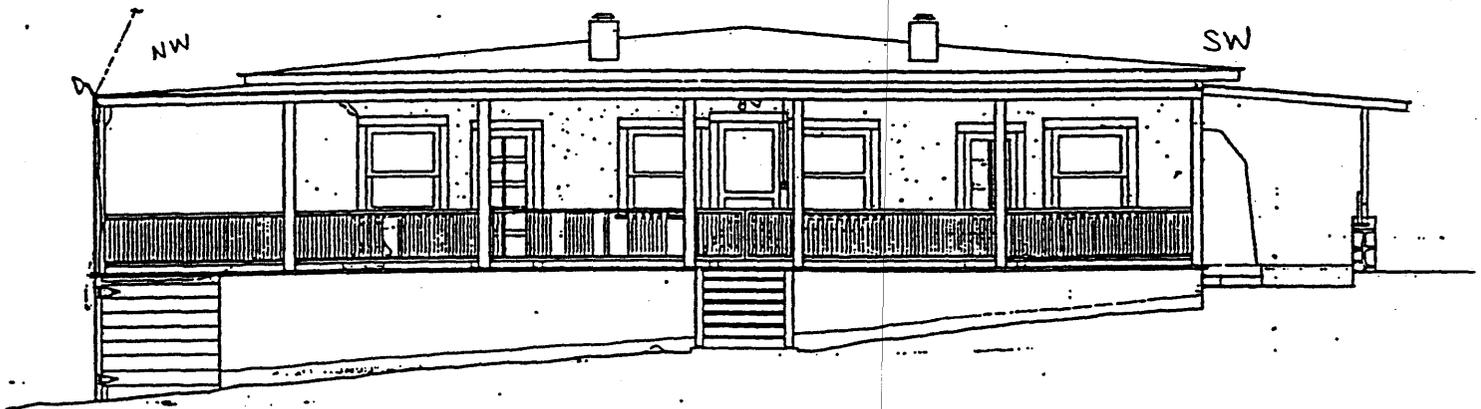
## Existing West Elevation

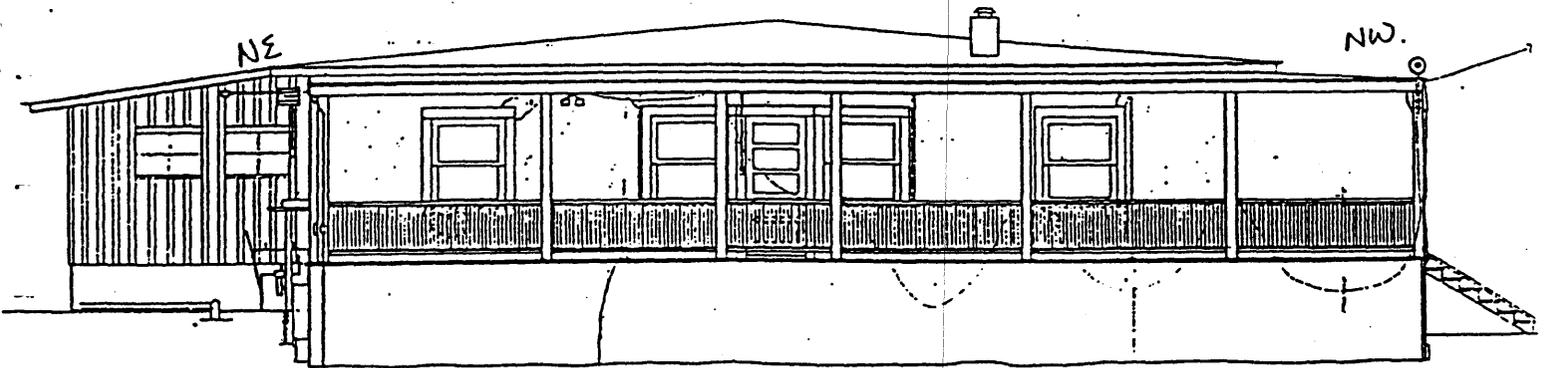
Figure G

## Existing North Elevation

The north elevation wrap around porch extends the full length of the north side **Photographs 15 & 16**. The base wall is equal in height and is approximately 6 ft. from the northwest to the northeast corner **Photograph 15**. The fenestration is symmetrical with a centralized five-panel door flanked by one-over-one double hung windows. On each side of the central entry is a double hung window **Photograph 17**. The porch floorboards, where original columns existed are in poor condition **Photograph 16**. The footprints of the original columns indicate that stairs leading directly to the entryway were original to the porch design. However, currently there are no stairs directly accessing the north side of the Adobe.

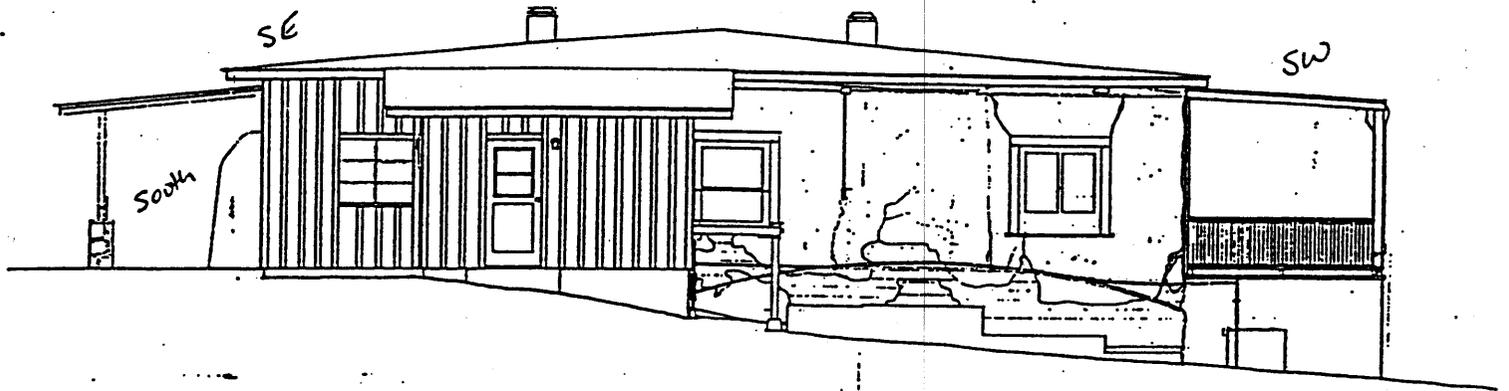
**Existing East Elevation**

As seen in **Photograph 20**, the east elevation is constructed on grade with a post-1950s shed roofed board and batten addition located on the southeast corner.<sup>7</sup> The addition is currently located where an original lean-to shed roofed patio existed<sup>8</sup> **Attachment B**. The northeast section of the house has moisture related deterioration and as shown in **Photographs 21 & 24** the plaster has eroded leaving exposed adobe bricks. As shown in **Photograph 23**, a contemporary concrete retaining wall has been placed along a portion of the deteriorating northeastern section to help prevent further foundation erosion.

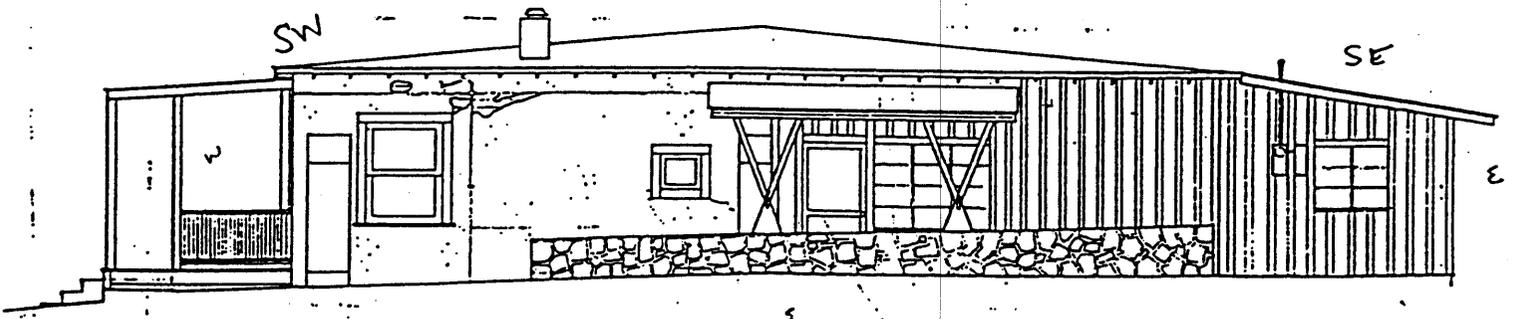
Figure F

**Existing South Elevation**

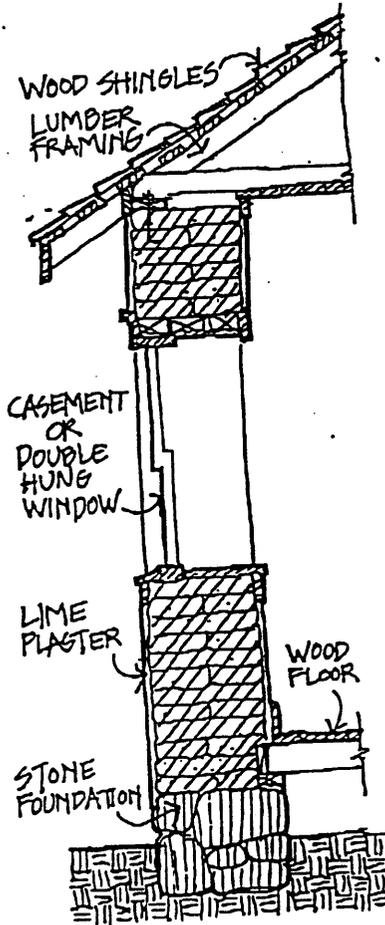
The Victorian System (See Figure 2)

As the U.S. Military established camps, posts and forts in the southwest and as railroads were constructed, Victorian age industrial products and processes arrived in the region. Two industrial structures changed the method of constructing adobe buildings, the sawmill and the limekiln. Using dimensioned lumber in place of logs and branches and lime as an exterior coating, adobe structures needed less maintenance. They could also pass as more traditional brick or stone Victorian structures through the use of gingerbread wood detailing and scoring of the lime stucco.

Figure 2  
The Victorian System  
(1882-1914)

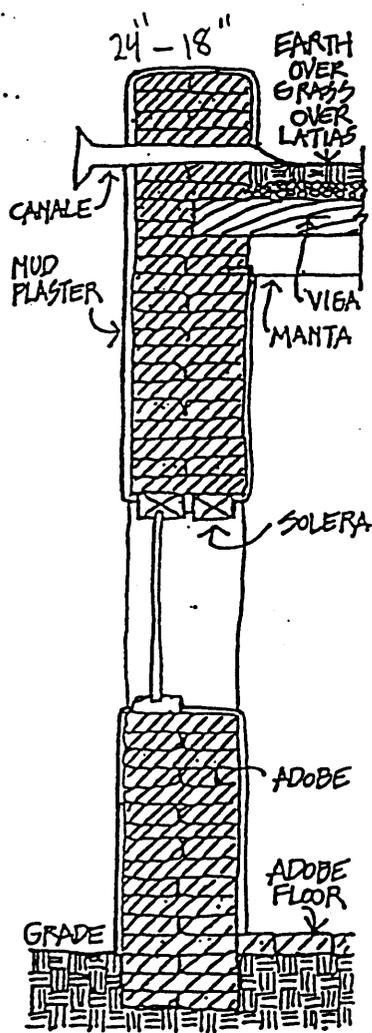
Figure A  
The Indigenous System  
(1848-1881)

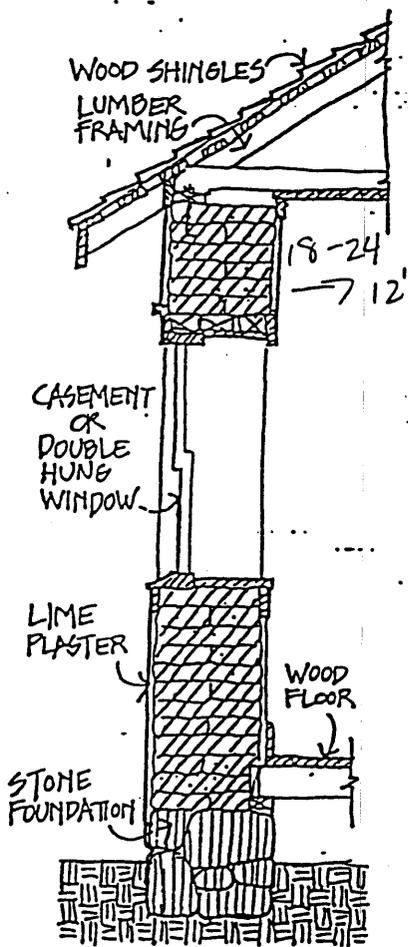
Figure B  
The Victorian System  
(1882-1914)

heavily influenced by Anglo building methods. The Victorian System named by Mr. Garrison for the era<sup>113</sup> is also referred to as an Anglicized-Mexican adobe. This classification of adobe construction is typified by its use of lime plaster covered adobe walls, stone foundations, raised wood framed flooring, large casement or double hung windows, 18 to 24 inch thick adobe walls, and a low to medium pitched roof covered in shake shingles.

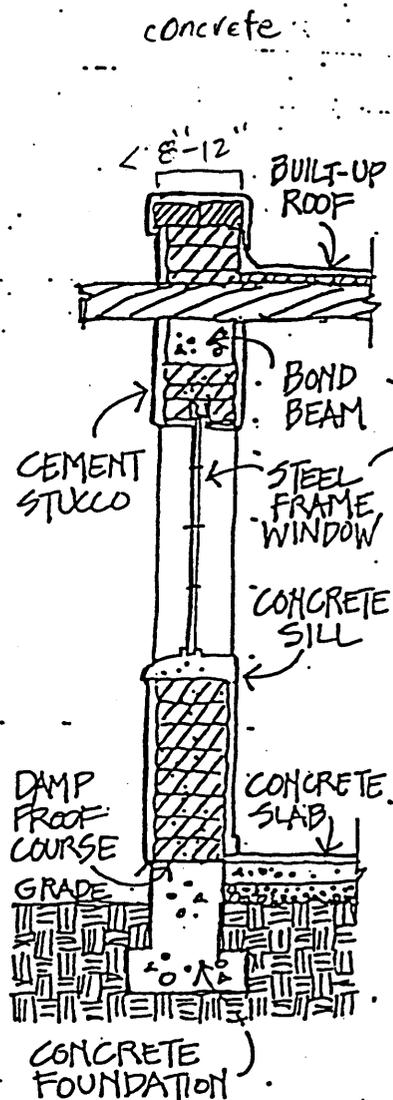
Figure C  
The Revival System  
(1915-1948)

In comparison, Mr. Garrison's defined Revival System (1915 to 1948) uses construction methods that resemble contemporary construction principles. Adobe stem walls are set on reinforced concrete foundations and the floor is a concrete slab-on-grade. Walls are adobe mud brick, ranging between 8 to 12 inches in thickness and are encased in Portland cement. Wood and steel-framed casement windows are used to create a contemporary building appearance. While the roof styles vary between pitched, hipped, shed, and flat, the roof traditionally rests upon a concrete beam on top of the adobe walls. This beam, known as a bond beam, provides structural stability.

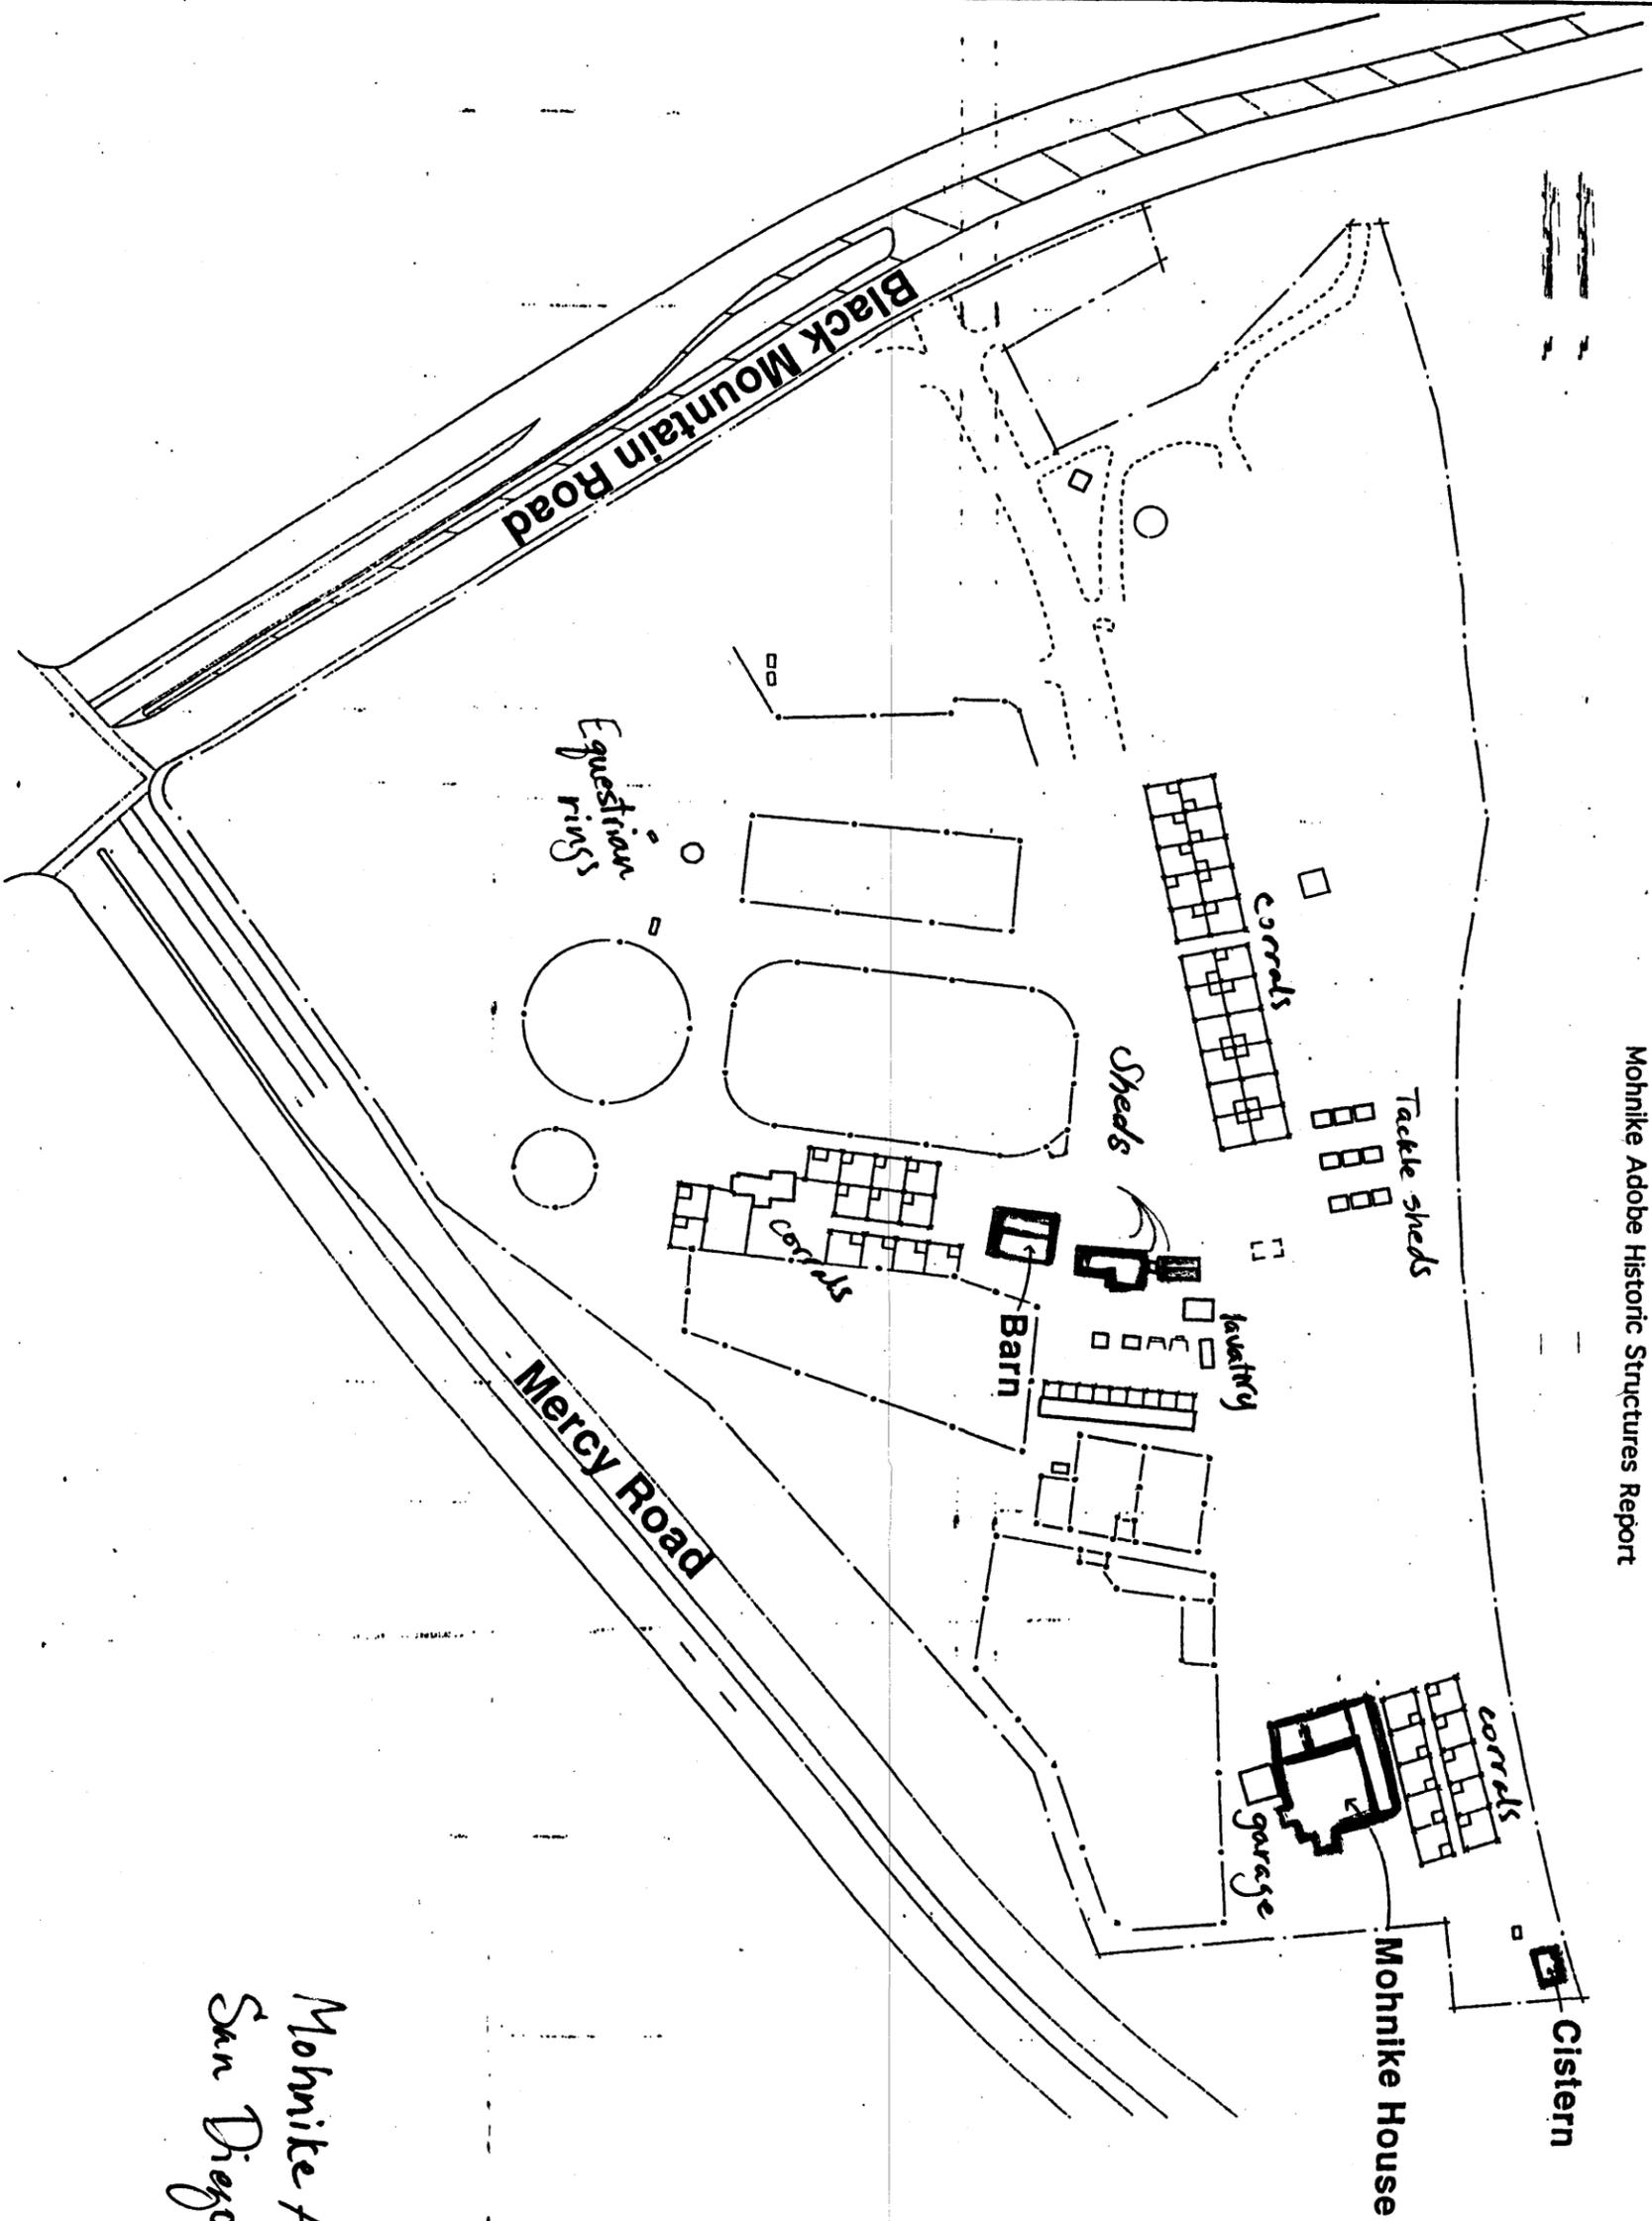
**Enlarged Partial Site Plan**  
NTS
