United States Department of the Interior
National Park Service
National Register of Historic Places
Registration Form

historic name North Rim Road, Black Canyon of the Gunnison National Park

other names/site number North Rim Road Historic District/ 5MN.3522

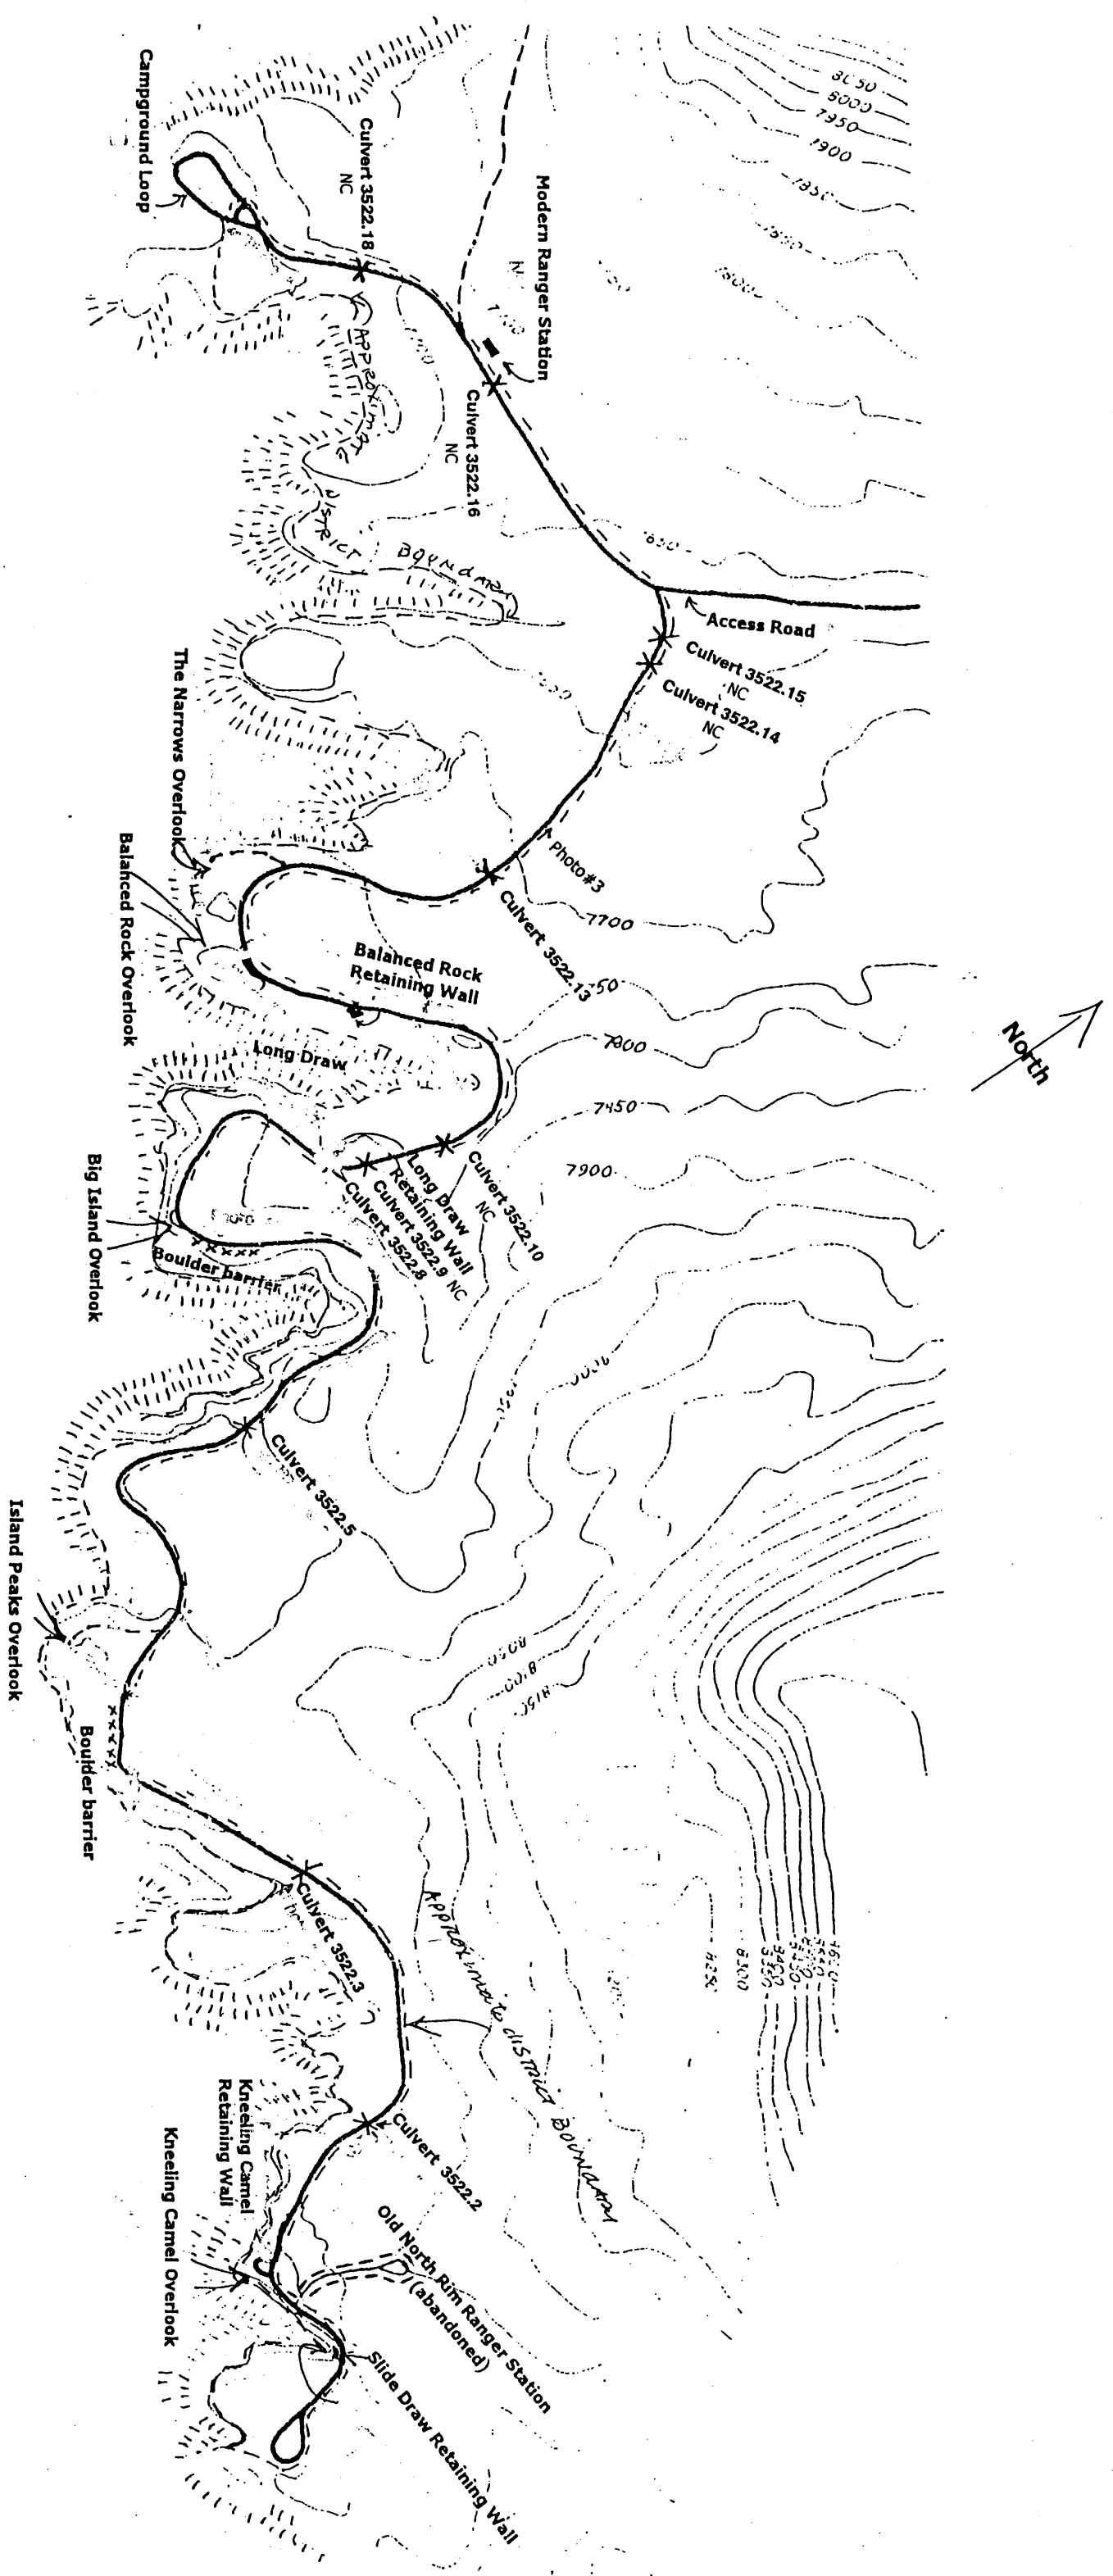
Black Canyon of the Gunnison National Monument

Schematic drawing showing alignment of North Rim Road and locations of associated overlooks, culverts, retaining walls and boulder barriers.
