National Register of Historic Places Registration Form

historic name Failing Office Building
other names/site number Gevurtz Building/Gasco Building/620 SW 5th Building

street & number 620 SW 5th Avenue not for publication
city or town Portland vicinity
state Oregon code OR county Multnomah code 051 zip code 97204

The 1907/1913 Failing Office Building is located at 620 SW Fifth Avenue in downtown Portland's historic commercial core on Lots 7 & 8 of Block 62. Architects William Whidden and Ion Lewis designed the original six-story building in 1907 and the six-story addition in 1913. The building's initial construction and later dramatic expansion was a response to the Portland's economic boom and an extraordinary demand for additional office space in downtown after the Lewis and Clark Centennial Exposition in 1905. The twelve-story building itself is representative of commercial architecture of the late-nineteenth and early twentieth-centuries, and features a reinforced steel-frame structure with facades of yellow brick and glazed terra cotta.

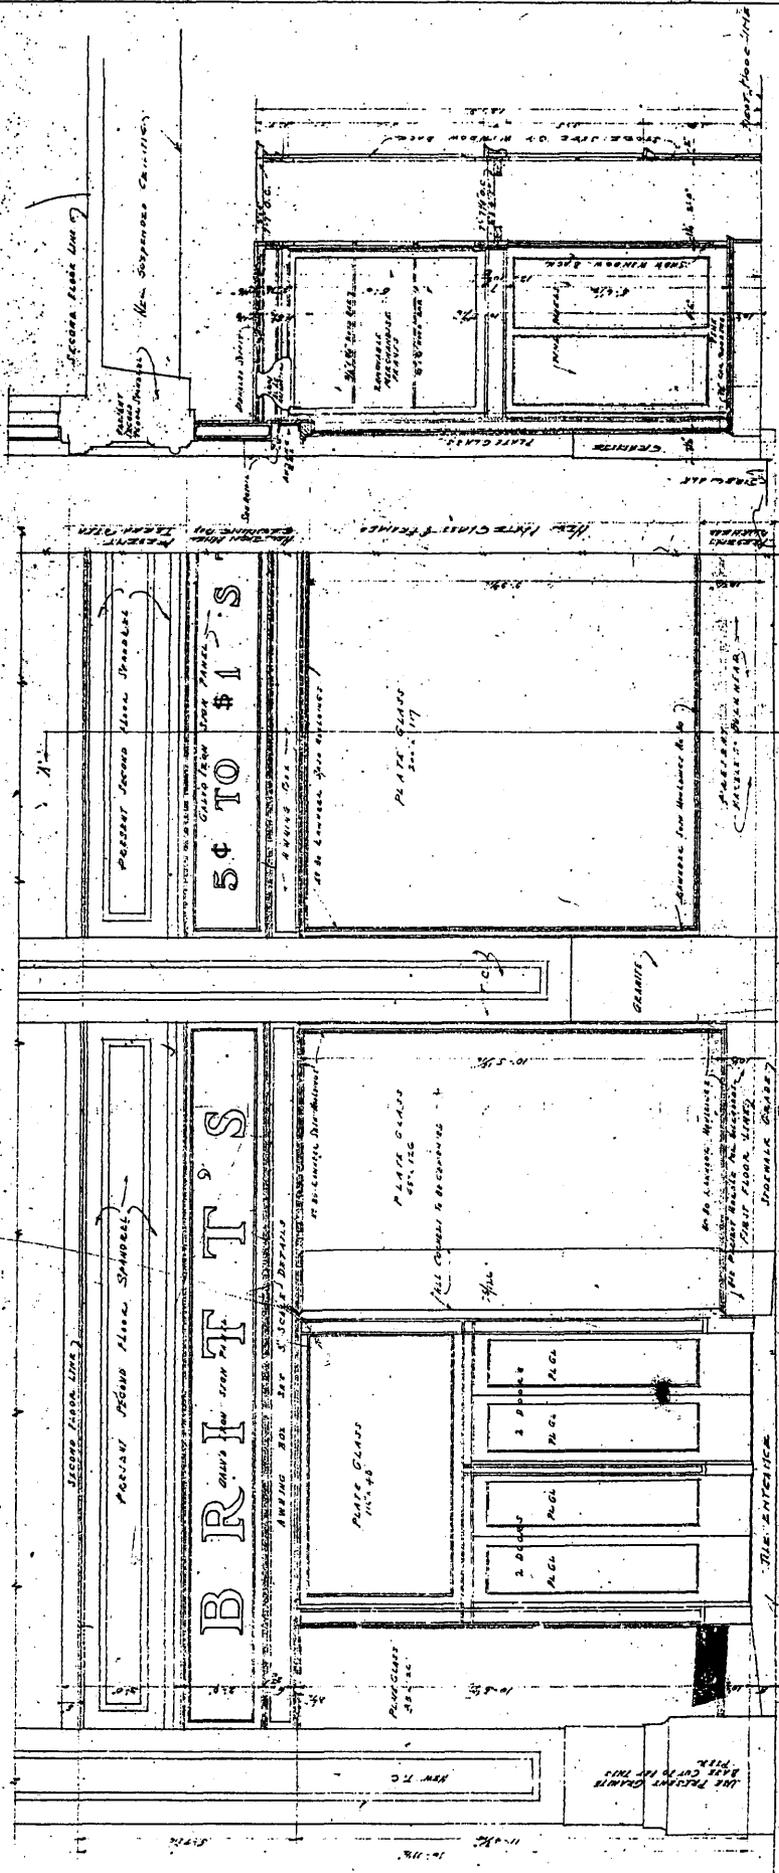
ELEVATION OF ENTRANCE & DISPLAY WINDOWS ON FIFTH AVENUE
 SCALE 1/4" = 1'-0"

SECTION THROUGH WINDOW ON LINE A-A
 SCALE 1/4" = 1'-0"

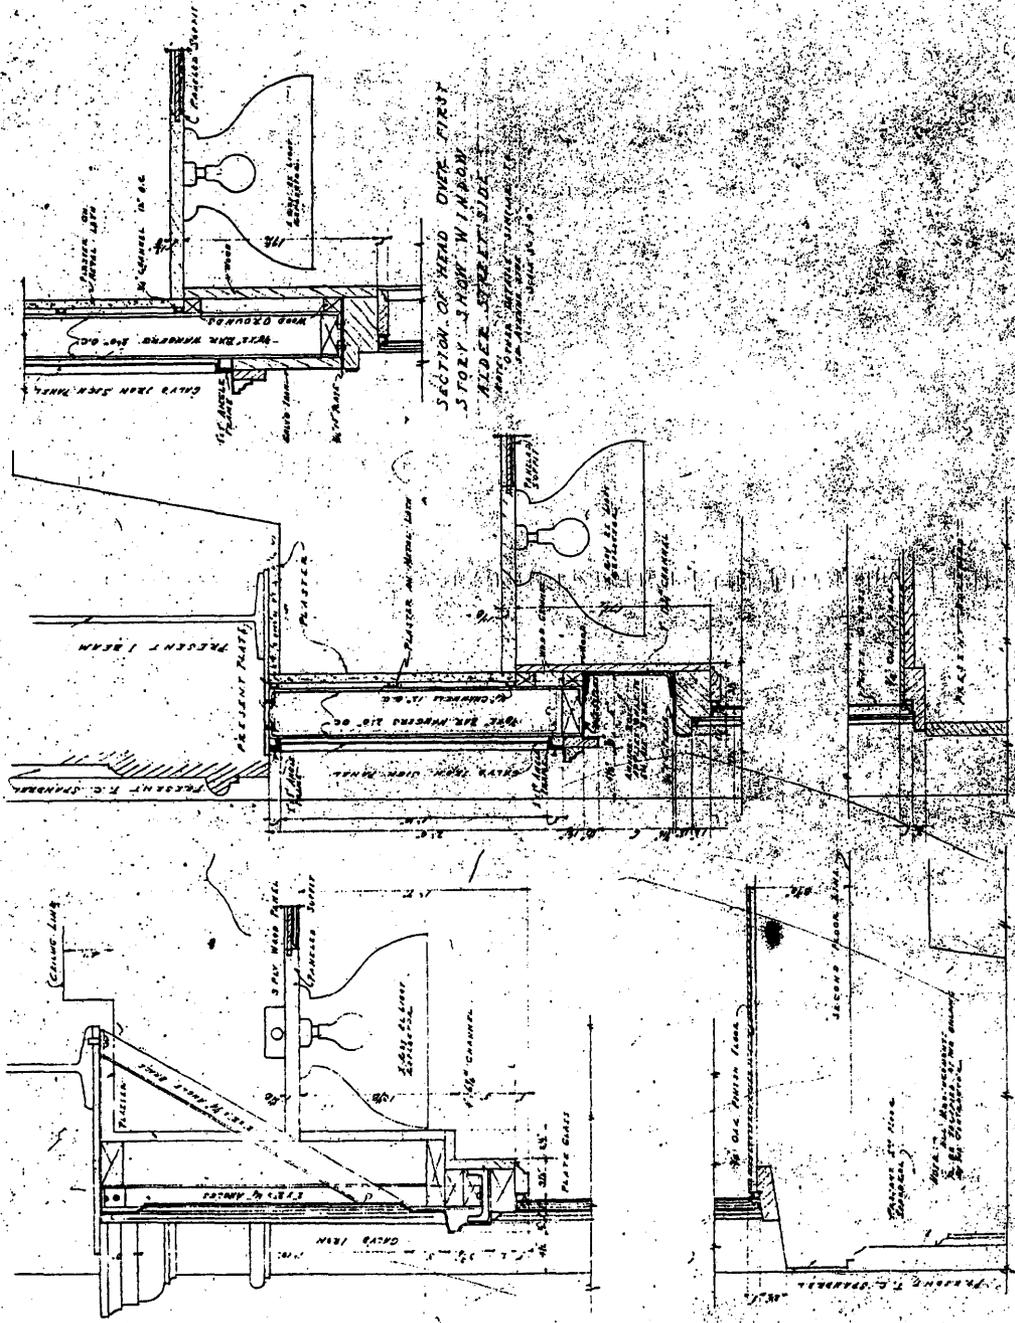
SECTION OF HEAD OVER FIRST STORY SHOW WINDOW REAR STREET SIDE

SECTION THRU 2ND STORY SHOW WINDOW SHOWING CONSTRUCTION OVER HEAD OF WINDOWS G. J. J. J.

SECTION THRU 1ST FLOOR SHOW WINDOW SHOWING CONSTRUCTION OVER HEAD OF WINDOWS G. J. J. J.

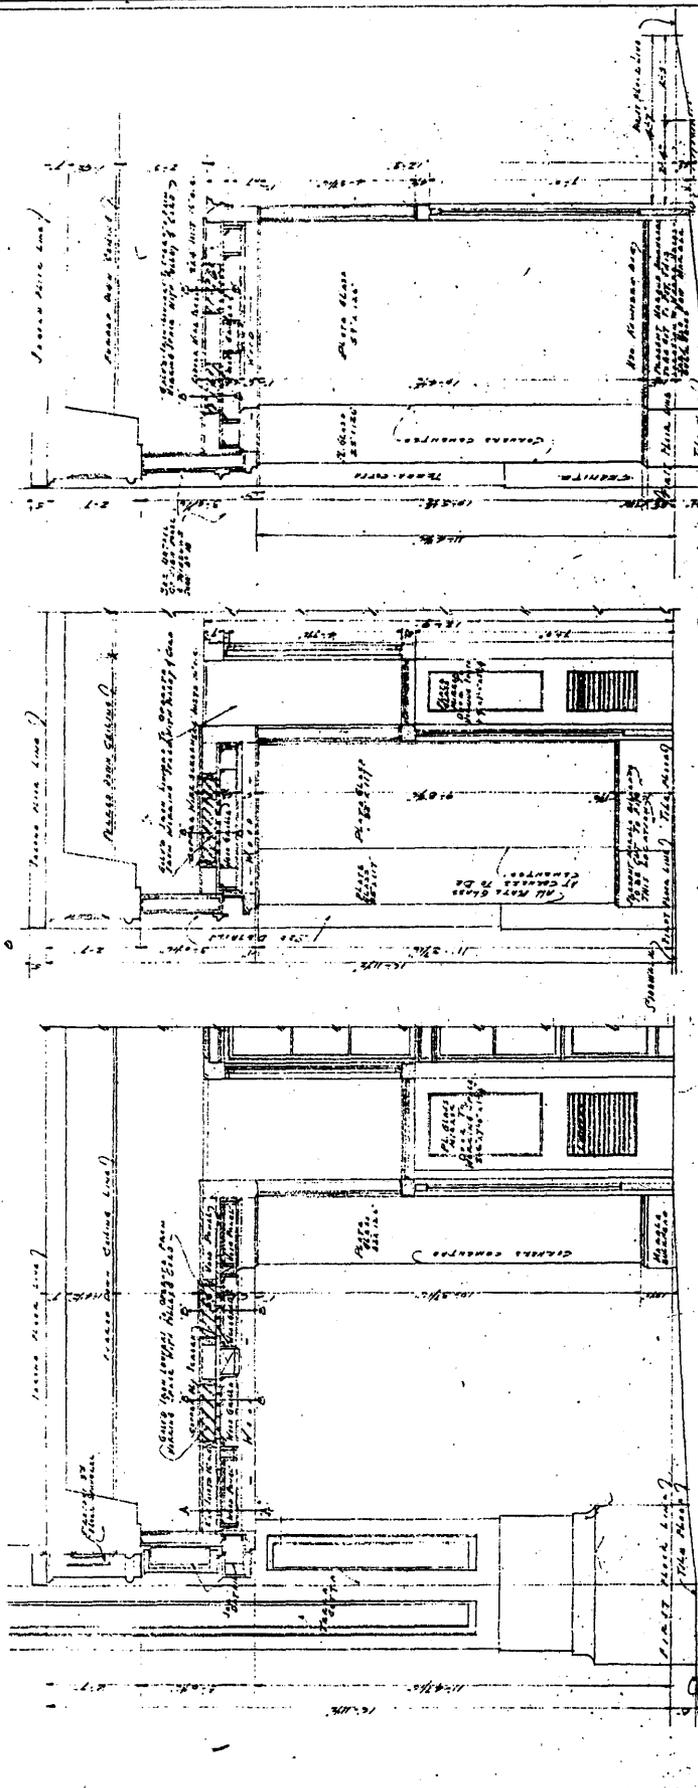
SECTION THRU SWAN & ALDER STREET ENTRANCES
Scale 1/4" = 1'-0"

SECTION THRU 5TH AVE. ENTRANCE
Scale 1/4" = 1'-0"

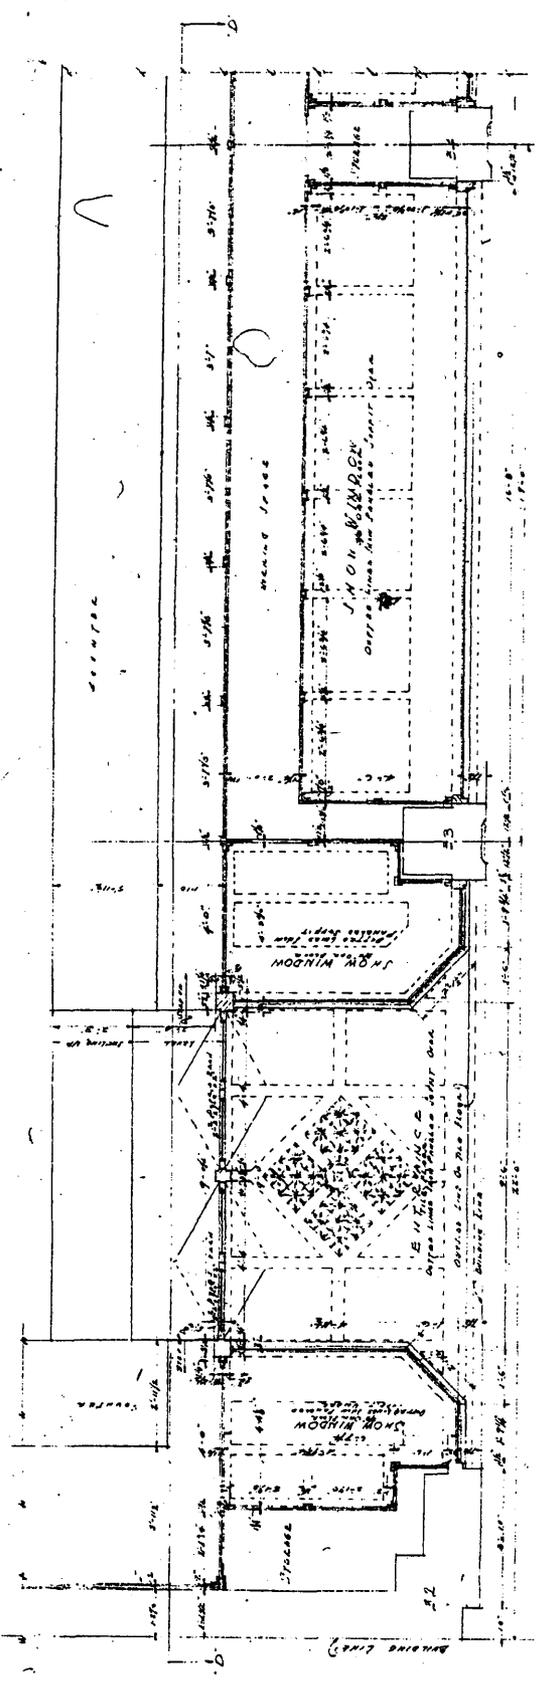
PLAN OF ALDER STREET ENTRANCE & SHOW WINDOWS ADJOINING

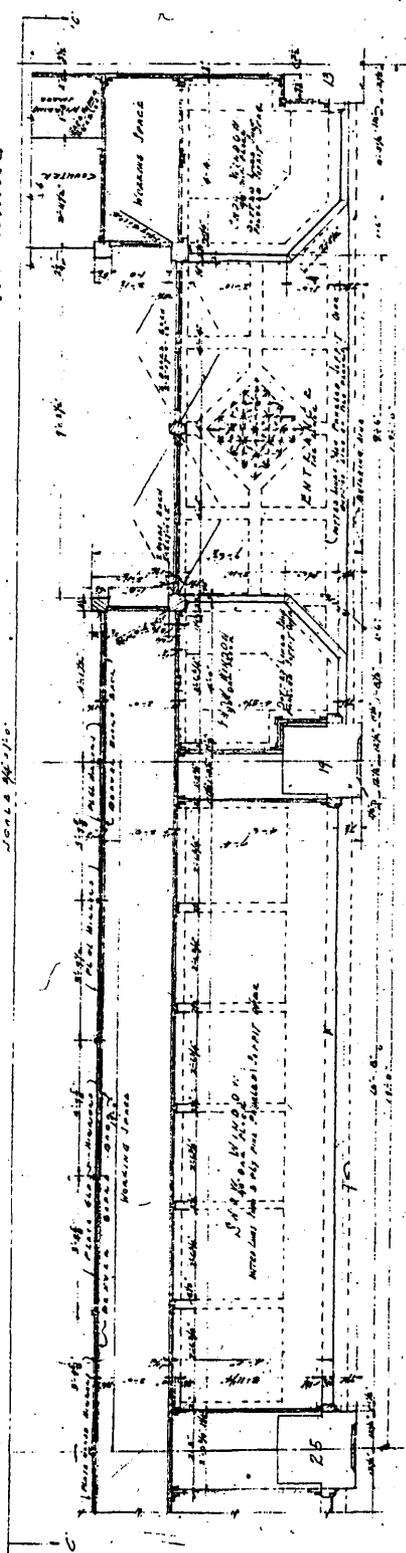
PLAN OF FIFTH AVENUE ENTRANCE & SHOW WINDOWS ADJOINING

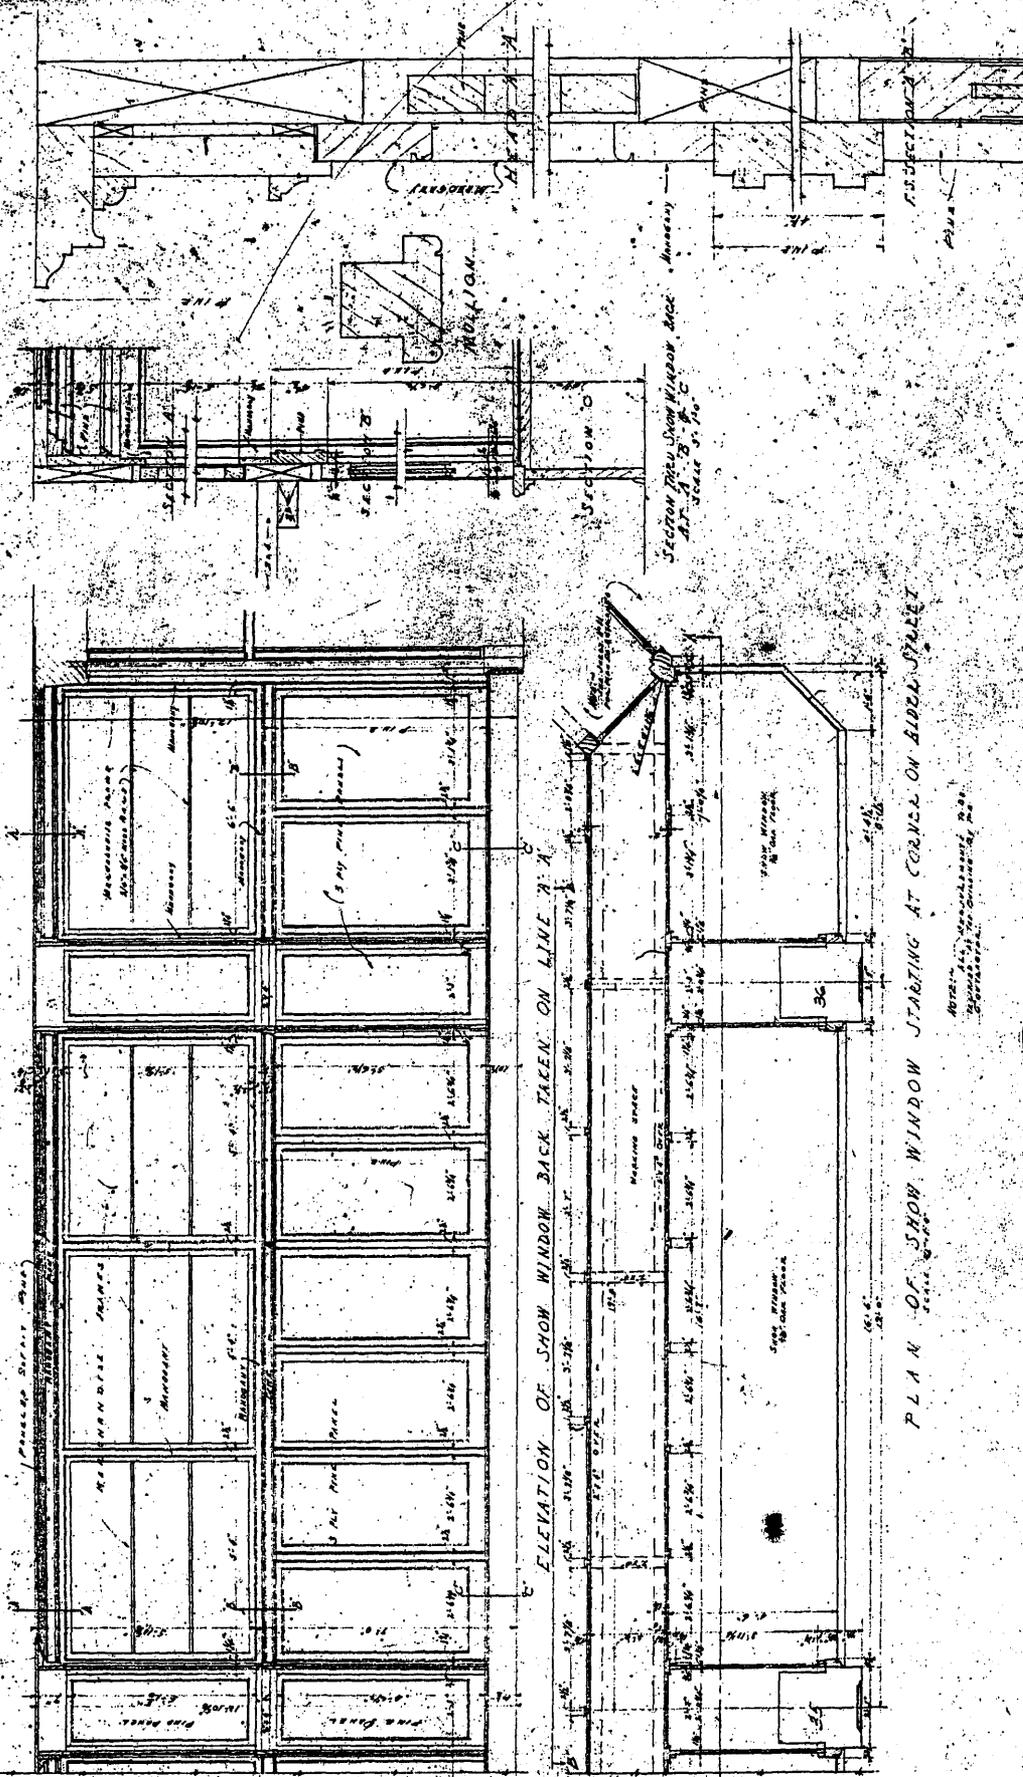
PLAN OF SHOW WINDOW STARTING AT CORNER ON BIDDLE STREET

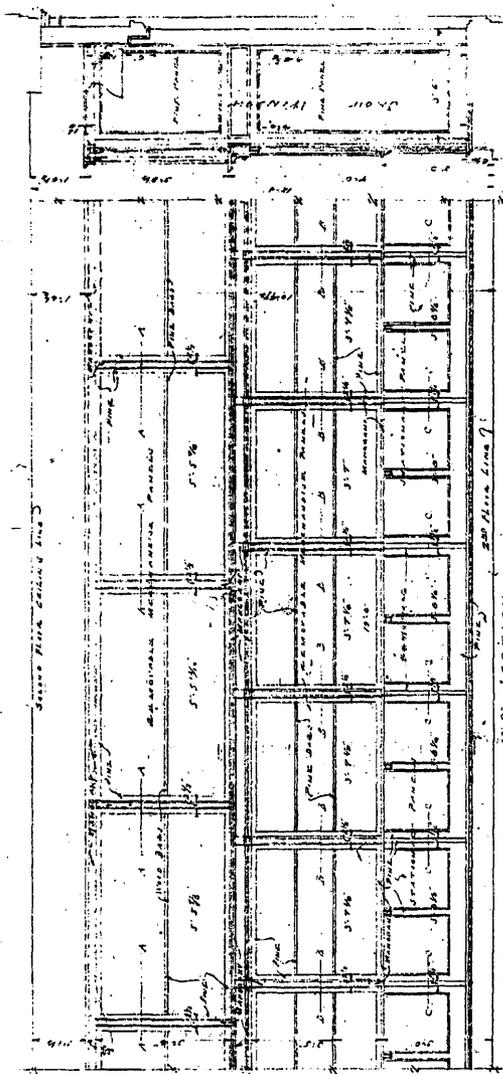
ELEVATION OF SHOW WINDOW BACKS LOOKING TOWARDS WINDOWS FROM STONE

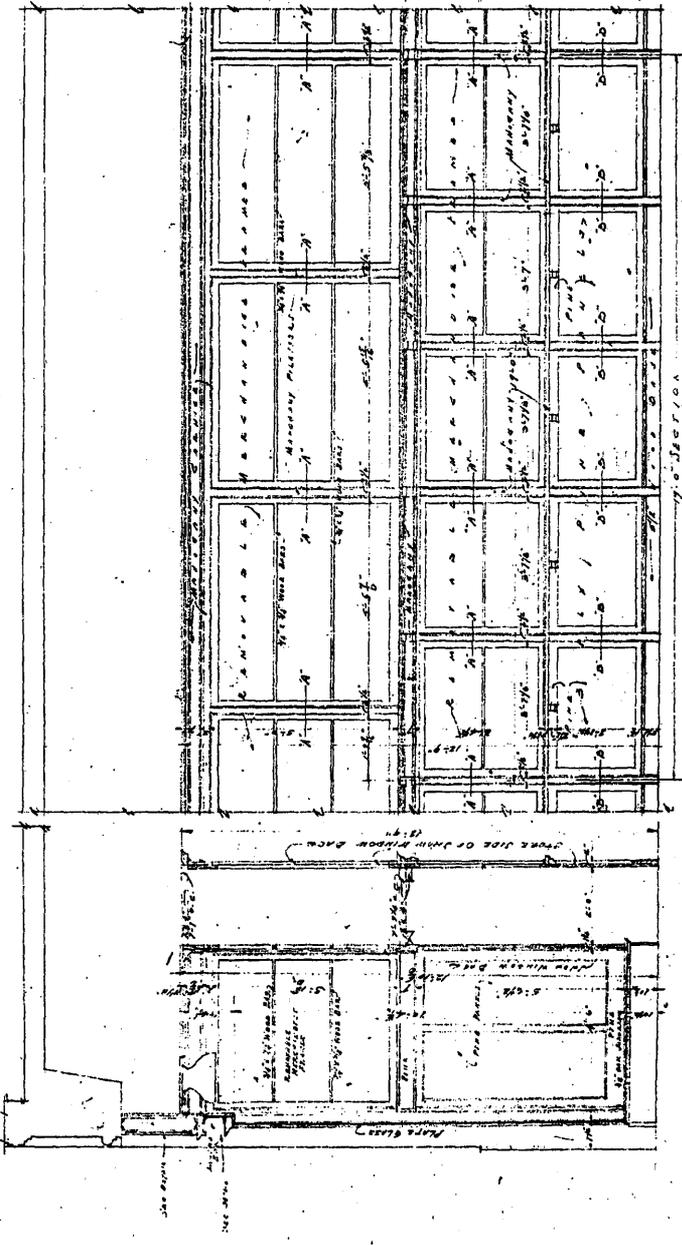
ELEVATION OF STORE SIDE OF WINDOW BACKS

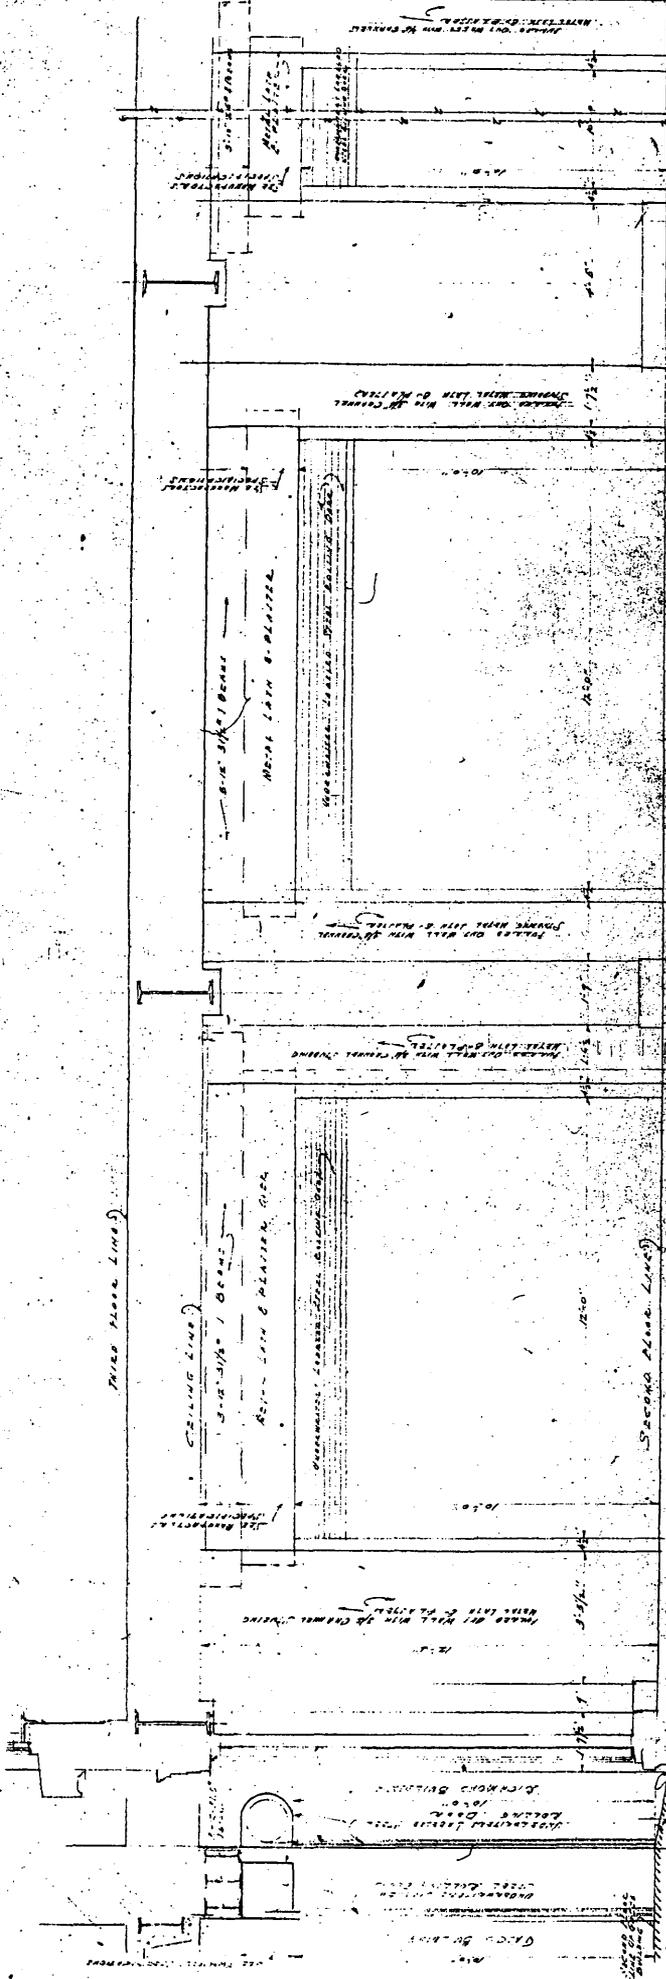
SECTION ELEVATION TAKEN FROM CHASE BUILDING TO SHOW EXTERIOR DIVIDING FLOORING UNDERMATH. LARGELY AT ANGLE TO CHASE BLDG.

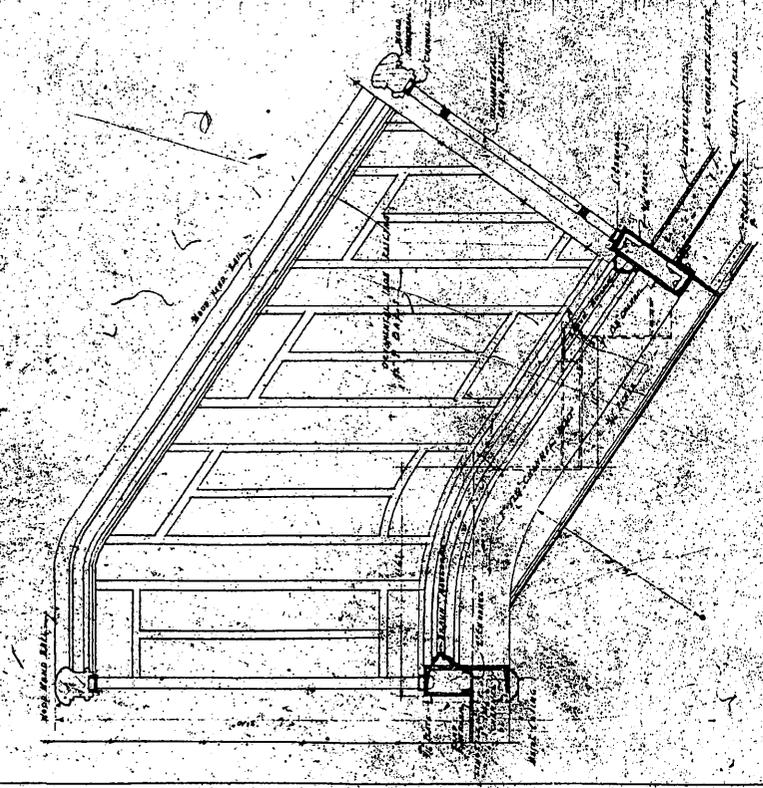
ELEVATION OF STAIR AT RAMP LANDING SHOWING RAILING

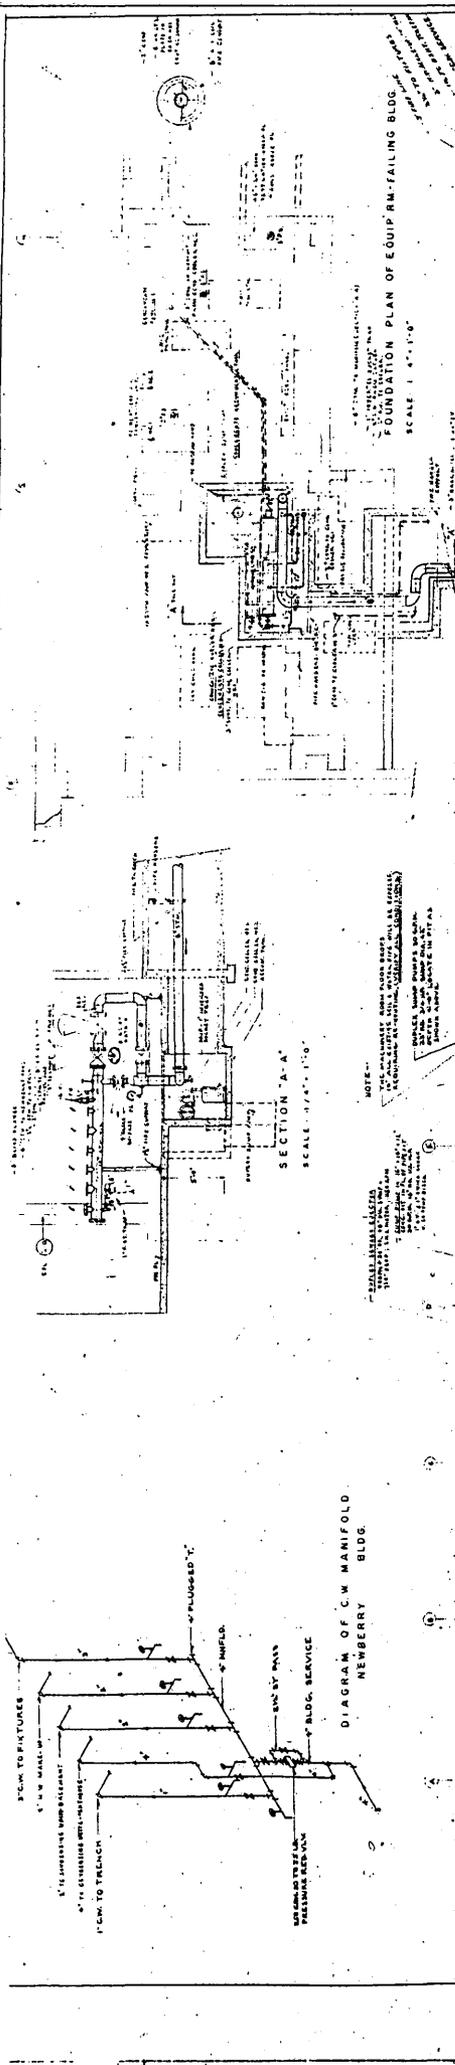
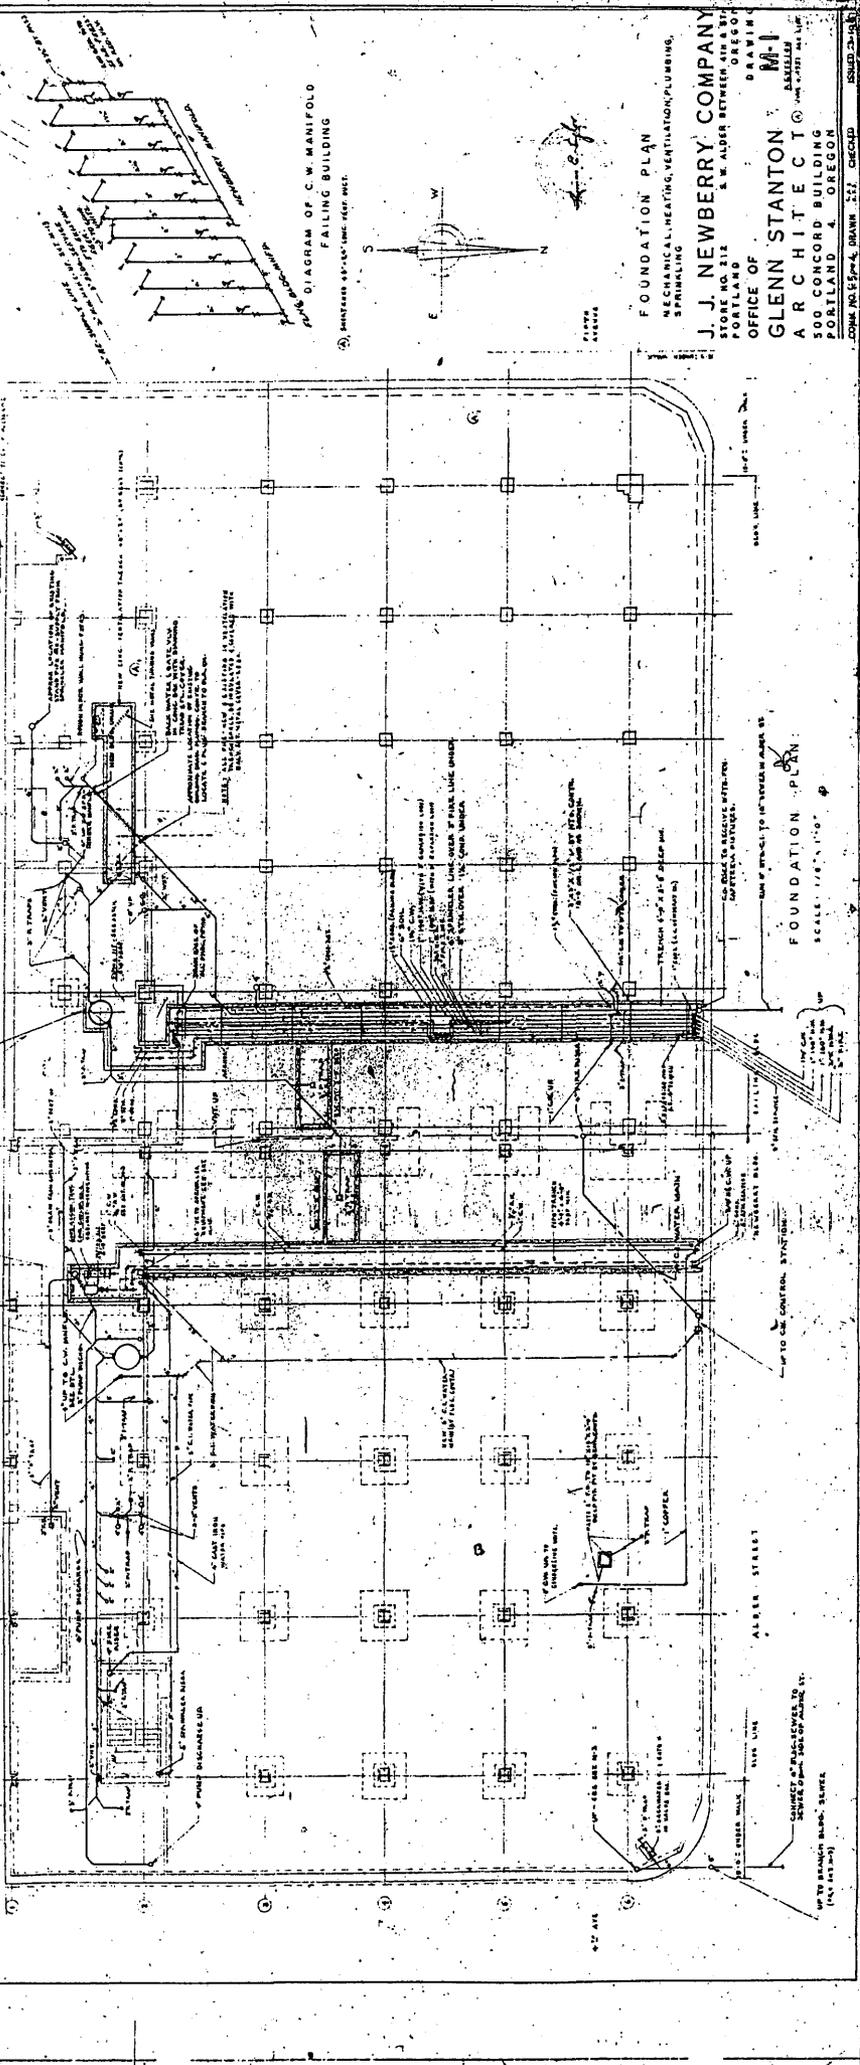
DIAGRAM OF C.W. MANIFOLD FAILING BUILDING
 MECHANICAL HEATING, VENTILATION, PLUMBING, SPRINKLING
J. J. NEWBERRY COMPANY
 STORE NO. 212 S. W. ALDER BETWEEN AIR & 17TH ST. PORTLAND, OREGON
 OFFICE OF DRAWING
GLENN STANTON ARCHITECT
 500 CONCORD BUILDING PORTLAND 4, OREGON
 DRAWING NO. 15-10-4, DRAWN 2-7, CHECKED 2-10-40

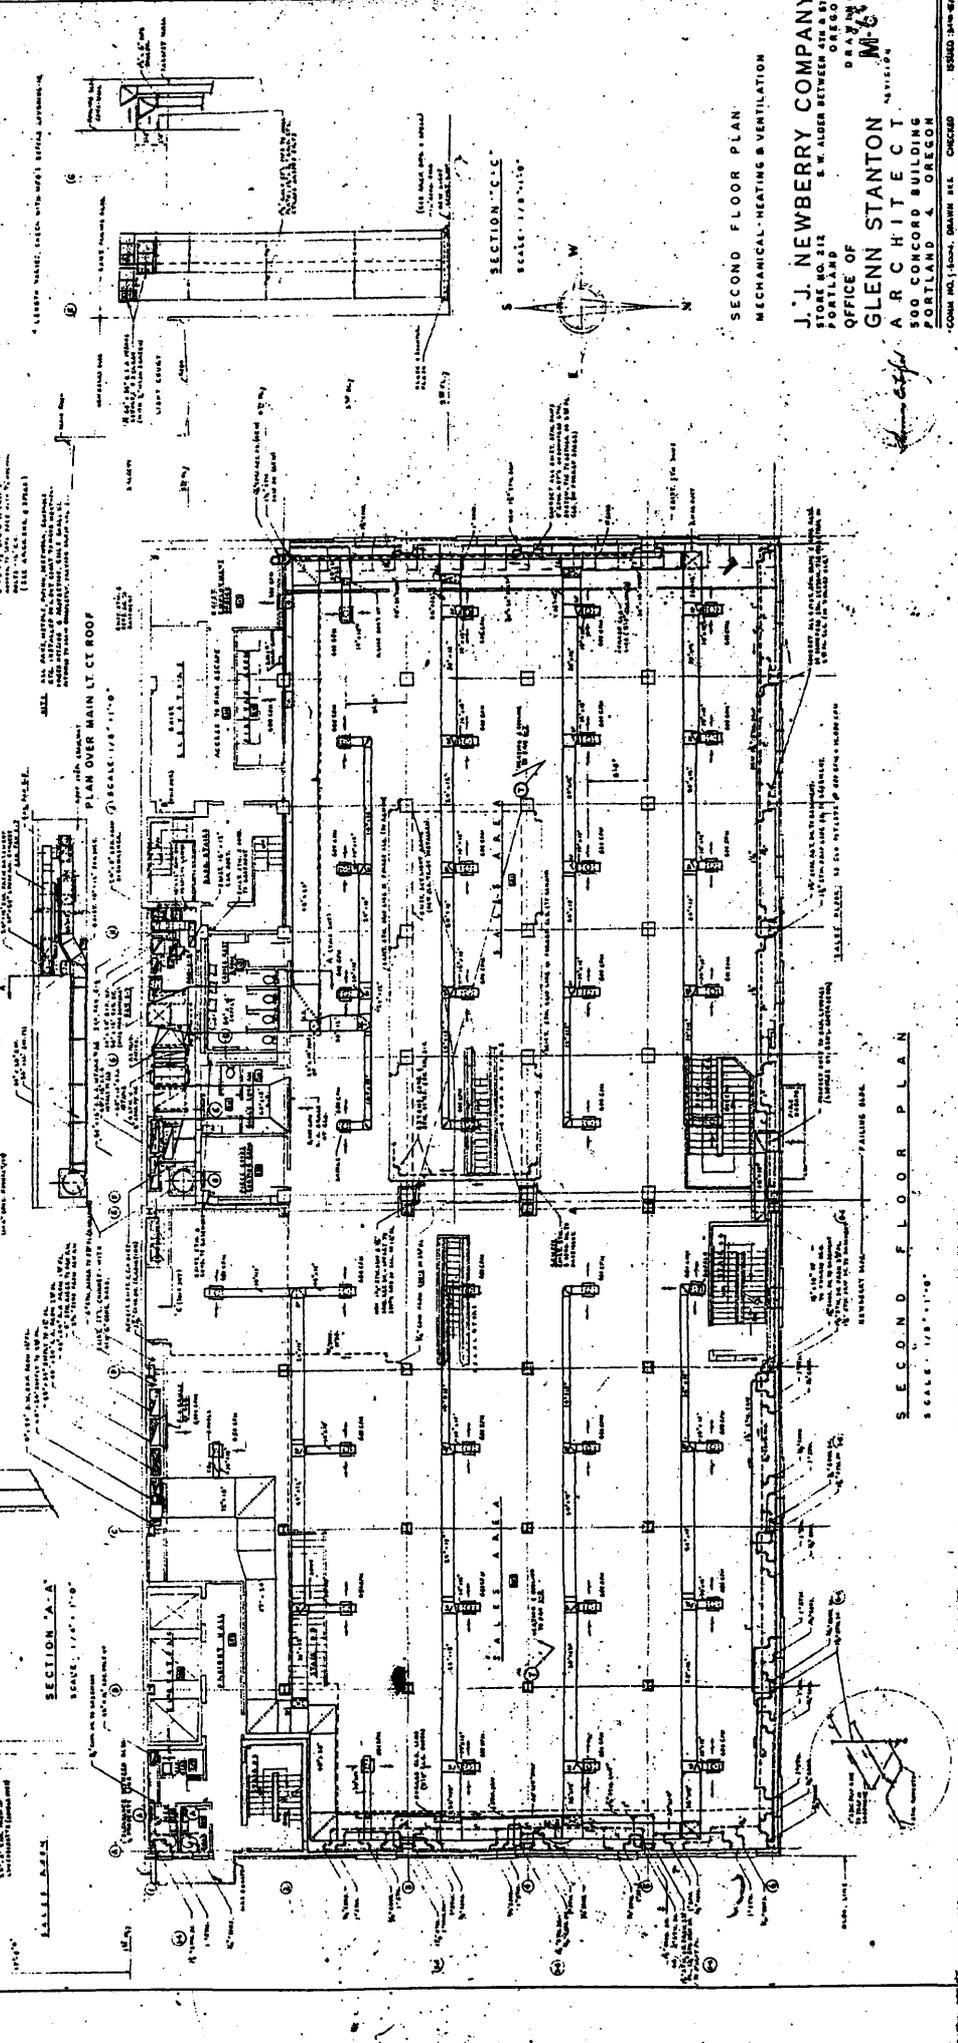
SECOND FLOOR PLAN
MECHANICAL - HEATING & VENTILATION

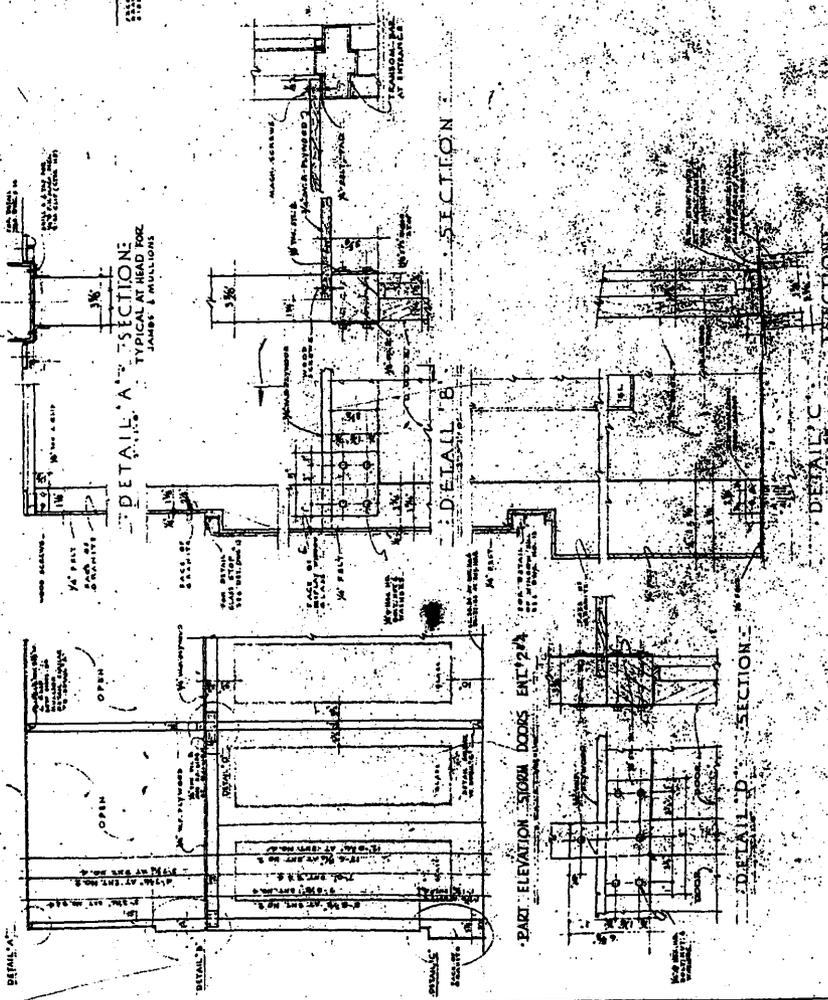
DETAIL A SECTION TYPICAL AT HEAD FORZ JAMBES & MULLIONS

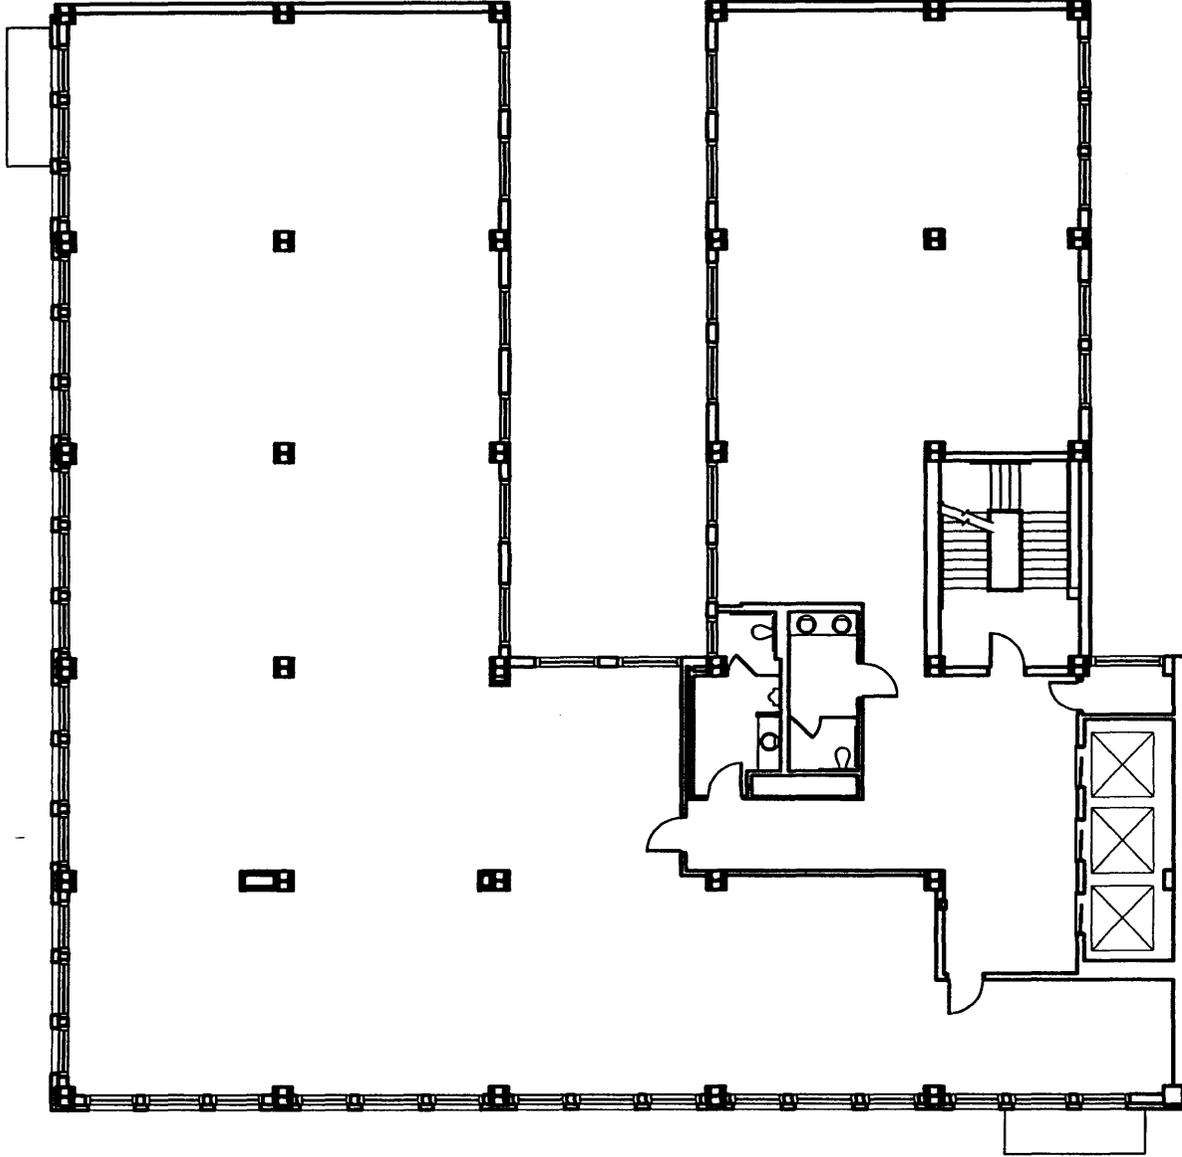
620 building - 4th floor

as-built plan
