NATIONAL REGISTER OF HISTORIC PLACES INVENTORY -- NOMINATION FORM

HISTORIC Dexter Arnold Farmstead

STREET & NUMBER Rural Route 1, Box 78
Sw of North Scituate on Chopmist Hill Rd

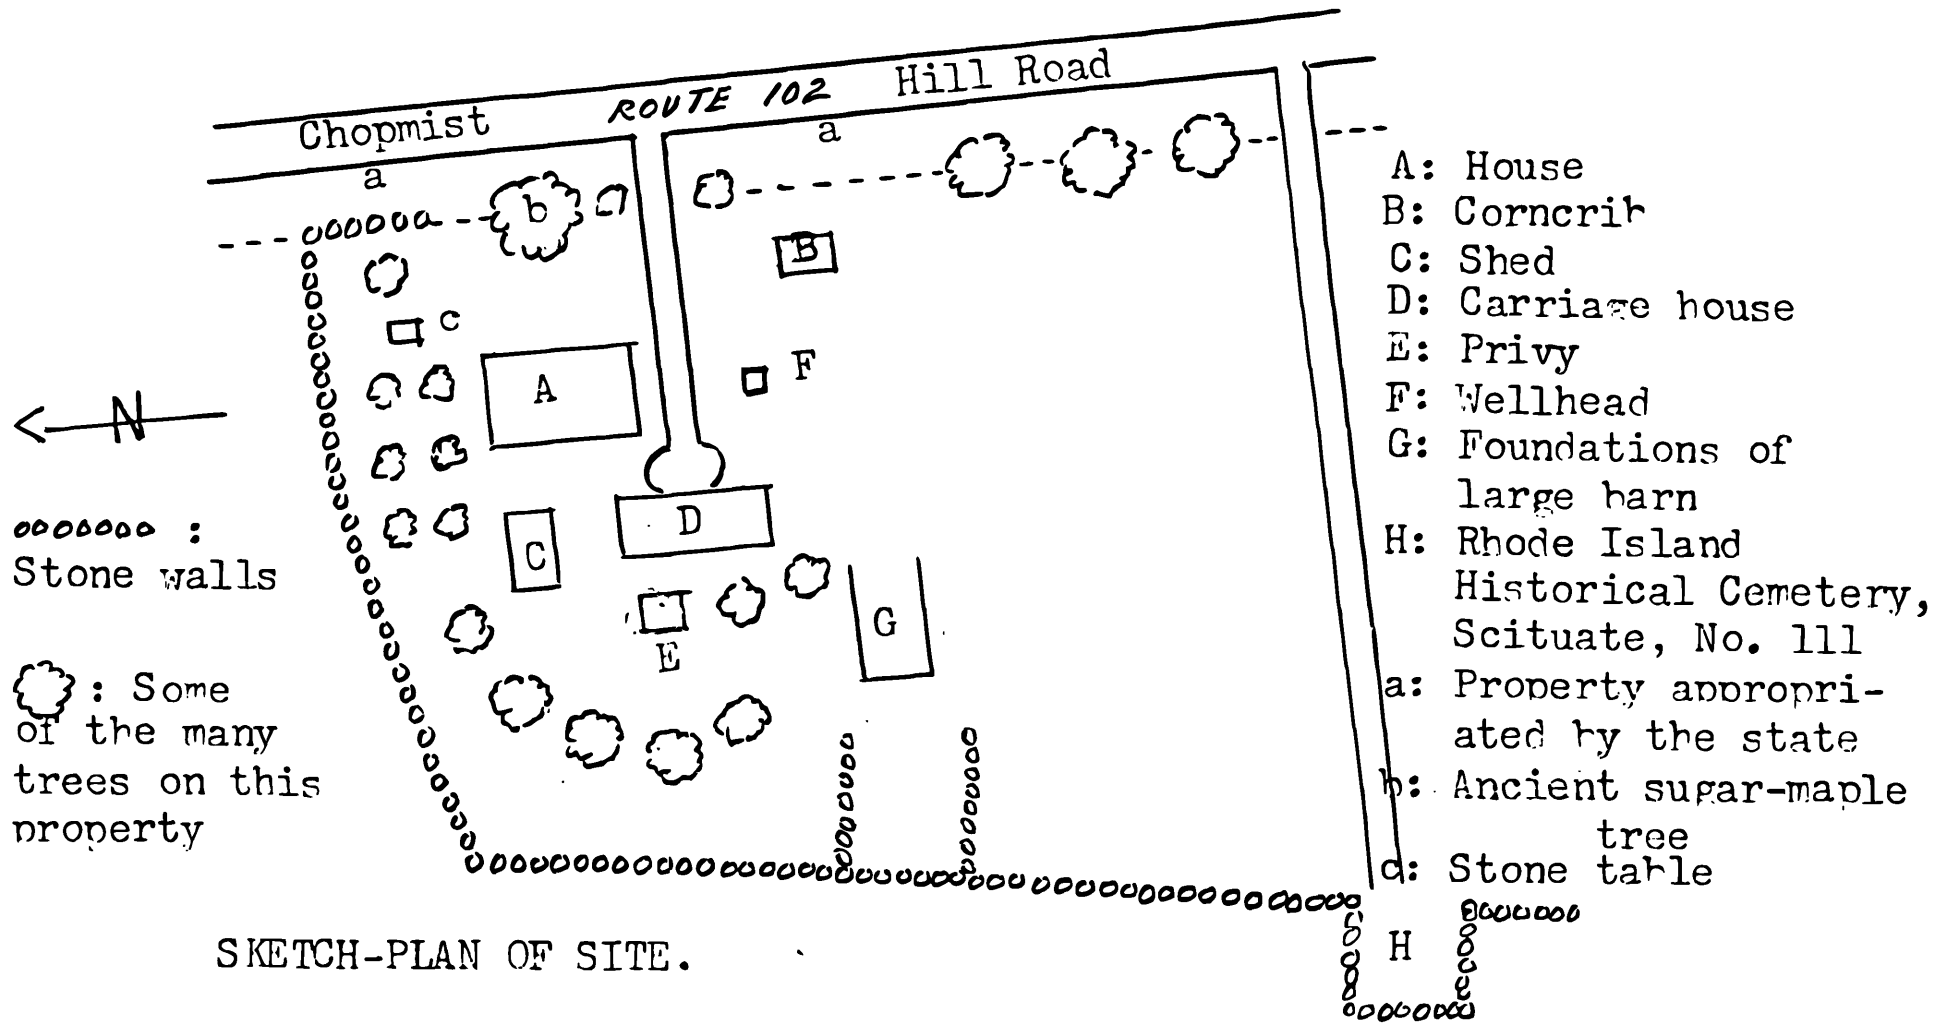
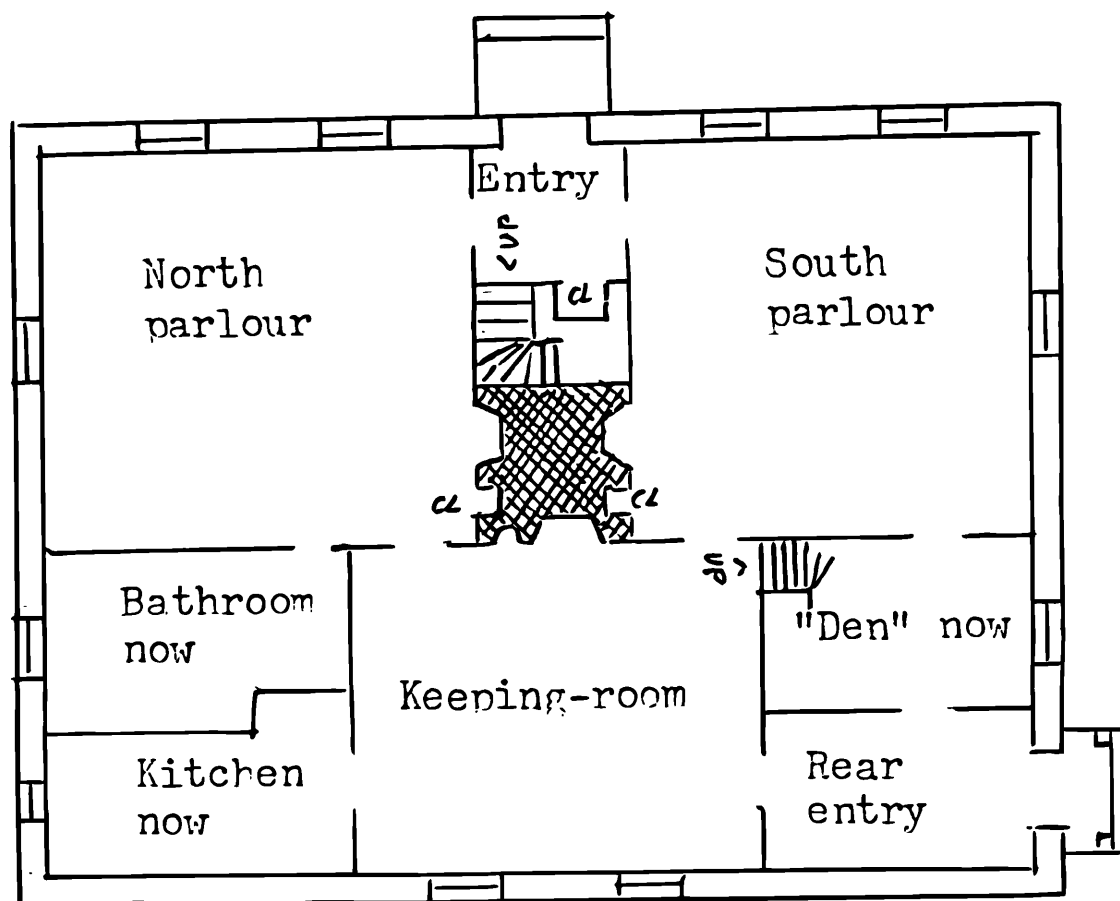
HOUSE PLAN (Not to scale). First Floor.

portion behind the chimney (see photo #6). However, the rear corner spaces of the house, flanking the keeping-room, contain two rooms each rather than the more usual one; thus there are seven rooms instead of five downstairs. These smaller rooms seem originally to have provided a bedchamber, a waiting room for the hired help, a milk room or pantry, and a rear entry or vestibule. Today the bedchamber, with its wall pegs for hanging garments still intact, has been made into a bathroom; the milk room, with its narrow nine-over-nine-sash window, has become a compact modern kitchen; the waiting room has become a den; and the entry remains an entry. Decorative trim such as mantels, doors and door hardware (see photo #5) has survived intact throughout the house, as has the original flooring and the horsehair plastering.

The small first-floor front hall has a tightly-angled stairway running up against the front of the chimney. The balusters of the plain stair rail are slim and square; the newels are plain and square with flat, cushion caps; the string is enclosed, with a white-painted, sharply moulded fascia. At one side, under the upper run of the stair, is a panelled door opening to a cupboard. Doors to left and right, like all other inside ones, are four-panelled and lead to the parlors.

These rooms -- as well as all others on this floor -- have narrow, moulded architraval door and window surrounds and a moulded chair rail above a plaster dado space; ceilings are eight feet high and join the walls without benefit of any cornice or moulding; corner posts are cased. The south parlor has a simple but handsome one-story mantel with panelled pilasters and frieze supporting a shelf with sharply moulded edges, and a cupboard (with doors) beside the fireplace. Mantel treatment in the north parlor is similar except that the pilasters and frieze are reeded. Woodwork in these and the smaller rooms is painted, while that in the large kitchen and the rear entry is stained a rusty brown. The west wall of the kitchen has the only two windows of the first-floor portion of that elevation, and the major portion of its east wall is taken up by the large cooking fireplace with bee-hive oven inset at its left. There is a flat wooden surround to hearth and oven, and a shallow shelf supported by a moulding runs above this; the space above this shelf is faced by the chimney's flat, unplastered stonework. At the southeast corner of the kitchen a narrow stair leads to the second floor.
