# CRATER LAKE

# PNRO INVENTORY

National Park Service  
Pacific Northwest Region  
Cultural Resources Division

1. SITE I.D. NO.		5. ORIGINAL USE Administrative Offices		7. CLASSIFICATION		9. RATING	
2. NAME(S) OF STRUCTURE ADMINISTRATION BUILDING #1 (LCS# 12011)		6. PRESENT USE Administrative Offices				10. DATE Completed 1935	
3. SITE ADDRESS (STREET & NO) Park Headquarters Munson Valley North Side Administration Circle				8. UTM ZONE EASTING NORTHING		11. REGION 10	
4. CITY/VICINITY COUNTY STATE Crater Lake National Park, Klamath, Oregon				SCALE 1:24 1:62.5 OTHER		QUAD NAME	
12. OWNER/ADMIN ADDRESS U.S. Department of Interior, National Park Service, Seattle, Washington

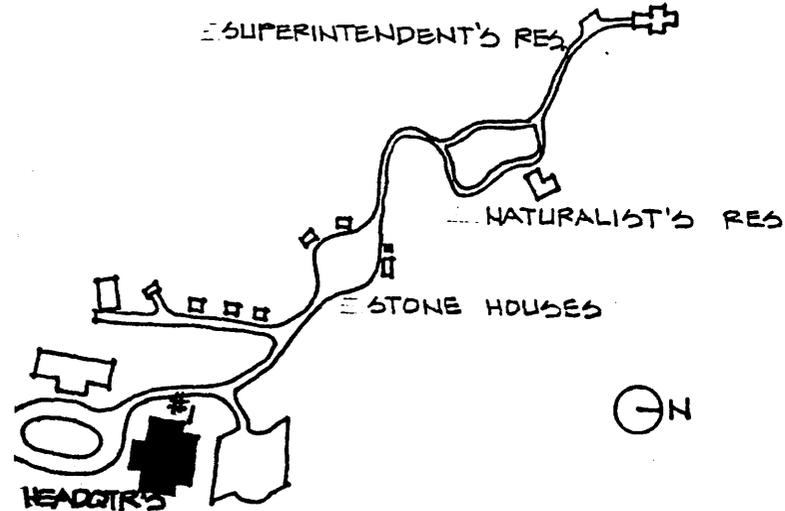
A rustic style stone and wood administration building; 6,498 s.f., 1-1/2 stories with partial basement. Ground floor is constructed of massive stone masonry; second floor is within steeply pitched wood roof structure. The plan is T-shaped, with main entry porch on the south elevation. Rear entry on north side has interior stairs to basement. The handsplit shake roof is 14/12 pitch with 1x12 bevel siding stained brown on the gable ends; original roof was a combination of shakes over shingles. To create a 3/4" thickness and heavier appearance, every fifth course was tripled, and the entire roof was stained green. Two 2-window and one 4-window shed roof dormers penetrate the roof on the south; three 2-window shed dormers penetrate roof on the north. The massive fireplace chimney is stone above the ridge line on the north side, resting on a corbelled brick interior structure. Windows are steel sash with heavy timber lintels; exterior doors are glazed steel. Exterior appearance matches original design except for "A-frame" snow tunnel added to south entry in 1958, which encloses the original stone steps and entry porch.

Interior construction is standard wood stud walls and wood joist floors. First floor houses public area, post office, superintendent's offices, first aid and restrooms, and administrative offices; a native stone fireplace separates the public lobby area from the office area. Second floor houses general offices. Interior finish of entry is 1x4 and 1x8 T&G V-joint paneling on walls, concrete floor, and exposed ceiling beams. Ceiling is acoustic tile added in the 1970s. Interior office finishes are generally painted plaster with standard cut wood moldings; original dark wood.

The Administration Building was rehabilitated 1986-87 in accordance with plans prepared in accordance with NPS-28 standards and reviewed and approved by the Oregon State Historic Preservation Office. The rehabilitation restored the exterior of the structure, including replacement of the roof, repointing of the masonry base as required, restoration of the original steel sash and doors (including new glazing and construction of interior storm windows), removal of the 1958 "A-frame" entrance portico, construction of a masonry snow tunnel on the east elevation of the building, and repainting according to the original color scheme.

The interior of the structure was partially reconfigured to meet contemporary office requirements and building codes. Office spaces were redesigned to maximize efficient utilization of the available space, while retaining a sense of the original layout. The main public lobby space on the first floor, with its native stone fireplace and ornamented ceiling rafters and paneling, was restored and original interior detailing, such as hardware, lighting fixtures and stairrails, were retained. New wall surfaces and flooring are simply finished (white wallboard, carpeting, clear stained oak moldings) in a manner compatible with the original finishes.

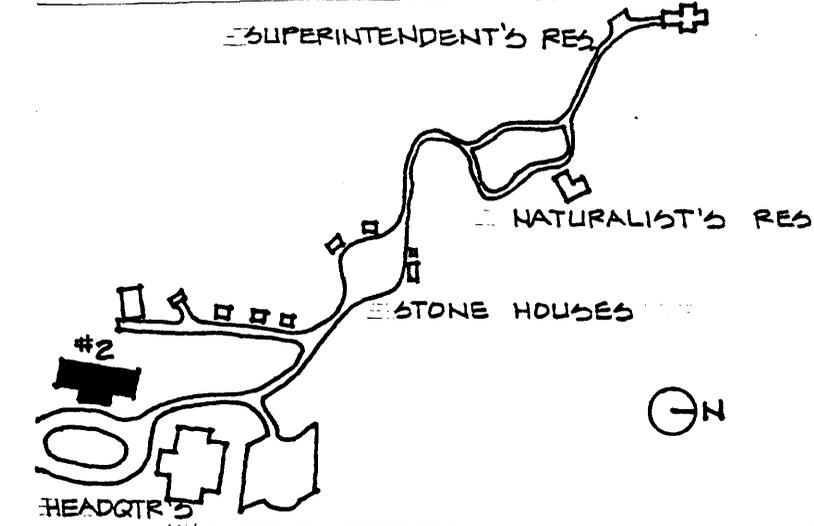
SOUTH ELEV.  
8-25-84

A rustic style stone and wood dormitory; 5,660 s.f.; 1-1/2 stories with partial basement. Ground floor constructed of massive stone masonry; second floor is within steeply pitched wood roof structure. T-shaped plan with entry porches on east elevation; stone side porches on south and north ends. Handsplit shake roof is 14/12 pitch with 1x12 bevel siding stained brown on the gable ends; original roof was stained green. Three 2-window shed roof dormers and two gable roof dormers penetrate the roof on the east side. Four 2-window shed dormers penetrate the roof on the west. Massive stone fireplace chimney rises above the ridge line on the east side, near the building's center; a second chimney extends above the west side. There is evidence of deterioration of the rear chimney above the roof and problems with snow sliding on the fireplace chimney. Windows are steel sash with heavy timber lintels. Two main entries: left side for women's area, right for men. Main entry doors are heavy plank construction with some original wrought iron hardware. Exterior appearance matches the original design, with the exception of the wood railing and stone balusters that have been removed from the front terrace.

The rehabilitation of the Ranger Dorm has brought this structure from a state of advanced deterioration to its current status as one of the architectural showpieces of the park. The original interior configuration, in which the two wings of the structure were completely separated to permit housing of both sexes in the same building, was opened up and redesigned to accommodate a visitor contact center and offices and research space for the park's interpretive staff. The main floor now incorporates a public interpretive space in the lobby, a small auditorium, restrooms and offices. Original detailing, including the massive native stone fireplaces, wood floors and exposed ceiling beams, wrought iron hardware and light fixtures, were retained and refurbished and supplemented as needed by reproductions or compatible contemporary fixtures.

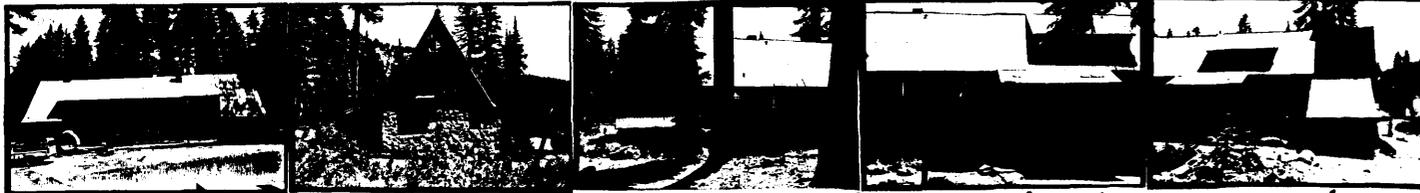
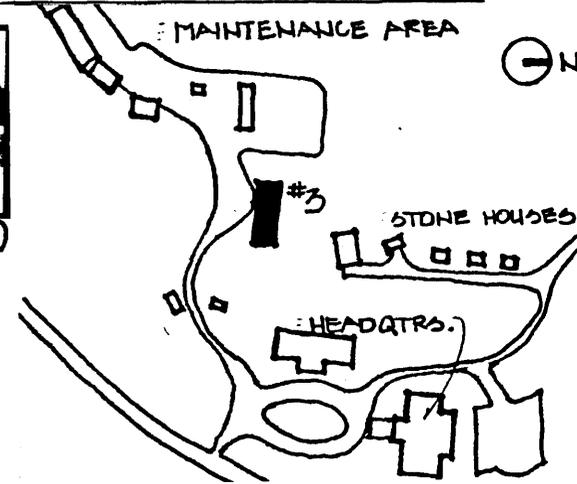
A rustic style stone and wood bunkhouse and mess hall; 7,631 s.f. (orig. 4,438 s.f.), 2-1/2 stories. Rectangular ground floor constructed of massive stone masonry with second and attic floors within steeply pitched wood roof. Sheet metal roof applied over original shake roof, with board and batten siding at gable ends and sidewalls of shed-roofed dormers which penetrate the roof on the north and south sides. An additional "dormer on a dormer" at the north side provides windows into attic floor. The roof pitches from the top of the first floor stone walls to the ridge at either side of building, which narrows the second and attic floor plans. A major addition to the building on the east end was completed in 1934, and generally matches the design of the original section. The only access to the second floor is provided by an exterior stair on the north side of the building, which is a poorly constructed replacement for an original log design stair; the stair is roofed over and enclosed within a pole and board structure. A small shed addition over original kitchen porch on NW corner was added sometime in the 1940s. A stone and concrete porch on the south side, added in 1935, provides entry into the main dining space on the ground floor. Windows are original wood sash with wire snow screens added. Doors are badly deteriorated flush panel type, not original. The stone work is in good condition but the roof and siding are deteriorated. Much of the original charm of the building has been lost through deterioration and replacement of exterior parts without regard for original design.

Interior construction is a conglomeration of changes over the years. Floor and wall construction are wood frame. What little original wood paneling remains is badly deteriorated with many coats of paint. Most interior doors, hardware

The Mess Hall was the most deteriorated of the three structures that have been rehabilitated since 1985. The interior was largely unusable as years of deferred maintenance and incompatible alterations had taken its toll on the structure and imminent collapse seemed possible.

The exterior rehabilitation included a new shake roof, repainting according to the original color scheme, repointing as required of the masonry base, addition of a snow entrance to the front elevation, and replacement-in-kind of the wood sash and doors. The interior was largely gutted and rebuilt, with new wall, floor and ceiling surfaces (wall board, lightly stained trim, carpet) and a new spatial layout (offices and laboratories for the Resource Management and Ranger Divisions).

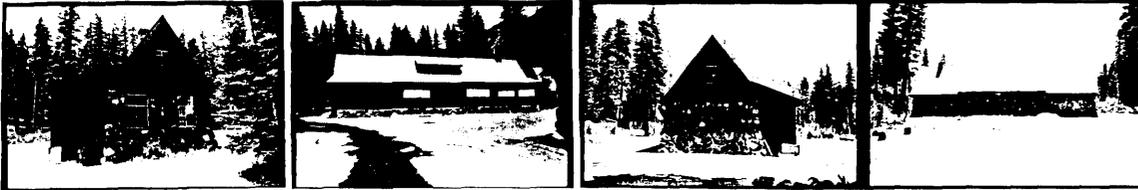
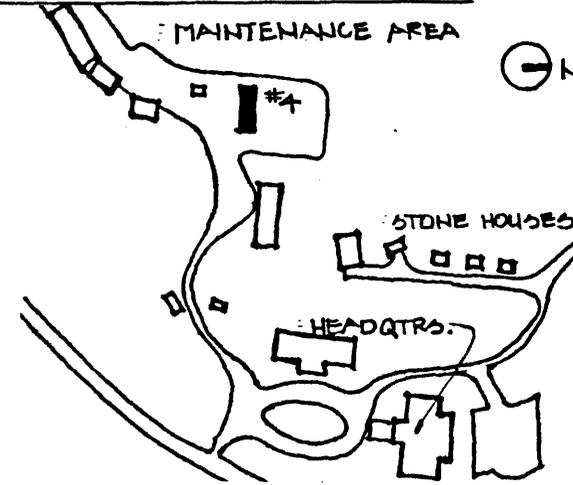
A rustic style stone and wood warehouse; 1,900 s.f. (original 900 s.f.); 1-1/2 stories. Ground floor constructed of stone masonry; second floor within steeply pitched roof structure. The plan is rectangular with a covered loading dock extending the length of the south side. Sheet metal roof applied over 24" sugar pine shakes, 12" exposed; 14/12 pitch roof. Bevel siding stained brown on gable ends; one 6-window shed dormer penetrates roof on south side. Windows are steel casements with heavy timber lintels. First and second floors are wood joist construction with 2" plank floor. Interior open stair to second floor storage. The center portion houses warehousing with office and restroom on the east end and cold storage on the west. Deterioration of the north stone wall, which has been pushed in by excessive snowdrift, is evident; permanent bracing has been installed on north wall and cut into floor.

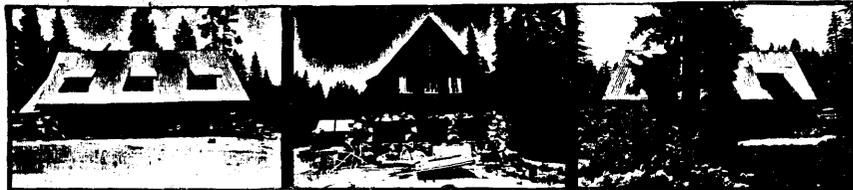
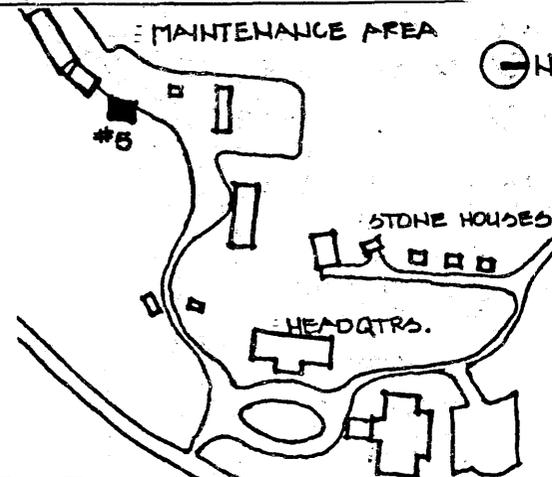
Rustic style stone and wood structure built as a machine shop and utility vehicle storage building; approximately 30'x60', 3,464 s.f., 2-1/2 stories. Ground floor constructed of massive stone masonry; second floor and attic within steeply pitched wood roof structure. Plan is rectangular. Exterior stairs to second floor are on the north side and are constructed of heavy round timbers. Metal roof applied over original split shake roof with a 15/12 pitch. Board and batten siding covers gable ends. Three 2-window shed dormers penetrate roof on east and west. Windows are steel casements with heavy timber lintels. Original masonry chimney has been removed. Enclosed stairs to third floor attic storage. Standard wood stud and joist construction. First floor interior has exposed concrete walls behind exterior stonework and plaster ceiling. Second floor walls have 1x6 "V" pattern boards, plywood ceilings and 1x4 T&G fir floors. Third floor walls and ceiling have 1x6 T&G "V" pattern boards and a 2x6 T&G floor. First floor houses the fire cache and emergency vehicles; second floor was a dormitory with kitchen and bathroom facilities, which now are used as office space. Overhead doors on five stalls with glass panes above and wood below replace original pairs of swinging type vertical board garage doors. Second floor was altered in 1939.

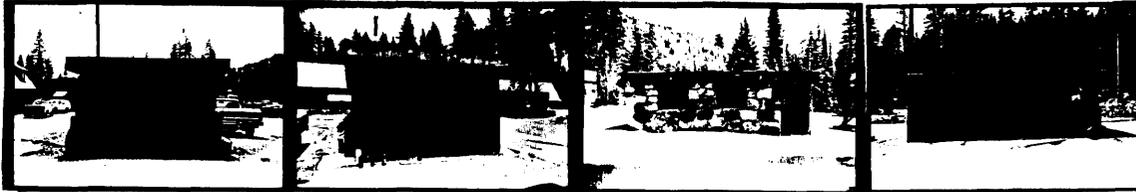
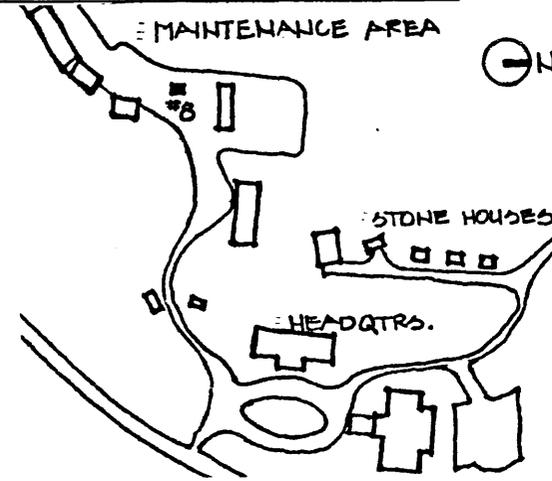
Rustic style stone and wood oil and gas house; 12'x20' originally with added enclosed 6x12 south porch, 308 sq. ft., one story. Walls constructed of large rustic stones with concrete backup. Plan is rectangular. South end has enclosed space housing fuel pumps. Doors on north and south are original paneled wood. Heavy timber lintels over doors and original steel windows. Flat roof replaces original steeply pitched shake roof. Original north end porch with stone columns is missing. Not much left of original building except some stone work (doors) and steel sash windows in east and west walls. Building has structural roof problems and poses a fire hazard.

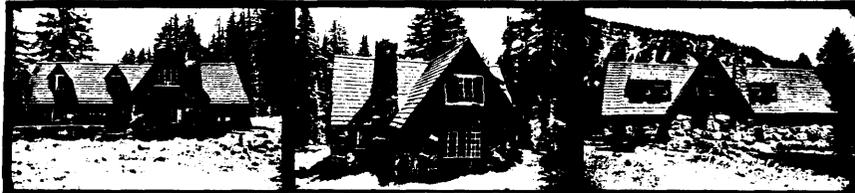
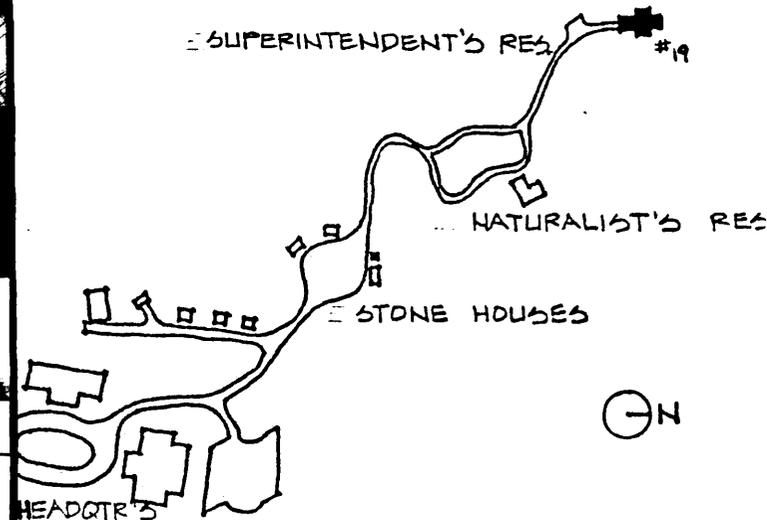
A rustic style stone and wood residence; 2,795 s.f.; 1-1/2 stories with garage and partial basement underneath. Ground floor is constructed of massive stone masonry with the second floor within a steeply pitched roof. The plan is cruciform with long axis north-south; garage entry on the basement south side. A large flagstone terrace of native park stone is located on southeast corner of the house. Shake roof is 16/12 pitch with gable ends at the four ends of the cruciform and dormers on the east and west sides of the roof. Massive stone chimney rises to ridge line on the north side of living room. Upper gable ends are board and batten siding over wood frame construction. Windows are steel sash. Main entry doors are heavy plank construction with special design hardware. Exterior appearance matches the original design.

Interior construction is standard stud walls, wood joist floors. Massive stone fireplace in living room has excellent cut native stone (rough burnt lava rock) and handmade wrought iron fixtures. First floor houses living room, dining, kitchen, entry hall, one bedroom with bath; open stair to one large bedroom with bath and three medium-size bedrooms with bath off central upper hall. Interior finishes: painted plaster with standard cut wood moldings--some painted, some natural S&V. Cabinets are painted wood. Interior hardware is original and of excellent quality with some repair and replacement needed. Hardwood floors on main level and upper level are VG fir. Finishes have generally

declined and some water stain and plaster cracking have occurred. Good collection of original furniture, needs refurbishing. Original wrought iron light fixtures need refurbishing. Oil furnace replaced original gravity air wood-fired furnace in 1964.

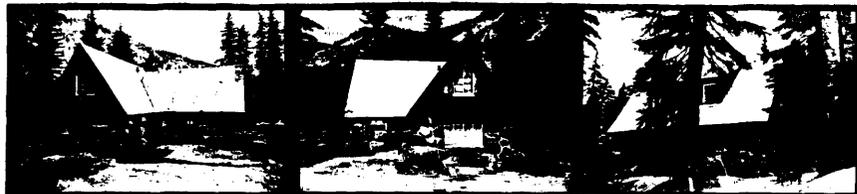
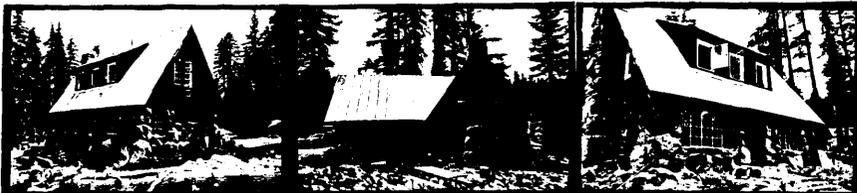
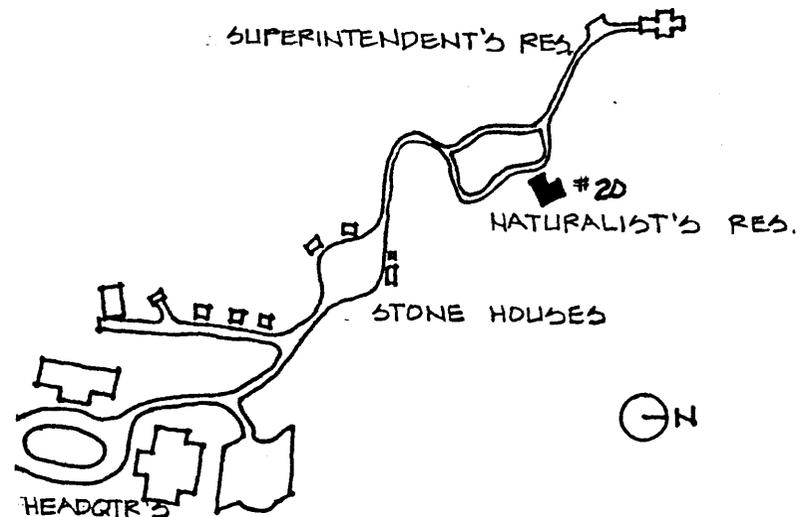
A rustic style stone and wood residence; 1,530 s.f.; 1-1/2 stories. Ground floor is constructed of massive stone masonry with second floor within steeply pitched wood roof structure. The plan is L-shaped with entry porch on the north side of the house away from existing road. Sheet metal roof applied over original shake roof is 16/12 pitch with wood board and batten siding at gable ends. A shed roof dormer with three windows penetrates the roof on the north side. Massive stone fireplace; stone chimney rises to above ridge line on the east side of the living room. There is evidence of chimney deterioration above the roof and problems with the roof. Windows are steel sash with heavy timber lintels. In addition to original north entry into living room, an exterior door into kitchen and another into downstairs bedroom now serve as entries into house. Doors are heavy plank construction with some original wrought iron hardware. Exterior appearance has been altered with change in roof material and grade changes around the house.

Interior construction is standard wood joist floors, stud walls with plaster. Fireplace has nice stone work but is in bad repair and very dirty. Ground floor plan includes kitchen, dining room, living room, and one bedroom with adjacent bath. Oil burning stove added in living room. Partial open stair from living room to upper hall. Two bedrooms and a single bath open off hall. A third long attic bedroom is reached through the east side bedroom. The interior finishes are badly deteriorated. Much of the exterior elegance shown in early photos is gone due to deterioration and site changes.

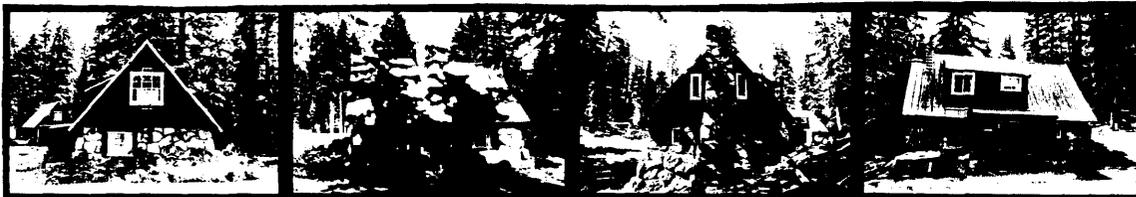
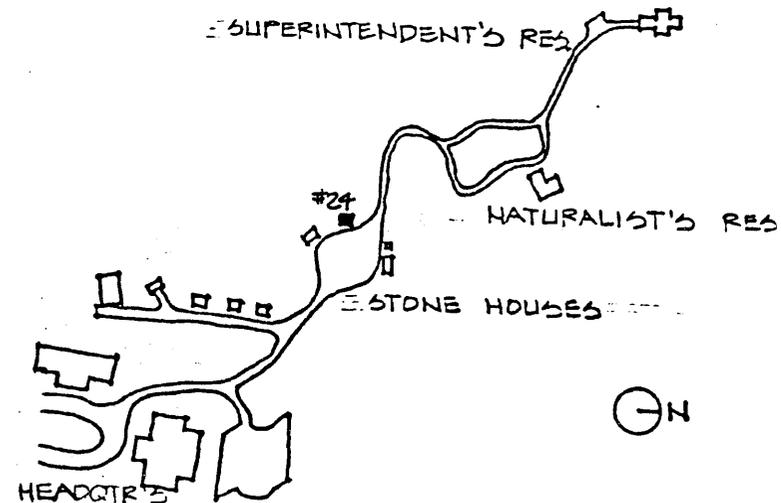
A rustic style stone and wood residence; 946 s.f.; 1-1/2 stories; rectangular space 18'x28'. Ground floor constructed of massive stone masonry with second floor within steeply pitched (14/12) wood roof structure. Sheet metal roof applied (1962) over original shake roof, with board and batten siding at gable ends. A shed roof dormer penetrates the roof on the east side with two windows into upper story rooms. Massive stone fireplace and chimney is exposed on the south end of house and rises above ridge line. Windows are original steel casements with heavy timber lintels. A snow tunnel shed at the main entry was built on top of the original flagstone porch on the east side in 1954. A rear entry on west side enters into rear porch area within house.

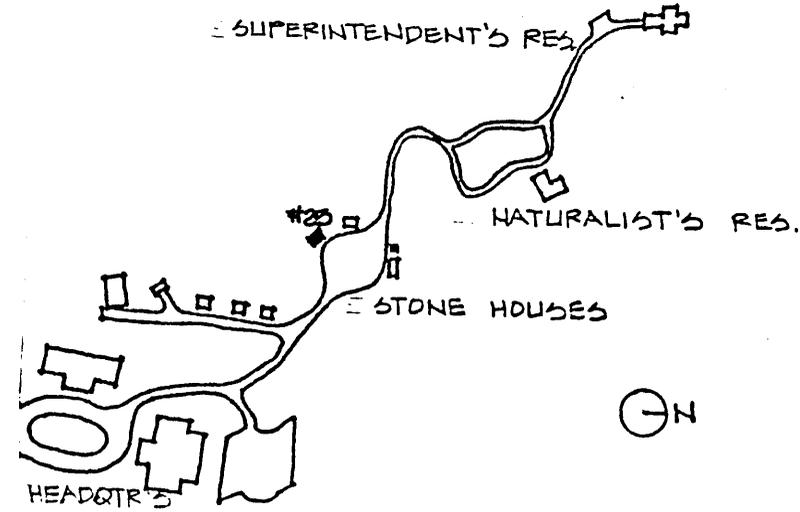
A rustic style stone and wood residence, 1,037 s.f.; 1-1/2 stories; rectangular space 18'x28'. Ground floor constructed of stone masonry with second floor within steeply pitched 14/12 wood roof structure. Sheet metal roof (1962) applied over original shake roof with board and batten siding at gable ends. A small gable roof dormer penetrates the roof on the west side with one window into an upper bedroom. Massive stone fireplace and chimney is exposed on the south end of house and rises above ridge line. Windows are original wood casements with heavy timber lintels. Unlike houses #24 and #28, the main entry door has no snow tunnel and the original flagstone porch was covered with a concrete slab poured up to the bottom of the door sill. A winter shed snow tunnel entrance (wood frame) was added to the north side in the mid-1950s, with access into kitchen. The third entrance, in the rear on the west side, enters into the rear porch/utility area.

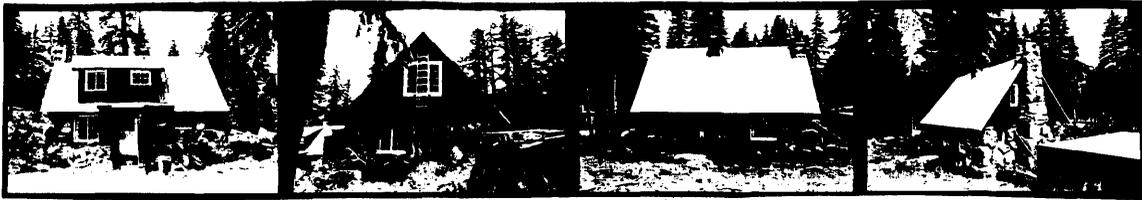
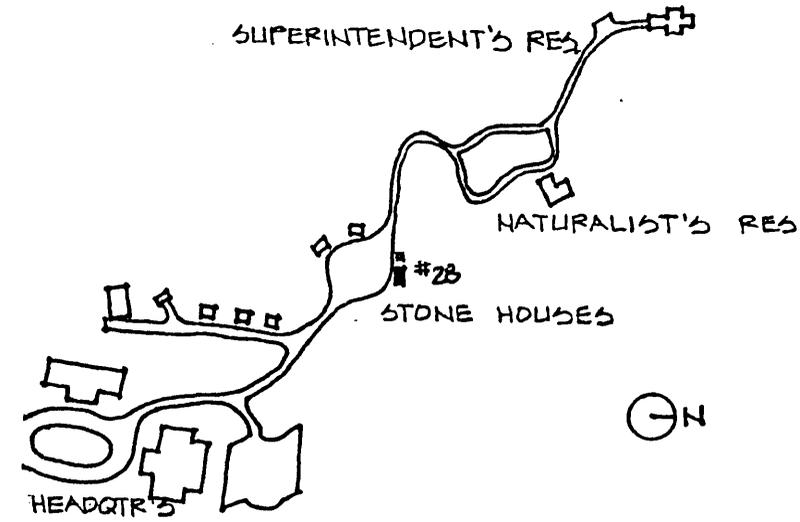
A rustic style stone and wood residence; 916 s.f.; -1-1/2 stories, rectangular space 18'x28'. Ground floor constructed of massive stone masonry with second floor within steeply pitched 14/12 wood roof structure. Sheet metal roof applied (1962) over original shake roof, with board and batten siding at gable ends. A shed roof dormer penetrates the roof on the south side with two windows into upper story rooms. Massive stone fireplace and chimney is exposed on the west end of house and rises above ridge line. Windows are original steel casements with heavy timber lintels. Main entry door into living room is now reached through snow tunnel shed entry added to south side of building in 1954. This was built over stone entry porch of the original design. There is some evidence of deterioration around the chimney and roof junction. A rear entry on north side enters into rear porch area within the house. A wood flat roof garage was added to the west during the 1950s; it is of poor design and appears structurally unsound.

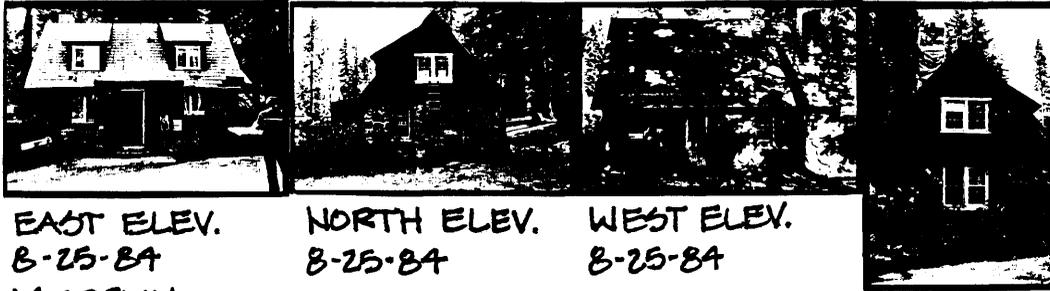
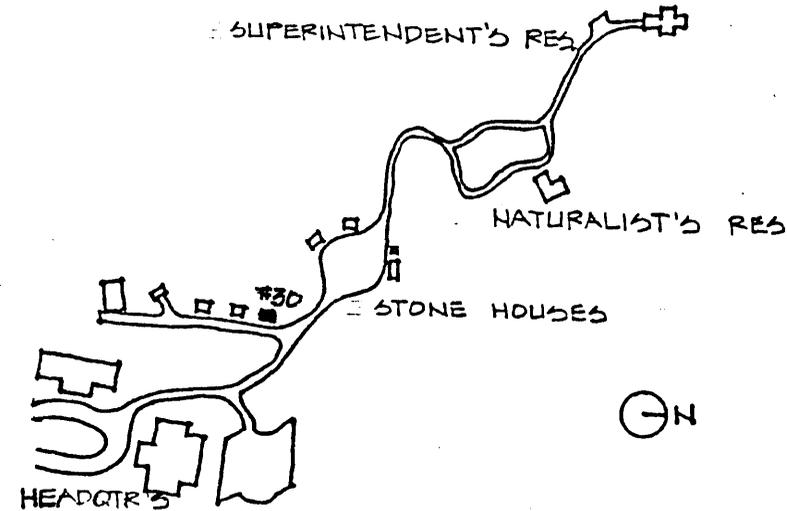
13. DESCRIPTION AND BACKGROUND HISTORY INCLUDING CONSTRUCTION DATE(S), PHYSICAL DIMENSIONS, MATERIALS, MAJOR ALTERATIONS, EXANT EQUIPMENT, AND IMPORTANT BUILDERS, ARCHITECTS, ENGINEERS, ETC.  
A rustic style stone and wood residence; 715 s.f.; 1-1/2 stories; rectangular space 15'x26'. Ground floor constructed of stone masonry with second floor with in steeply pitched 14/12 wood roof structure. Aluminum shingle roo applied over original shake roof with board and batten siding at gable ends. There is some evidence of deterioration t the roof at the corner of eaves. Two small shed dormers added in 1938 penetrate the roof on the east side with window into upper bedrooms. An interior unexposed brick wood stove flue has a concrete block chimney which penetrates th roof. Windows are original wood casements with heavy timber lintels. A snow tunnel/wood storage shed at the main entr was built on top of the original flagstone porch on the east side in 1954. A rear entry on west side leads into rea porch/utility area.

The ground floor interior is an open-plan living room, kitchen, eating space, and bath, with a partial open stair t upper floor. Heating system consists of a wood burning stove and electric space heaters. The upper floor has tw bedrooms with stained fir plywood paneling on walls and ceiling. Interior construction is standard wood joist floors stud walls with plaster. There is evidence of dryrot in the ground floor. Interior finishes are generally in good shap with original 1x4 fir floors, plaster, and wood panel doors. Living room has carpet covering wood floors.

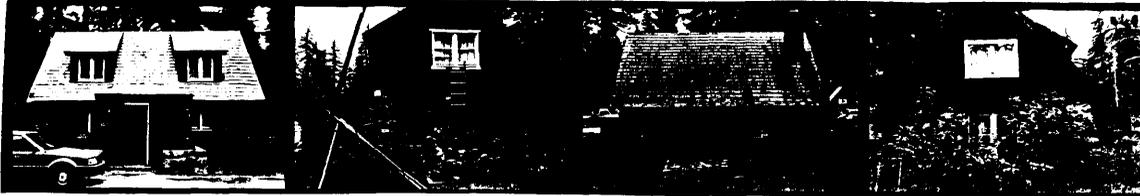
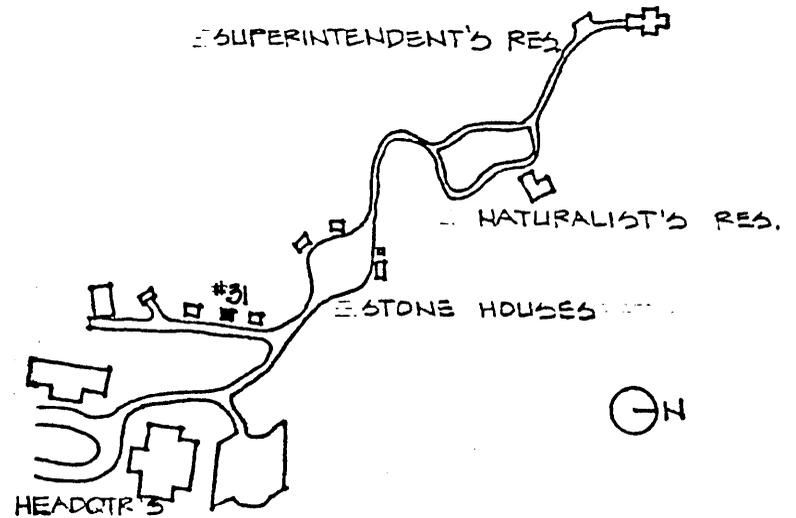
A rustic style stone and wood residence; 715 s.f.; 1-1/2 stories; rectangular space 15'x26' at ground floor constructed of stone masonry with second floor within steeply pitched 14/12 wood roof structure. Aluminum shingle roof applied over original shake roof, with board and batten siding at gable ends; windows open into bedrooms in both gable ends. There is some evidence of deterioration to the whole roof, especially at the corner of eaves. Two small shed roof dormers on east side, with windows into upper bedrooms, were added in 1938. Interior brick wood stove flue in living room with a stone chimney above the roof. Windows are original wood casements with heavy timber lintels. A snow tunnel/wood storage shed, originally designed for an oil tank, is located at the main entry and was built on top of the original flagstone porch on the east side in 1954. A rear entry on the west side enters into the rear porch/utility area.

The ground floor interior is an open-plan living room, kitchen, eating space, and full bath, with partial open stair to upper floor. Heating system consists of a wood burning stove and electric space heaters. The upper floor has two bedrooms with plaster walls and ceiling. Interior construction is standard wood joist floors, stud walls with plaster. Interior finishes are in good shape with original wood floors, plaster, and wood panel doors. Carpet covers living room floor.

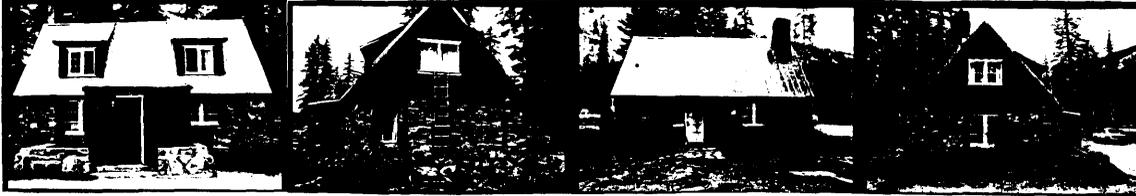
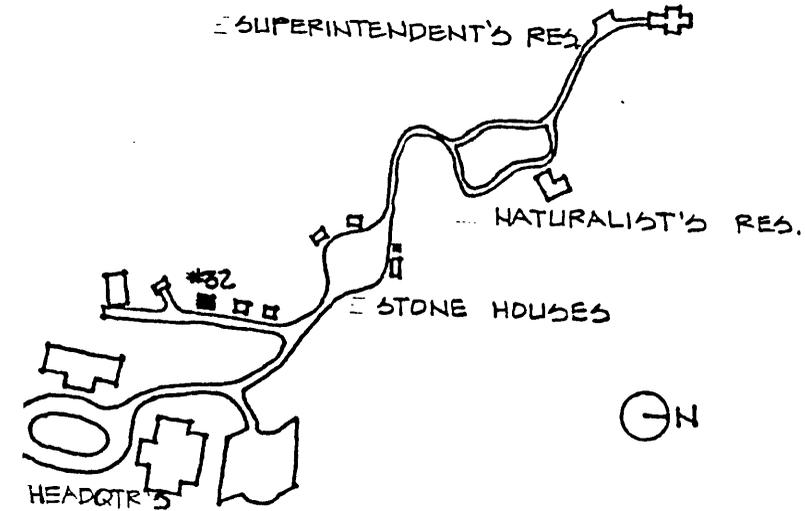
A rustic stone and wood residence; 715 s.f.; 1-1/2 stories; rectangular space 15'x26'. Ground floor constructed of stone masonry with second floor within steeply pitched 14/12 wood roof structure. Sheet metal roof applied over original shake roof, with board and batten siding at gable ends; windows in both gable ends open into upper bedrooms. Two small shed roof dormers on east side, with windows into upper bedrooms, added in 1938. Interior brick wood stove flue in living room, with stone chimney above that penetrates roof. Windows are original wood casements with heavy timber lintels. A snow tunnel/wood storage shed--originally designed for an oil tank--is at the main entry, and was built on top of the original flagstone porch on the east side in 1954. A rear entry on the west side enters into the rear porch/utility area.
