NATIONAL REGISTER OF HISTORIC PLACES REGISTRATION FORM

historic name: Bryce Inn

other name/site number: General Store, Head House, HS-118

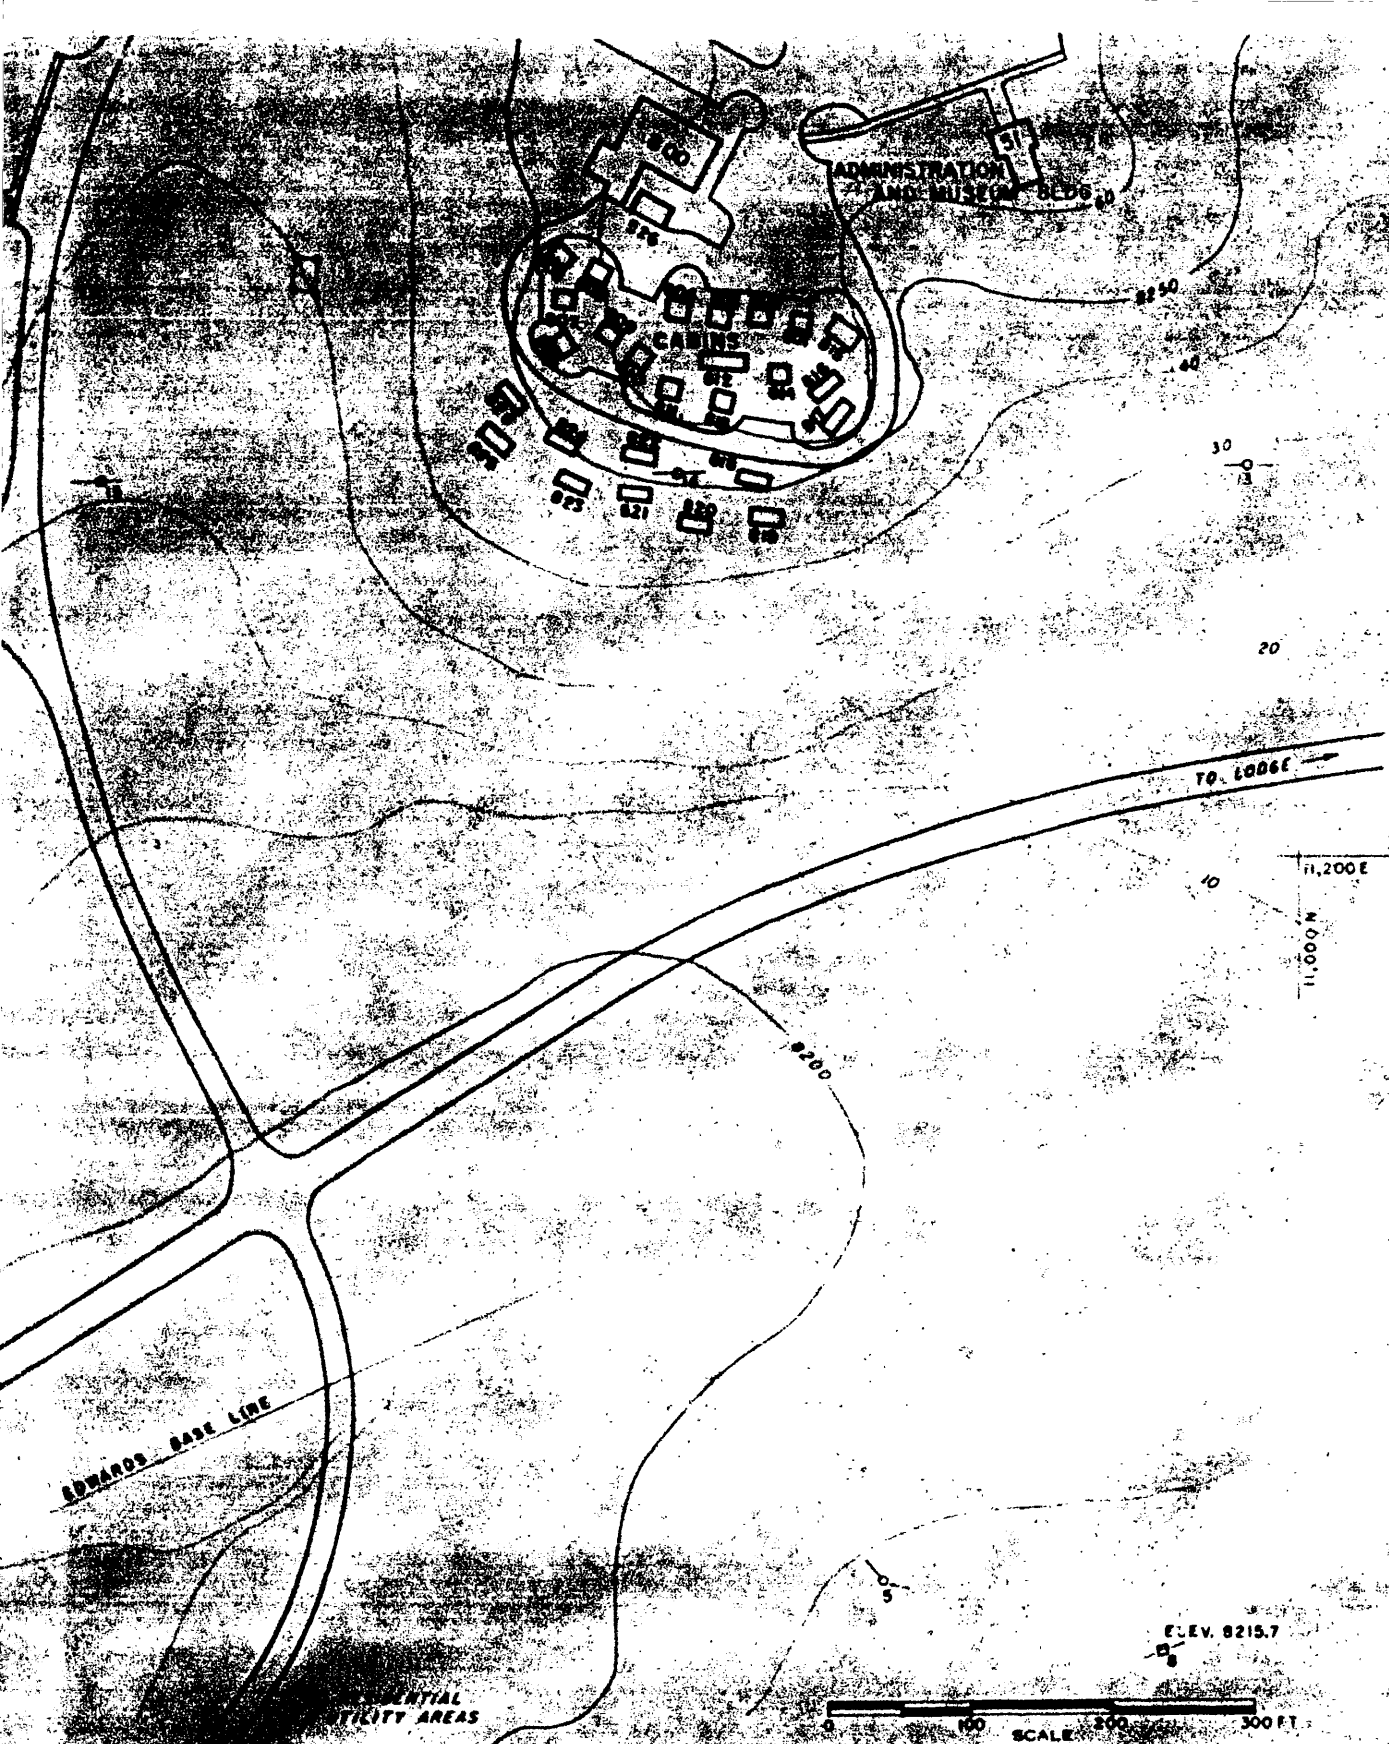
OLD ADMINISTRATION BUILDING AND BRYCE INN
BRYCE CANYON NATIONAL PARK

CAMPGROUND & INN
 PART OF THE MASTER PLAN
BRUCE CANYON NATIONAL PARK

The boundary of the Bryce Inn is shown on the accompanying site plan.
