National Register of Historic Places
Registration Form

historic name Dimmick - Judson House

street & number 906 NE Eighth Street N/A not for publication

DIMMICK-JUDSON HOUSE (c. 1865)
906 NE Eighth Street
Grants Pass, Josephine County, Oregon

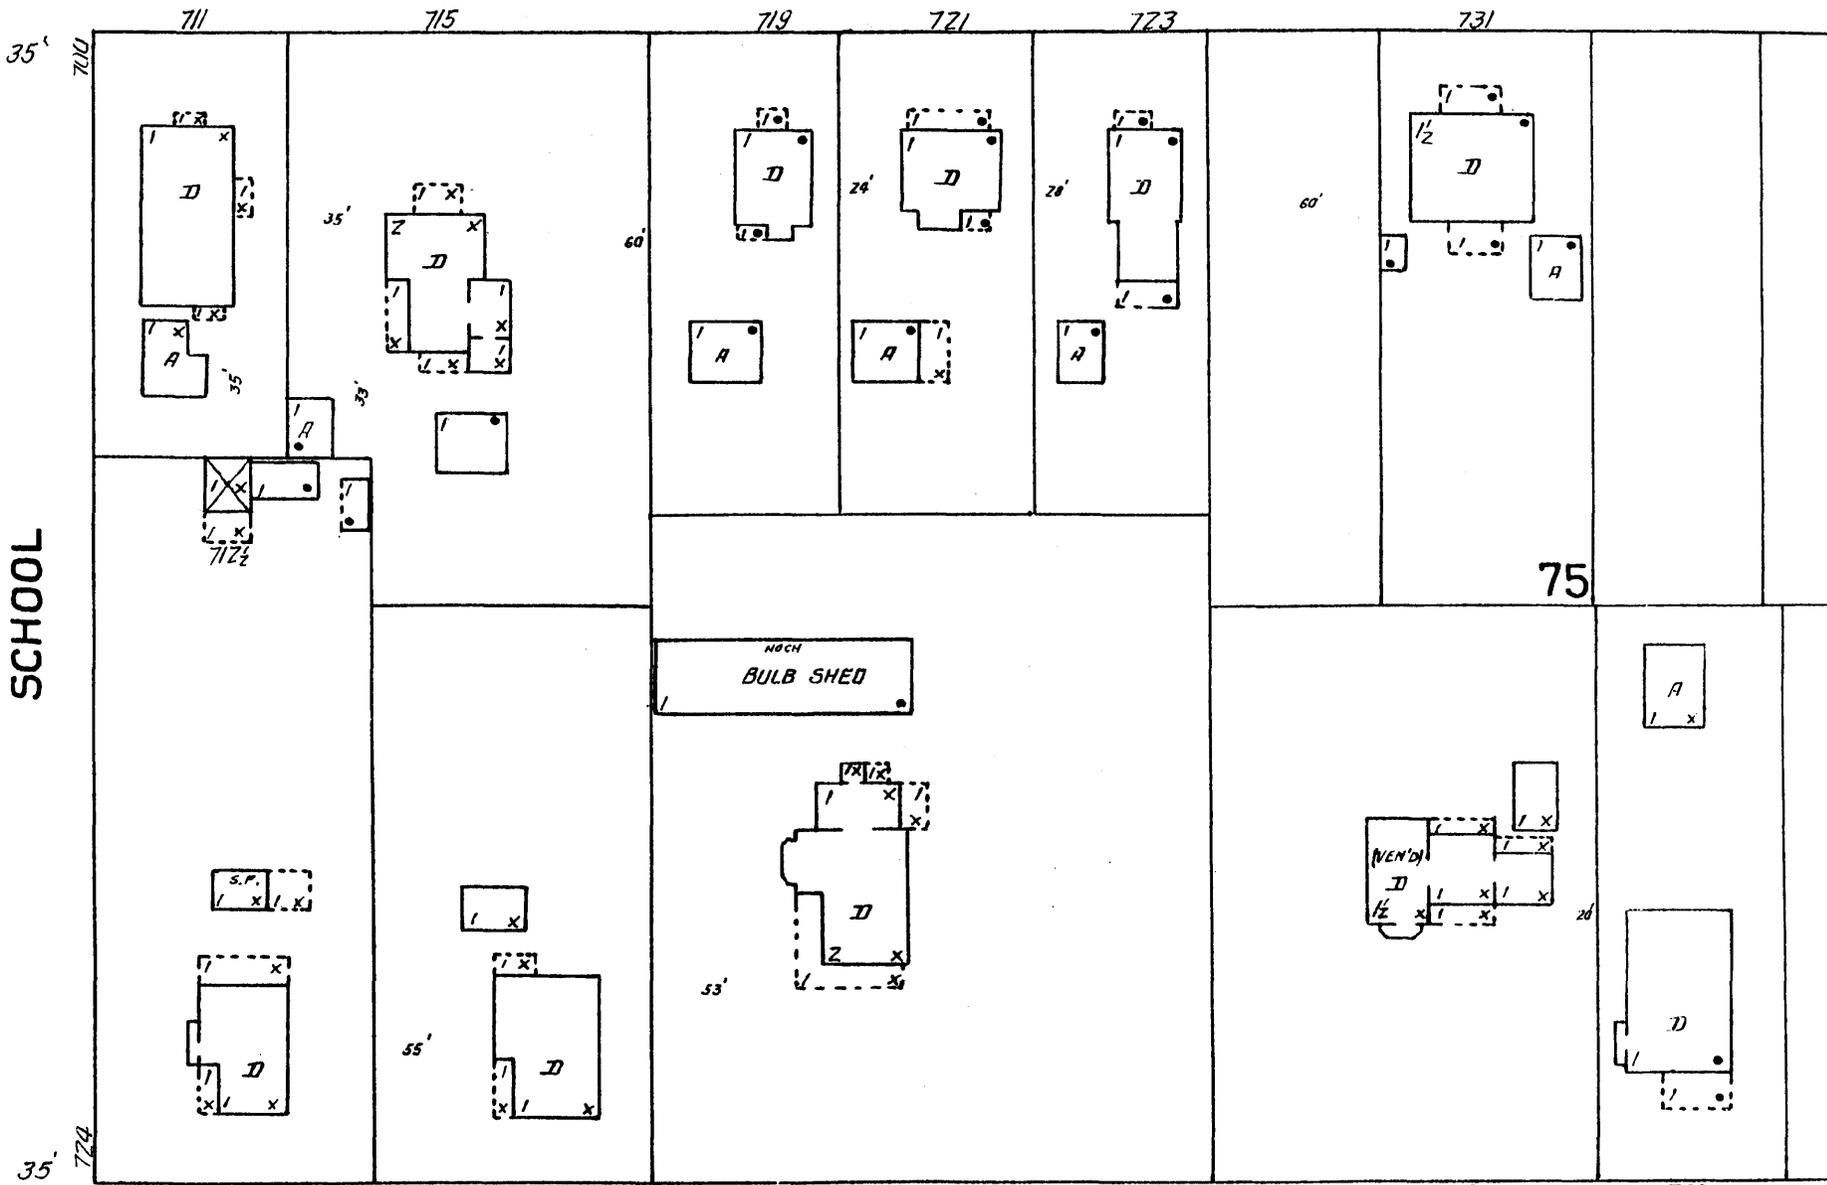
SEPT. 1930
GRANTS PASS
ORE.

EXTERIOR SURFACES. The exterior brick component of the house appears to be of veneer according to the 1930 Sanborn insurance maps. This is the first year this part of Grants Pass was included on the Sanborn insurance maps. The veneer was probably applied during the tenure of the Judson family. The brick is of simple running bond without headers or decorative banding. The window and door openings have a segmented double brick arch. The brick is a common soft brick of a red-orange color, crumbling badly in some places due to weathering. There has been an attempt to repair the deterioration and provide some decorative relief by painting some of the bricks white. The brick appears to be veneer rather than a structural element and is set on two courses of brick at the foundation.

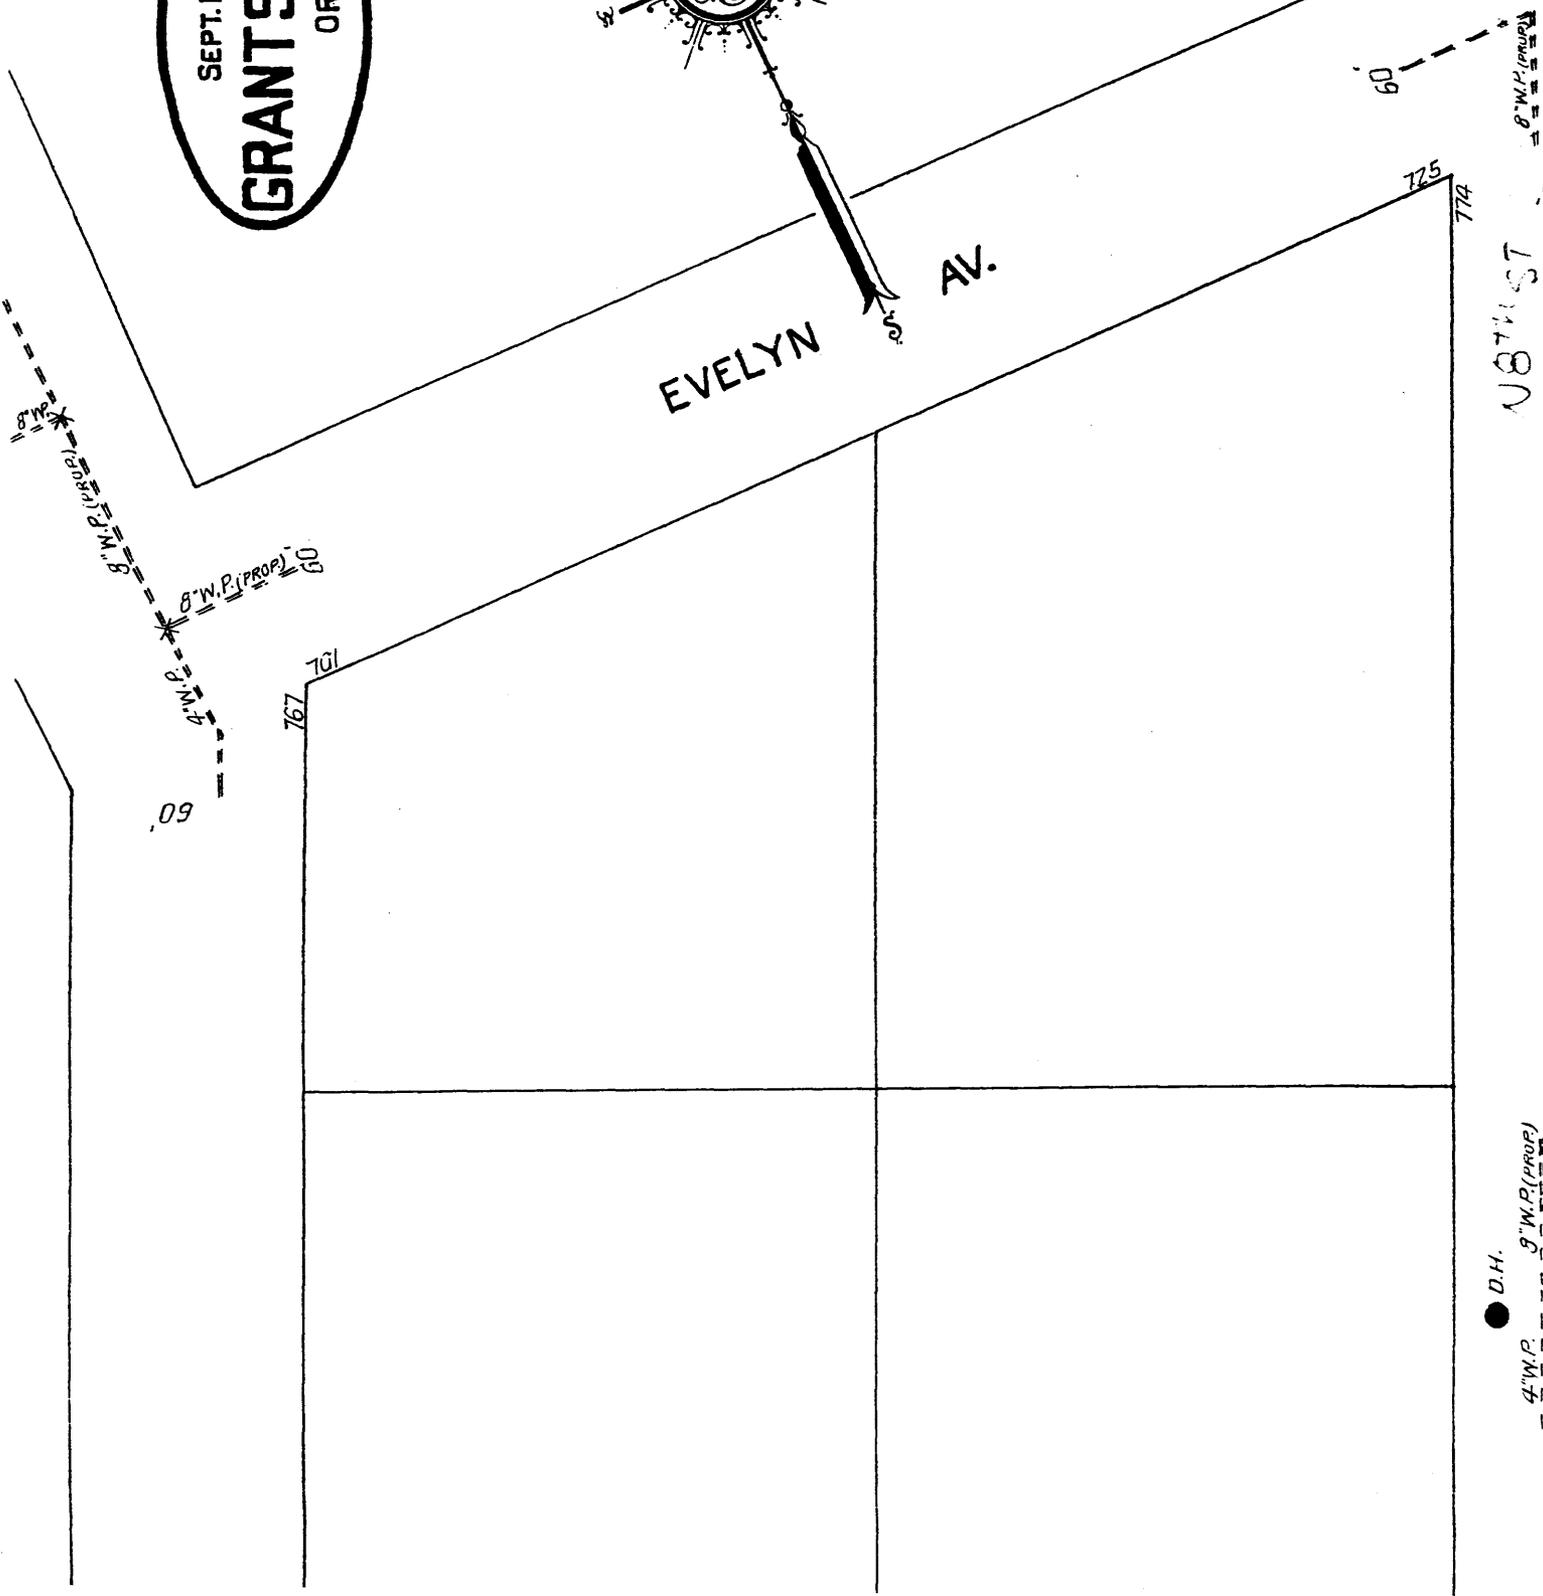
36-5-17-21

The nominated area of 0.17 acres encompasses the entire tax parcel presently associated with the historic Dimmick - Judson House. The accompanying detail from an assessment map shows the westerly boundary line of the nominated area intersecting the site of a non-historic shed built about 1957. In 1990, the westerly half of the shed was removed to eliminate an encroachment onto the neighboring parcel. Whereas the footprint of the shed originally measured 12 x 20 feet, the present ground plan dimensions are 12 x 12 feet, and the outbuilding stands entirely within the bounds of the nominated property.

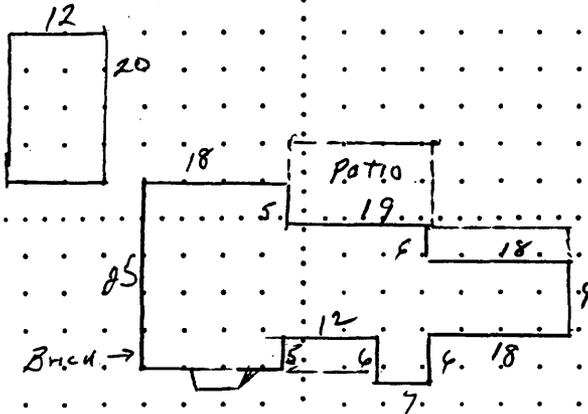
BUILDING DIAGRAM

$18 \times 25 = 450$
 $15 \times 19 = 285$
 $9 \times 18 = 162$
 $6 \times 7 = 42$

939

rear. The house includes approximately 939 square feet on two floors.

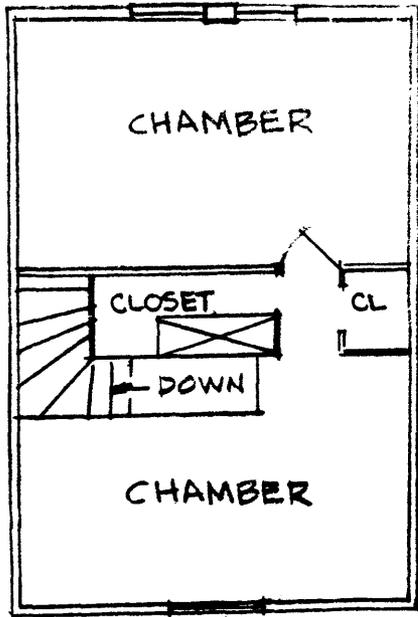
SECOND FLOOR

FLOOR PLAN. The two-story volume contains four rooms, two bedrooms upstairs and two parlors downstairs. The upstairs rooms are accessed by a dogleg stair, a small winding staircase without balustrade, which wraps around the central chimney. The downstairs rooms of the two story portion are currently used as a bedroom and a living room.

BEDROOMS. The upstairs contains two rooms which are currently used as a sleeping area for guests. The front room contains one window looking east; the rear room contains

paired windows looking west. While the center of the rooms are full ceiling height, the ceiling slopes and the sides of the rooms are under the eaves and the actual wall height is only about four feet.

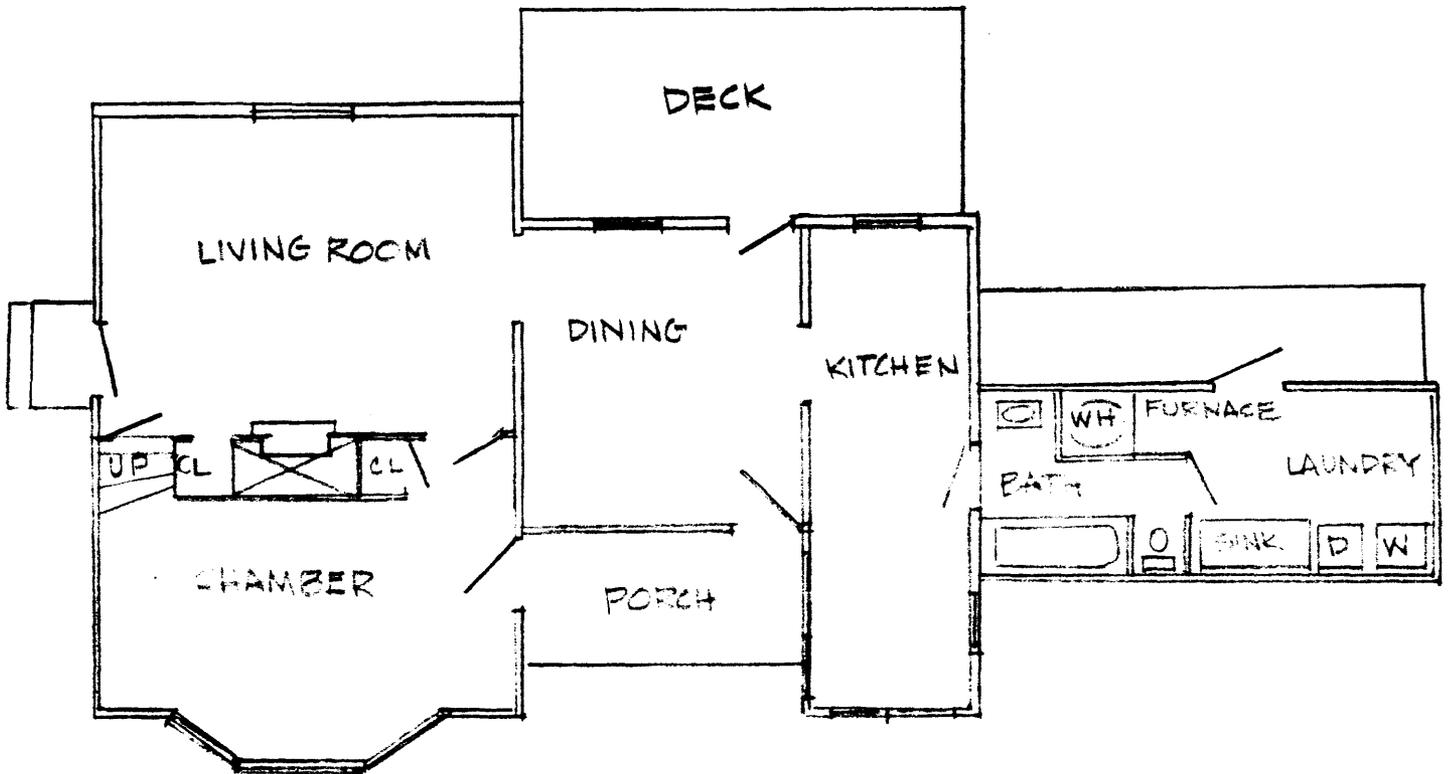
FIRST FLOOR

The middle volume of the house is one story in height and contains two rooms, one currently used as the entrance hall/dining room and the other as a kitchen. There are no interior hallways or corridors.

The third volume, the ell or shed on the north end of the house contains two rooms; one that has been made into a laundry/utility area and the other is the bathroom. The laundry is used for the mechanical systems, (furnace, water heater) and for miscellaneous storage. There is a trap door in the laundry leading to a small, concrete lined cellar under the storage/laundry room. Including the laundry area, there are a total of seven rooms and one bathroom in the house. There is no attic and no basement.

The floor plan appears to have retained its original spatial configuration. There are no false walls or added interior partitions. The house does not have conventional closets. The upstairs bedrooms contain two chimney closets large enough to accommodate clothing storage. The two downstairs rooms also have small closets fitted within the angles of the central chimney.

The interior of the main volume is organized as parlor and sitting room divided by a fireplace chimney flanked on the south side by a built-in closet, with a dogleg stair wrapping around the chimney to upstairs bedchambers. On the opposite side of the central chimney from the closet
