National Register of Historic Places Registration Form

historic name Drayton Mill

street & number 1802 Drayton Road not for publication

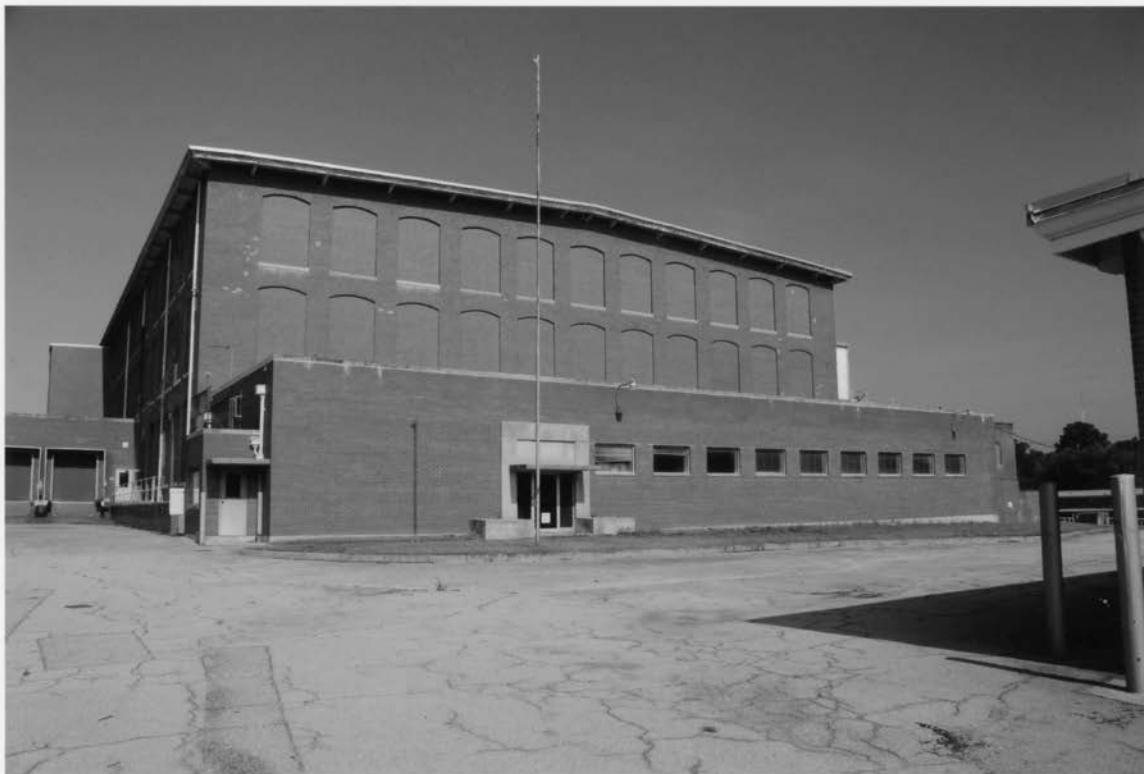
1. Drayton Mill
1802 Drayton Road, Spartanburg vicinity
Spartanburg County, South Carolina

Drayton Mill east elevation, one-story office addition in foreground

employee showers. In 1958, a one-story office addition (44' X 128') was added to the east end of the main mill and a one-story warehouse/loading dock addition of 47'-3" X 324' was added to the south side of the main mill. The east addition is constructed of red brick with a plain concrete coping. The east facade of this addition has an entry on the south end consisting of a single full-glass door flanked on each side with a full-glass side light and nine flat-topped horizontal windows with concrete sills. The doorway is surrounded by large concrete flat panels, topped with a projecting concrete cover and flanked at the base with two concrete planters. This addition has a small projecting guard house on the south elevation with a half-glass metal personnel door on the east and a plate glass window on the south. On the north end of this addition is a stoop and stair for an employee's entrance of red brick topped with a concrete slab. The windows of the easternmost bay of the north facade, on the first, second and third floor were enlarged to become access doors for modern equipment. A concrete loading dock with metal roof was added to the first floor, presumably at the same time. The warehouse/loading dock addition of 1958 consists of twenty-nine pilastered bays in red brick capped with concrete coping. The pilasters are capped with a beveled concrete cap. A foundation vent and high louver are located in every other bay of the south elevation. The east elevation has three loading dock doors and a half-glass metal personnel door on the right. The west elevation of this addition has one loading dock door and a metal ladder access to the roof. At the time of this addition an elevated walk was constructed at the first floor level and extending to the east just beyond the corner of the main mill block.

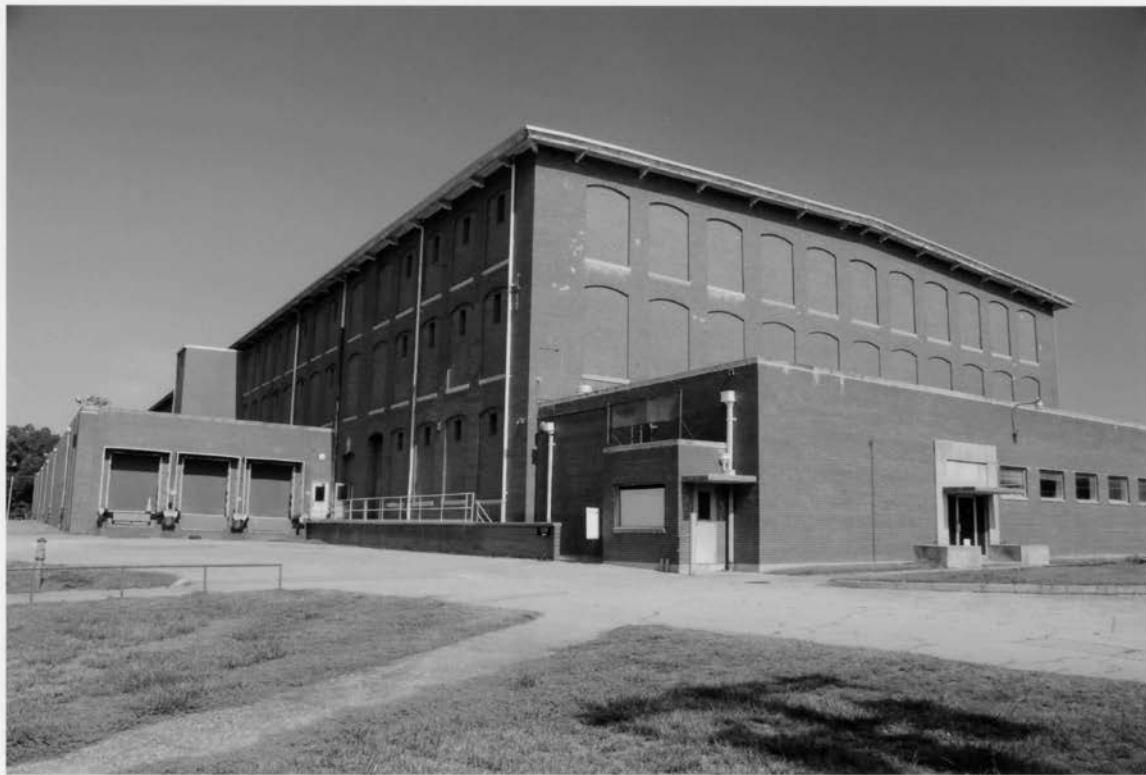
2. Drayton Mill
1802 Drayton Road, Spartanburg vicinity
Spartanburg County, South Carolina

Drayton Mill, south and east elevations with warehouse addition (at left) and office addition (at right)

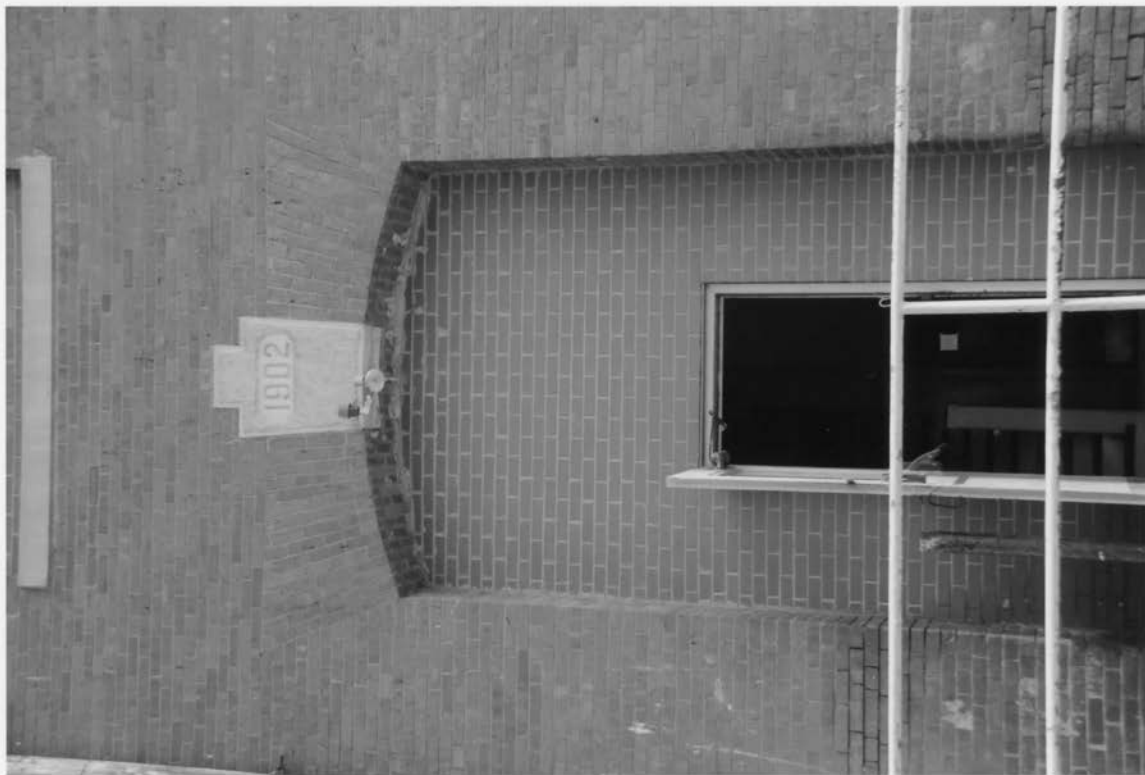
3. Drayton Mill
1802 Drayton Road, Spartanburg vicinity
Spartanburg County, South Carolina

Drayton Mill entrance detail on east end of south elevation

The principal entries are on the south elevation in the sixth bay from the right and in the first bay on the left. These doorways lead directly into the stairways of the building. Doors and windows are segmental arched. The windows were originally paired nine-over-nine wooden sashes with arched paired six-light transoms. Segmental arches located above each window embellish the fenestration, and continue the curve of the arch into the wall. The main entry door on the right end of the building is ornamented with a granite keystone incised with the date 1902. The brickwork of this arch differs from the windows in that it is a flat or jack arch. In plan, just behind the main stair, sits an original elevator and directly behind that is the 9'-0" deep by 12'-4" wide dust chimney. The dust chimney was a shaft running from the first floor through the roof for the burning of production lint. The access door is located only at the first floor.

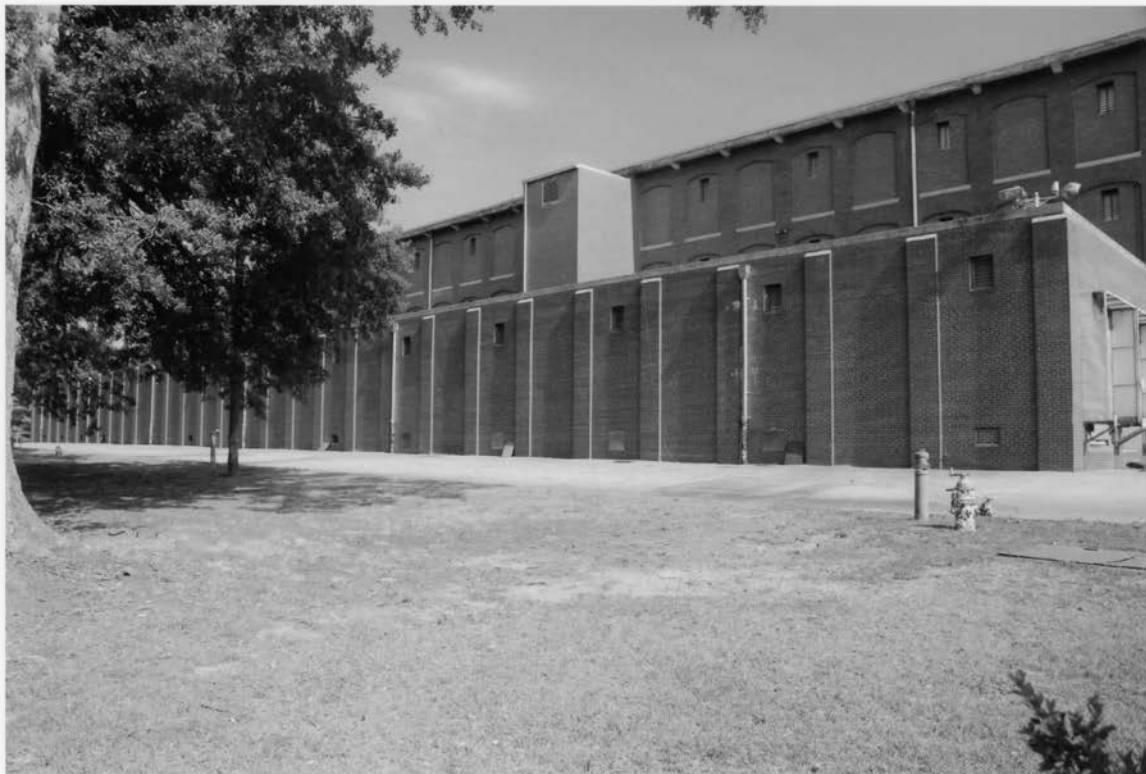
4. Drayton Mill
1802 Drayton Road, Spartanburg vicinity
Spartanburg County, South Carolina

1958 warehouse on south elevation of Drayton Mill

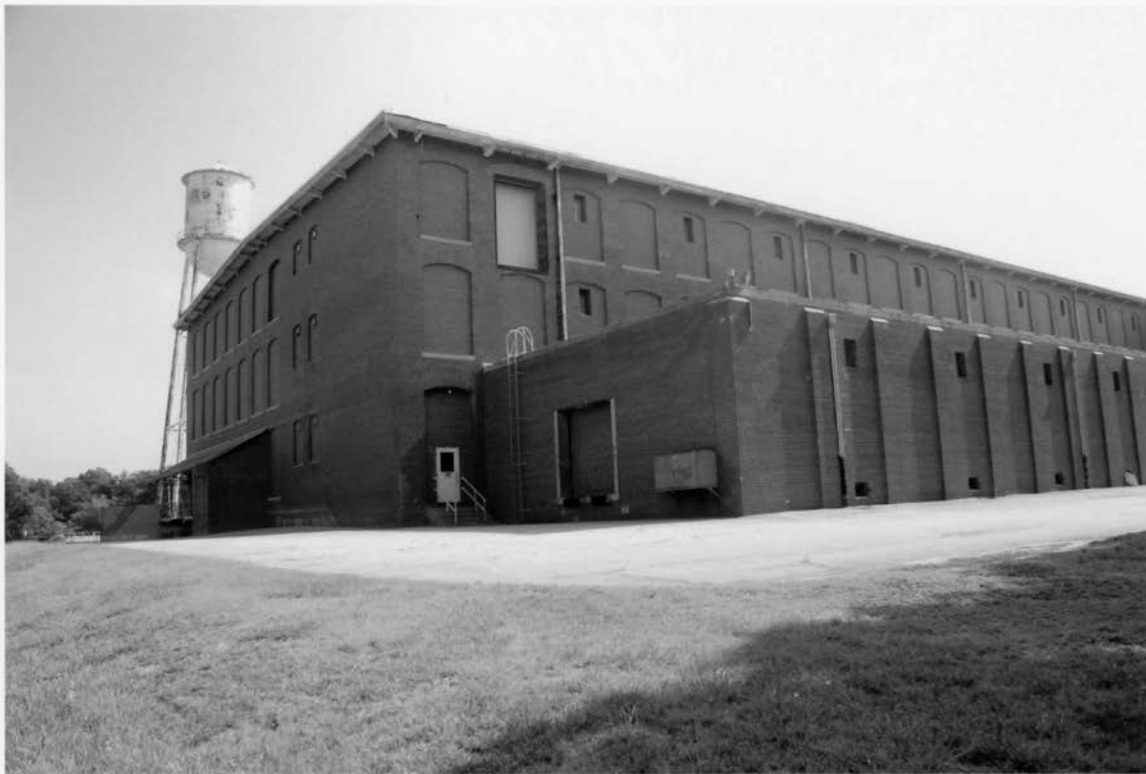
5. Drayton Mill
1802 Drayton Road, Spartanburg vicinity
Spartanburg County, South Carolina

Drayton Mill, east end of south elevation with one-story warehouse addition

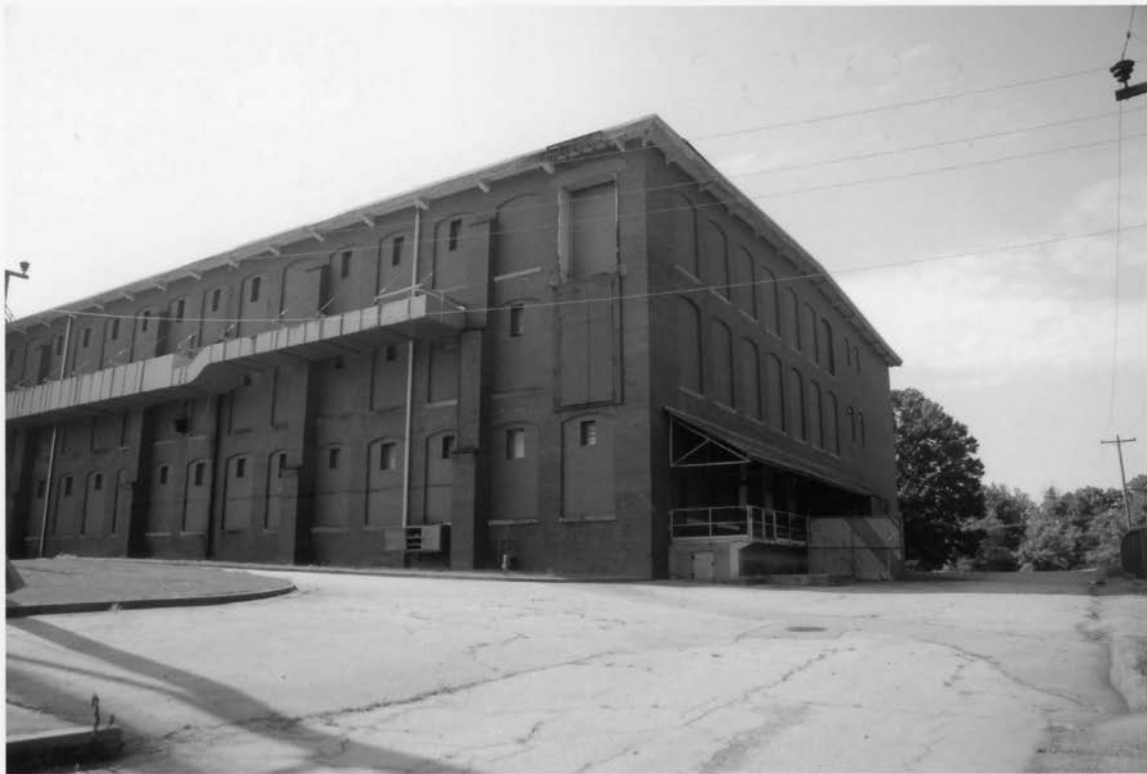
6. Drayton Mill
1802 Drayton Road, Spartanburg vicinity
Spartanburg County, South Carolina

Drayton Mill, south and west elevations with one-story warehouse addition

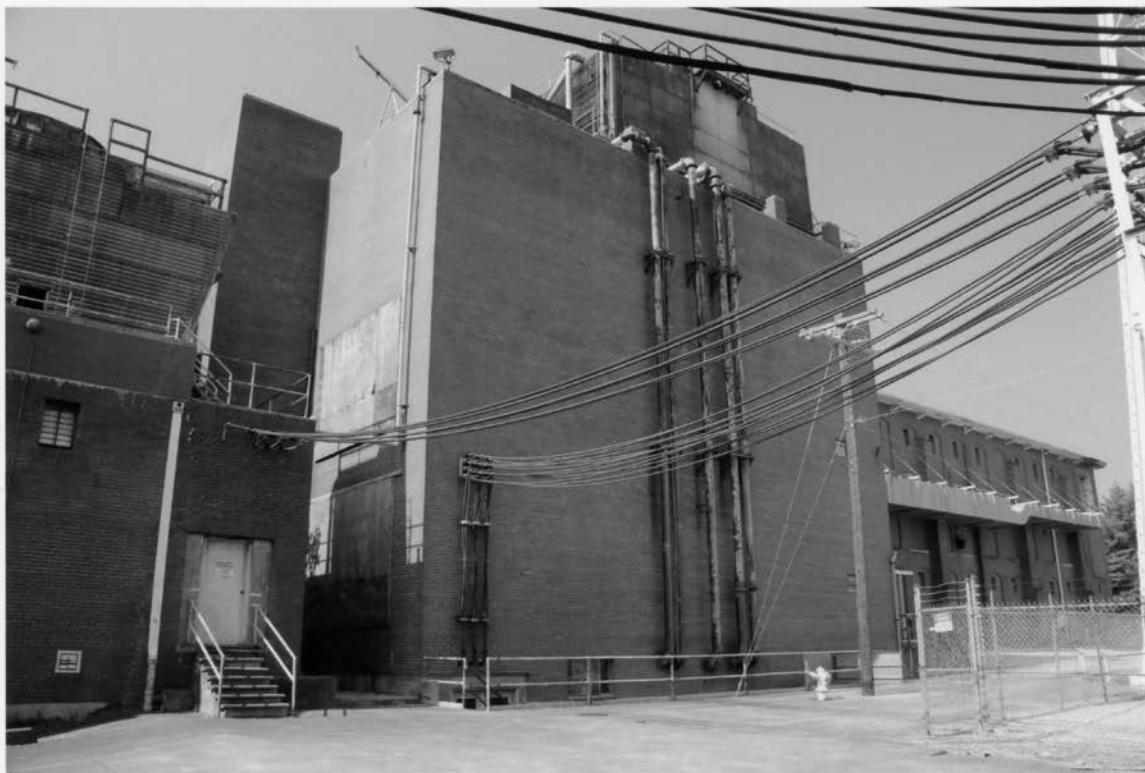
9. Drayton Mill
1802 Drayton Road, Spartanburg vicinity
Spartanburg County, South Carolina

Drayton Mill, north elevation and air conditioning tower

In 1944, Lockwood Greene and Company designed a new air-conditioning system for the weaving building at Drayton Mills.¹⁴ This installation involved the removal of the seven-bay sawtoothed northern clerestory and replacing it with a slightly sloped roof and two large HVAC penthouses.

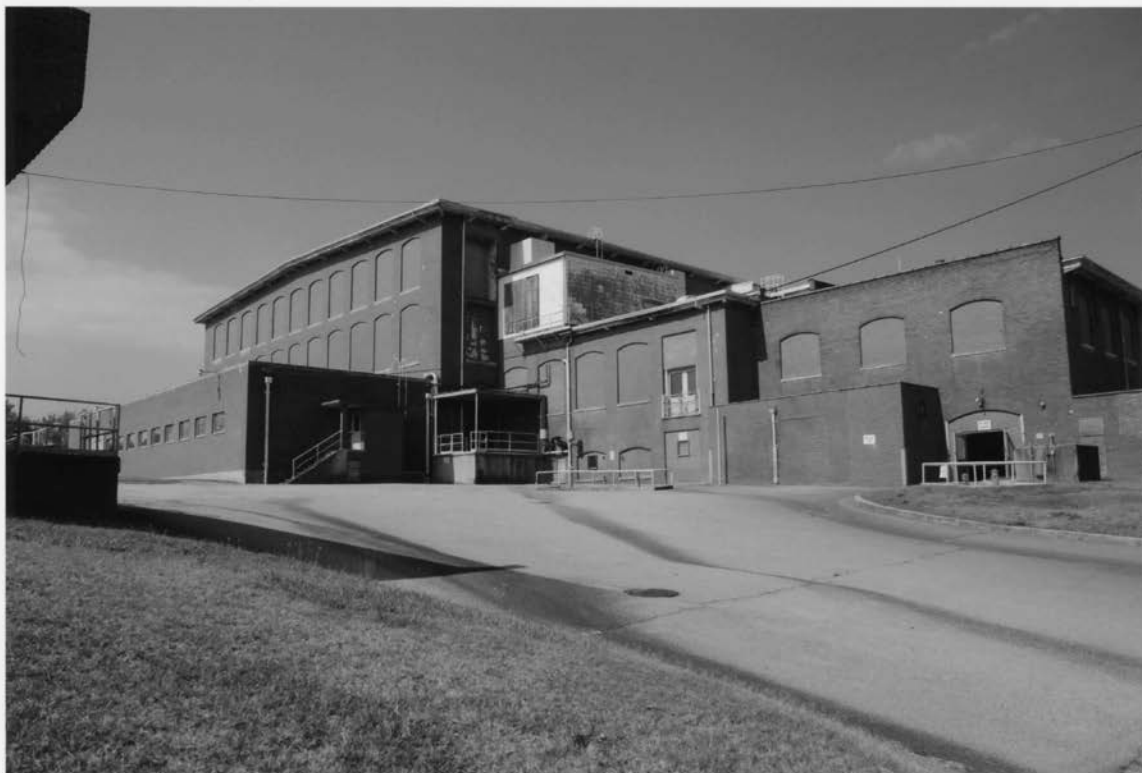
10. Drayton Mill
1802 Drayton Road, Spartanburg vicinity
Spartanburg County, South Carolina

Drayton Mill, north elevation, air conditioning tower and water tower

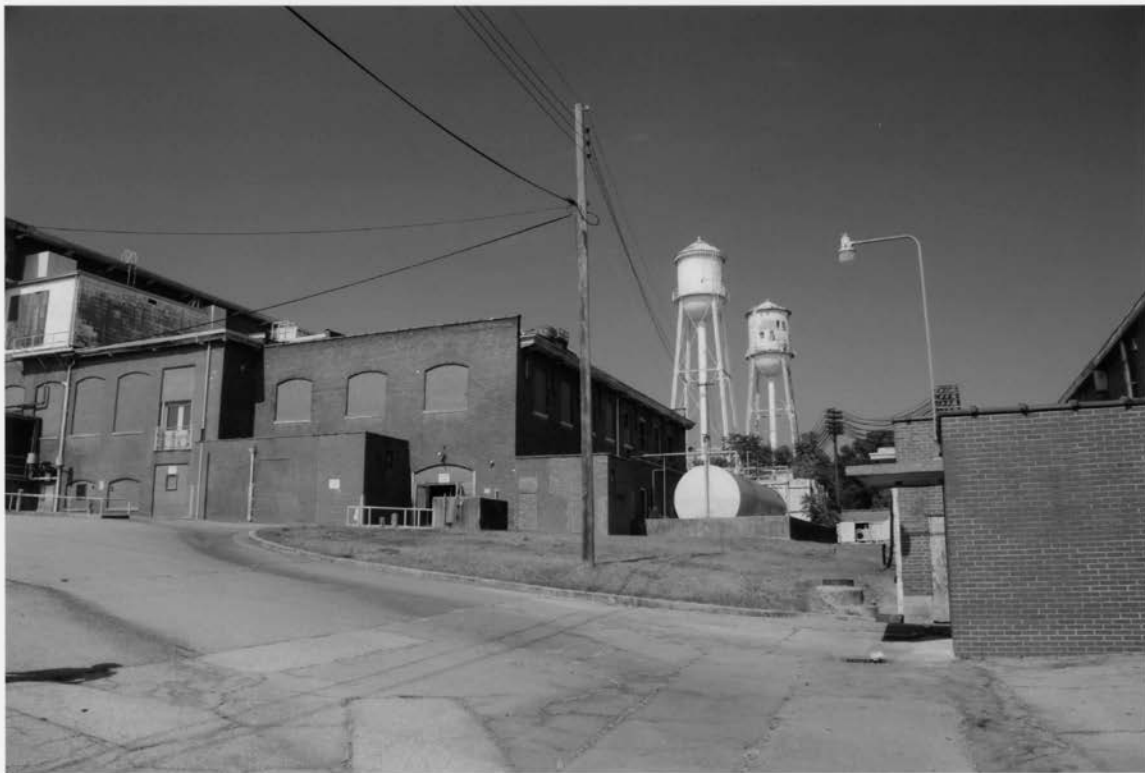
11. Drayton Mill
1802 Drayton Road, Spartanburg vicinity
Spartanburg County, South Carolina

Drayton Mill, east elevation with office addition and boiler room

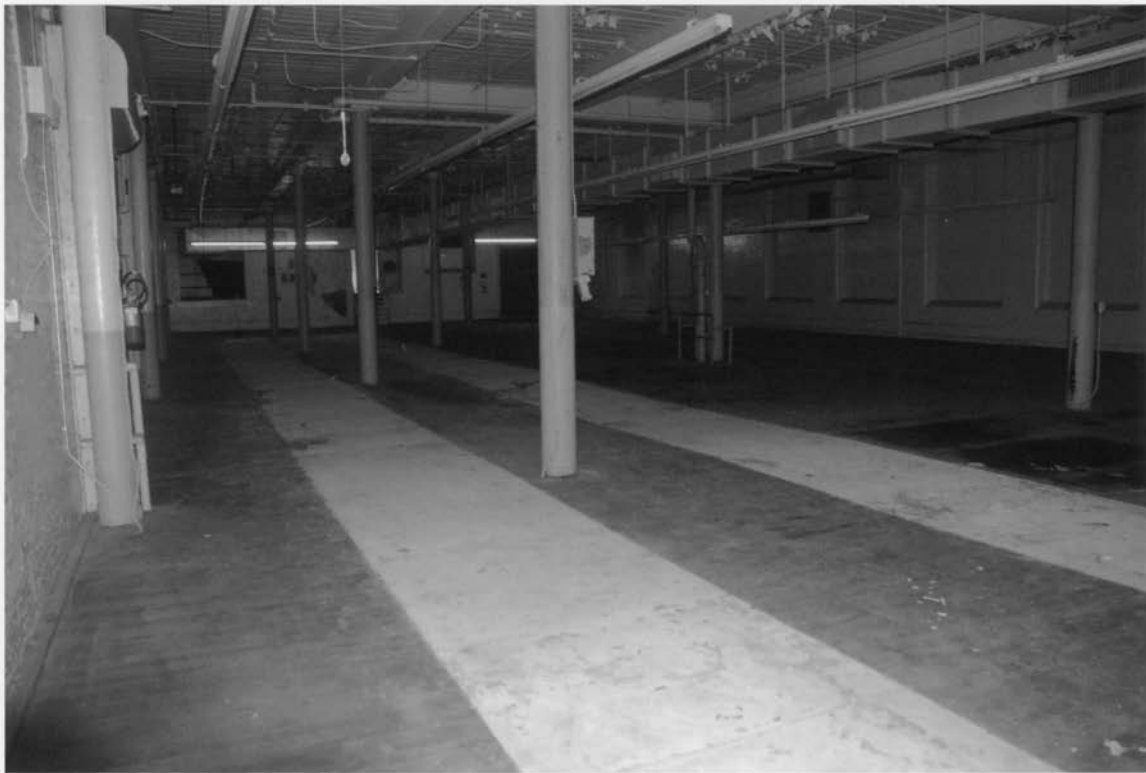
14. Drayton Mill
1802 Drayton Road, Spartanburg vicinity
Spartanburg County, South Carolina

Drayton Mill, interior, first floor, picker room

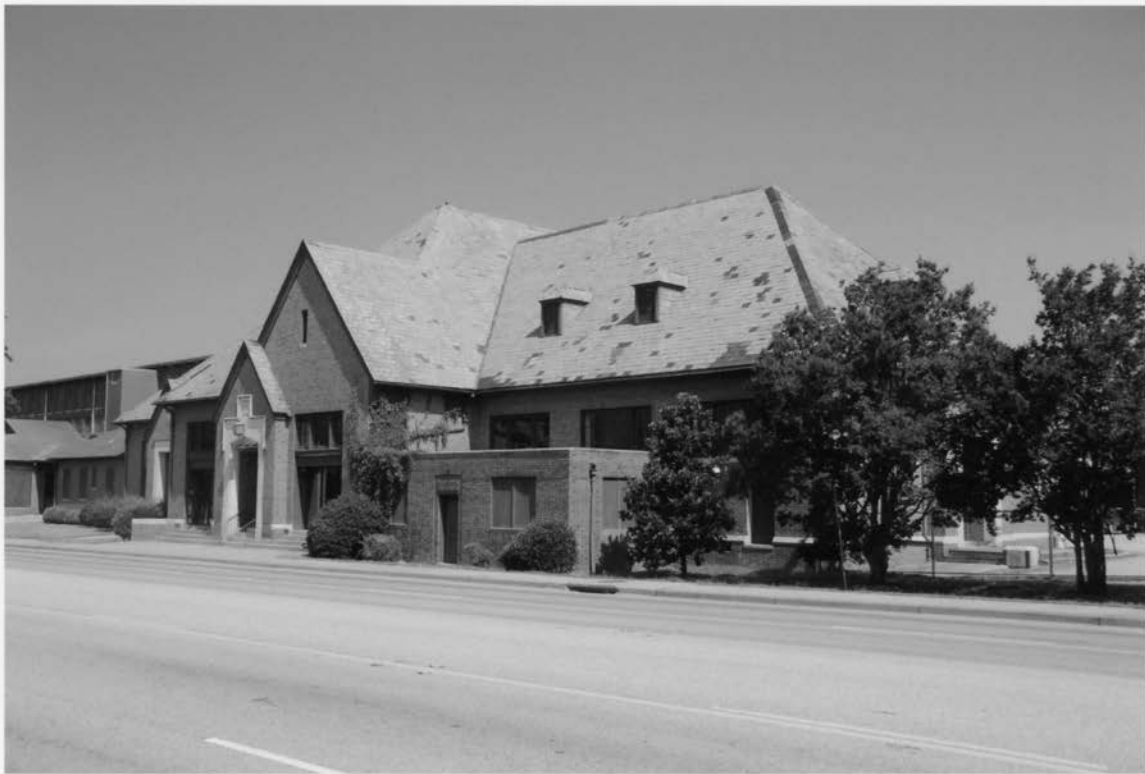
18. Drayton Mill
1802 Drayton Road, Spartanburg vicinity
Spartanburg County, South Carolina

Company store and office, south and east elevations

The Company Store and Office Building, situated along Drayton Road on axis with Milliken Street, has a cruciform plan, and its walls are laid with red brick in Flemish bond pattern. Designed by Joseph E. Serrine, textile mill engineer and designer of note in South Carolina and the region, in a Tudor Revival-French Eclectic style, the building's dominant and complex hipped roof is covered in slate shingles. A molded limestone and brick water table defines the first floor line. The Drayton Road (south) elevation is developed in three sections. The roof of the left section has a small six-over-six light dormer, the central section's roof has a louvered dormer and the right roof section has two louvered dormers. The central hipped roofed element features a steeply-pitched, engaged and nested gabled projecting entrance that is Tudor Revival in its appearance and form. The larger gable has a vertical rectangular vent in the center. The store's entrance double doors are nine light over two panels. Above the double doors is a horizontal panel and above that is a three-light peaked transom. These elements are featured within a recessed peaked portal of smooth finished cut limestone, laid in either a vaguely Tudor Revival or Collegiate Gothic surround. The arch is more stylized [square with peak] than traditional where the arch begins to curve above the spring line. The spandrels above the peaked arch are floriated and decorated with shields. A large central block that tops the entrance composition is decorated with a floriated quatrefoil panel which supports an original copper and opaque glass lantern. The entire surround, which features a molded dripstone, is regimented. The entrance is flanked each side by a three sash transomed storefront composed of a central six light transom flanked each side by a four light transom with a three panel storefront below. These storefronts have a flat soldier coursed head. The original three sash multi-light wooden store front windows have been replaced with a three light glass and aluminum frame. The storefront and central door are

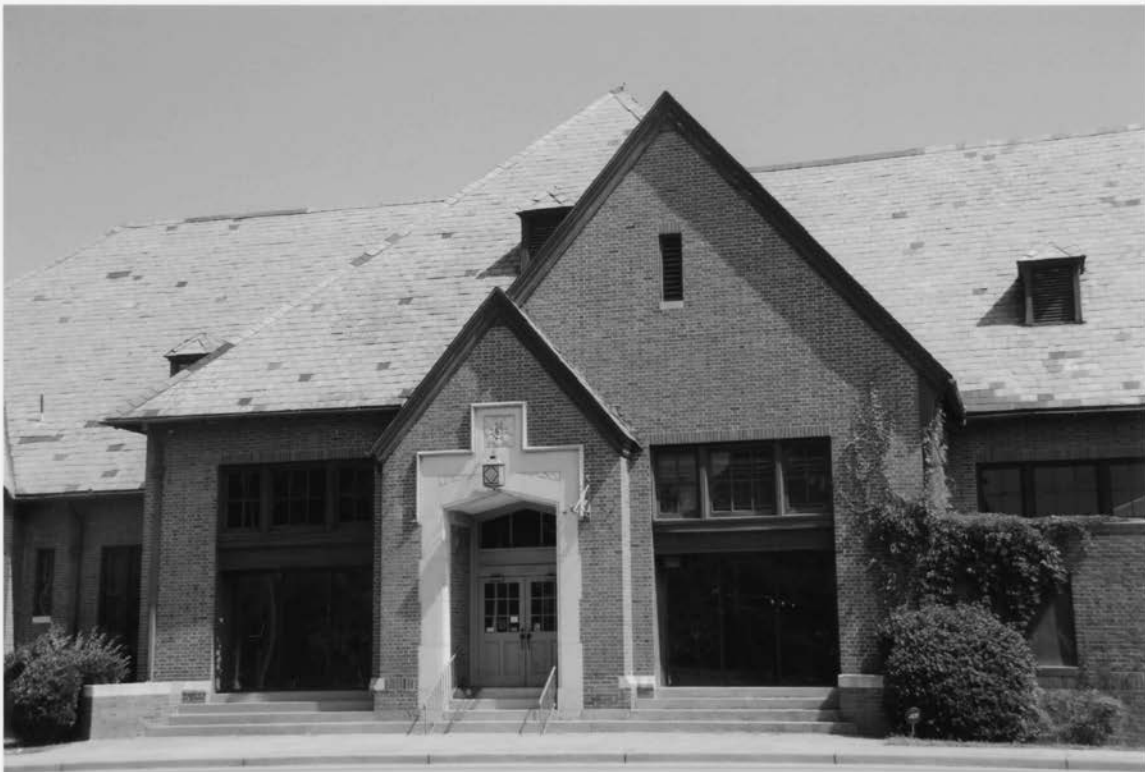
20. Drayton Mill
1802 Drayton Road, Spartanburg vicinity
Spartanburg County, South Carolina

Company store and office, south elevation, entrance detail

united by four concrete steps with stone-capped cheek walls. The right side of the south facade has three highly-placed, three-sash horizontal windows topped with a flat soldier coursed head. The left or office side has a central projecting-gabled, recessed double-leaf entrance. The recessed double doors have six lights over one panel with a seven light transom. The entrance has a smooth-finished cut limestone surround with a molded cornice. A square flush lozenge in limestone decorates the entrance gable. To the left of the entrance are two nine-over-nine-light tall windows and on the right is a small two-over-two-light window and to its right is a tripartite window composed of a central six-over-six window flanked each side by a two-over-two-light window. Each window has a flat soldier coursed head.

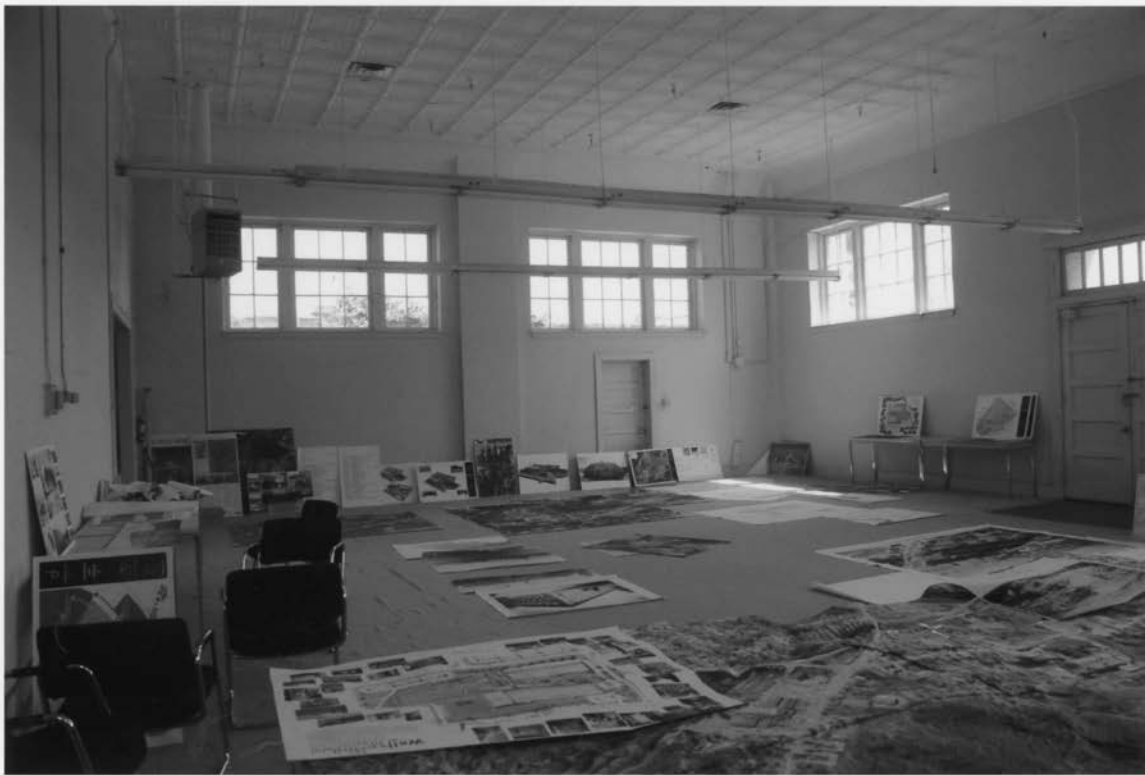
26. Drayton Mill
1802 Drayton Road, Spartanburg vicinity
Spartanburg County, South Carolina

Company store and office, interior, looking northeast

The interior consists of three major spaces. The central space is a large sales area measuring sixty-one feet square. The space has an elaborate pressed-tin ceiling. To the right is a large pressed-tin ceilinged space thirty-five feet by forty-eight feet and was the location of the grocery sales area. To the left of the central space is a suite of business and bookkeeping offices. There are five offices, a large open office area, two vaults and a stairway to a second floor office area. The entrance to the office area is off Drayton Road. A corridor accesses

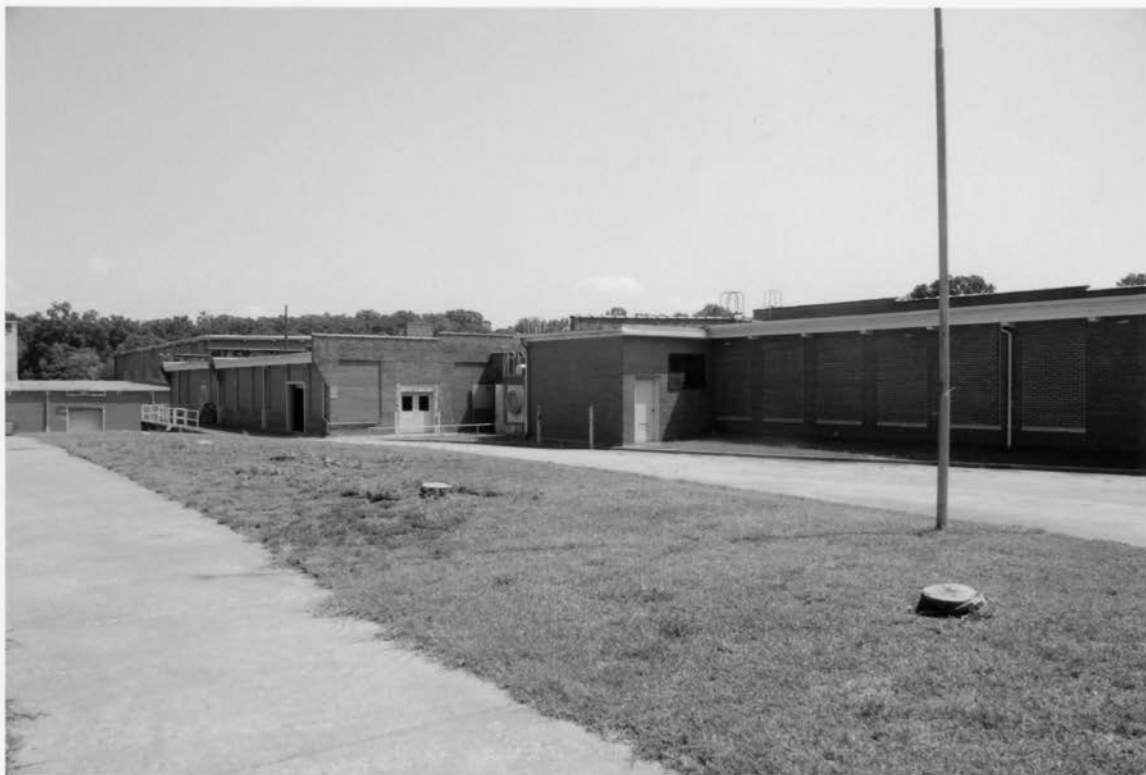
31. Drayton Mill
1802 Drayton Road, Spartanburg vicinity
Spartanburg County, South Carolina

Cotton warehouse, west elevation

Located immediately east of the Main Mill Building, the cotton warehouse complex has an irregular plan. The north section of the cotton warehouse, containing five rooms or sections, was the first to be built. The room on the southwest corner was the opener room. In this room cotton bales were opened and fed into a conveyor that carried the cotton to the main mill's picker room on the east end of the first floor. The picker room, generally located on the first floor of a Lockwood Greene and Company mill, was a space equipped with special machines to clean the cotton, collect any cotton seeds that had not been extracted during the ginning process, and finish the cotton before going to the spinning area. The room on the northwest corner of the warehouse complex was used for mill supplies. The three rooms to the east of this room were used for the storage of cotton bales. In 1948 a second opener room and shipping warehouse were added to the south of the first opener room. Two other shipping warehouses were added in the late 1960s to the east of the 1948 additions. At that time the open area between the old and new warehouses was roofed. The one story 1948 opener room has red brick exterior walls, a concrete floor, and heavy timber framework. Three rows of square wooden posts support the roof framing and provide an open plan. A low pitched roof structure with large exposed rafter tails caps the building. The southern elevation, which is six roof bays wide, has a single metal personnel door in an opening that was originally six feet wide. The ridge of the roof is oriented north to south. The western elevation is twelve roof bays long with brick-filled windows in bays four through nine from the right (south). A small mechanical room was added in 1958 to this elevation in the tenth through twelfth bays. A metal door is located on the south side of this addition. The 1918 opener room is six window bays wide on the west side. Five of the window bays are infilled with brick, and the second window bay from the south was converted to a roll-up door. The roof of this building and the roof of the supply house to the north slopes from a high point on the east to a low point on the west. The opener room, supply house and the three cotton warehouses of the 1918 section are all separated by a corbelled parapet. The supply house is four bays on the western side of which three window bays are infilled with brick. The second bay from the south is a double door bay topped with a flat (jack) arch. A loading dock and ramp runs across the six bays of the opener room to the two southernmost bays of the supply house. The north elevation of the supply house is a solid red brick wall with a stepped parapet. The walls of the north elevation of the next two easternmost cotton warehouses are weatherboard-clad with sliding dock doors and roofs that slope down to the north. The sliding door of the westernmost wood-clad cotton warehouse opens to a concrete ramp which crosses over Building No. 5 (Pump Building) and goes to the third level of Building No. 7 (Weaving Building) to the cloth room. The northeast elevation of the easternmost cotton warehouse is a solid red brick wall. The northeast and east walls of the easternmost 1968 warehouse are solid red brick with a parapet. A seven-bay loading dock runs along the northeast elevation of the easternmost warehouse. The north elevation of the two 1968 warehouses and of the 1948 warehouse is a thirteen-bay concrete loading dock with a metal roof supported on steel pipe columns.

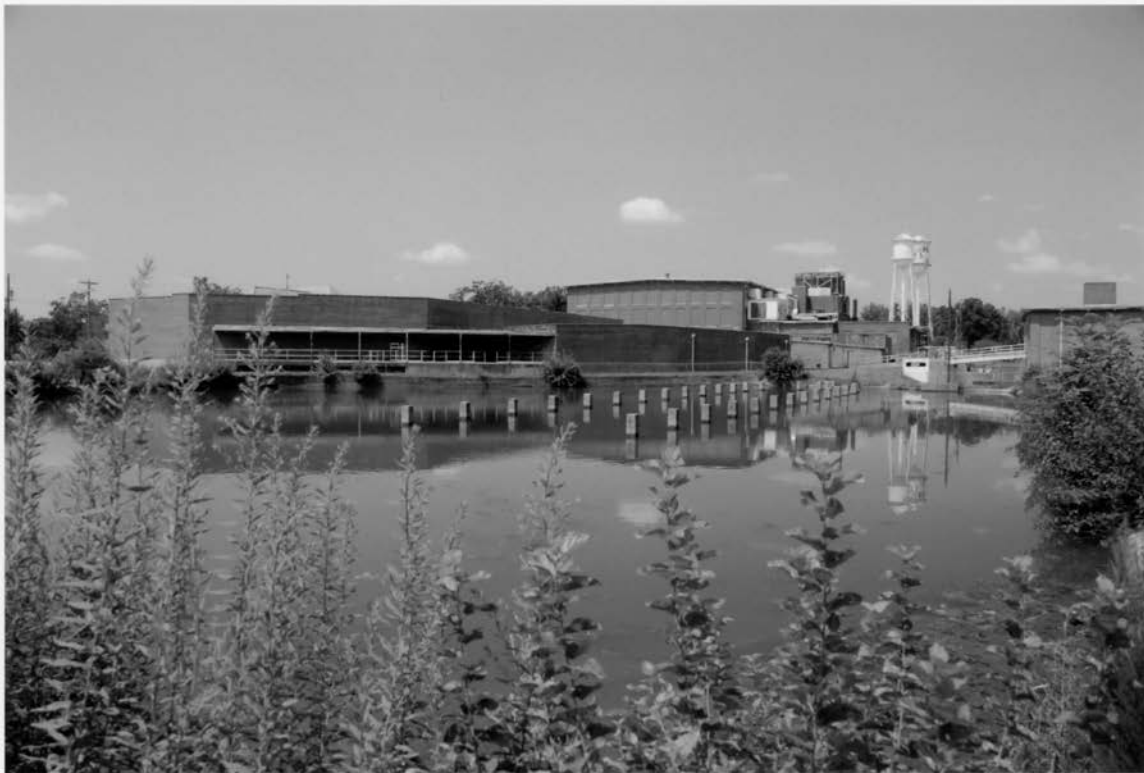
34. Drayton Mill
1802 Drayton Road, Spartanburg vicinity
Spartanburg County, South Carolina

Mill pond in foreground, looking southwest towards cotton warehouse and mill

8. Mill Pond (1902) Located northeast of the 1918 Warehouse Building and its 1948 and 1960s additions, just beyond a railroad spur that enters the property, this 1,500,000 gallon reservoir served as a cooling pond for the mill's power plant.

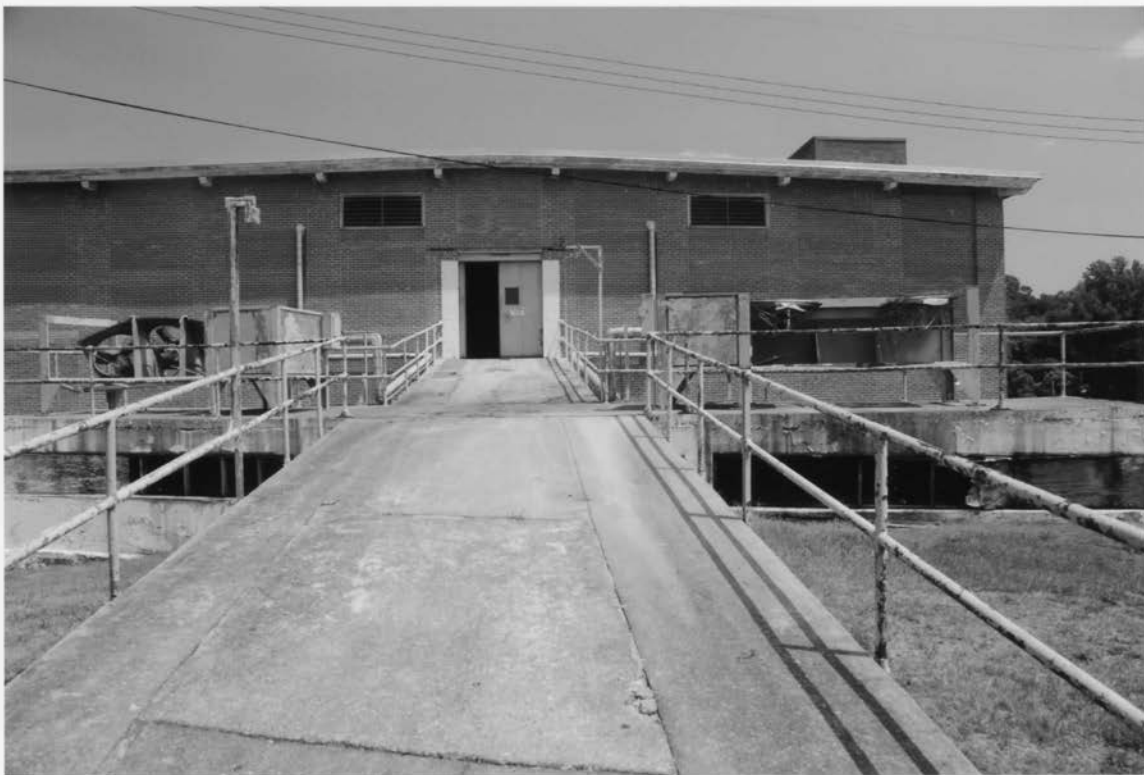
37. Drayton Mill
1802 Drayton Road, Spartanburg vicinity
Spartanburg County, South Carolina

Ramp from cotton warehouse to weaving room, south elevation of weaving room

5. Pump Building (1958) A white-painted concrete block building 11'-3" by 50'-0" which supports the ramp extending between Building No. 4 (Cotton Warehouse) and Building No. 7 (Weaving Building). The building is oriented on its long side from the northwest to the southeast.

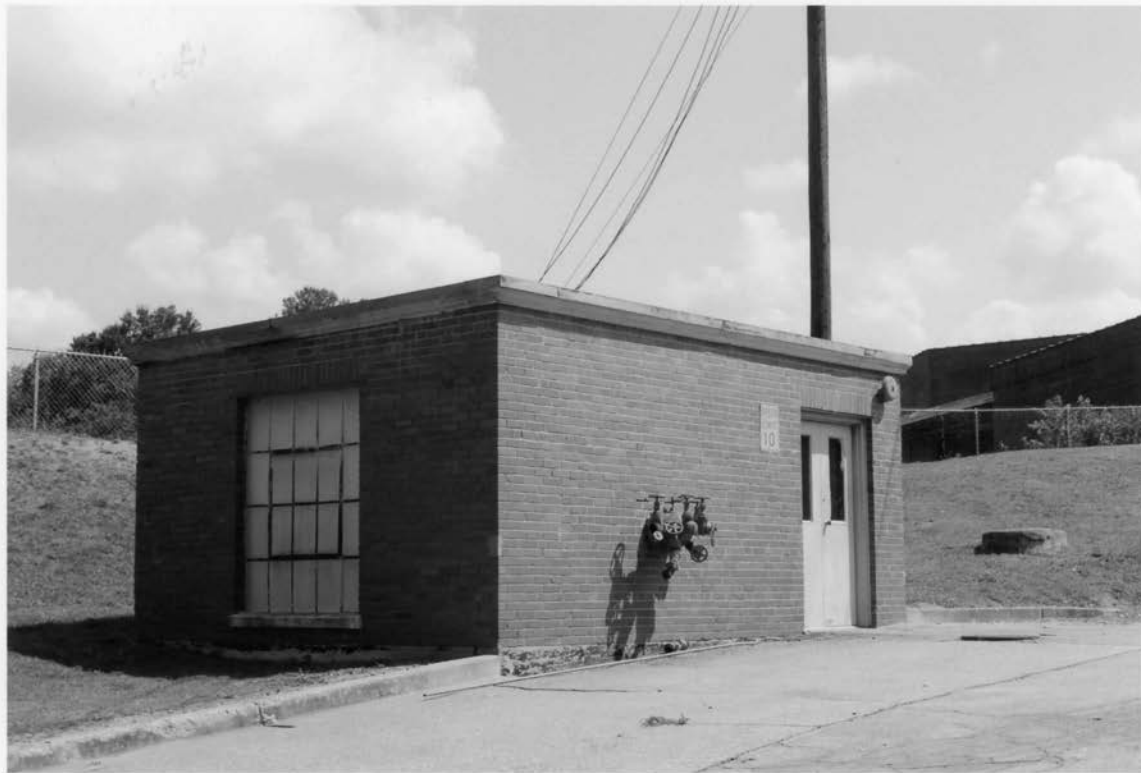
38. Drayton Mill
1802 Drayton Road, Spartanburg vicinity
Spartanburg County, South Carolina

Pump house

6. Pump Building (1958) Located northeast of the 1918 Warehouse Building and just west of the mill pond, this red brick building measuring 15' by 20' contains the pumps that supply water from the mill pond to the two water towers that supply water to the fire sprinkler system. The building has a flat roof and a double-leaf, half-glass metal personnel door on the west side and a metal twenty-light window on the north elevation.

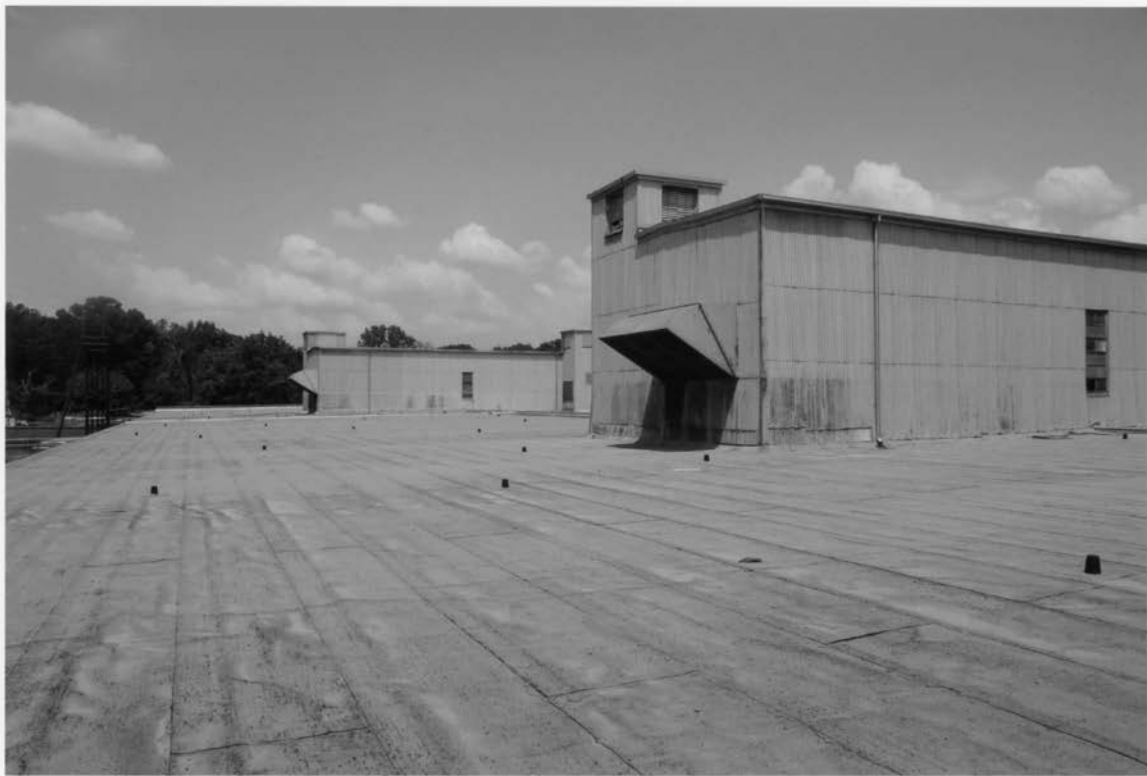
40. Drayton Mill
1802 Drayton Road, Spartanburg vicinity
Spartanburg County, South Carolina

Weaving building roof, looking northwest

7. Weaving Building (1928, 1949) Located to the north of the Main Mill Building, this red brick exterior bearing wall and steel structural frame building measuring 193' by 450' housed the weaving operations on the first floor, warehousing on the ground level and cloth room measuring 93' by 193' on the second level. The first floor steel beam roof structure is supported by seventeen steel columns running east to west and six steel columns running north to south. The second floor cloth room is oriented north and south and its steel roof framing is supported by two rows of steel columns running east to west and six steel columns running north and south. The exterior wooden cornice of the cloth room is supported on wooden rafter tails mimicking the wood framing of the

original 1902 mill. There are twenty-one roof bays on the east elevation of the cloth room section, and nine roof bays on the north and south facades of the cloth room section. All windows of this section have been infilled with red brick. Originally going south to north there were large flat-topped steel windows in the second bay and the fourth through the twenty-first roof bay of the second floor, steel windows were also in the fourth through the twenty-first roof bay of the first floor and on the ground floor there were small horizontal steel windows in the second and fourth bays medium size windows, in the fifth through the tenth bays, large windows in the eleventh through the thirteenth bays, and in the eighteenth through the twenty-first bays. Two shipping doors were cut in the wall of this level centered on the fourteenth-fifteenth and the sixteenth-seventeenth bays. A modern covered dock was added at this area. The north elevation of the cloth room section is nine window bays wide on all three levels, and all windows are infilled with brick. The south elevation of this section is also nine bays wide with a central sliding door on the cloth room level leading to a ramp that goes to the 1918 warehouse. This door is flanked each side by four window bays, all infilled with brick. The first floor level is nine window bays wide with brick filled windows. The south elevation of the first floor weaving area has from right to left a modern roll-up door, a projecting brick personnel entry block with a half-glass double-leaf metal door and concrete slab cover, several narrow brick additions, and a reinforced concrete double tunnel oriented north and south which connects the basement area of the Main Mill Building No. 1 with the weaving area to the north. The wooden rafter tails have been cut off, and the stubs are now covered with metal plates. The north elevation in 1930 east to west was originally two levels of large steel windows for six bays, two bays of restrooms, eighteen bays of large steel windows, two bays of restrooms, and fifteen bays of large steel windows. The windows to the west of the first restroom tower are now covered by a red brick HVAC addition for eleven of the window bays to the west. The last fifteen window bays are covered by a large addition measuring 114'-8" to the north and 152' to the west. This red brick, one-story addition was added in 1949 and has a concrete floor system the spans the creek which flows to the southwest. The roof of the Weaving Building No. 7 originally had one flat bay to the north and six sawtoothed clerestory/skylight bays to the south. The northern windows were of steel sashes. This roof configuration was changed prior to 1951, and two large HVAC penthouses were added to a low-sloping roof which slopes from the center of the building in a north and south direction. The west elevation originally of seven bays followed the profile of the roof. When the roof was changed the sawtooth pattern was removed, and the roof line was redeveloped to follow the new roof line. The pilasters that define the original sawtooth pattern still remain, and a loading dock was developed on this elevation.

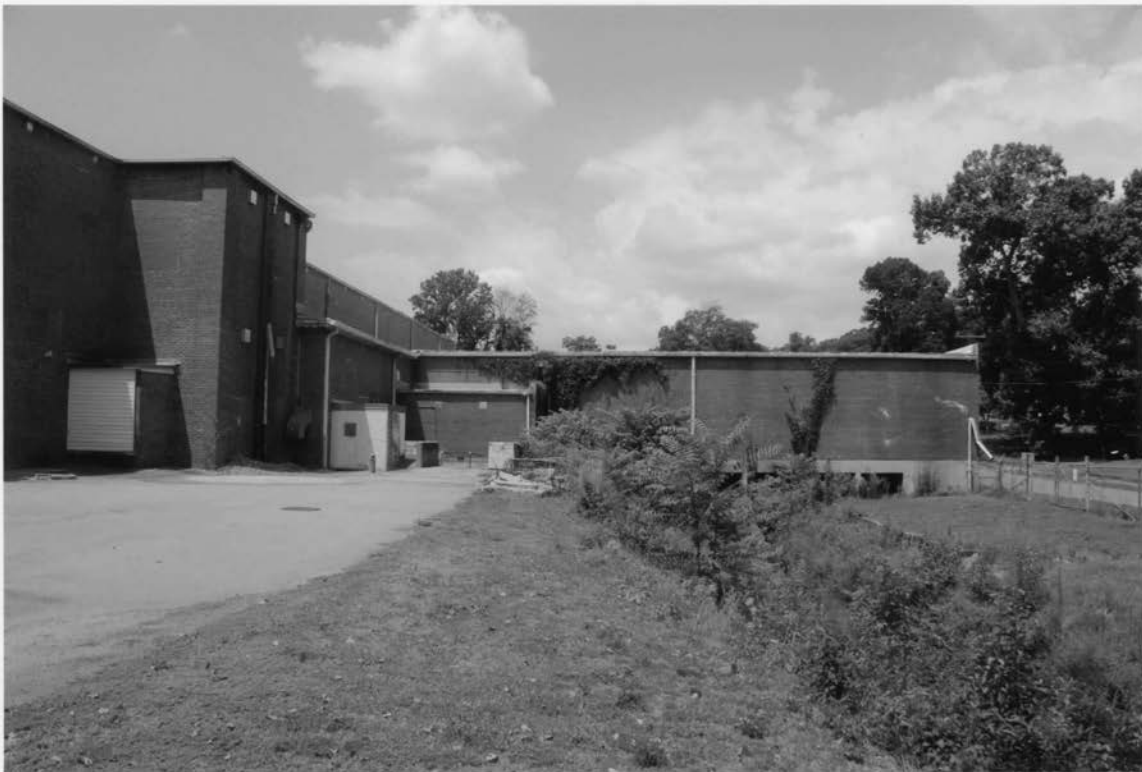
41. Drayton Mill
1802 Drayton Road, Spartanburg vicinity
Spartanburg County, South Carolina

Weaving building (west elevation) and weaving building addition (south elevation)
