National Register of Historic Places Registration Form

historic name Drayton Mill

street & number 1802 Drayton Road not for publication

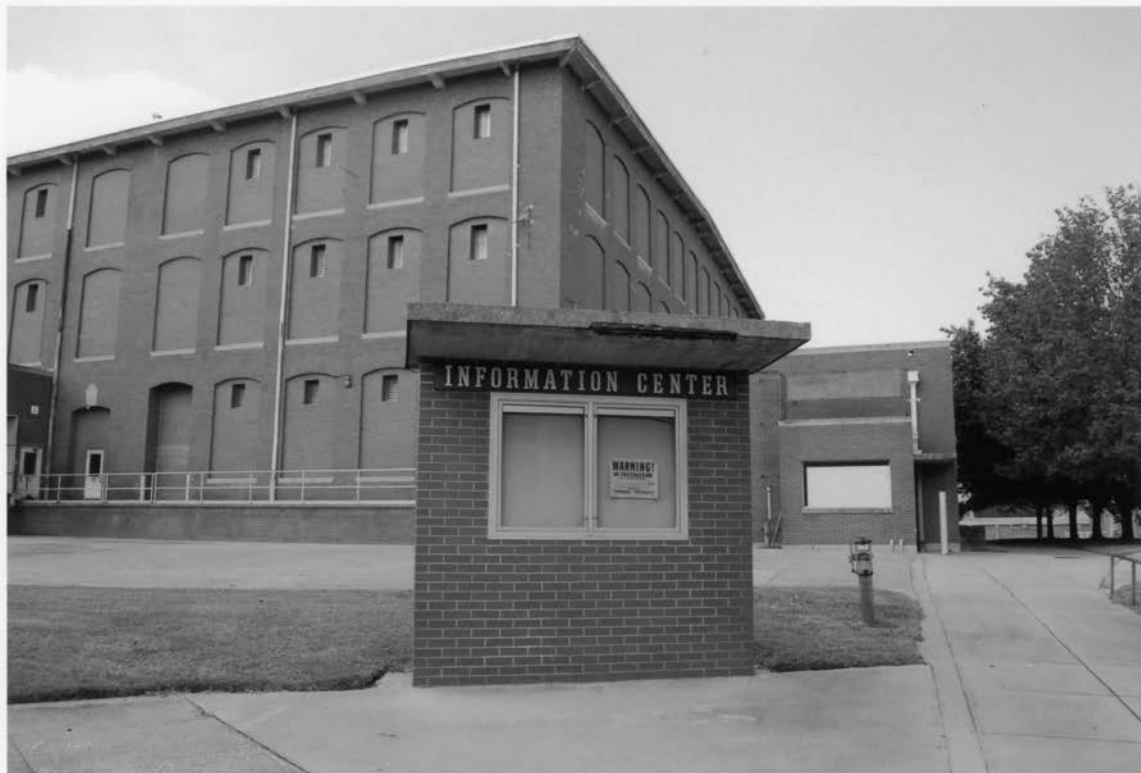
47. Drayton Mill
1802 Drayton Road, Spartanburg vicinity
Spartanburg County, South Carolina

Information center, southeast corner of mill

11. Information Center (1958) Located immediately north of the main turnstile pedestrian entrance into the property and between the Company Store and Office Building and Health Clinic, this small kiosk represents the introduction of a small piece of mid-twentieth century modern architecture into this otherwise late Victorian and early twentieth century complex of resources. The structure consists of a red brick wall (approximately 8.5 feet wide by 10 feet tall by one foot thickness) laid in running bond and includes a double-leaf glass information display window and a cantilevered and slightly-tilted reinforced concrete box cap that shelters the front of the information center.

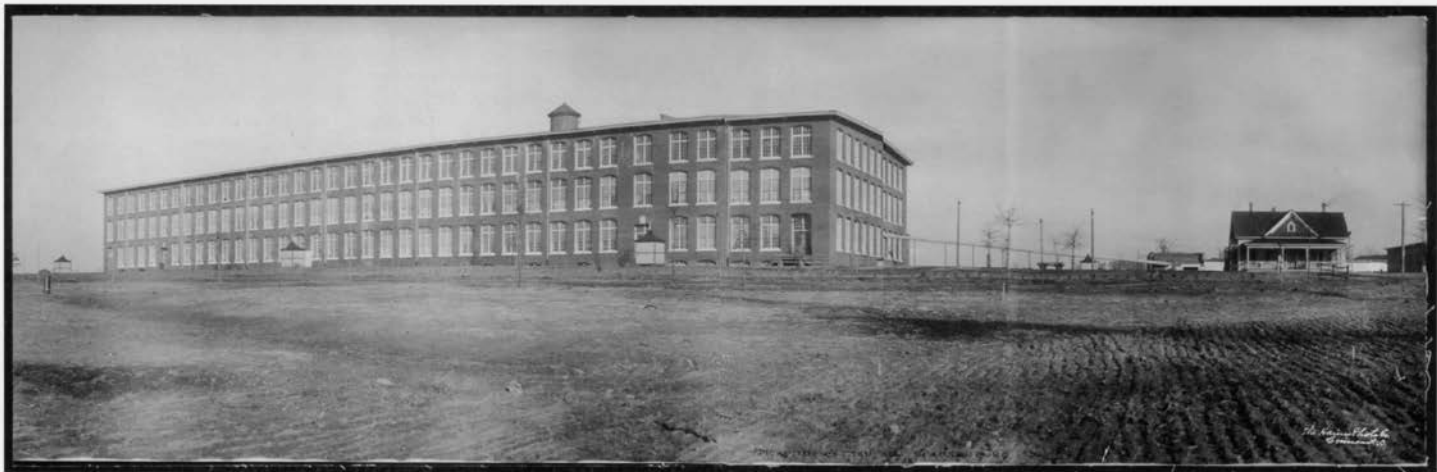
48. Drayton Mill
1802 Drayton Road, Spartanburg vicinity
Spartanburg County, South Carolina

South elevation, 1912

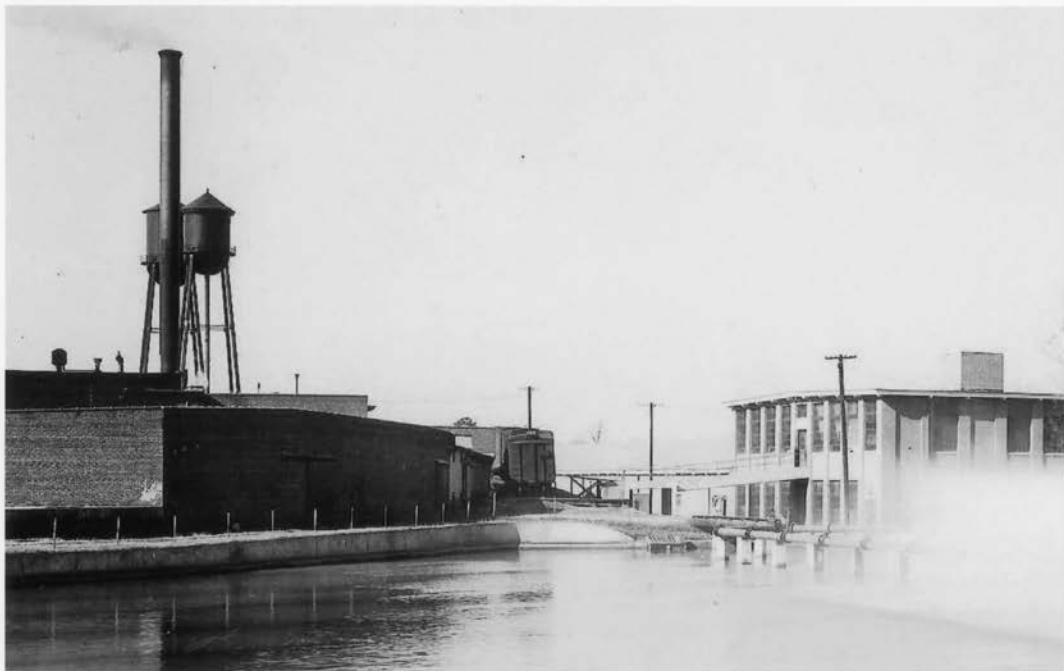
52. Drayton Mill
1802 Drayton Road, Spartanburg vicinity
Spartanburg County, South Carolina

Post-1928 view of warehouses, water towers, and steel smokestack at left; weaving room at right; and cooling pond in foreground

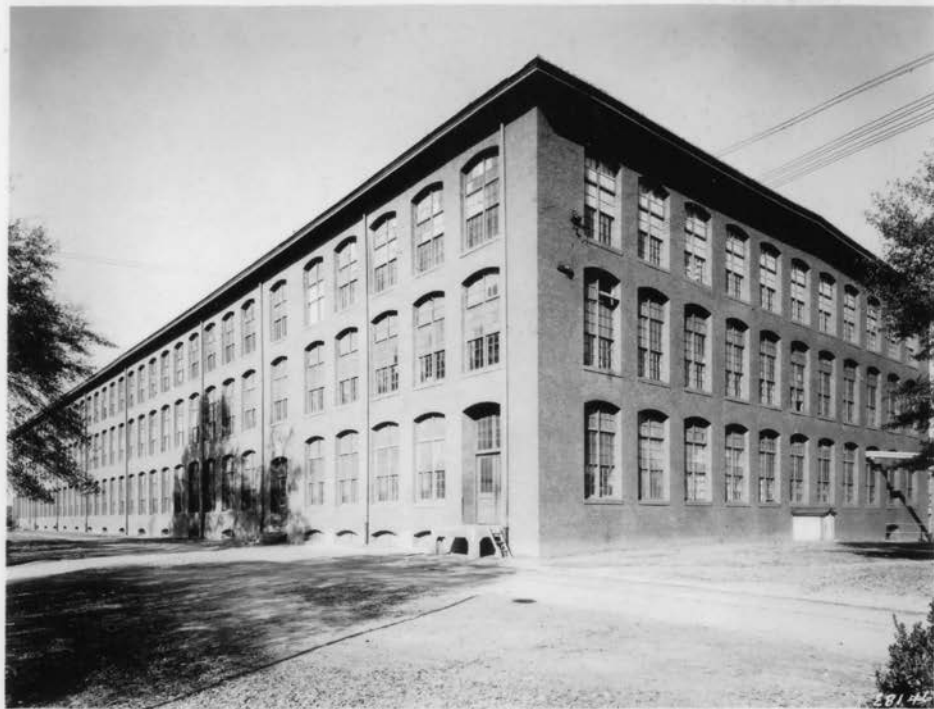
55. Drayton Mill
1802 Drayton Road, Spartanburg vicinity
Spartanburg County, South Carolina

SPINNING MILL.—IN ADDITION TO CARDBING AND SPINNING, THIS BUILDING
CONTAINS COTTON AND RAYON WARPING AND WINDING, SLASHING,
DRAWING-IN AND STORAGE FOR BEAMS, COLORED YARN, ETC.

Southeast oblique view of Main Mill building, ca. 1930

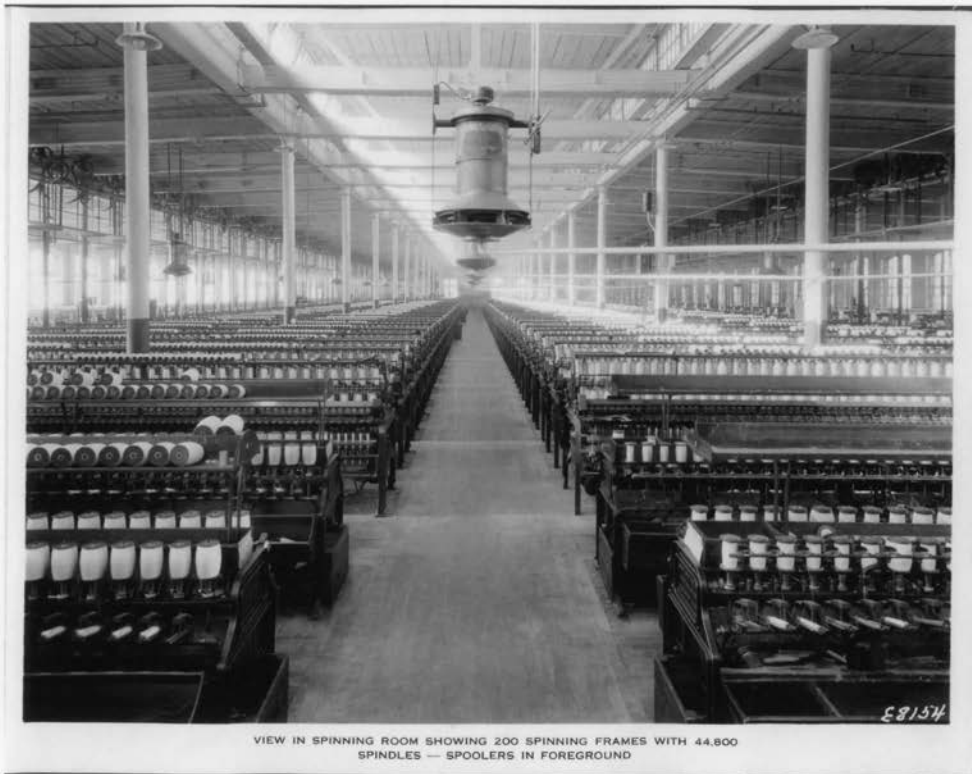
56. Drayton Mill
1802 Drayton Road, Spartanburg vicinity
Spartanburg County, South Carolina

VIEW IN SPINNING ROOM SHOWING 200 SPINNING FRAMES WITH 44,800
SPINDLES — SPOOLERS IN FOREGROUND

Ca. 1930 interior view of spinning mill, third (uppermost) floor with roof monitor visible

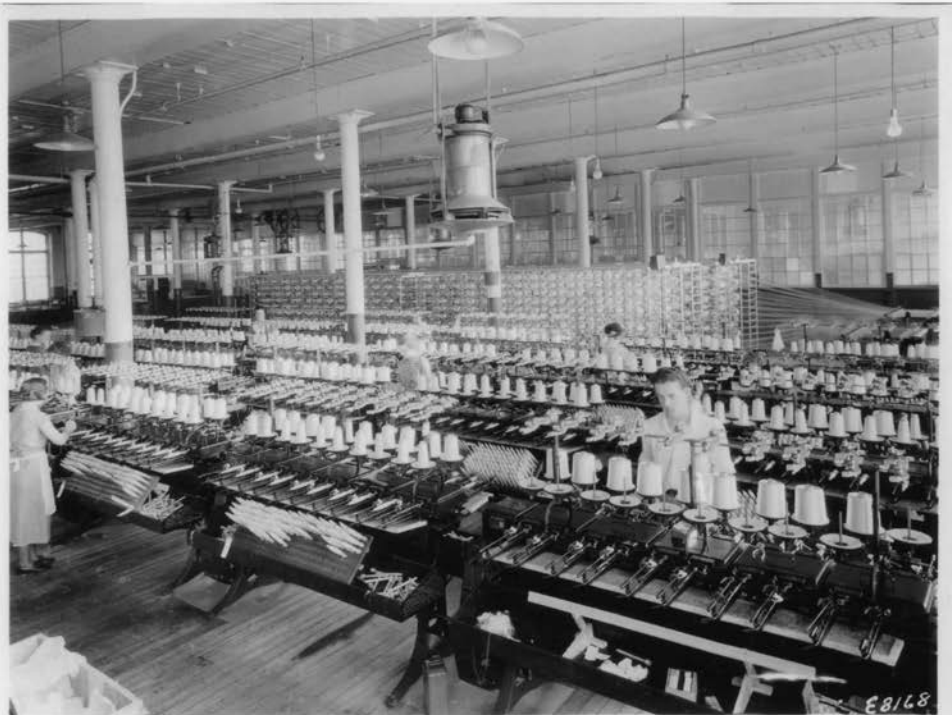
RAYON QUILLING — WARPERS IN REAR

Ca. 1930 interior view of Rayon Quilling and Warping Processes; window partition in background
