HISTORIC   Hollenburg Pony Express Station

Cottonwood Station (Hollenberg Ranch Pony Express Station),
    Hanover, Kansas, Landmark Inspection, June 21, 1977

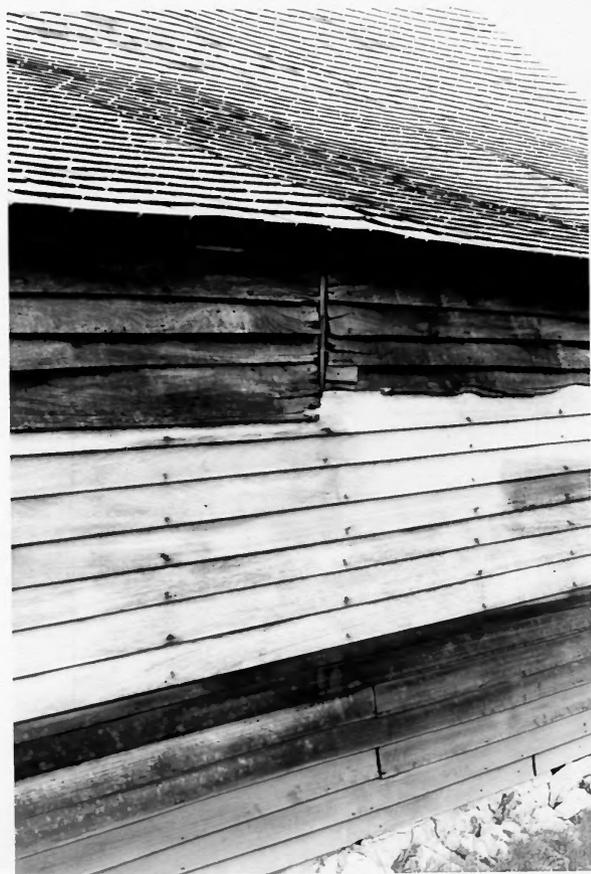
DESCRIBE VIEW. DIRECTION. ETC. IF DISTRICT. GIVE BUILDING NAME & STREET   PHOTO NO
      Facing east to rear of Pony Express Station.
