BERGEN COUNTY STONE HOUSE SURVEY

INDIVIDUAL STRUCTURE SURVEY FORM

HISTORIC NAME: Vanderbeck House

LOCATION: 69 Vanderbeck Ave~~nue~~ ~~(Block 84, Lot 17-35)~~

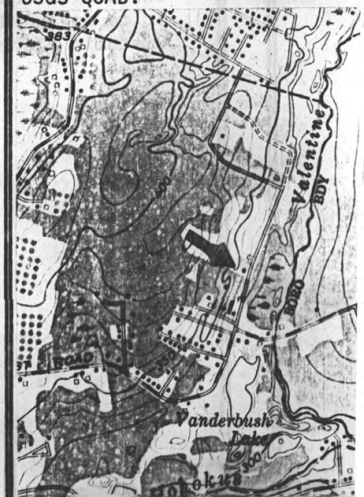
PHOTO

A second story has been added in the Victorian era. The fireplaces and most of the floorboards were removed, but the present owners are restoring it by adding new fireplaces, etc.

Although altered, the house appears to be early. The cellar walls have been cemented over, so early hatches, etc. are not discernable.
