**NATIONAL REGISTER OF HISTORIC PLACES
INVENTORY - NOMINATION FORM**

AND/OR HISTORIC:
HOYT FARM HOUSE, BETSEY BARNUM HOUSE

STREET AND NUMBER:
713 Bedford Street

3.0 Conditions Assessment

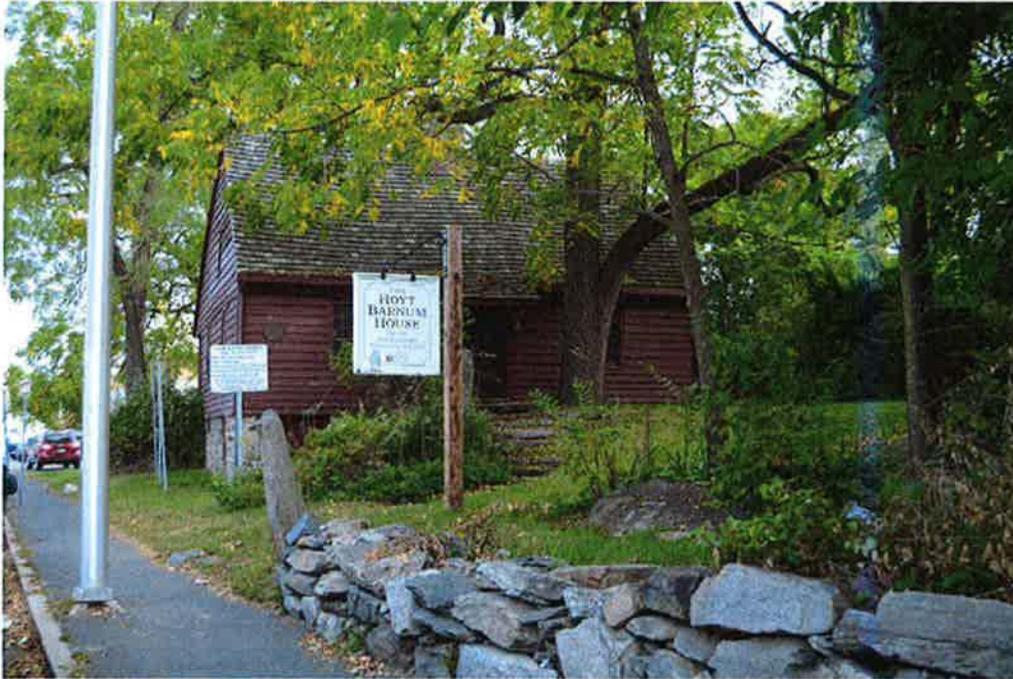
Photo 1. Hoyt-Barnum House, looking northeast from the Bedford Street sidewalk

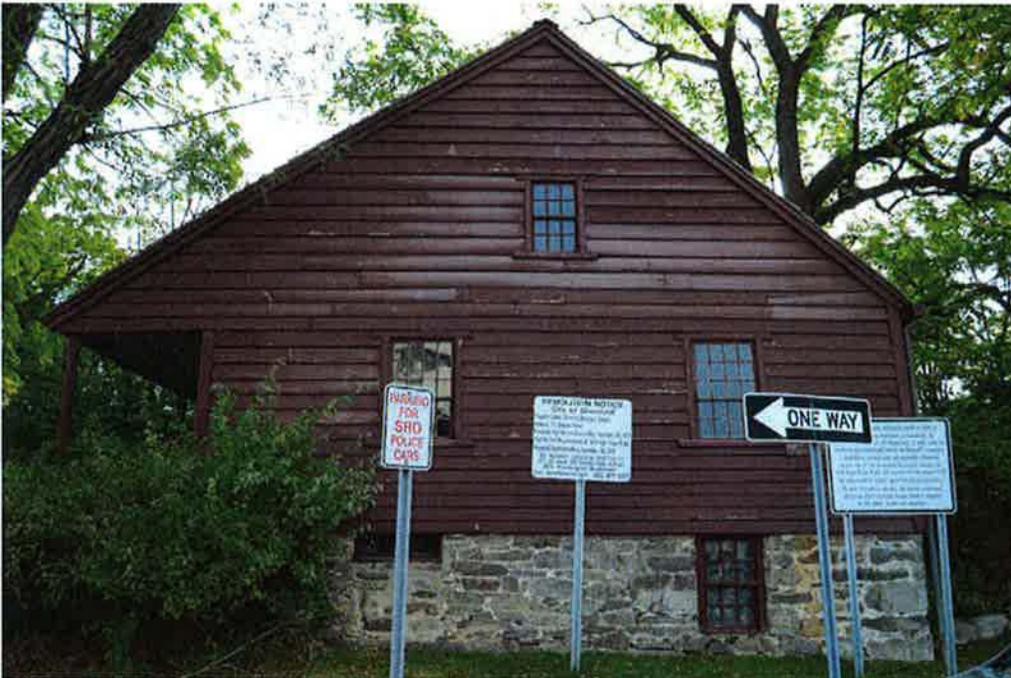
Photo 6. West elevation of the Hoyt-Barnum House, looking east from the Bedford Street sidewalk. The ghost marks for the former full-size window at the north side of the foundation are visible.

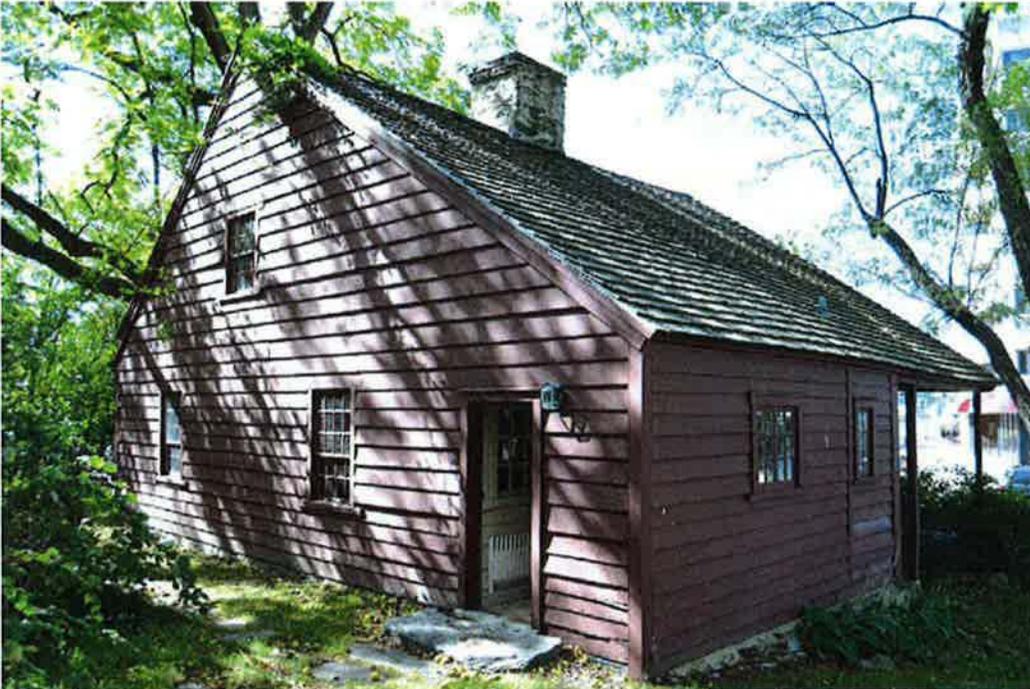
Photo 9. North and east elevations, looking southwest. The original exterior north wall clapboards and window are visible just within the doorway of the rear ell.

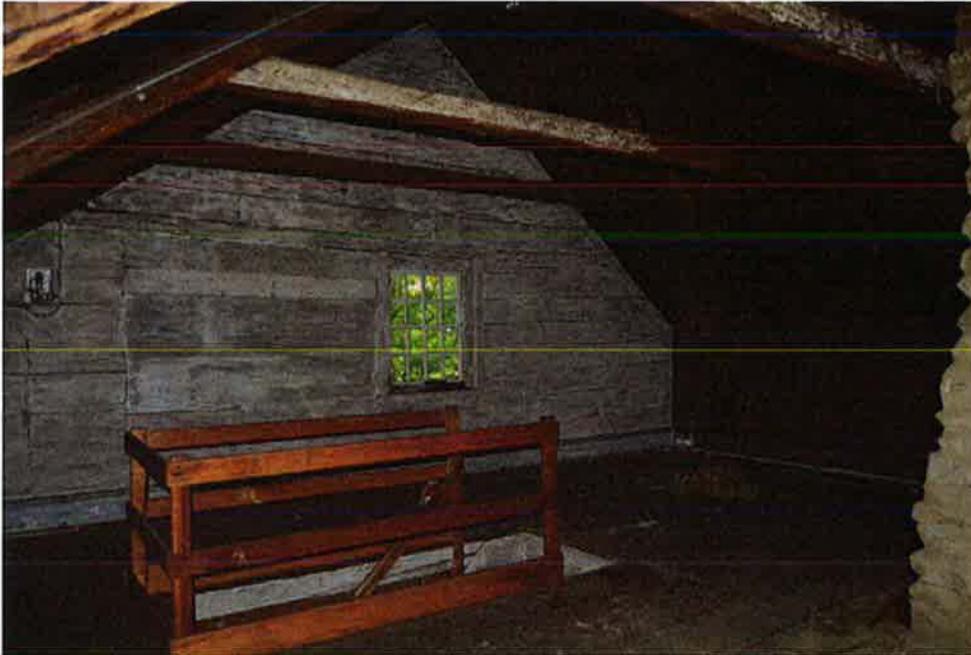
Photo 22. Attic looking southeast to the stairwell and east and south walls showing a corner of the chimney, roof framing, and floor boards. Ghost marks of a nineteenth-century window are visible north of the window, and twentieth-century knee wall cabinets are visible along the south wall.

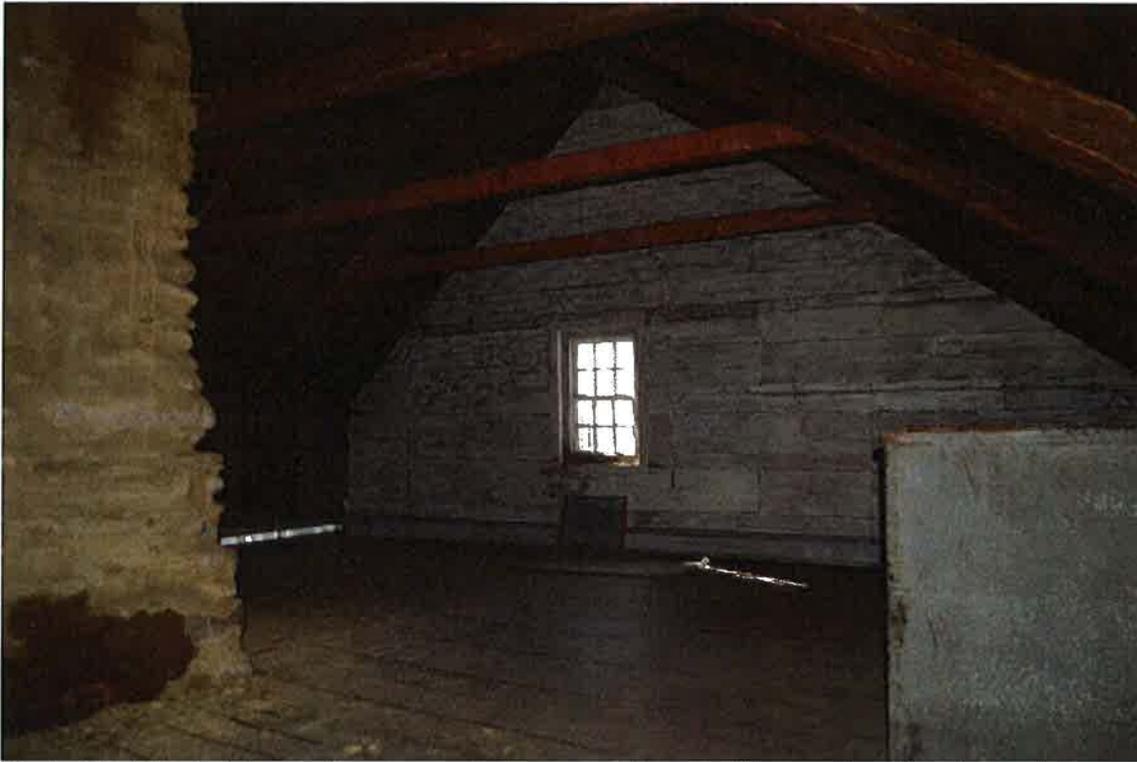
Photo 24. Attic looking southwest towards the west attic wall. Ghost marks of a nineteenth-century window are visible north of window, and the two collar beams to the west of the chimney are replacements.

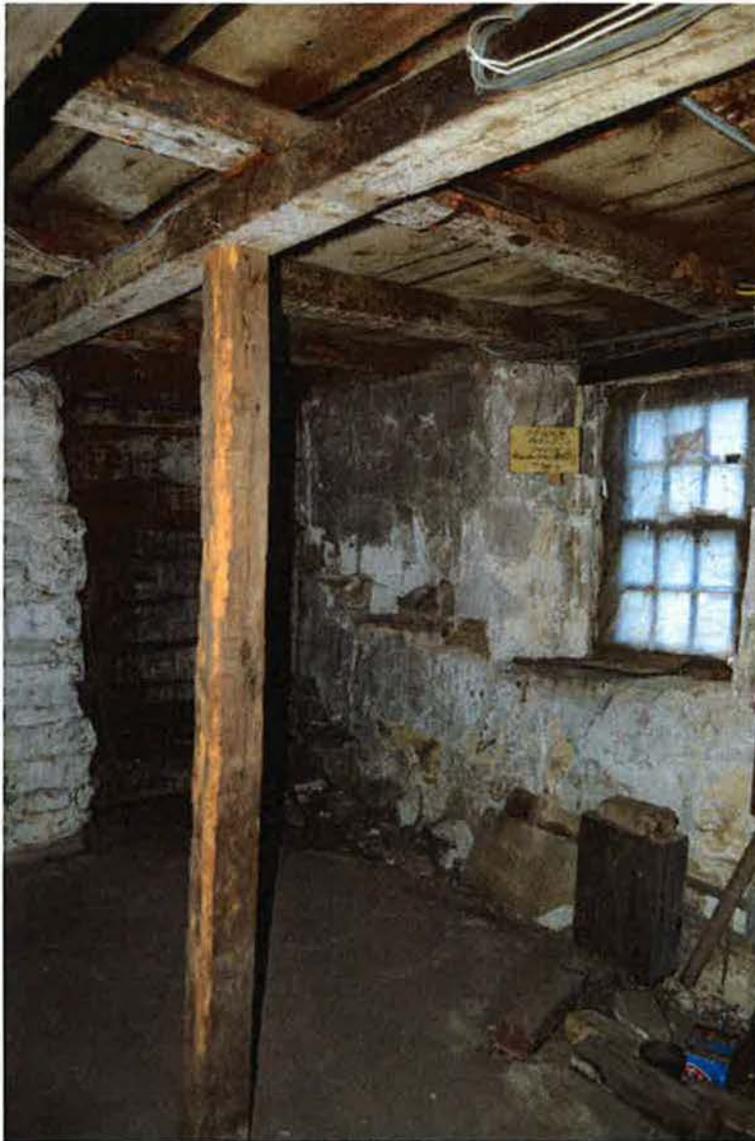
Photo 29. Cellar looking southwest from near the fireplace showing the south and west foundation walls. The original exterior door is visible on the left, and the original joists below the West Room still maintain bark.

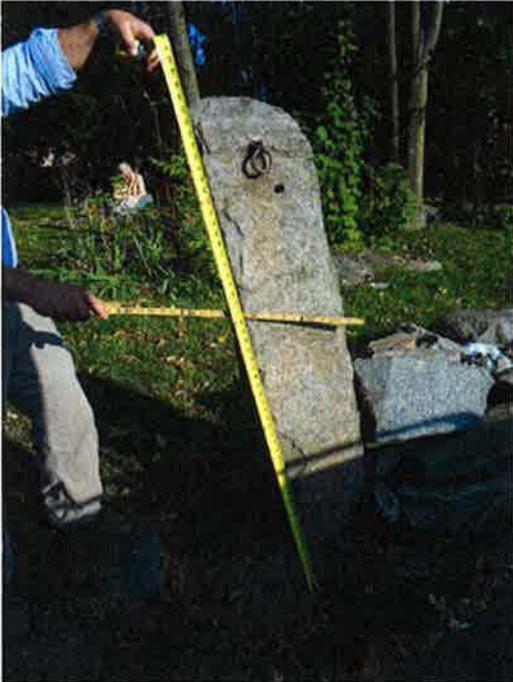
Photo 2 - Vertical Stone at entry path

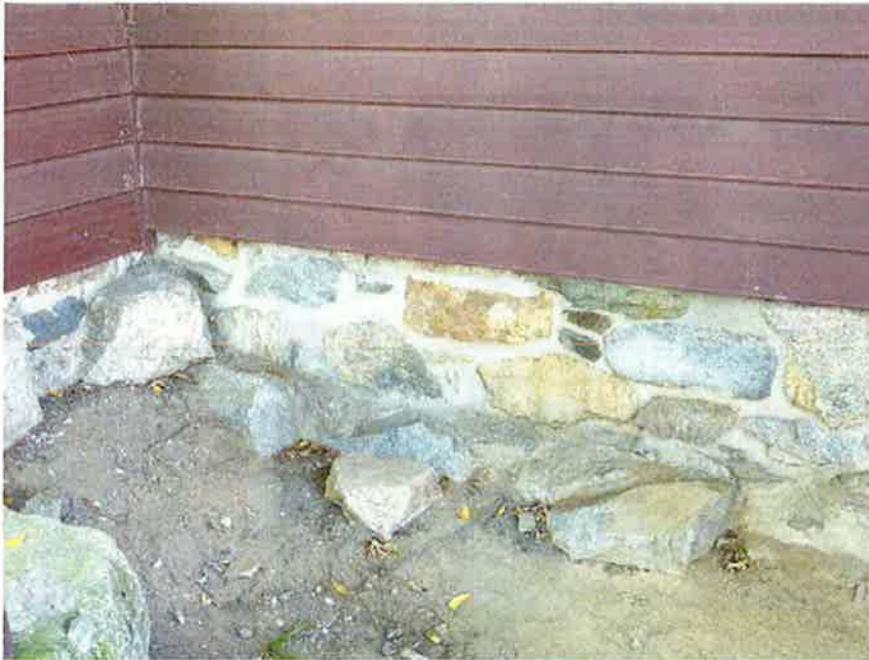
Photo 3 - Cement rich pointing mortar at Southeast corner of North elevation at removed porch

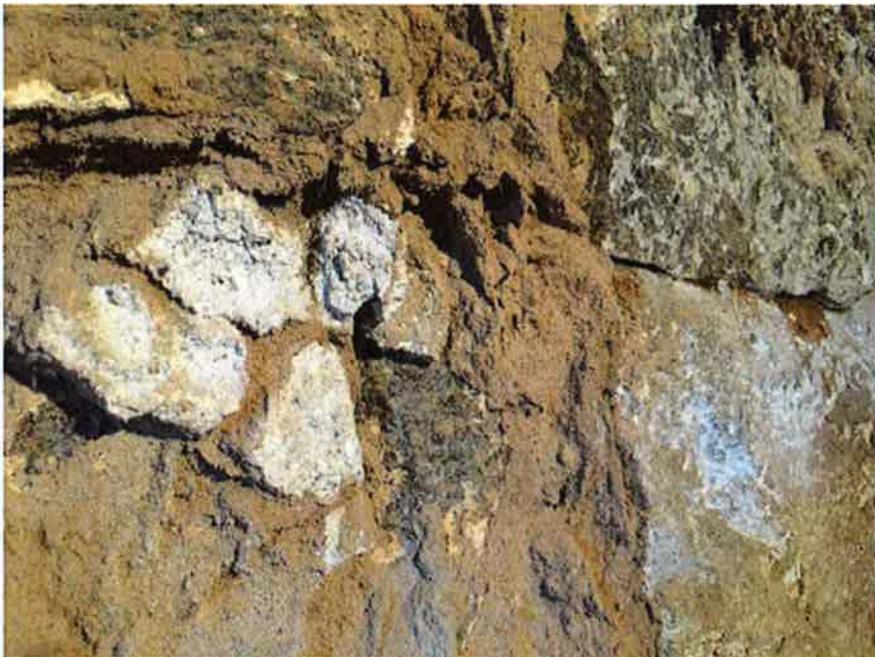
Photo 5 - Mortar displacement consistent with insect activity.

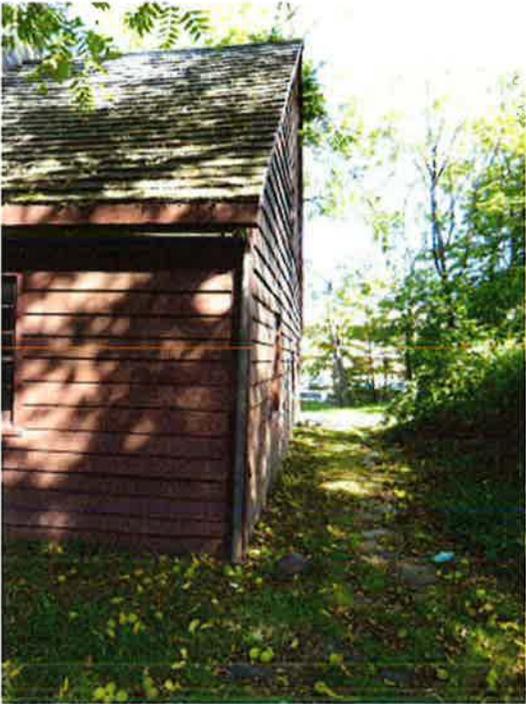
Photo 6 - South Elevation, east side, clapboard in contact with grade.

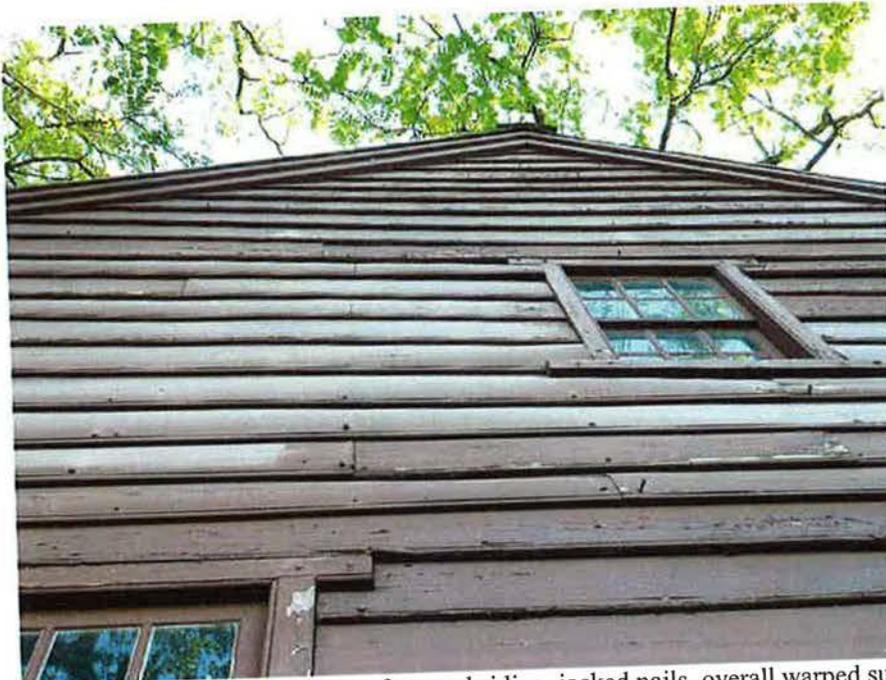
Photo 9 - West gable overview of cupped siding, jacked nails, overall warped surface.

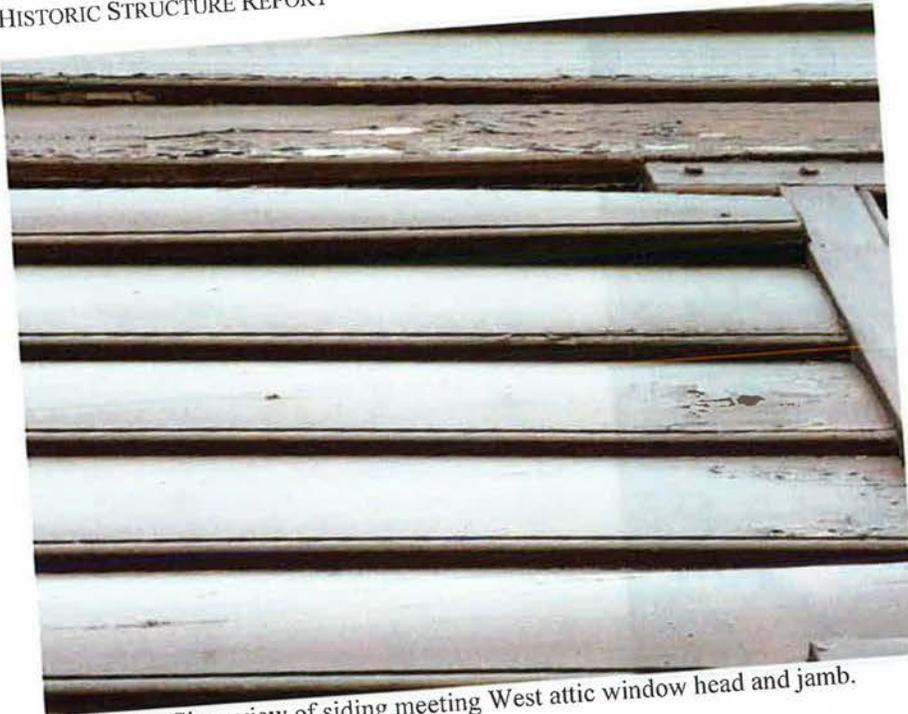
Photo 9a - Close view of siding meeting West attic window head and jamb.

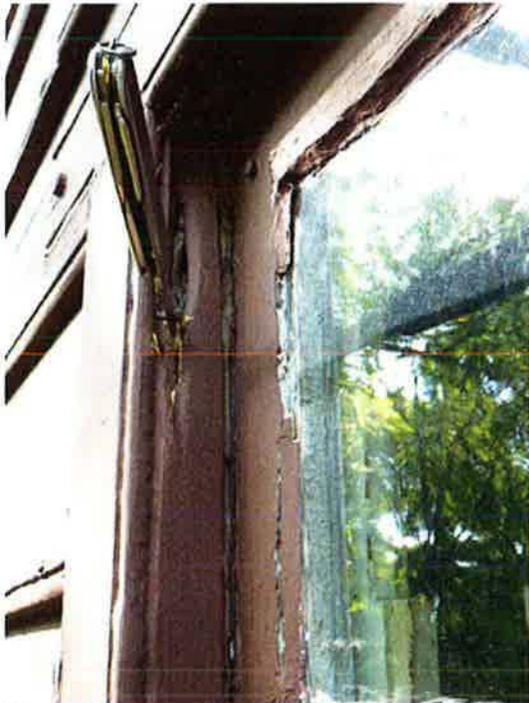
Photo 11 - Rotted jamb, East elevation, SE Room

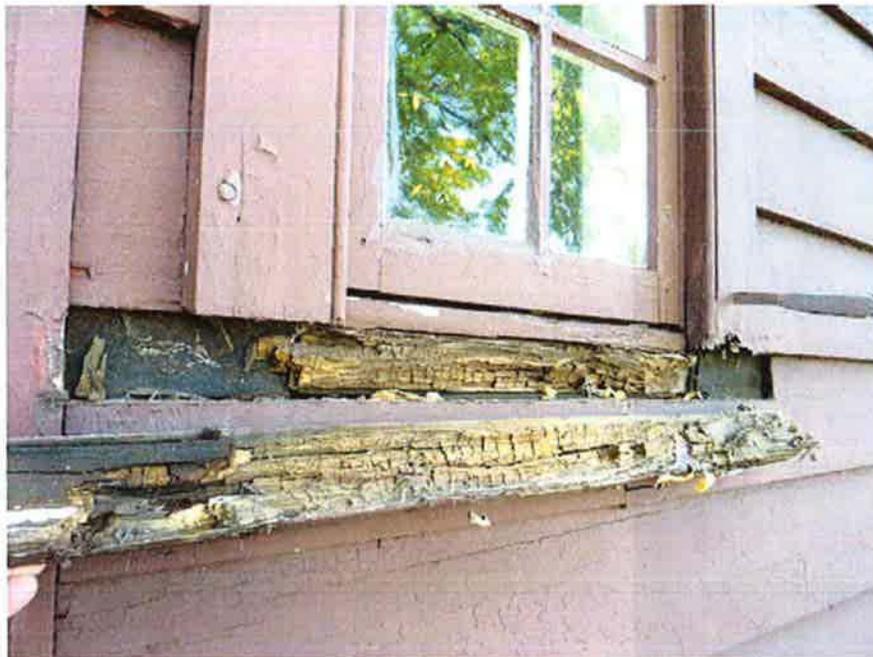
Photo 17a - Toilet window, exterior, rotted sill

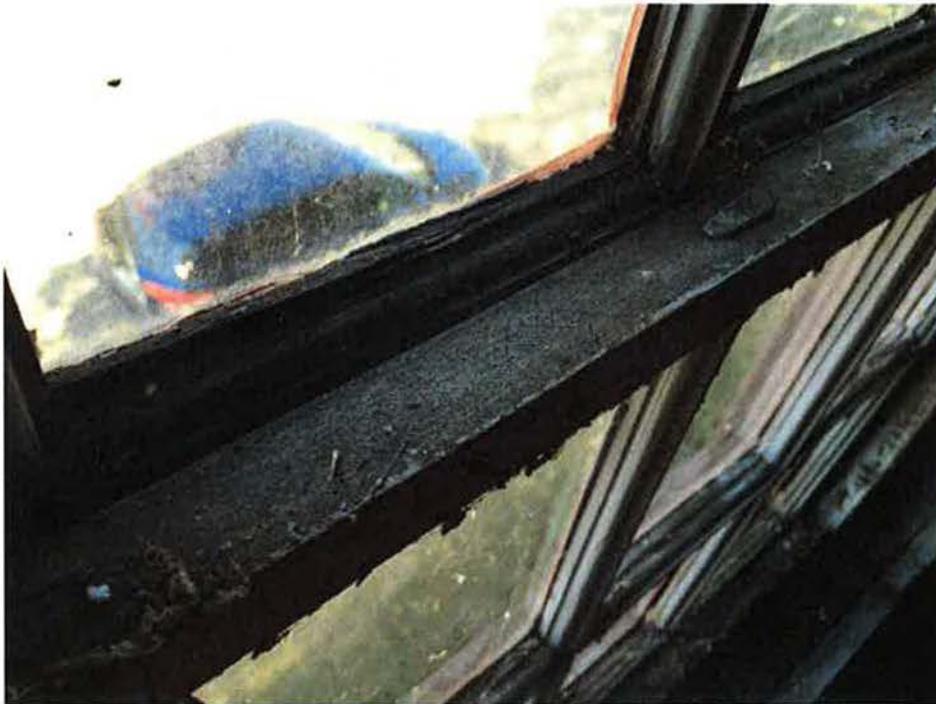
Type- 1a (Photo 19) varies in that the mullion tenons show a lozenge profile.

Photo 19 - Type 1a Window looking down on meeting rails

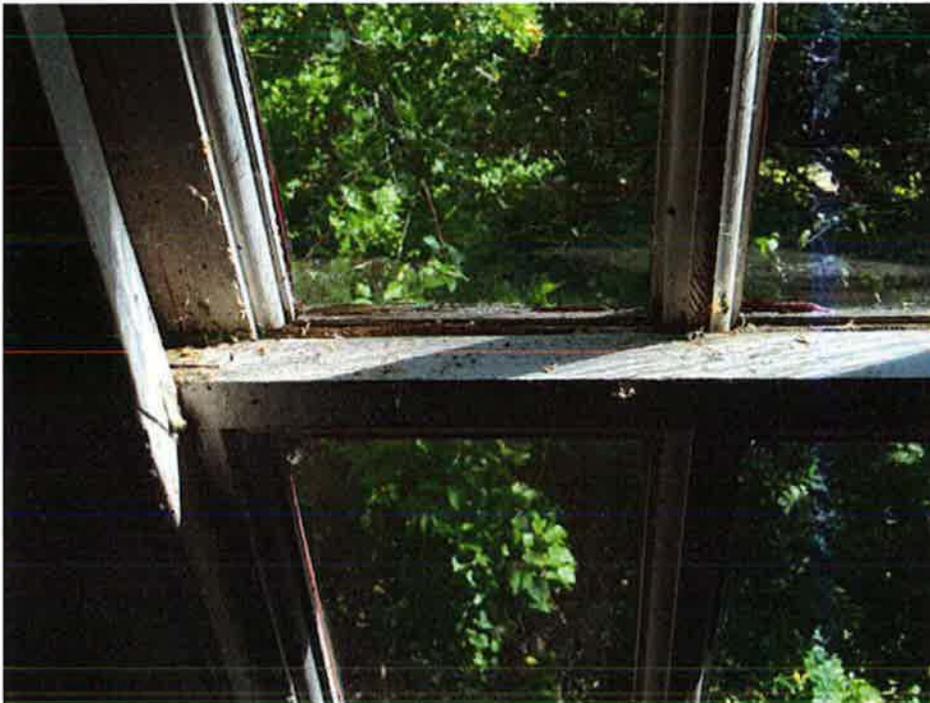
Type 1b (Photo 20) Varies in that the mullion tenons show a round profile

Photo 20 - Type 1b window looking down on meeting rails

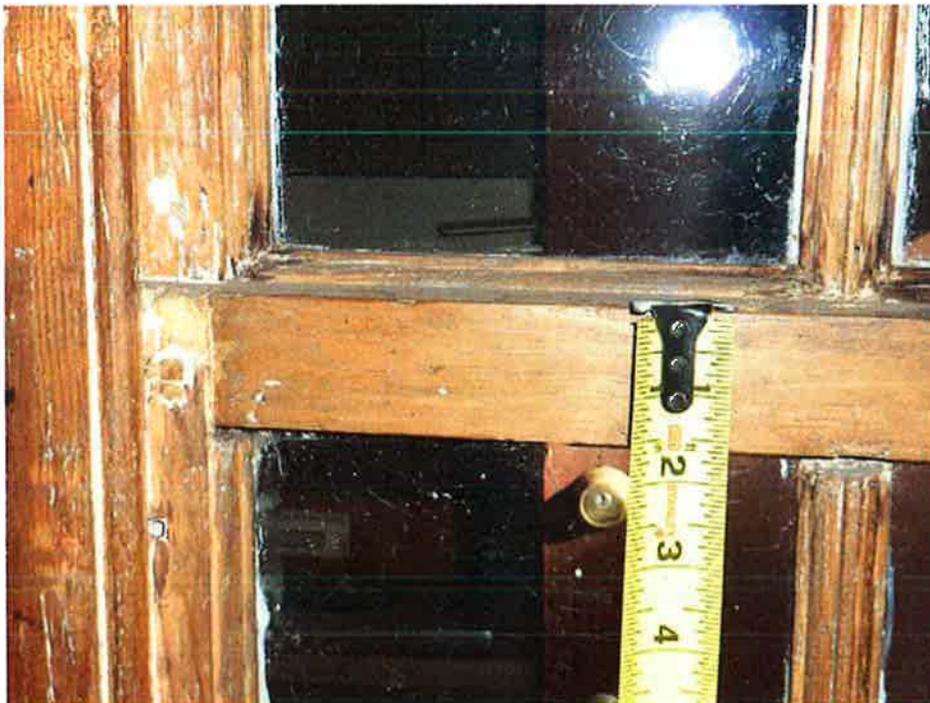
Type-2 (Photo 21)- are among the older sash and in the most distressed condition. Frames are approximately 1” thick, mullions are 3/4” wide. The vertical mullions are through mortised showing a 1/2” x 5/8” tenon. Tenons are secured with wooden pegs. Molding faces are beaded rather than flat.

Photo 21 - Type 2 Window looking at meeting rails

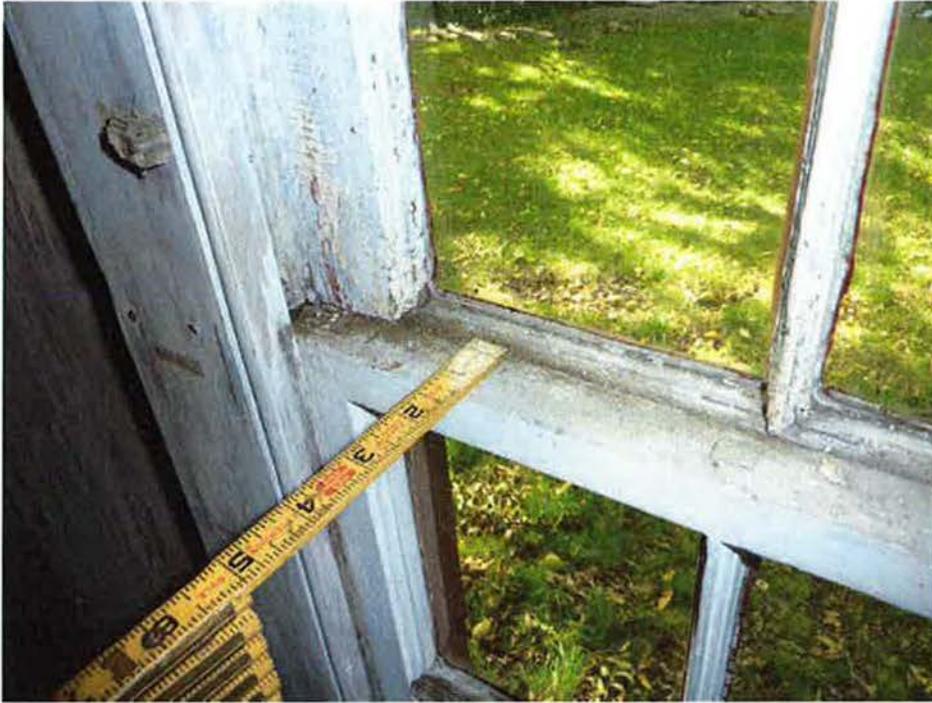
Type-3 (Photo 22) are older sash with narrower sections with ovolo rather than radiused profiles

Photo 22 - Type 3 Window looking down on meeting rails

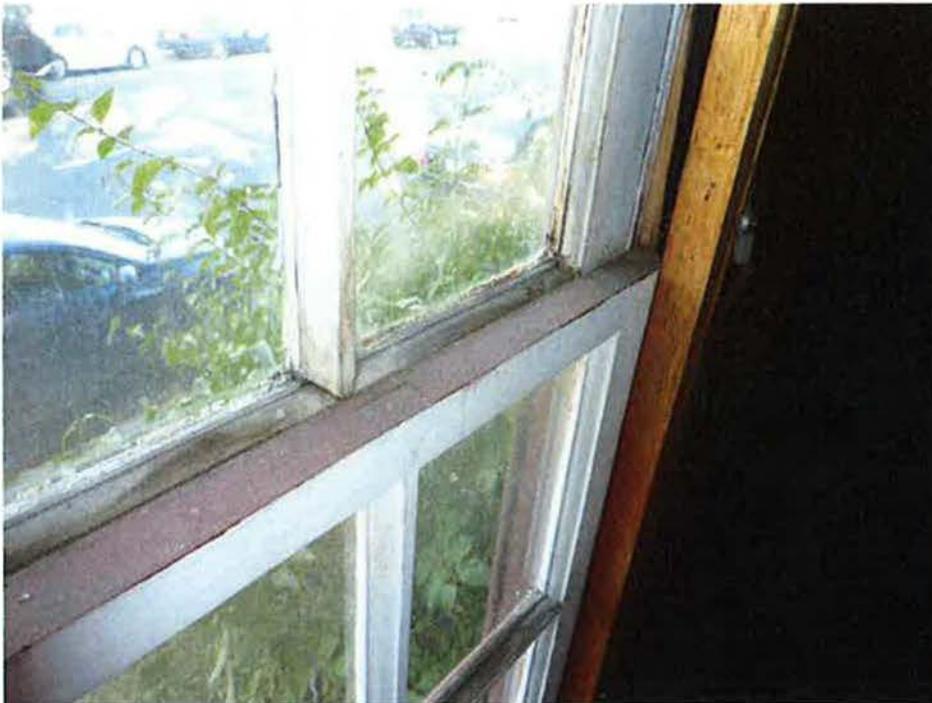
Type-4 (Photo 23) has chamfered molding, rectangular tenons.

Photo 23 - Type 4 Window looking down on meeting rails

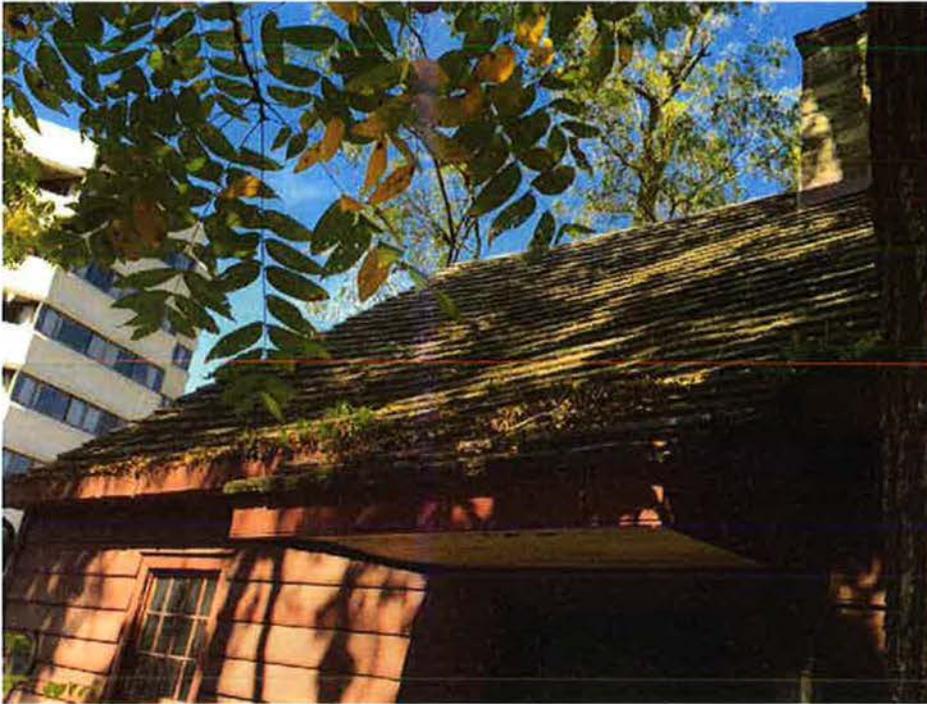
Three roof projections are found: (1) the typically minimal sloped soffit and fascia perpendicular to the slope projecting from the house approximately six inches; (Photo 24) (2) the extended shed added to shelter the front door, having a pronounced eave and board soffit; (3) the six foot overhang of the “porch,” whose eave-line relationship is consistent with the front of the house. The porch is open to the roof deck and framing. Visual inspection did not indicate leakage from ice dams, vermin infiltration, or insect habitation.

Gutters are used only on the south facing slope starting at- and pitching away from the shed over the entry. A copper half-round gutter connects to 3" copper elbows and leaders directly connected and discharging into presumed storm sewer lines at the east and west corner. There is no lower cleanout. The gutter is set into an open-top box-shaped construction finished to emulate a rough adze finish (Photo 29). The assembly is supported by square section spikes forged with a flat face retaining bar terminating in a scroll and fastened to the gutter face with a Phillips screw (Photo 30). The spike end is driven through the clapboard into the upper beam. The gutters were loaded to overhanging with debris at the time of this inspection.

Photo 24 - View of later entry shed and minimal overhang along balance of façade. Note debris accumulation in gutters.

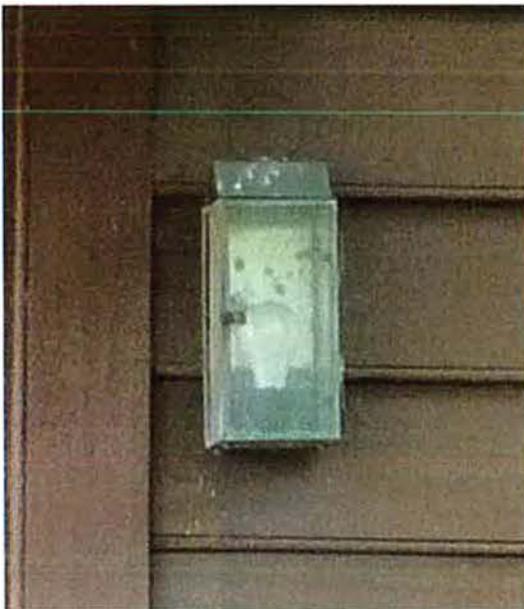
Two exterior light fixtures were noted, both electrified replicants of older lantern formats. The light adjacent to the main door (Photo 25) is a four inch by ten inch framed rectangular case made from folded brass with a folded metal top vent. All glass is intact; a lamp was installed but not tested. The kitchen entry light (Photo 26) is fabricated from sheet metal into a tapered case with a formed roof with finial, and punched and pierced ornament at the broad top face. All glass was intact, no lamp was installed. The patina of both fixtures suggests brass

Photo 25 - Electrified lantern replica, hinge side of main door

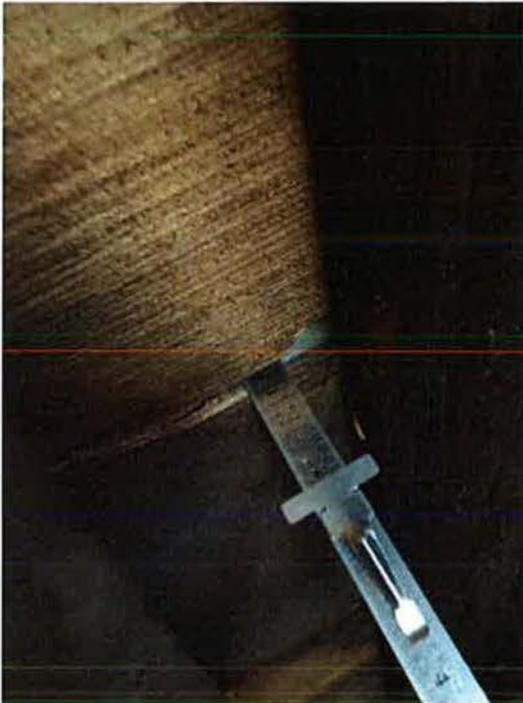
Viewed from the interior, older cedar shingles are visible through the gaps in the roof sheathing. Overlaying these shingles is an application of blue urethane foam board probed to be ¾" thick, likely one of a family of contemporary nail-base-roof-insulation panel products (Photo 28). To the credit of the installer, random fasteners were not evident penetrating the sheathing.

Photo 28 - Penetration into visible urethane foam=3/4"

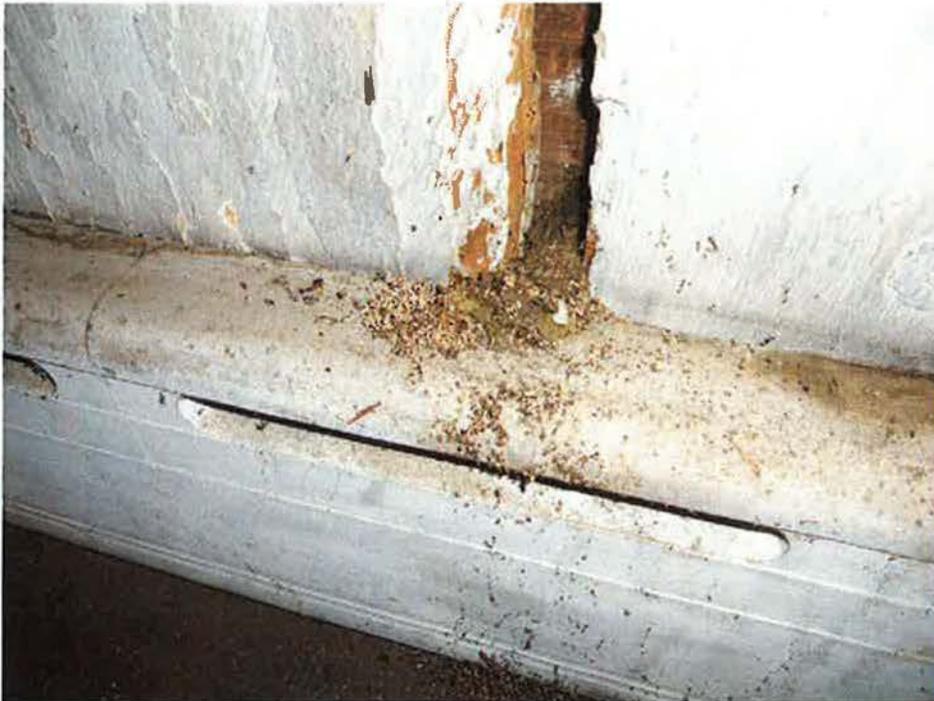
SOUTH EAST ROOM (Parent's Room)			
ELEMENT	COMPONENT	DESCRIPTION	CONDITION
<i>Floor</i>		Wide plank, closely spaced, N/S orientation	Good
<i>North Wall</i>		Random width, square edge, closely spaced vertical boards finished to resemble a lime wash	Good
	Window	None	
	Passage	Nominal 3" trim in conventional head-over jam arrangement.	Good
	Base	None	
	Features	Smoke detector located just above and to right of door opening. Thermostat located to right of door opening.	
<i>East Wall</i>		Random width, square edge, closely spaced vertical boards finished to resemble a lime wash	Good
	Window	Type 3	Poor
	Passage	None	
	Base	Cast iron baseboard radiation	
	Features	None	
<i>South Wall</i>		Random width, square edge, closely spaced vertical boards finished to resemble a lime wash. Of notable concern was the presence of wood particles consistent with carpenter ants below the window, sill on the radiator. (Photo 33)	Verify

Photo 33 - Wood detritus typically associated with carpenter ants
