# DATA SHEET

## NATIONAL REGISTER OF HISTORIC PLACES INVENTORY - NOMINATION FORM

COMMON:  
**Leesburg**

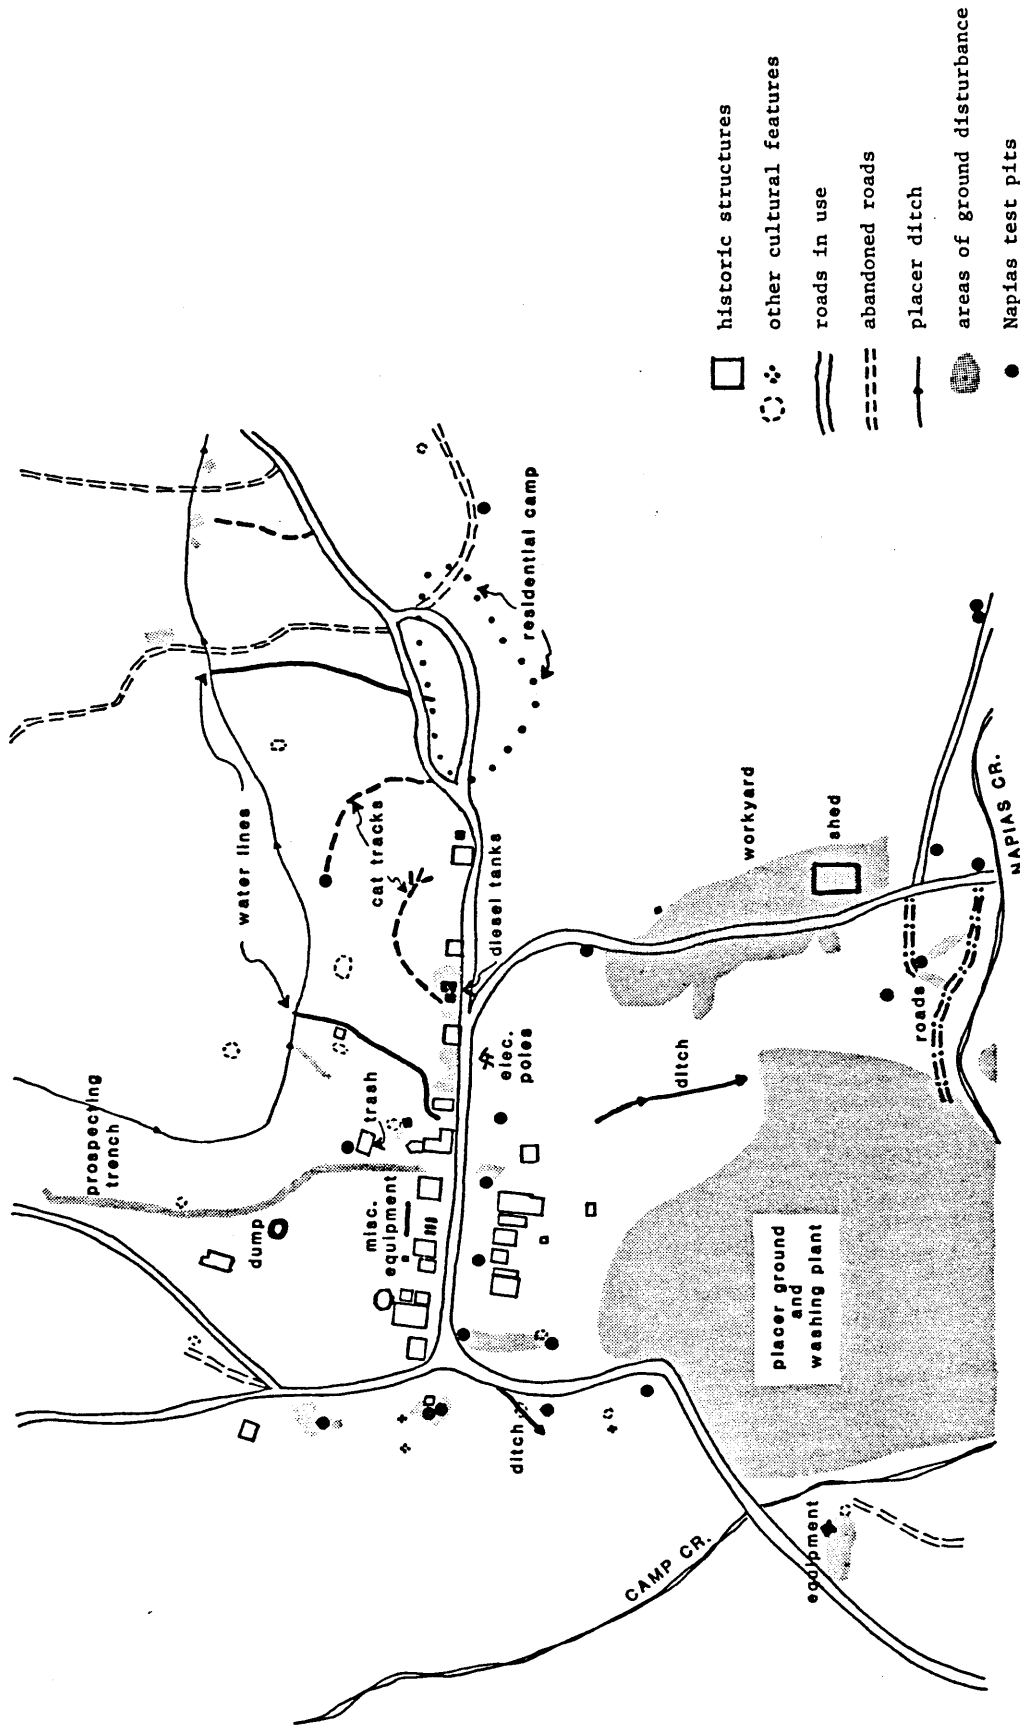
Since Napias Mining Company has begun work at Leesburg, they have initiated numerous ground-disturbing activities and have moved numerous pieces of large equipment to the townsite. Archeological survey preceded some but not all phases of the company's work. As per the 1980 operating plan, the company's placer pit excavation and settling pond construction created a large depression covering almost 10 acres. Archeological survey preceded approval of the operating plan (CRM-SL-63). No cultural resources were reported in the affected area. In 1981, Napias built a metal shed to house their equipment, again after archeological survey and clearance (CRM-SL-203). In fall 1981 or spring 1982, several ground-disturbing activities occurred prior to any archeological clearance. These include excavation of a long prospecting trench north of the townsite (Fig. 3), blading of a work yard north of the equipment shed, clearing of an area for two diesel tanks, excavation of a large hole to be used as a domestic dump, digging a ditch in front of Structure 15, and excavation of two outhouse pits and some test pits and trenches. Napias also set up a diesel-powered generator just east of Structure 15. Feature 32 was used as a dump fairly recently, perhaps by Napias employees.

Fig. 3. Napias Mining Company mining activity areas at the Leesburg townsite.

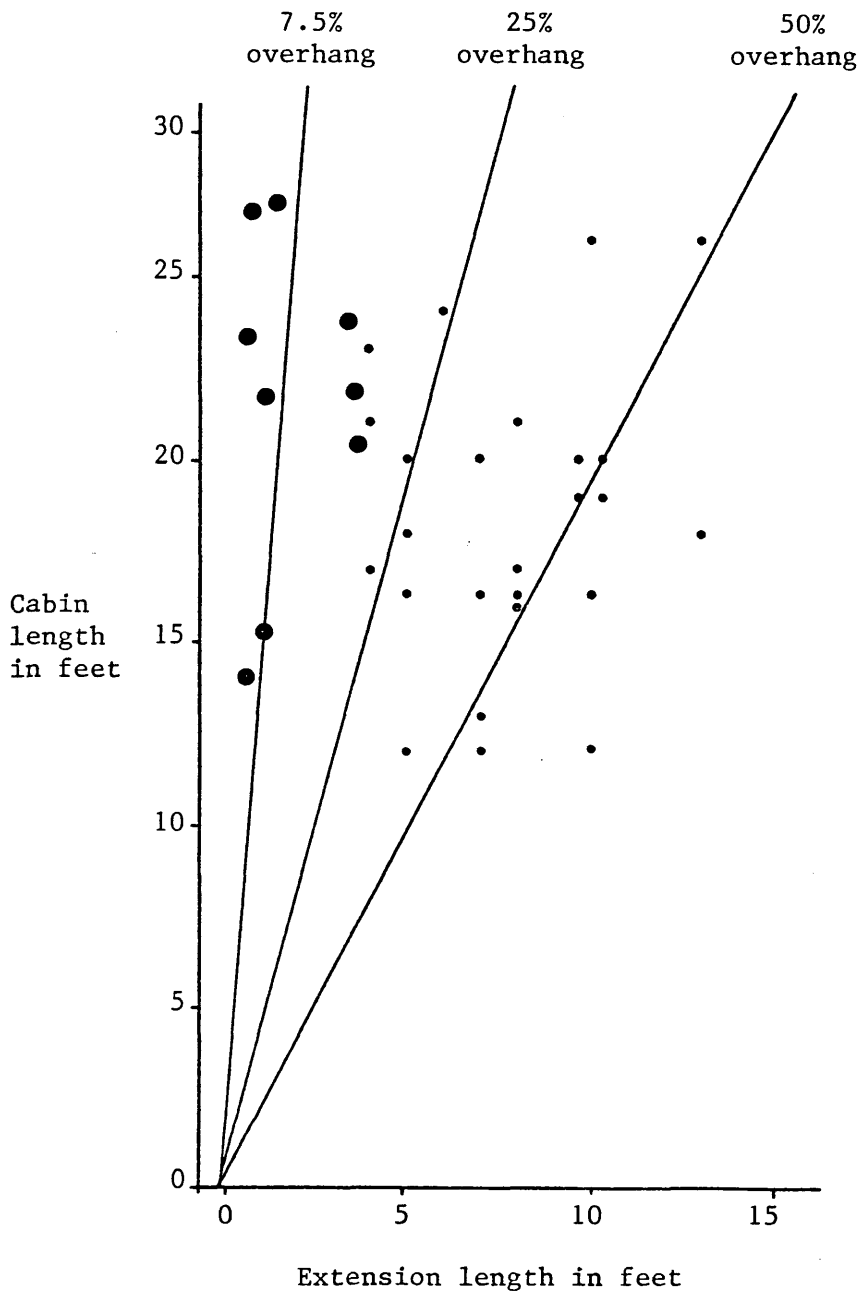
None of the nine structures at Leesburg for which adequate information is available fits the definition of a Rocky Mountain style cabin as reported by Wilson (1981:334). Like the Rocky Mountain Cabin, all Leesburg cabins do have front facing gables and many have a single, off-center door at a gable end. But where the front roof overhang at Rocky Mountain Cabins averages 50% of their lengths, at Leesburg the average is about 7.5% (Fig. 6). Also the roof slope for Rocky Mountain Cabins is generally less than 45° (less than 6:12), but four of the nine Leesburg structures have pitches of more than 45°.

Fig. 6. Comparison of Rocky Mountain Cabin style and Leesburg cabin roof overhang (after Wilson 1981:41). • represents cabins that Wilson found in the typical Rocky Mountain style while ● represents Leesburg cabins. Leesburg cabins have significantly less roof overhang.

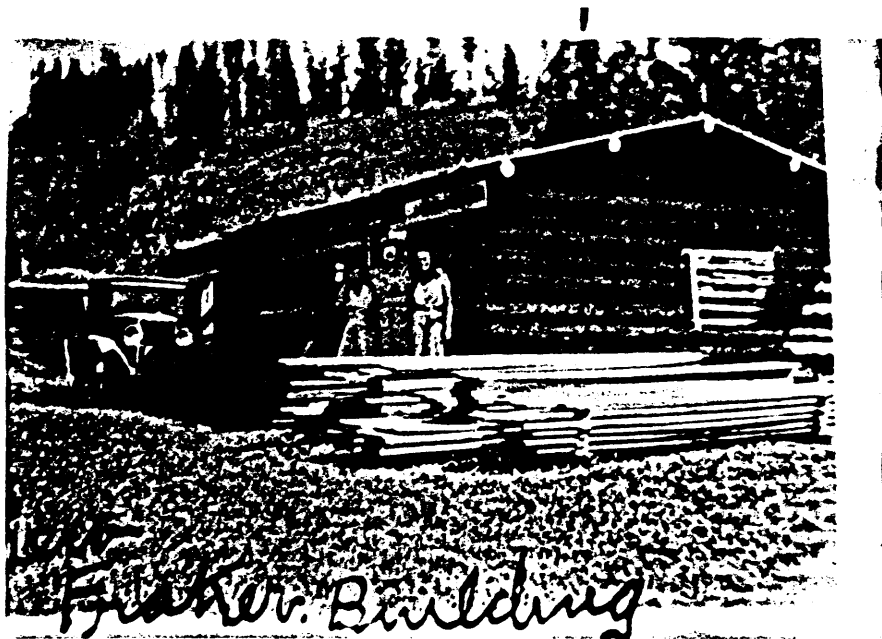
Feature 10 is a four room, saddle-notched log structure (Fig. 9). It was built in 1937 by Mike and Maude Fraker who used it as a boarding house and post office (Paul Fitzgerald and Marjorie Sims). The building is presently being used by the Napias Mining Company as a cookhouse and boarding house. Feature 10 is in good condition due both to its comparatively recent construction and to fairly continuous maintenance.

Fig. 9. Photograph of Feature 10 during construction in the mid-1930's.  
(Lemhi County Historical Museum, Salmon.)

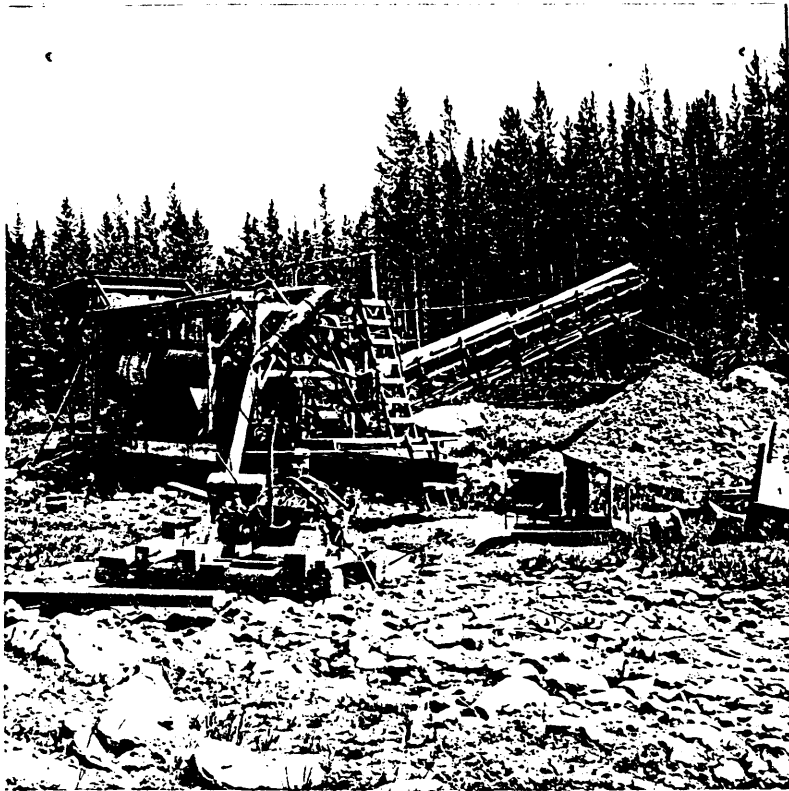
Feature 75 is the remains of a placer gold washing plant that dates to about 1955 (Fig. 14). Artifacts at the feature which is now covered with willows include the heavy, timbered foundation for the plant, a hopper, some parts of the conveyer, and some metal pipe and troughs. The operation was apparently short-lived because there are only a few piles of tailings at the feature.

Fig. 14. Historic photograph of the Feature 75 washing plant. (Minerals Office, Salmon National Forest Supervisor's Office, Salmon.)

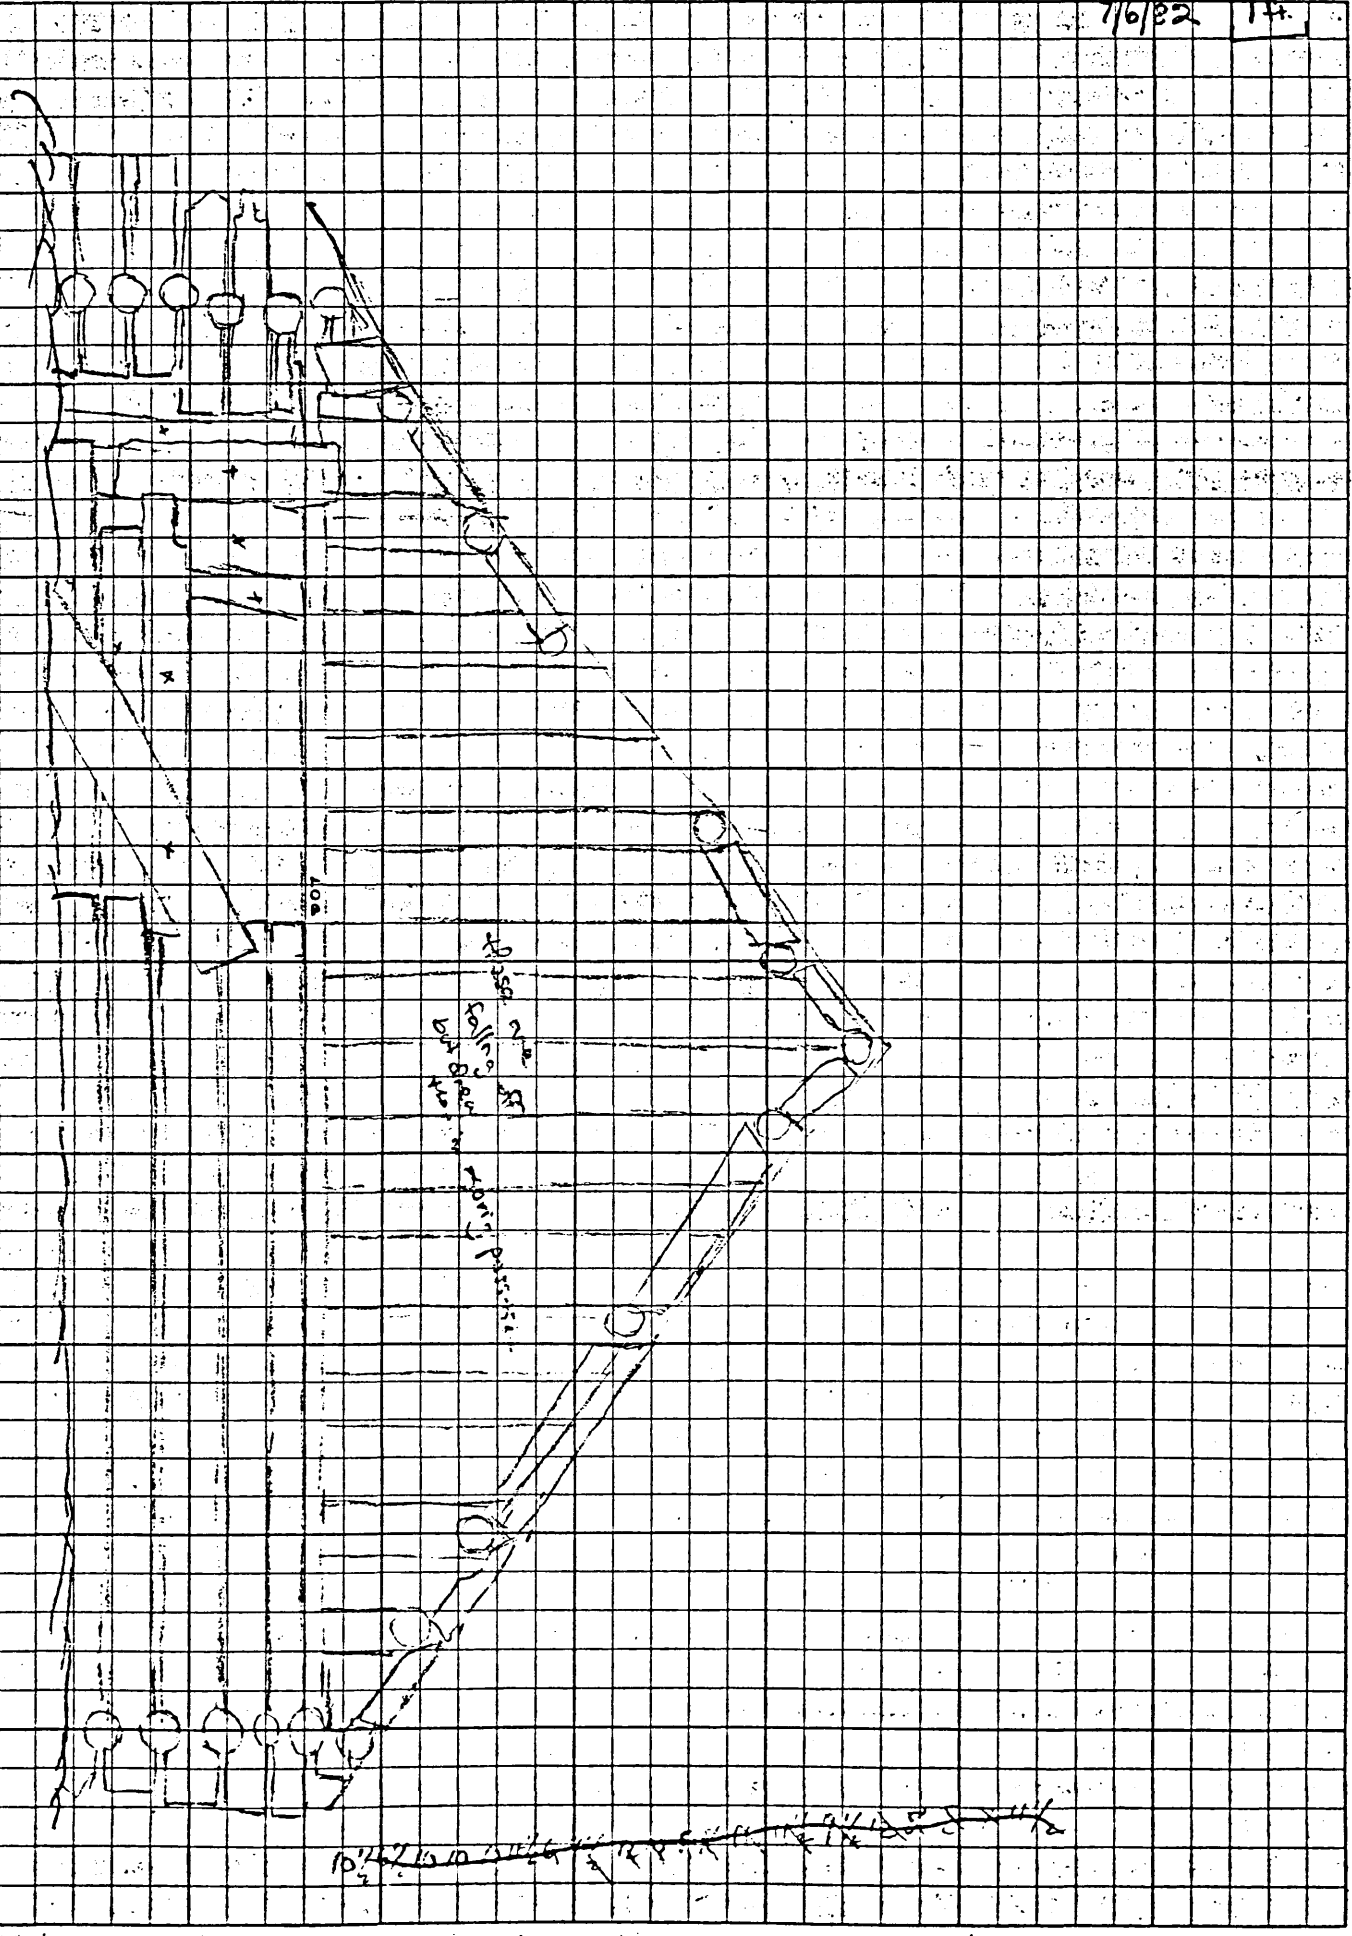
Structure 2  
profile of north wall

Feature 2 is a large, apparently two room, Lincoln-log-notched structure. It was first used as a saloon and later as a barn by Monte Colwell, a Leesburg stagedriver (Dick Shoup and Marjorie Sims). Derrold Slavin reports that the interior was once papered with an 1873 newspaper and so the building must be at least 110 years old. Feature 2 is in poor condition because the west wall and the roof have collapsed.

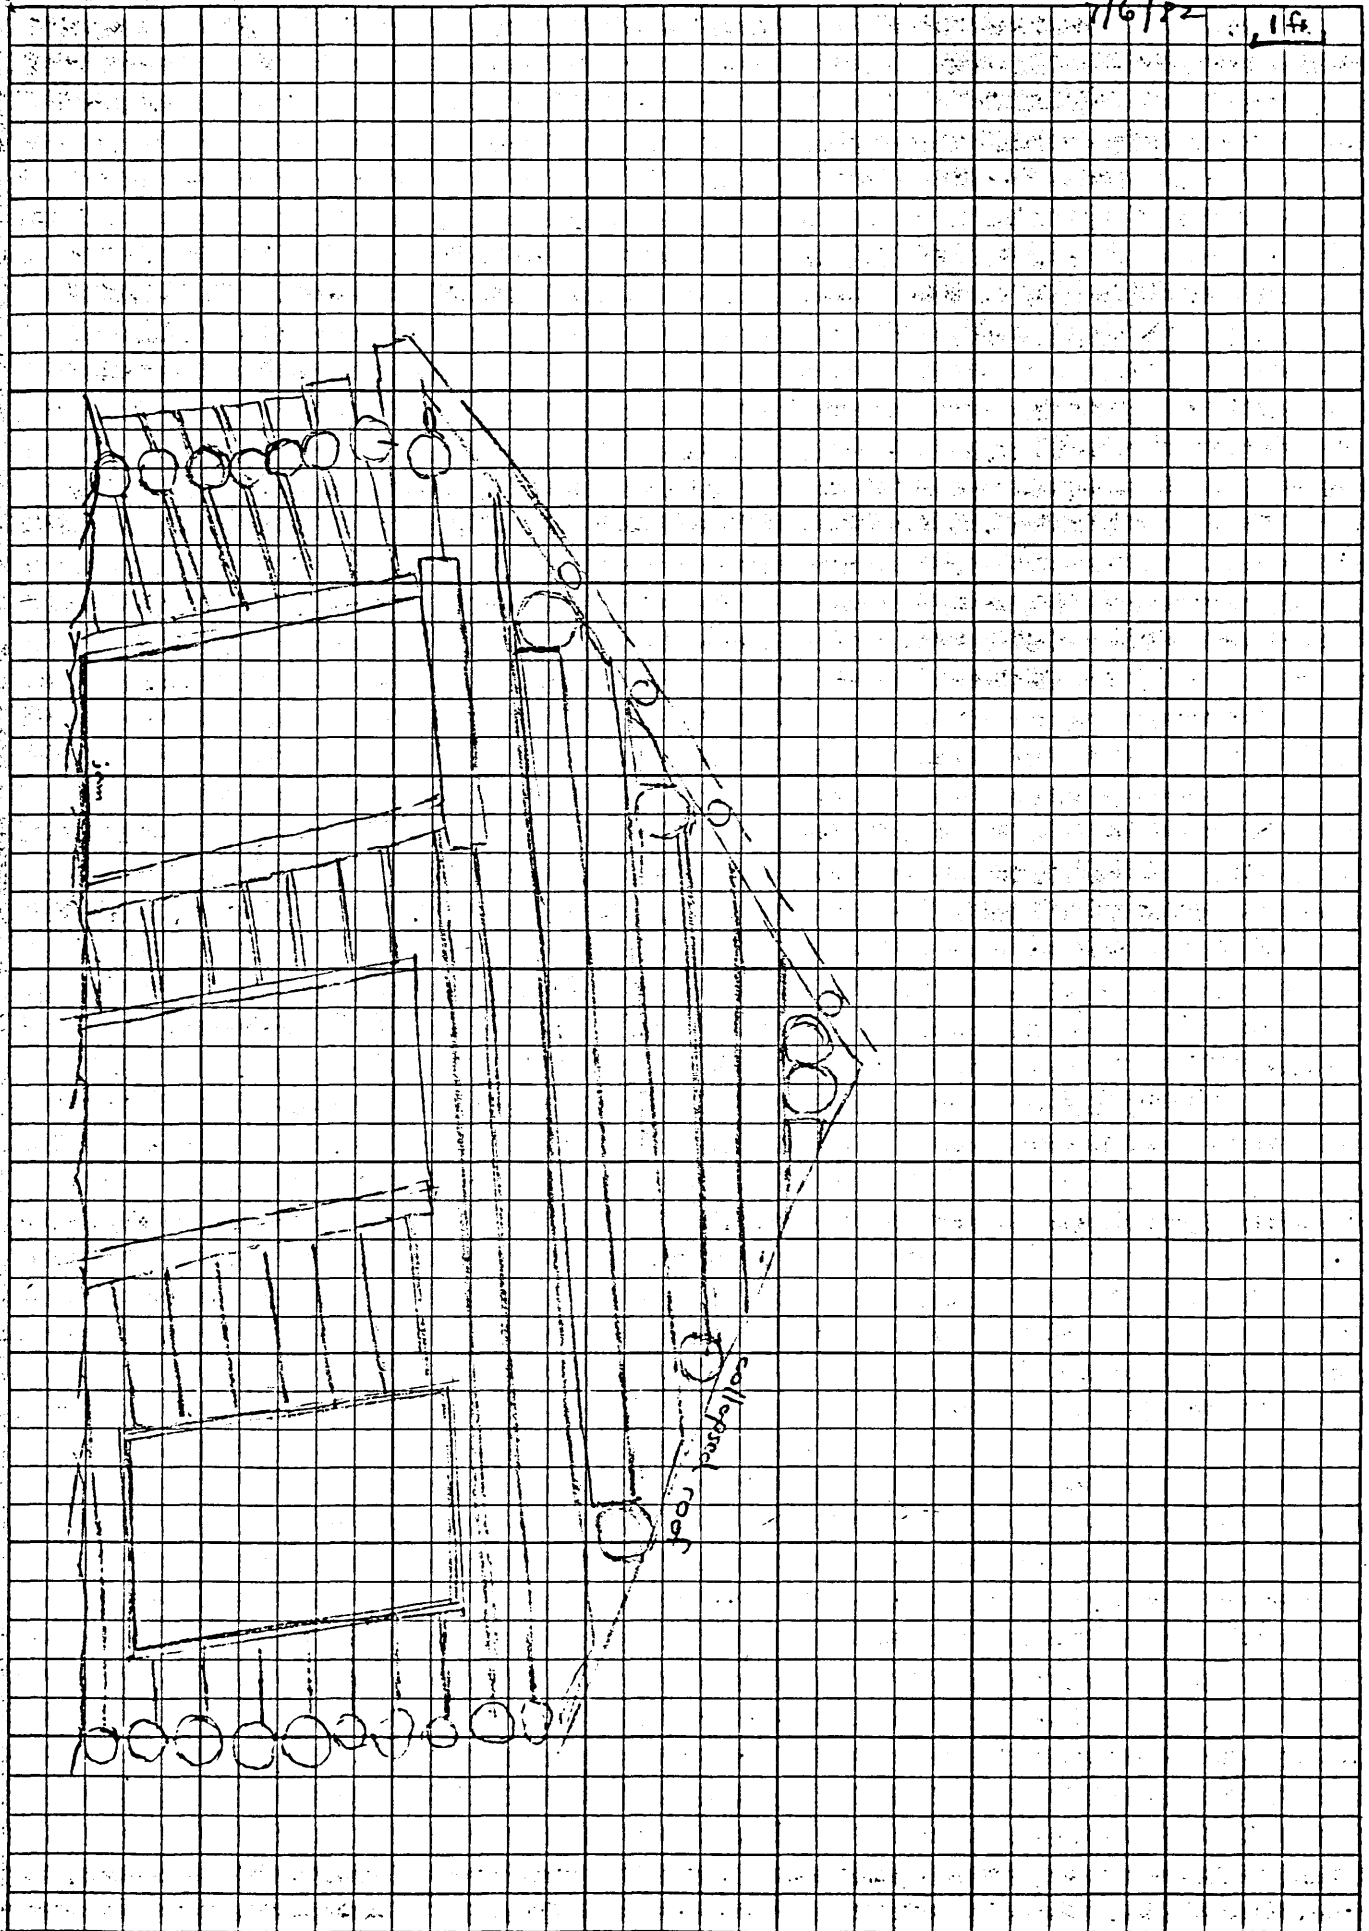
Structure 3  
profile of south wall  
1/6/22

Feature 3 is a single room, saddle-notched structure that was reportedly used by Monte Colwell as his office when he drove the stage from Salmon (Marjorie Sims). It was apparently constructed in the nineteenth century as the cut nails in the jams evidence. It is in fair condition; the west wall leans toward Feature 2 and the roof has collapsed.

Buildings in a poor state of repair or in ruins would not be repaired under the proposed stabilization program. Those buildings needing minor repairs to the walls or a new roof would have priority in the program. The buildings that would most benefit from a stabilization program are Feature 3 (roof), Feature 9 (roof and foundation along the north side),

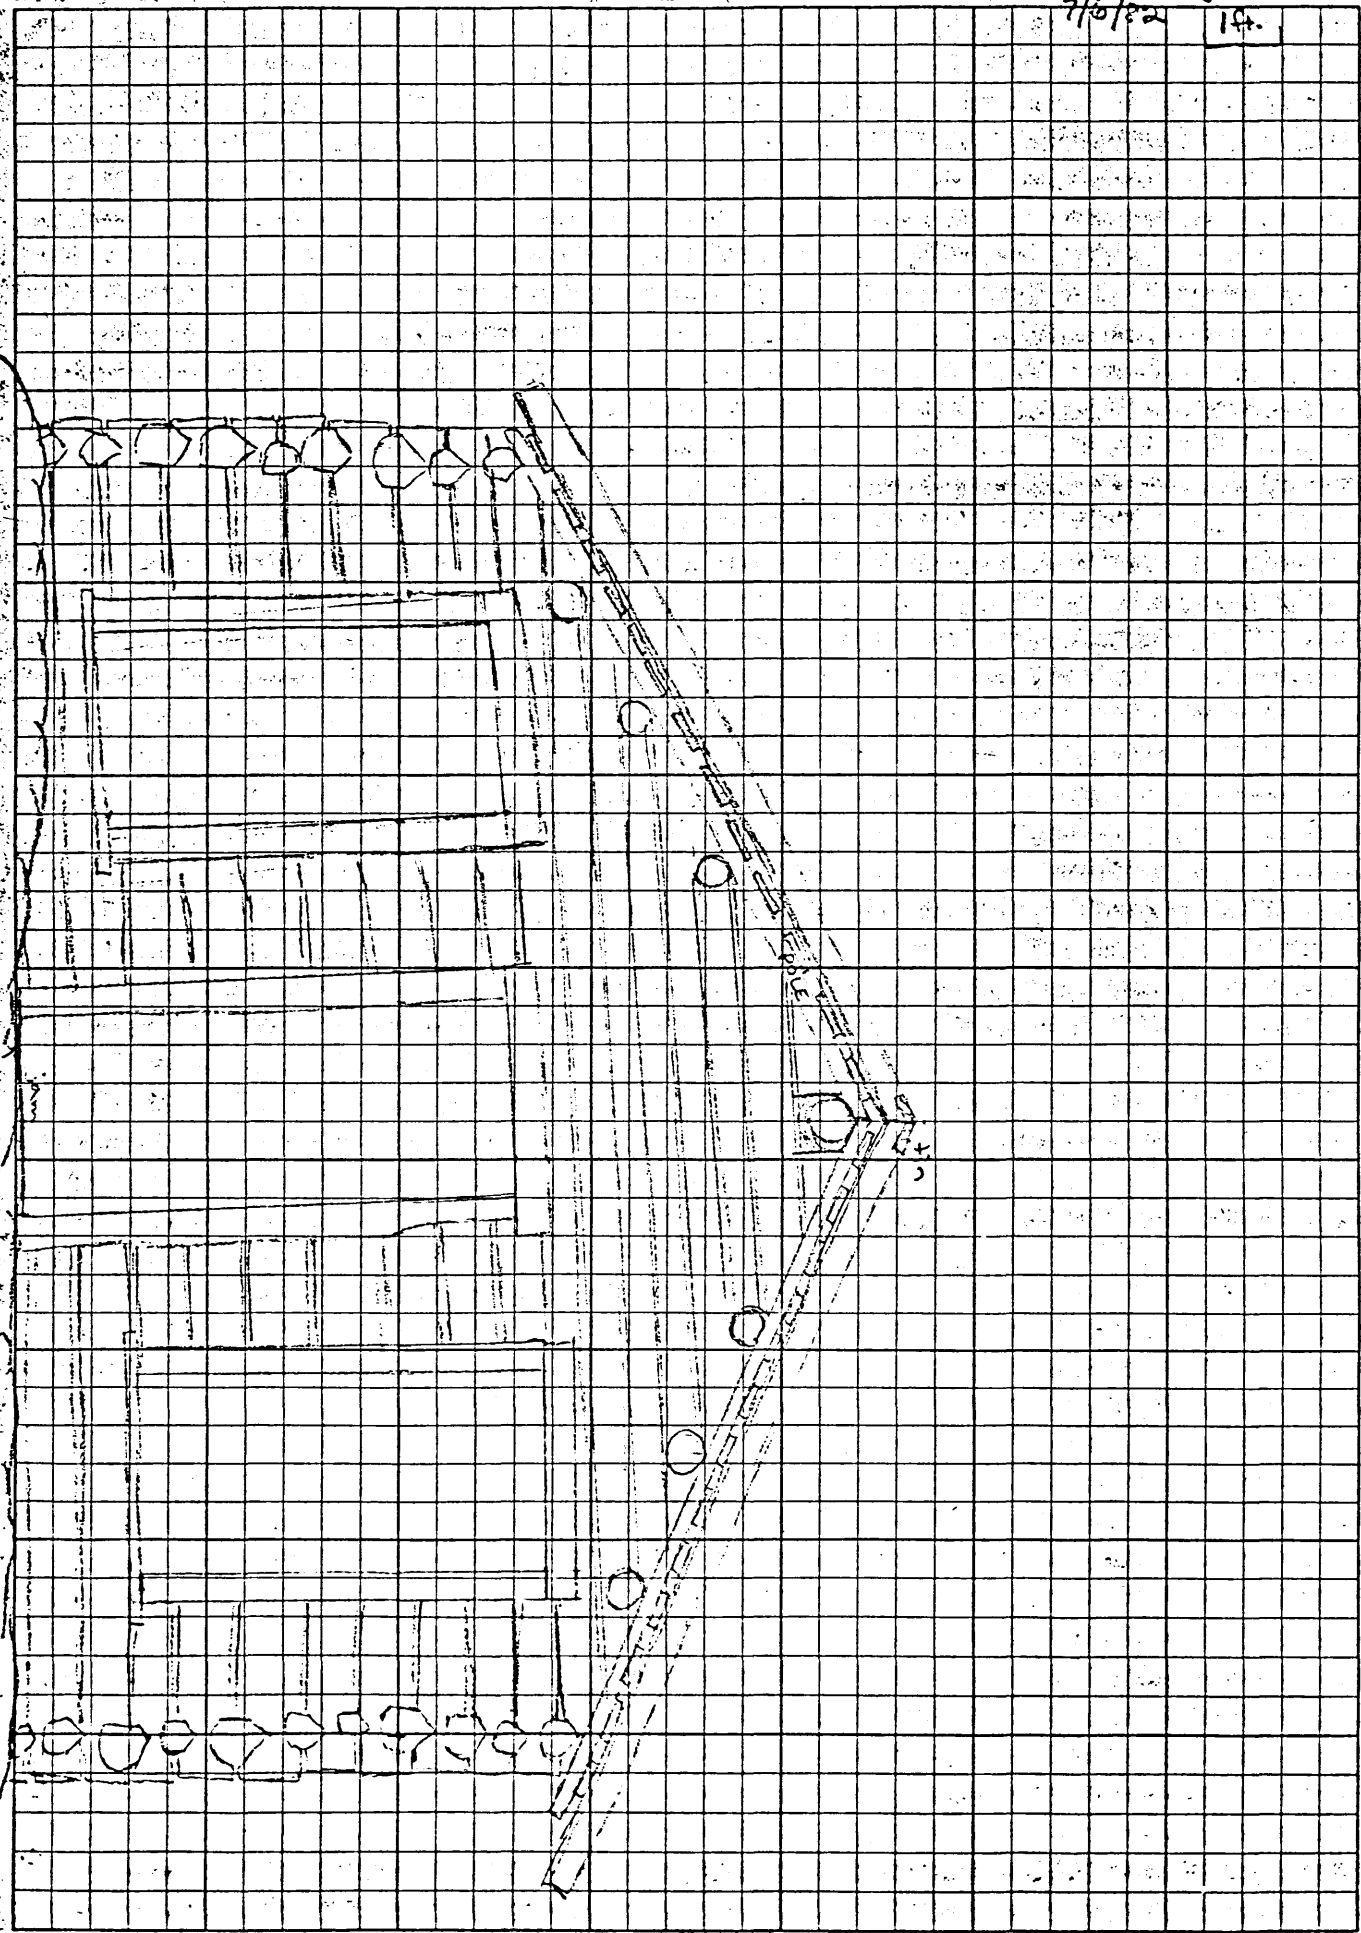
Structure 1  
profile of Swall  
7/6/82 1ft.

Feature 1 is a one room, saddle-notched log building and lean-to. During the 1930's, it served as a residence (Dick Shoup and Paul Fitzgerald). The use of wire nails throughout the structure suggests a construction date of the 1890's or later. Feature 1 is in fairly good condition.

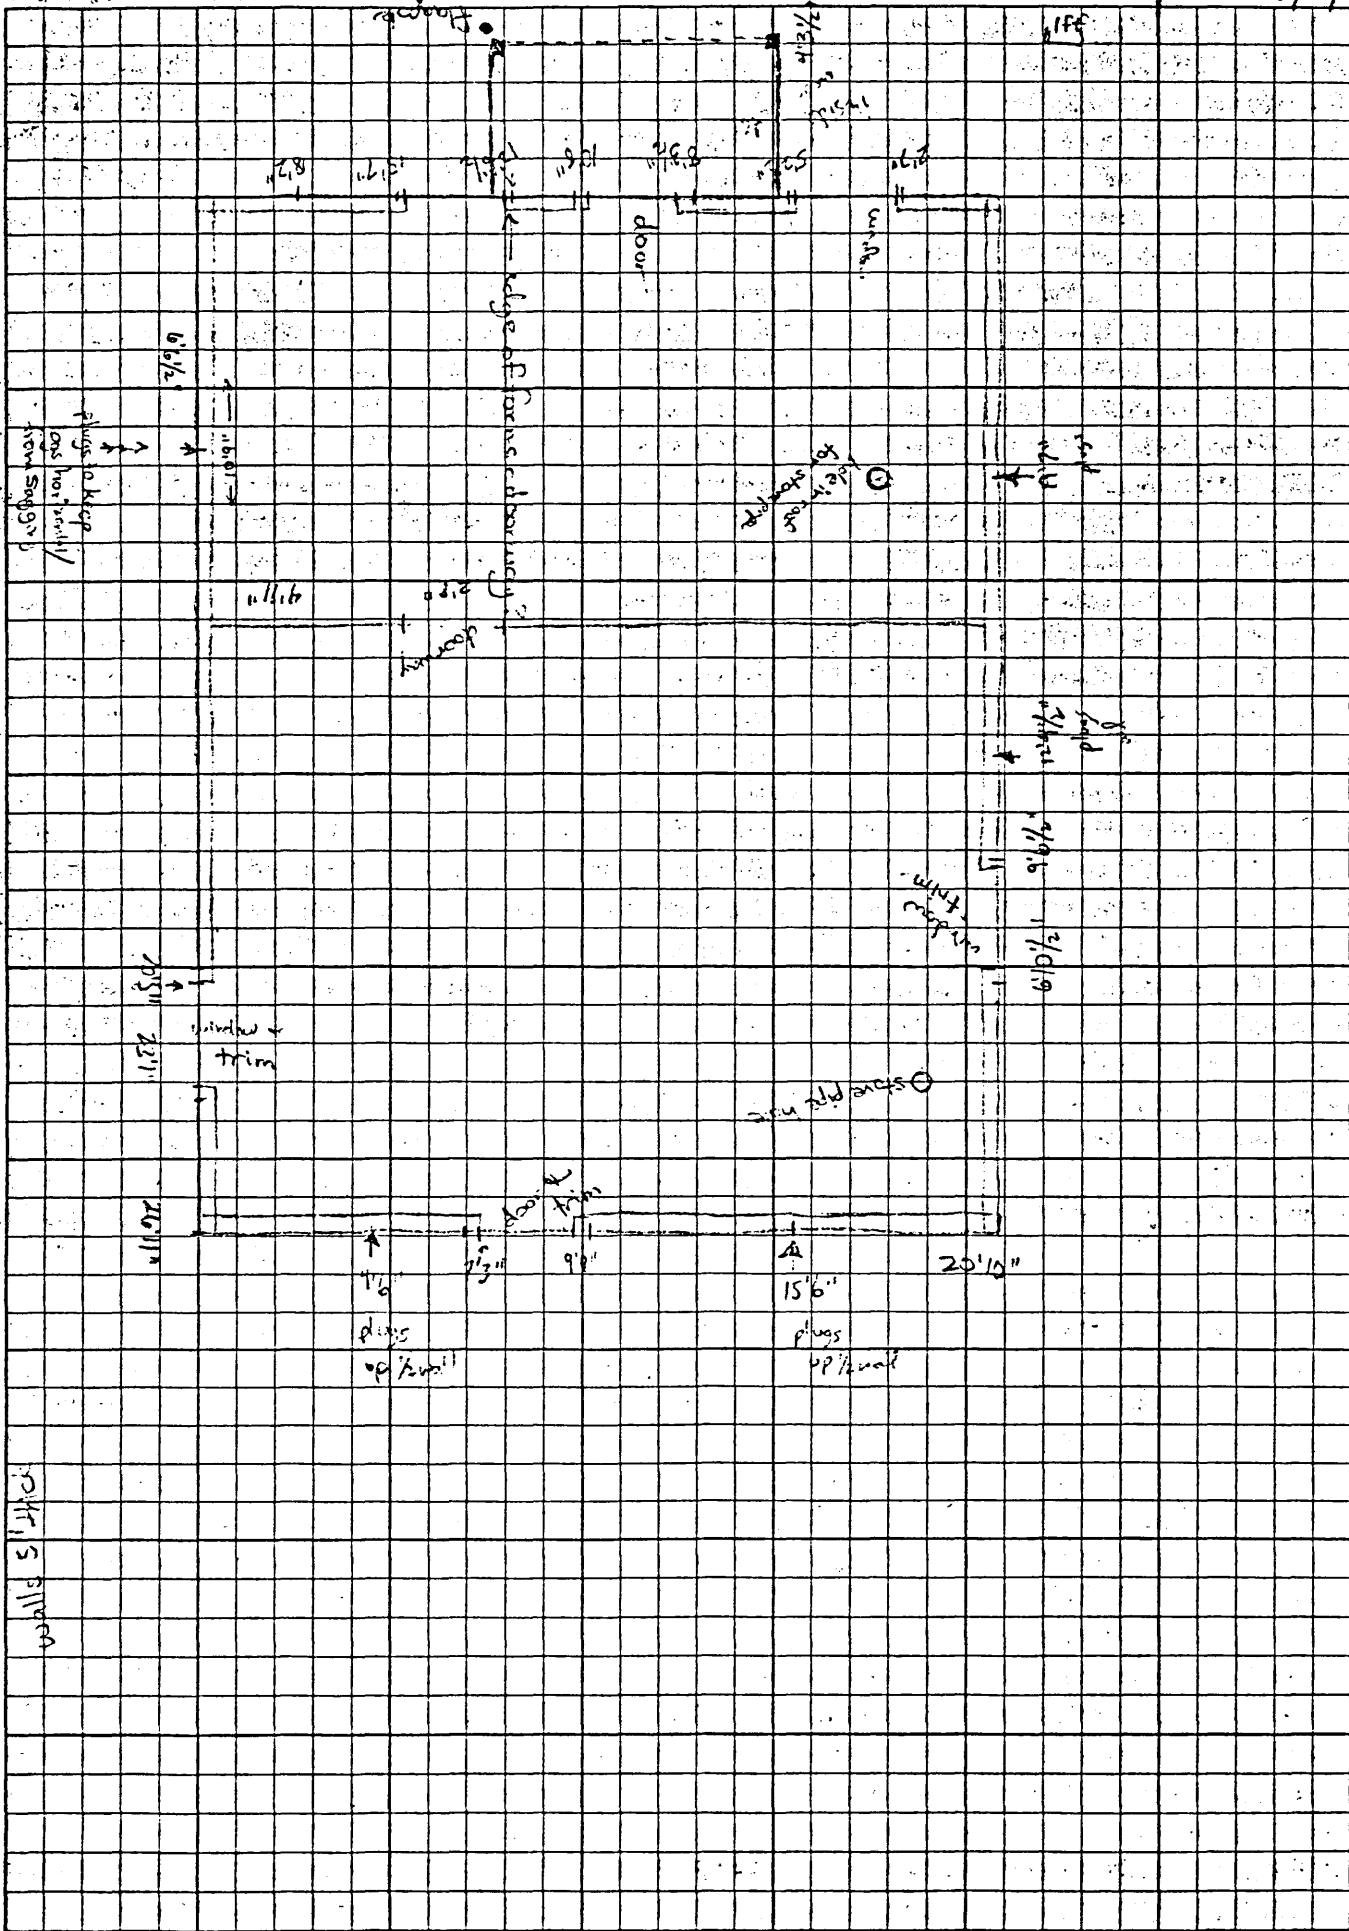
SL-86  
Structure 9  
profile of S wall

The building is in fairly good condition, but about 40% of the roof shingles are missing, the west wall is bowed in, and there is some settling along the north wall.

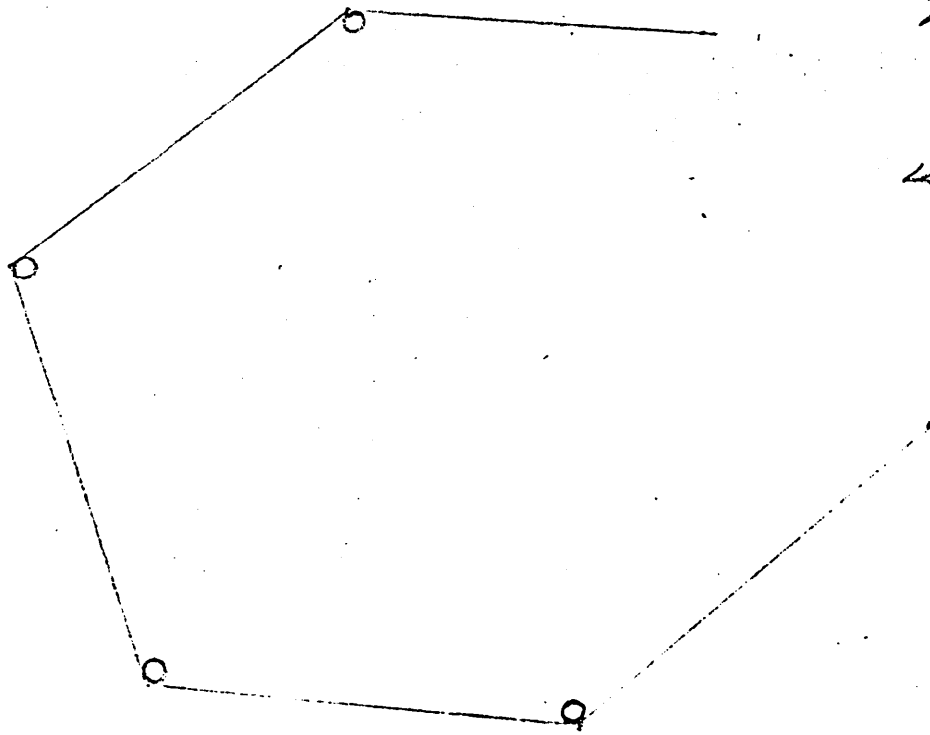
SL-26 Leesburg  
Structure II  
top view  
7/2/22  
scale:  1ft.

Feature 11 is a one room root cellar situated at the north end of Feature 10. It is not certain if it was built at the same time as Feature 10. It is in poor condition because the roof and walls are partially collapsed.

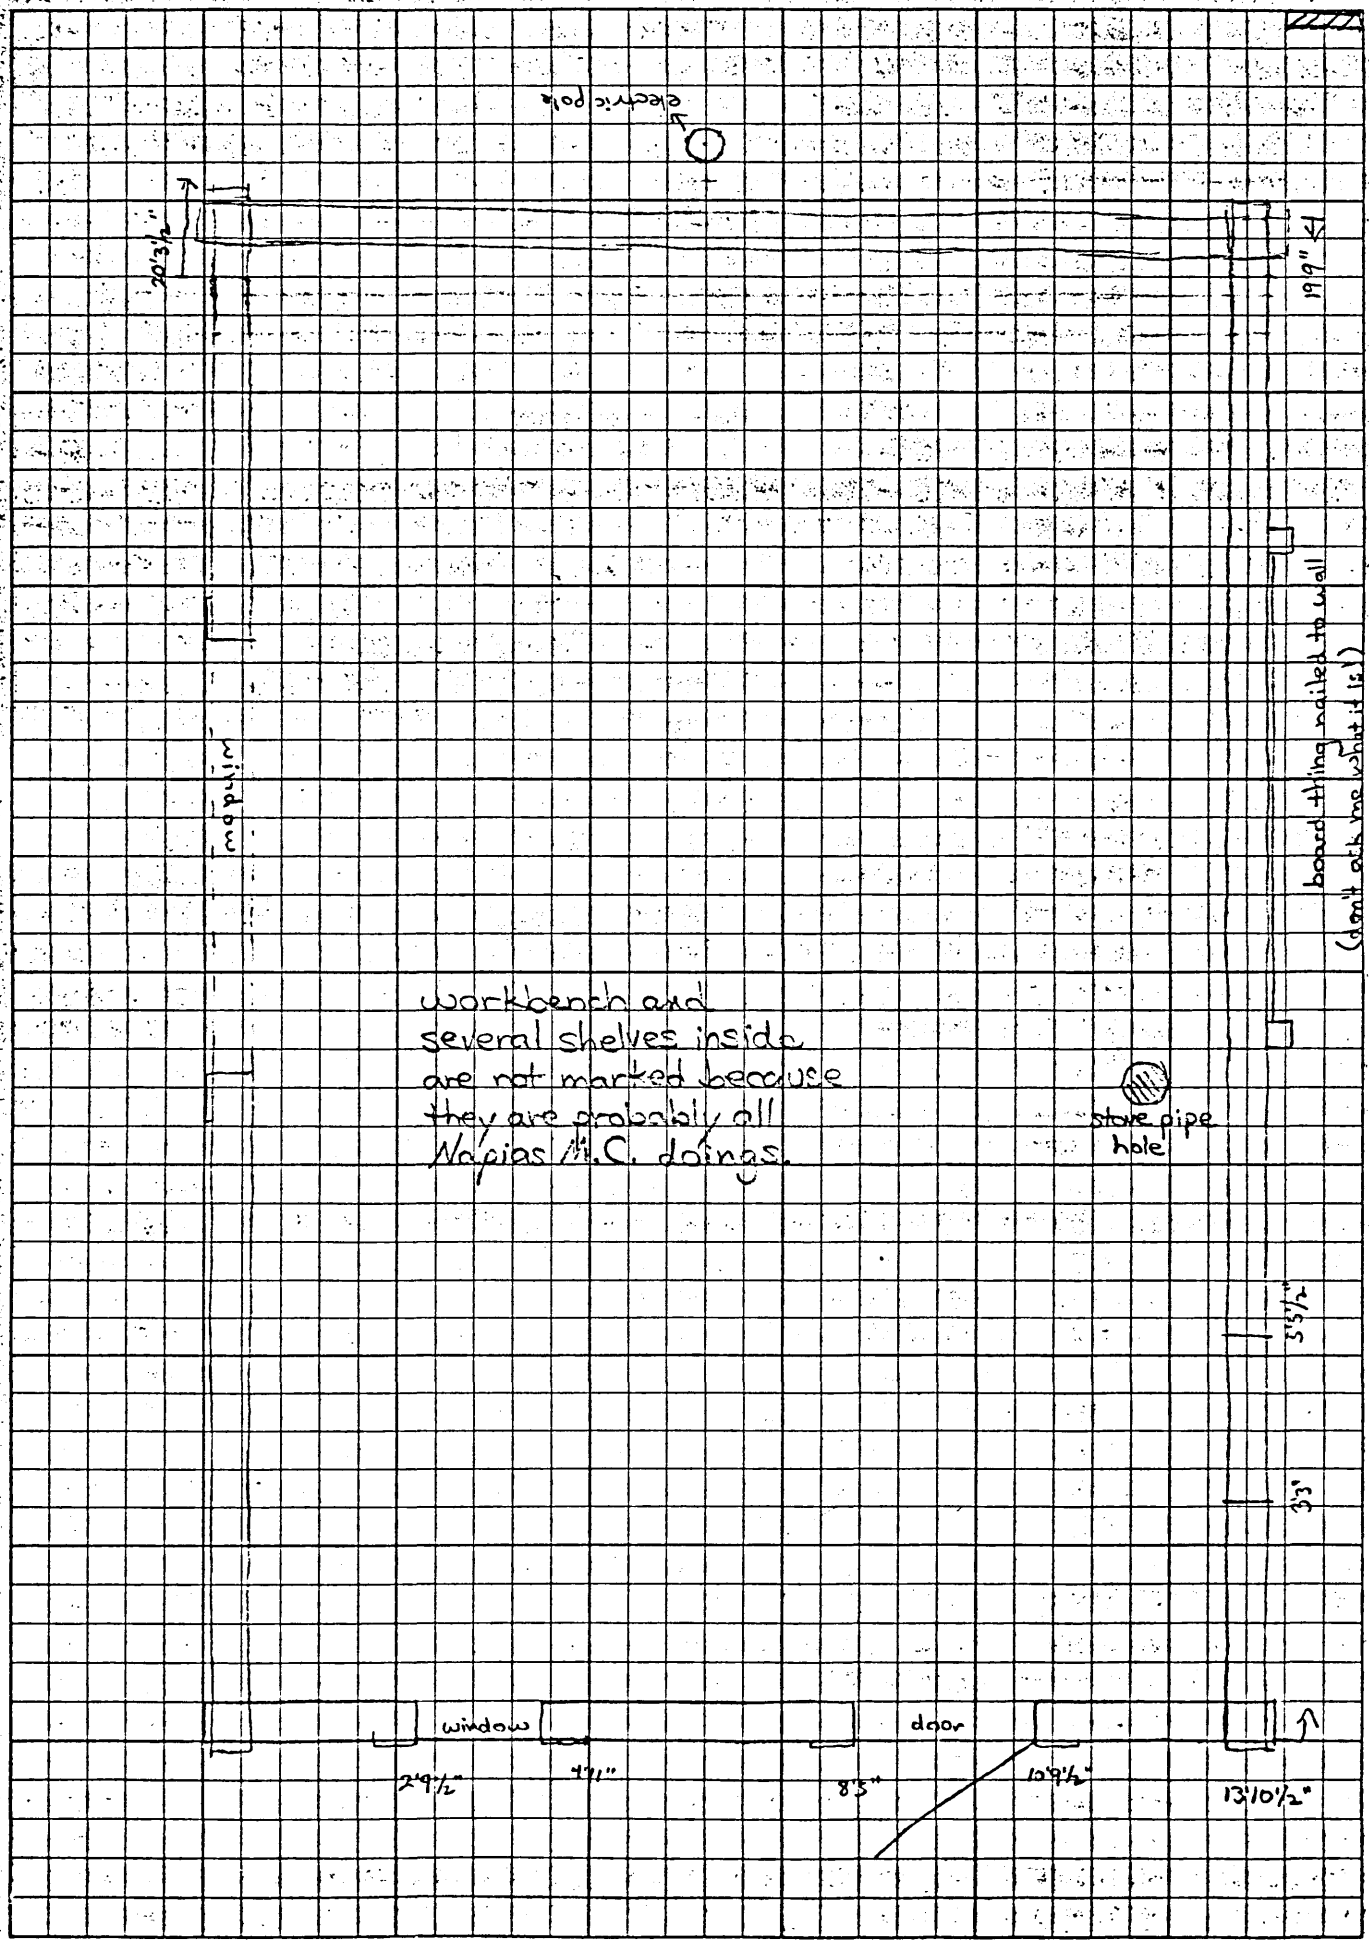
SL-86  
Structure 12  
profile of S wall-

Feature 12 is a two room, saddle-notched log building (Fig. 10). It was built in 1935 by Mr. Fitzgerald and two other men to be used as a schoolhouse (Paul Fitzgerald). Napias currently uses the structure as an office, and occasionally as sleeping quarters. Feature 12 is structurally sound although the bottom wall logs are rotting and the roof and floor are deteriorating.

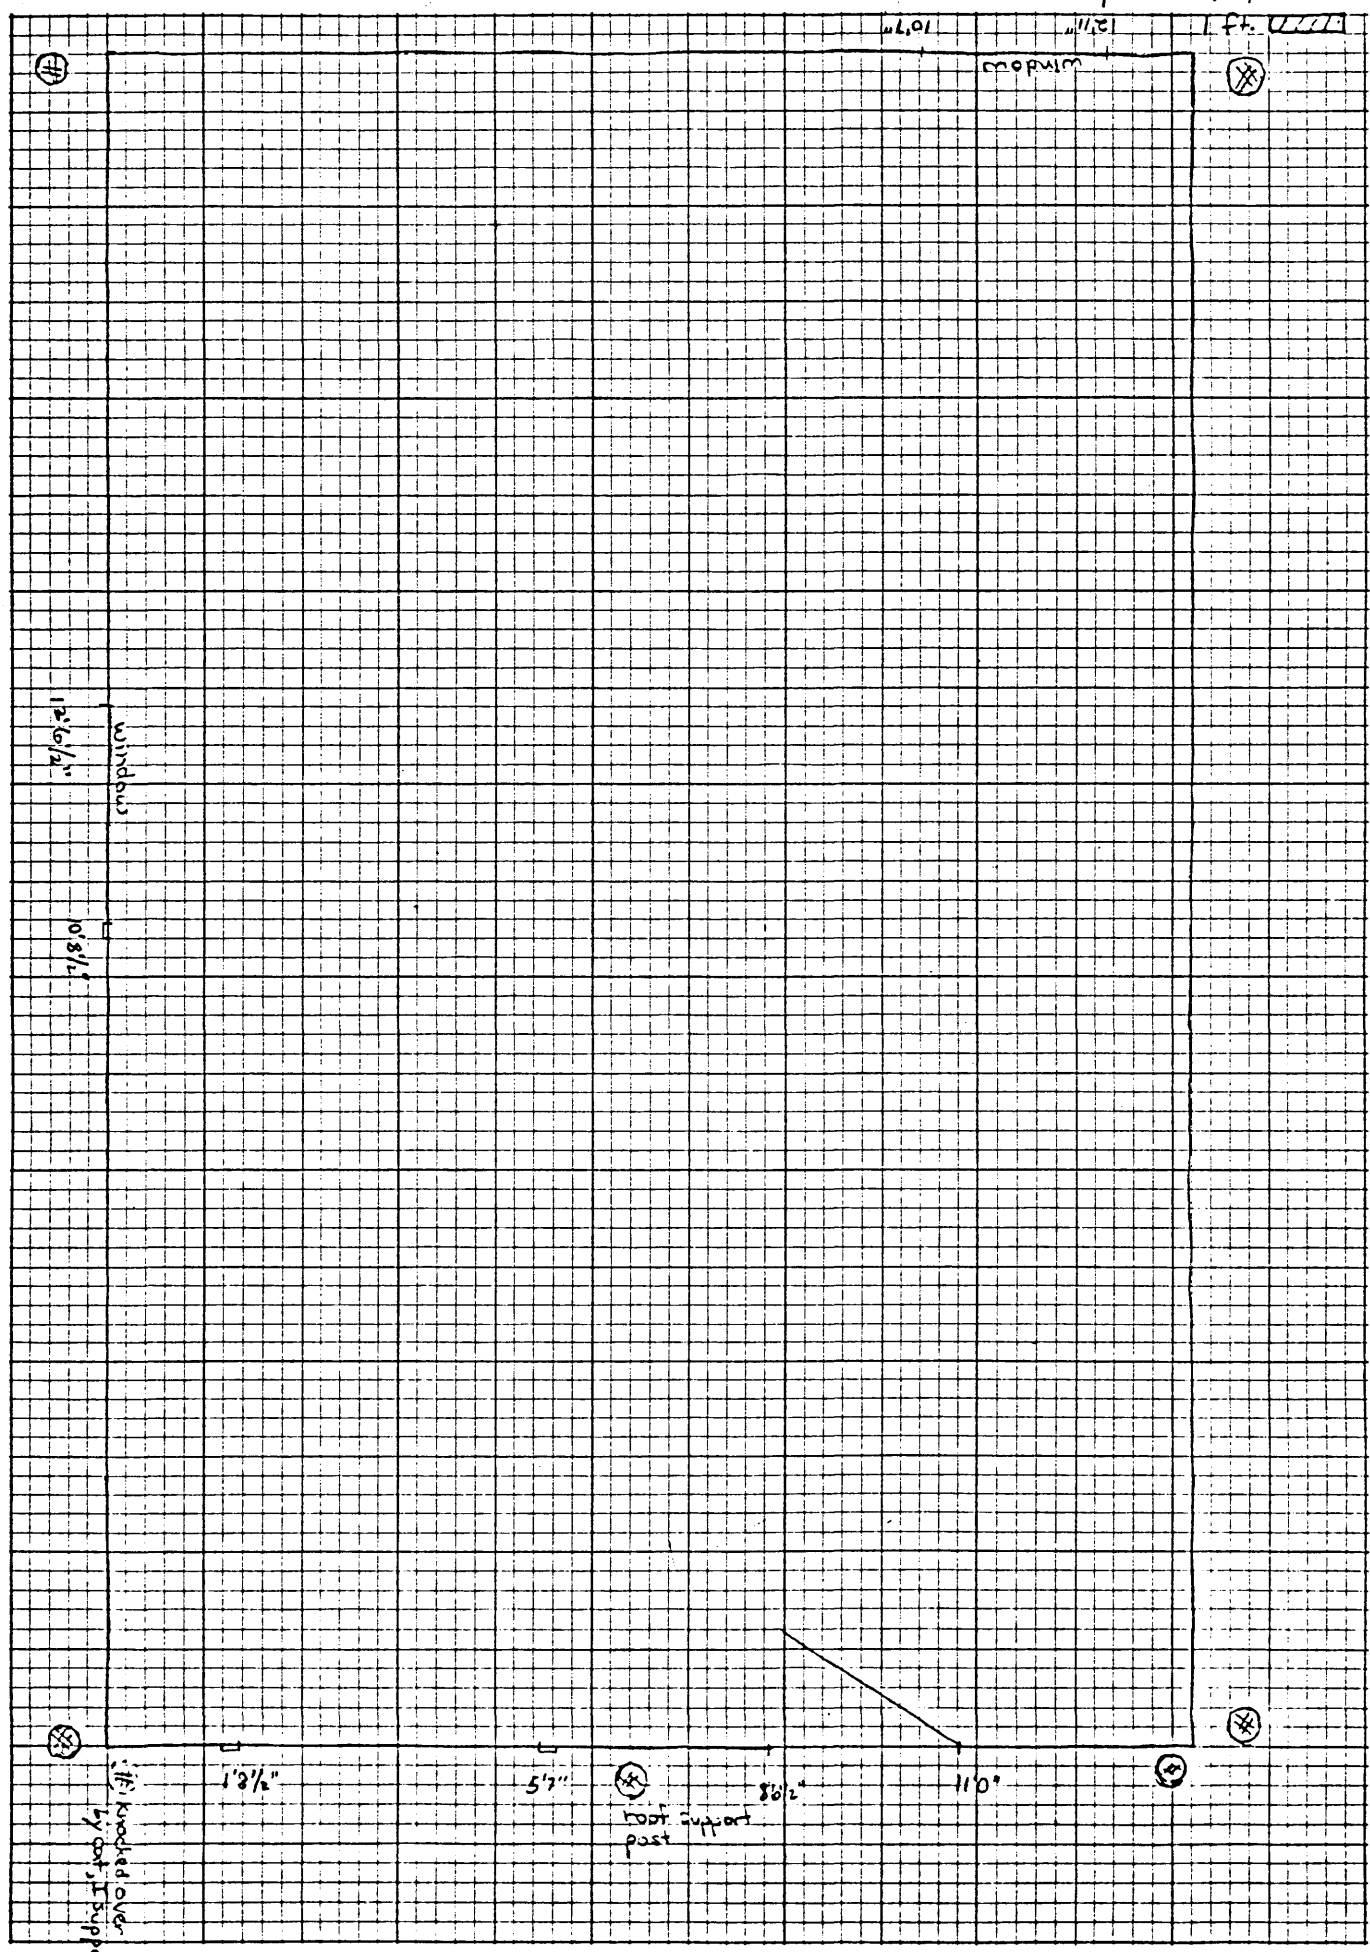
Structure 17  
floor plan 7/15/82

Identify defects to both primary (walls, roof) and secondary (porch, doors, windows) as slight, minor, major, critical, ruin. Specify deterioration. The building is in critical disrepair. The N wall falling out the east wall is sagging inward. Doors and windows missing. East 1/2 of roof sagging with several holes. The interior is full of recent trash.
