# DATA SHEET

## NATIONAL REGISTER OF HISTORIC PLACES INVENTORY - NOMINATION FORM

COMMON:  
**Leesburg**

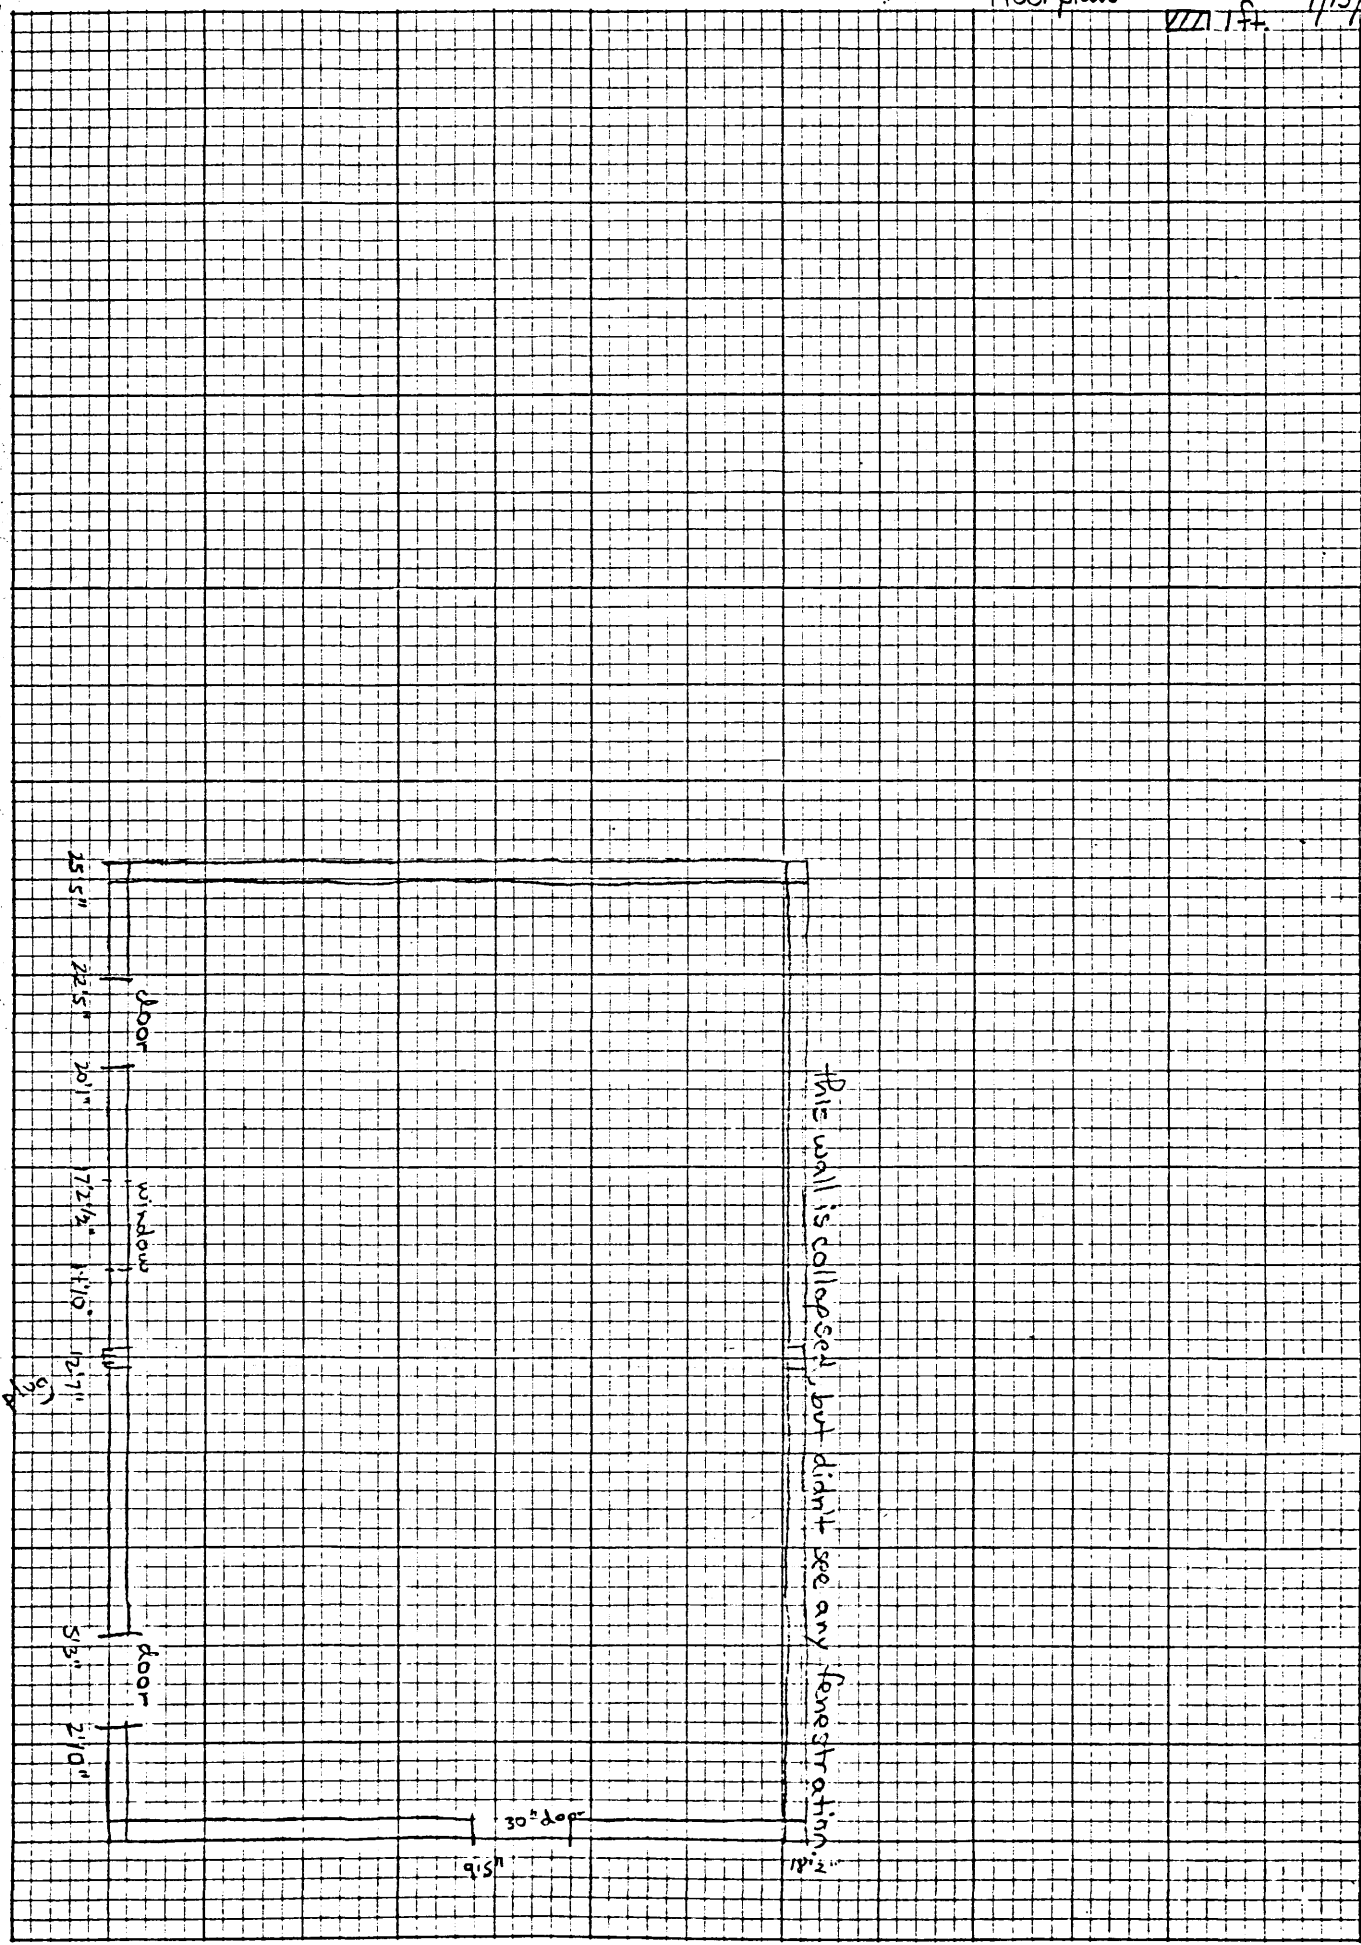
Structure 15  
floorplan  
7/15/82

Identify defects to both primary (walls, roof) and secondary (porch, doors, windows) as slight, minor, major, critical, ruin. Specify deterioration. This feature is a mess. The roof is almost completely collapsed; the walls are falling or have fallen. There is green water standing on the floor rotting the wood. Napias Mining Co. dug a ditch right in front of the building and the dirt next to and underneath F-15 is slumping, further weakening the structure.

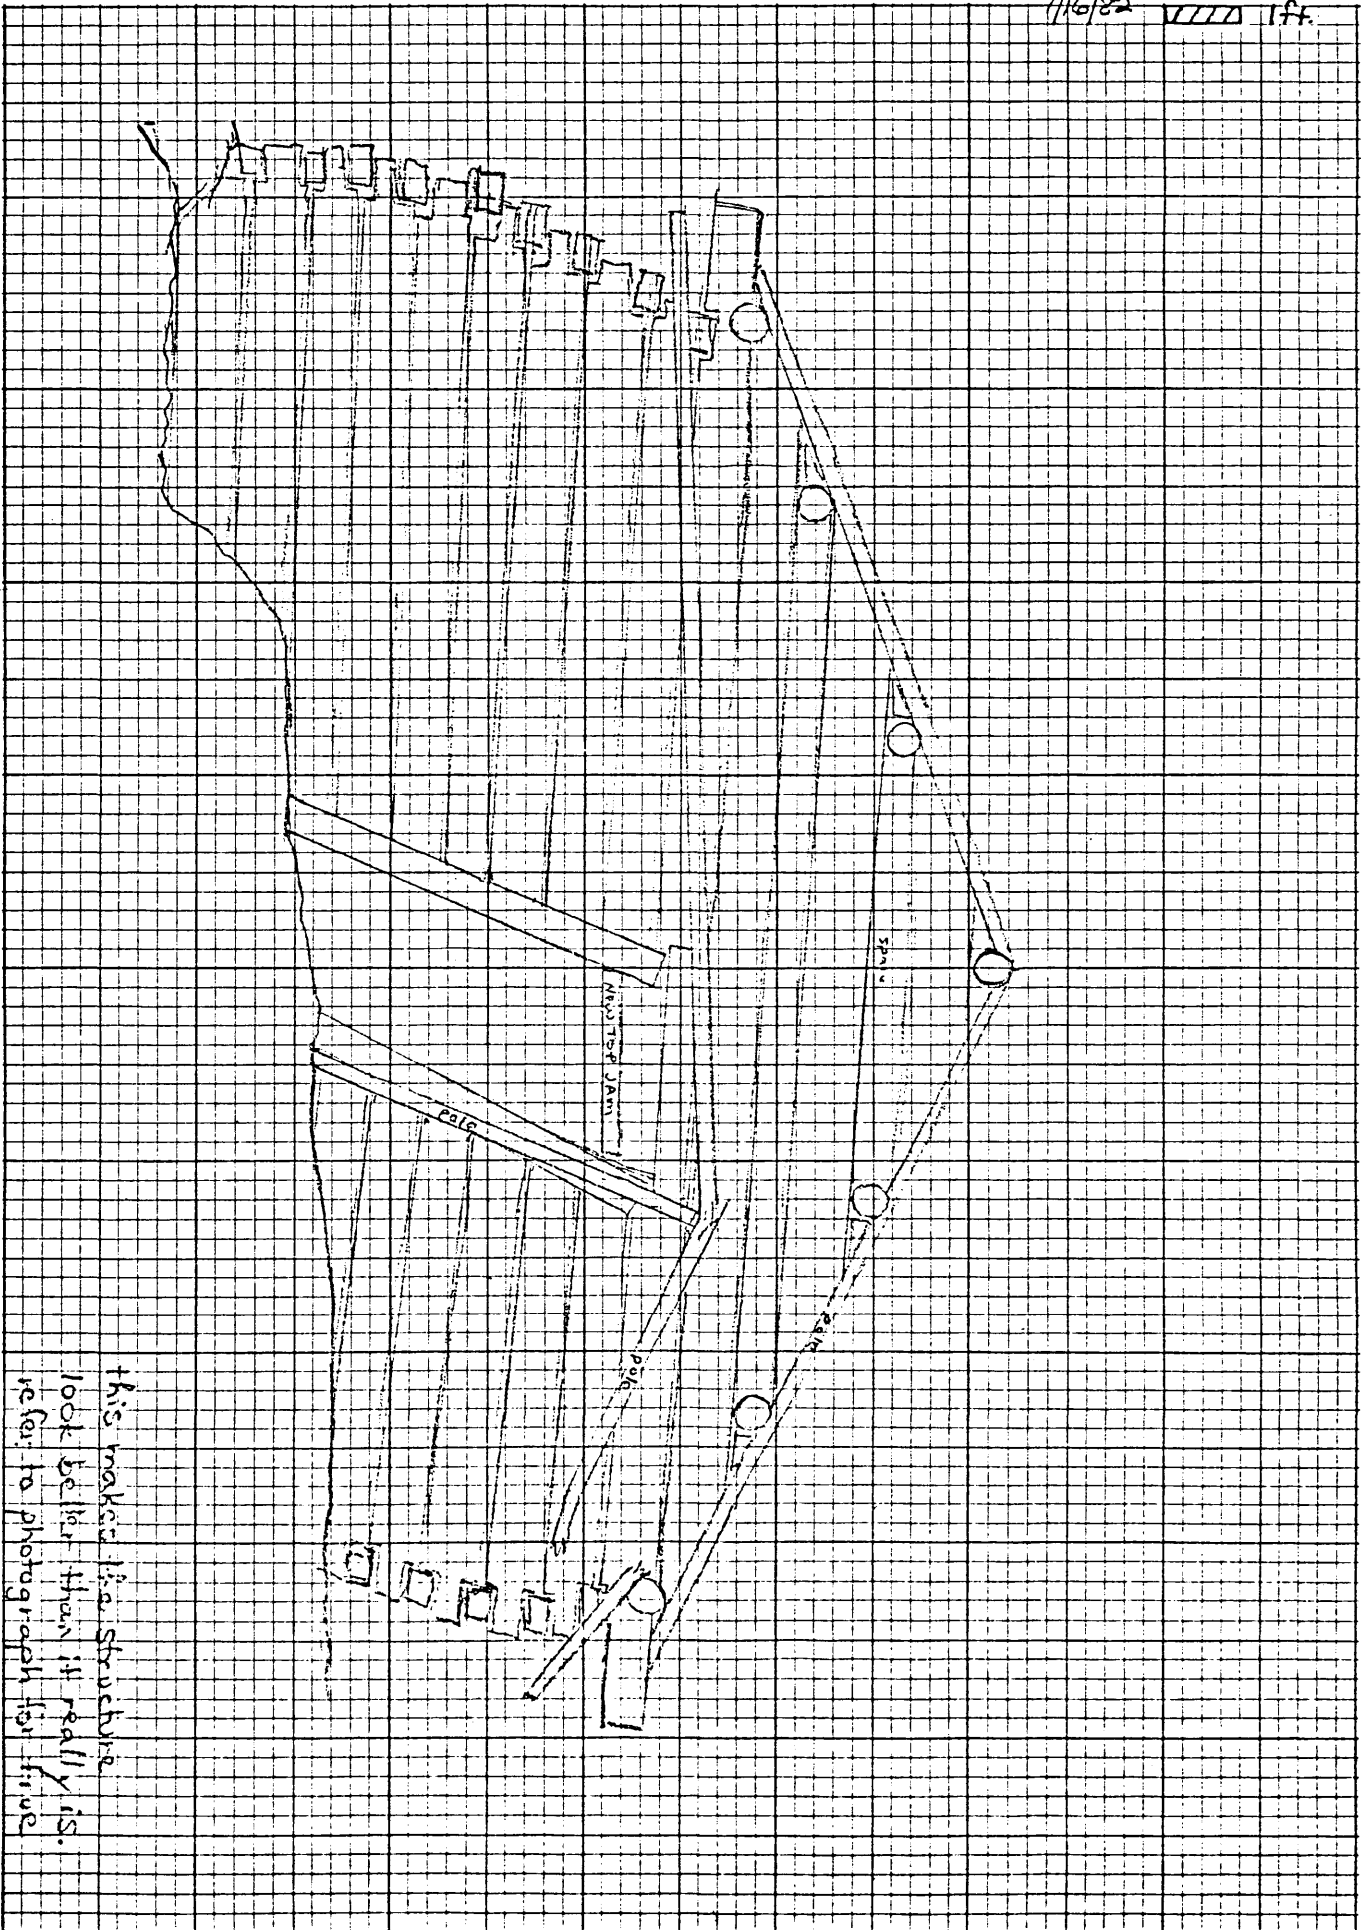
Structure 15  
profile of south wall  
7/10/82 11111 1ft.

This makes the structure  
look better than it really is.  
refer to photograph for true  
state of affairs.

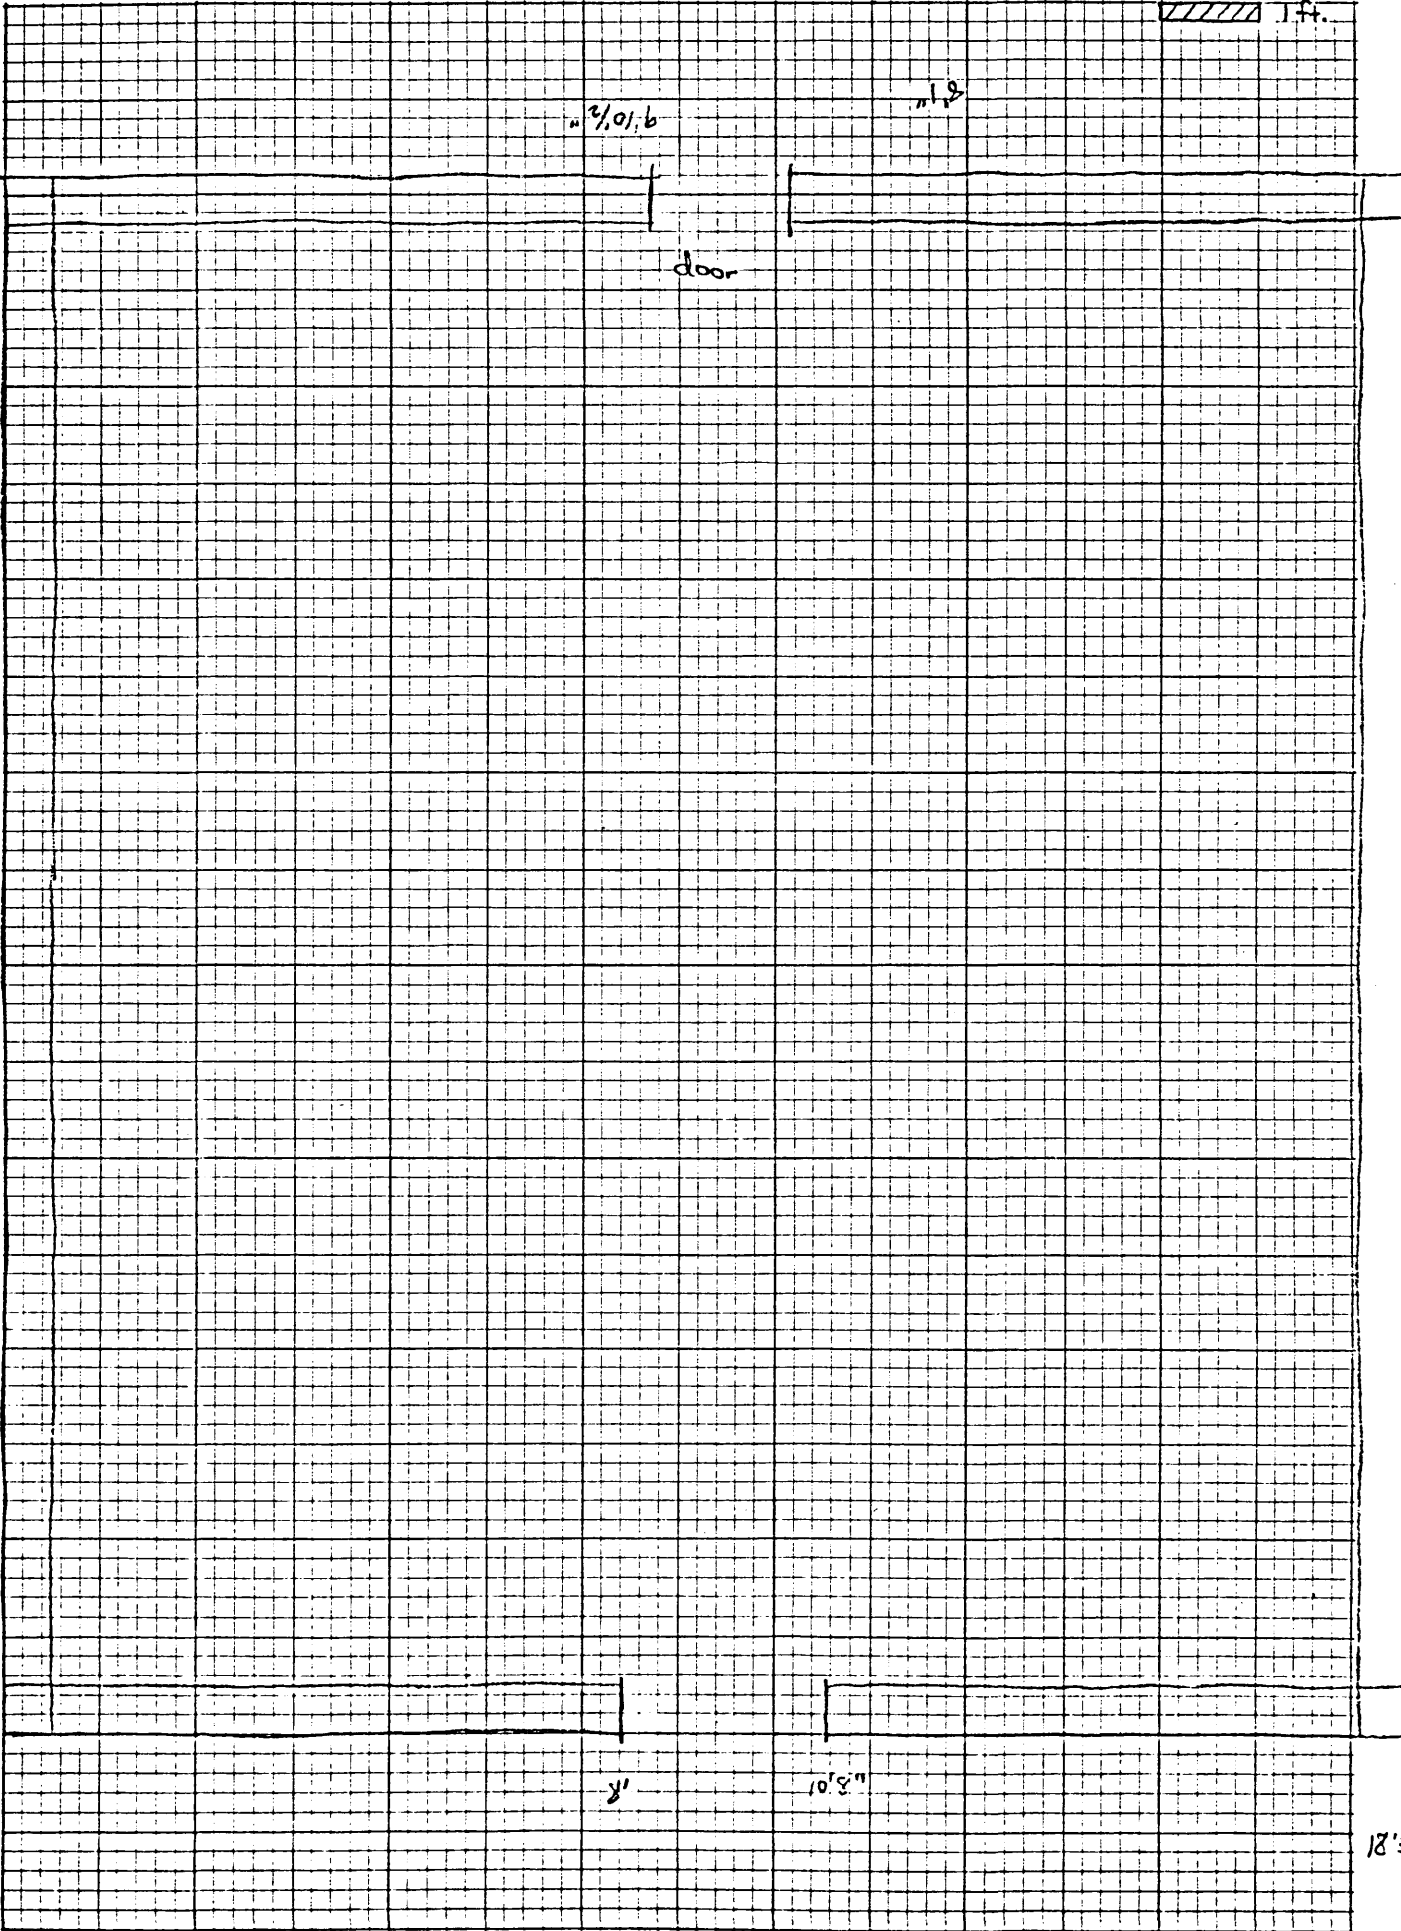
Structure 16  
floor plan 7/15/82

Identify defects to both primary (walls, roof) and secondary (porch, doors, windows) as slight, minor, major, critical, ruin. Specify deterioration. The roof has collapsed and the walls are partially collapsed. Bottom logs are rapidly deteriorating because of the high water table. The fire that charred some of the interior logs doesn't appear to have done much damage. The doors are gone.

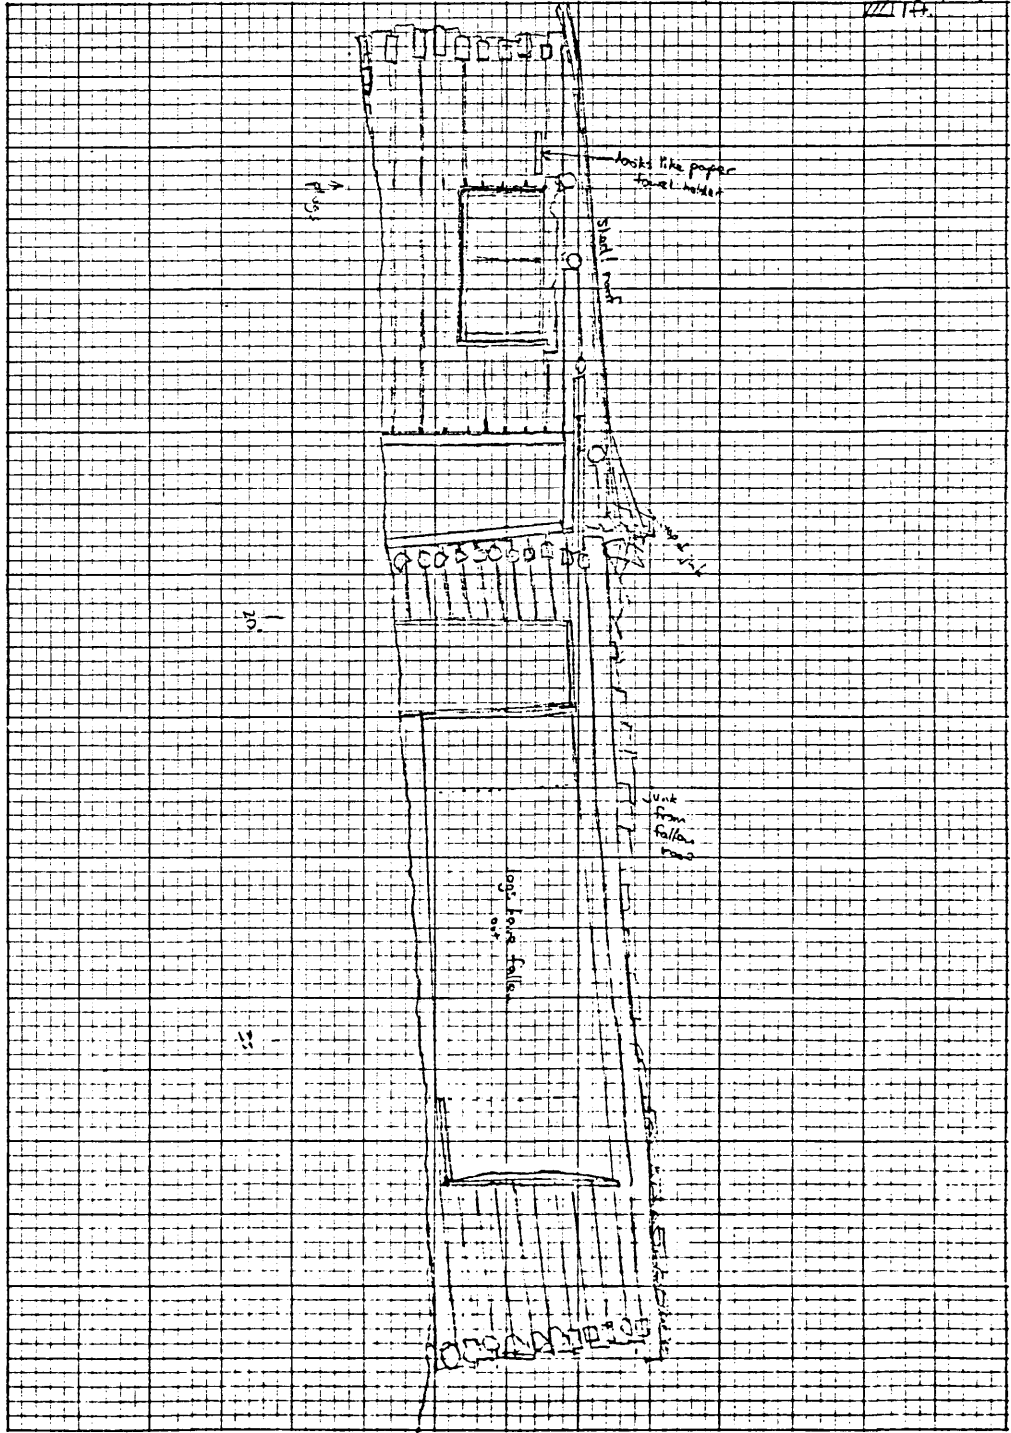
SL-86 Leesburg  
Structure 17  
profile of east wall 7/20/22  
1/11 ft.

- C: 66 X 37 in. One of those tall windows. The left side is missing because the east wall fell out there.
- D: 65 X 36 1/2 in. Was probably identical to Window C had green trim on top inside. Right side fell off when that section of wall collapsed. Two end loop things in inside trim to hold roller shade.

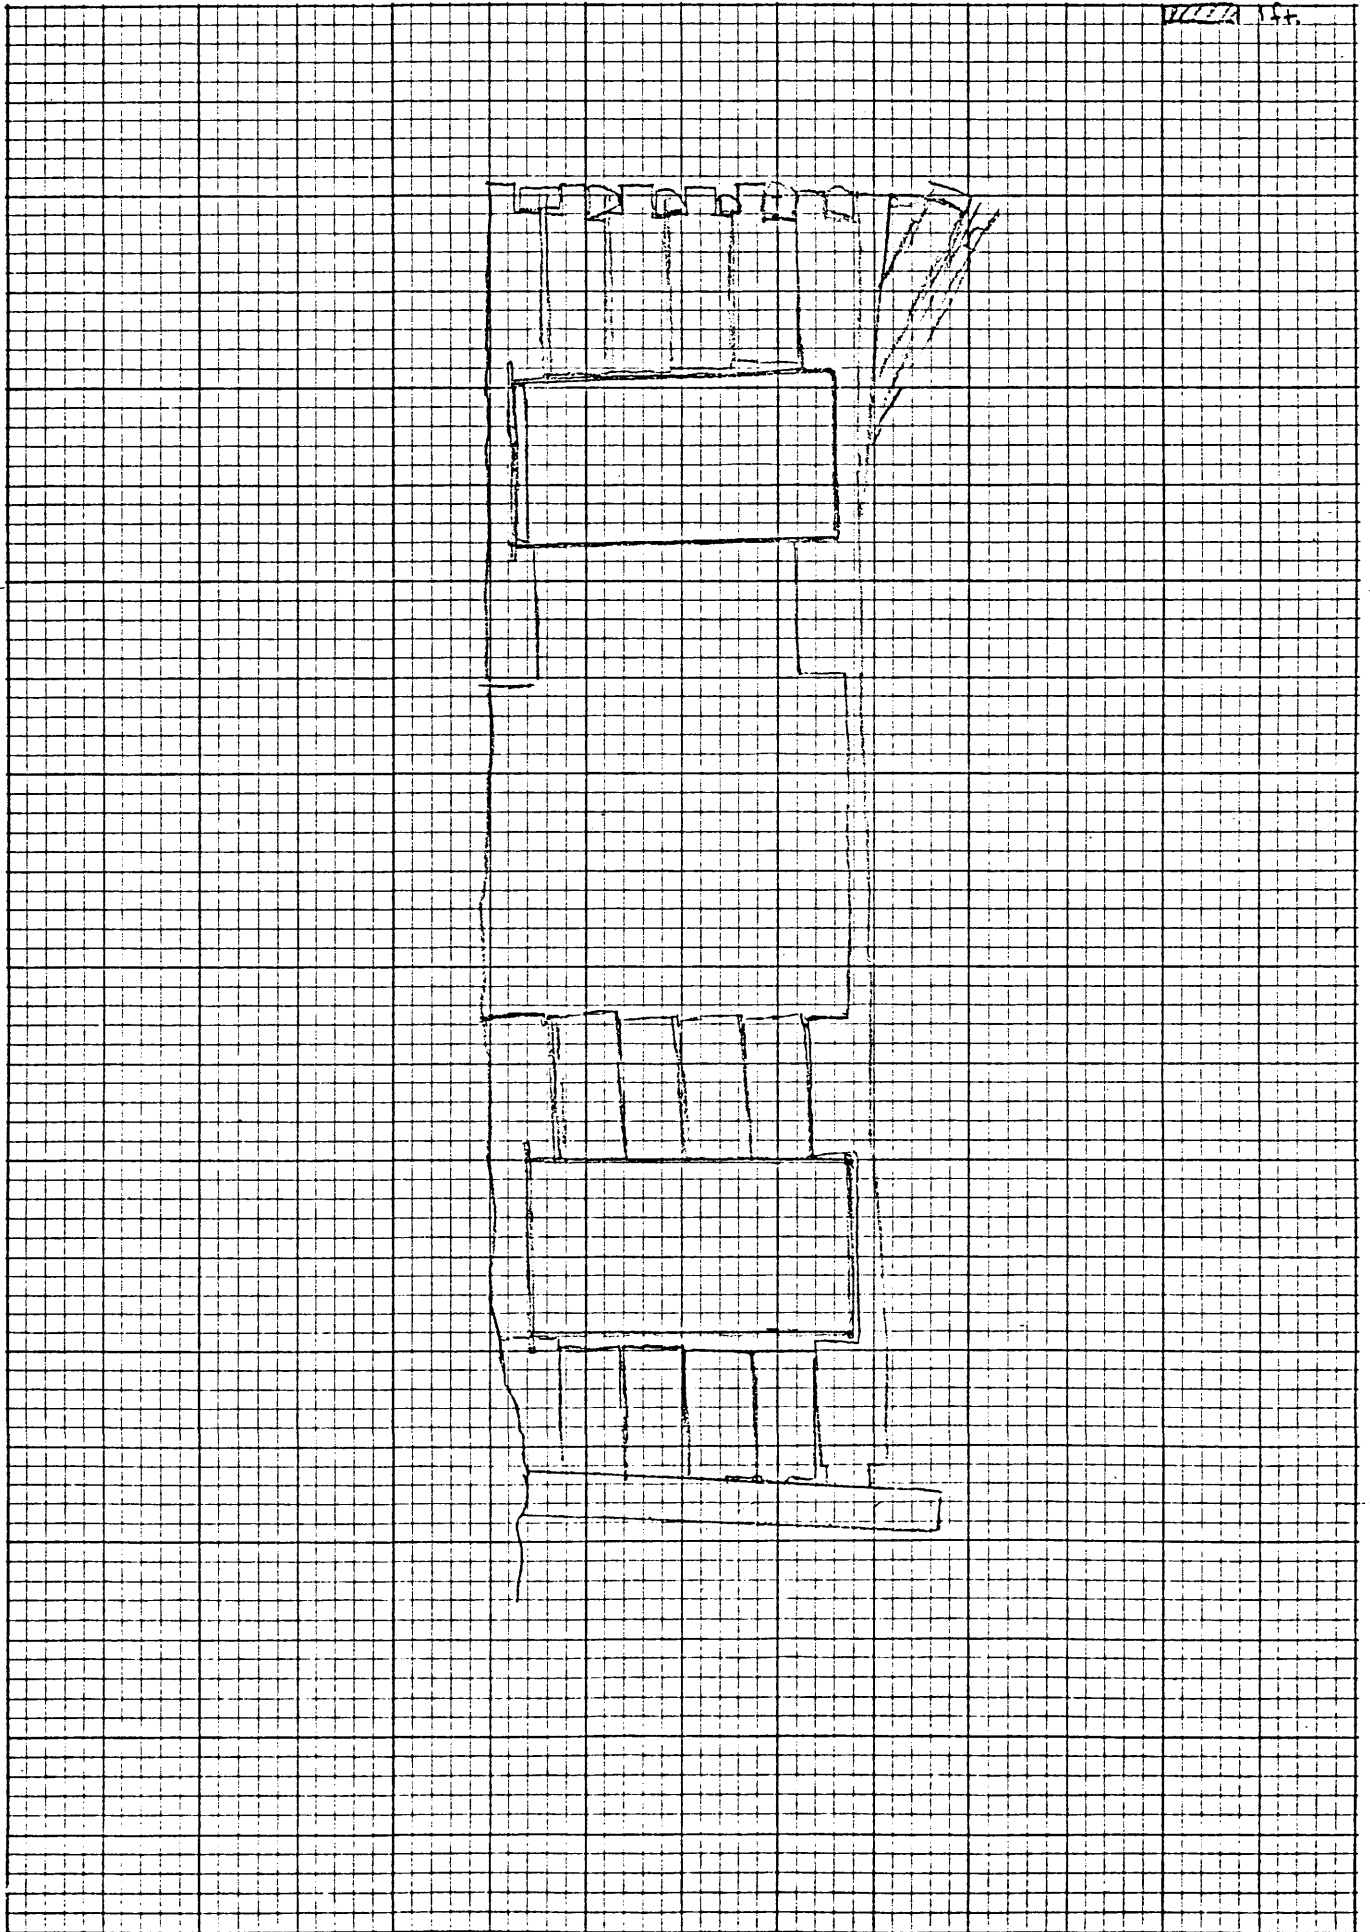
Structure 18  
profile of north wall 7/20/82

Identify defects to both primary (walls, roof) and secondary (porch, doors, windows) as slight, minor, major, critical, ruin. Specify deterioration. Roof totally collapsed, walls in second room 0-3 logs high, walls in front room faring better w/most of N and E walls still standing. Only 1 window frame remains intact..

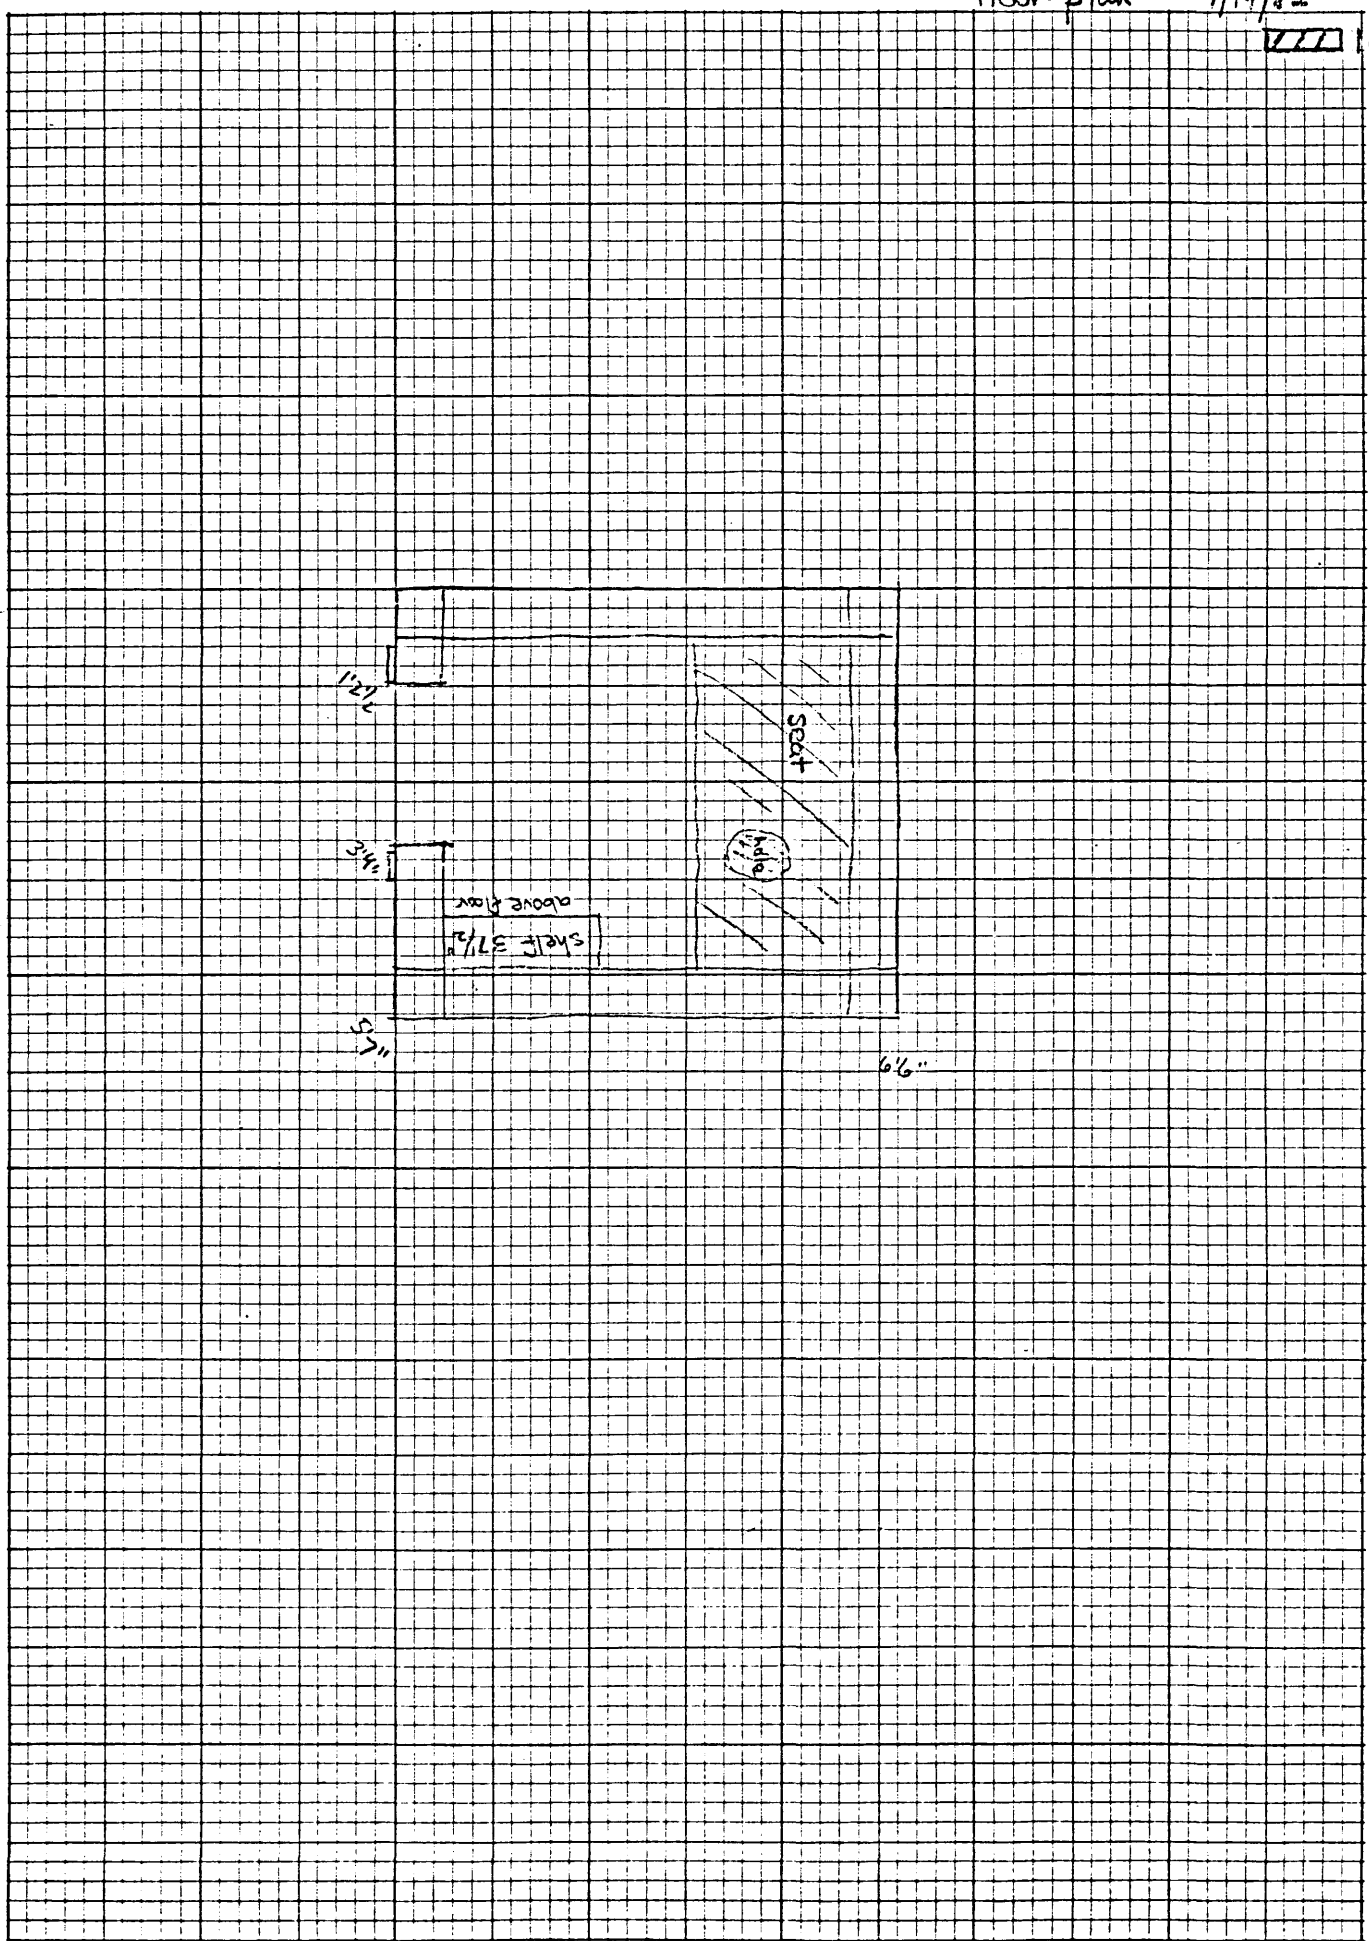
Structure 19  
floor plan 7/19/82

Identify defects to both primary (walls, roof) and secondary (porch, doors, windows) as slight, minor, major, critical, ruin. Specify deterioration. Slight damage to lower wall logs because they are standing in water. Also, the roof has several holes in it. Building tilts slightly to the east.

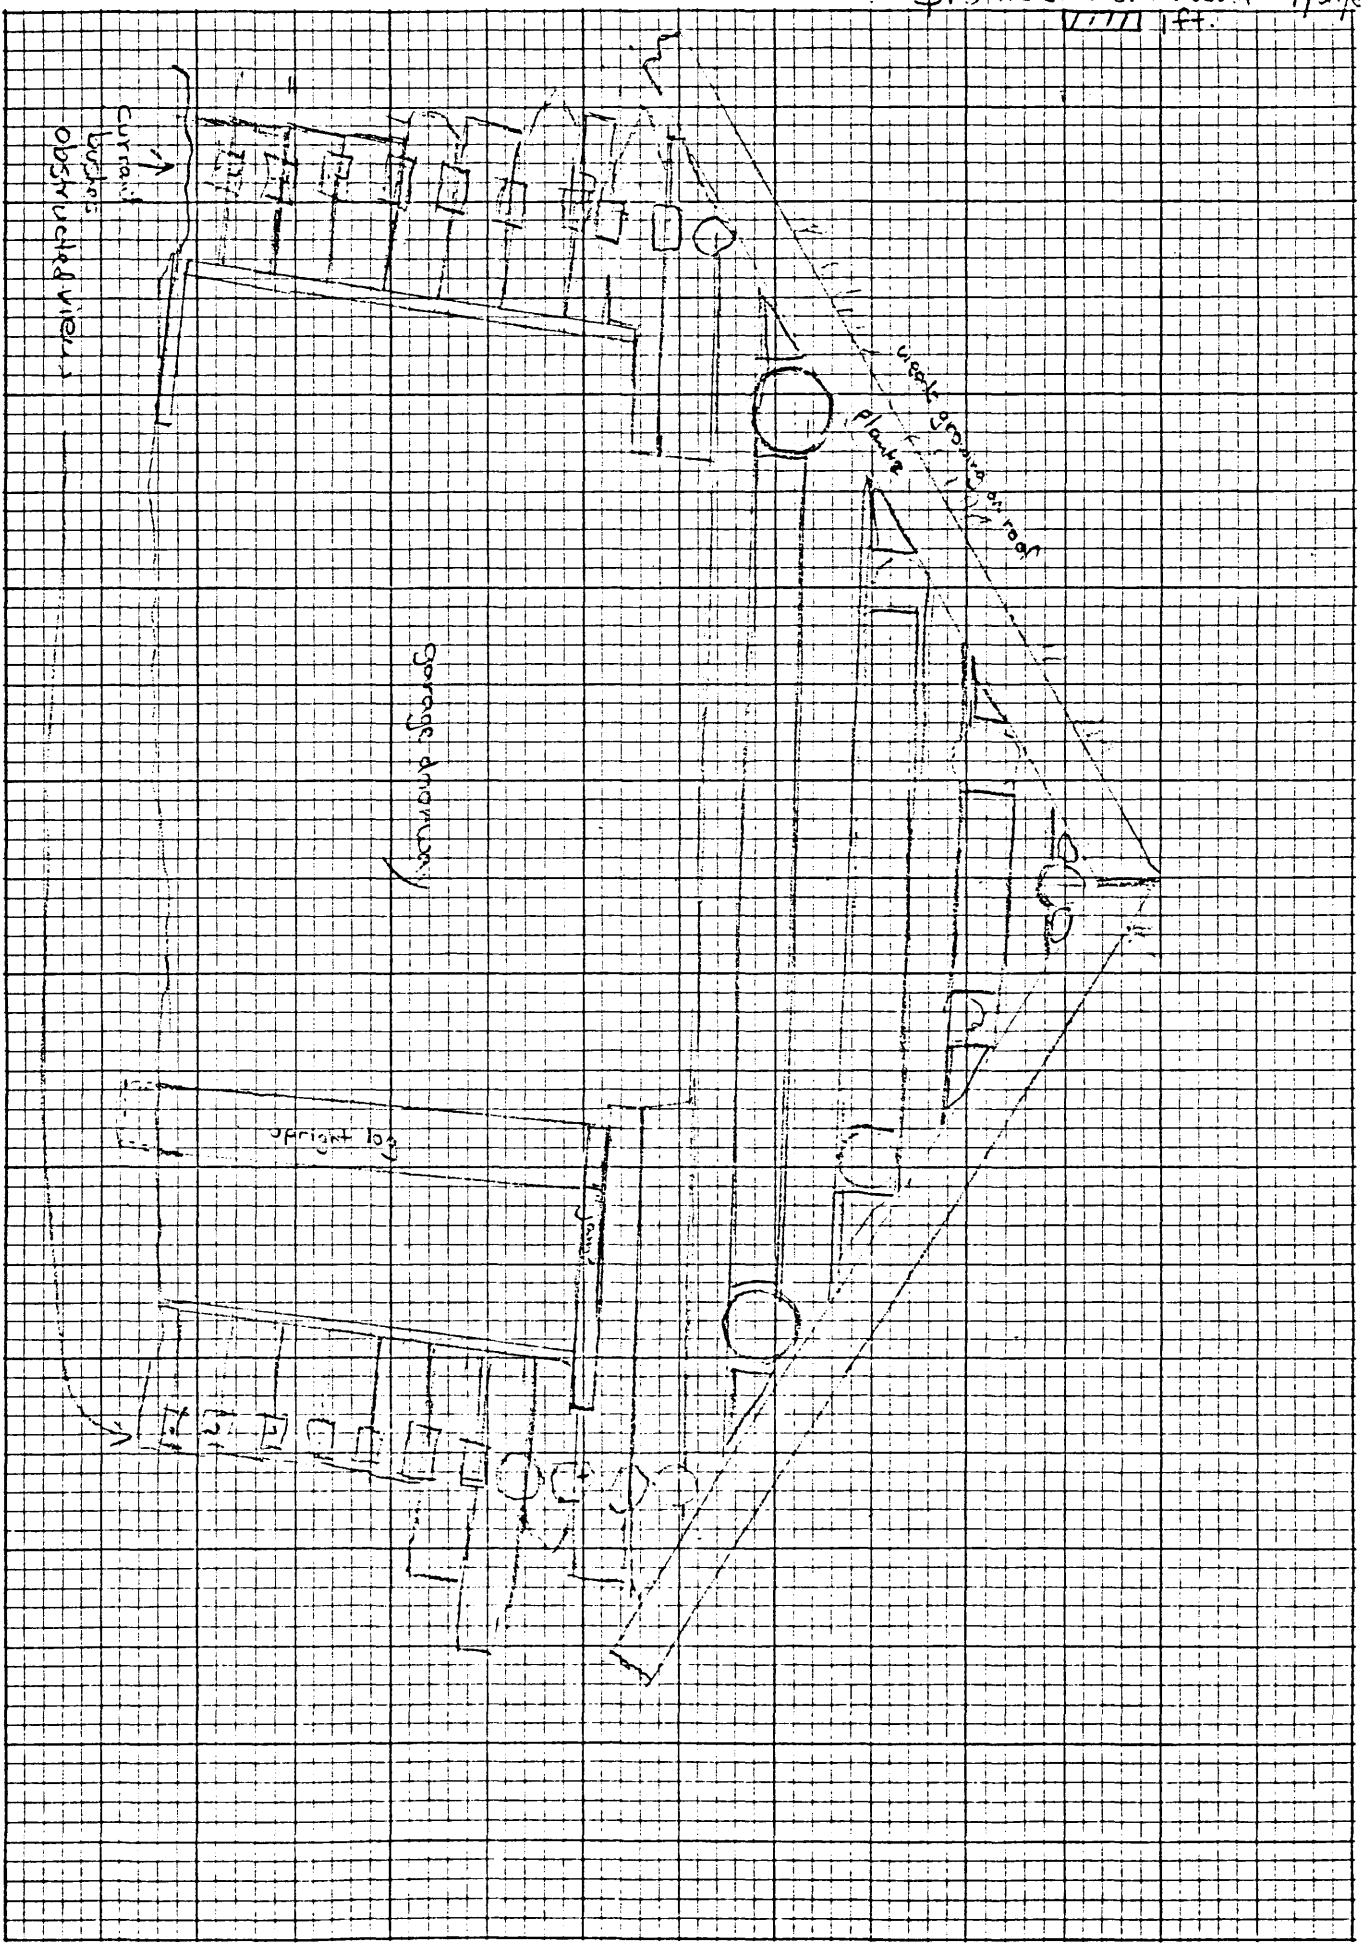
Structure 20  
profile of north wall 7/2/22  
11111 ft.

Summary (1-2 sentences about function, form, condition): Structure 20 is a workshop that used to be the butcher shop. It is in fairly good condition but, when the west wall collapses as it threatens to do any time now, the building will rapidly deteriorate.
