# PRE-PLANNING FOR THE MAJOR RENOVATION OF BUILDING 210

ASSET CONDITIONS  
ASSESSMENT AND ANALYSIS

PMIS #310907A

December 1, 2021

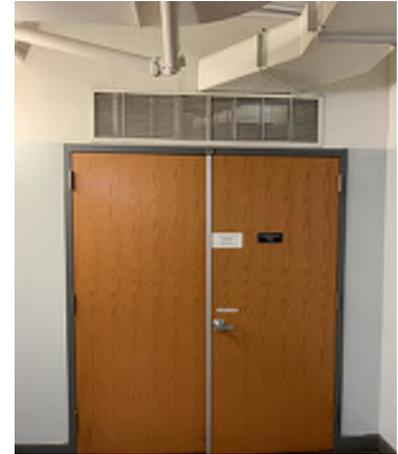
As a Group B (Business) occupancy, interior public corridors are required to be rated.<sup>2</sup> Many of the primary public corridors are separated by what were originally exterior walls between living space and the outdoor "porches." Triple-wythe brick masonry walls have an inherent fire rating greater than 1 hour, but it is likely that the openings, whether they be doors, windows, or infill construction do not. Air transfer grilles penetrate and are dispersed throughout these particular walls and are not equipped with fire and/or smoke dampers [see "Mechanical" on page 55 and Figure C-2].

Transfer grille to corridor [C-2]

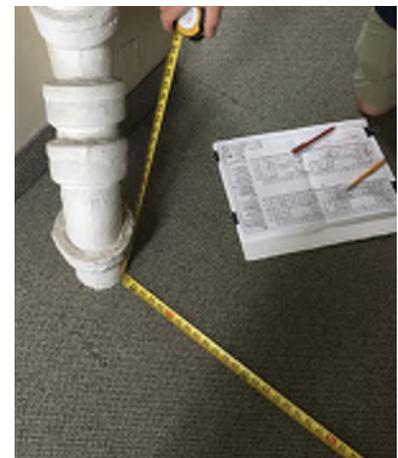
Regardless of occupant type using corridors and hallways, all that are part of an accessible means of egress must be unobstructed and maintain a clear width of at least 44 inches [Figure C-3].<sup>3</sup> An exception for corridors used by 50 or fewer occupants does exist, which allows a reduction to 36 inches, but this should only be applied when absolutely necessary.

Obstructed means of egress [C-3]

Any future program(s) for the building should consider additional storage space within close proximity of offices and labs to discourage placement of loose items and cabinets in corridors and hallways.

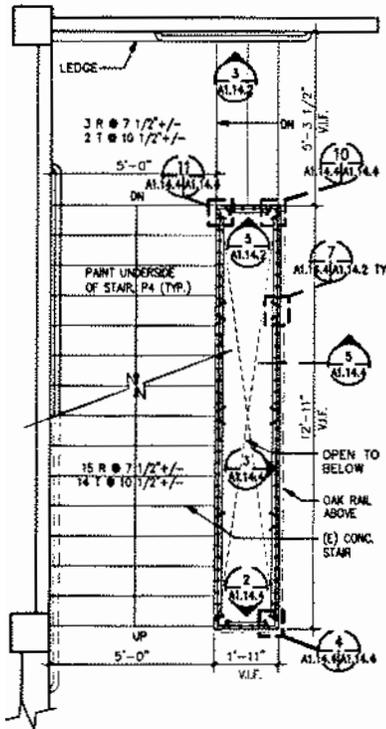
[C-4] Typical egress stair. Unknown author, 1995.

Drawings provided by NPS indicate each stair run is 60” wide [Figure C-4]. Assuming this is accurate, the stairs can accommodate up to 200 exiting occupants.<sup>4</sup> So, as of the time of the survey, Stair C is not compliant and any programmatic changes could result in the same for Stairs A and B. Calculations for the lower floors produced no deficiencies.

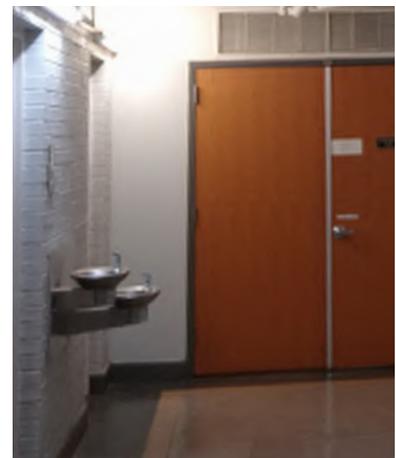
Drinking fountains acting as horizontal projections into egress path [C-7]

<sup>7</sup> **NYC Building Code, Section 1003.3.3.** Structural elements, fixtures or furnishings shall not project horizontally more than 4 inches over any walking surface between the heights of 27 inches and 80 inches above the walking surface.

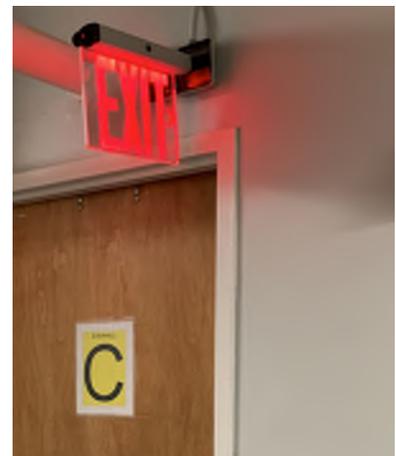
Typical stair identification signage [C-8]

<sup>8</sup> **NYC Building Code, Section 3002.3.1.** Stairway and elevator identification signs indicating each by alphabetic letter shall be posted on both sides of each stair door and at every landing, respectively.

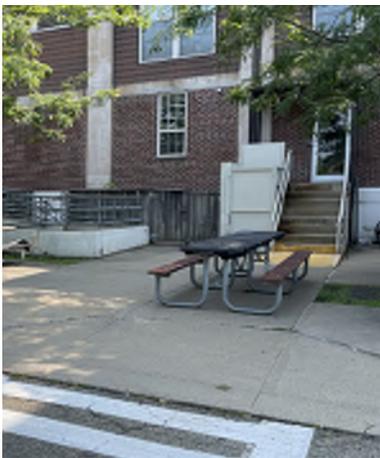
[AC-2] Accessible path obstruction

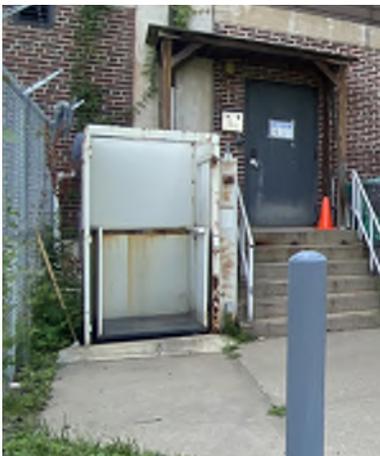
[AC-3] Park Police platform lift

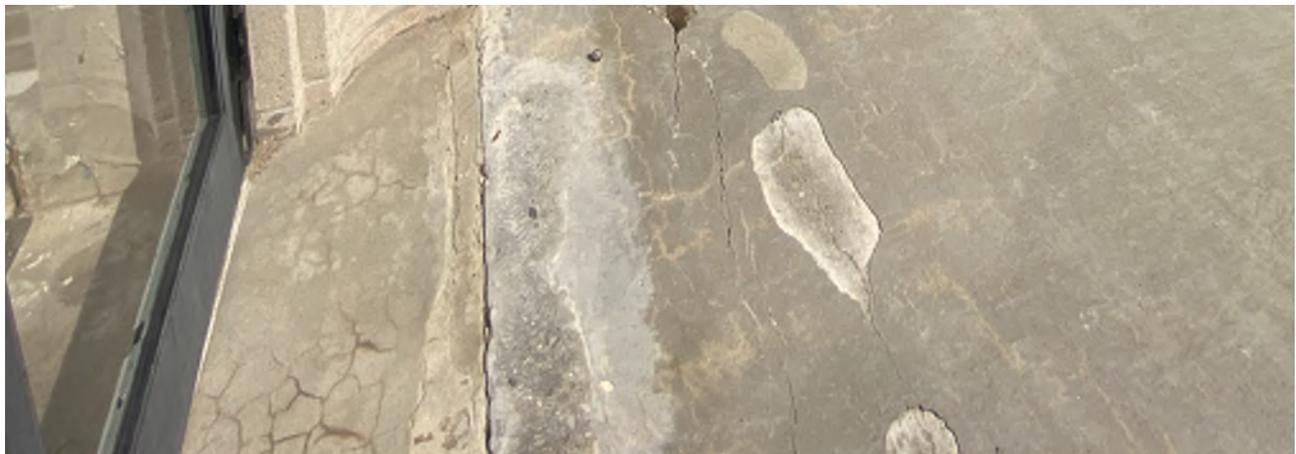
Landing edge at building threshold [AC-6]

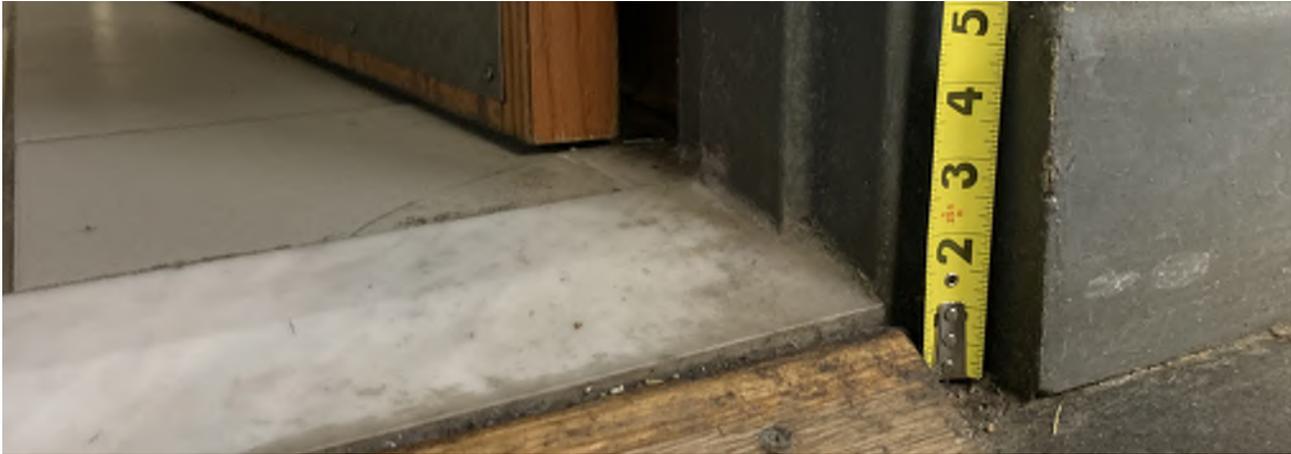
[AC-8] Typical threshold at former existing wall to “porch” corridor

- Higher than permissible door thresholds, some more than 1 inch.<sup>17</sup>
  - These conditions were consistently located along the doors from the main building to the “porches,” which now make up a significant portion of the main corridors at each level [Figure AC-8].

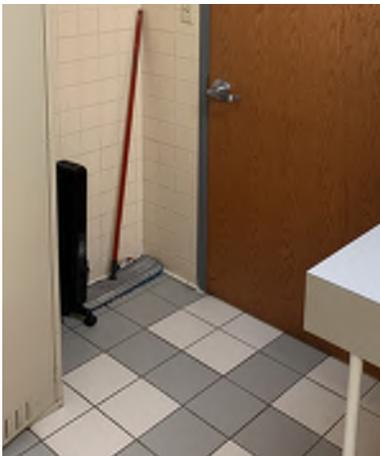
[AC-9] Obstructed door clearance

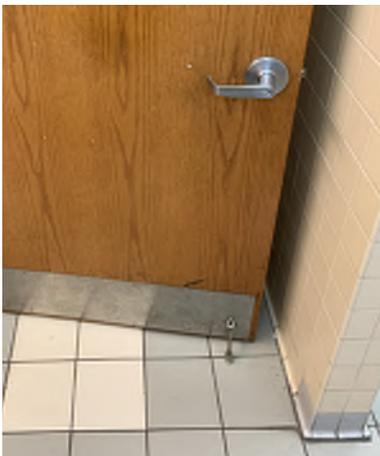
[AC-10] Obstructed door clearance

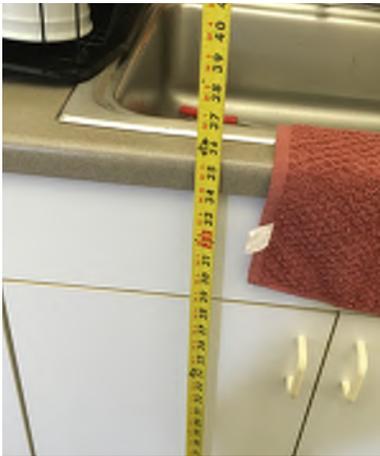
[AC-12] Non-compliant worksurface

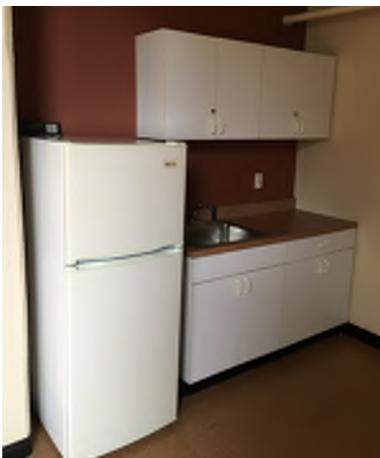
[AC-13] Non-compliant kitchenette

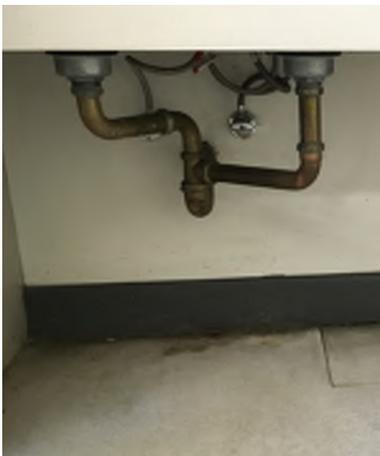
[AC-14] Exposed drain pipes

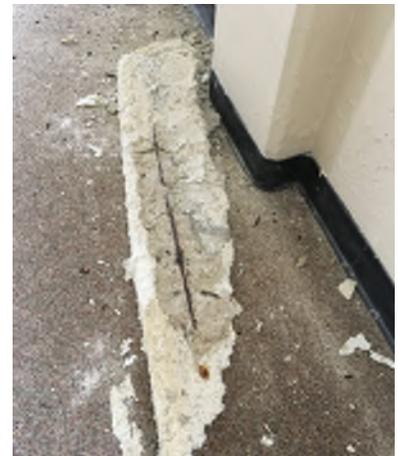
Fallen insulation [A-5]

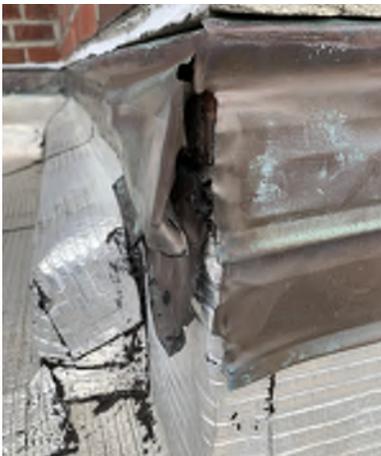
[A-8] Damaged counterflashing

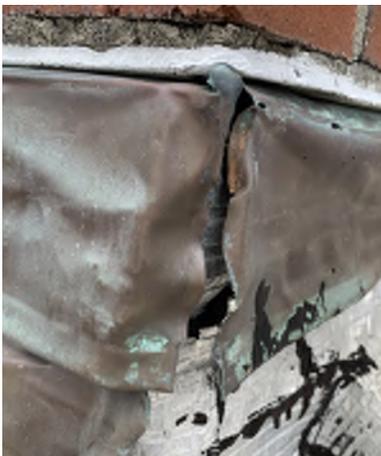
[A-10] Damaged counterflashing

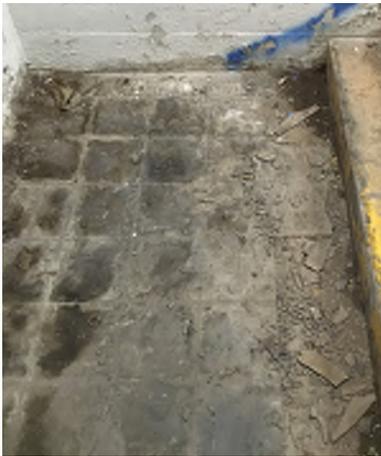
[A-24] Asbestos floor tile

There is a wide variety of finish treatments throughout and no real cohesive connection between them [Figure A-19]. For flooring, there is: carpet (both broadloom and tile) at corridors and offices; cork flooring and wall base at Level 2; sheet vinyl flooring at Level 3 exhibit spaces; vinyl composition tile (VCT) at laboratories and common areas; ceramic/porcelain tile at restrooms; and rubber treads at interior stairways. Though beyond the scope of this assessment, two (2) fields of exposed asbestos tile were observed in the basement, and Facilities staff indicated that the cork at Level 2 may have been utilized to contain a hazardous material in-place [Figures A-24 and A-25]. Regardless, these materials can compromise a safe, healthy work environment; they should be removed.

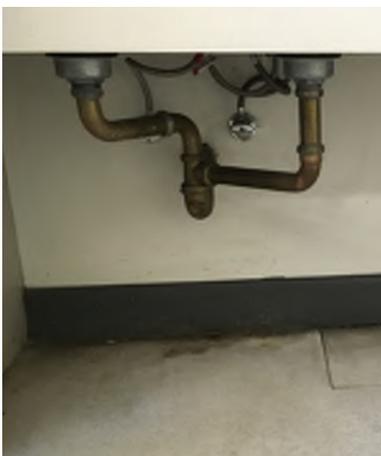
[AC-14] Exposed drain pipes

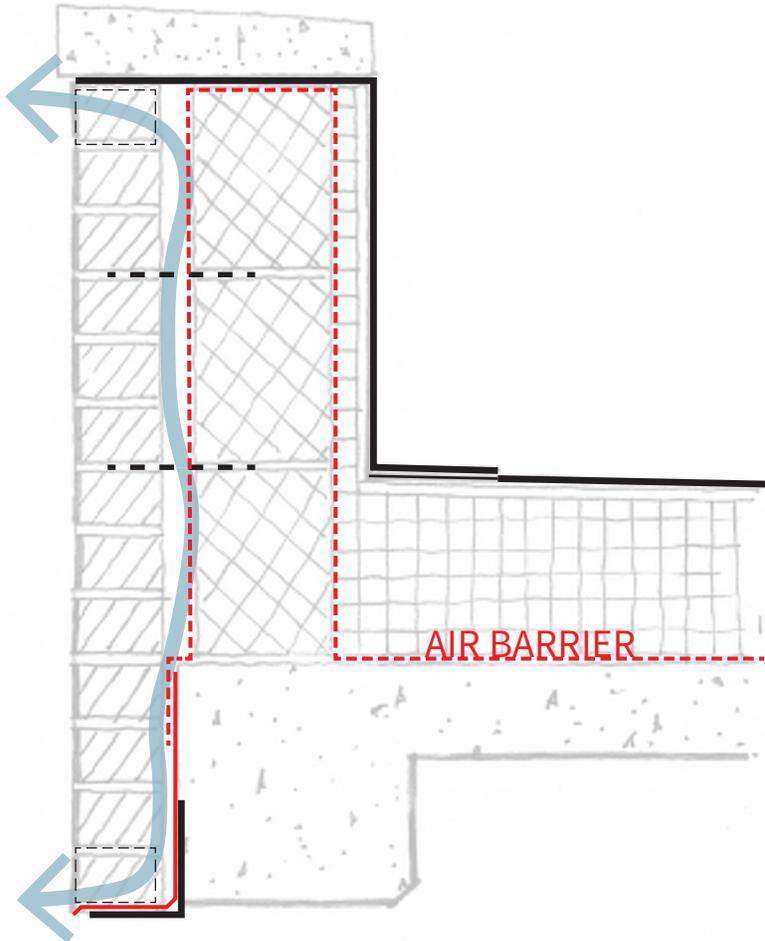
Potential parapet cavity detail [A-29]

Due to the cost and disruption to the existing historic fabric, a full demolition of existing and rebuild of the exterior walls to include an internal cavity is neither reasonable or feasible. However, given the failed attempts at solving the water infiltration issues, now is a time to consider doing so at the parapets. Because of the building's historic classification, if rebuilt, the exterior wythe of brick, at a minimum, should be retained. Pending approval by the SHPO, salvaged bricks from the inner-most wythes could be used to replace defective or incompatible units in the outer-most wythe, while concrete masonry units could be used facing the roof. A 1-inch minimum cavity, equipped with drainage net, continuous through-wall flashing, and weep vents, is recommended between the outer brick wythe and internal masonry wythe [Figure A-29]. Upon removal of the existing parapets, any internal damage to the concrete structure or steel lintels could be identified and repaired.

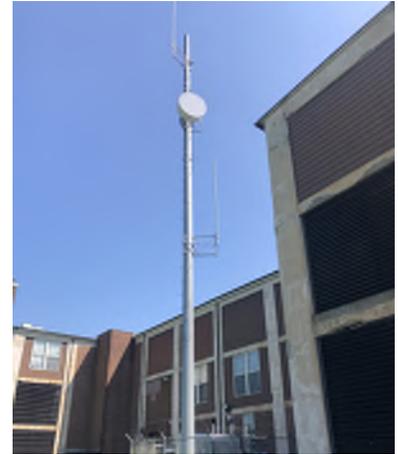
[L-4]

drive forks, providing access to the freight elevator and Park Police entrance respectively. Within the “V” of the fork, there is a radio tower for Dispatch operations [Figure L-4].

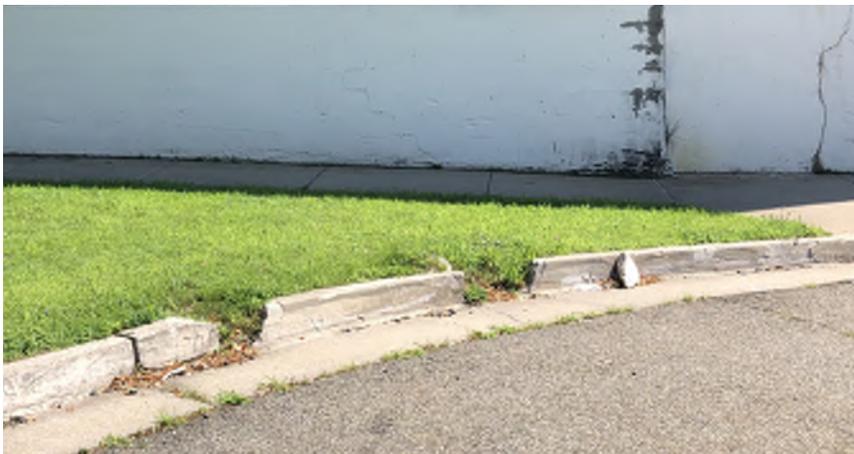
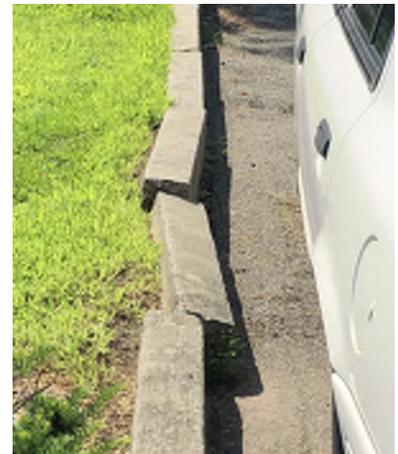
Wearing surfaces of on-site pavements are in good condition with no obvious potholes or pavement defects to impact drivers. Numerous cracks within the asphalt driving surfaces are not currently impacting the drivability, but potentially lead to future near- and medium-term issues caused by winter freeze-thaw cycles. Seasonal weeds have emerged in quite a few areas [Figure L-5]. Associated curbs and gutters adjacent to drive aisles are in good condition. Notable exceptions are at the Park Police and northwest parking lots. Damage incurred in these two (2) locations are different. At the Park Police lot, there is segmental displacement, while curved sections at the northwest lot are fractured [Figures L-6 and L-7]. Both are likely due to impact from vehicles.

Repair, replace, or reset broken and displaced curbs. Consider using steel-faced and/or reinforced curb to extend their life.

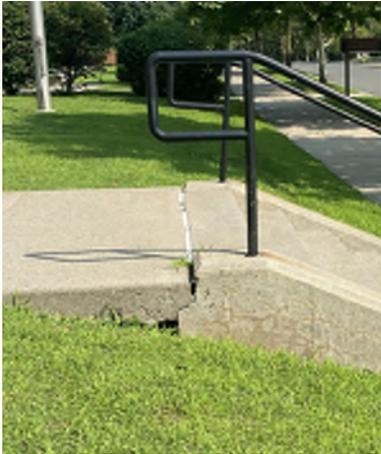
[L-8]

The small, cast-in-place concrete steps traversing the berm between the New York Avenue sidewalk and the building sidewalk are in fair condition. Erosion of the lawn and soil along the cheek walls has exposed the foundations

and initiated separation between the walking surface and stairs [Figure L-8]. Continued exposure will lead to destabilization of the hardscape.

The small staircases connecting the New York Avenue sidewalk to the primary building sidewalk are in relatively good condition, but the softscape abutting the cheek walls needs attention. Any cracks in the sidewalk or adjacent cheek walls must be repaired, and the slope stabilized. This can be achieved by replacing inches of topsoil and planting grasses with deep roots, as the slope is gentle and does not require intensive stabilization.

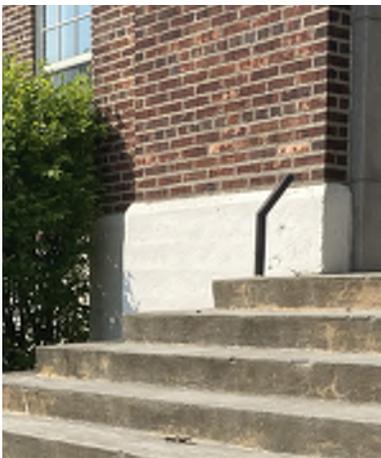
[L-9]

There is visible deterioration at all four (4) pyramidal staircases on the east side of the building. The concrete is cracked and chipped, and the finish has worn off in various places making degradation noticeable from afar. Spot repairs have been made over time, but issues discussed throughout this report continue to exist. Associated handrails are in poor condition, as some are loose or even completely missing [Figure L-9].

- High Priority, 1 – 2 Years
  - Repair/Replace stairs and handrails along New York Avenue façade
  - Remove and replace the northwest ramp
  - Repair cracked and heaving sidewalks

Though currently functional, staircases leading to each of the four (4) primary entrances should be replaced in order to safely serve occupants. The proclivity of cracking and chipping suggests that the cause correlates directly with the original construction method. Spot repairs will remain unproductive. The new cast-in-place stairs should resemble the existing and include embedded handrails of a complementary design and durable material. Despite there being no requirement, it would be beneficial to add handrails to the adjacent accessible walking path as well so that an optimal experience for users with disabilities can be provided. In conjunction with

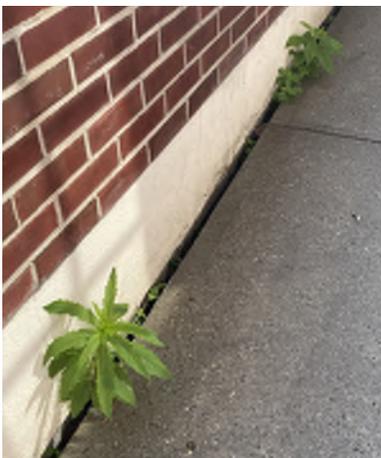
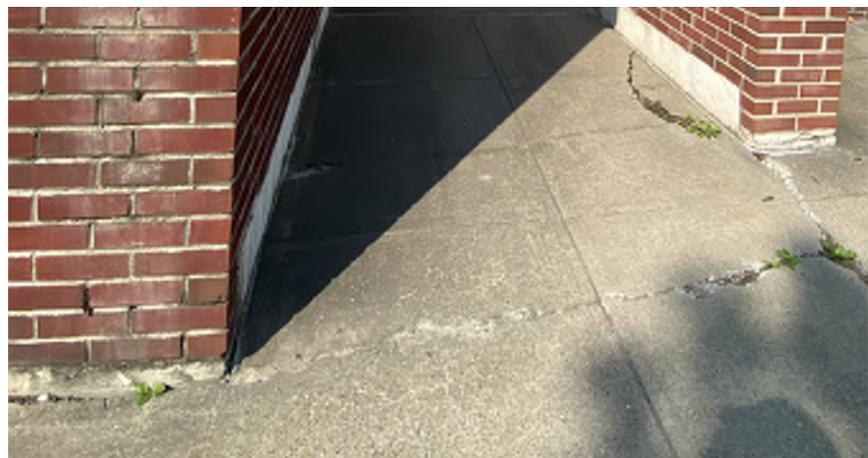
The sloped walking surfaces, enclosed by brick walls, make up the only path to an accessible entrance on the east side of the building. Attention was paid to the composition, as the small plaza atop the stairs makes the addition feel original. However, while close, the brick color chosen is clearly different when compared to the original. After 20+ years, there are various signs of deterioration including cracks in the concrete, spalling and chipping of the brick walls, and weeds growing from within the perimeter joints [Figures L-10 and L-11]. Cracks in the walking surface are significant and present a tripping hazard [Figure L-12].

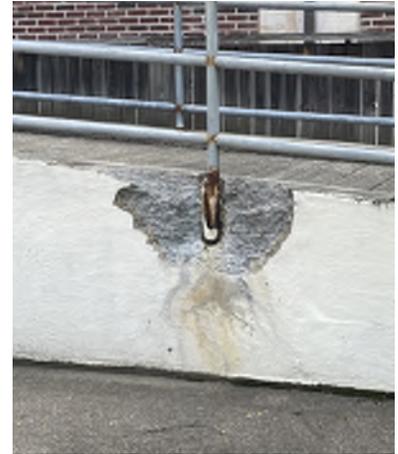
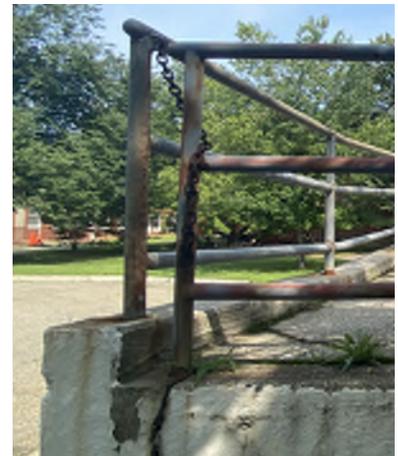
The concrete ramp/stair in the northwest courtyard is in very poor condition [Figures L-13 and L-14]. Deep cracks are visible in the support walls, and there are signs of separation at railing posts. Welded joints along the railings are corroded and ready to fail.

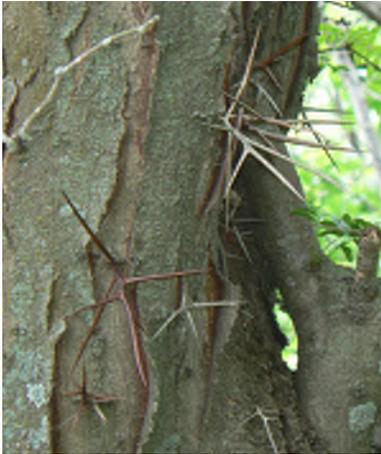
[L-15]

In the western parking lot, the Honey Locust trees selected were incorrect—the thornless variety was specified but not planted. As a result, there are trees with large, dangerous thorns located in a pedestrian area [Figure L-15]. The planting bed within the curbed island is eroded, likely because storm water flows from the asphalt to the inlet within via a curb notch. Soil has shifted from the bed to the sidewalk due to over-saturation during rain events [Figure L-17]. The Honey Locusts here do not appear to be thriving.

A new planting strategy should be designed using low-maintenance, native species that celebrate the ecology of the greater Gateway National Recreation Area. Healthy trees can be preserved but the Honey Locusts at the rear should be removed and replaced with a thornless variety. Removing these trees without replacement is discouraged as they provide the benefit of shading over the expansive hardscape. The majority of the perennial and shrub plantings have diminished over time without replacement. What is left is largely composed of non-native and invasive species, so they should be replaced.

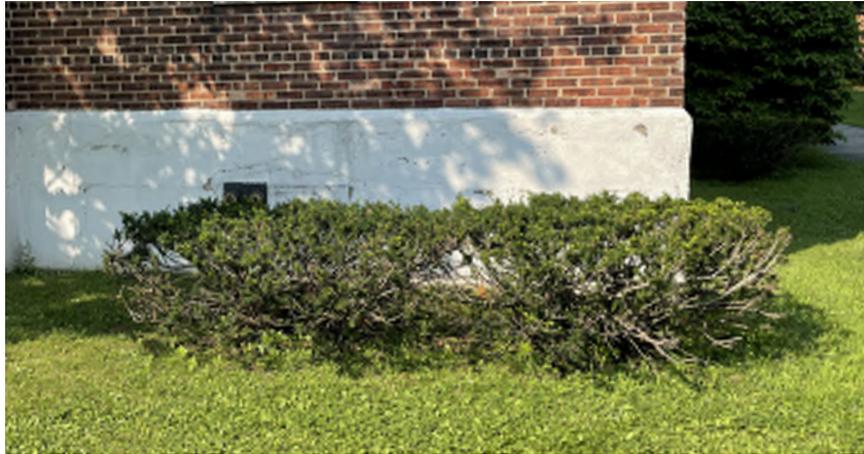
[L-16]

Variation in plant species and overall interest created by the vegetative landscape is minimal. The proposed plan from the last major renovation in the mid-1990s is more robust, so either the plants were removed from the scope, or were not properly maintained, died, and not replaced [Figure L-16]. The primary shrub species include Yew (non-native), Viburnum (non-native), Euonymus (non-native and partially invasive), and Juniper (non-native). There is no evidence of perennials left in the planted zones. Tree

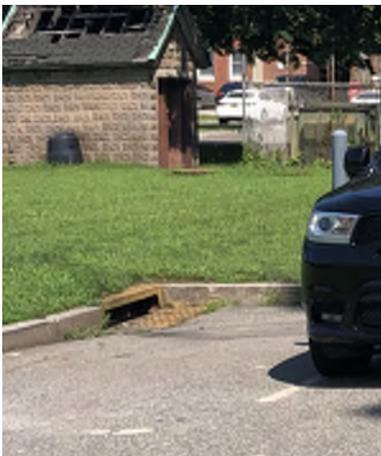
[L-18]

Based on the appearance of surface hardware (inlets, grates, and manhole covers), the existing drainage system appears to be in good condition. Several combination inlets have large curb openings that can allow the passage of large items into the drainage system [Figure L-18]. However, other than one (1) field inlet appearing clogged with debris, the drainage system seemed to be functioning well with little evidence of ponding water [Figure L-20]. Gateway staff did indicate that flooding is prevalent in areas of the northwest parking lot that are beyond the scope of this study.

Clean all drainage structures and pipes to remove accumulated sediment and debris. Replace all combined inlets with either a grate-only inlet or a new combined opening frame/grate/curb piece that has a curb opening with a smaller vertical clearance and intermediate ribs to prevent larger debris from entering the system.

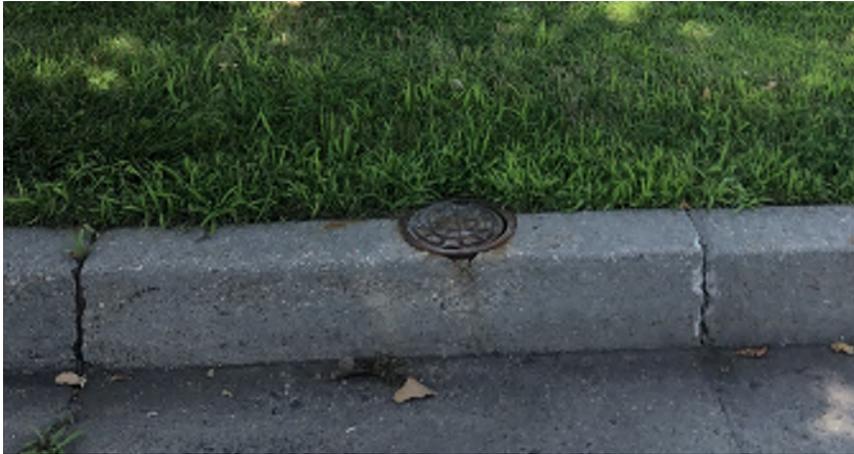
[L-19]

Electrical system components are scattered through the premises, including two (2) large transformers, a small transformer, and an emergency generator and switch gear, presumably powered by natural gas [see “Electrical” on page 69]. Other utility hardware castings appeared in good condition, but one (1) water service curb valve located just south of the lot line is located within the curb. While not damaged to date, this location could be by vehicle strike or winter plowing operations [Figure L-19].

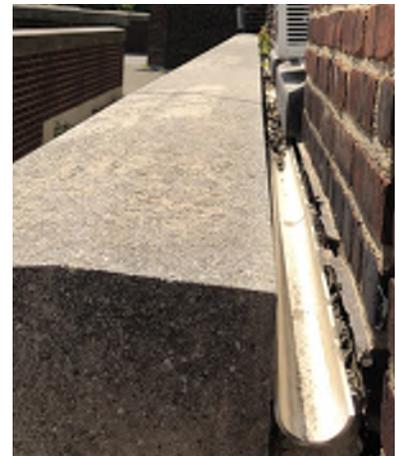
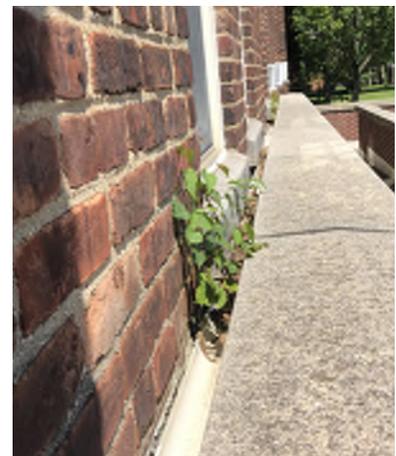
Between the original building and the walking surface addition, a half-section of PVC pipe, concealed by capstones, was installed to convey captured rainwater. Over time, differential settlement has occurred, causing the mortar and caulk sealing the gap between the pipe and the building to deteriorate and dislodge. As is the case with the parapets, the open gaps allow water to infiltrate and collect in the cavity [Figures L-21 and L-22].

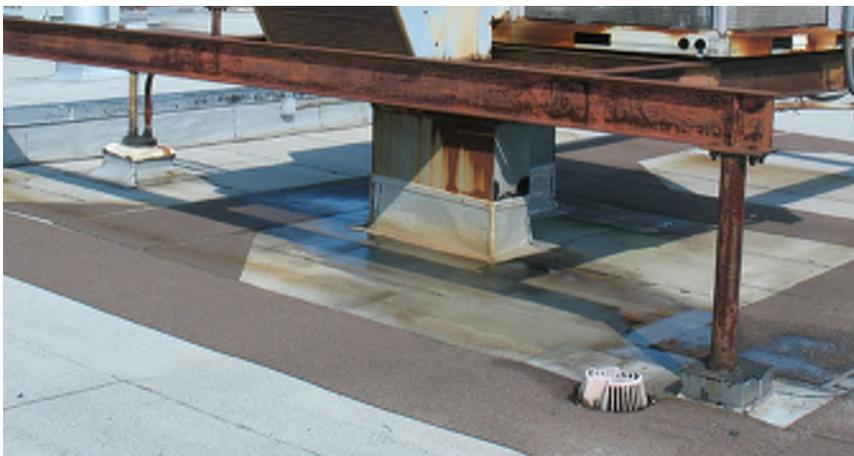
*[S-8]*

The original coating on the steel framing installed in 1977, and on the mechanical equipment platforms, has mostly or completely failed. Surface rust with moderate pitting and flaking was observed at all locations. The loss of coating and corrosion is most pronounced on the horizontal surfaces of member flanges where rainwater ponds [Figures S-6 to S-9]. Note that the corrosion process is active and ongoing.

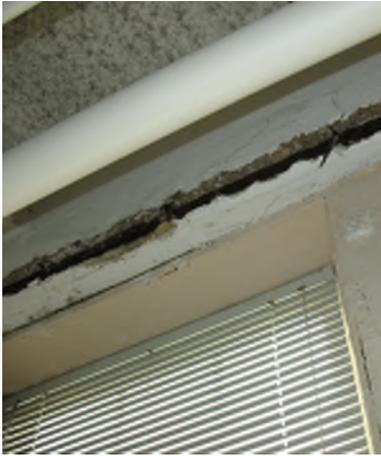
[S-10] Concrete girder deterioration

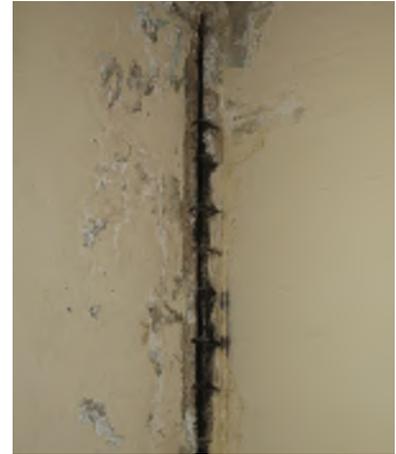
Spall with exposed and corroded reinforcement [S-14]

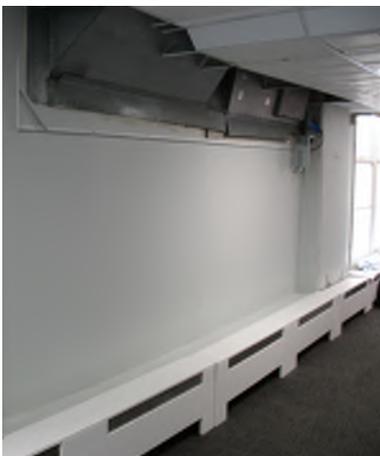
[S-32]

- Concrete beams and columns along west elevation
- Concrete beams and columns along north and west elevations of “porches” (Figures S-23 to S-26)
- Concrete and masonry failure (e.g. extensive cracking from infilled window openings, spalling, exposed and corroded reinforcement)
  - North, east, and south foundation walls (concrete)
  - West foundation walls (masonry) (Figures S-27 to S-31)
- Loose construction under moderately-applied pressure
  - Exterior west wall along grid line “E” at Level 2, between grid lines “23” and “24.” This wall is non-original, wood-framed infill and contains a mechanical louver [Figure S-32].
- Non-functioning or missing expansion joint covers and/or filled joints.
  - Building expansion joint between grid lines “7” and “8”
  - Building expansion joint between grid lines “21” and “22”

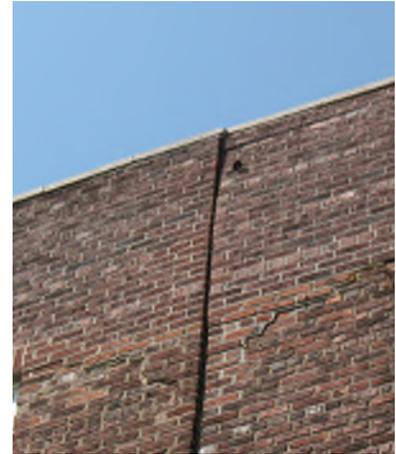
[S-33]

At the interior, building expansion joints have been filled with cementitious parging at column faces, or fabricated joint covers that do not appear to allow for adequate movement were installed. Besides visual observation, this issue is evidenced by out-of-plane differential wall movement at the east elevation parapet wall. Plus, there are east-west cracks observed at Levels 1 and 3 extending through the slabs and beams of the respective floors, crossing several building bays. Previously installed crack monitors were observed along the cracking at Level 3. It is also possible that the expansion joints, as originally located, and previous reconstruction of the east parapet wall, have contributed to the cracking and out-of-plane conditions [Figures S-33 to S-34].

prefabricated expansion joint material. For interior locations, replace joint covers that do not allow for movement, or bridge the joints with covers fastened to each side.

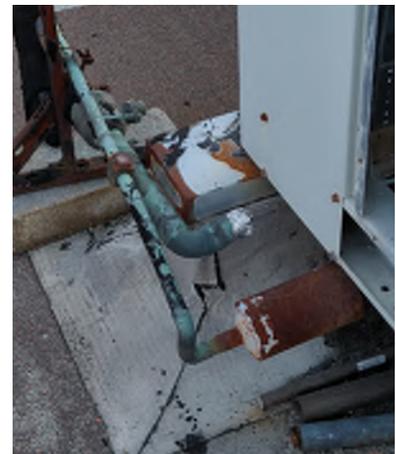
[M-1]

None of the existing air-cooled condensing units associated with Level 1 are operational; most have been disconnected from their associated refrigerant piping [Figure M-1]. The air handling units for Level 1 are operating, but because the condensing units have malfunctioned, there is no active cooling. The units are simply recirculating ambient air. Due to a lack of cooling by the main system, window-mounted air conditioning units have been added. There is also a mini split system that appears to serve the Collections Room.

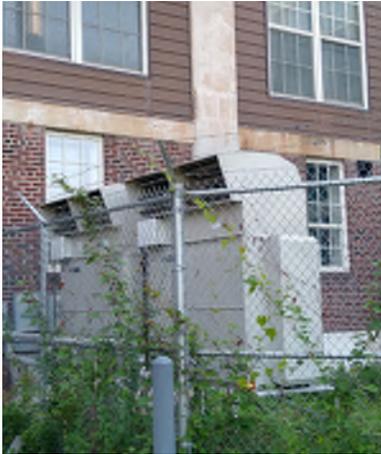
[M-2]

Dispatch, recently renovated and an outlier of Level 1, is conditioned by a variable refrigerant flow (VRF) system [Figure M-2]. In this system design, untreated outdoor air is brought in through a small louver above the ceiling at the west wall. The untreated outdoor air is ducted directly to each of six (6) fan coil units where it is conditioned locally [Figure M-3]. Refrigerant piping interconnects the fan coil units to two (2) large outdoor condensing units and is used for the localized cooling.

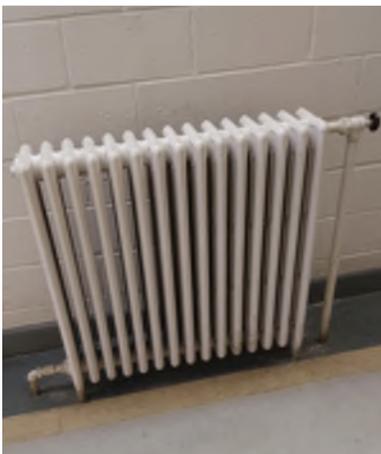
[M-4]

For heating, there are several hot water radiators along the exterior walls on Levels 1, 2, and 3. The radiators are in fair condition [Figure M-4], but the system itself may be original to the building as it is diagrammed in drawings dated 1927. Hot water unit heaters are dispersed throughout the Basement, including the laboratory at the south end, and are in fair condition.

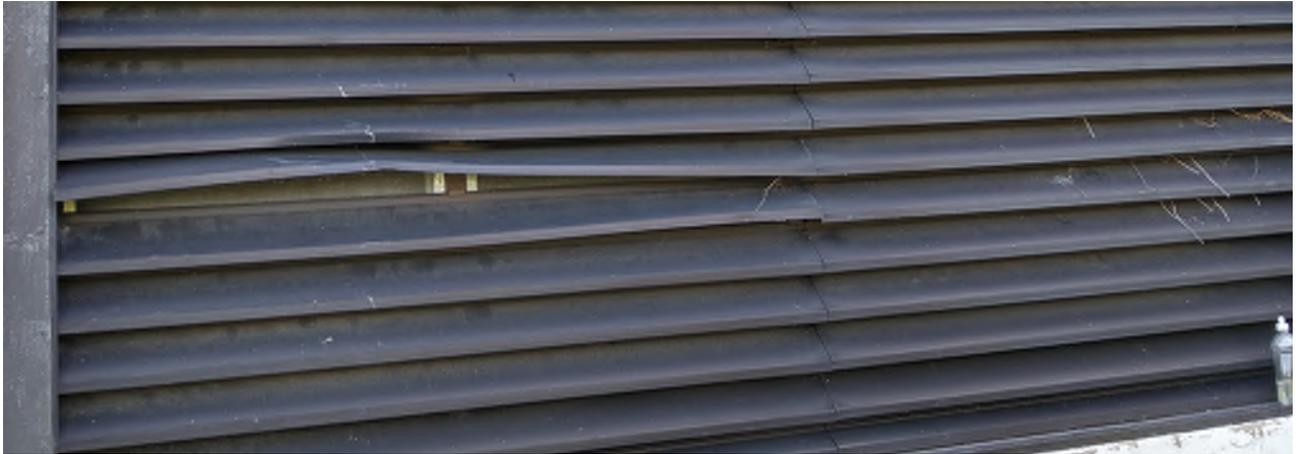
[M-5]

- AHU-1A, Level 1
  - 8,200 CFM of supply air; 1,000 CFM of outdoor air; external return air fan sized for 7,800 CFM
  - Located in a dedicated mechanical room on Level 1
  - Manufactured by Trane; Installed in 1996
  - Fair condition, but well past its expected life
  - Air intake louver is damaged [Figure M-5]
- AHU-1B, Level 1
  - 8,200 CFM of supply air; 1,000 CFM of outdoor air; external return air fan sized for 7,800 CFM
  - Located in a dedicated mechanical room on Level 1
  - Manufactured by Trane; Installed in 1996
  - Fair condition, but well past its expected life

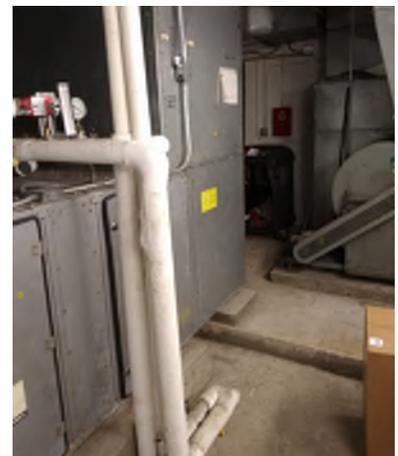
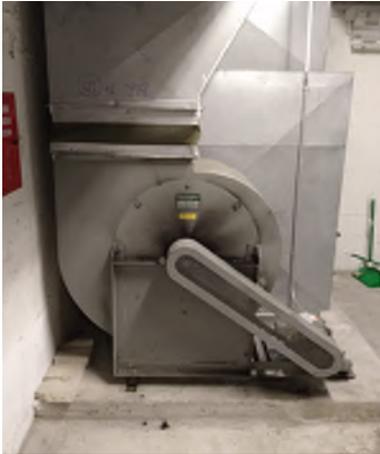
- AHU-1C, Level 1 [Figure M-7]
  - 8,200 CFM of supply air; 1,000 CFM of outdoor air; external return air fan sized for 7,800 CFM [Figure M-8]
  - Located in a dedicated mechanical room on Level 1
  - Manufactured by Trane; Installed in 1996
  - Fair condition, but well past its expected life

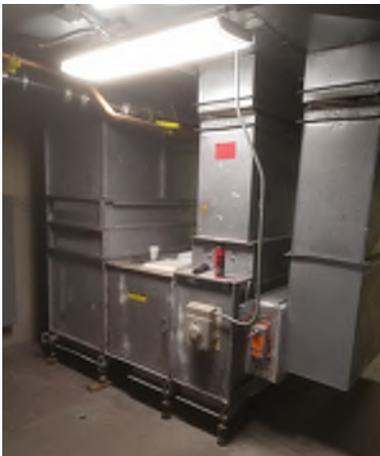
[M-9]

- Unnamed, Level 2 (North) [Figure M-9]
  - CFM undetermined
  - Located in a dedicated mechanical room on Level 2
  - Manufactured by Trane; Installed in 1996
  - Fair condition, but well past its expected life

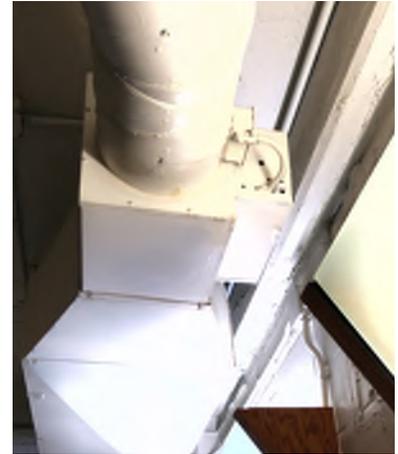
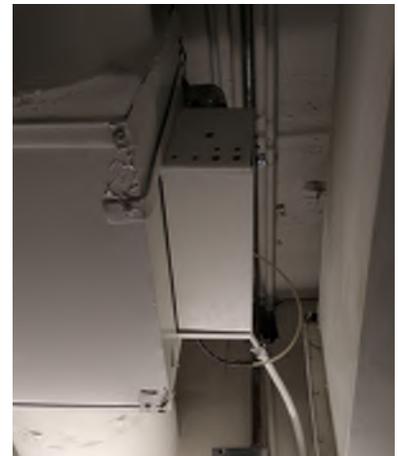
There are several VAV boxes that do not have the clearance required in front of their control panels [Figures M-11 and M-12].<sup>32</sup> Some outdoor air intake louvers at Level 2 are immediately adjacent to relief louvers and/or exhaust fans [Figure M-13]. At least 10 feet between these elements will avoid recirculation of exhaust/relief air back into the building.<sup>33</sup>

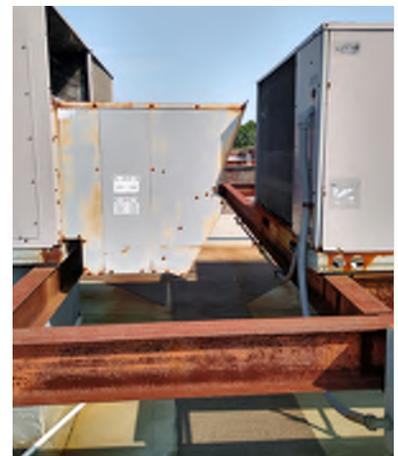
[M-14]

RTU-5 and RTU-7 were not operating  
All units are rusted, particularly the base rails and gas piping  
[Figure M-14]

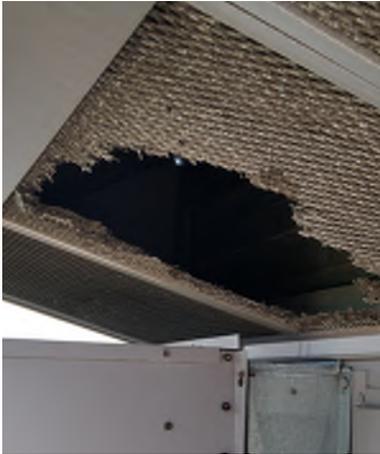
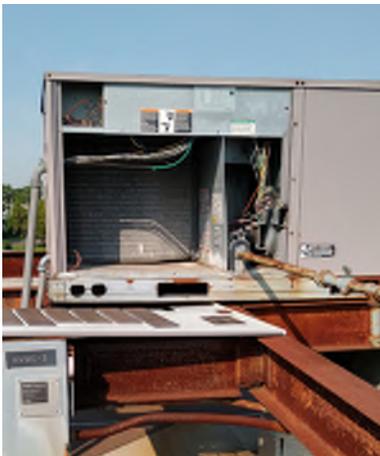
The outdoor air intake hood for RTU-7 is too close to the condensing unit for RTU-8. This can cause hot air discharge from the condenser to enter the intake, requiring additional cooling. The intake for RTU-4 has a large hole in the bird screen, and the cover panel for RTU-3 has been removed [Figures M-15 and M-16].

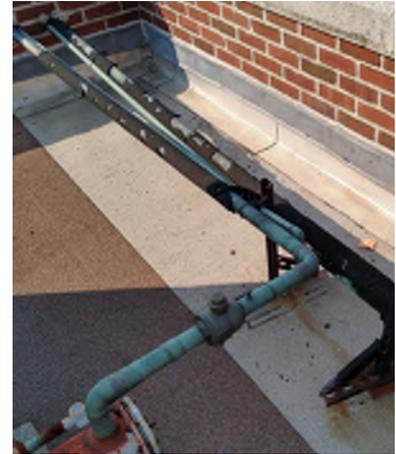
[M-18]

- Refrigerant Piping [Figure M-18]
  - Poor condition
  - Associated insulation is deteriorated and in poor condition
  - Exposed lines at the Budget Office (Level 1); condensation is dripping due to the fallen insulation [Figure M-19]
- Ductwork & Diffusers
  - Good to fair condition
  - Neither supply or return air networks are insulated, including exterior ducts
  - Noisy; likely due to above normal air velocity
  - Cold air drafts in the laboratory on Level 2

Loose or fallen insulation for refrigerant piping needs to be replaced as soon as possible. Condensation from exposed piping is and will continue to cause damage to furniture, fixtures, and finishes.

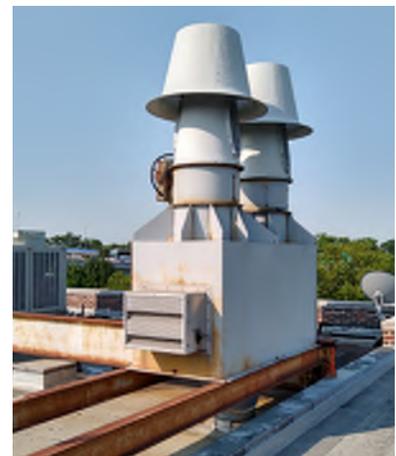
[M-20]

There is significant vibration caused by the two (2) roof-mounted exhaust fans associated with the Level 2 laboratory [Figure M-20]. Vibration could be felt standing on the roof slab, so energy is traveling through the rooftop steel structures and through the concrete. Typically, vibration isolators are installed under these units, but none were observed. The fans themselves show signs of corrosion from the local salt-infused air.

- High Priority, 1 – 2 years
  - Replace fallen insulation on refrigerant piping
  - Fix/Replace the damaged louver in the Boiler Room
  - HVAC on Levels 1 and 3 (excluding Dispatch)
  - Install vibration isolators at rooftop exhaust fans
  - Relocate intake and exhaust louvers at Level 2
  - Provide intake louvers sized to handle 100% outdoor air during economizer mode
- Moderate Priority, 2 – 3 Years
  - Replace HVAC at Level 2 (South)
  - Provide ventilation for the Basement

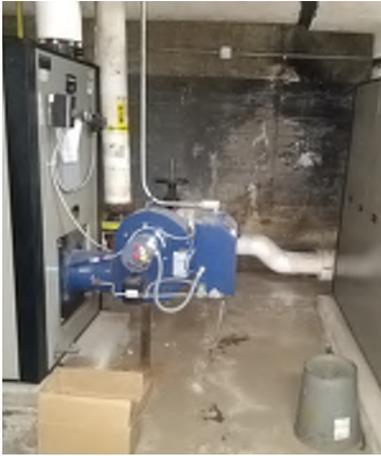
[M-21]

Boiler 1 is installed in very close proximity to Boiler 2. There does not appear to be enough clearance to pull out the burners for service [Figure M-21]. An exterior opening exists in the Boiler Room, which likely handles the relief air for the space. The louver intended to cover the opening has fallen.

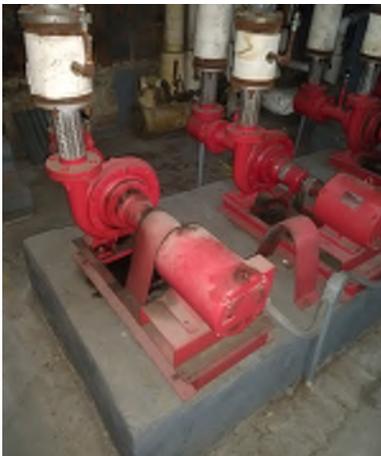
[M-22]

The boiler pumps do not have vibration isolators [Figure M-22]. These pumps produce a good amount of vibration, so without isolators, the vibration can be transferred to the building structure and either cause damage or affect occupant comfort.

- Replace the Boiler Room heating and ventilating unit
- Provide vibration isolators for heating water pumps
- Low Priority, 4 – 5 Years
  - Replace HVAC at Level 2 (North)
  - Replace toilet exhaust fans
  - Replace all heating water pipe insulation
  - Replace heating water piping in fair or poor condition

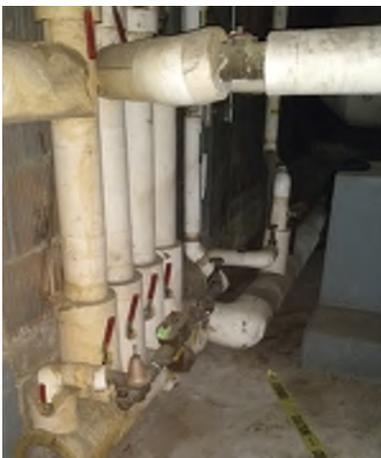
[M-23]

Heated water piping within the Boiler Room is covered with dirty fiberglass insulation. For the most part, the insulation is in fair condition, but there are areas where the insulation has fallen or is older and in poor condition [Figure M-23]. Outside the Boiler Room, the heated water piping is insulated with a combination of fiberglass and elastomeric insulation. Much of the elastomeric insulation is wrapped with layers of duct tape [Figure M-24]. Unlike in the Boiler Room, most of the insulation is in fair to poor condition. Where the insulation is still properly installed, the condition of the piping could not be verified. Some of it appears to have been installed in 2009 and is likely in good to fair condition.

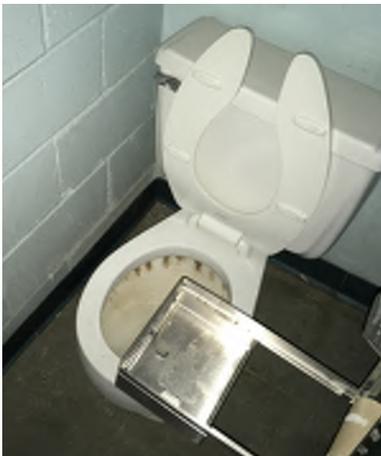
[P-10]

- Basement Restroom
  - One (1) floor-mounted water closet [Figure P-10], one (1) lavatory
  - Located near the base of Stair C
  - Poor condition; appears to be unused
- Basement Laboratory
  - One (1) trough sink [Figure P-11]
  - Located at the base of Stair A
  - Fair condition
- Level 1 (South) Group Restrooms
  - One (1) Mens wall-mounted water closet, one (1) urinal, two (2) Womens water closets, two (2) total lavatories
  - Automatic flush valves and faucets
  - Two (2) total floor drains
  - Two (2) drinking fountains; bi-level [Figure P-12]
  - Located adjacent to Stair B
  - Good to fair condition

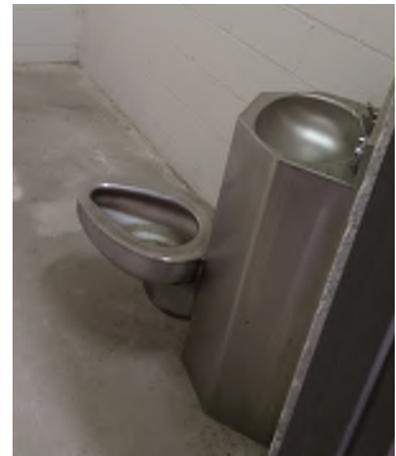
[P-13]

- Park Police Holding Cells and Interview Room
  - Two (2) total stainless steel combination water closet/lavatory units [Figure P-13], one (1) stainless steel two-compartment kitchen sink
  - Manual operation
  - Fair condition

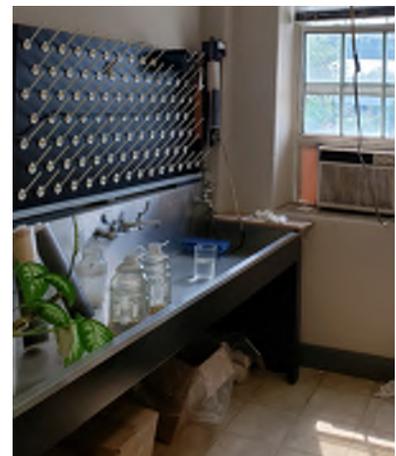
[P-14]

- Superintendent’s Unisex Restroom
  - Inaccessible during walk-through
- Level 2 Laboratory
  - Two (2) lab sinks [Figure P-14], one (1) emergency shower/eyewash [Figure P-15], several hose bibs

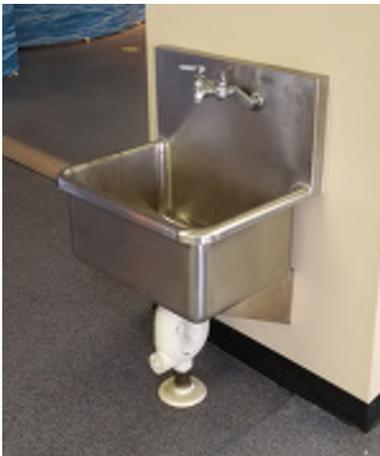
[P-17]

- Level 3 Exhibits
  - Two (2) stainless steel single-compartment utility sinks [Figure P-17]
  - Two (2) cold water hose reels
  - One (1) floor drain
  - Good condition

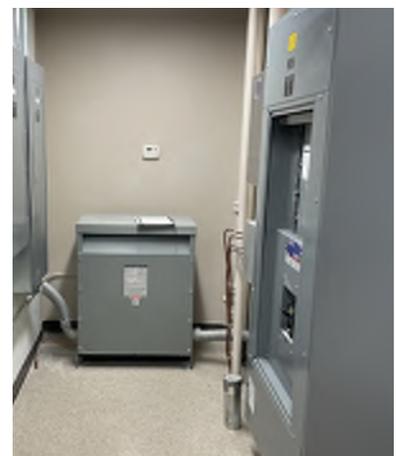
*Dispatch electrical room [E-3]*

electrical room, specifically for Dispatch, that feeds electrical equipment within a closet in the space [Figure E-3]. It is assumed that this equipment will require no work as part of a future modernization of the building.

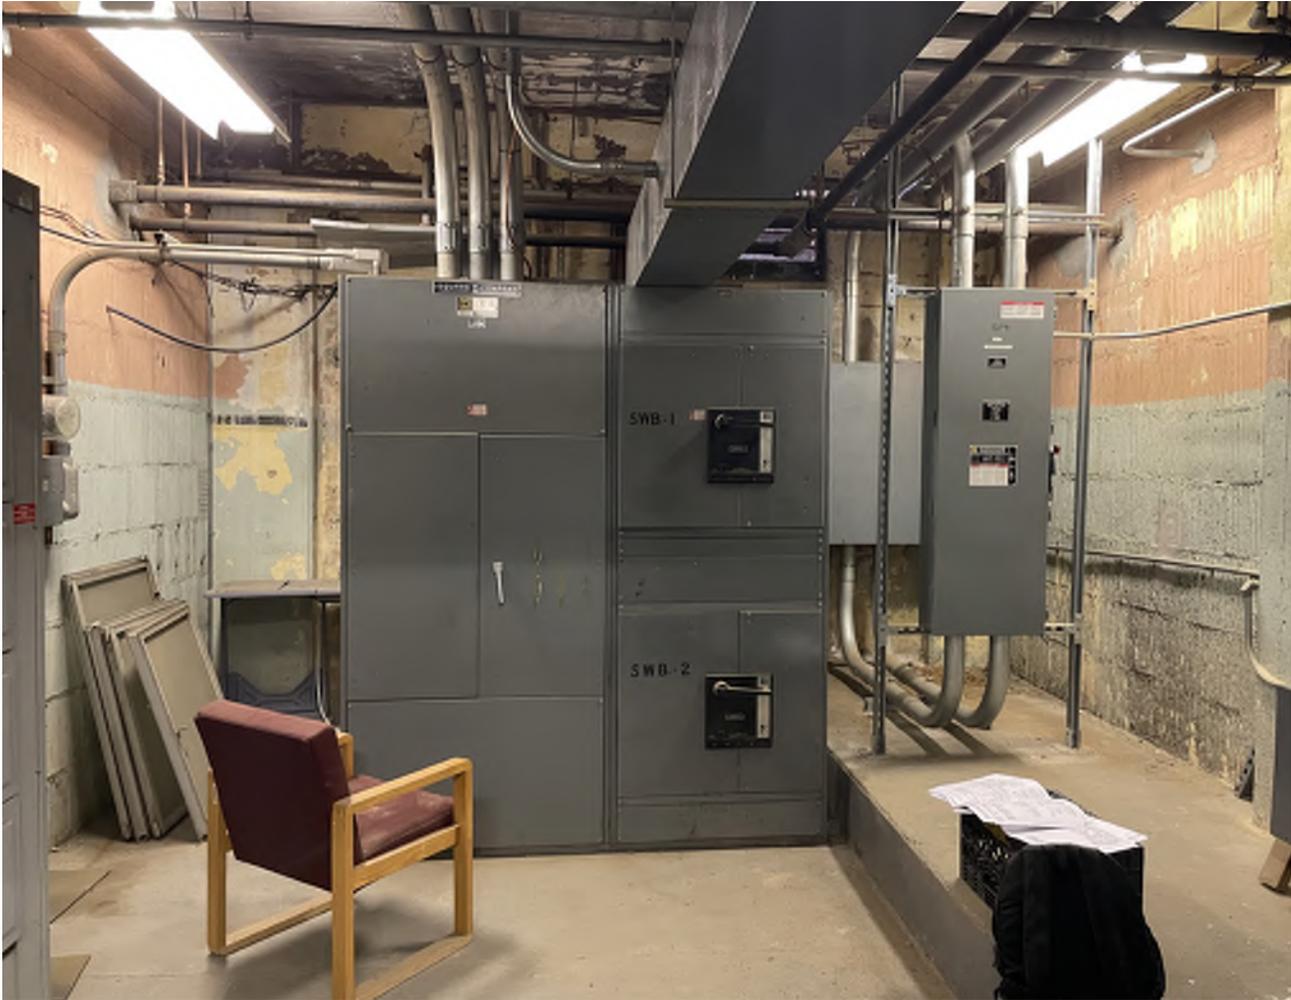
Secondary service to the building is routed underground from the transformer to a main switchboard (SWBD-Main) at a centrally-located electrical room in the Basement [Figure E-4]. The majority of the facility’s electrical distribution equipment is located here. Other branch circuit panelboards are dispersed throughout the basement, and in mechanical rooms, lab spaces, and stairwells Levels 1, 2, and 3.

[E-4] Basement electrical room

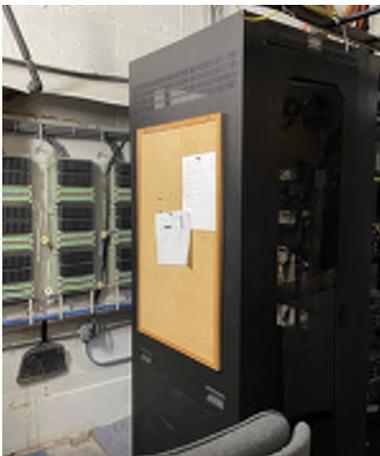
The main communications equipment is located within a telephone room in the Basement. The room is secured and is across a hallway from the main electrical room [Figure E-5]. There are telephone punch down blocks, network interface boxes, fiber connections, and a data rack. The data rack has a series of service routers, network switches, computer servers, and uninterruptable power supplies that serve the various office spaces throughout the building.

[E-5] Basement telecommunications room

The main telecommunications equipment in the Basement is in very good condition. Items appear to have been updated as new technologies to improve working conditions, security, and internet speeds have emerged. Exposed data cable trays exhibit great workmanship, as cabling is routed in a neat and organized fashion. These trays can be reused when the building is modernized.

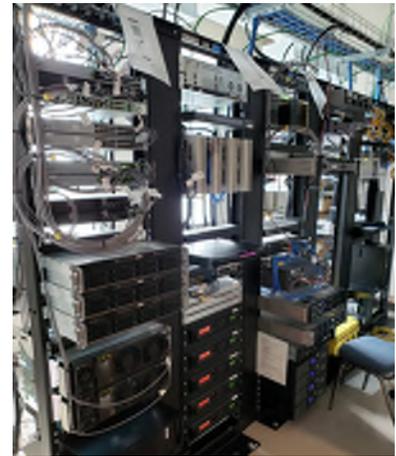
Similar to the electrical system, Dispatch has its own communications systems. Two (2) conduits and cabling from the main telephone room travel through the open basement and up to a telephone room in the Dispatch space [Figure E-6]. The data rack has service routers, computer servers, network switches, and phone, security video, and radio equipment. A large, functioning radio tower is located outside the building at west side. It is assumed this equipment will require no work as part of a future modernization of the building.

Dispatch telecommunications room [E-6]
