# PRE-PLANNING FOR THE MAJOR RENOVATION OF BUILDING 210

ASSET CONDITIONS  
ASSESSMENT AND ANALYSIS

PMIS #310907A

December 1, 2021

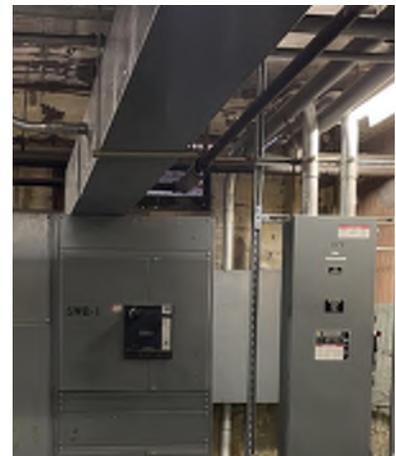
There are numerous water pipes running directly over the main switchboard [Figure E-7]. To alleviate this issue, a temporary drip pan and hose was installed in the event a pipe(s) was to leak. This is a code violation for dedicated working space for electrical equipment.<sup>36</sup> Since this is the main switchboard for the building, if water were ever to get in this equipment and cause a problem, there would be significant downtime to replace it. However, because Dispatch and Park Police are backed up by generators, those areas could still operate if such a failure was to occur.

<sup>36</sup> **NFPA 70 National Electric Code, Section 110.26(E)(1)(a).** All switchboards, switchgear, panelboards, and motor control centers shall be located in dedicated spaces and protected from damage. No piping, ducts, leak protection apparatus, or other equipment foreign to the electrical installation shall be located in this zone.

Pipes over Switchboard Main [E-7]

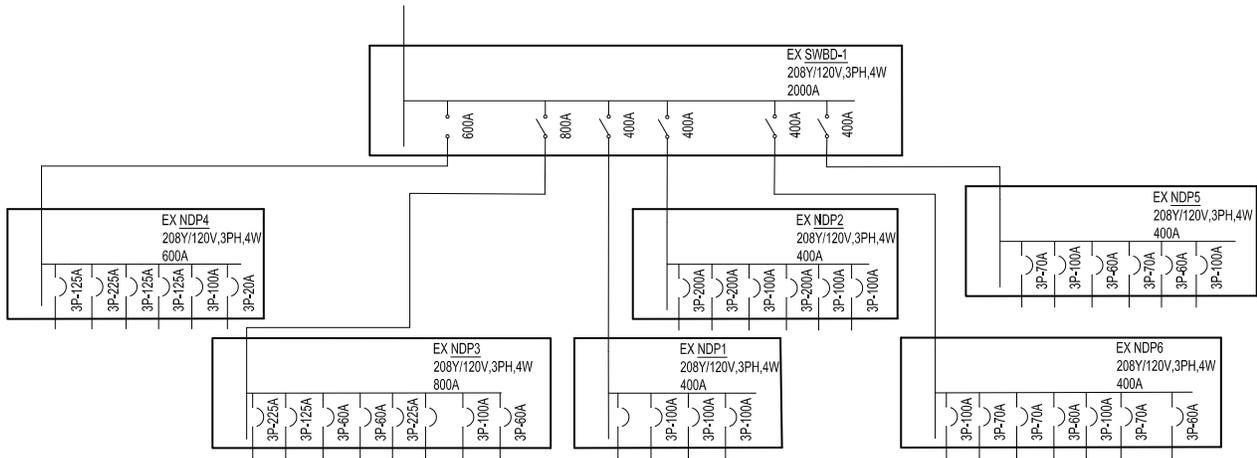
- Switchboard 1 [Figure E-9]
  - 2000-amp, 208Y/120V, 3-phase, 4-wire switchboard
  - Fed from a 2000-amp service disconnect in the Switchboard Main
  - Located in the Basement electrical room
  - Serves six (6) main panelboards also located in the Basement
  - Installed prior to the 1995 renovation
  - Good condition, but has outlived its useful life

[E-9] Switchboard-1 one-line diagram

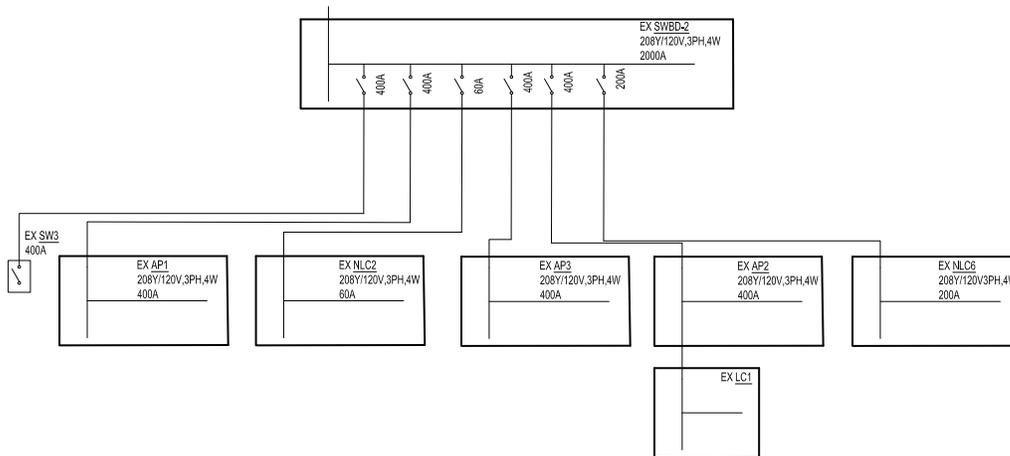
[E-10] Switchboard-2 one-line diagram

- Switchboard 2 [Figure E-10]
  - 2000-amp, 208Y/120V, 3-phase, 4-wire switchboard
  - Fed from a 2000-amp service disconnect in the Switchboard Main
  - Located in the Basement electrical room
  - Serves five (5) main panelboards and a safety switch also located in the Basement
  - Installed prior to the 1995 renovation
  - Good condition, but has outlived its useful life

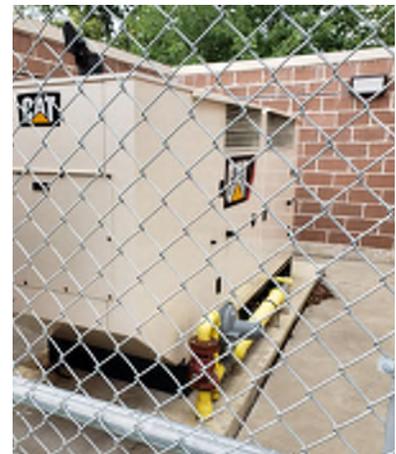
Dispatch generator [E-15]

When Dispatch was renovated six (6) years ago, a 150kw, natural gas-powered Caterpillar generator was installed to provide emergency backup for that service. It is located at the west side of the building and within a masonry enclosure for protection and security [Figures E-15 to 16]. The system has an automatic transfer switch, a manual transfer switch, and a docking station for connecting to a roll-up temporary generator in the event the main generator were to fail. This redundancy is vital given the importance of Dispatch operations. A remote generator status panel resides within the open office of Dispatch. The system appears to be in good working order. It is assumed this equipment will require no work as part of a future modernization of the building.

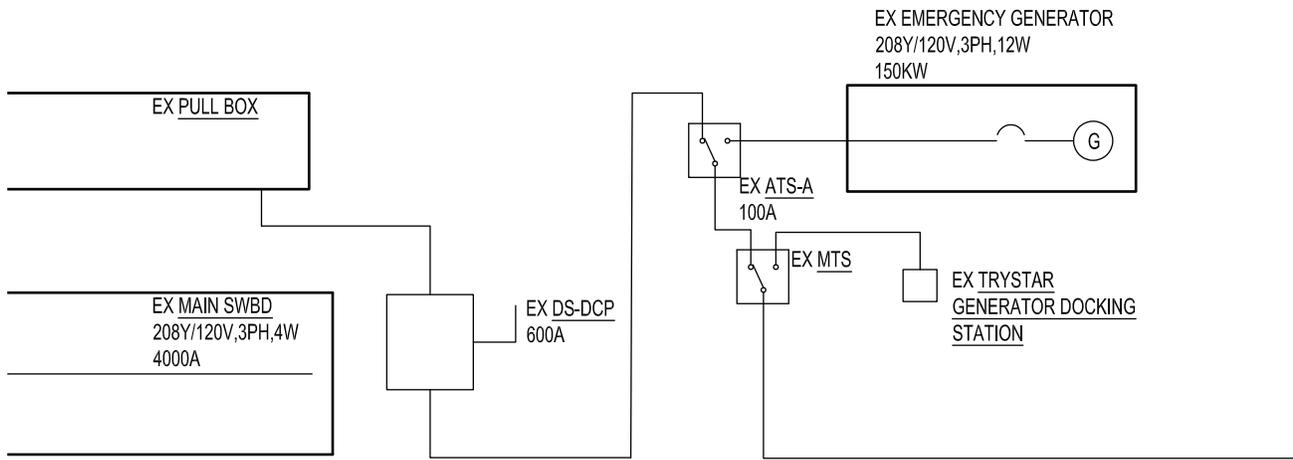
[E-16] Dispatch emergency power one-line diagram

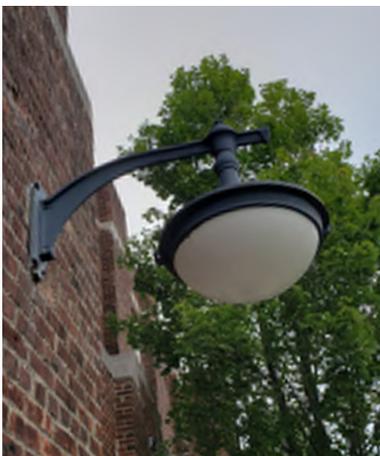
Limited exterior lighting was observed around the perimeter of the building. At each of the four (4) main entrances along New York Avenue, there are two (2) decorative wall sconces [Figure E-19]. Both the northeast and northwest

[E-19] Decorative exterior sconce

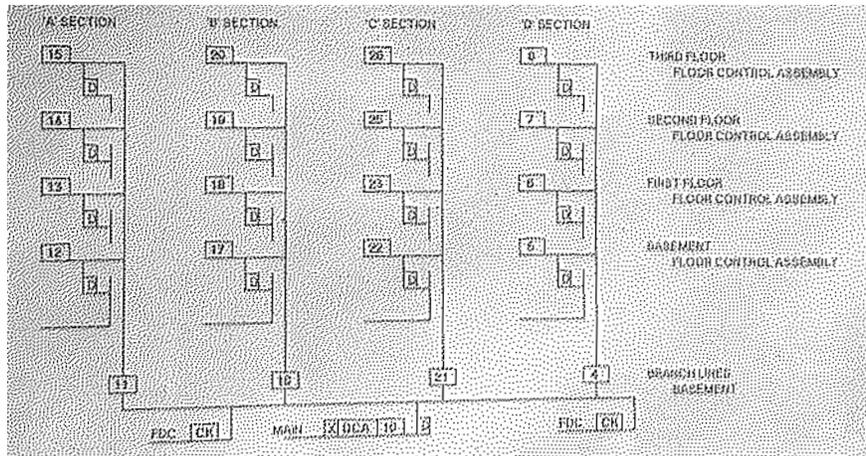
Each stairwell riser is equipped with a 4-inch “outside screw and yoke” (OS&Y) control valve, which allows the riser to be isolated, and a floor control valve assembly. The control valve assembly consists of a supervised butterfly control valve, water flow switch, and test/drain at each floor level. Each floor level is divided into four (4) zones covering approximately 6,000-7,000 square feet. A schematic of the full system was observed during the walk-through [Figure FP-3].

Given the configuration described above, the absence of a hydraulic placard, and no hydraulic-centric information in previous drawing sets, the system was likely installed via the pipe schedule method, common of the 2000s, as opposed to a hydraulically-calculated system. A pipe schedule system is one of which pipe sizing is selected from a schedule that is determined by the occupancy classification of the building. The schedule provides a given number of sprinklers allowed to be supplied from specific sizes of pipe. Alternatively, a hydraulically-calculated system uses a mathematical analysis of the water-carrying capacity of the pipe network to ensure that adequate

[FP-3] System schematic diagram

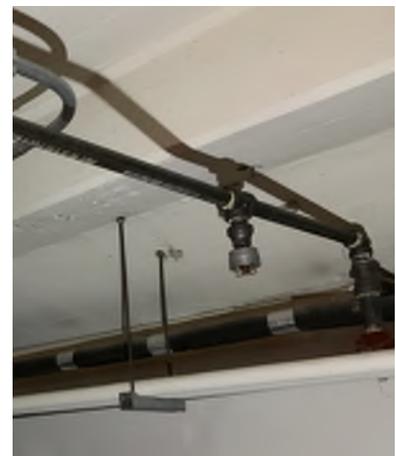
Non-compliant sprinkler head location [FP-6]

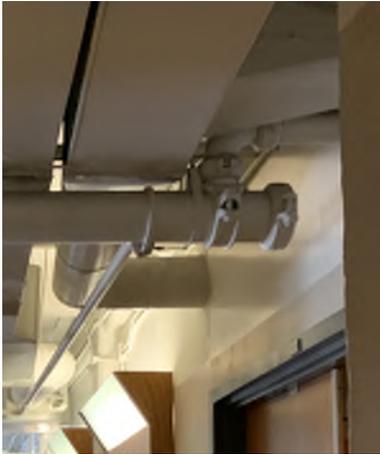
[FP-7] System obstruction

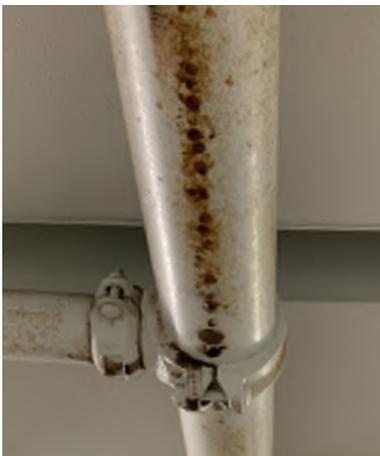
[FP-8] Surface corrosion

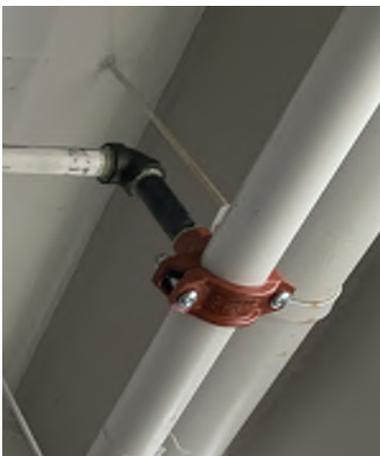
[FP-9] Retrofitted mechanical tee fitting

- The water flow switch on the system appears to be a retrofit, as typically alarm check valves will employ water motor gongs and pressure switches for water flow notification.
- Numerous saddle tees, or mechanical tee fittings, exist throughout the system [Figure FP-9]. These fitting types are used in retrofits as they can save time and money. In general, they have a higher rate of failure and should only be used in spot conditions, not throughout an entire building.
  - Installation involves drilling a hole into an existing larger pipe, then wrapping the pipe with the fitting. A gasket is provided around the drilled hole. As the tee is tightened to the pipe, the gasket forms a seal to the existing pipe, and new threaded or grooved pipe can be connected. Over time, the gasket wears and breaks down, causing slow leaks from underneath the fitting.

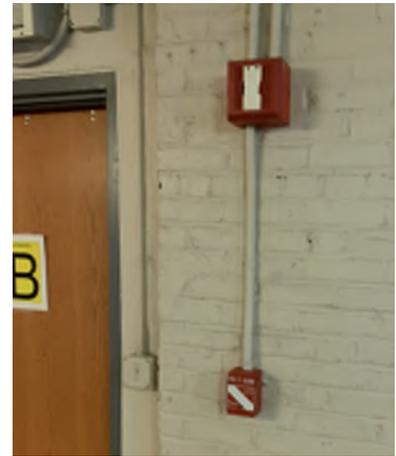
- There is no evidence of any recent or regular inspections.<sup>44</sup> The last inspection tag is dated April 2016.
- Notification appliances installed no longer comply with current codes.
  - The existing appliances (Edwards #2452) are Underwriters Laboratory (UL) listed to Standard 1971, which complies with the ADA requirements, but they are not set to a candela setting capable of providing complete coverage throughout all public areas [Figures FP-10 to 11].<sup>45</sup>

Edwards #2452, missing strobe [FP-10]

- High Priority, 1 – 2 years
  - Replace the fire alarm system
  - Add additional appliances to provide adequate audible and visual coverage

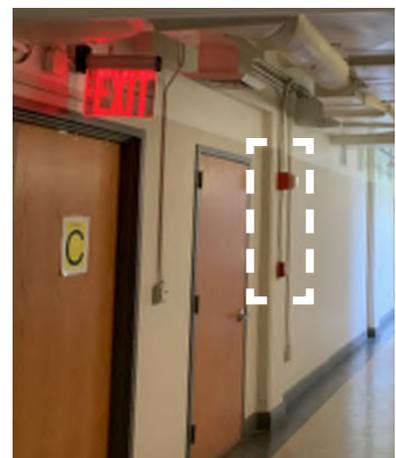
Non-compliant pull station location [FP-12]

- Audible tone testing was not be measured, but existing strobes are either not installed at the correct elevation with respect to the finished floor, or there are not enough units to provide coverage for some spaces.
- Manual pull stations are located more than 5 feet exit doors [Figure FP-12].<sup>46</sup>
- There is unprotected fire alarm wiring, or free air wiring, in mechanical rooms. The wiring observed specifically serves duct smoke detectors [Figure FP-13].
  - While free air wiring is permitted per the National Electric Code, it is best practice to provide conduit for all wiring in order to prevent accidental mechanical damage.
- Some Warden telephone stations were tagged with “Out of Order” signs [Figure FP-14]. No testing was performed to confirm their status.

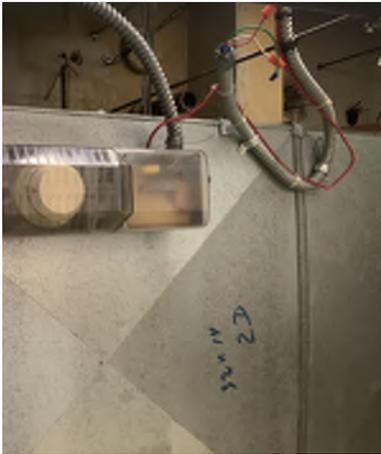
[FP-13] Unprotected free air wiring

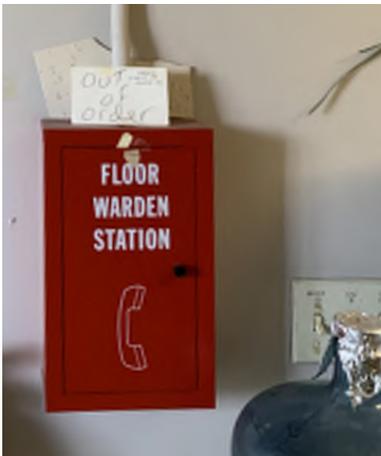
[FP-14] “Out of Order” Warden telephone

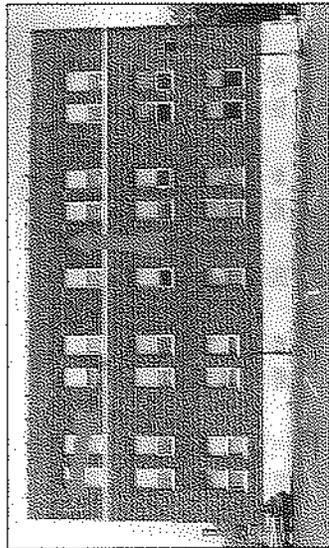
**Figure 6:145**  
 Building 210, south side showing difference in replacement brick at the parapet and the infill of basement windows. Arrows identify structural cracking and rust jacking of lintels.

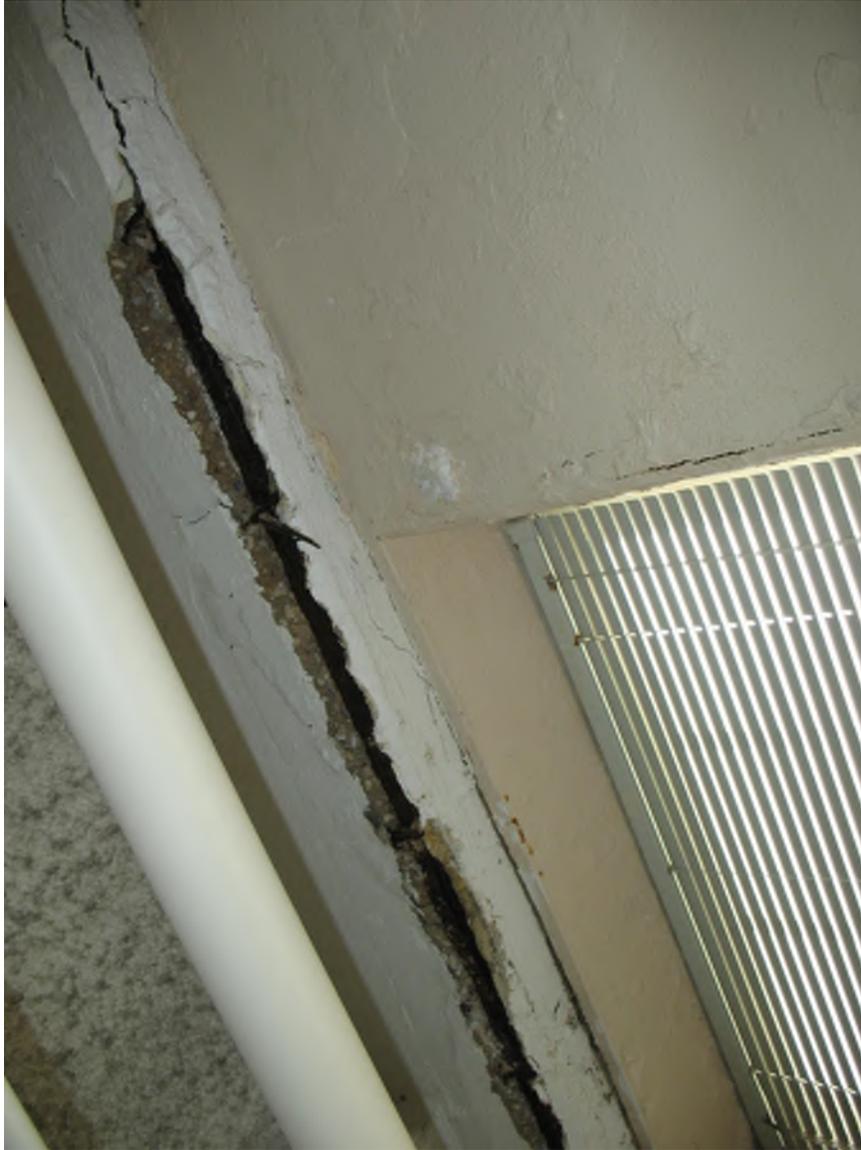
The deterioration includes cracking and spalling of the concrete, as well as corroded reinforcing steel (reference Figures P-1, P-2 and P-3 below). The steel corrosion noted on the grid line “1” girder, between lines “B” and “C” has advanced to the point of delamination and partial loss of cross section. Cracks observed along the bottoms of the members may also indicate a partial loss of bond along the reinforcing bars.

**Figure P-1:** Concrete girder along grid line "1," spanning between grid lines "B" and "C"

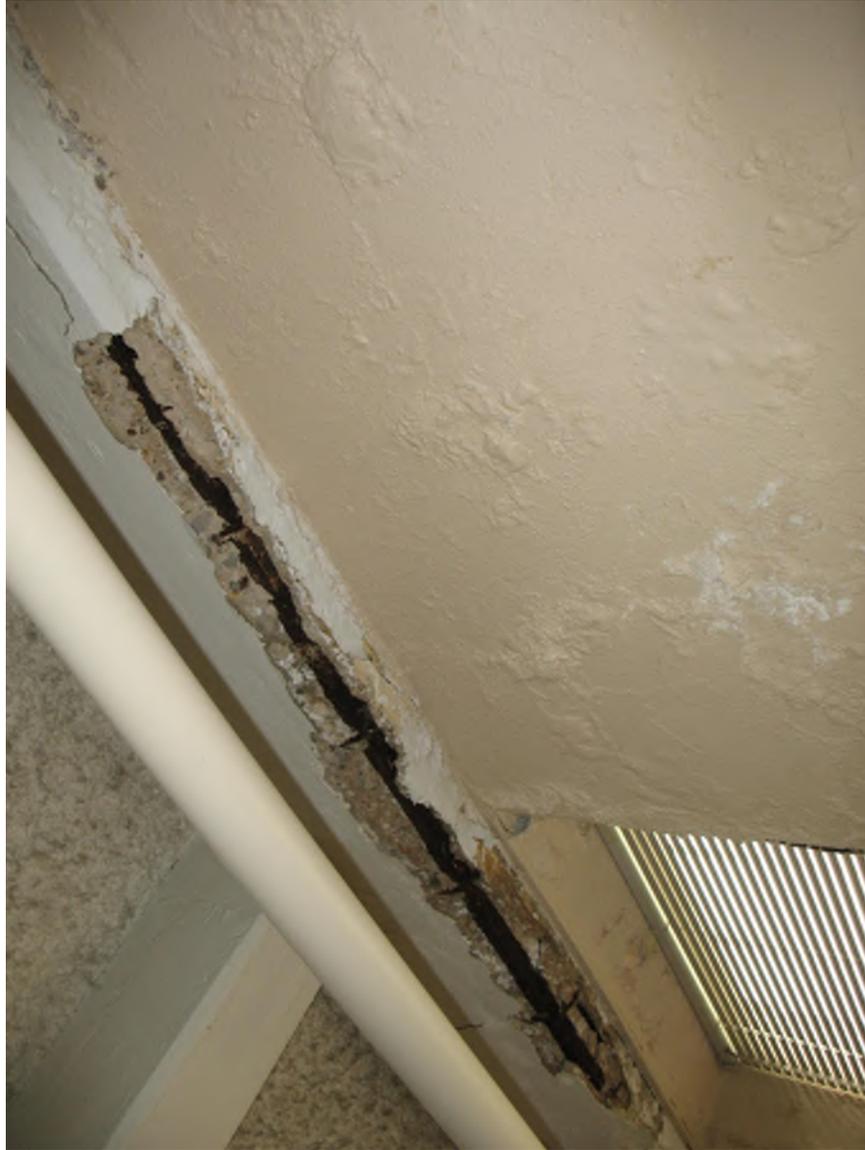
Figure P-2: Concrete girder along grid line "1," spanning between grid lines "C" and "D"

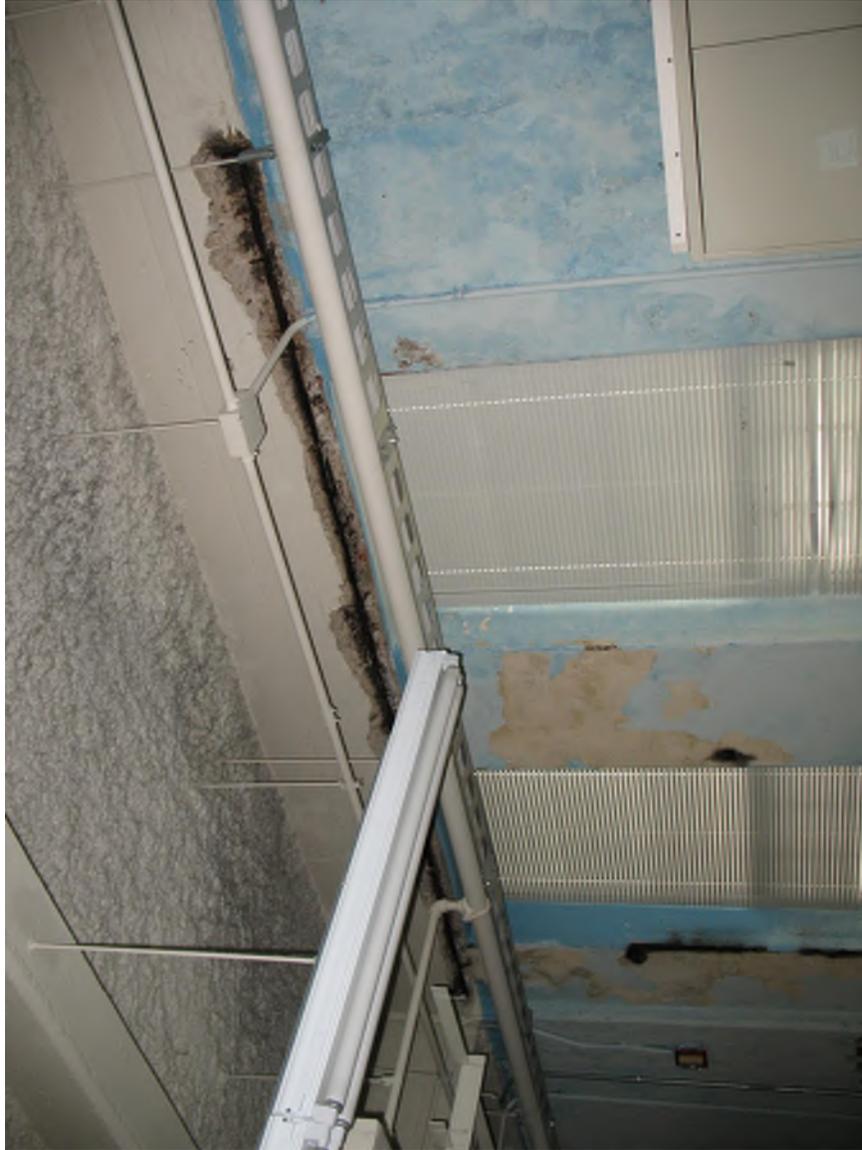
**Figure P-3:** Concrete girder along grid line "B," spanning between grid lines "5" and "6"
