SEISMIC EVALUATION OF SELECTED BUILDINGS AND STRUCTURES AT SCOTTY'S CASTLE

Death Valley National Park, Death Valley, California

DeSimone Consulting Engineers, P.L.L.C.

January 19, 2006

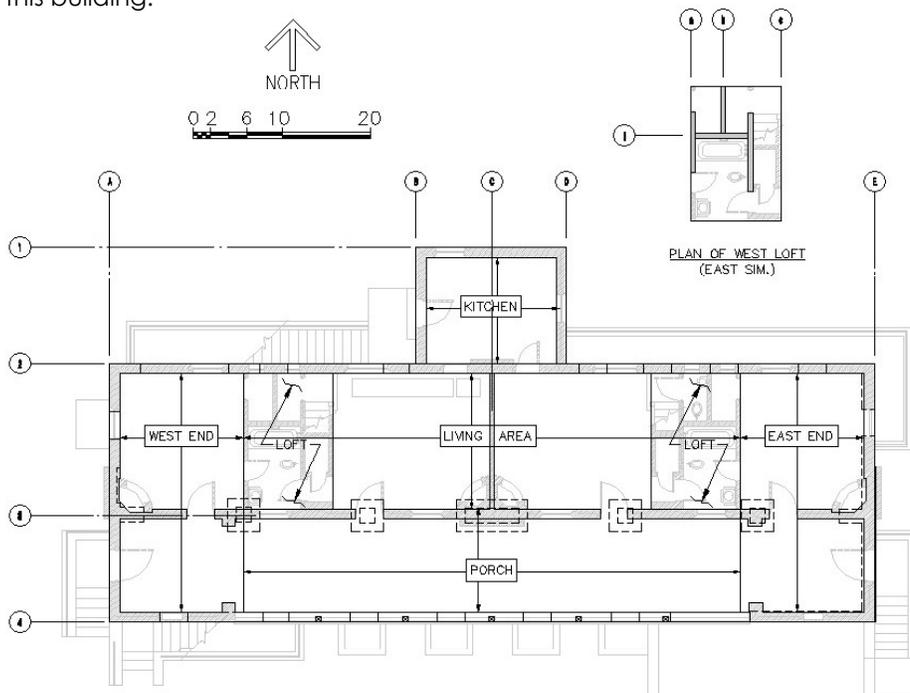
Figure 2.1: Guest House Layout Plan

The Guest House is a one-story wood structure with a concrete basement. The structure is rectangular in plan, with a main area of 86 ft x 30 ft and a kitchen area on the north face of 17 ft x 13 ft. The foundation system consists of a concrete slab on grade and spread footings. The foundation walls are of concrete. The ground floor is a concrete slab supported by the basement concrete walls and concrete columns with drop panels. According to the original drawings, the perimeter walls are made of wood studs with a layer of hollow clay tiles and insulex added for insulation. The interior of the walls is finished with metal lath and plaster, while the exterior is finished with stucco. The roof framing is comprised of wood rafters supported by wood trusses and straight tongue-and-groove sheathing. The roofing material is clay tiles. There are two living units on the first floor, with each unit having a loft area that is used as bedroom, that measures approximately 12 ft x 18 ft. The loft floor framing consists of wood rafters and wood sheathing with a finished wood floor. There is a porch in front of the living quarters at the south side of the building. The roof of the porch consists of wood rafters and tongue-and-groove sheathing. Wood posts support the south edge of the porch. Figure 2.1 shows the floor plan of the Guest House. Photo 2.1 shows the south elevation of this building.

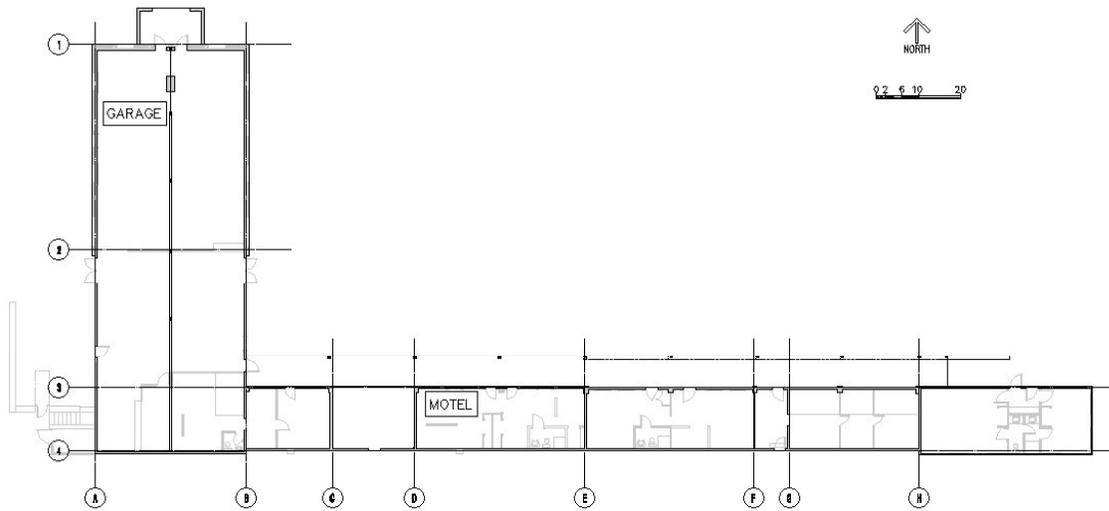
Figure 2.2: Long Shed Layout Plan

The Long Shed is a one-story wood structure with no basement. The structure can be divided into two parts: the Garage portion (currently used as a Gift Shop and Café) and the Motel portion (currently providing office, storage and residential spaces). Both portions are rectangular in plan. The Garage portion measures 97 ft x 36 ft, and there is a porch entrance area of 9 ft x 16 ft attached to the north end. The only drawing available for this structure was for the remodeling of part of the Garage (current Gift Shop). However, field observations provided different information than contained on the drawing. We believe that the foundation system is a continuous concrete footing. The perimeter and interior walls appear to be made of wood studs with plaster and metal lath on both sides. The roof framing consists of wood joists, rafters, and straight sheathing. The roofing material is clay tiles. The Motel portion measures roughly 15 ft x 200 ft. There is no existing drawing for this area. In addition, most of the structural elements are covered and their configuration could not, therefore, be established. However, by accessing the attic space above the suspended ceiling, it appeared that the framing in the office area is similar to that of the Garage. At the east end of the Motel portion, there appears to be an additional unit similar to the rest of the Motel portion. On the north face of the Motel portion, there is a canopy that is approximately 7 ft. wide. Clay tiles comprise the roofing material for the majority of the Motel portion except for the addition on the eastern end and the canopy on the north side. The roofing over these two areas is bituminous felt. Figure 2.2 shows the floor plan of the Long Shed. Photo 2.2 shows the exterior of the Garage portion (current Gift Shop) and the porch entrance area looking southeast. Photo 2.3 was taken in the courtyard area looking southwest where the Motel portion joins the Garage portion of the structure.

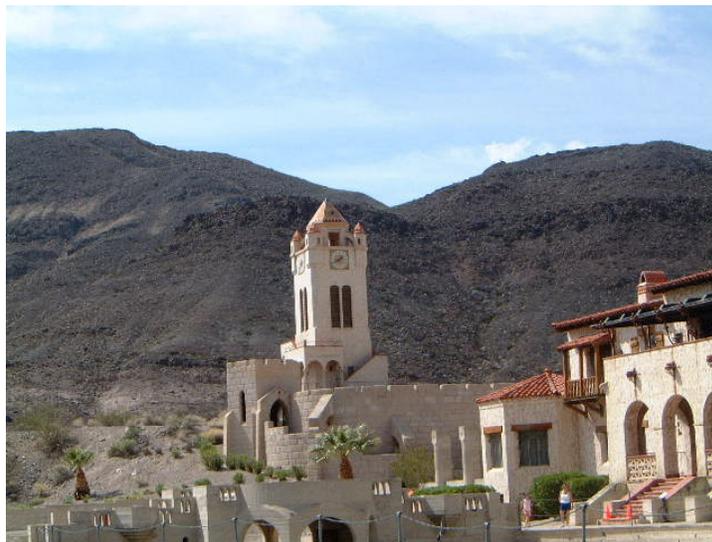
Photo 2.4: Southeast Elevation of the Chimes Tower

The Chimes Tower is a four-story structure of roughly 58 ft in height, with the main tower footprint measuring approximately 18 ft x 18 ft at its base. The first two stories, namely the Mechanism floor and the Chimes Chamber floor, are constructed of concrete; the top half of the building, namely the Cupola and the roof, are made of wood. This building rests on a concrete foundation that comprises a slab-on-grade and spread footing. The concrete portion of the building has a concrete perimeter wall that tapers from a 15-inch thickness at the base to a 6-inch thickness at the top (the Chimes Chamber floor). The framing system for these two floors is comprised of a concrete slab with beams. There are two balconies and one stair landing, all of concrete construction, outside the footprint of the tower. Concrete walls extend from the base of the structure to support the north stair landing. The south balcony is supported by concrete columns and arches extending from the base of the structure. Concrete corbels extending from the tower support the west balcony. For the wood structure, the walls are built of wood studs, diagonal sheathing, and stucco/plaster on metal lath. The Cupola floor is a concrete slab supported on wood joists. Similar to the walls, the roof construction is comprised of wood rafters and diagonal lumber sheathing. The roofing material is clay tiles. Figure 2.3 shows the floor plans of the different levels of the Chimes Tower. Photo 2.4 shows the southeast elevation of the structure.

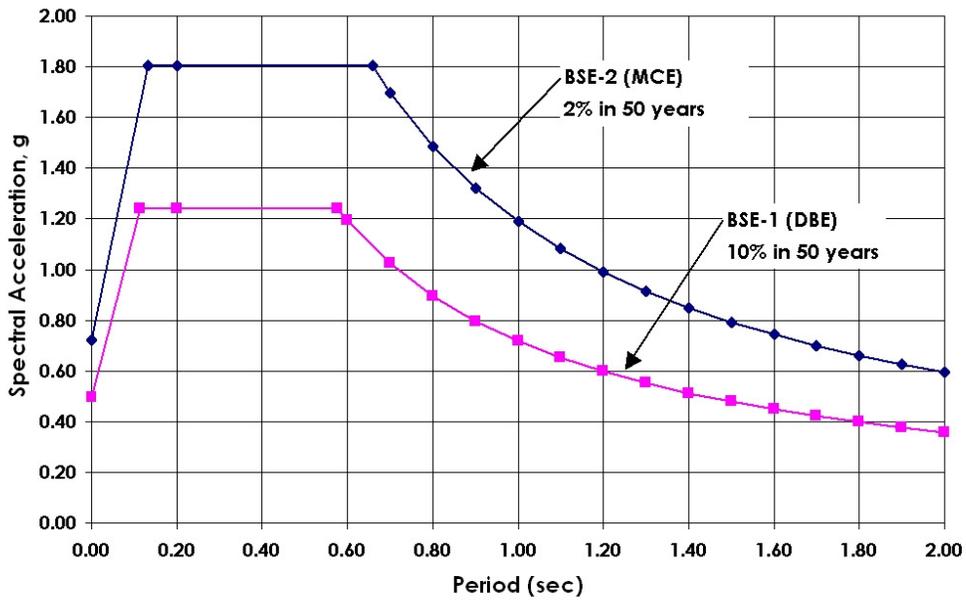
Figure 3.1: Generalized Site Response Spectra

The selected FEMA 356 evaluation criteria was based upon the Basic Safety Earthquake 1 (BSE-1) that represents a 10% probability of exceedance in 50 years (475-year return period). The corresponding performance objective was selected to be "Collapse Prevention". This criterion is similar to the State Historic Building Code and is in accordance with the Secretary of Interior's Standards of Historic Preservation. Response spectra were computed based upon FEMA 356 guidelines. Two response spectra were obtained, one for the BSE-1 (a 10% probability of exceedance in 50 years event), also called the Design Basis Earthquake (DBE); and one for the BSE-2 (a 2% probability of exceedance in 50 years event), also called the Maximum Credible Earthquake (MCE). Figure 3.1 shows the generalized site response spectra for the BSE-1 and BSE-2 seismic events.

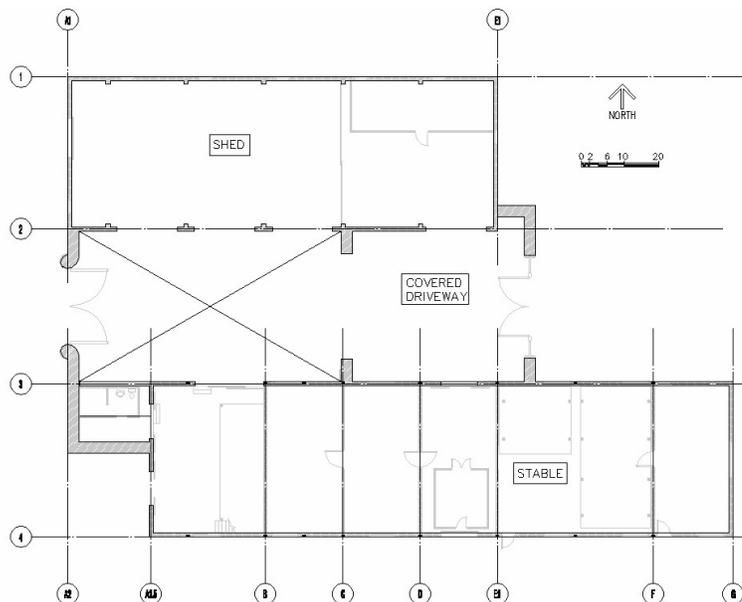
Figure 2.1: Floor Layout Plan

Scotty's Castle is located at the Death Valley National Park, California. The Stable building consists of three attached structures: a stable, a shed, and a covered driveway that connects the two structures. The original stable was built in 1920 as a stand-alone structure. In 1928, extensive remodeling of the stable took place and new perimeter walls as well as new roof structures were constructed. In addition, two new buildings were added namely, the shed and the covered driveway. All three structures are one story tall. Figure 2.1 shows the floor plan of the building.

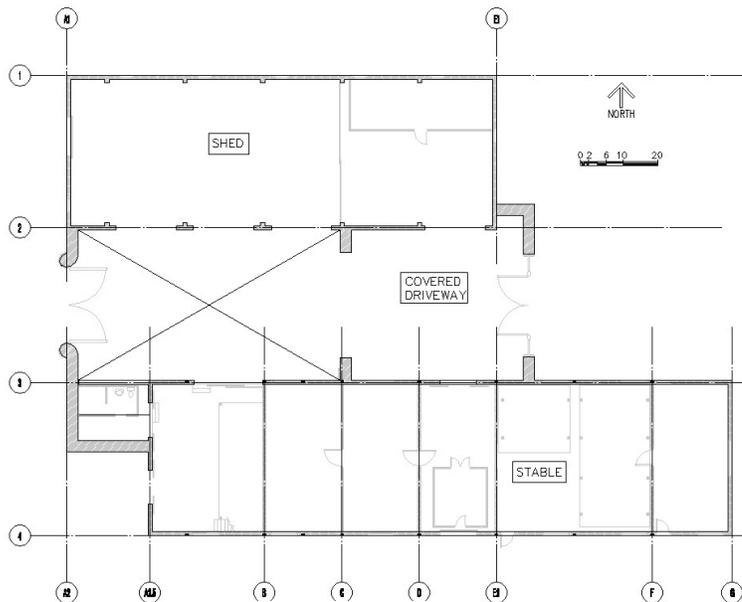
Figure 3.2: Floor Plan

For FEMA 356 analysis, in the east-west direction, all shear walls except the wall on grid line 3 have adequate strength to resist the applied loads. The shear wall on grid line 3 has a DCR of 1.64 and therefore, has inadequate strength to resist the lateral loads. In the north-south direction the walls on grid lines A2, C, E2 and F do not have adequate strength to resist lateral loads. The DCR for these walls ranges from 1.23 to 2.25. All other walls have DCR ratio less than 1.0 and therefore, have adequate lateral load resisting capacity.

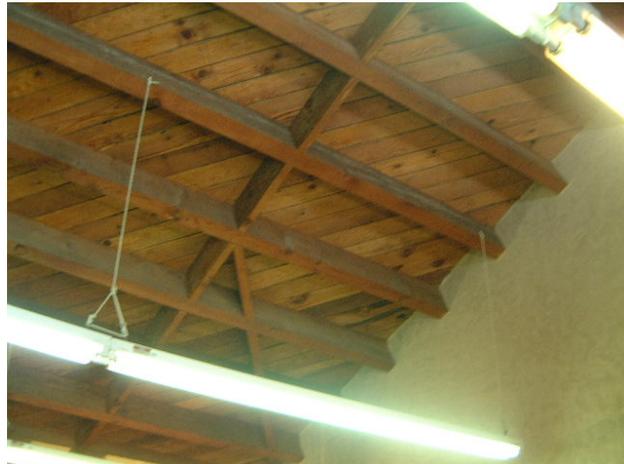
Photo-4: Roof Framing in Stable

1. The structures appear to be in good condition overall. The gravity framing of the structures, where exposed, is found to be in good condition. Member sizes and connections of roof trusses appear appropriate and adequate for their respective loading.
2. There was no sign of major damage of the structures. There are, however, some cracks on the exterior plaster of the structures, mostly around windows and under the tile roof.

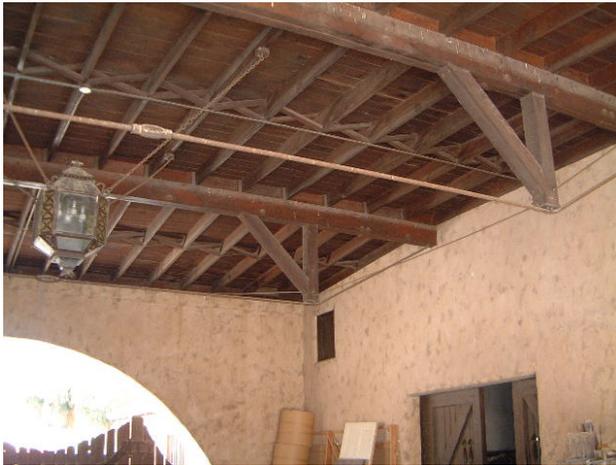
Photo-7: Roof Framing, Covered Driveway

Table 3.3 presents a summary of the roof diaphragm evaluation. The roof diaphragm over the shed building is found to be inadequate based upon both the UCBC and the FEMA criteria. The diaphragm for the covered driveway is also found to be inadequate to transfer earthquake forces in the east-west direction. The diaphragm for the stable is found to be satisfactory due to their relatively short spans.

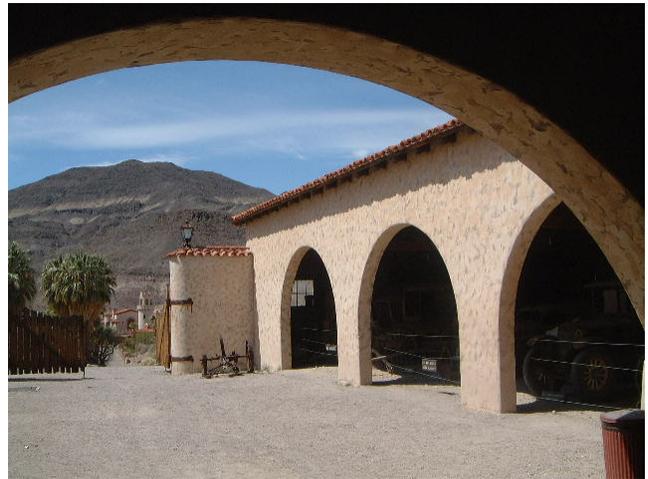
Photo-8: South Wall of Shed

1. Existing wood stud and lath and plaster shear walls at the stable and the covered driveway do not have adequate shear capacity to resist lateral loads.
2. The shed and the covered driveway roof diaphragms are found to have inadequate shear capacity to resist the lateral loads.
3. The wall to roof diaphragm anchorage for in-plane forces does not appear to be adequate in all of the three structures. In addition, out of plane wall to diaphragm anchorage for the shed building is not adequate to resist the wall out-of-plane loads.
