CONDITION ASSESSMENT AND TREATMENT RECOMMENDATIONS

GRANDVIEW SCHOOL MONUMENTAL LIMESTONE ENTRANCE

HARPERS FERRY NATIONAL HISTORICAL PARK  
HARPERS FERRY, WEST VIRGINIA

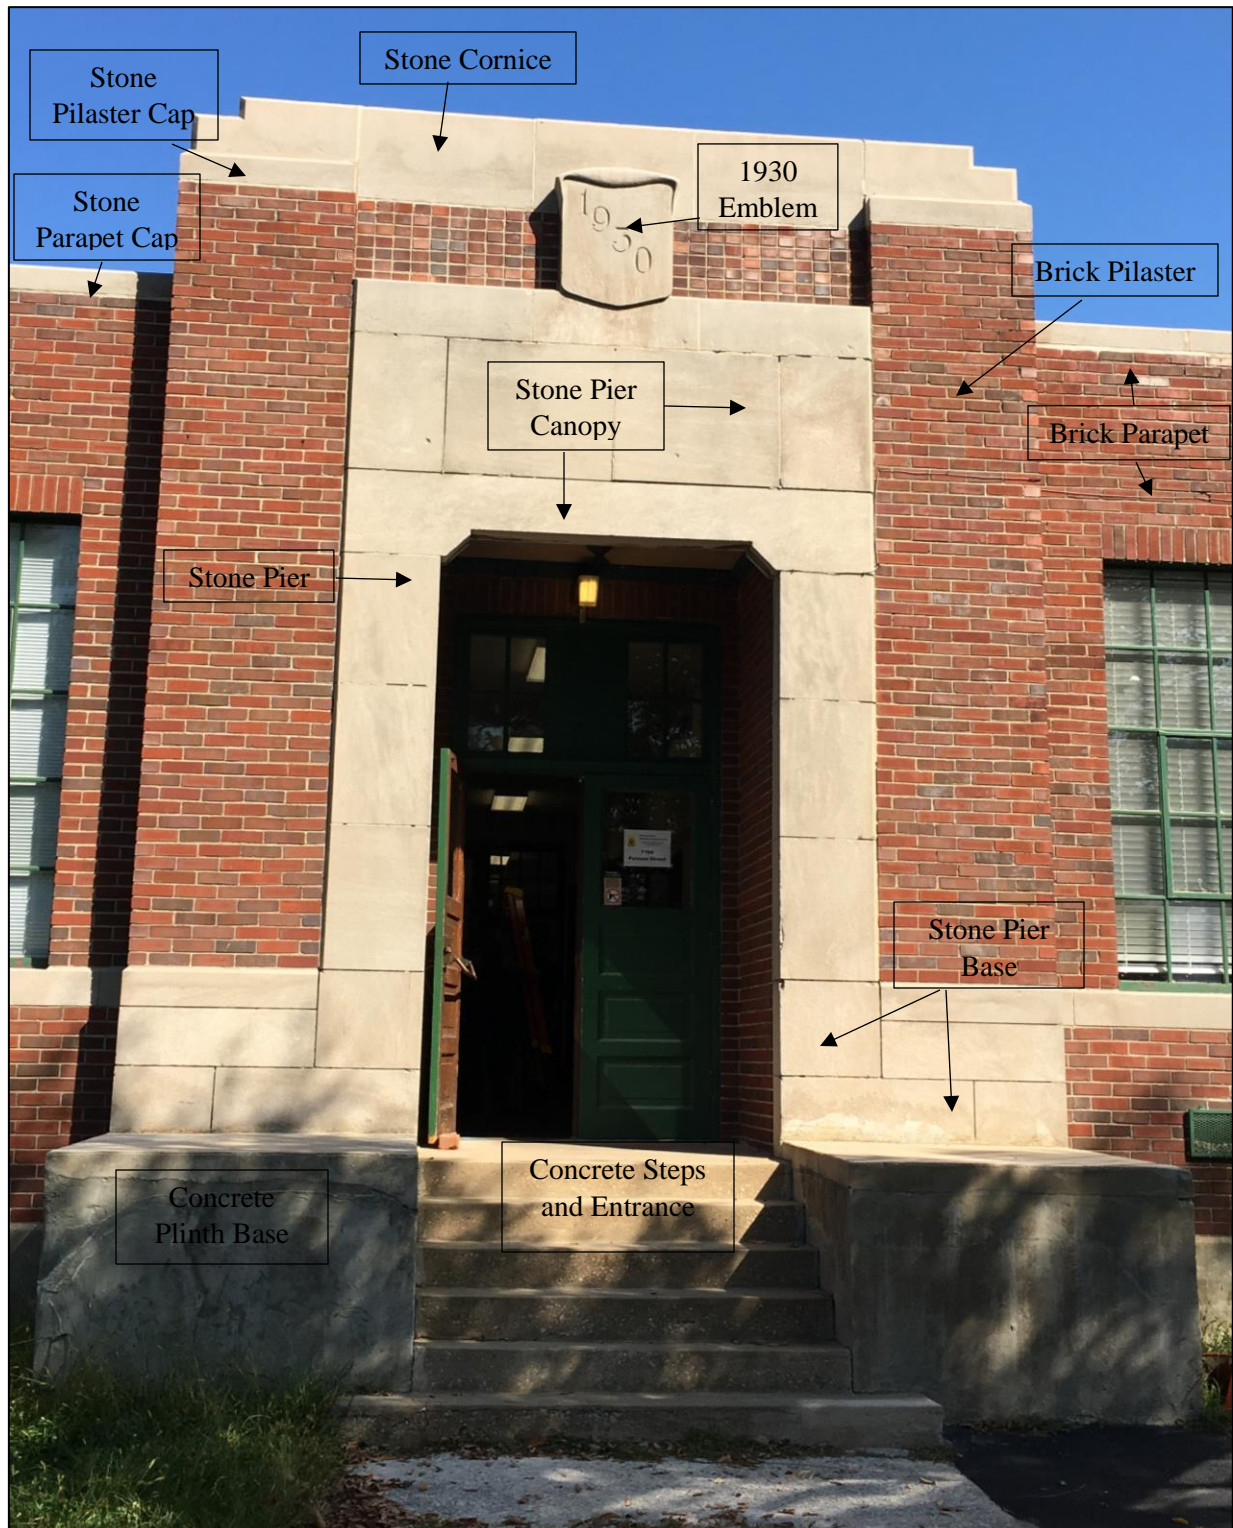
**Stone Cornice, Stone Pilaster Cap, 1930 Emblem, Stone Pier Canopy**

**ARCHITECTURAL KEY ELEMENTS  
ART DECO MONUMENTAL ENTRANCE**
