RR 0227 ~
Survey # 6-7

NEW JERSEY TRANSIT RAILROAD STATION SURVEY

FACILITY NAME: Hillsdale

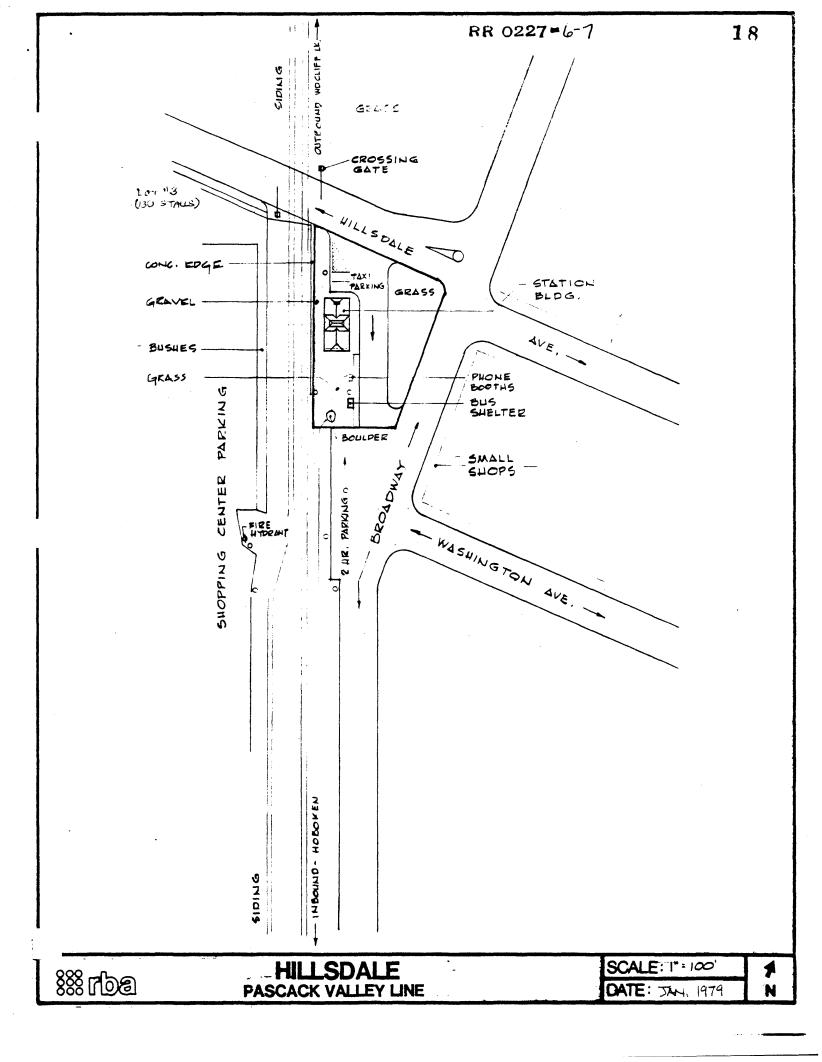
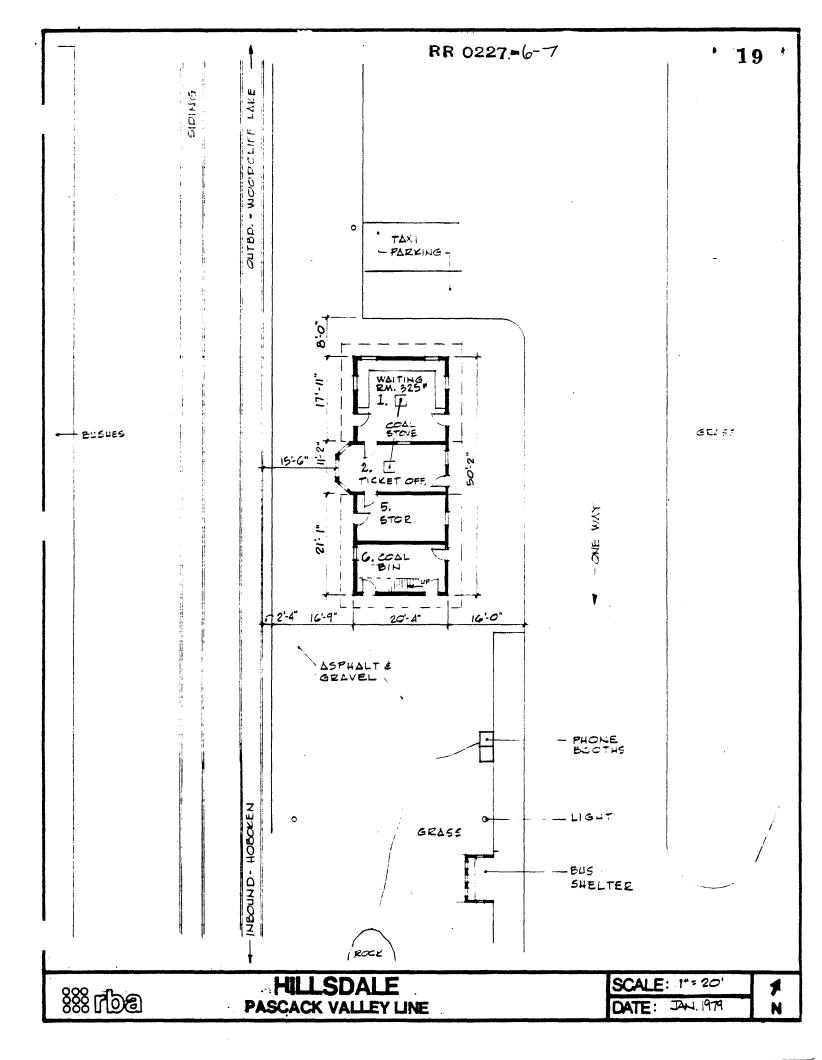
M.P.-21.5

Looking northwest to the Hillsdale station. The neat little FREIGHT HOUSE and a tastefully decorated outhouse will be noticed in both pictures.
