National Register of Historic Places Registration Form

historic name María Dávila Semidey School

other names/site number Escuela María Dávila Semidey

street& number 300 Muñoz Rivera Street

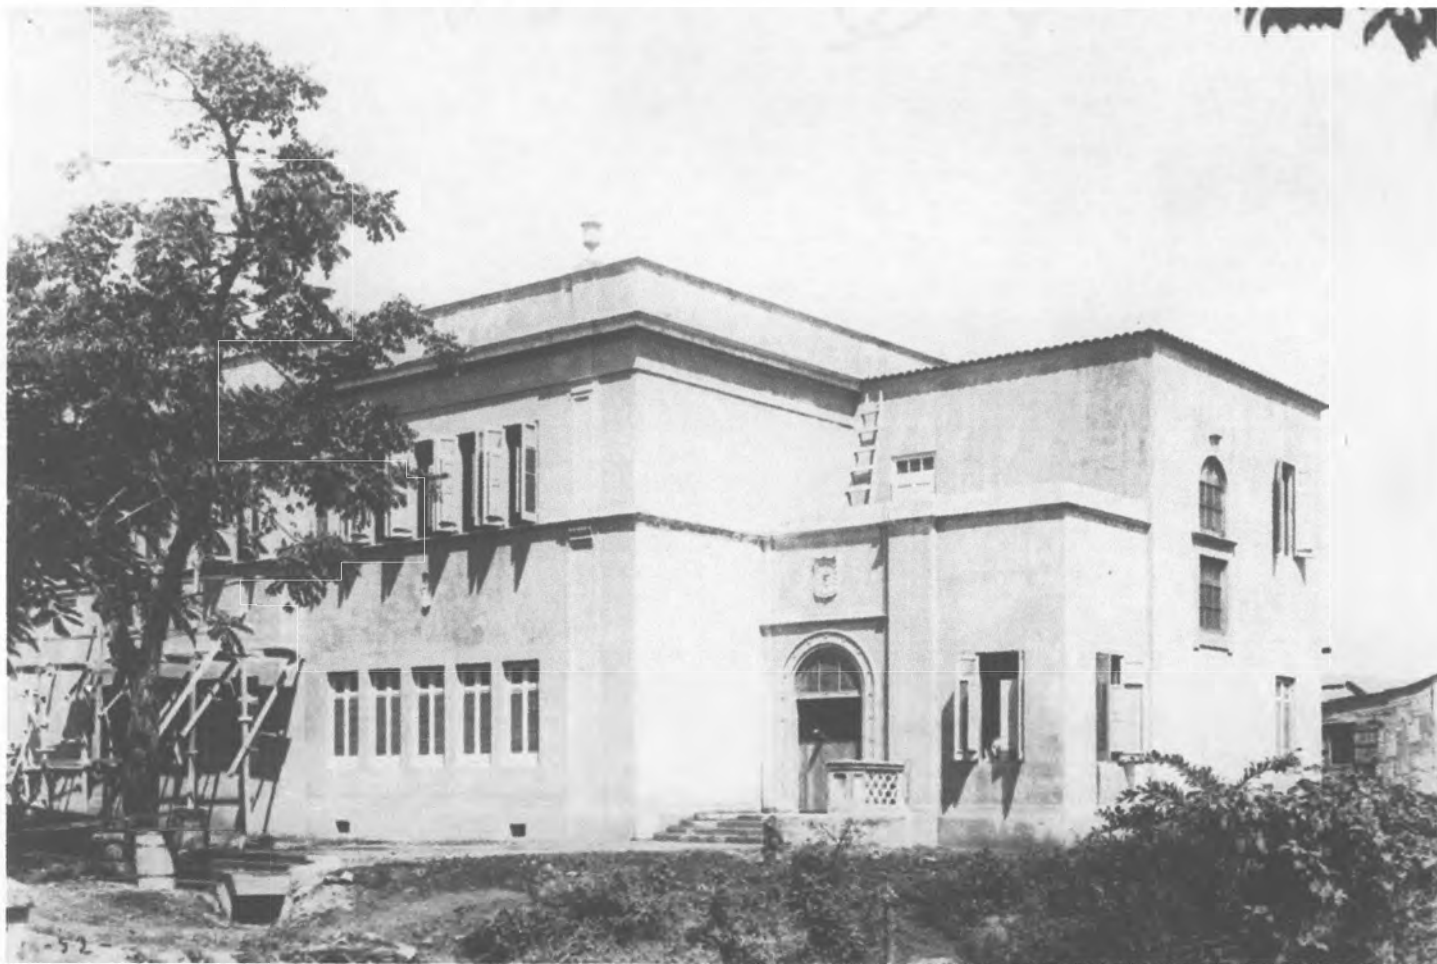
Historical view of the main (south) façade. The two-story school is articulated into three (3) volumes, a main, larger one, flanked by a pair of smaller, identical bodies at either side. Source: Archivo General de Puerto Rico, Fondo Obras Públicas Album, # 306.

As it happens in the property's main volume, the façades facing south of the east and west volumes also exhibit greater ornamental emphasis. After all, access to the school was originally through the entrance doors located within them. As designed, one approached the building through a series of concrete sidewalks leading to a four-step stoop. On the west entrance, nowadays, a concrete ramp has replaced the steps⁸.
