**National Register of Historic Places
Registration Form**

historic name "Daniel Lyons" Shipwreck
other names/site number N/A

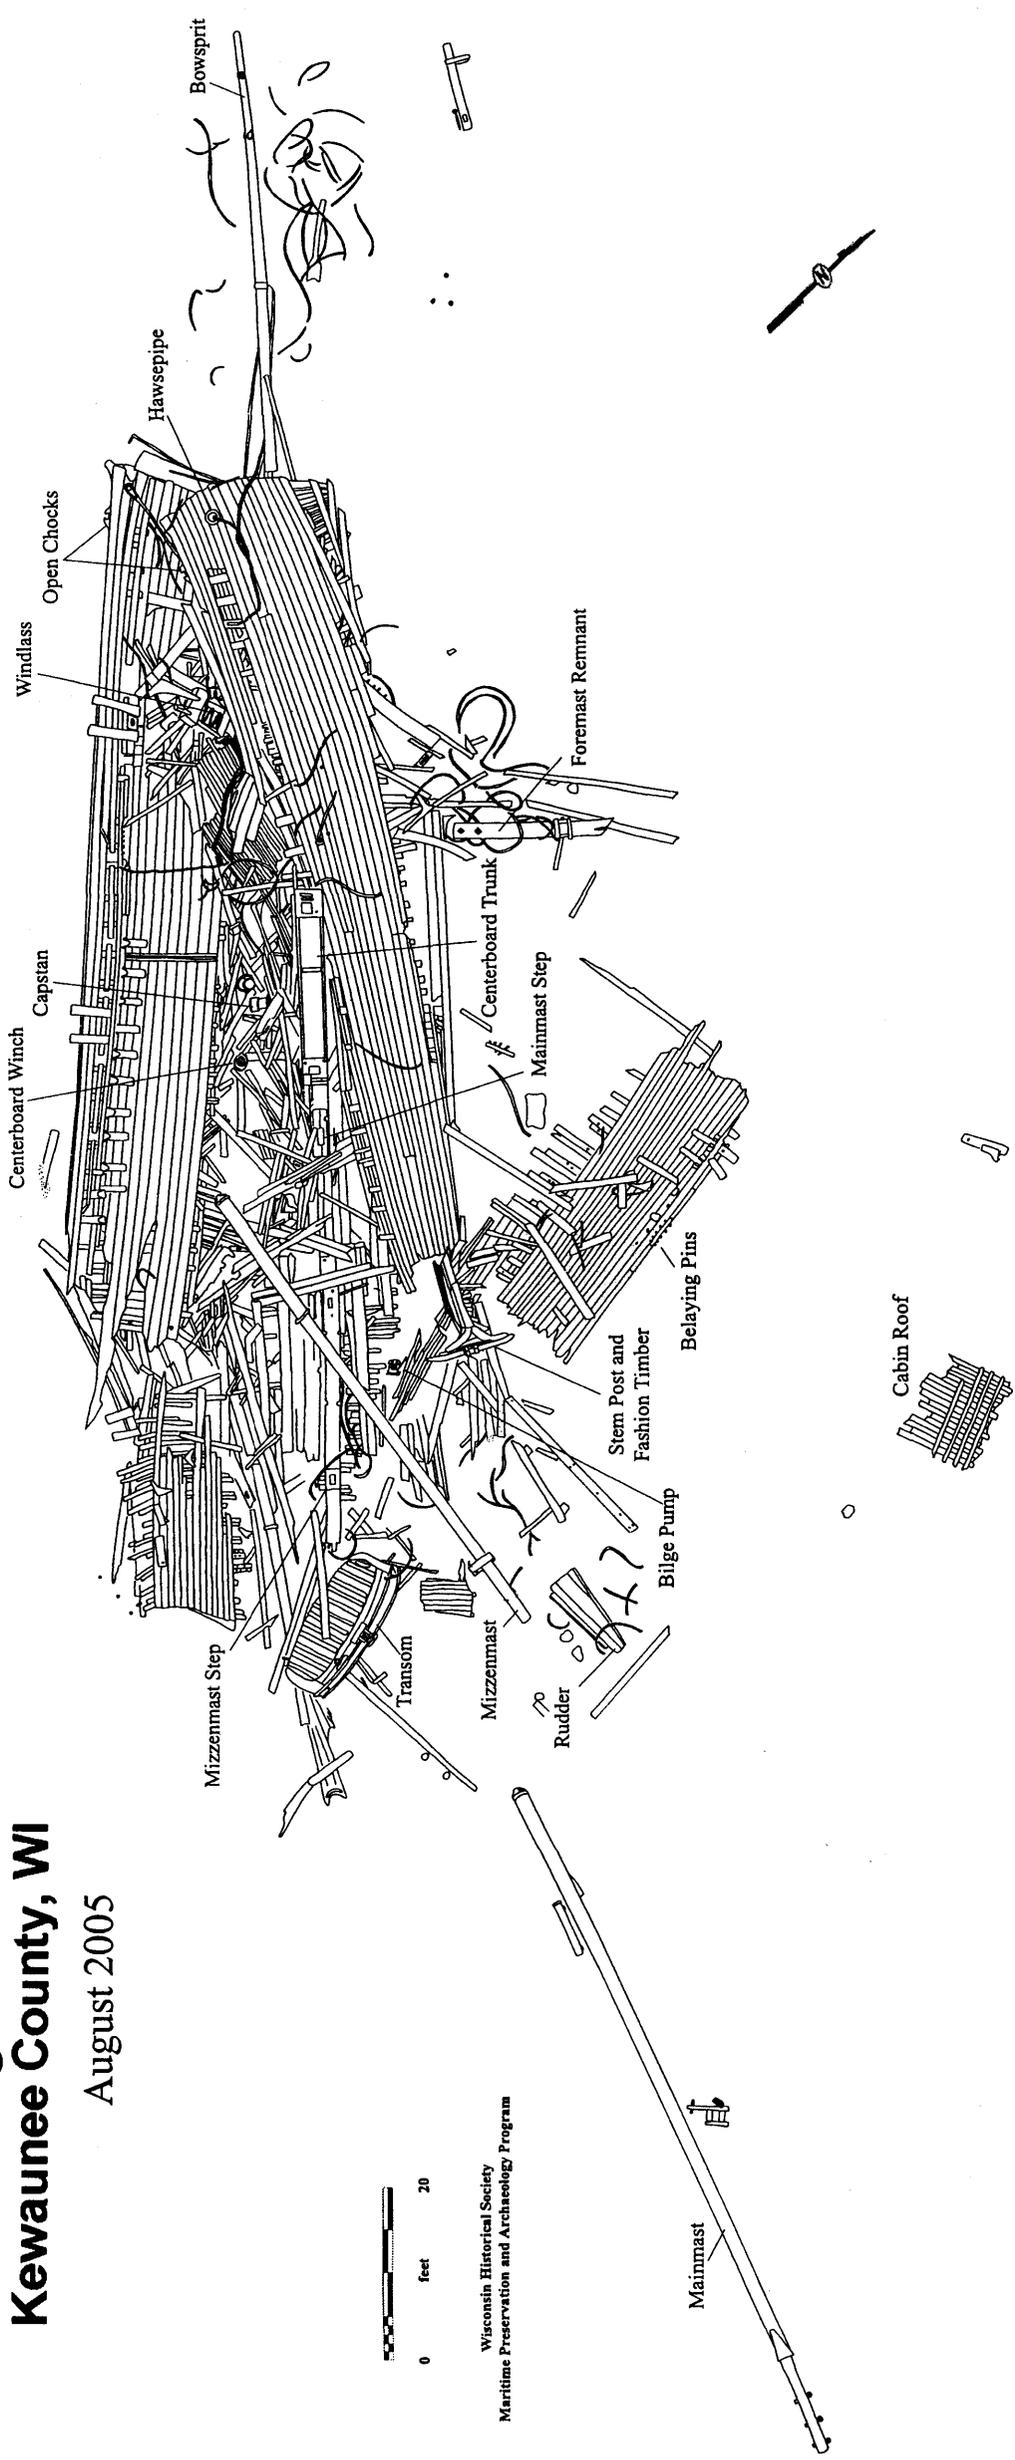
"Daniel Lyons" Shipwreck Lake Michigan Kewaunee County, WI

August 2005

Located 4 miles off Stoney Creek's outlet into Lake Michigan, 9 miles northeast of Algoma, Wisconsin, the *Daniel Lyons* lies in 110 feet of water, somewhat broken up, but with nearly all hull structure and rigging represented. Built in Oswego, New York, in 1873 by the famous shipwright George Goble of the Goble and MacFarlane Shipyard, she was the first three-masted canal schooner built in Oswego. *Daniel Lyons* became the yard's signature ship and the blueprint for all other canal schooners built by Goble. Canallers were a unique vessel type developed on the Great Lakes, designed to transit the Welland Canal locks while carrying the maximum amount of cargo through the canal locks with only inches to spare. Grain was transported from ports on western Lake Michigan, collected from the newly settled farmlands of the Midwest, to eastern ports on Lakes Erie and Ontario (largely the cities of Buffalo, New York, Oswego, New York and Kingston, Ontario). Vessels returning to Lake Michigan were often loaded with coal, used for heating Midwestern cities and powering factories. The *Daniel Lyons* provides historians and archaeologists the unique opportunity to study construction techniques on Great Lakes canal schooners and the grain trade. The *Daniel Lyons* site has yielded significant information on canal schooner construction and has the potential to yield further information.
