National Register of Historic Places  
Registration Form

historic name General Butler, Shipwreck

other names/site number VT-CH-590

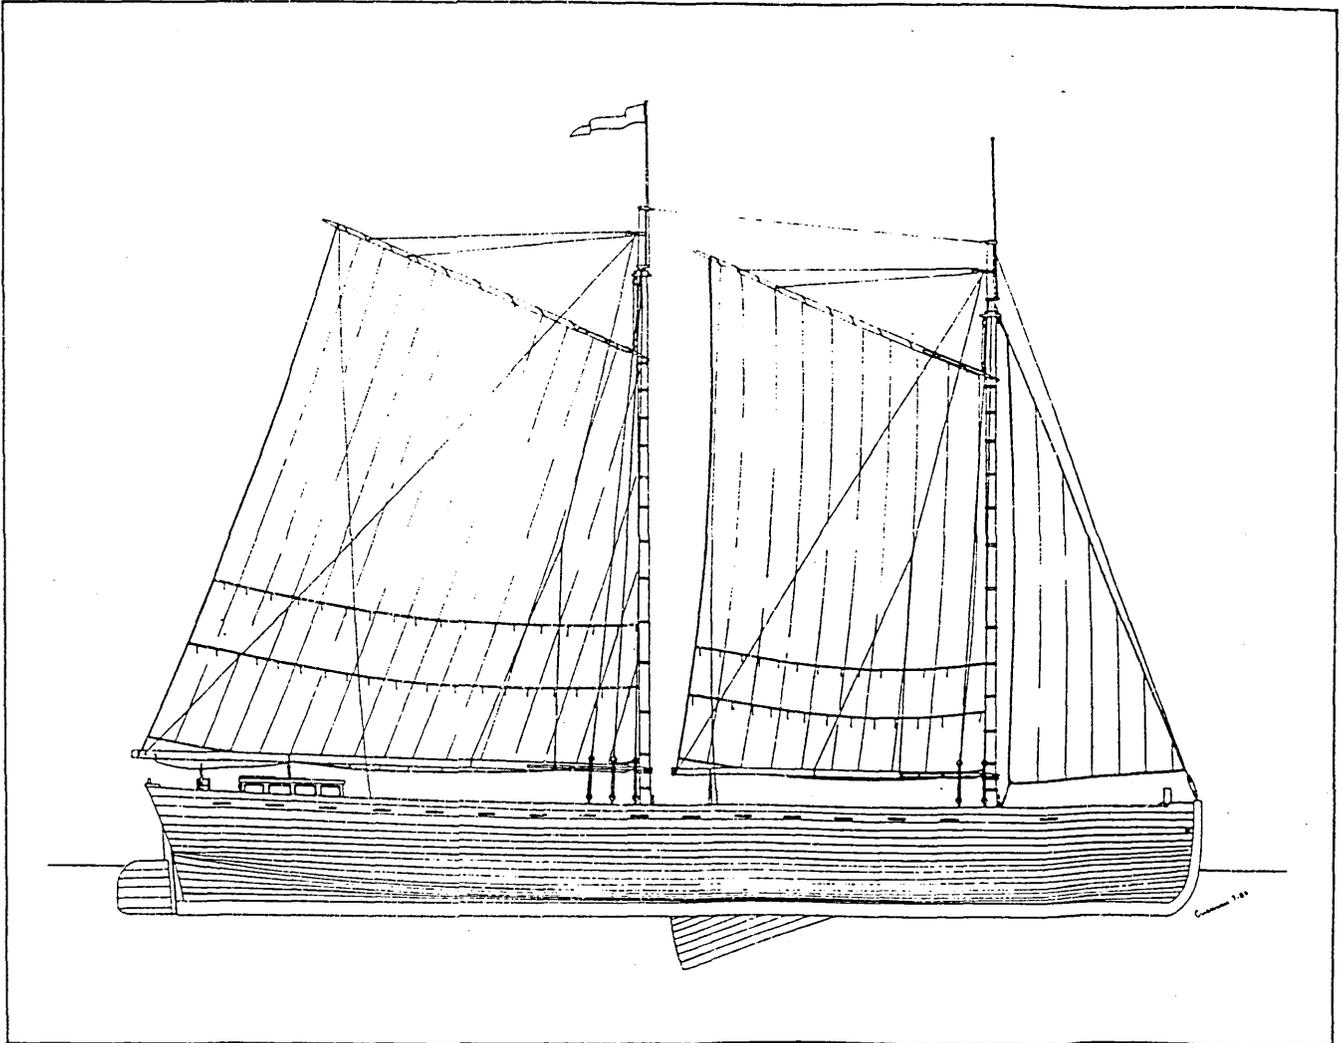
Figure 1: Reconstructed view of the *General Butler* (drawn by Kevin J. Crisman, 1985).

The shipwreck of the *General Butler* is a Lake Champlain sailing canal schooner of the 1862 class, built after an enlargement of the Champlain Canal and its locks (Figure 1). The vessel was built in 1862 in Essex, New York, by local shipwrights John Hoskins, Wesley J. Hoskins, and John Ross using a chine log construction technique. This shipbuilding technique was commonly practiced by Champlain Valley boat builders for many different types of vessels and was the predominant technique used to build sailing canal boats. After fifteen years of service on Lake Champlain, the vessel accidentally struck the Burlington breakwater and sank in 1876. The *General Butler* sits upright on the sandy lake bottom nearly intact in 35 ft (10.7 m) of water 300 ft (91.5 m) west of the breakwater (Figure 2). The vessel's masts, spars and blocks were removed from the vessel shortly after it sank. Today the vessel remains in nearly the same condition as when it sank, except for slight erosion and corrosion, and silt within its hold.

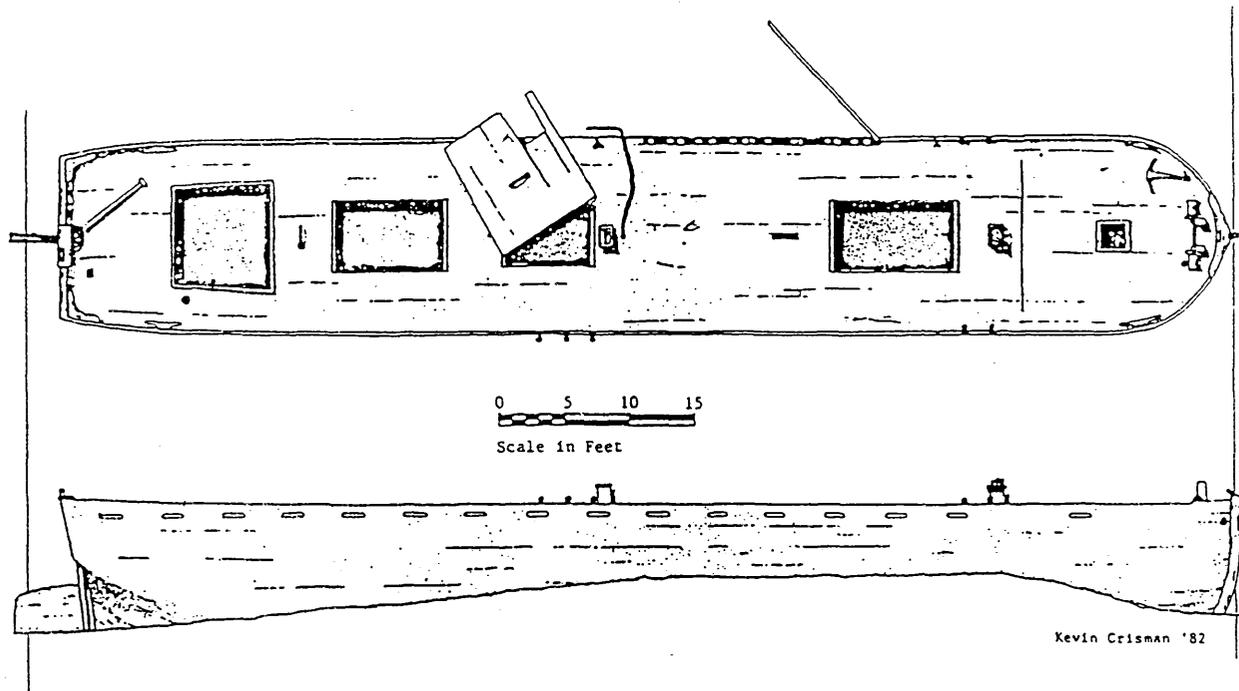
Figure 2: The schooner-rigged canal boat *General Butler*, VT-CH-590 (drawn by Kevin J. Crisman, 1982).

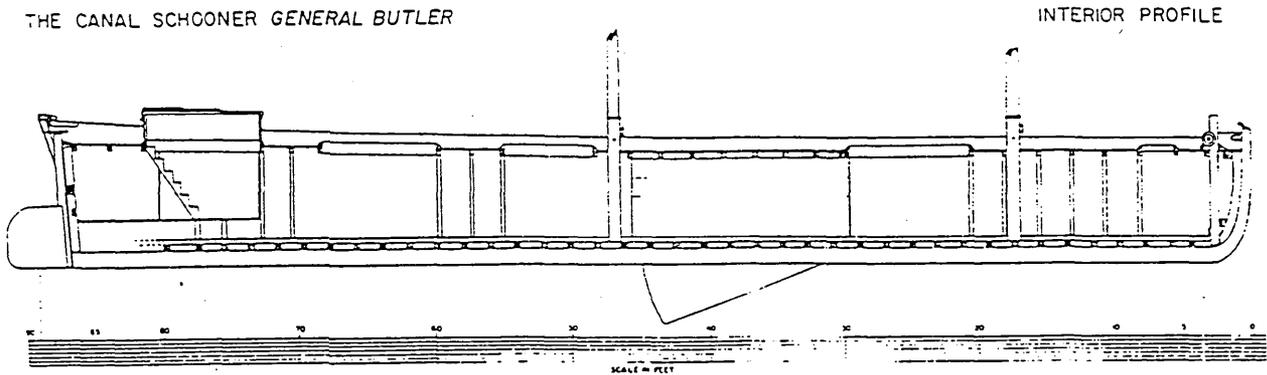
Figure 3: The interior profile of the *General Butler* (drawn by Kevin J. Crisman).

The *General Butler* is 88 ft (26.8 m) long, 14 ft (4.3 m) in beam with a depth of hold just over 6 ft (1.80 m). The hull form and construction methods for sailing canal boats are similar to those employed on contemporary standard towed canal boats (Figure 3). The hulls of sailing canal boats were modified to permit not only negotiation of the Champlain and Chambly canals but also navigation of Lake Champlain. Despite the light framing technique, these vessels were well built for the calm waters on which they traded. They could carry cargoes in their hold or on deck. The *General Butler* was carrying a load of marble within its hold when it sank in 1876.

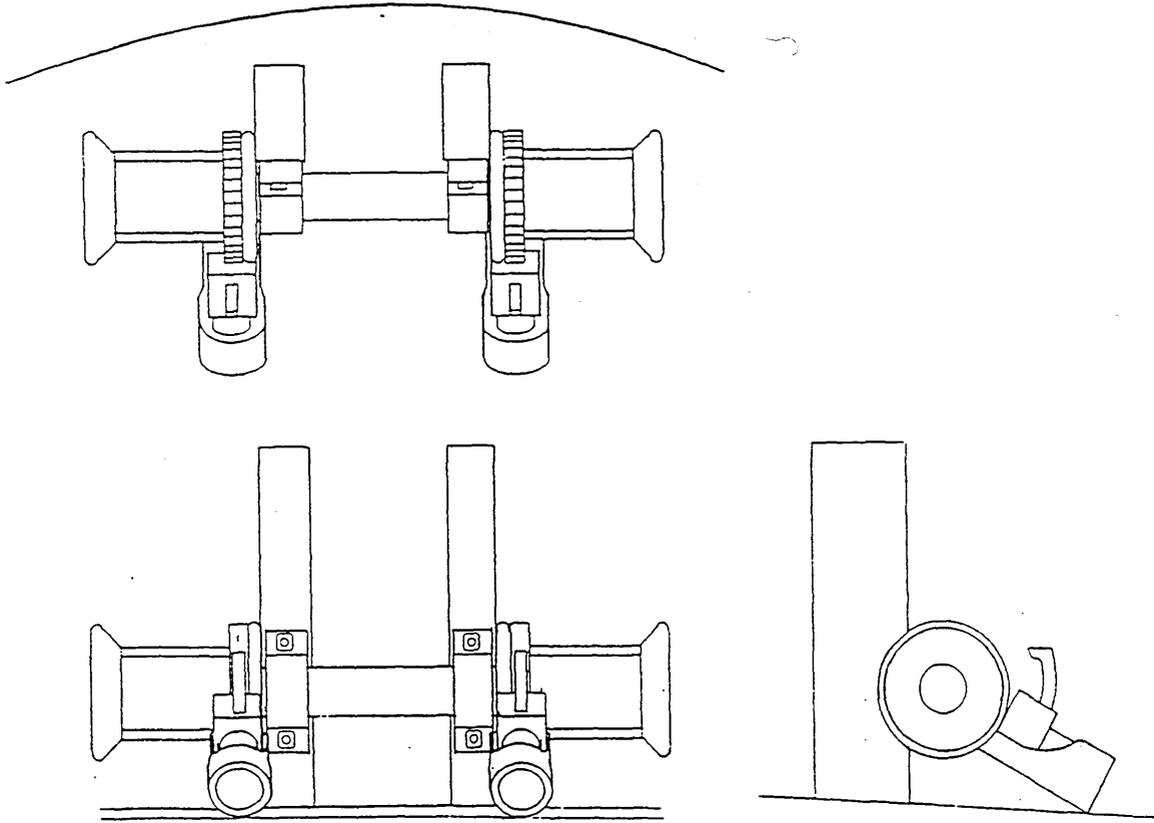
Figure 5: Three views of the *General Butler's* windlass (drawn by Joseph R. Cozzi, 1995)

second appears to be obscured by other timbers. The 1 in (2.5 cm) head of the visible fastening suggests a 0.75 in (1.9 cm) diameter through bolt secured by a nut placed in a square cutout in the rub plate. No fastenings between the apron and keel plank were noted. However, the 1 in (2.5 cm) heads of two iron fastenings in the upper face of the keelson suggest drift bolts that pass through the apron and into the keel plank. The upper face of the apron also supports the base of two white oak windlass bitts (Figure 5).

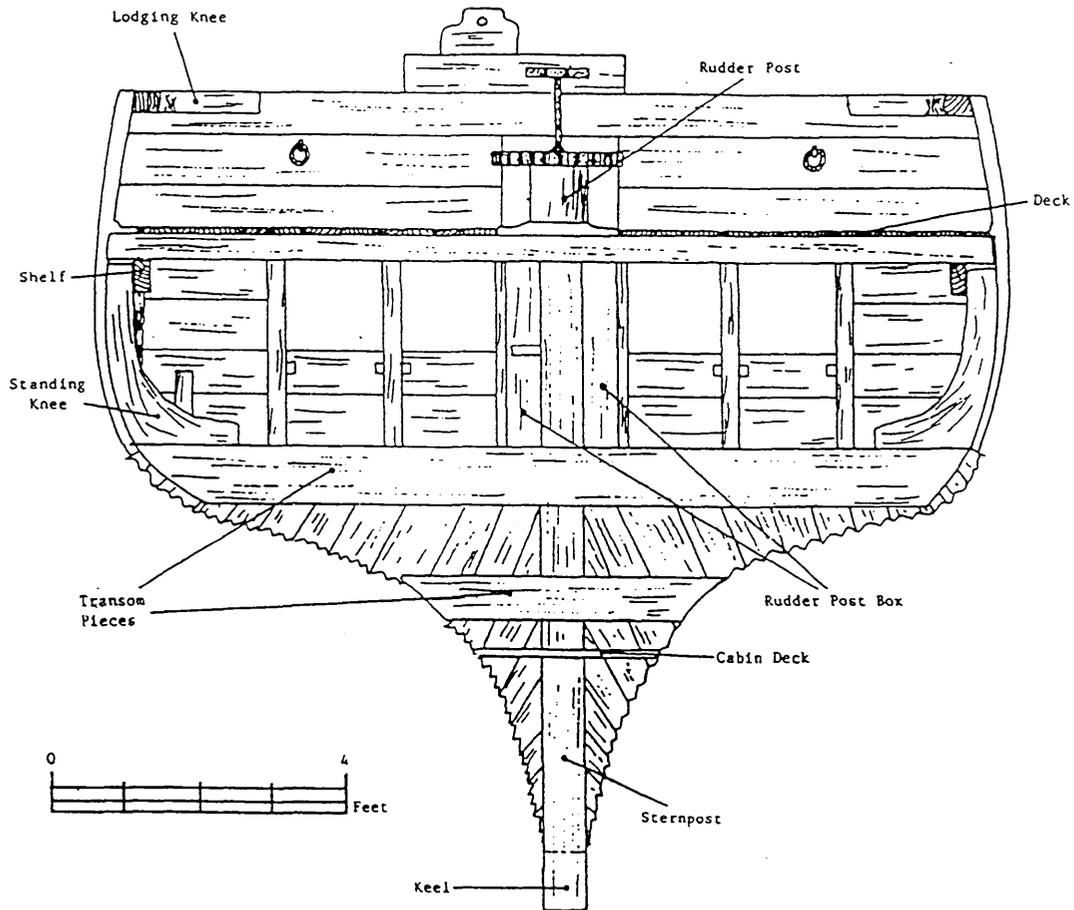
Figure 6: Stern of the *General Butler*, looking forward (drawn by Kevin J. Crisman, 1982).

The *General Butler*'s sternpost is visible in the after cabin from the cabin deck up to the underside of the main deck (Figure 6 and 7). The sternpost is made of white oak. The sternpost was excavated on the outside of the vessel in 1983. This was done to reach the keel plank, which was found to be consistently molded and sided by 7 in (17.8 cm) throughout its reconstructed length of 7 ft 11 in (2.41 m). The forward face of the sternpost is notched to receive the two transom pieces. The port and starboard faces are rebated beginning at the forward edge at the base and proceeding upwards diagonally toward the after edge of the sternpost at the level of the first transom piece. The sternpost sets plumb on top of two deadwood pieces that are in turn resting upon the keel plank. This vertical sternpost is a common characteristic of sailing canal boats, as indicated by the *General Butler*, boat plans in the papers of Orson Saxton Spear and the Burlington Harbor shipwreck, a sailing canal boat off North Beach in Burlington, Vermont

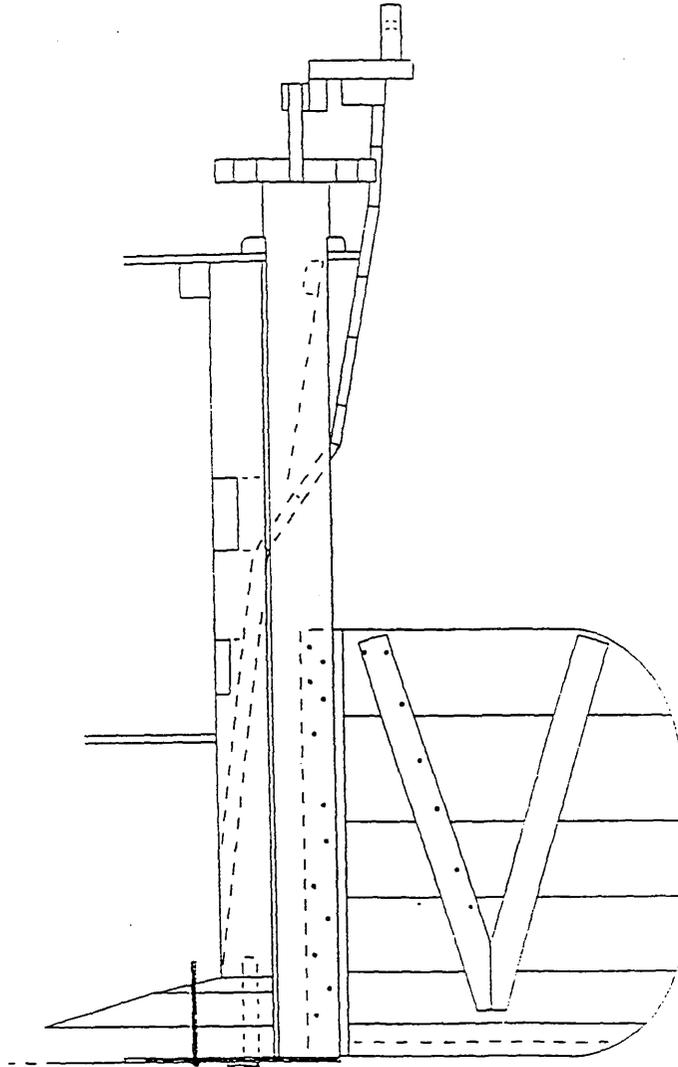
Figure 7: Centerline profile of the *General Butler*'s stern (drawn by Joseph R. Cozzi, 1995).

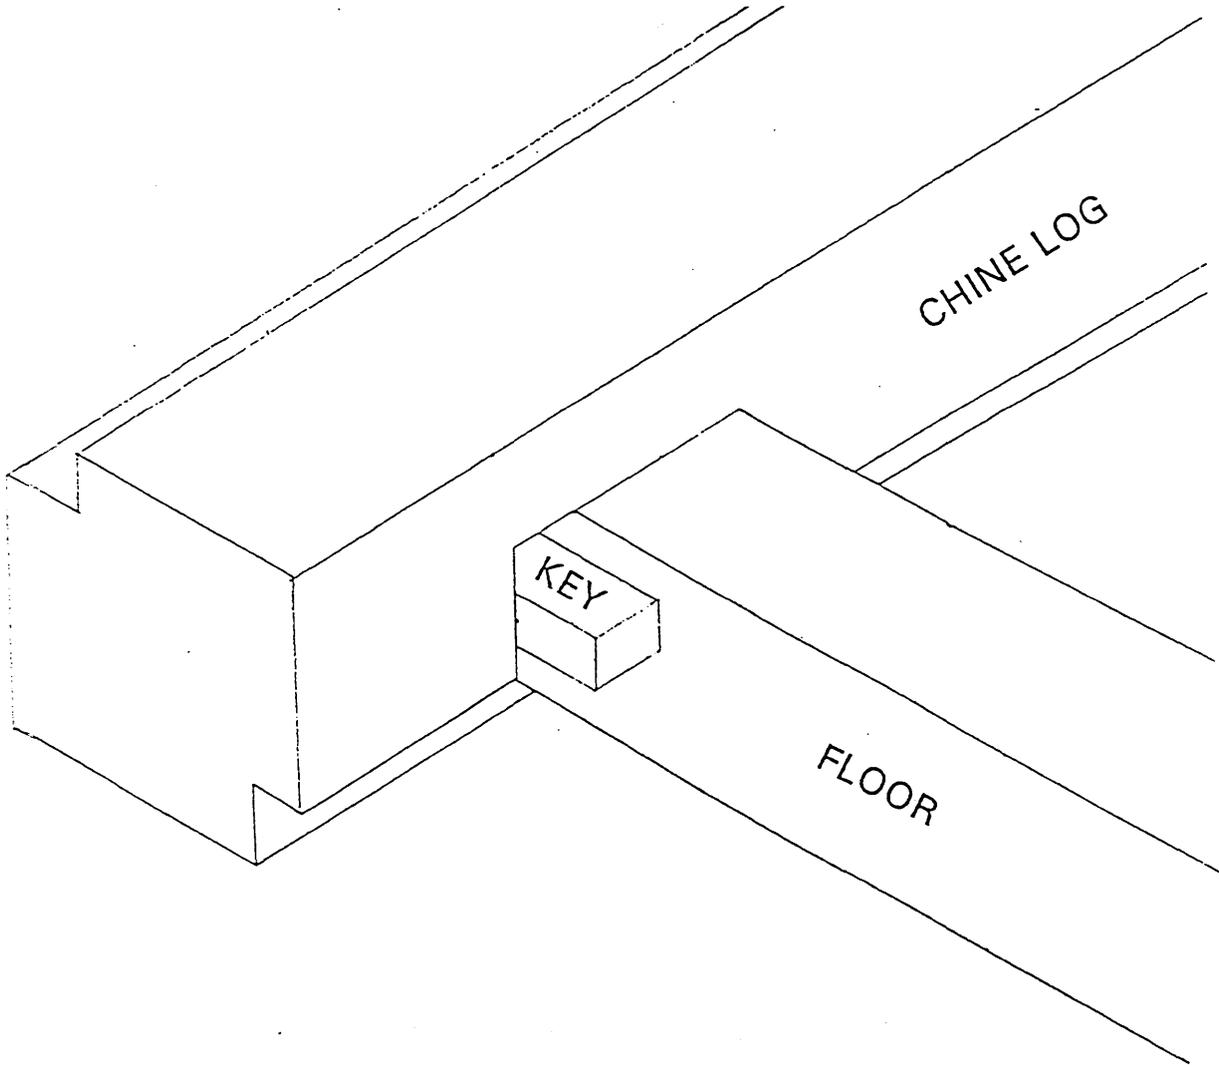
Figure 8: Method of mortising the floors into the chine log of the *General Butler* (drawn by Joseph R. Cozzi, 1995).

The *General Butler* is a chine boat (Figure 8). The vessel has chine logs, sometimes called chine girders, that run longitudinally at the point where the vessel's bottom meets the sides. Unlike the keel plank, the chine logs have substantial molded dimension and provide considerable longitudinal support, which is lacking on the vessel's centerline. The starboard chine log was examined during an excavation in 1993 just forward of the vessel's centerboard trunk. A wood sample of the chine log was taken and identified as hard maple. One objective of 1995 project was to locate the ends of this timber. Unfortunately, time only allowed the forward end of the timber to be uncovered. The chine log is sided 10.25 in (26 cm) and molded 10 in (25.4 cm). It is rebated to receive both the bottom and the side planking. The forward end of the chine log begins approximately 11 ft (3.4 m) back from the forward face of the stem, and at this location has a sided dimension of 7 in (17.8 cm). This marks the transition between the chine construction and the more traditional plank on frame construction of the bow.

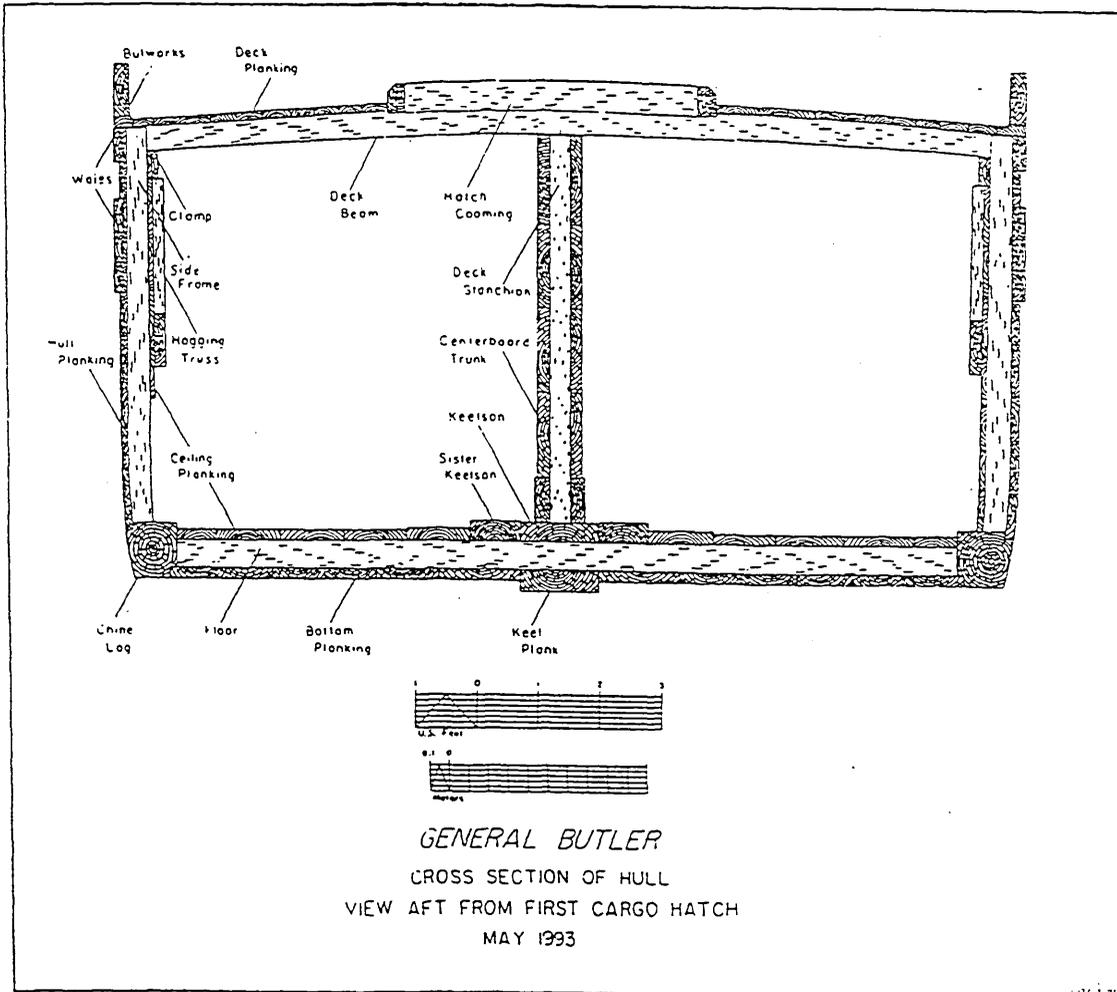
Figure 9: A cross section of the *General Butler* hull, view aft from first cargo hatch (drawn by Joseph R. Cozzi, 1993).

The intact and buried condition of the *General Butler* hinders a complete investigation of the vessel's framing (Figure 9 and 10). However, a limited excavation and detailed recording of fastenings on other timbers does permit some discussion of frame locations and assembly. The chine log served as a point of attachment for floors and futtocks, each of which were mortised into the chine log. The ends of the floors were cut down to produce tongues approximately 0.75 to 1 in (1.9 to 2.5 cm) less in molded dimension. The tongue was probably cut with a dovetail on the tongue's after face, at least for the timbers forward of amidship. The tongue was secured into a mortise in the chine log by the dovetail and by a wooden key driven into the mortise on the timber's opposite face. The heels of the futtocks were also secured with keyed-mortise joinery, and the details of the joint are presumed to be similar to those of the floors and chine log.

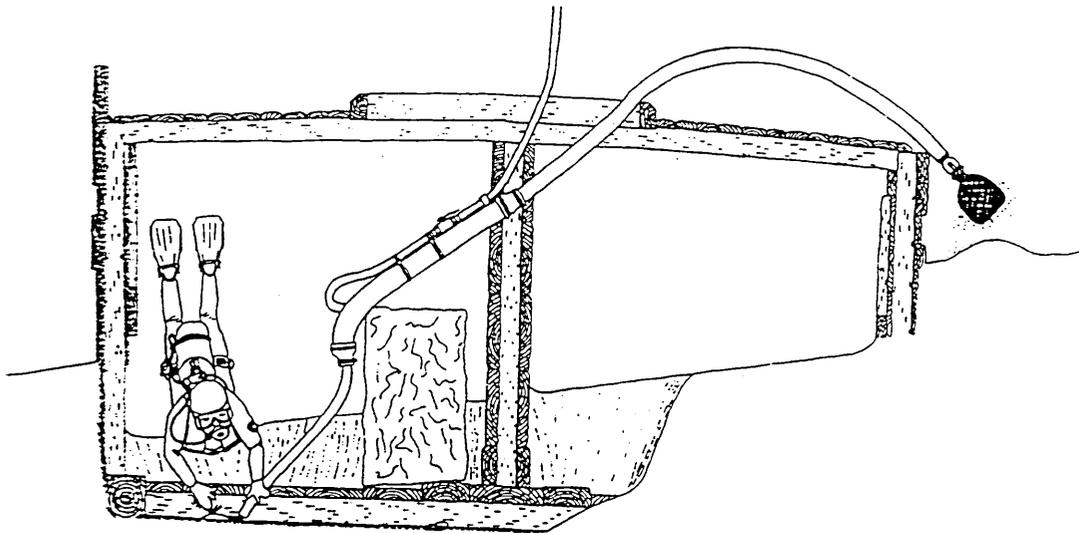
Figure 13: Profile view of the *General Butler* at the after end of the centerboard trunk (drawn by Joseph R. Cozzi, 1995).

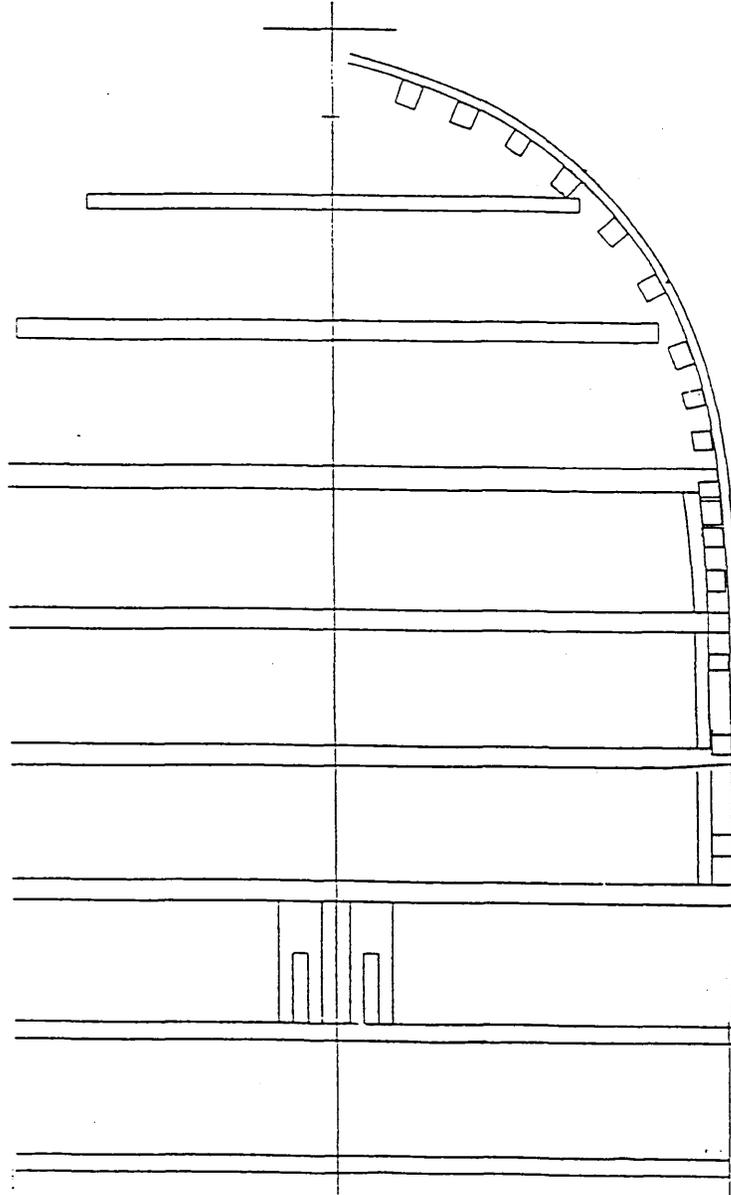
Figure 11: The deck beam spacing in the bow of the *General Butler*  
(drawn by Joseph R. Cozzi, 1995)

The *General Butler*'s deck structure is supported by stanchions that rise from the keelson to the underside of the deck beams (Figure 11 and 12). Of the stanchions sampled, two were made of white oak, while the other two were hard maple. Iron tie-rods were in evidence along with several stanchions. The deck beams are roughly 4 in by 4 in (10.2 cm by 10.2 cm) timbers that are cambered 2 in (5.1 cm) to permit water to drain from the deck. The deck beams are spaced 27.5 in (69.9 cm) between their forward faces. Four deck beams were sampled and all proved to be of white oak. The deck of the *General Butler* consists of white pine planking 1 in (2.5 cm) thick. The planks vary in width, but average 4.75 in (12.1 cm), with the most common size being 4.5 in (11.4 cm). The waterway is a 2.5 in (6.4 cm) thick, and is between 7 to 10 in (17.8 to 25.4 cm) wide. The waterway maintains its thickness beneath the bulwarks, but narrows to meet the thinner deck planking. Each deck plank is nailed to the supporting deck beam with two iron nails placed diagonally across the joint. The deck is pierced by five hatchways. The forwardmost is a companion way leading to the stem cabin. There are three cargo hatches. The aftermost hatch supported an above deck structure that was part of the after cabin. A wood sample taken from the starboard hatch coaming of the companion way was identified as white oak.

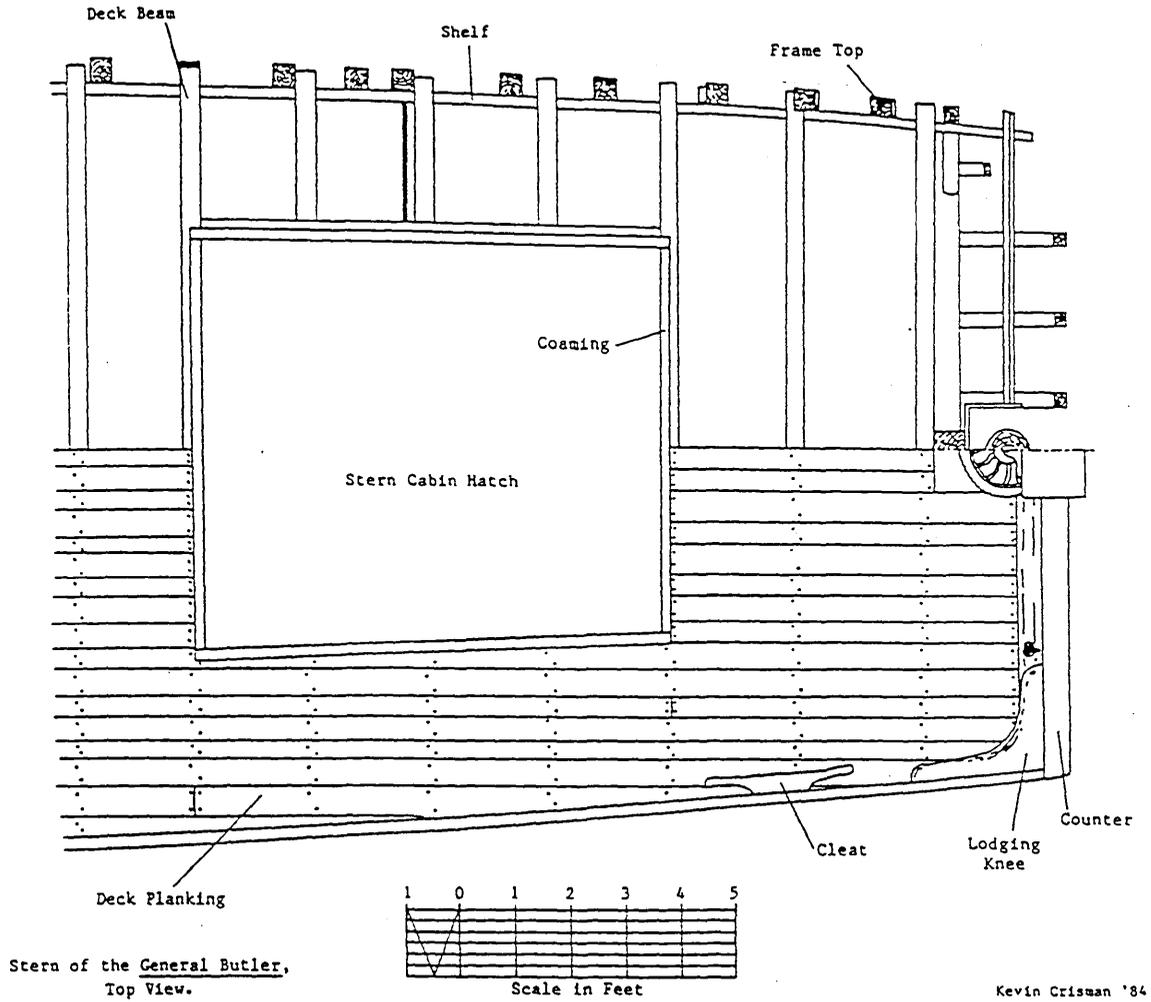
Figure 12: The stern of the *General Butler*, top view (drawn by Kevin J. Crisman, 1984).

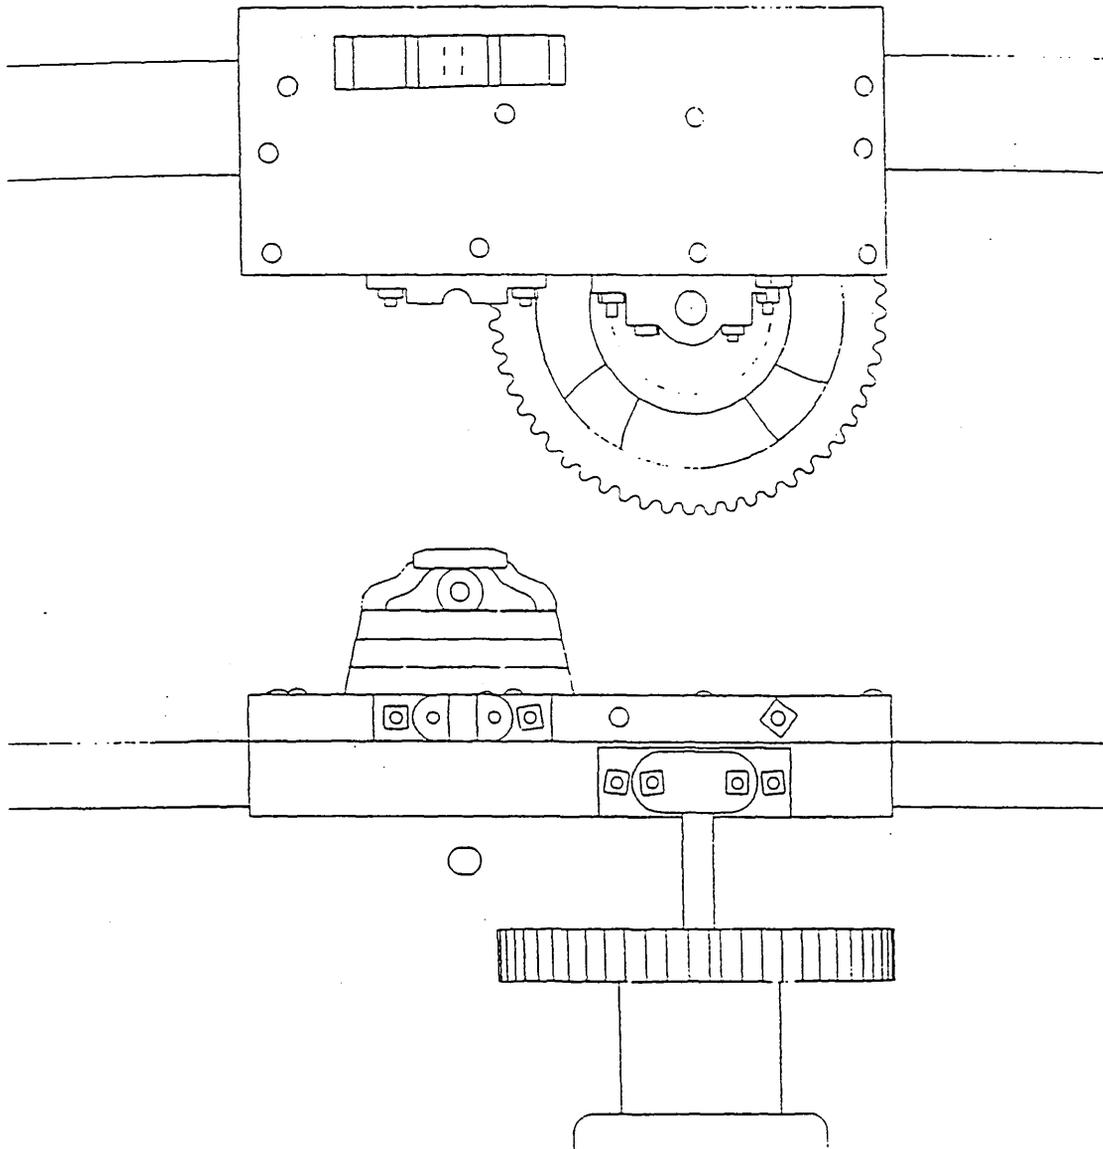
Figure 13: Remains of the *General Butler's* steering apparatus, top and side view (drawn by Joseph R. Cozzi, 1995).

The *General Butler* was originally wheel-steered. Historical accounts of the wrecking event describe the steering system failing, at which time the crew chained a tiller to the rudder post. This white oak tiller is still chained to a gear on top of the rudder post, which was made from American elm (Figure 13). This gear along with hardware and planking located on the stern rail, and iron rust marks on the stern deck are all that remain of the original steering apparatus. The wheel would have been mounted on an axle that passed through an upright plank on the stern rail. The other end of the axle would have been supported by missing framework coming up off the deck. The movement of this axle would have been transmitted to a vertical axle that in turn would have transmitted its movement to the gear on top of the rudder post. The rudder post gear has 56 teeth and is 22 in 55.9 cm) in diameter.
