National Register of Historic Places Registration Form

historic name Collins House

street & number 108 Baldwin Street

city or town Bloomfield Township

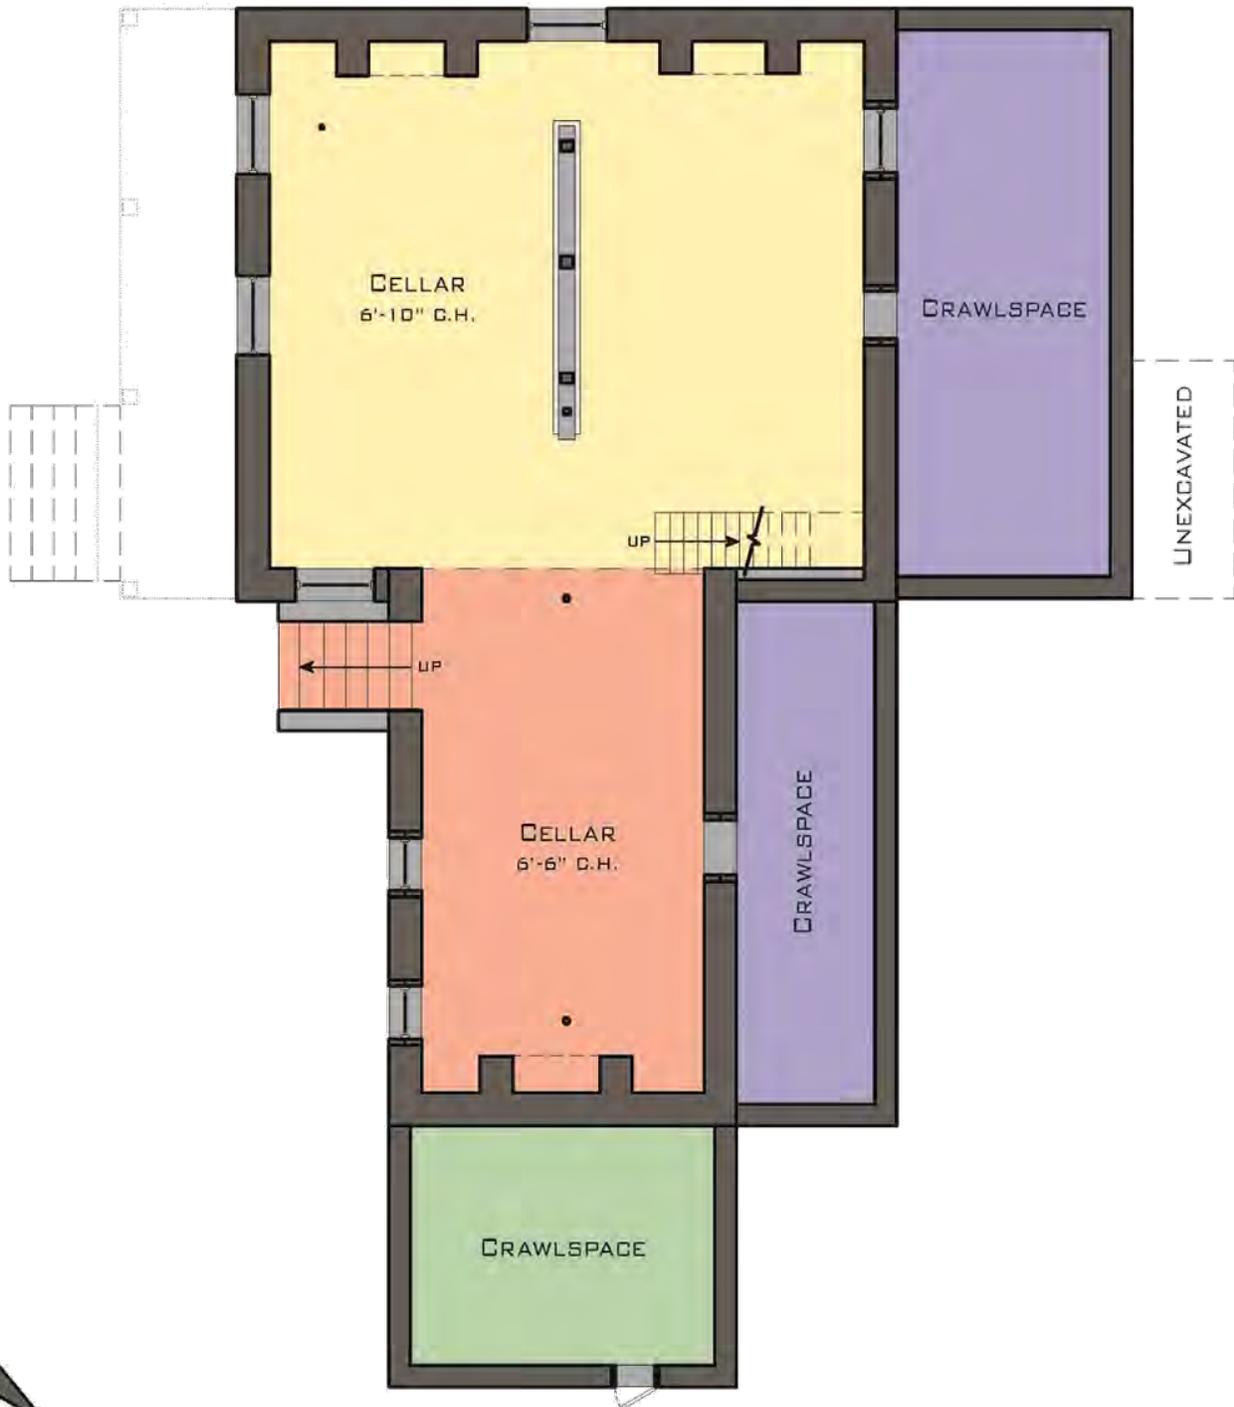
CELLAR PLAN
 SCALE: 1/8" = 1'-0"

| | PRIMARY ADDITION - CA. 1820 - ISAAC COLLINS | | REAR ADDITION - POST 1937 |
| | SECONDARY ADDITION - CA. 1850 | | |

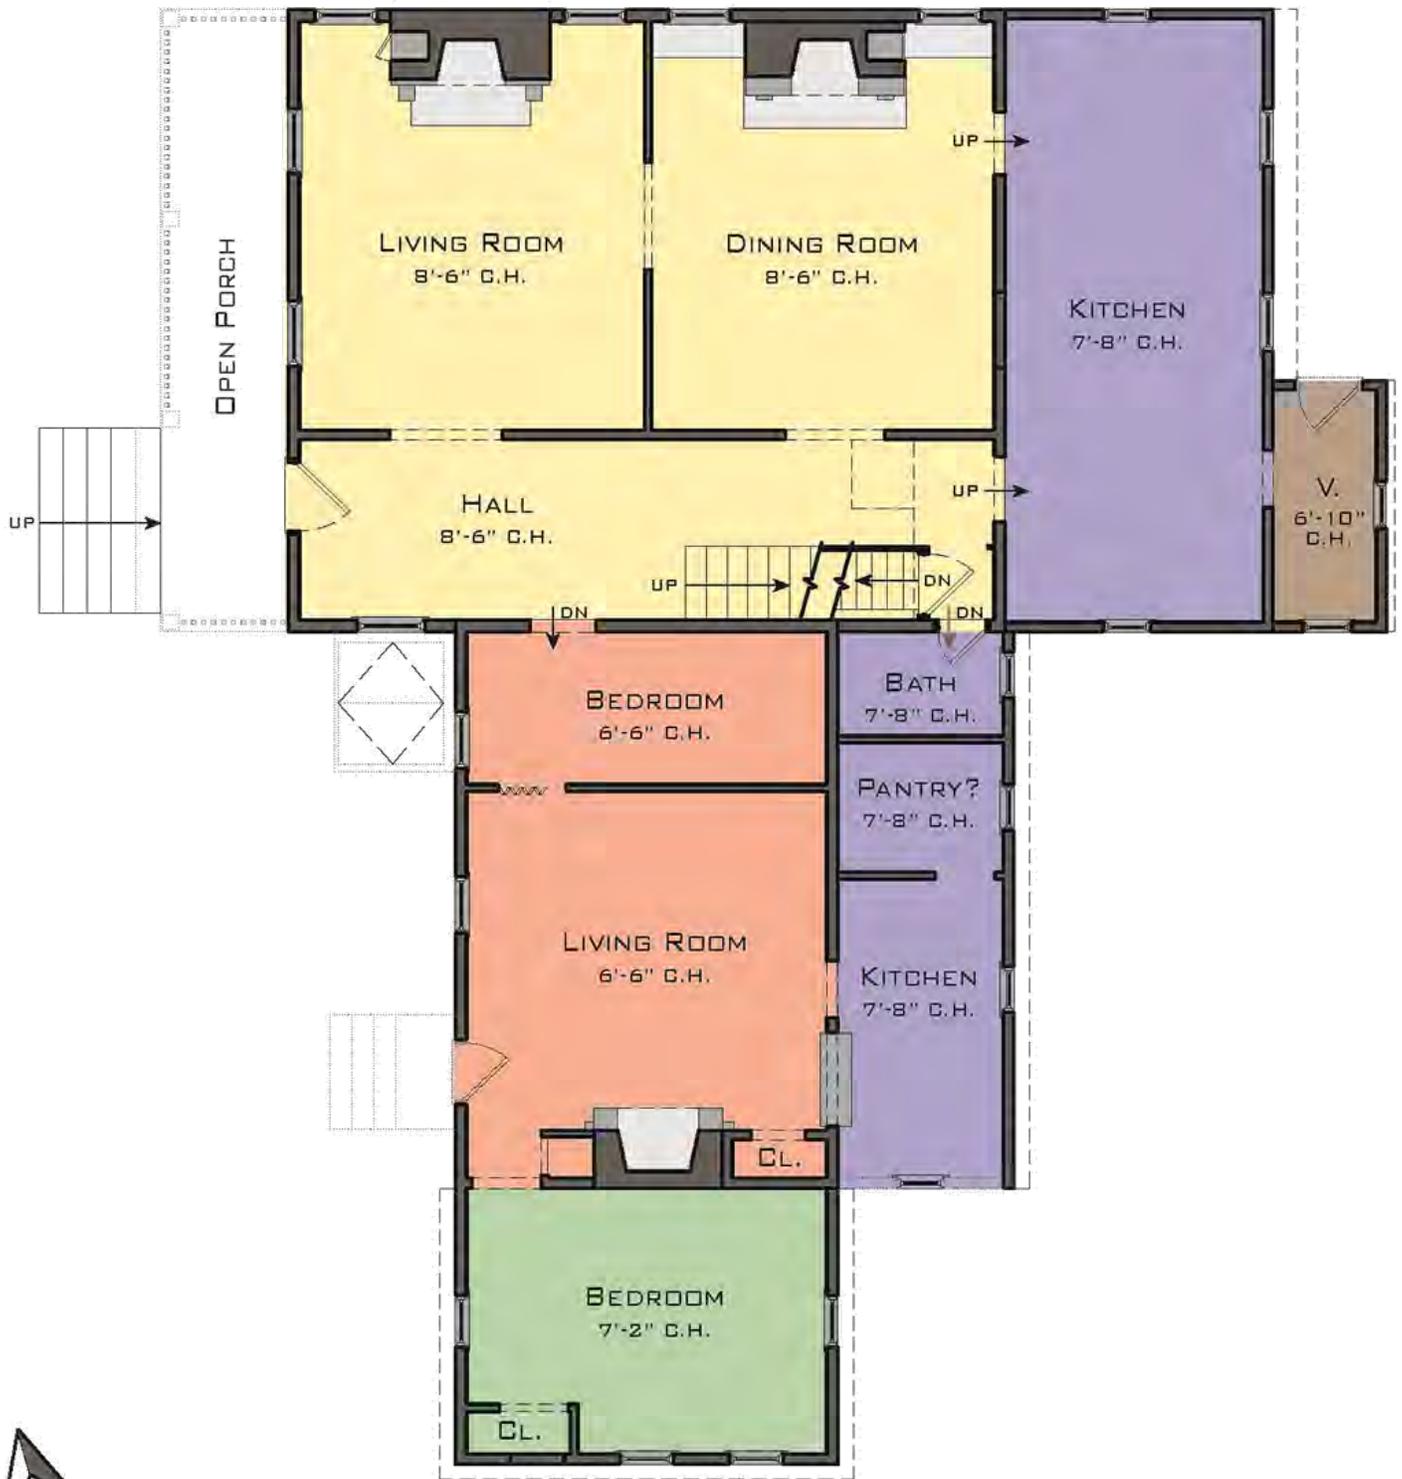
FIRST FLOOR PLAN

- ORIGINAL DWELLING - CA. 1790s - JOHN COLLINS
- PRIMARY ADDITION - CA. 1820 - ISAAC COLLINS
- SECONDARY ADDITION - CA. 1850
- REAR ADDITIONS - CA. 1900
- REAR ADDITION - POST 1937

- EXISTING WALLS & PARTITIONS
- CHANGE IN CEILING HEIGHT ABOVE
- BUILDING COMPONENT KNOWN HISTORICALLY BUT NO LONGER EXTANT

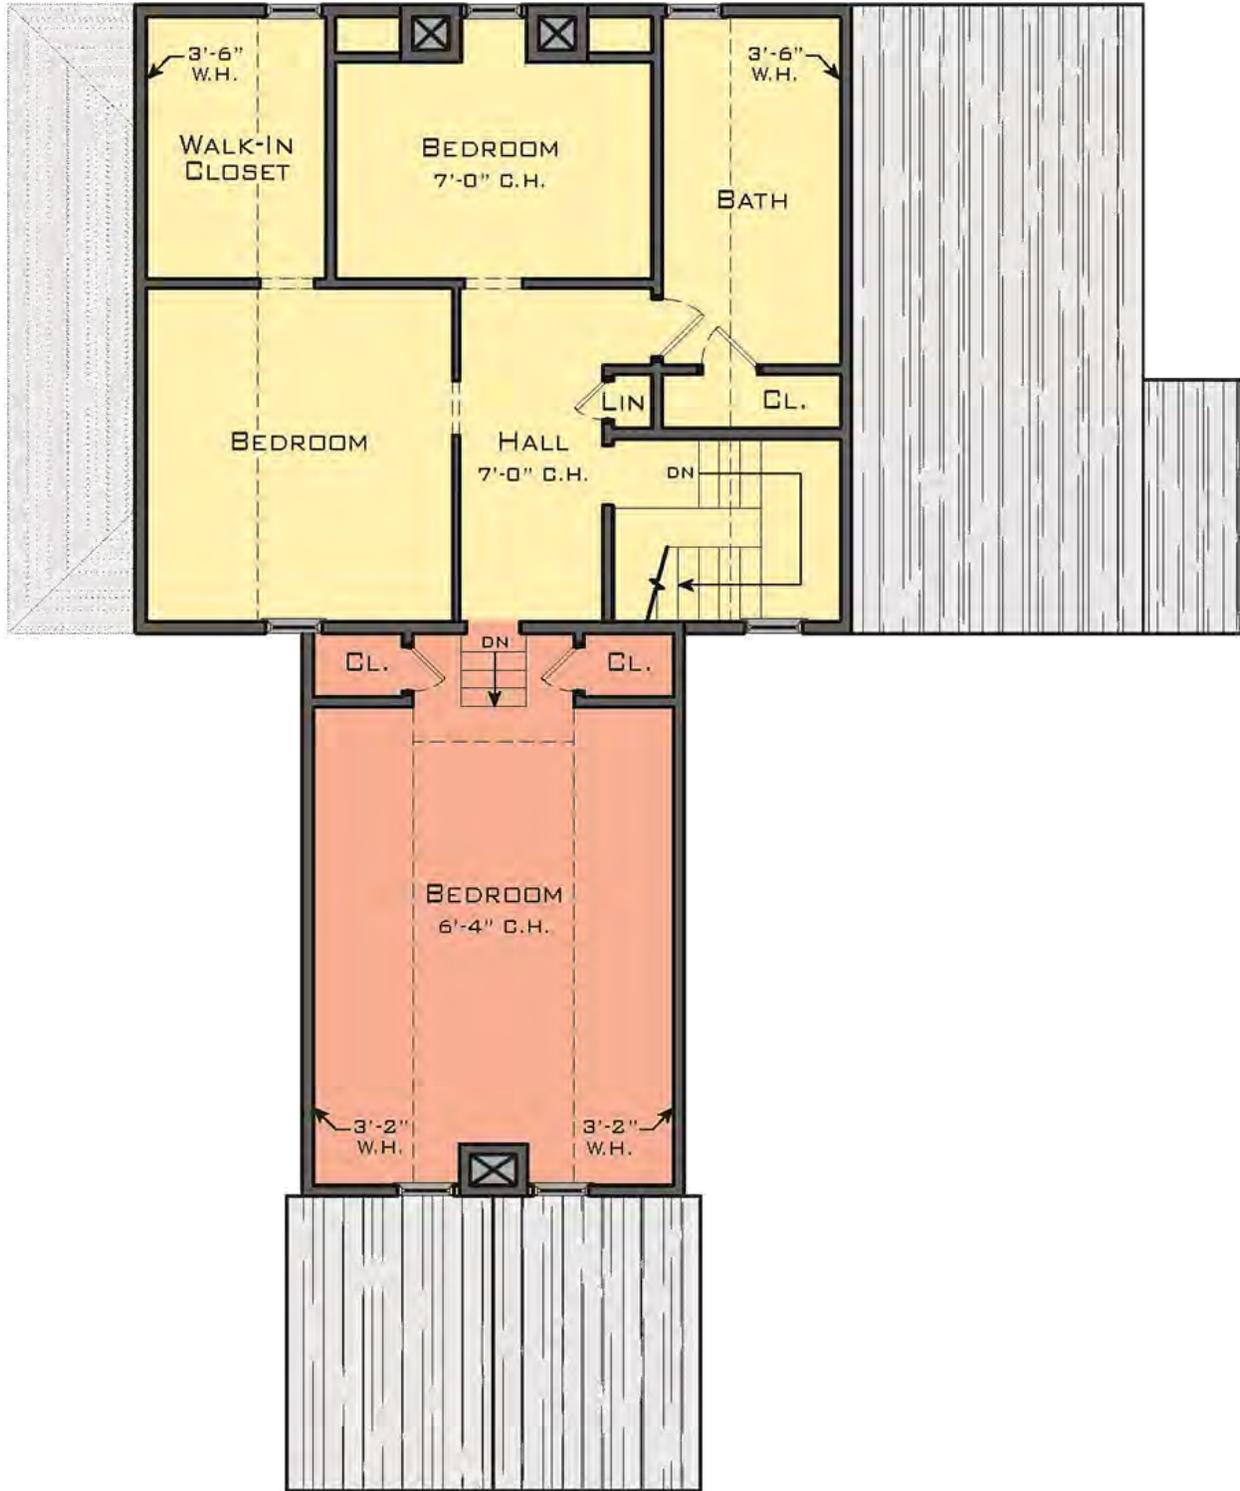
SECOND FLOOR PLAN

| | PRIMARY ADDITION - CA. 1820 - ISAAC COLLINS | | REAR ADDITION - POST 1937 |
| | SECONDARY ADDITION - CA. 1850 | | |

SCALE: 1/8" = 1'-0"

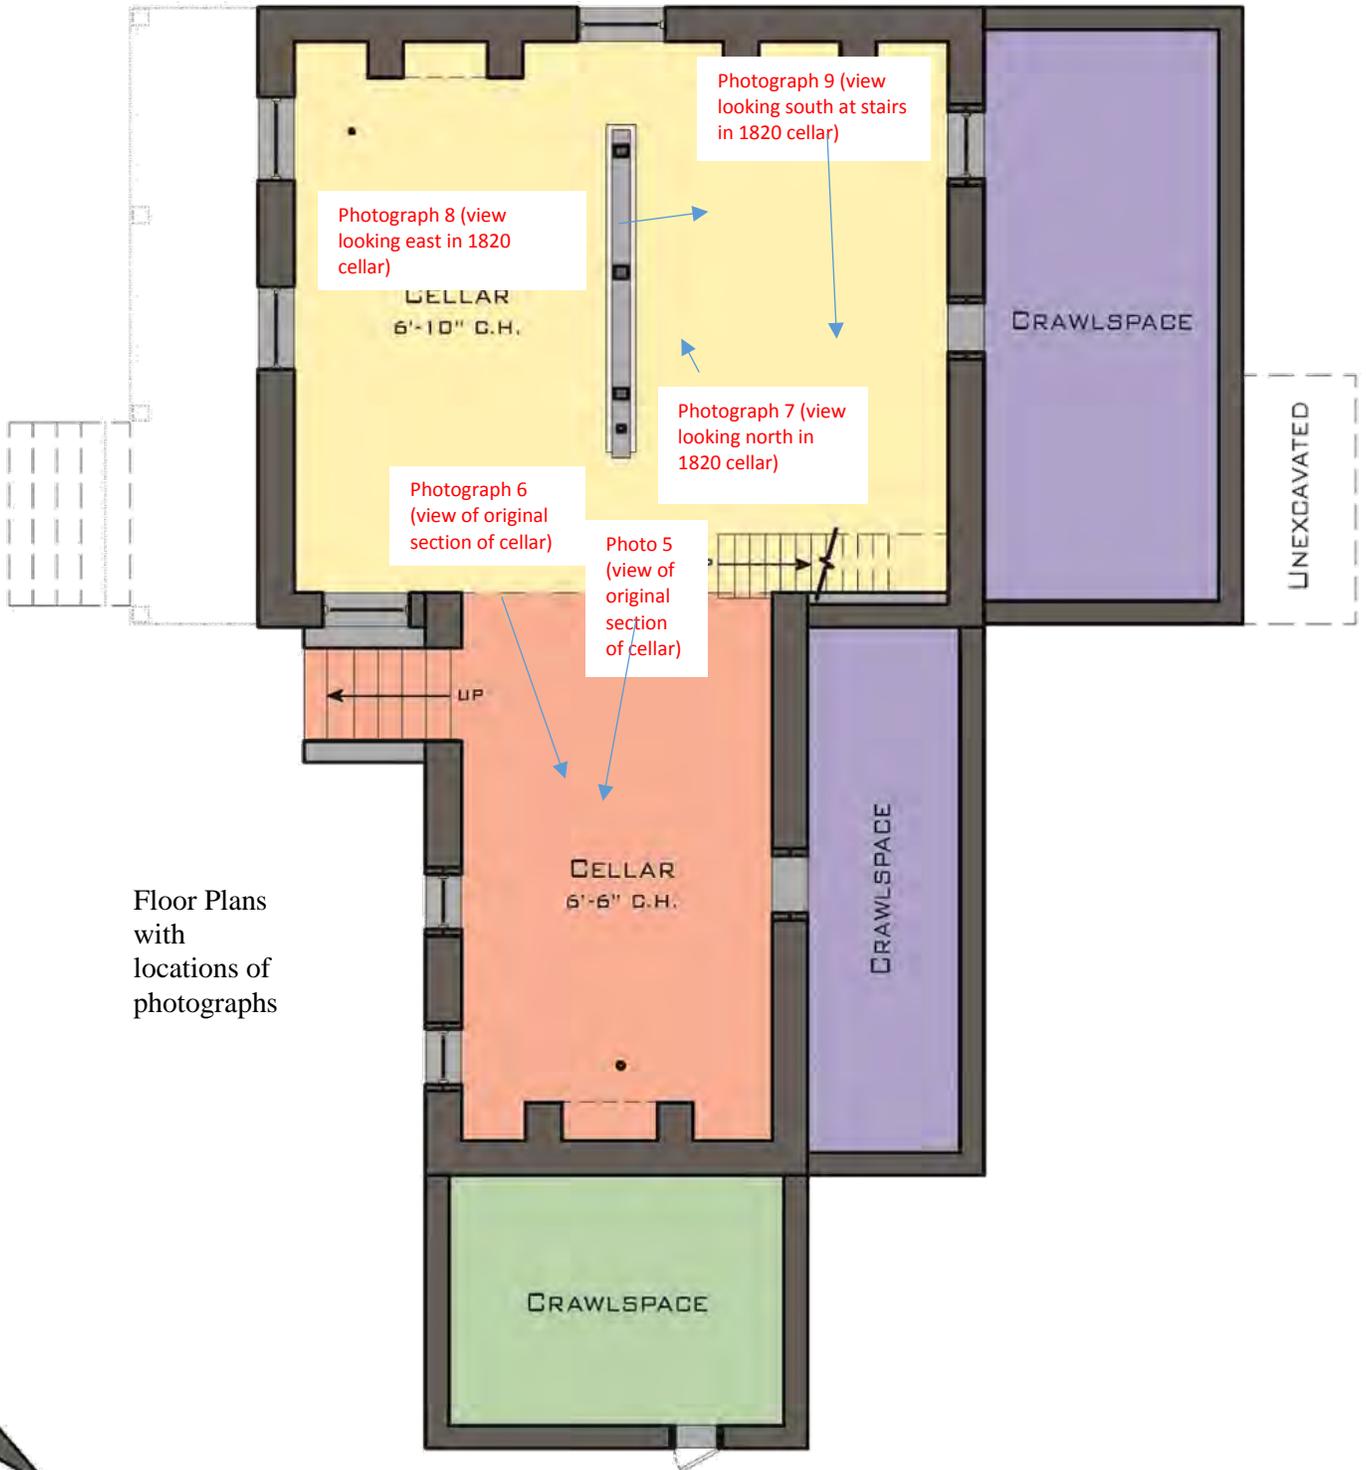
Floor Plans with locations of photographs

- ORIGINAL DWELLING - CA. 1790s - JOHN COLLINS
- PRIMARY ADDITION - CA. 1820 - ISAAC COLLINS
- SECONDARY ADDITION - CA. 1850
- REAR ADDITIONS - CA. 1900
- REAR ADDITION - POST 1937

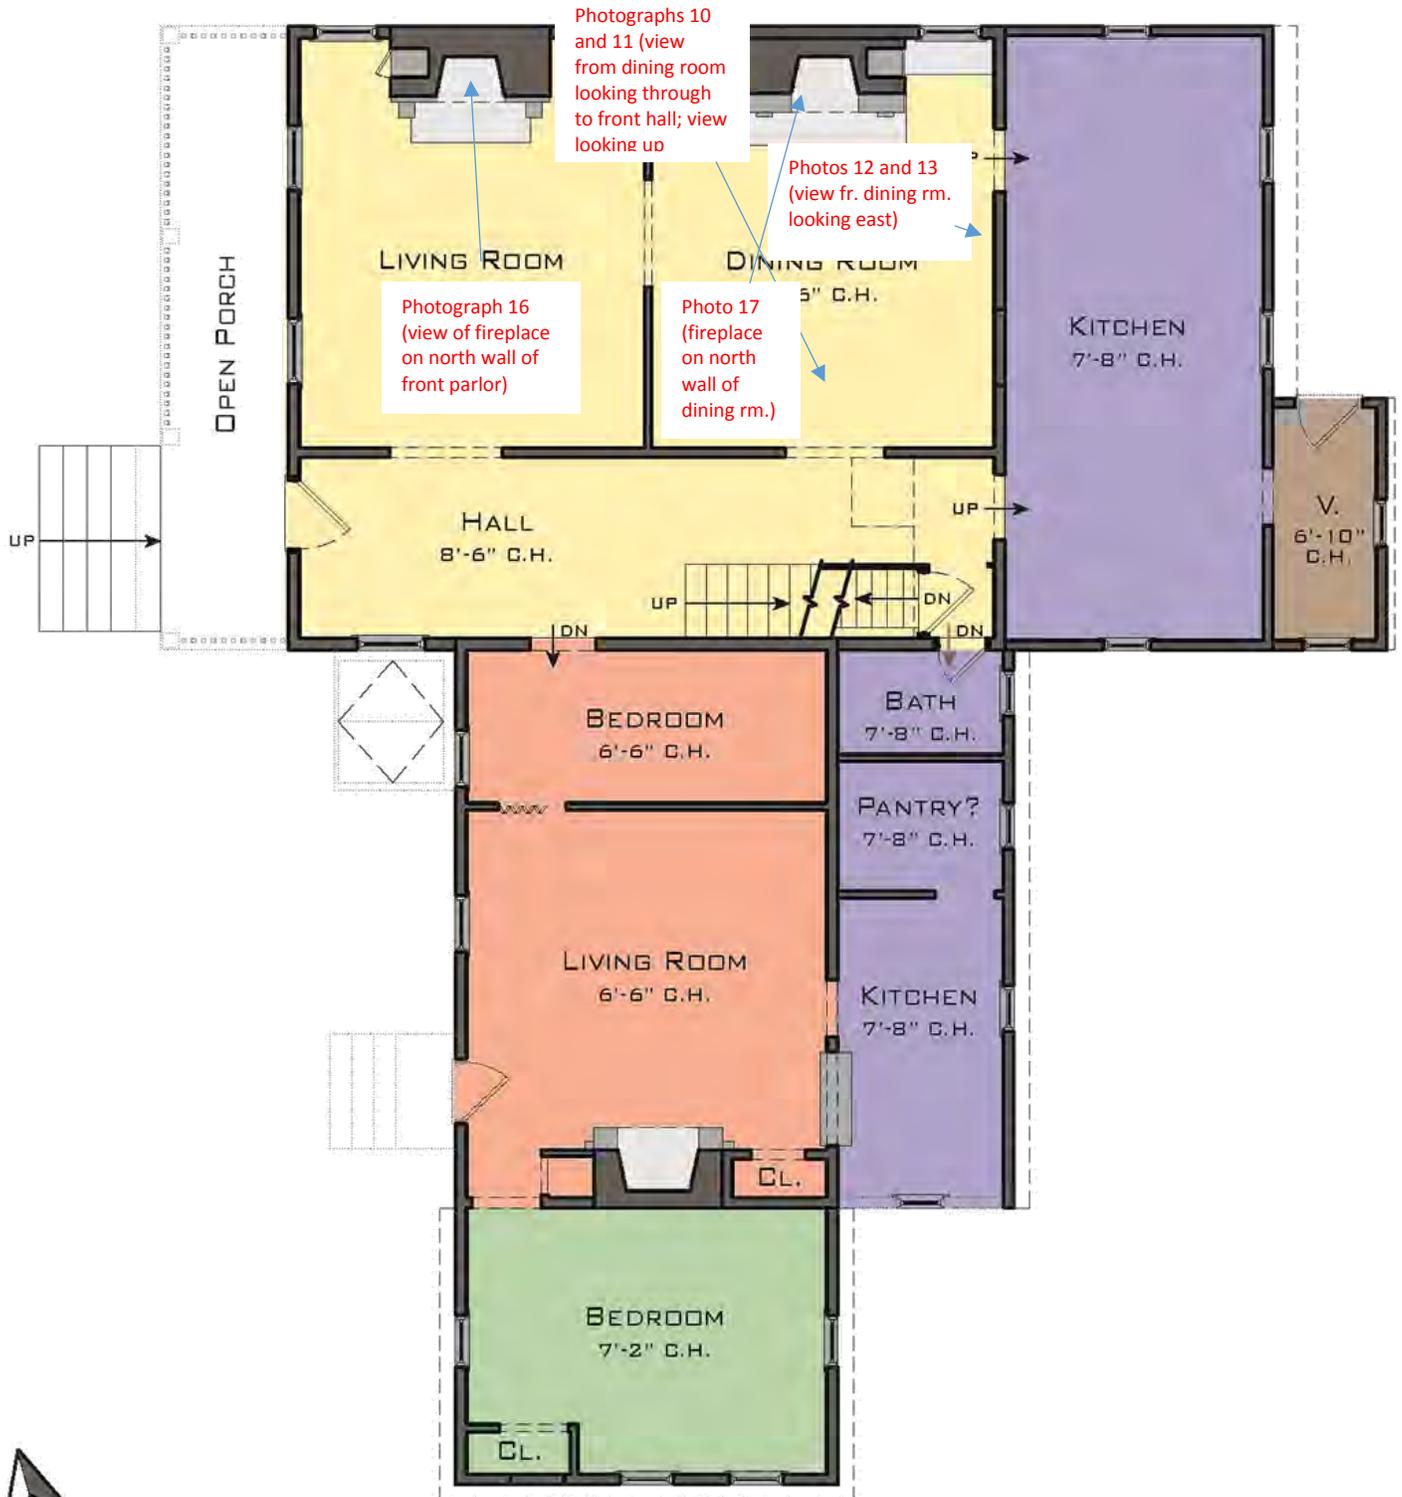
FIRST FLOOR PLAN

- ORIGINAL DWELLING - CA. 1790s - JOHN COLLINS
- PRIMARY ADDITION - CA. 1820 - ISAAC COLLINS
- SECONDARY ADDITION - CA. 1850
- REAR ADDITIONS - CA. 1900
- REAR ADDITION - POST 1937

SCALE: 1/8" = 1'-0"

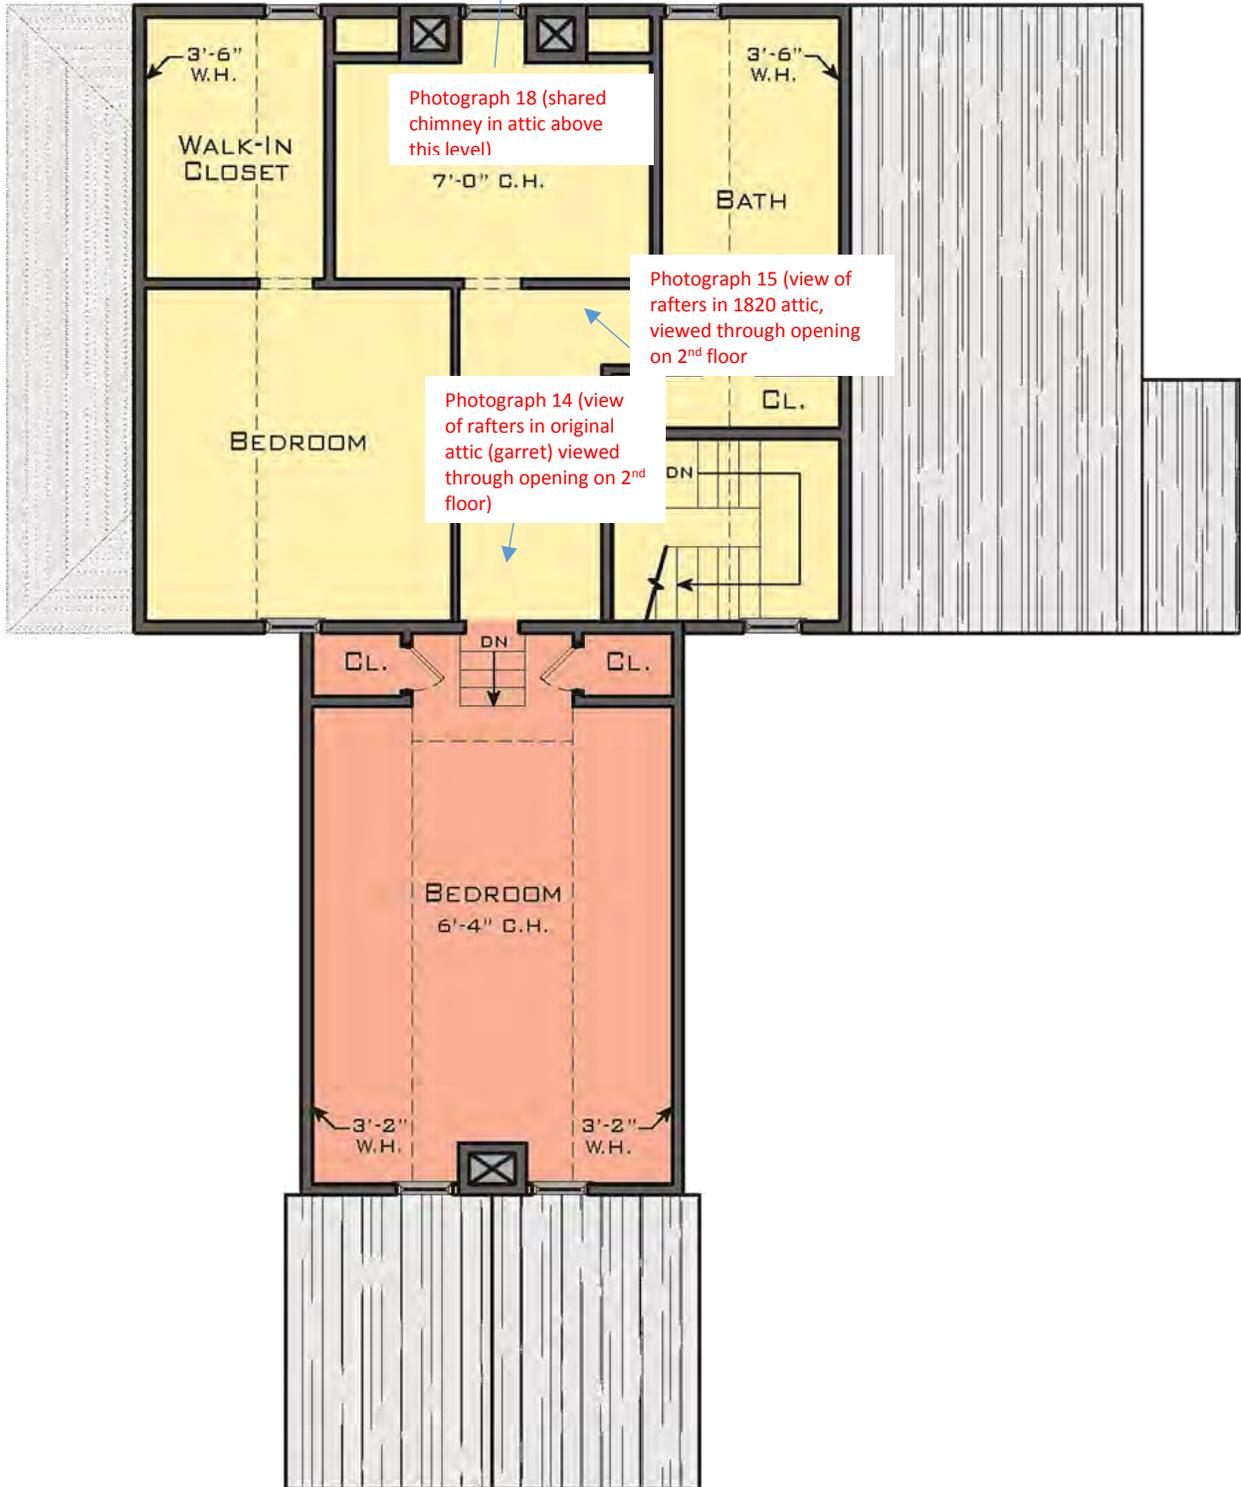
SECOND FLOOR PLAN

- ORIGINAL DWELLING - CA. 1790s - JOHN COLLINS
- PRIMARY ADDITION - CA. 1820 - ISAAC COLLINS
- SECONDARY ADDITION - CA. 1850
- REAR ADDITIONS - CA. 1900
- REAR ADDITION - POST 1937

SCALE: 1/8" = 1'-0"

- EXISTING WALLS & PARTITIONS
- CHANGE IN CEILING HEIGHT ABOVE
- BUILDING COMPONENT KNOWN HISTORICALLY BUT NO LONGER EXTANT

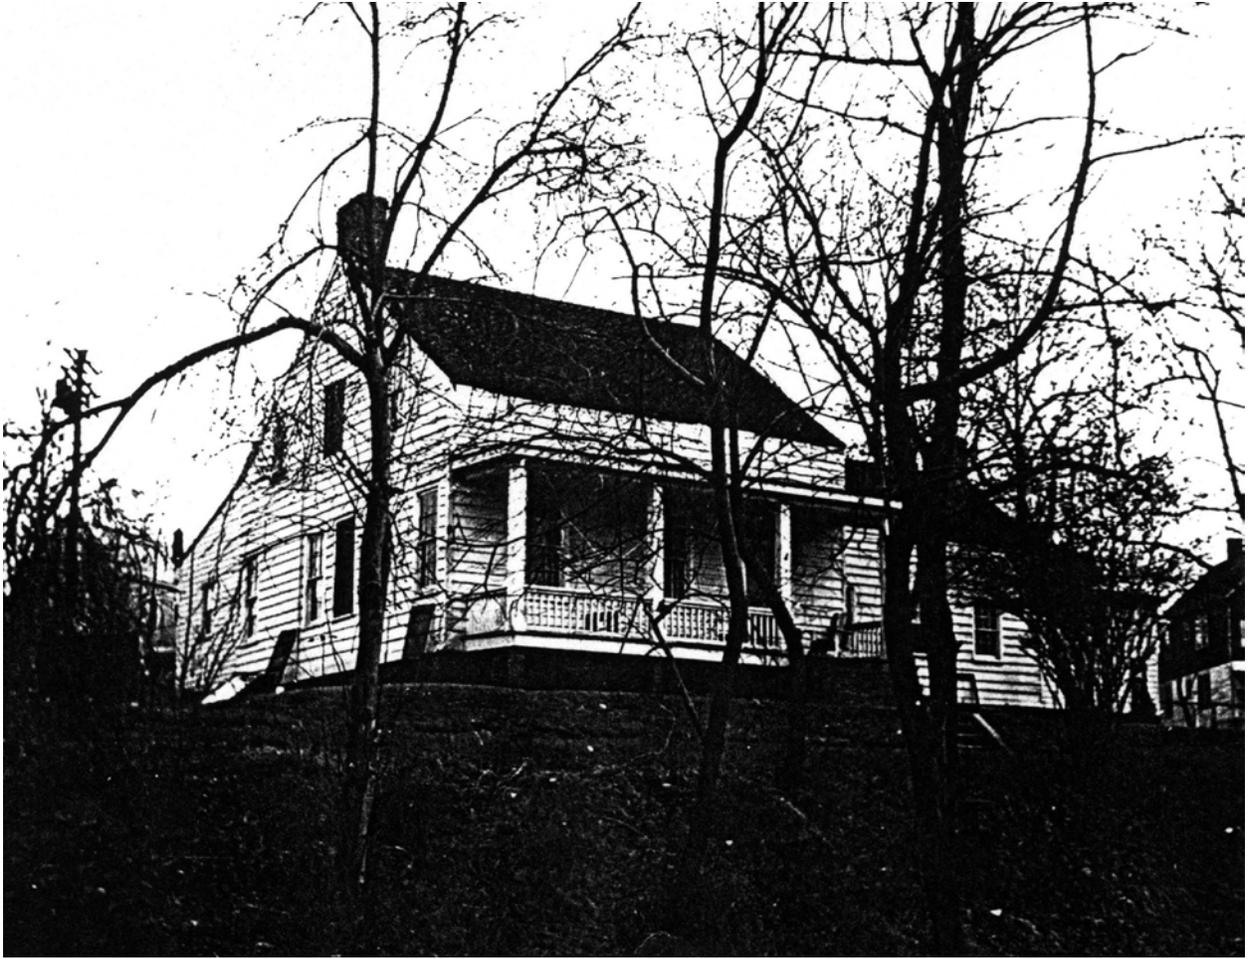
Historic Photograph 1: Northwest view of ca. 1820 section of Collins House taken in the 1960s.
Source: Morrell, et al.

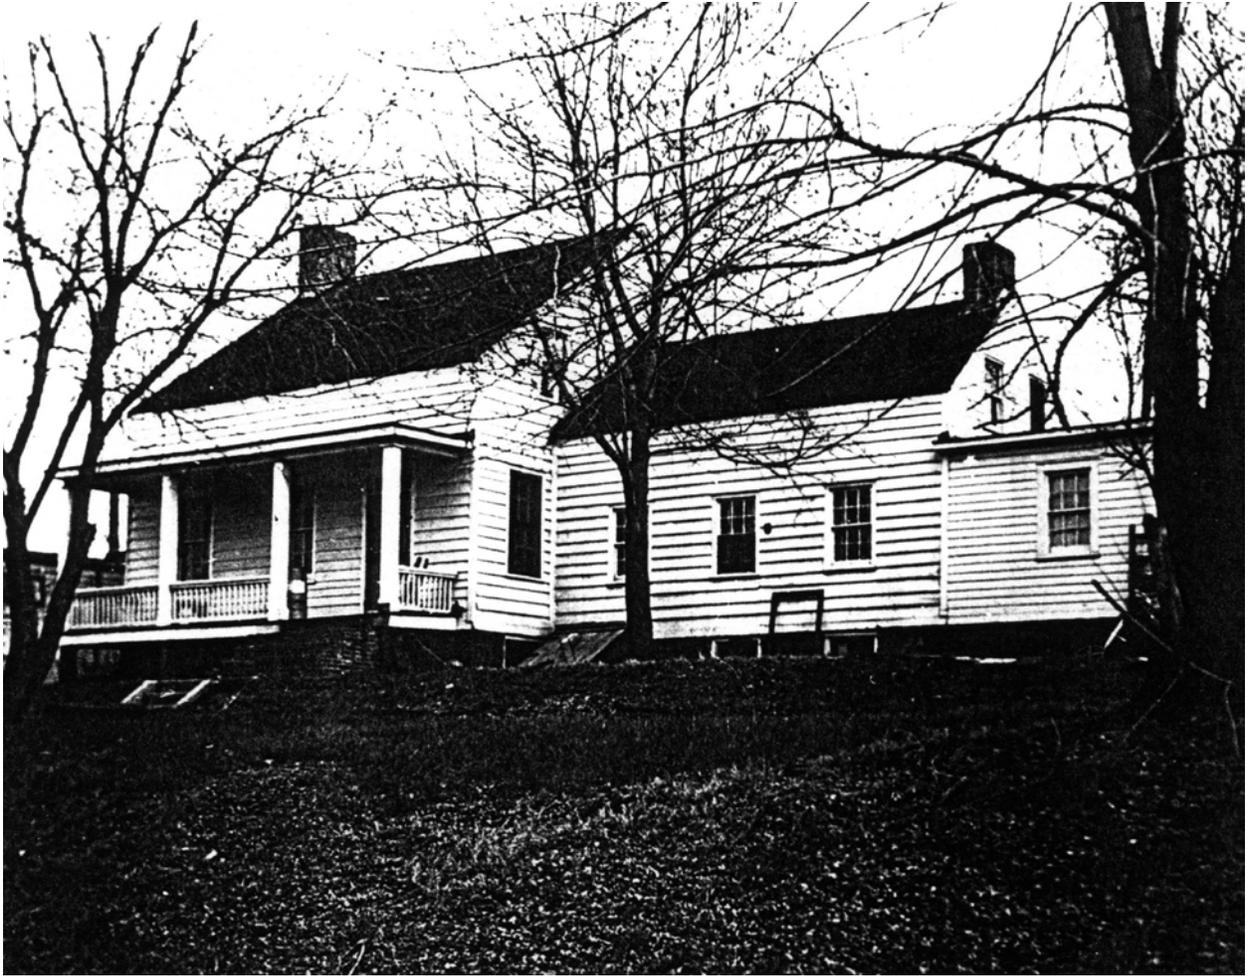
Historic Photograph 2: Western façade Collins House taken in the 1960s. 1820 addition on left, ca. 1790 original dwelling in center; ca. 1850s addition on right.
Source: Morrell, et al.

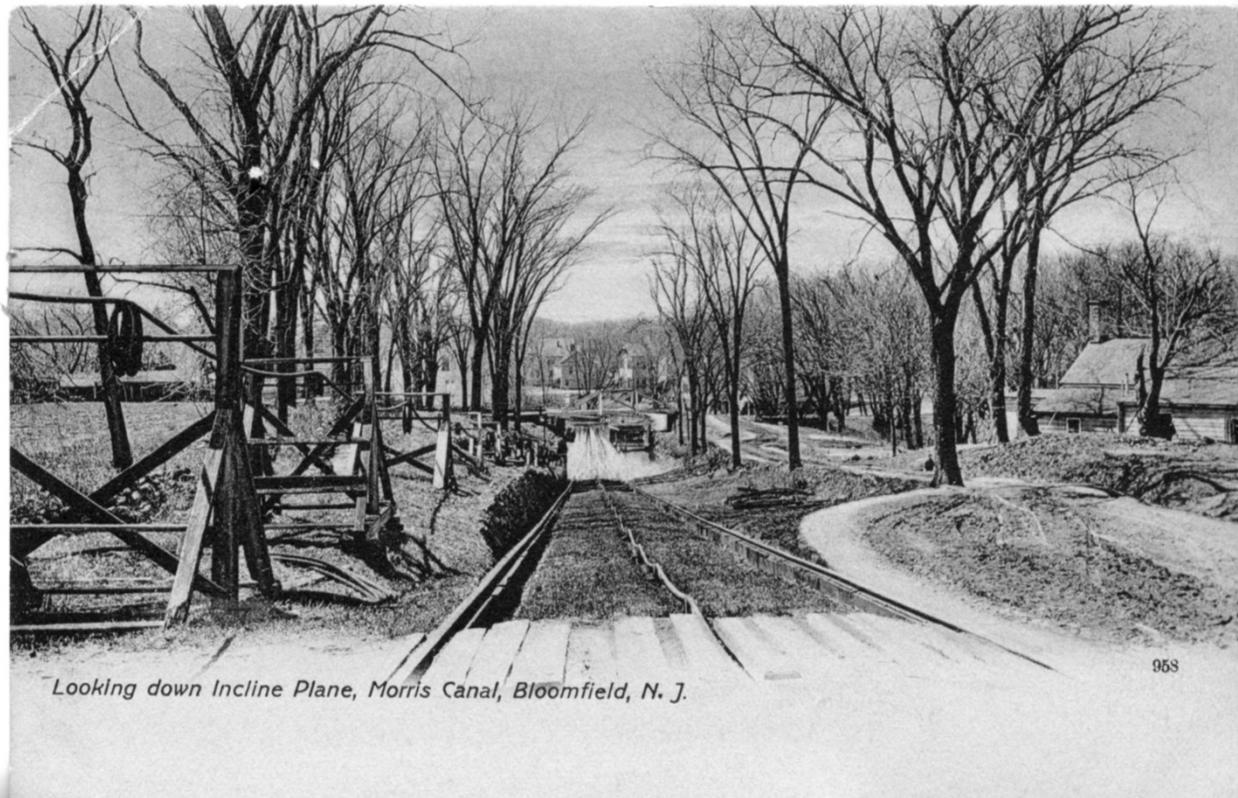
Historic Photograph 11: Postcard labeled “Looking down inclined Plane, Morris canal, Bloomfield, N. J.” Looking south down Inclined Plane 11 East. Rear of Collins house is on the right. Plank road crossing the plane is visible at the bottom of the photo.

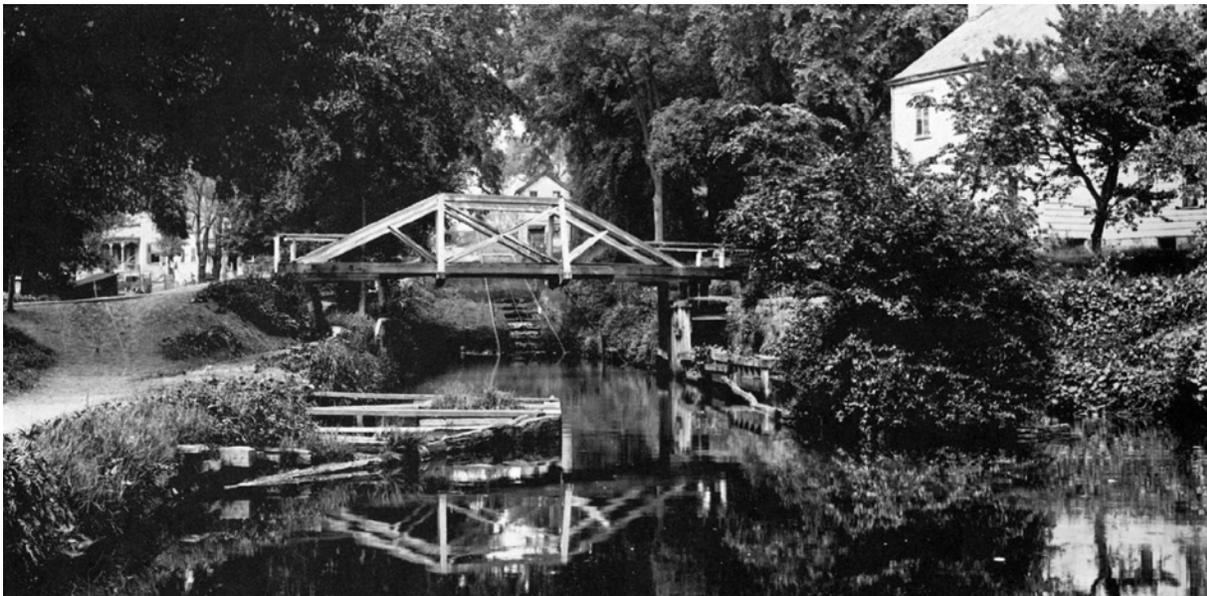
Historic Photograph 12: Foot of the Inclined Plane taken from the James Street Bridge facing north. Baldwin Street Bridge is in the foreground. The Collins House is visible through the trees on the left.

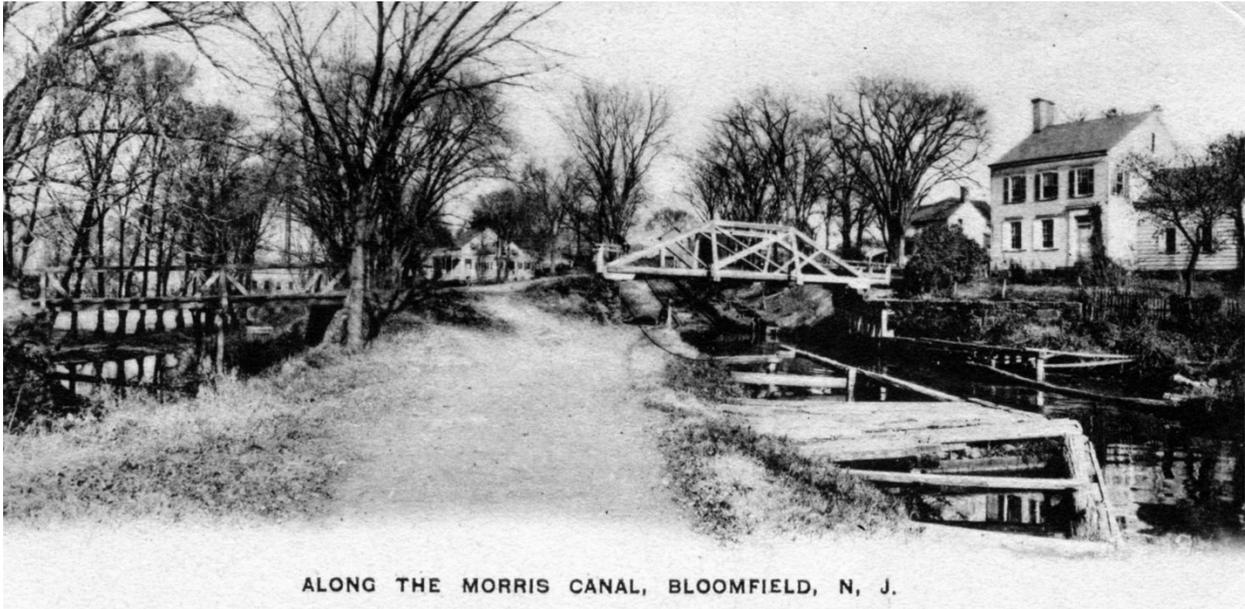
ALONG THE MORRIS CANAL, BLOOMFIELD, N, J.

Historic Photograph 13: Postcard labeled “Along the Morris Canal, Bloomfield, N. J.” Foot of the Inclined Plane taken from the tow path near the James Street Bridge facing north. Baldwin Street Bridge over the canal in the foreground on the right. Baldwin Street Bridge crossing Third River on the left. The Collins House is in the center of the photo. Diamond Paper Mill and smoke stack are visible in the distance on the left. Source: Historical Society of Bloomfield, 90 Broad Street, Bloomfield, NJ

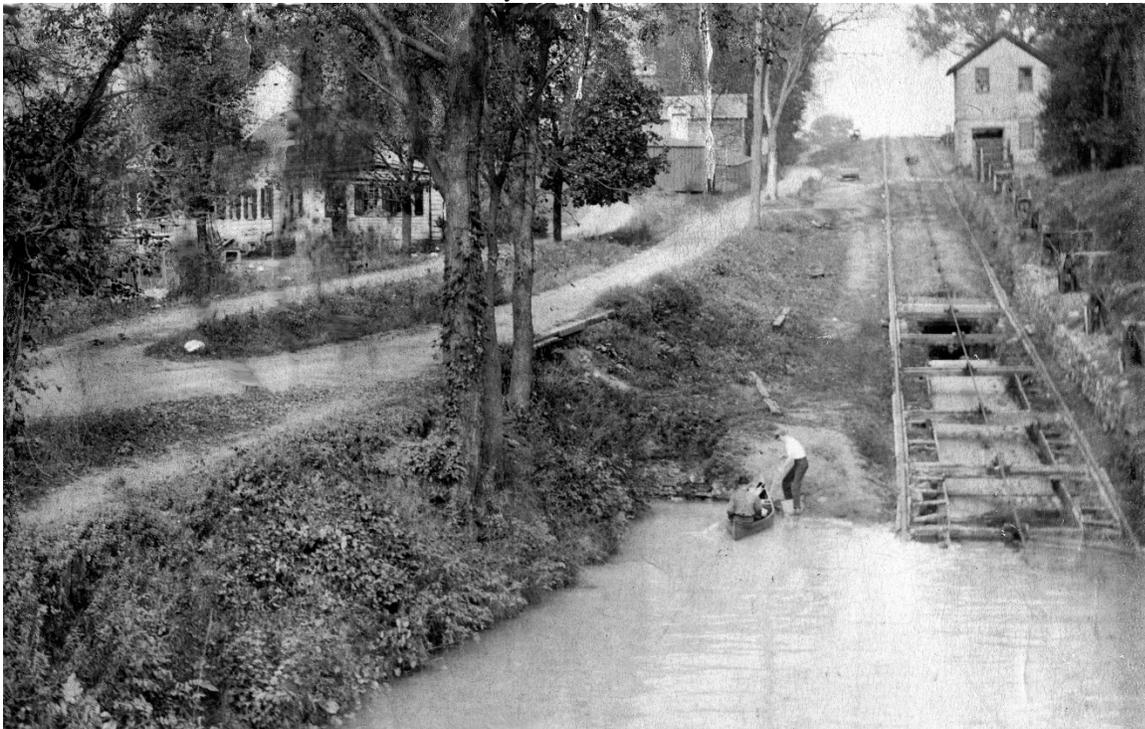
Historic Photograph 14: Foot of the Inclined Plane taken from the Baldwin Street Bridge facing north. The Collins House is on the left. Children using a canoe give a sense of scale of the Inclined Plane. Source: Historical Society of Bloomfield, 90 Broad Street, Bloomfield, NJ

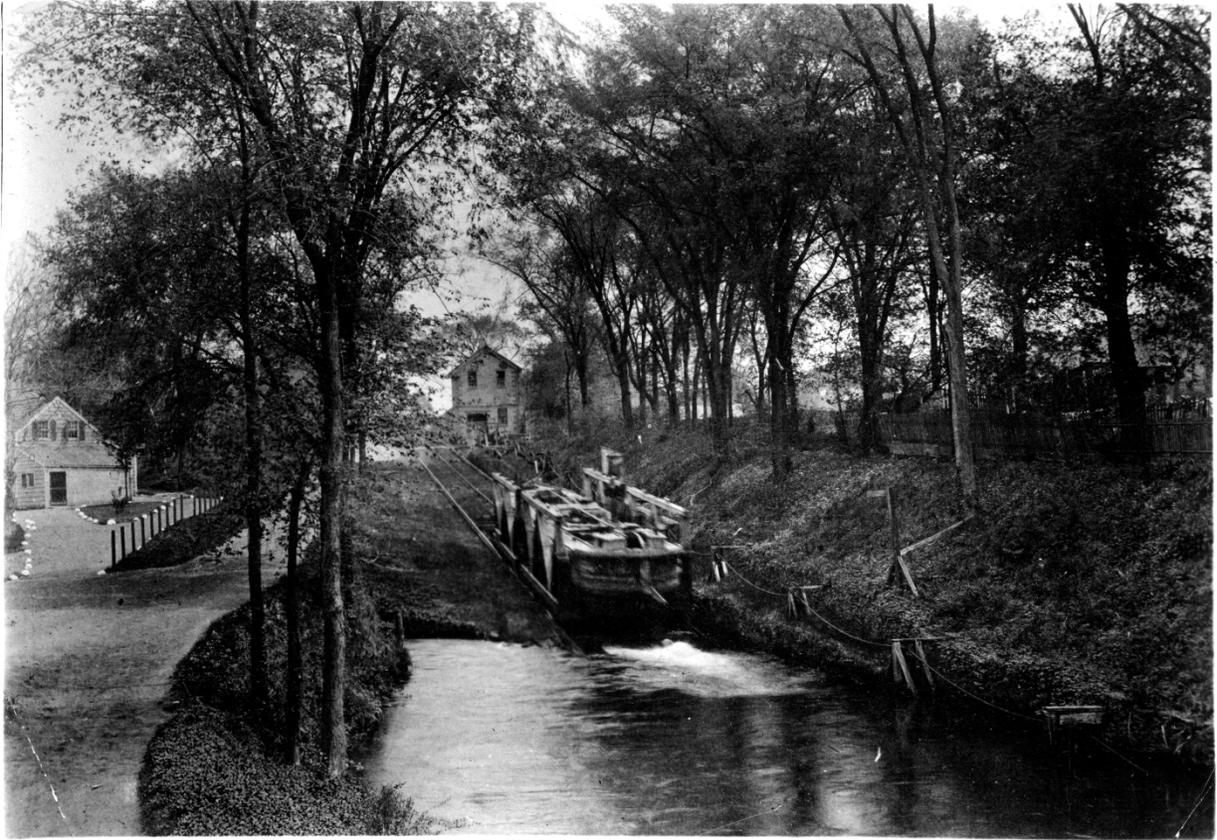
Historic Photograph 15: Foot of the Inclined Plane taken from the Baldwin Street Bridge facing north with a boat ascending the plane. The Collins House is on the left.

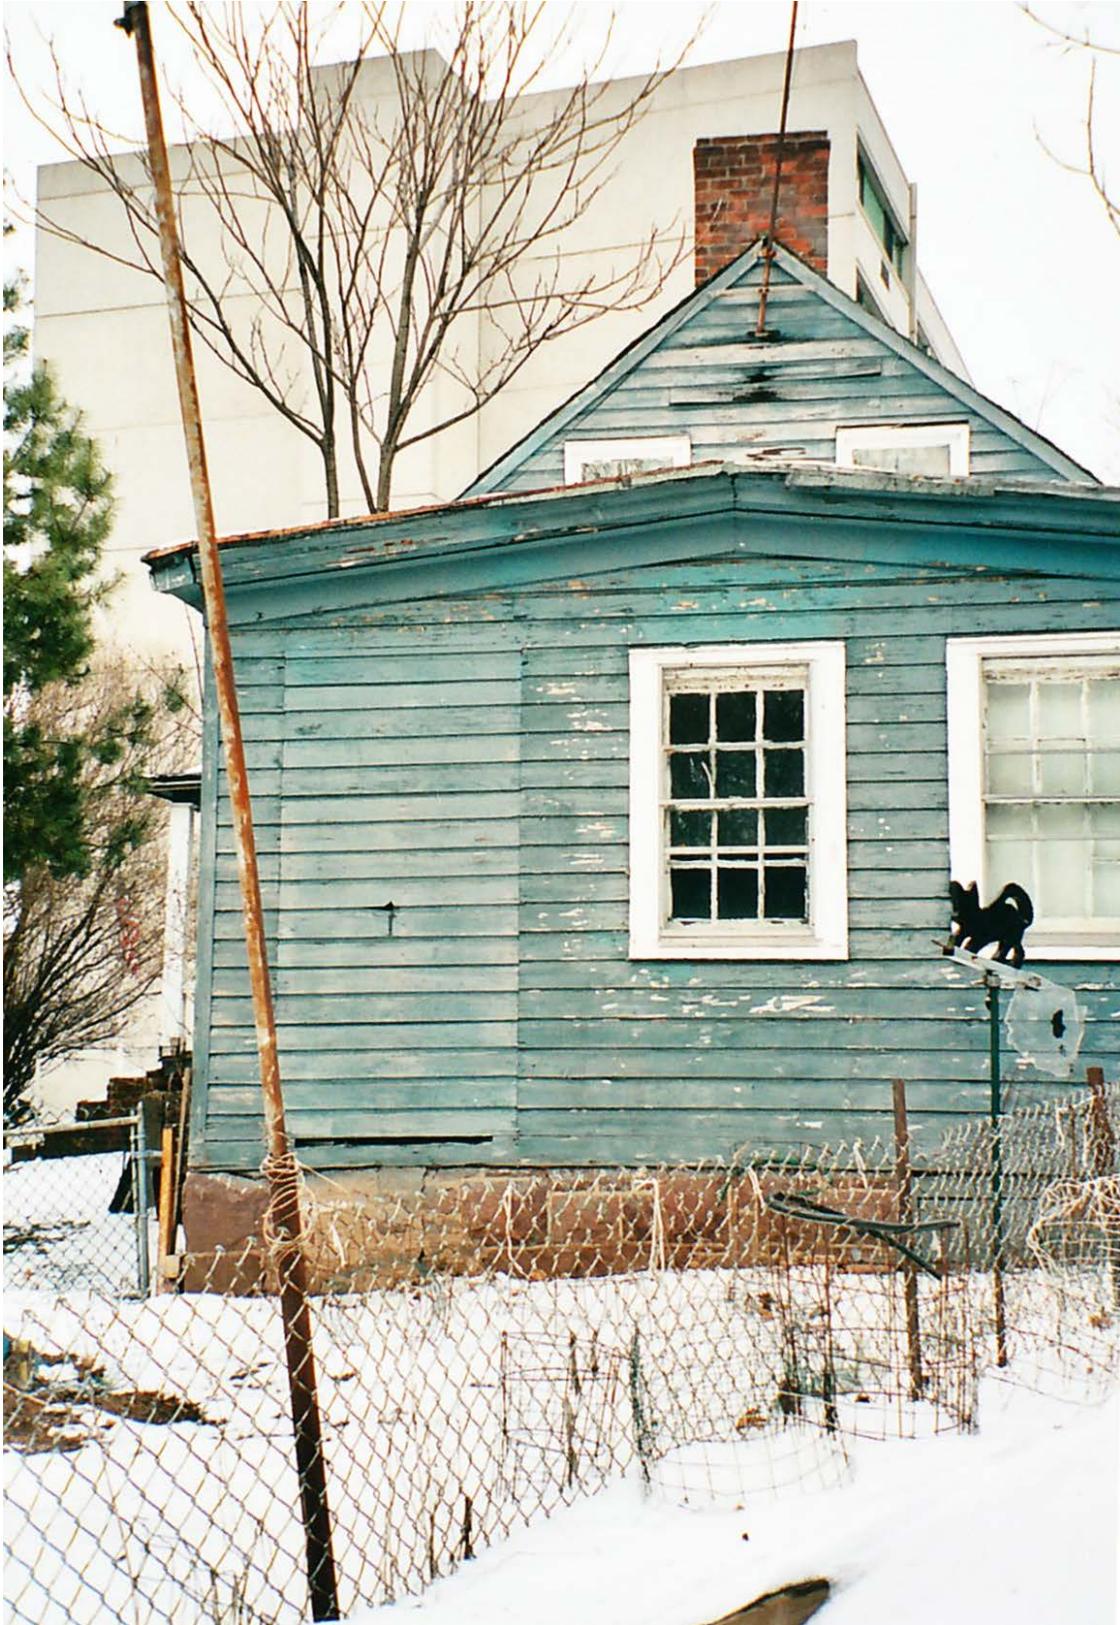
Historic Photograph 16: View of south elevation of ca.1850 southern addition to Collins House showing evidence of sealed-off door. Photograph taken by Miriam Michalski, 2004.

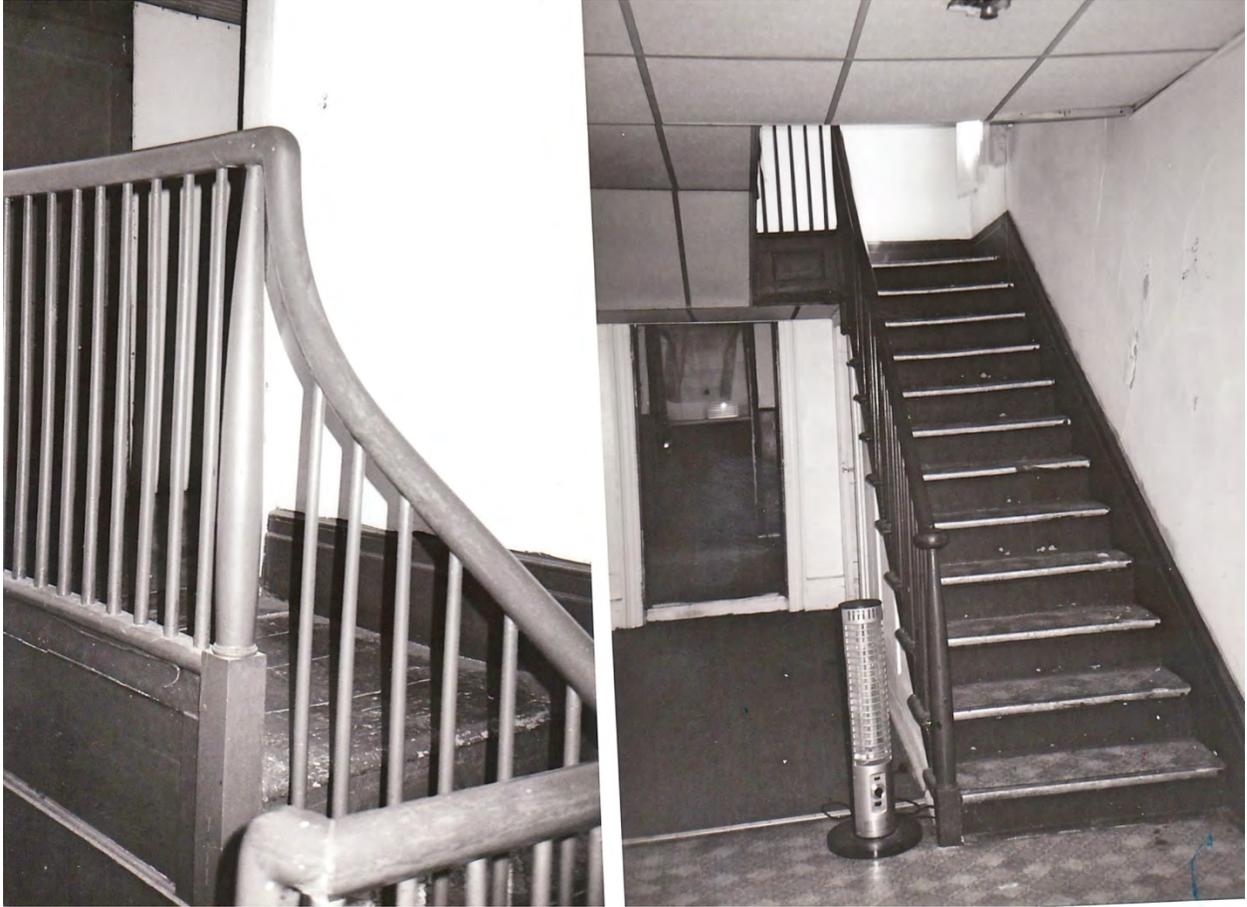
Historic Photographs 18 and 19: Federal staircase details in Collins House prior to vandalism. Photograph taken by Miriam Michalski, 2004.
