National Register of Historic Places Registration Form

historic name Collins House

street & number 108 Baldwin Street

city or town Bloomfield Township

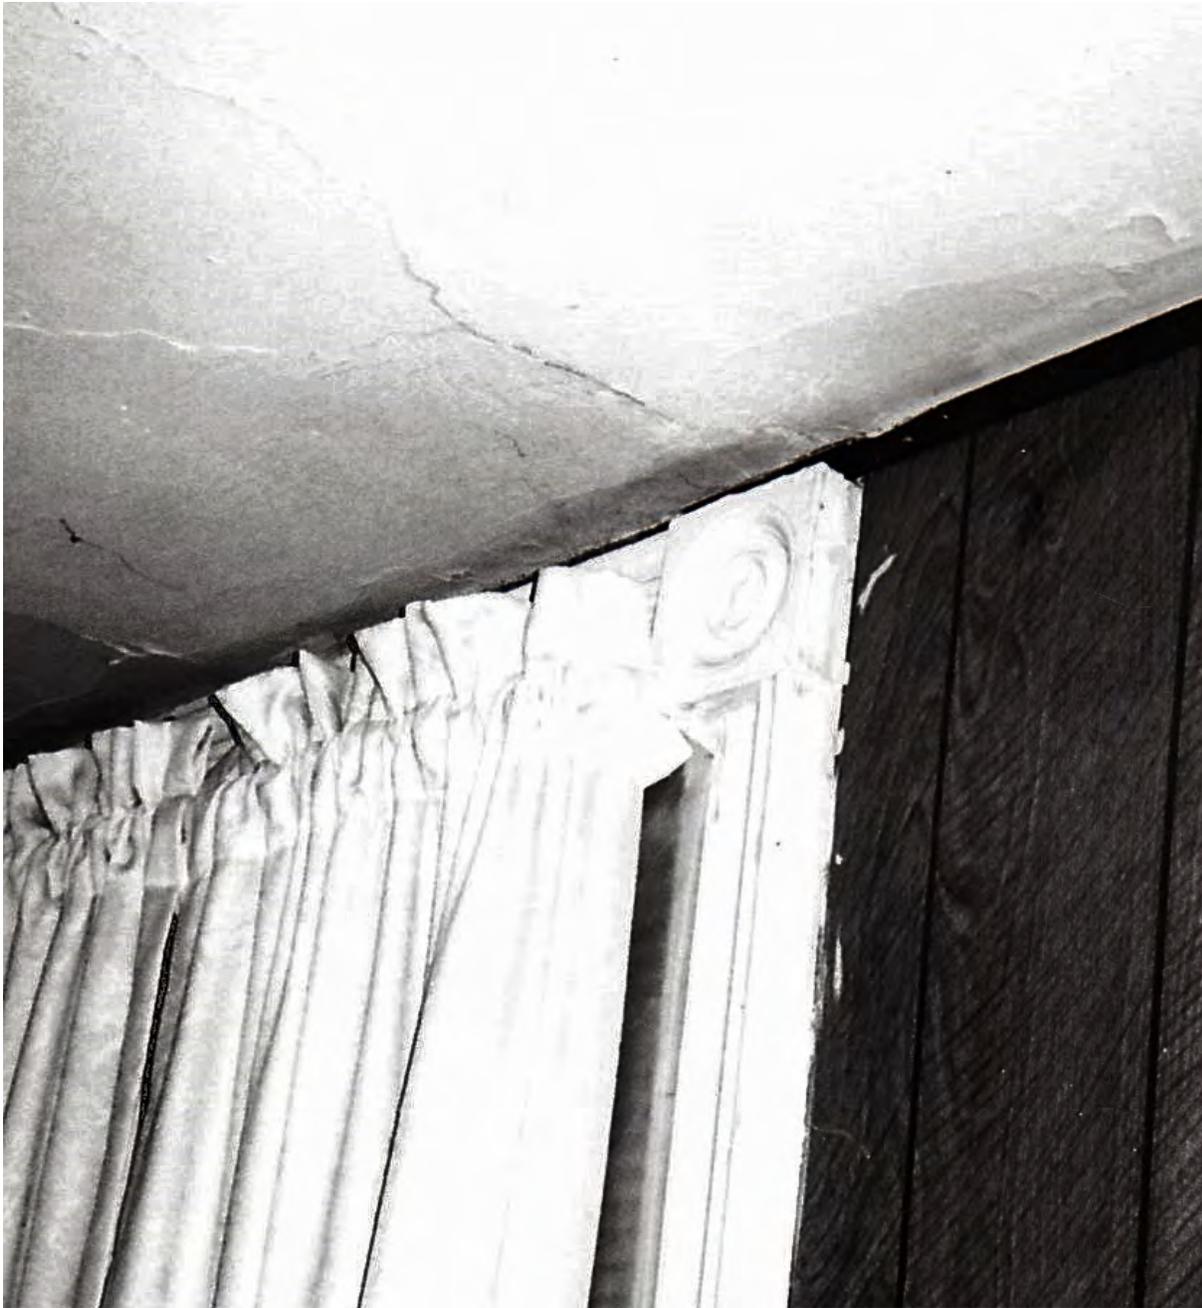
Historic Photo 20: View of woodwork detail in front parlor. Photograph taken by Miriam Michalski, 2004.

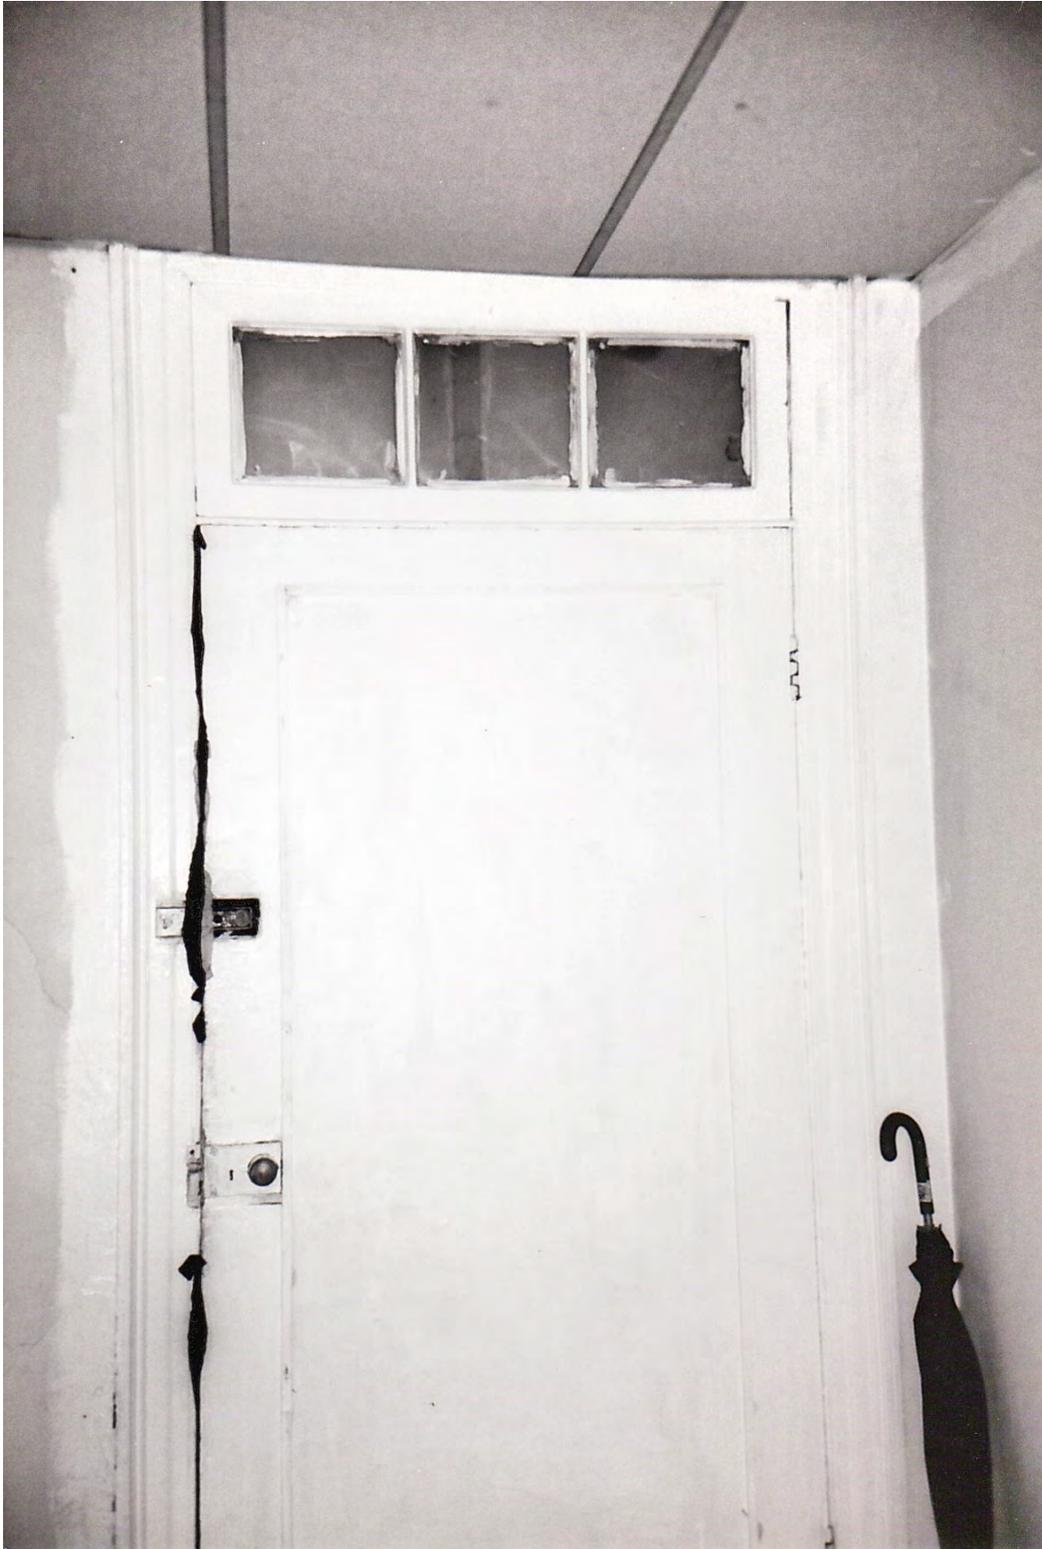
Historic Photograph 21: Interior view, facing west, of the front door, showing original hardware and 3-light transom window.

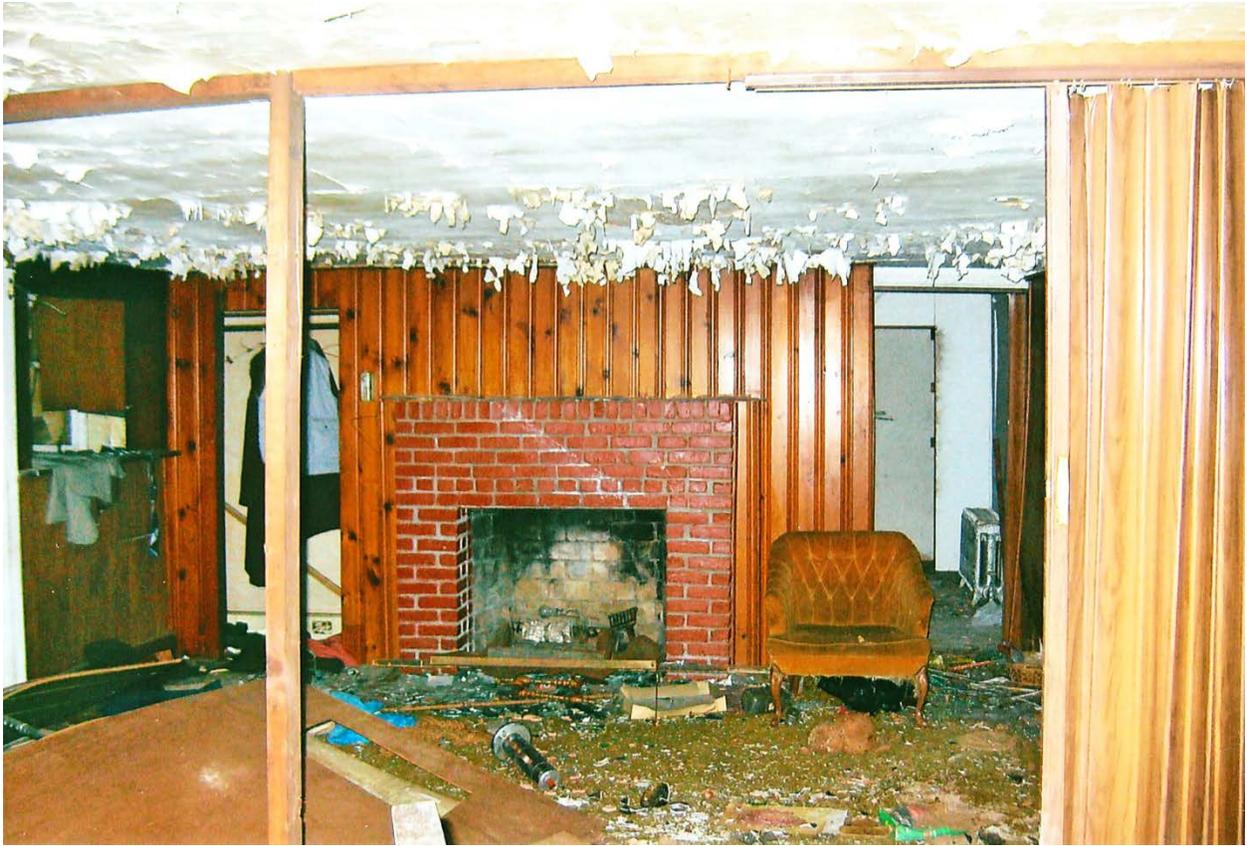
Historic Photograph 23: Interior of 1790 portion of Collins House facing the south wall of the main structure. (Door on far right leads to ca. 1850 addition). Note wood paneling and brick facing added to the front of the original fireplace. Photograph taken by Miriam Michalski, 2004.

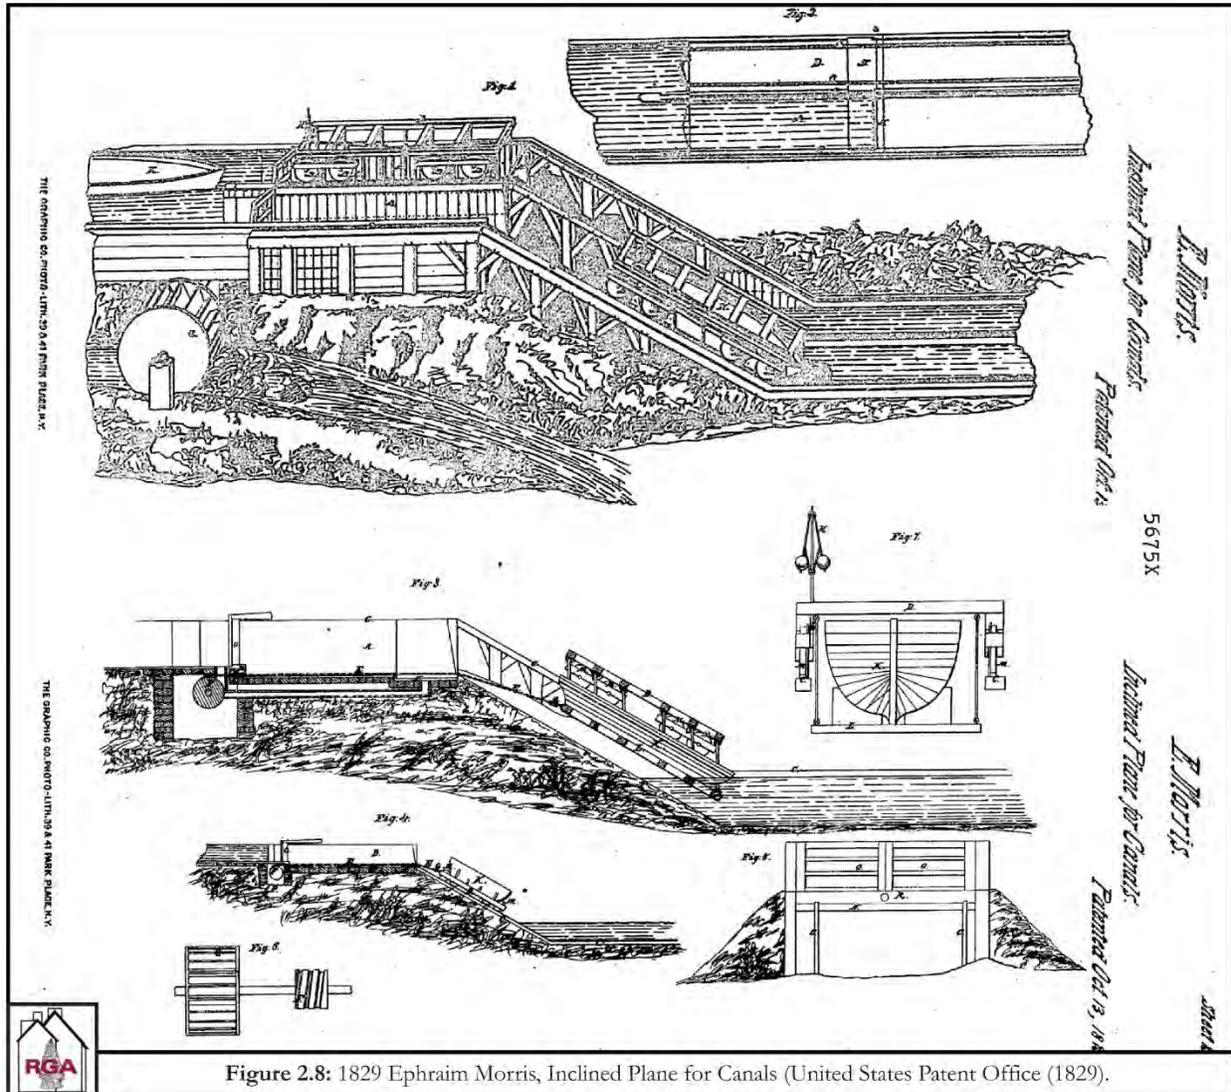
Figure 2.8: 1829 Ephraim Morris, Inclined Plane for Canals (United States Patent Office (1829).

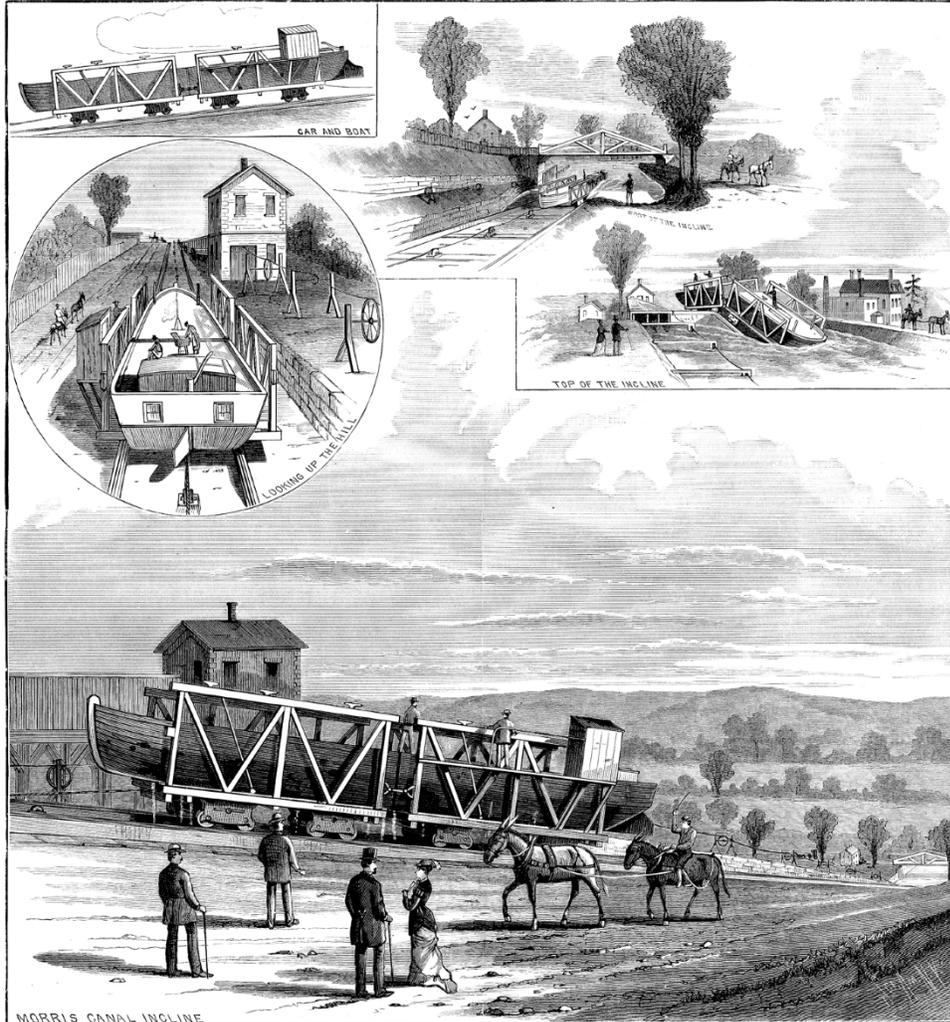
— HYDRAULIC LIFT ON THE MORRIS CANAL, AT BLOOMFIELD, N. J. —

This huge drum is revolved by a turbine water wheel 4½

feet in diameter, placed in the wheel house half way down the incline. The turbine is supplied with water from the upper level and discharges into the lower level. The operation of transferring a boat from one level to another is very rapid; we are informed that four minutes is the usual time for making the transfer. The car not only enters the water below to receive the boat, but enters the water of the upper level to allow the boat to float off. One of our views shows a boat entering the water of the upper level. There are twenty-three of these inclines upon this canal and twenty-four ordinary lift locks. Three of the inclines are double. This lock at Bloomfield gives an idea of the facility with which ponderous bodies may be handled by exceedingly simple means.

Scientific American Article May 20, 1882 featuring the Inclined Plane in Bloomfield. The Collins House is depicted in the circular illustration center left showing a boat ascending the plane.

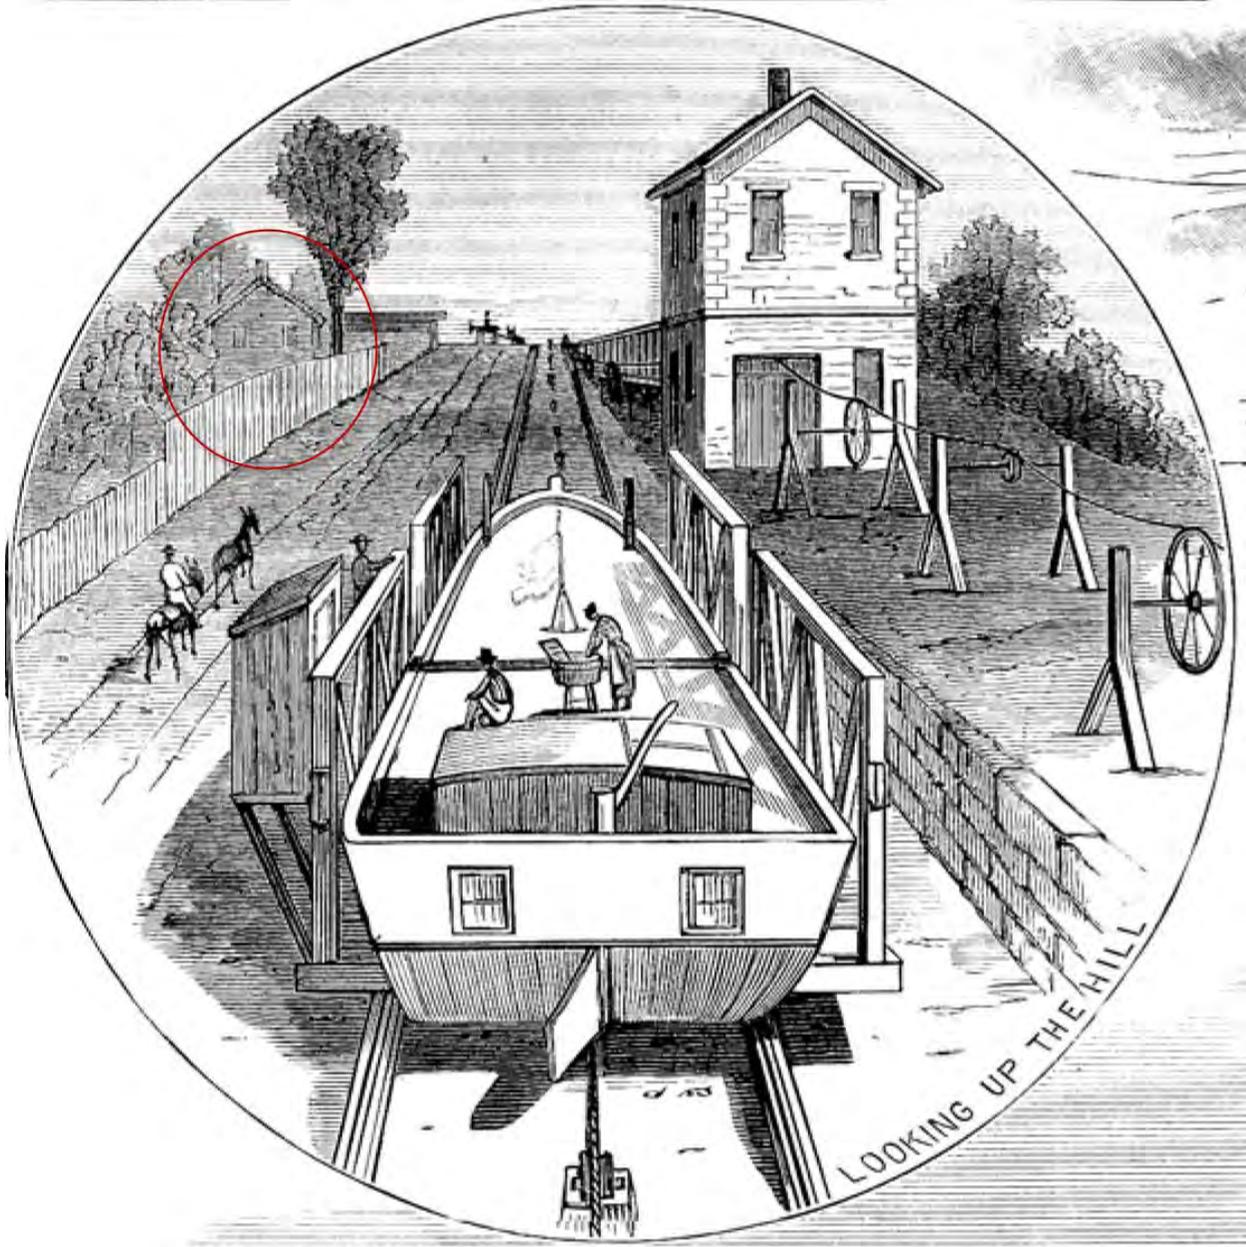
Enlarged illustration from Scientific American, May 20, 1882 showing the Collins House. The artist apparently shows the house as closer to the plane and further uphill than in actuality to fit it into the illustration.

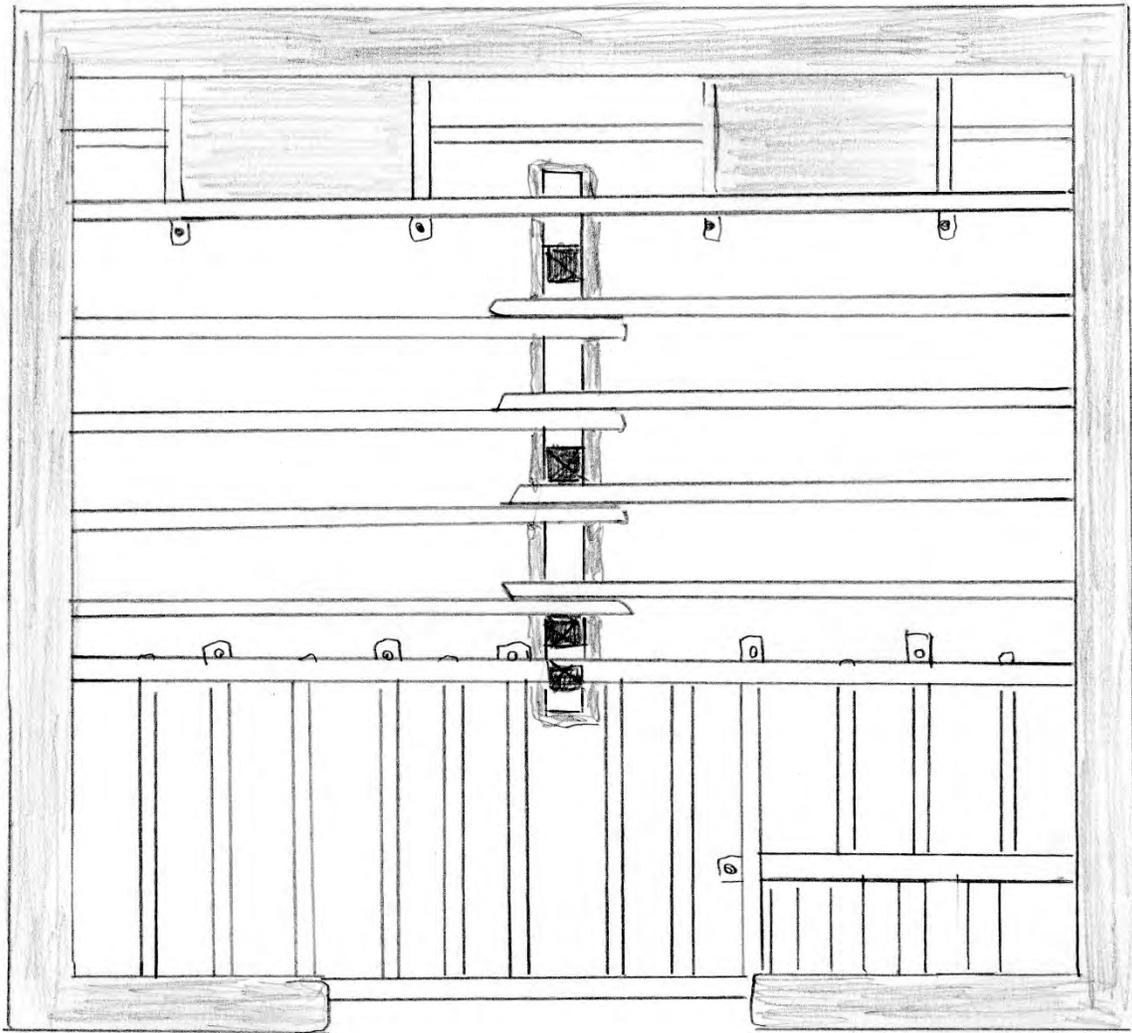
Illustration 1 New – First floor joists in the cellar of the 1820 addition

Drawing illustrates the first floor joists in the cellar of the 1820 addition. Joists on the northern two-thirds of the room are half the width of the dwelling, run east/west and overlap above the central support beam. Joists in the southern third of the room run north/south and are connected to the southern-most east/west joist with mortise and tenon joints. Mortise and tenon joints are also indicated in the joists supporting the hearths at the north wall.

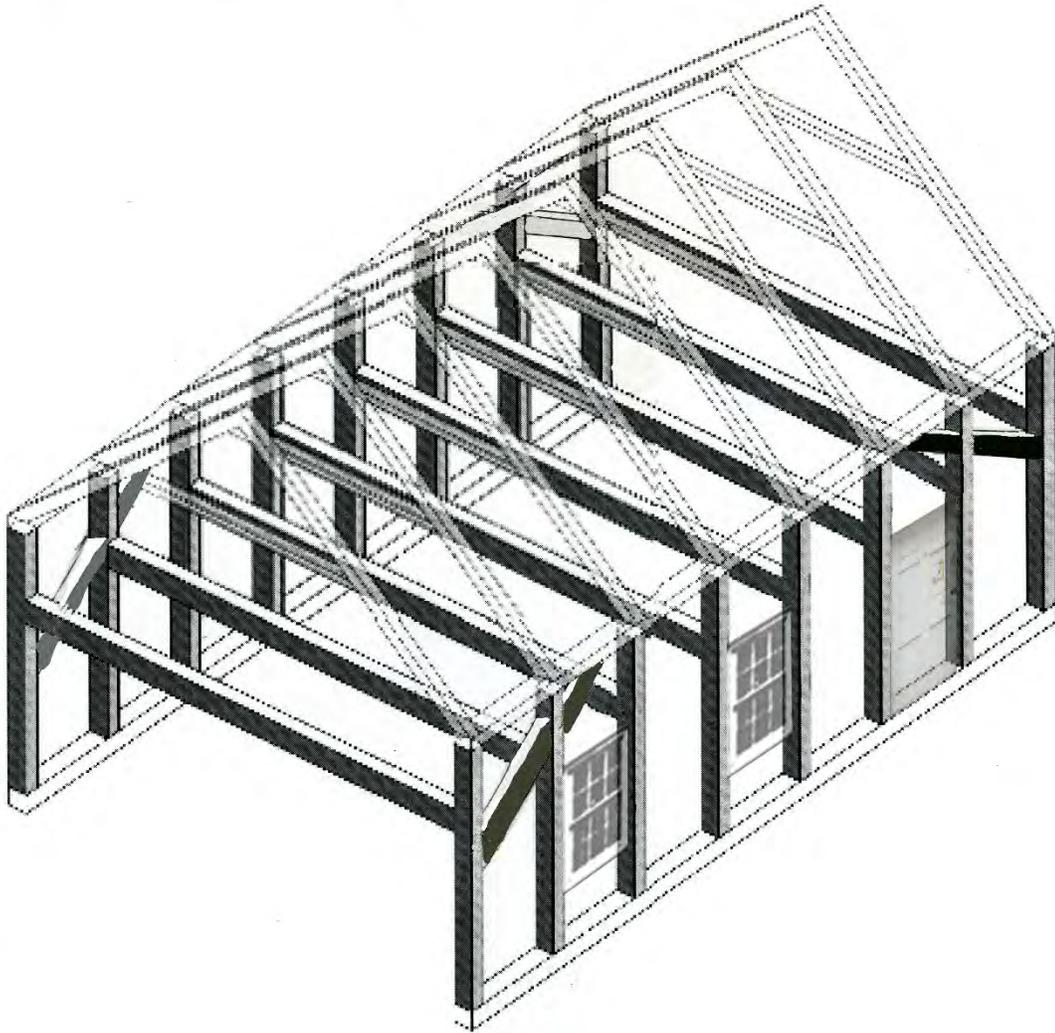
Illustration New 2 – Eight anchor bents used to construct the original dwelling

Drawing illustrates the eight anchor bents used to construct the original dwelling showing approximate location of windows and original door. Knee braces were used on each corner perpendicular to the north/south walls. Drawing adapted from an illustration in Janet Foster, "Domestic Architecture in Colonial New Jersey," *Garden State Legacy.com*, Issue 6, December 2009.

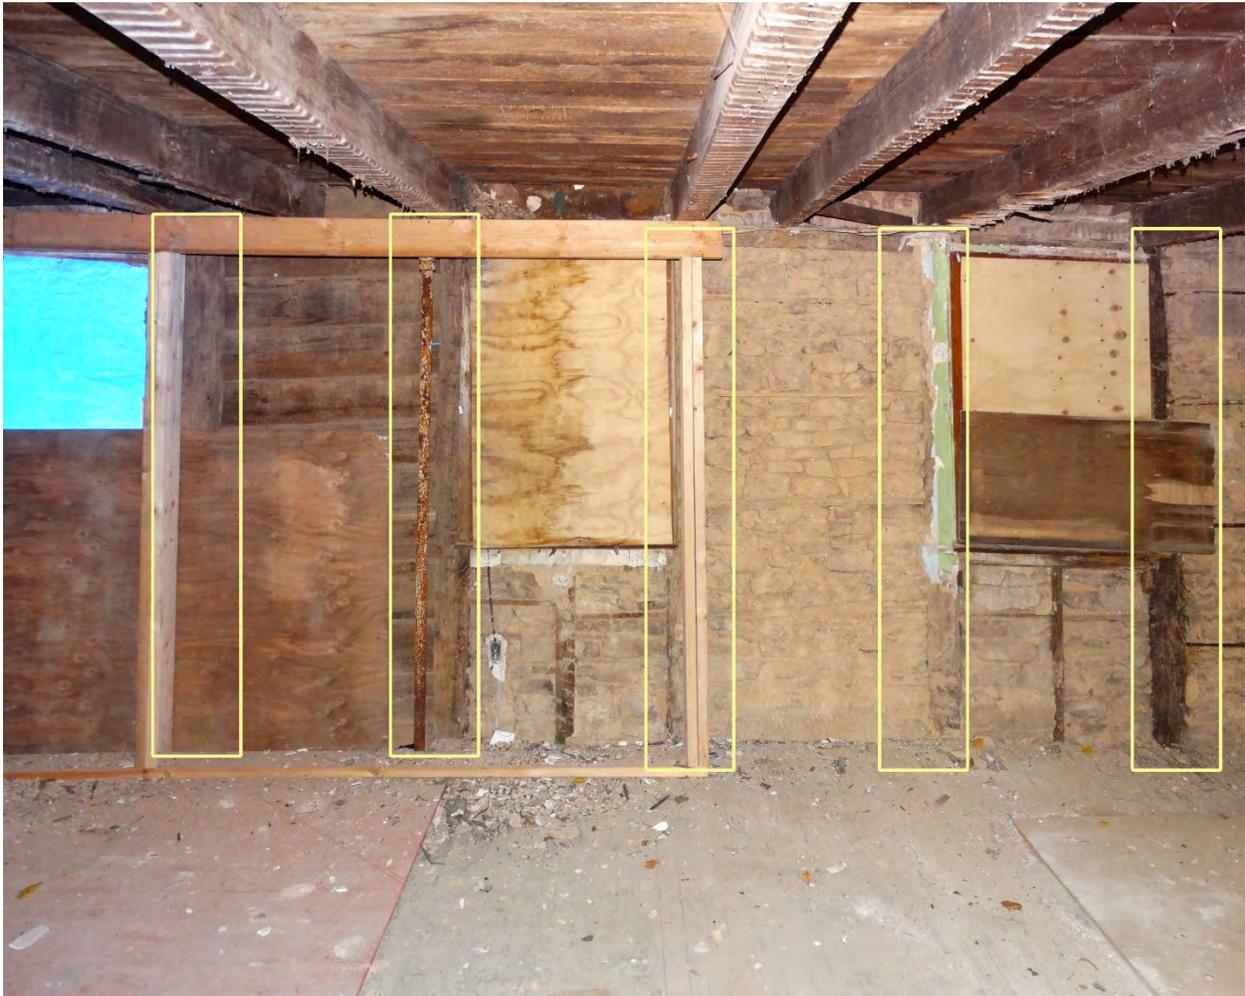
Illustration New 3 – Location of anchor bents in original dwelling

Original dwelling - Interior west wall. Highlighting shows the location of the five interior anchor bents. Note the irregular spacing between the bents and irregularly spaced joists above the bays that don't contain windows.

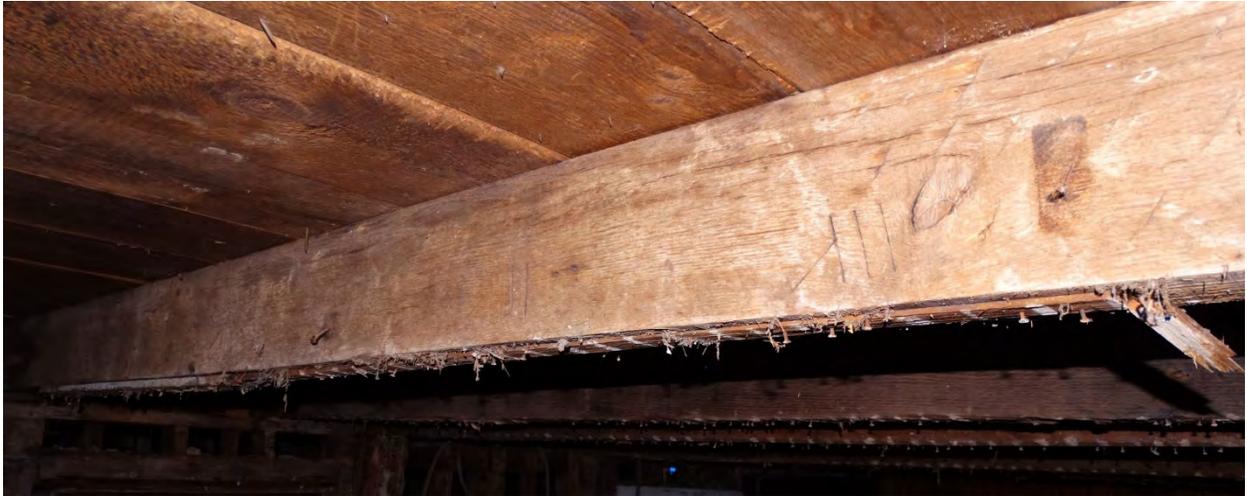
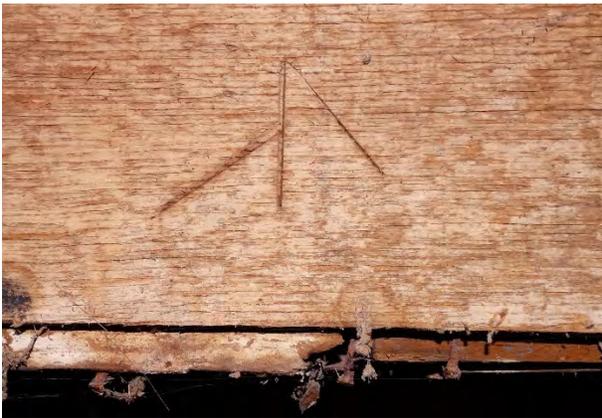
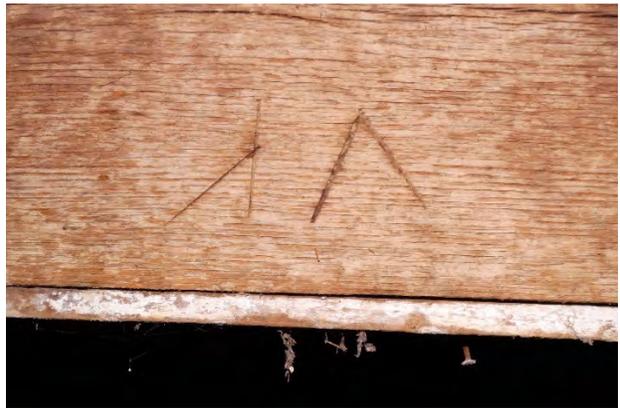
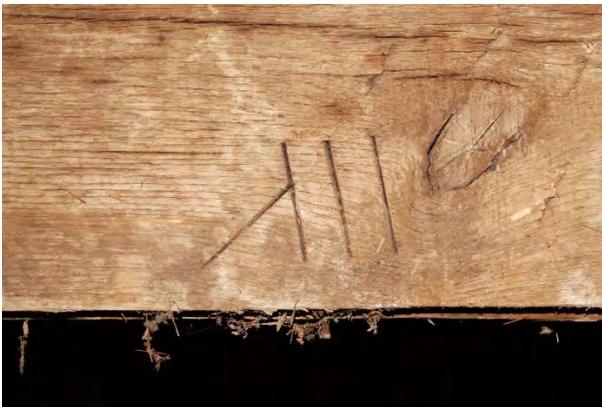
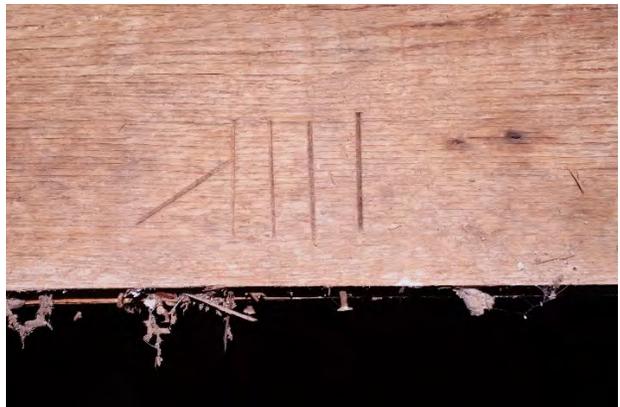
Illustration New 4 – Carpenters marks

This tie beam of an anchor bent in the original dwelling has four carpenter's marks shown in the four close-ups below.

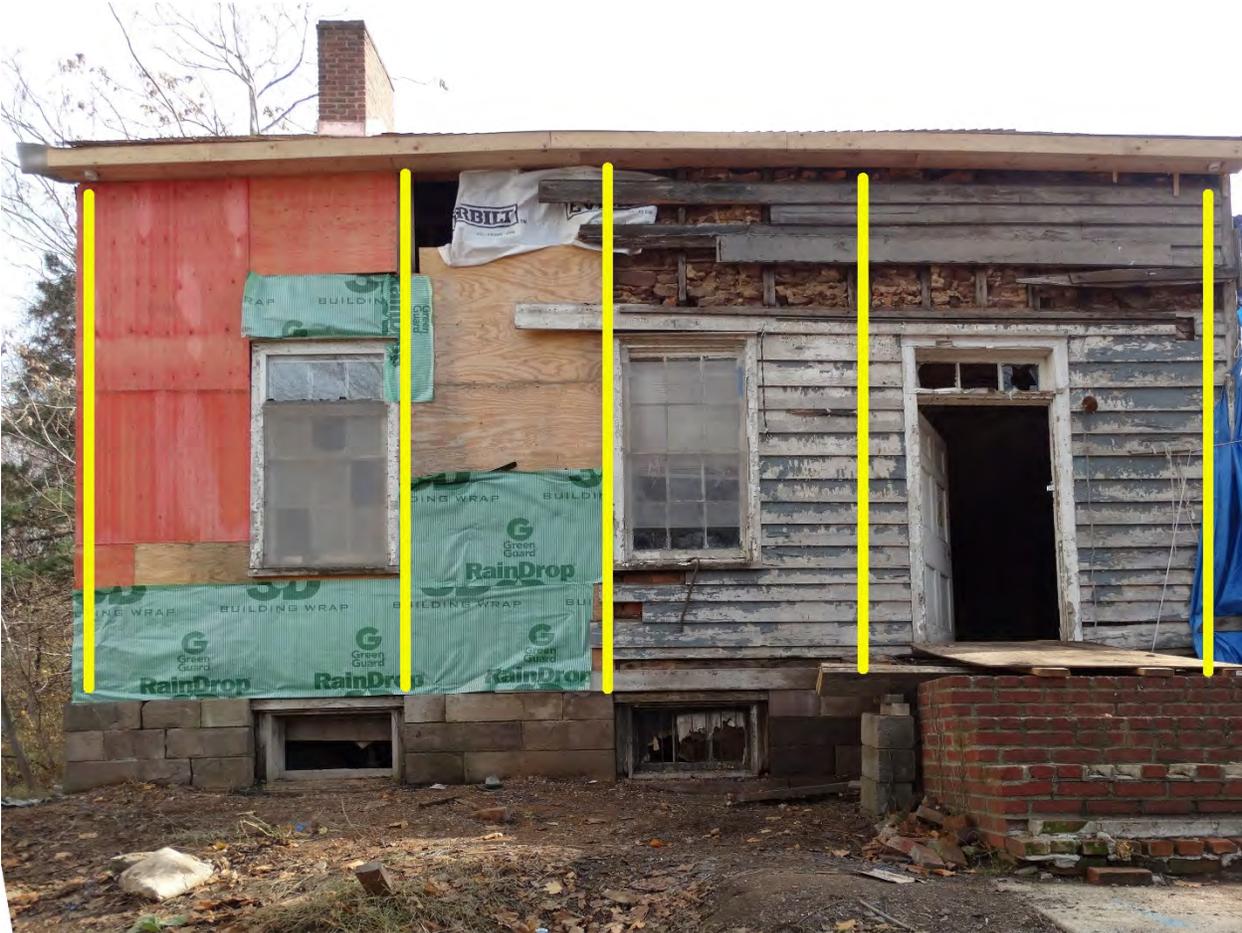
Illustration New 5 – Location of anchor bents in 1820 addition

West elevation of the 1820 addition showing the approximate location of the five anchor bents.

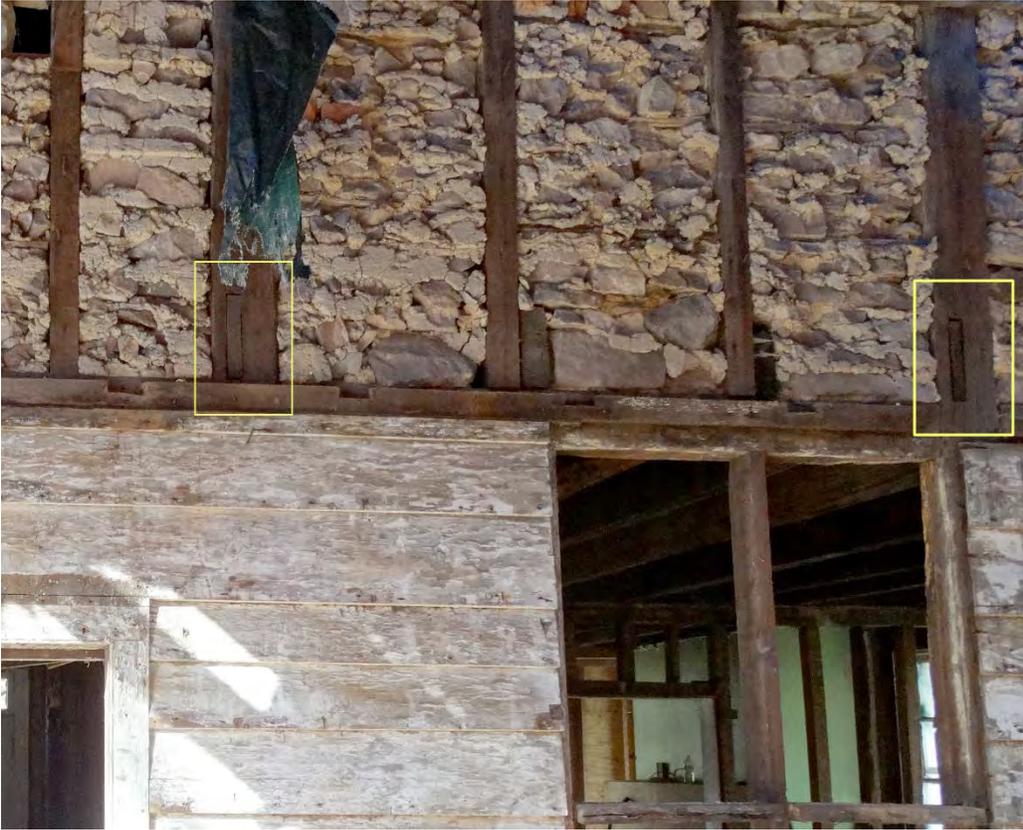
Illustration New 6 – Tenons of anchor bent joints

Through tenons of two anchor bent mortise and tenon joints viewed from the exterior of the east wall.

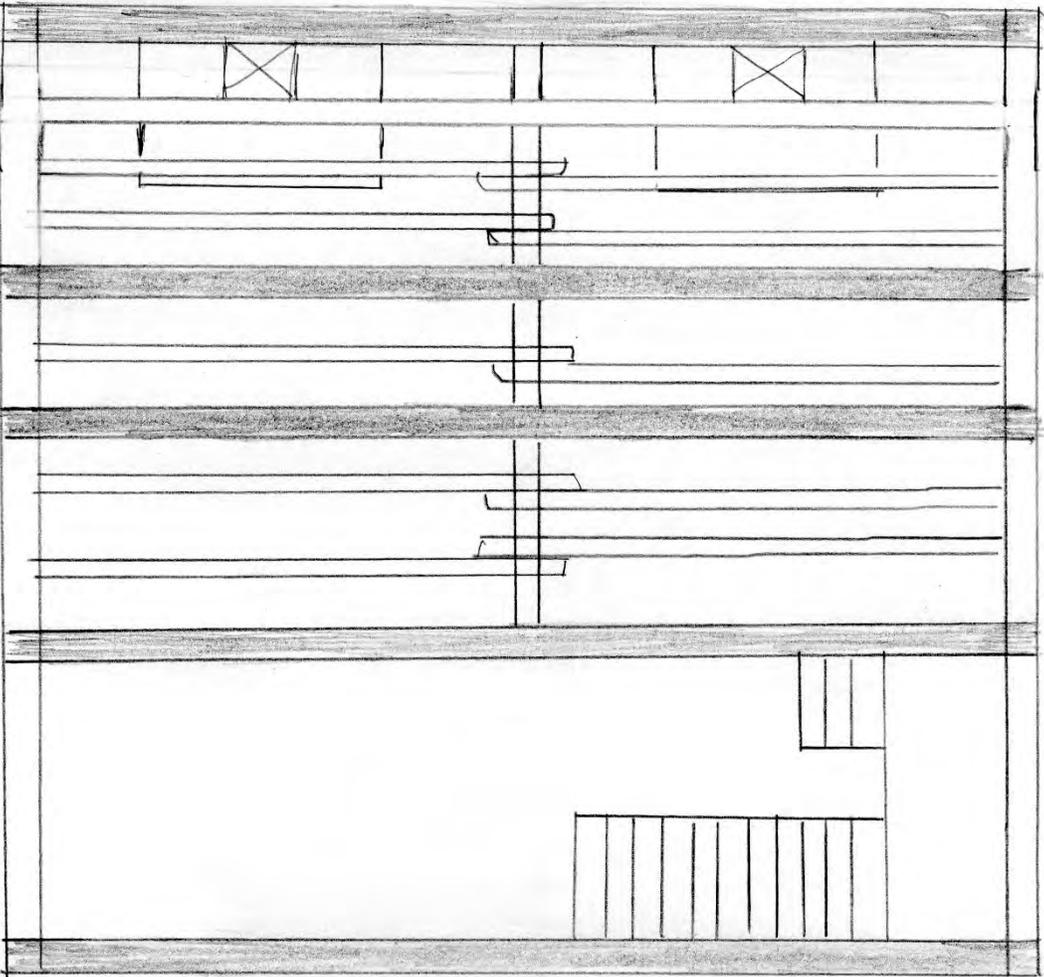
Illustration 7 New – Second floor joists in the ceiling of the first floor of the 1820 addition

The five anchor bents are shaded. Joists between the anchor bents are irregularly spaced, are half the width of the room and overlap above the north/south wall in the center of the room.

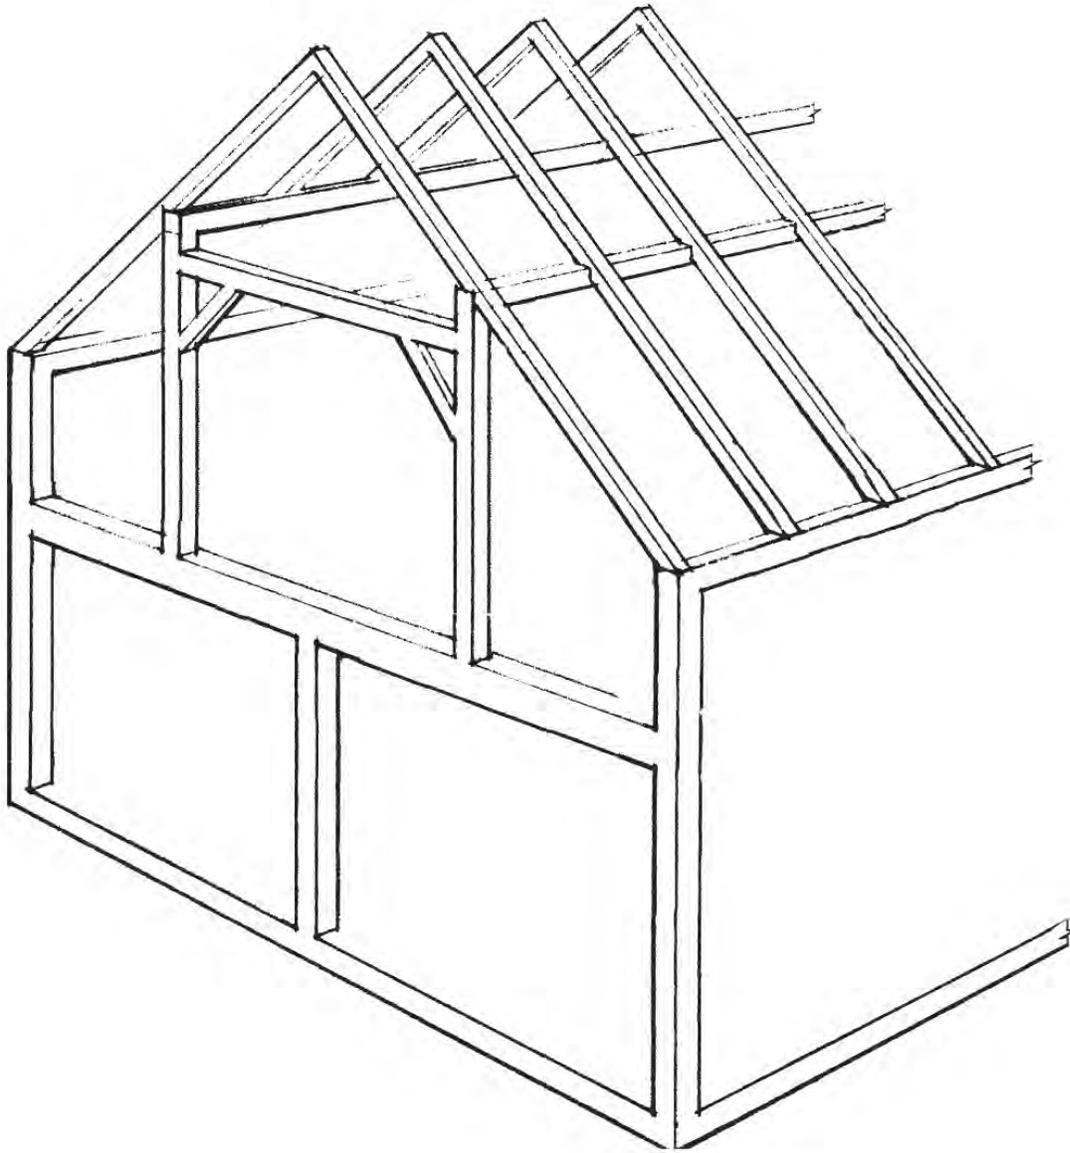
Illustration New 8 – Purlin posts, bent girt and collar purlins in second story and attic of the 1820 addition

Drawing of Purlin plates adapted from Sobon, Historic American Timber... representing the south elevation of the 1820 addition. Some framing members are omitted for clarity.

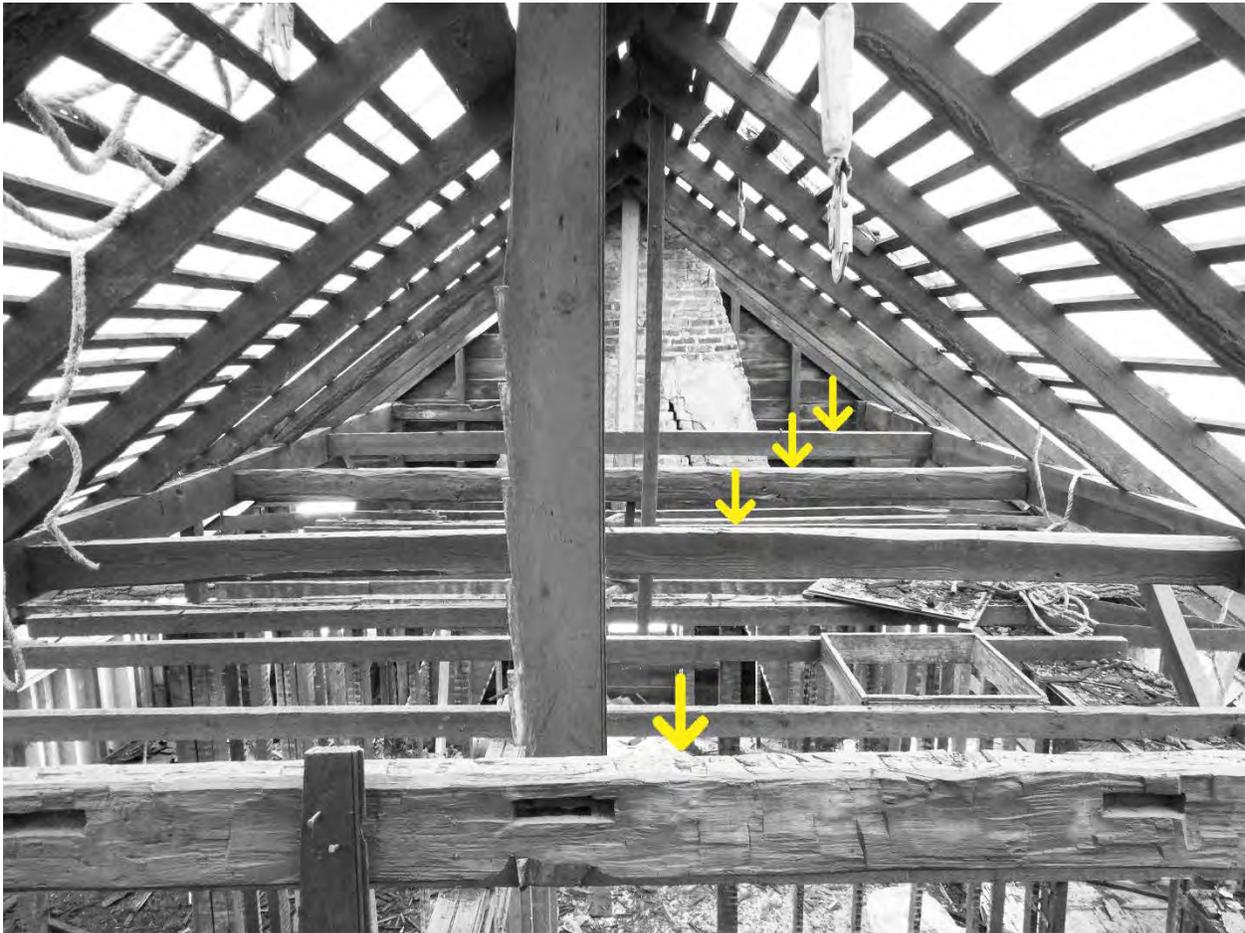
Illustration New 9 – Collar ties and collar purlins in the attic of the 1820 addition.

Attic in the 1820 addition view from the south end of the attic looking north. The four collar ties are indicated with arrows. The chimneys from the two first-floor fireplaces seen as separate chimneys on the second floor come together to form a single chimney at the far end of the north wall. Birdsmouth cuts in common rafters are visible where the rafters rest on the collar purlins. Collar tie in the foreground has three empty mortises whose purpose is not apparent. Ceiling joists are 17" below the collar ties. A wind brace made of a piece of repurposed clapboard is attached to the tie beam in the foreground.

Attic of 1820 addition facing north showing chimneys joining into a single shared chimney. Repairs to the brick are visible on the right (east side) of the chimney. Later wind braces are visible in the center of the attic space tying the rafters to the purlin collar ties and ceiling joists.
