# NATIONAL REGISTER OF HISTORIC PLACES REGISTRATION FORM

historic name Canyon Creek Charcoal Kilns

other names/site number 24BE804

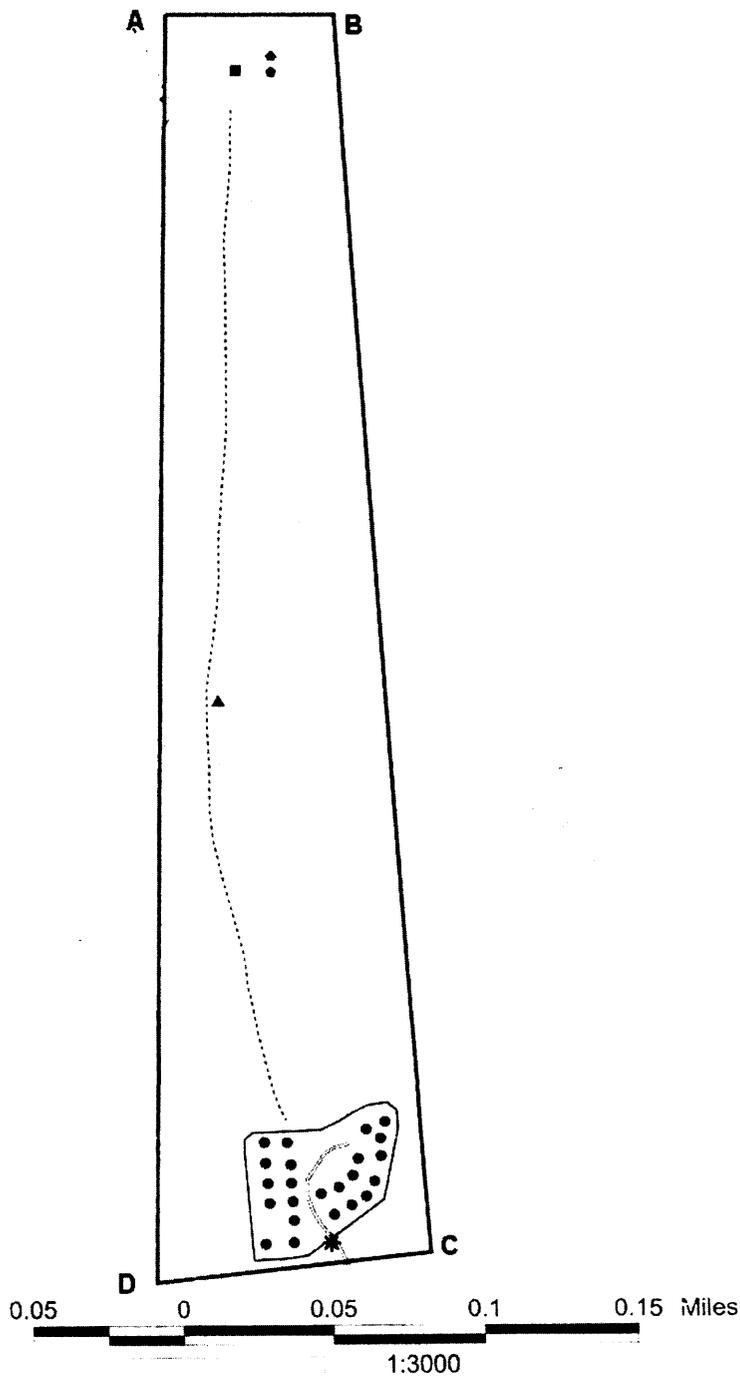
□ Canyon Creek Charcoal Kilns NRHP Boundary

- ▲ Cull Pile
- Dump
- Kiln
- Loading Platform
- ◆ Log Habitation
- - - Road Segment (Structure #24)
- - - Log Chute Route (Site #26)
- \* Interpretive Sign
- Jack-leg Fence around Kilns
