KENTUCKY HISTORIC RESOURCES
Individual Inventory Form

Resource # TA-2
Taylor _____ County

John Chandler House

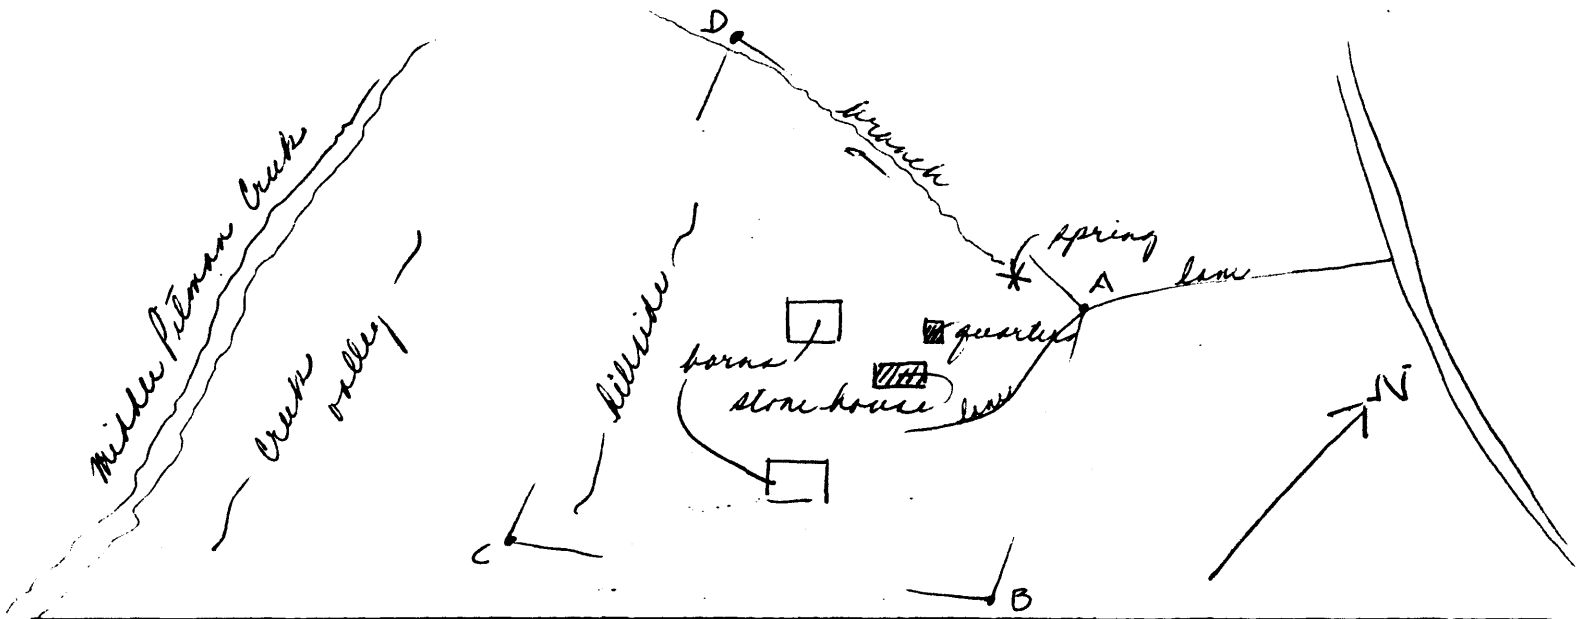
43. Site Plan and Boundary Description and Justification:

Beginning at A, northeast of the stone house, at the lane, thence south-southeast 800 feet to B; thence west-southwest 1150 feet to C at the bottom of the hill; thence north-northwest 1300 feet to D at the spring branch; thence with brance east-southeast 1300 feet to the beginning, containing the stone house, frame slavequarters, spring and later barns. The house and quarters are contributing.

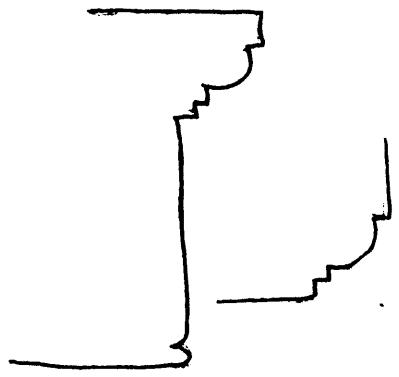
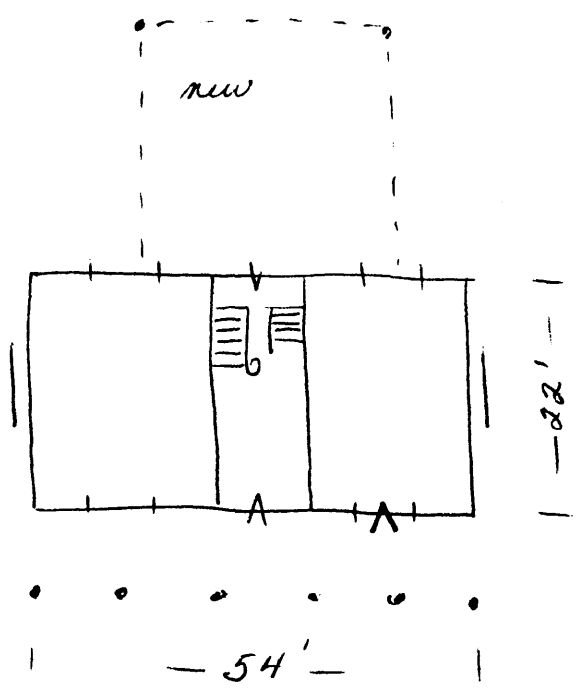
44. Description and House Plan:

Six openings in spacing for five bays.

One and one-half story, five-bay, central passage, dry-stone house, ca. 22 x 54. Masonry of square-tooled grey limestone laid in courses, some broken; best work on front. Walls are 26 inches thick, filled with clay. Exterior chimney, each gable end. Openings without voussoirs spanned by timber lintels and having nailing blocks in masonry to attach surround; ovolo trim on frame. Door sills are one piece stone, squared at corners; plain board reveals. Extra doorway (original) in east room, between windows. Cellar entrance on east end, south of chimney, has batten door with strap hinges.

U-shaped stair in center passage has turned balusters, handrail curved around newell, bottom step voluted. Original mantels, each room, have decorated corner blocks. Chairrail.

Early 20th century changes include a brick ell added to rear of house, garage built on west end, floor joists replaced? (2 x 10 circular sawn), eaves widened, dormers added, front porch rebuilt, doors replaced, and masonry repointed with concrete. These changes are more than fifty years old. Colonial Revival style. Recently the parlor walls were sheathed with panelling.

Northeast of the house is a two-room board and batten quarters. Interior brick chimney north gable end. Enclosed corner stair on partition wall. One door in south end, one door and one window west side, one window east side (one door, one window, each room).

Unique pattern of piercing with six openings in five-bay spaces. Second door occupies space between fourth and fifth bays. Only early stone house and said to be oldest house in county. Well built and well cared for.
