National Register of Historic Places Registration Form

Historic name: Schubert-Graber Log-Post Shop

Street & number: 6561 Powder Valley Road

City or town: Zionsville State: Pennsylvania County: Lehigh

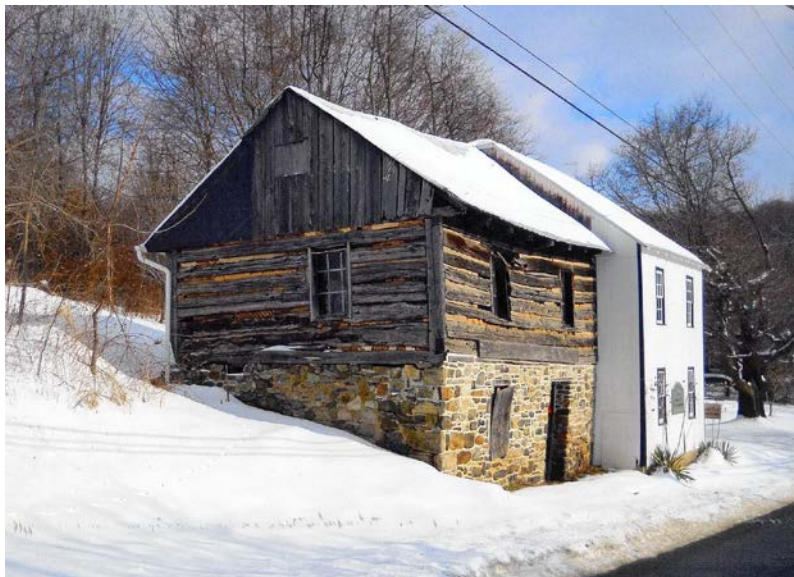
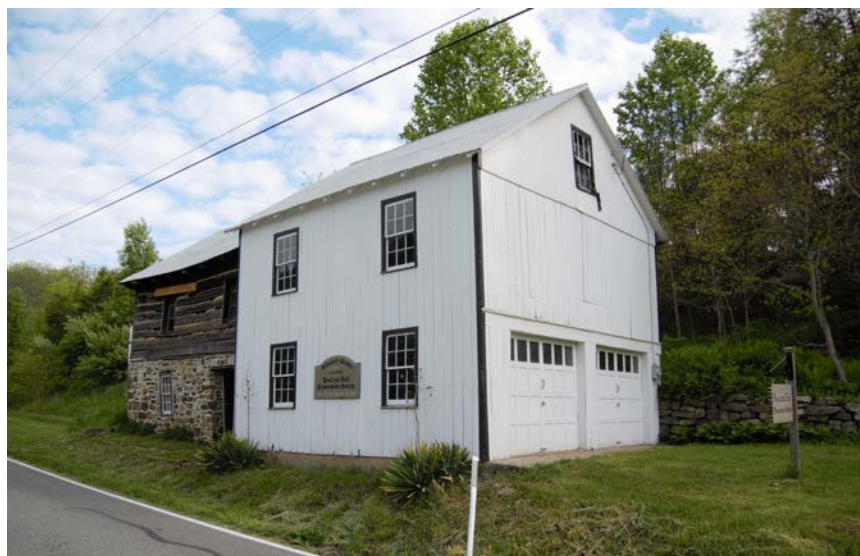
Current views of the Shop, from Powder Valley Road, facing SE (above) and NW (below). The shop portion of the building is c.1795-1820, with remnants of a prior c.1770 building or structure; the frame garage addition is c.1936.

The Schubert-Graber log-post shop reflects three periods of construction. The “first period” building, believed to be the first building or structure in this location, roughly dated between 1765 and 1775 and was largely demolished or rebuilt, leaving behind roughly forty-six percent of its first floor stone walls and many cross-cornered logs that were reused when the building was apparently rebuilt c.1795. This second period, c.1795, consists of the salvaged first period wall logs, which were reused in the corner-posted log structure that now stands on the site, positioned in part on the remnants of the first period stone walls. Physical evidence suggests that the portions of the first building (c.1770) reused in the second period building date at least 20 years prior to the existing building (c.1795). The second period consists of the current two story stone and corner-posted log shop that was placed directly on portions of the original

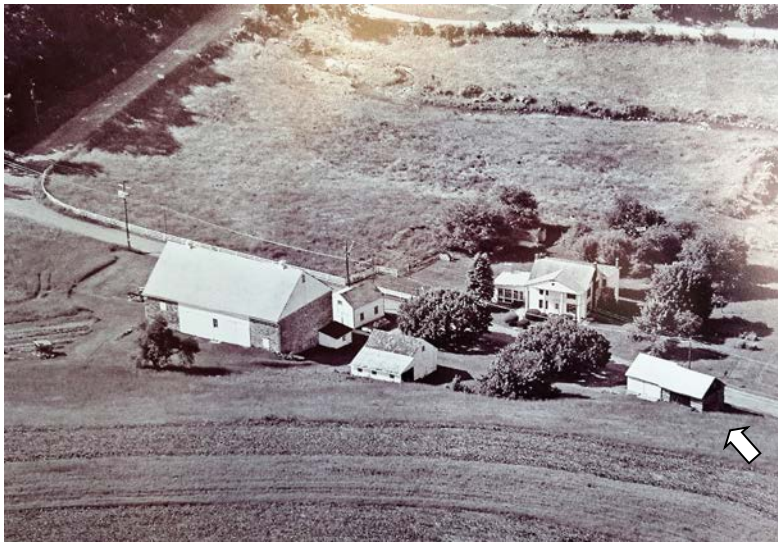
This 1974 aerial view shows the rear elevation of the shop (indicated by arrow), barn, and other outbuildings.

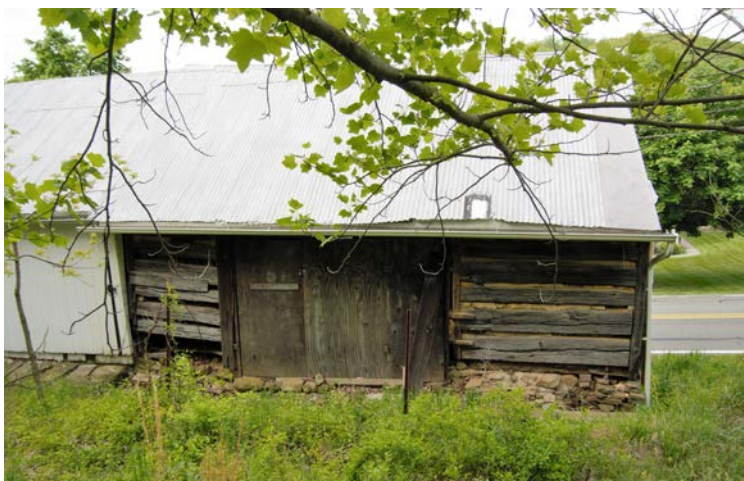
The rear elevation from the hillside above the shop, showing the wagon access-area into the upper level. The wagon doors are currently covered by plywood.

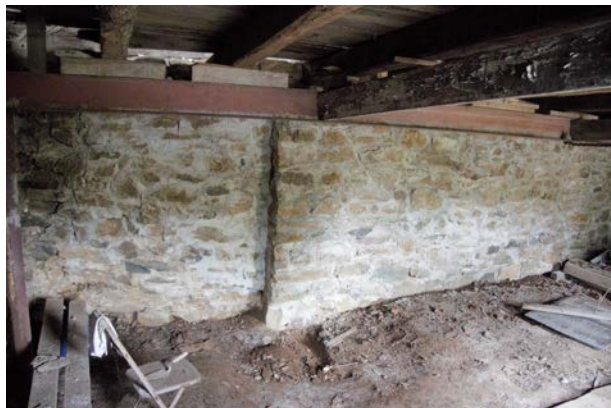
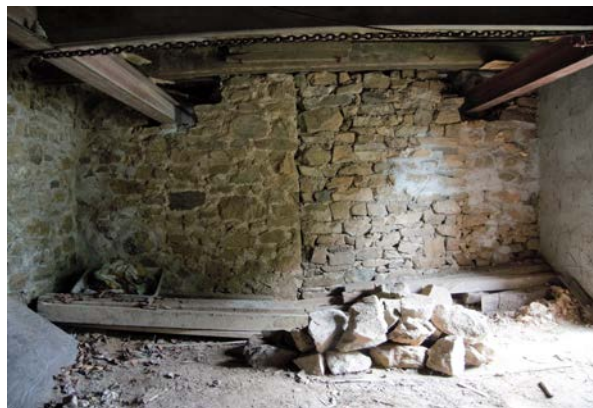
Stone walls in the shop's ground level: The left photo shows a portion of the first period wall, built into the bank, with the original, thicker portion jutting out past the added (second period) portion. The vertical seam in the right photo shows where the first and second period foundations meet. The end of the first period wall, the left half of the wall, is believed to have been the edge of a door opening.

Forty-six percent of the existing first floor stone walls, consisting of two-thirds of the rear, bank wall and half of the south gable stone wall, pre-date the current building, and were retained to form part of the current shop's first story. The first floor's stone north gable end and west front wall reflect the "second period" of construction when the existing shop was built. About 25% of the existing fully exposed front wall fronting onto the road was rebuilt and 100% repointed in 1993.¹ The front wall's current first floor window frame and sash set was replaced with an exact duplicate of the window unit. The original door frame was replaced with modern 2" x 6" set of temporary jambs and plywood door. The original door jamb remains in storage over the garage. The original jamb is in good condition and can be restored and returned to its original position. The original door is missing, and has not been replicated.

The southern portion of the rear wall, which pre-dates the current shop building, is banked into the hill rising behind the shop. This first period bank wall is 17'-7" in length and 30" thick. The bank wall thickness is far heavier than normally encountered for a masonry wall. The first period bank wall was so well built it remains in a near vertically plumb condition. Added to the north end of the first period stone bank wall is an 18" thick, 8'-3" second period stone wall built to extend the bank wall for the current shop. The shorter north extension bank wall's stone work is not tied or knitted into the original first period stone wall. The newer masonry extension is only butted against the former end of the first period east stone wall. The newer portion of the bank wall extension is only 18" thick, which was far more typical of stone wall construction of both periods. Normally these bank walls, even for the larger barns, were only 18" or 21" to 24" thick.

The shop's southeast gable-end wall as it exists today consists of first period and second period stone work. The current building's 18' width is approximately evenly divided with the east half being the first period and the west half of the south wall consisting of newer second period stone work. There is a clear demarcation in the form of a vertical line easily observed where the two south wall sections join on the interior. In the first period construction there was a door located against the west end of the remaining first period wall. The door and jamb were removed and a new extension of the south wall using sandstone was built against the old wall end. In the mortar joint clearly visible between the first and second period south gable stone work, a series of wood grain impressions remain from when the wet mud mortar was

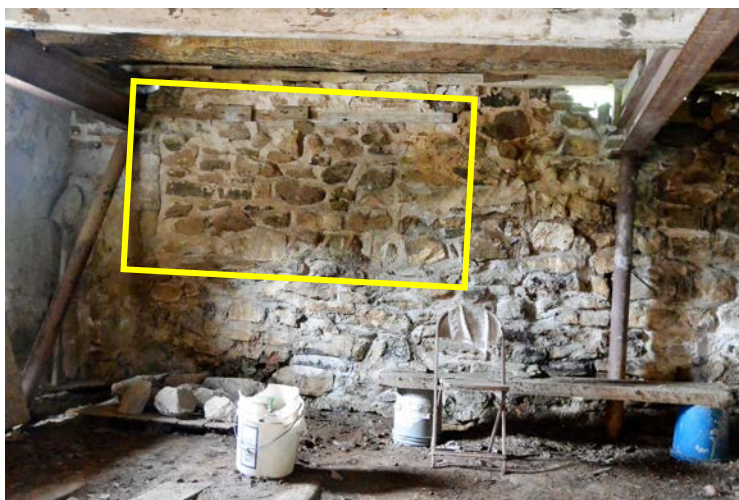
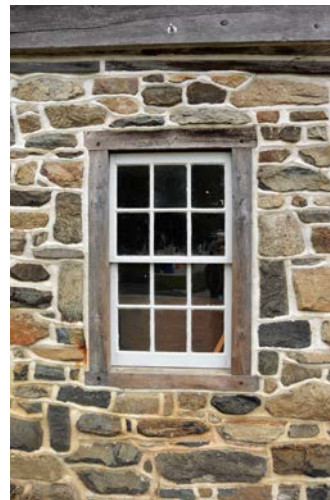
The outline (left photo) surrounds an area believed to be a former window. The vertically-oriented jamb stones flanking an existing window (right) were typical in well-laid stone masonry. This wall, facing the road, has been repointed.

The exterior of the rear stone bank wall is completely obscured by the hillside. The southeast gable end stone work is completely under cover inside the first floor of the garage addition. The northwest gable end wall is partially hidden by the grade of the hill. There is evidence of a window in the first floor's northwest gable end near the front wall. The outline of the window can be observed from the interior.² However, the exterior outline of the window can be faintly seen in the exterior stone work. No dateable evidence exists concerning the north gable slider window. Whether the former window was original to the c.1795-1820 second period construction or was installed later only to be eventually in-filled cannot be determined. The window is definitely in the second period's c.1795 portion of the wall and not the earlier first period wall.

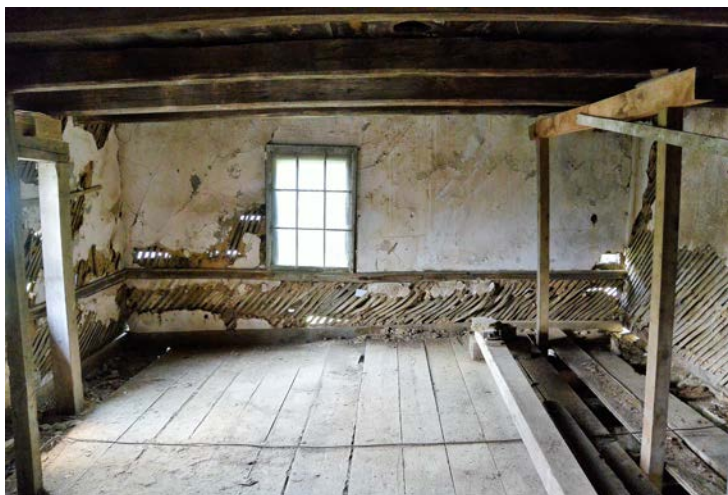
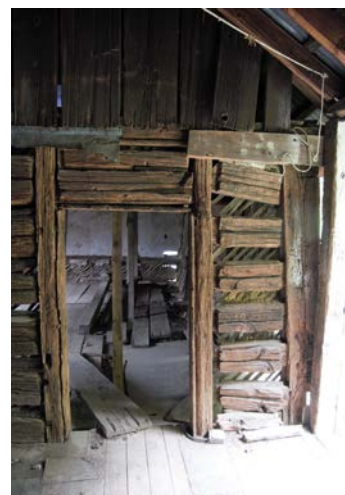
Second floor view of the interior, showing the north-facing gable-end wall (left) and the former exterior Dutch door of the south-facing end wall, now covered by the interior of the garage addition (right). These Type 1 door posts are typical of every building with door openings in log walls.

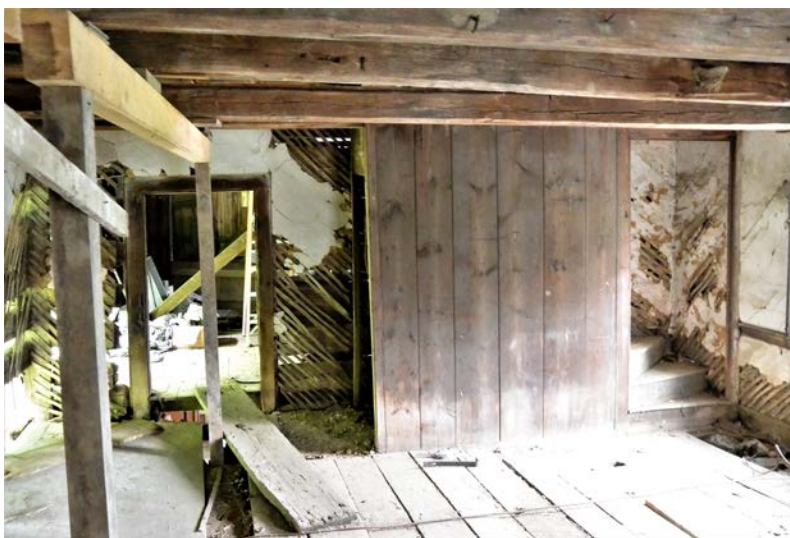
Staircase connecting the second floor interior to the loft, with former exterior Dutch door opening to the left of the staircase.

There are no stairs or a ladder that provide interior access between the second and first floors. There is a staircase to the loft located in the southwest corner of the shop room just west of the south gable Dutch door that originally lead to the exterior. The Dutch door now opens into the second floor of the garage addition. On the staircase wall that leads to the loft there is a large circle scribed into the boards. The circle was scribed into the stair wall using a pair of steel tipped compass points. The metal points of the compass were lodged in the ends of wooden handles. The scribe was used in making large circles for laying out wheels, barrel bottoms, lids and many other items; the presence of the circle supports the idea that the building was a shop for Melchior Schubert, a cooper.

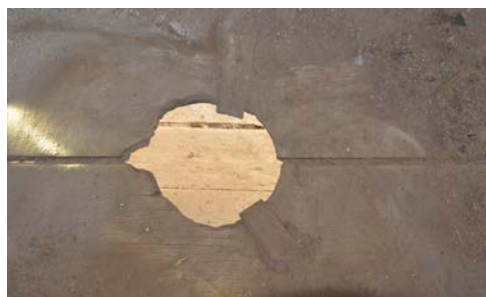
Looking down from the loft through the stove pipe opening. Two of the three metal spacers remained nailed to the flooring. Charred edges of the flooring indicate hot conditions existing, and flooring was overheated.

The only evidence there was ever any heat in the current building was a 5" diameter circular hole cut through the loft flooring. Placed evenly around the hole and screwed to the floor were metal spacers called "stand-offs". A smaller diameter vent pipe passed through the floor. The metal standoffs kept the hot wood stove pipe away from the wood flooring. The size of the flue hole in the floor indicates a 4 - 1/2" vent pipe suggesting a small wood stove was used to heat the north room at least for a short period of time.

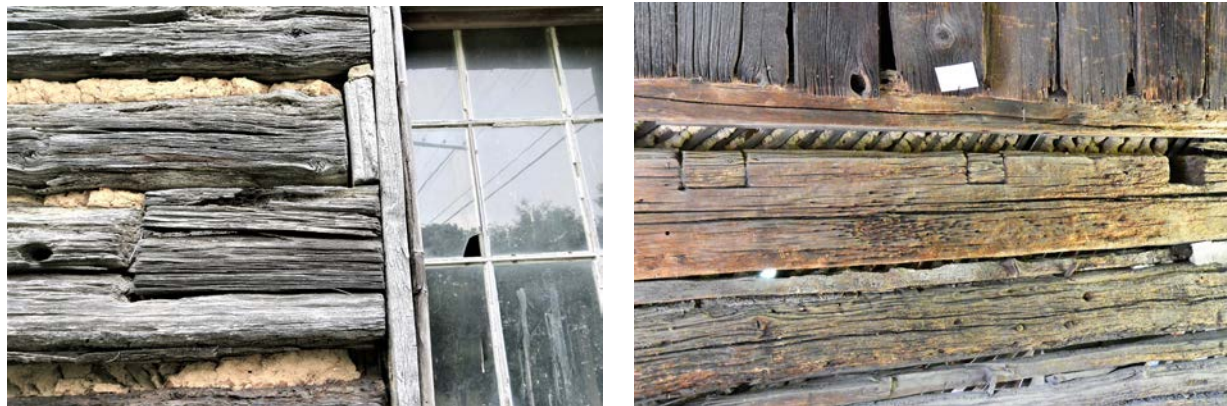
In the left photo, two blocks are visible left of the window. The smaller, upper block extended a log's width. The larger block below it filled in a window or door opening cut for the earlier building. In the right photo, this log, just under a top plate, had four joists remaining from the prior building.

The character of the in-fill horizontal wall logs provides further evidence that they were salvaged from the earlier first period building. The evidence includes cut-down portions of formerly-longer logs and one remaining "V" shaped notch. There are a few instances of log blocks used to fill in gaps in the logs just a few inches too short. Two south gable logs located just under the gable tie plates have joist seats filled in and reused as wall logs. Another log has an empty cutout where a window was formerly located in the earlier building. With the exception of six new infill wall logs needed to complete the c.1795 initial raising of the shop, the remainder of the infill wall logs between the four corner posts and the various wall openings consists only of reused wall logs from the first period's "V" notched log crib¹¹. The use of the salvaged logs is easily traced to the former building on the first period stone foundation. A significant telltale sign is the one surviving V notch high in the east shop wall has the same slope and the same spread at the junction of the V or the apex as do the V notches in the associated farmhouse across the road. Each of the current shop walls have openings. The salvaged logs were mostly shorn of their V notched ends. The salvaged logs were cut to fit the distances between posts and opening jambs. All but one of the V notches was cut off. The squared, cleaned log ends were cut into tenons. It appears obvious from the reuse of the former wall logs that the master builder purposely planned the new building to gain maximum use of the first period building wall logs. The reuse of the existing first period logs in the expanded second period structure reduced the need to harvest and hew about two dozen more new logs from the forest or woodlot.

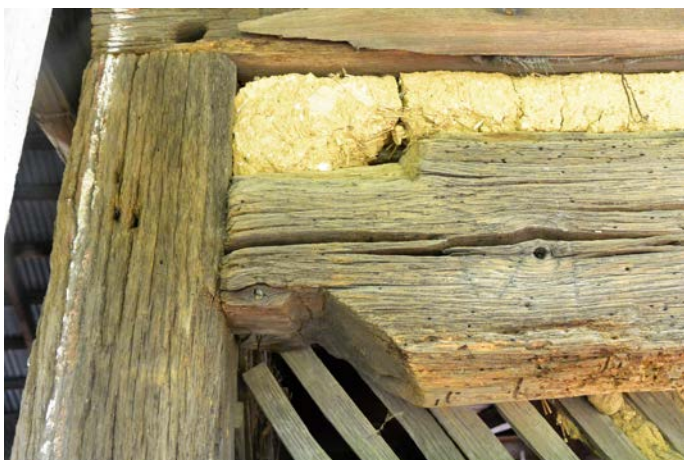
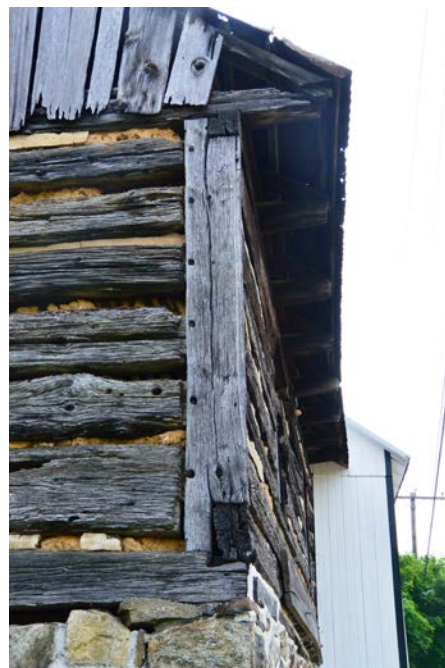
Below, a reused log with a prior "V" notch still visible. Right, a new corner post created for the second period of construction when the original building was rebuilt.

In addition to the reused older logs, there were many new logs used in the timber frame for the enlarged structure. New logs were hewn from fresh trees felled during the second period construction. The new logs were for the floor joists needed for the expanded size of the building, four corner posts, the sills that ran the full length of the walls, the three long logs that spanned the length between the west, front eave wall corner posts, the three logs that spanned the width of the north gable wall between the corner posts and the full length top plates that captured the four corner post tops. The corner posts were neatly hewn on all four sides to create a smooth, flat condition. The skill of the person who cut the four corner posts is readily apparent in the sharp right angles of the corners and the flat smooth condition that can still be observed of the protected interior post surfaces.

The four corner posts are all constructed with the same design. The eave sill ends are formed in a dovetail sandwiched by the gable sills and the posts. The back sides of each of the posts have a stub tenon¹² that is mortised into gable sill. The stub tenon assists in keeping the post from twisting. There are eight posts. Four of the posts were for the corners of the building's second floor log walls. The remaining four posts formed the two door locations. Two of the posts located in the south gable defined the only man door leading into the second floor. The last two posts formed the opening in the east rear wall for the large wagon doors. The four corner posts have two sides each that receive the tenoned ends of the horizontal logs. The other sides remain uncut and face out to the exterior. The four corner posts measure roughly 6" thick by 9" wide. The wider corner post sides face the gable ends, while the narrower sides face the eave walls. The four door posts each have only one side intersecting with the log walls while the remaining three sides are flat. The four door post sides that intersect with the logs make a grand total of twelve post sides that receive the tenons of the horizontal infill logs.

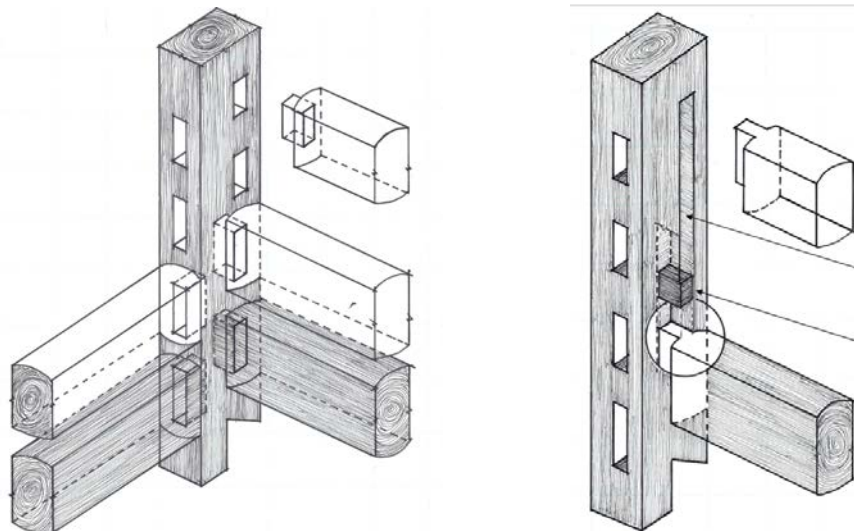
Two types of mortises were used in the corner posts—individual mortises, shown in the left drawing, and trench mortises, in the right. Small oak blocks in the trench mortise spaced the logs the desired distance apart.

the grooves between the logs to support the logs in their desired locations. The remaining two post sides each had a long continuous trench mortise cut nearly the full length of the posts. These two posts are situated side by side only 18" apart, adjacent to each other at the south wall next to the southeast corner. One post is the southeast corner post and the other is the east side south wall man door post. Why the shop's posts exhibit two completely different types of mortises has yet to be discerned. Each of the corner post tops were locked in place with an offset cog further secured by mortise, tenon and peg joinery.

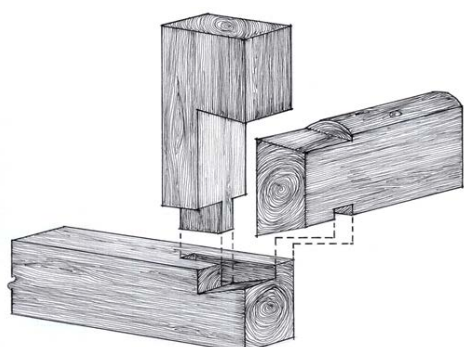
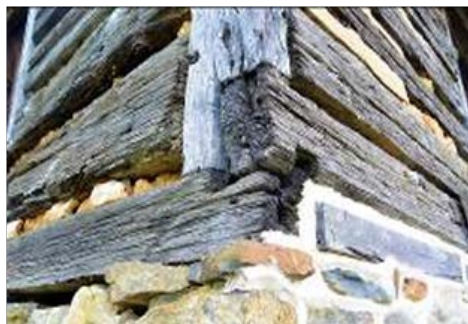
Complex joinery was needed to keep the building tight and sturdy. The drawing illustrates the corner post bottom to sill joinery used in the shop.

The structural design for the building's second-floor framing did not include braces¹³. Braces were typical members often made of oak used to stiffen a frame against the pressures of the wind. The shop has four corner posts and log in-fill, but no braces. In order to compensate for the lack of braces, the builder had to firmly secure the upper and lower post ends with complex joinery. The joints include stub tenons, by-pass mortise and tenons, half dovetails, laps and cogs. The complexity of the corner joinery securely locked the intersecting sills, plates, posts and wall logs together into a rigid frame.

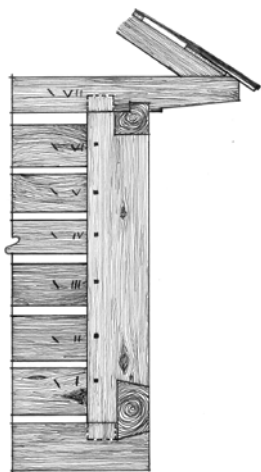
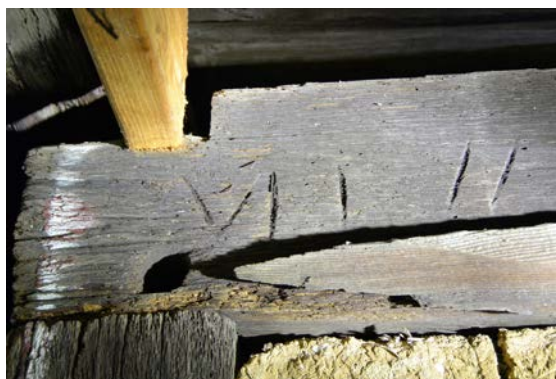
Roman numerals and markings carved into the logs indicated how they would fit together. Slashes indicated a particular wall, and numbers denoted the order of the individual logs within that wall. Here the numbers rise from the bottom log up, from 1 to VII.

In the shop building, the series of Roman numerals and slashes uniquely identify the pairing of members and indicate to which wall panel they belong. The shop wall Roman numerals ascended from the bottom sill to the top plate numbering 1 through 7 (in the Roman style I thru VII). Slashes were observed only on the two opposing eave walls. A Roman numeral followed by a single slash (/) told the builders the logs with single slashes were part of the west front wall. A Roman numeral followed by a pair of slashes (//) indicated the logs belonged together in the east, rear wall. For instance, the top plate joint on the east wall over the south end corner post is marked "VII //". No evidence exists of the south or north gable-end wall logs being marked. The absence of the marks on these two unmarked walls is not unusual. The differences between the two remaining unmarked gable walls were great enough in terms of the length of the logs and the differences in the window/door opening sizes and locations, that the builders were able to identify which logs belonged in a certain wall as they were being raised.

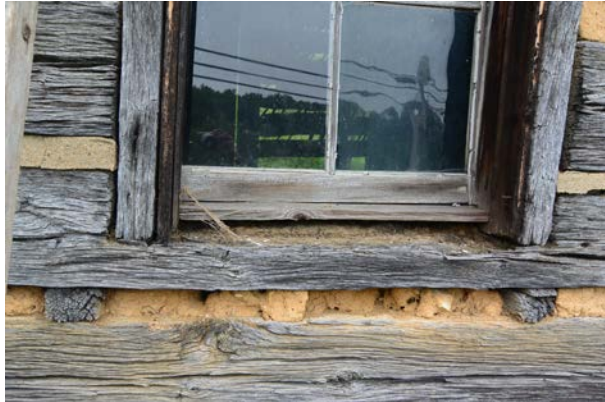
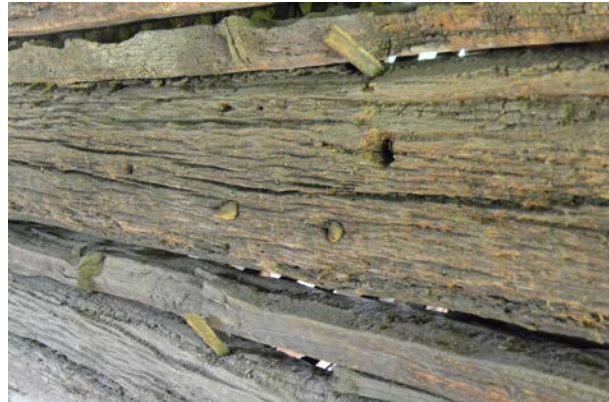
Evidence suggests that many log interstices never had chinking (left). Only the south wall was fully chinked (right), and the chinking was only for the exterior daubing. A few of the long chinking pieces were pegged in place.

With somewhat wide interstices between the logs in all four walls, only the south gable end retains a small amount of split wood chinking.¹⁵ Chinking is used to bulk fill the gaps between the logs. There was very little chinking remaining in the front, north gable and rear walls. Almost no chinking remains in the rear wall. For instance, the narrow spacing of the crack between east wall's top courses indicates the crack was never chinked and daubed. In many other cases the narrow cracks between the logs did not appear to have any chinking ever installed. It almost seems as if there was no great need for totally chinking the logs and the three walls were never fully chinked. It is apparent the daubing¹⁶ was installed mostly from the exterior in all four wall walls to fill the openings between the logs. In many places it was observed the mud daubing was pushed in from the exterior toward the middle of the logs. There were no wood grained imprints left on the interior sides of the daubing indicating there was no wood split block or stone chinking in those locations. Only in the south wall are there long split wood wedges and pole chinking forced between the logs to fill the interstices higher in the wall. The longer pole chinks were held in place with short wooden pegs driven into the logs to secure the oversized chinking place. The irregularity and scarce use of chinking throughout the walls was due to the fact the building was apparently planned as an unheated shop and not a dwelling. The interior sides of the logs were intended to be covered with plaster and did not need to be chinked and daubed. Only what appears a half-hearted attempt to install chinking in the shop walls was undertaken and the effort was never completed.

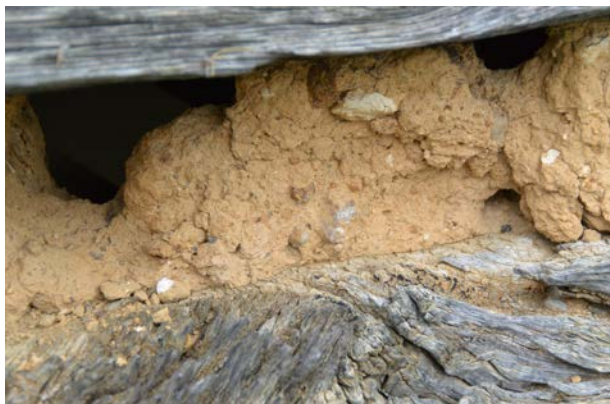
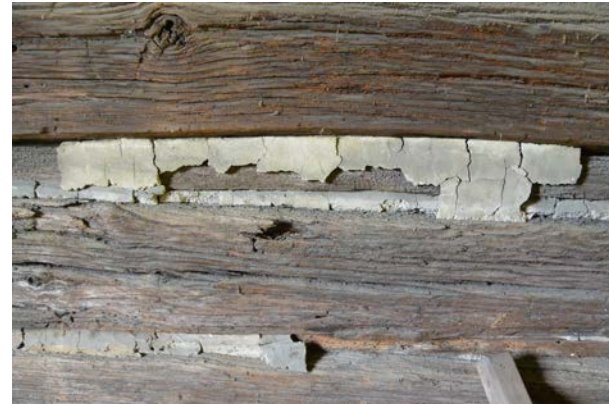
The mud daubing, a mixture of clay, stream bed sediment/sand, and a very little chunk lime was used to fill the bulk of the cracks. (left) Without lime coat protection, the mud daubing weathered very quickly. Very small amounts of original lime daubing were located on both the gable end walls. The south gable daubing, shown here (right), was applied during two different periods. The narrow V joint profile is original. It was later covered by the more liberally-applied lime coat during a second campaign of daubing.

¹⁶ Daubing is a clay/lime applied over chinking to fill the gaps between logs. Daubing used in the Schubert shop consisted of two basic types. The bulk of all daubing was a cheap clay mix applied to fill the gaps between the logs. The bed daubing was a soft and impervious application that would wear away very quickly if left exposed to the weather. A harder finish daubing was lathered over the clay bed daubing. Almost a pure mixture of lime, the finish daubing was troweled over the bed material to protect it from the weather.

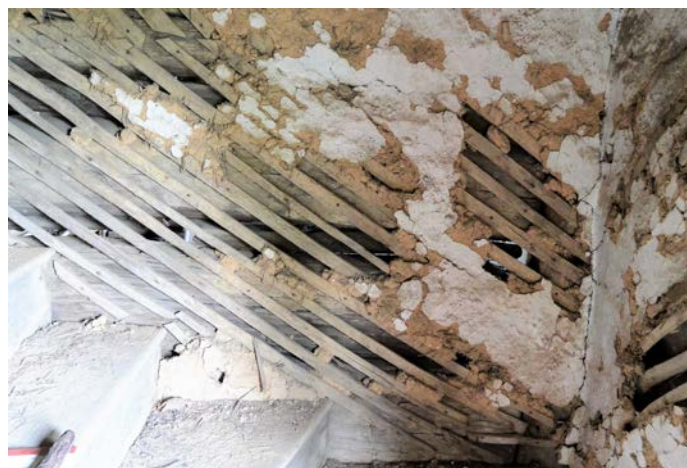
Looking through the lath in the second floor stairwell, no interior daubing was ever present in the south wall, and very little was present in the other three log walls.

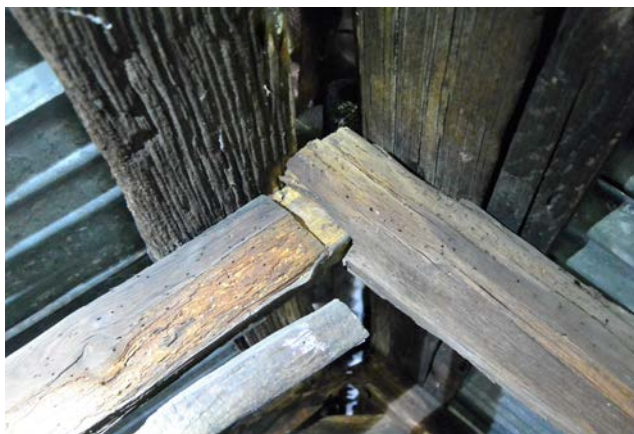
The rafter peaks were joined with open mortise and tenon joints, a very common method for joining rafters together except there was never any pegs. The lack of pegs here is very usual.

All of the original second period oak rafters remain in place measuring 4-3/4" wide by 4" deep. The rafters are roughly hewn all four sides with waney edges¹⁸ and sap wood¹⁹ left at corners. Some bark remains on the rafters. The rafters are not tapered from foot to peak. The rafter foot ends are stub-tenoned to fit into the shallow mortises cut into the top ends of the loft joists. The rafter foot to loft joist connections are not pegged. The rafter peak joints are open mortise and tenons also lacking pegs.

Of the thousands of log buildings inspected, the nomination's author has never seen rafter peak and foot joints left without pegs. Pegs were a necessary part of securing the joints of the rafter to the building. When high winds blow across a roof peak, there is a tendency for the leeward side of the roof panel to lift. A very strong wind approaching 60 mph can take a roof off a building. It is truly remarkable the rafters

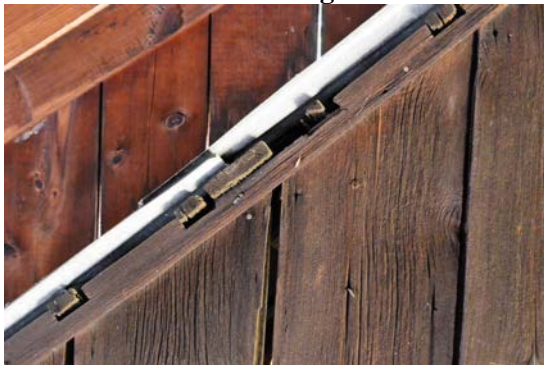
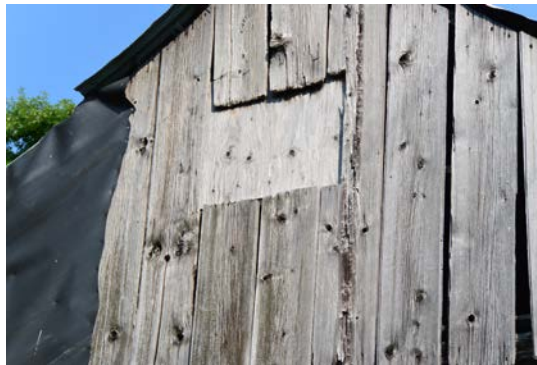
Visible from inside the garage addition, left photo, looking at the original south end wall, barges were cut around the roof lath and had 1/4 inch beads along the bottom edge. The bead is hard to see in the photo as most of the beading has weathered away. The photo on the right shows the north end's tongue and groove boards. The north gable end barges are no longer extant.

The original south gable barge boards remain. The south gable barges survive due to the garage addition covering the gable. The remaining barges are a feature seen from inside the second story of the garage. Made from a small piece of hemlock measuring 1" x 2-1/4" wide, the barge boards were nailed to the face of the vertical siding. The barges were cut to fit around the roof laths which extend past the barge boards to allow a minimal overhang. The small barge is beaded at the lower edge. The two north gable barges are no longer extant. Both of the gable ends above the loft floor level were sheathed with vertical random width, tongue and grooves, sash sawn hemlock boards. Small battens were placed over each crack where

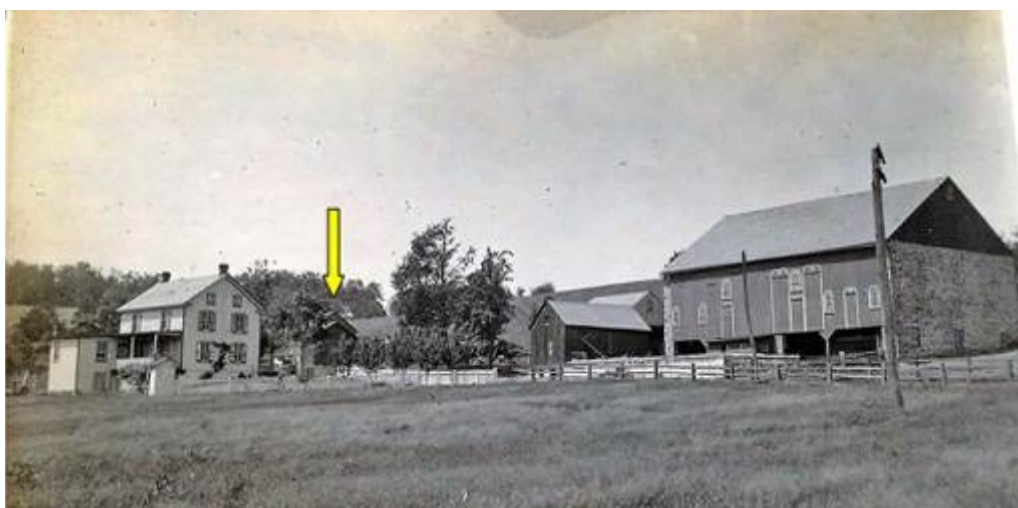
Farmstead, c.1936. The yellow arrow points to the log shop with its earlier addition.

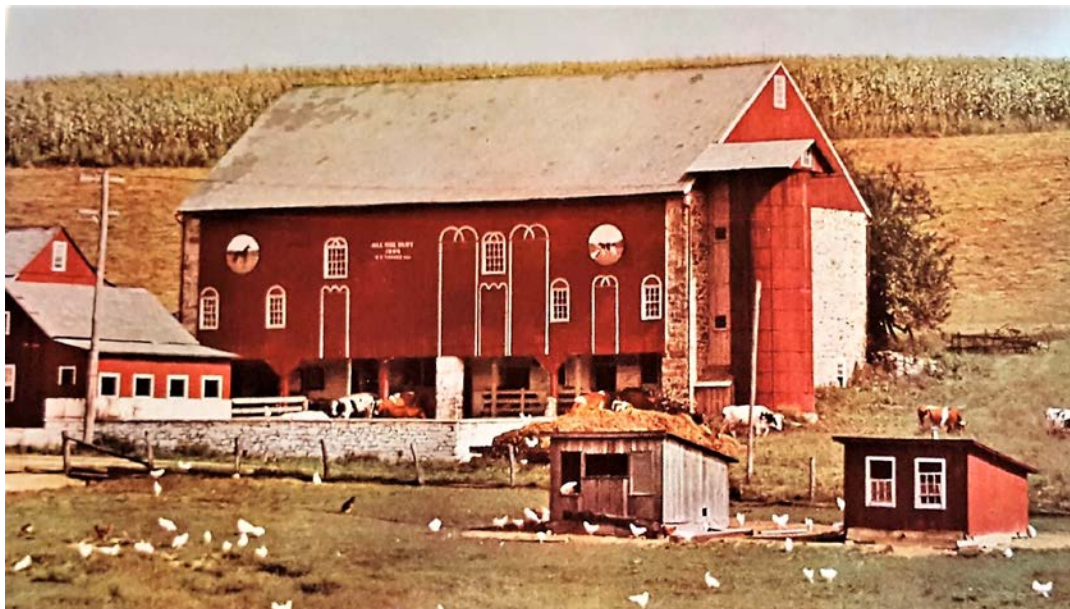
Image used in a 1938 issue of National Geographic magazine, showing chicken coops, wood silo, barn, stone barnyard wall, and piggery/chicken house, and gable end of drive-thru corn crib. (all demolished)

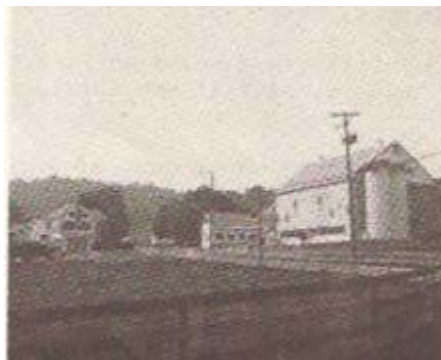
Undated newspaper article showing two wood silos on south end of barn

Standing against the south gable wall of the stone end barn was a pair of wooden silos. Paul Manwiller remembered the two wooden silos. He also remembered Elmer Graber telling him the first of two wooden silos was built in the 1930s which coincided with details shown in historic photos. A c.1936 photo has no silo in the view. A 1938 photo published in the *National Geographic Magazine* showed the first of the two wooden silos in place. A later newsprint photo had both silos in place. A 1974 aerial photo did not show the silos which had already been torn down. According to Paul Manwiller, the two silos were used for storing silage.

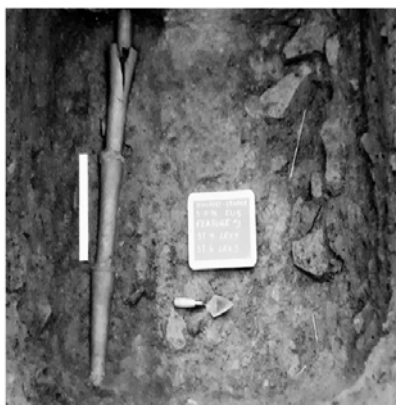
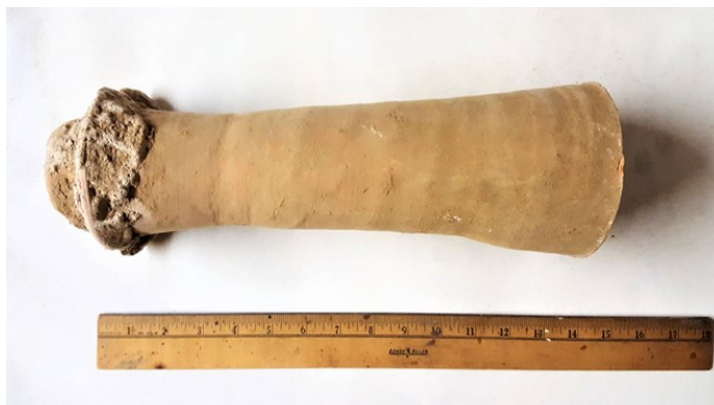
Clay pipe remnants of the water system uncovered during archeological investigations around the shop, 1994-1996.

President Mordaunt also had in his possession for safe keeping one extraordinary pottery artifact recovered during the archaeology field work in 1996. A single, intact hand-thrown, clay water pipe section along with two other incomplete pipe sections was excavated about four feet below the ground surface. The pipes were removed from the excavated unit located very near the northeast corner of the log-post shop. The other two recovered clay pipe sections are unaccounted for. It is possible the two missing clay pipes are stored with the other bagged and tagged artifacts in the garage. According to Mr. Mordaunt, one partially exposed piece of clay pipe was left in the ground when the excavated units were backfilled.

The remaining 15" long piece of clay pottery stored at Mordaunt's house is an intact unglazed water pipe flared at one end to receive the narrow end of another pipe of similar shape. A clump of lime based mortar was adhered to the one end where two pipes were joined. The mortar was used to seal the pipe sections together against leakage. A dated May 11, 1996, photo showed four sections of clay pipe in place at the bottom of the unit. The clay pottery sections were part of a water piping system that brought water directly from a fresh water spring further up the hill down to the farm house and the 1865 barn located south of the shop building. The four sections of piping observed in the archaeology photo ran north to south by-passing the small log-post shop on its way to the barn. No dates are known or estimated for the clay water pipe system.

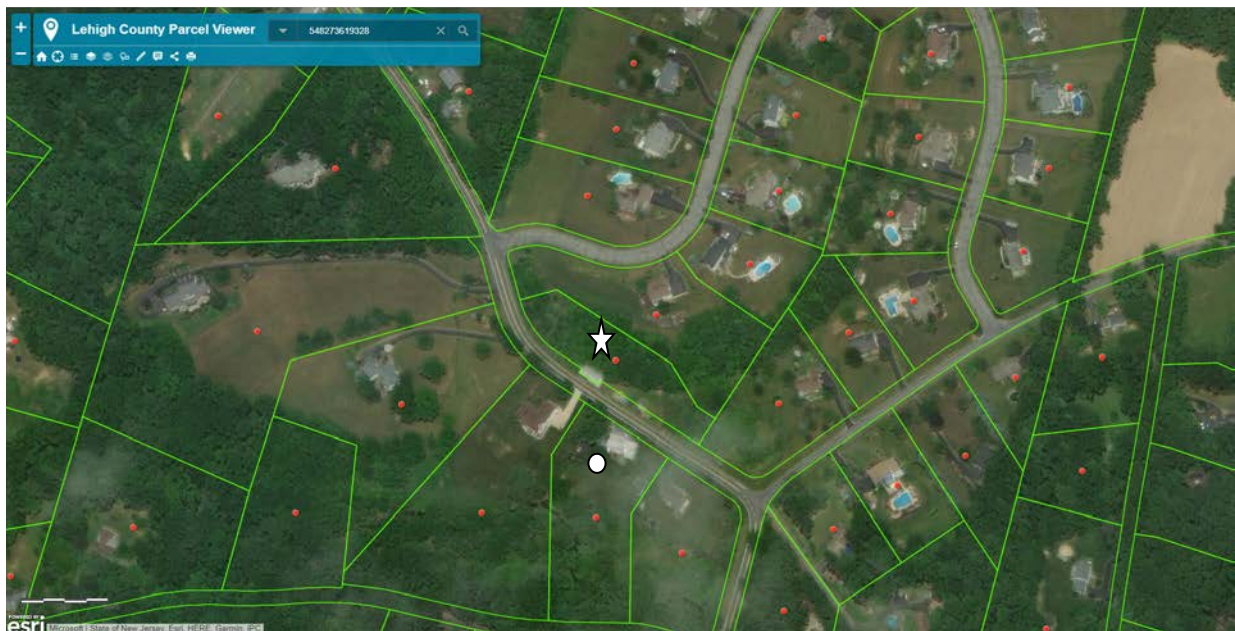
Figure 2: Site Plan with Boundary; parcel marked with “star” shape; 2018 Tax Parcel Map, Lehigh County, accessed 1/17/2018. Boundary corresponds to tax parcel # 548273619328. The boundary likely includes sites of former agricultural outbuildings or structures that may have had functional relationships with the log shop, and may be considered “contributing” with further study. The historically-associated farmhouse across Powder Valley Road (parcel marked with white circle) is not included within the boundary, but may contain information relevant to the history and development of the Log Shop. The southern boundary should follow the road edge, unless further study identifies sites under or across the road that contribute to the shop’s significance and retain integrity.

The Parcel is currently identified as 548273619328 in Lehigh County's online tax parcel mapping (see Figure 2); the boundary should follow the road edge even though not shown in the parcel boundary online.

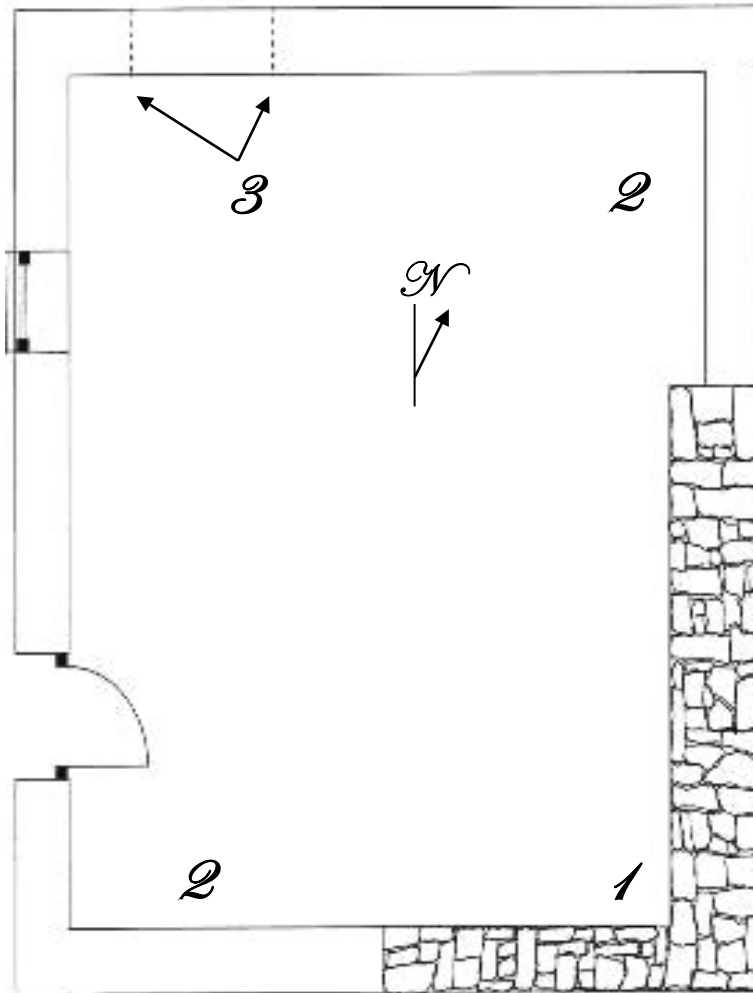
Drawing 1: First Floor plan showing the two periods of stone walls.

1. First period foundation bank walls reused in second period log-post shop.
2. Second period expanded foundations built for log-post shop
3. Ghost lines in foundation indicate an earlier horizontal slider window; period unknown. A c.1976 photo shows opening closed.

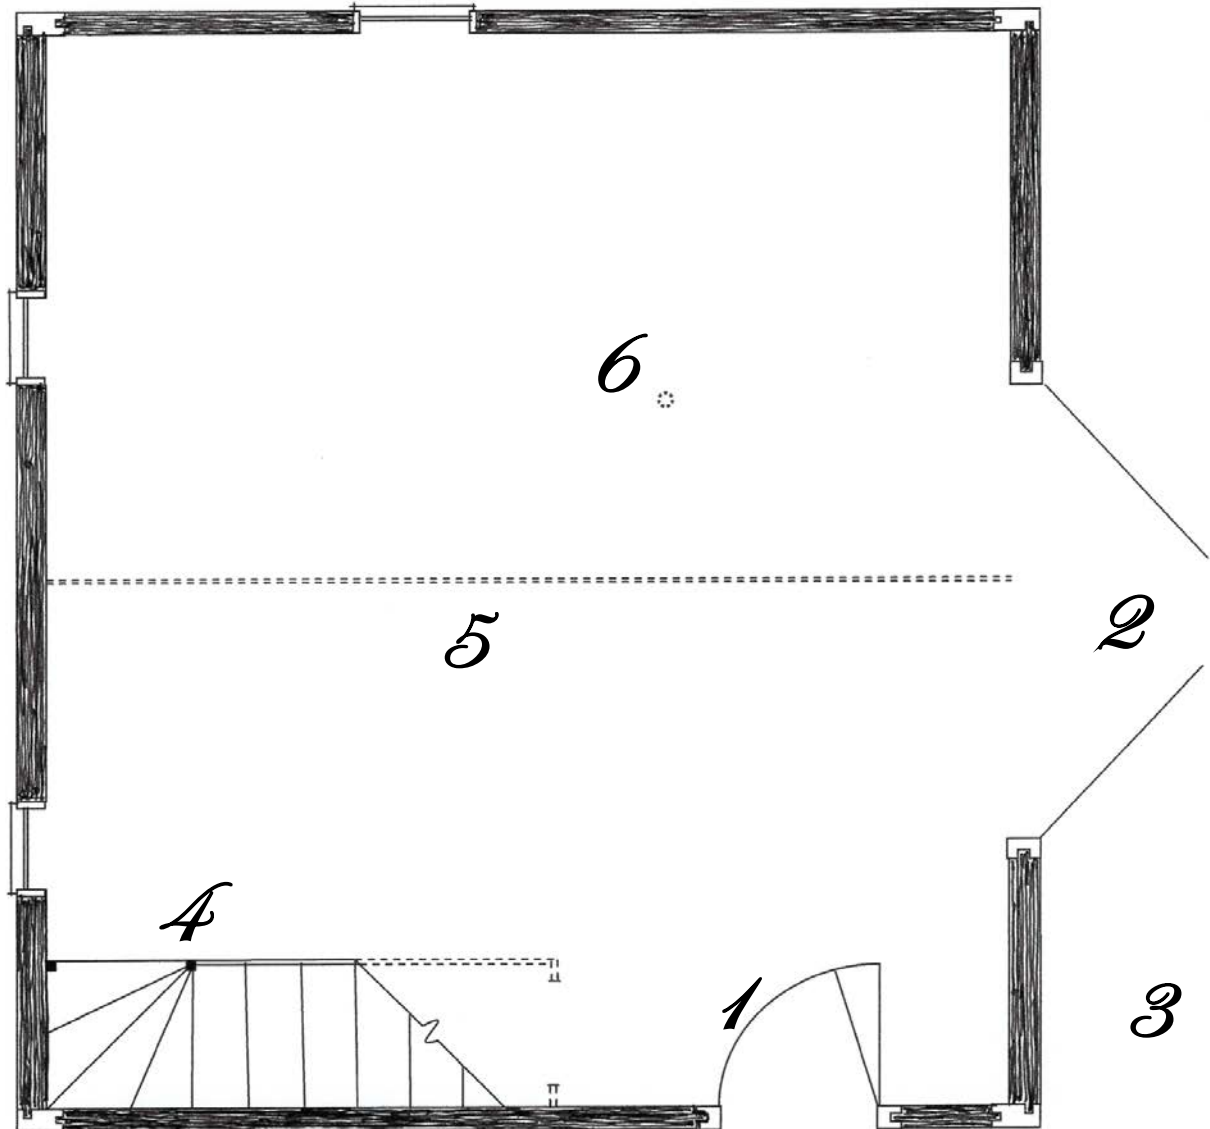
Drawing 2: Second period plan second floor log-post level, noting location of certain construction details.

1. Double leaf over/under dutch style strap hinge hung door
2. Wagon doors were framed original to log-post walls
3. Corner posts mortised to receive tenoned log ends
4. Staircase to loft, not to lower level, never had doors hung in either opening
5. Temporary vertical board wall in workroom, period unknown, not original.
6. Flue hole cut in loft floor for temporary work room. No other evidence of heat.

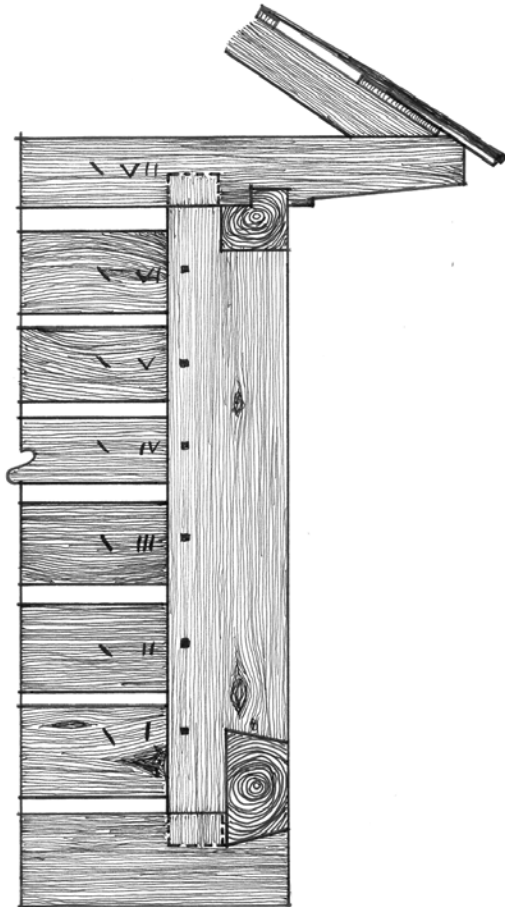
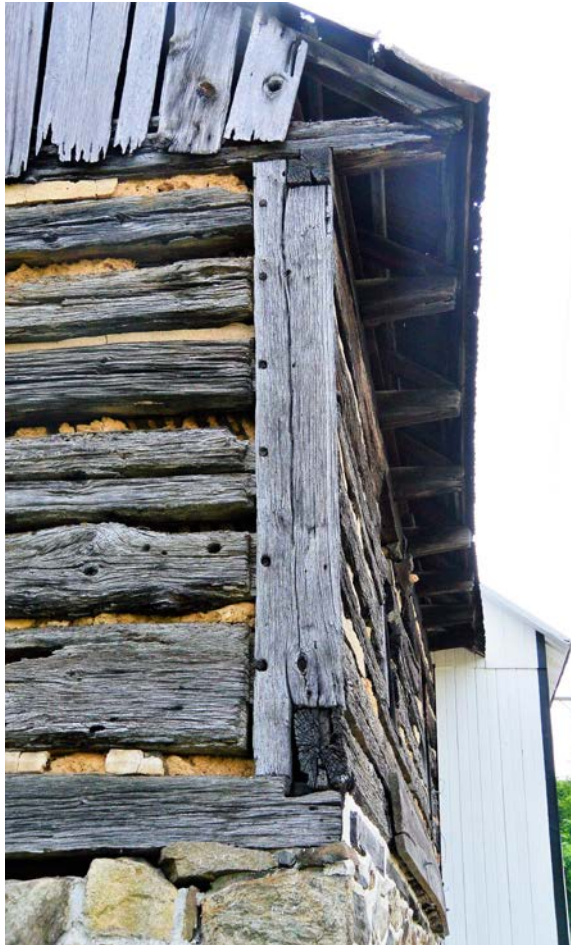
Drawing 3: Corner post at northwest gable elevation

1. Eave sill at post base is captured by full dovetail, formed by gable sill and post. Back part of post has a stub tenon mortised down into gable sill.
2. Each log was tenoned and held in posts by individual mortises. Two opposing posts, one corner and one man door post, had trench mortises. The “why the posts had two types of mortises” is not yet understood.
3. The tops of the corner posts were locked in place with an offset cog and pegged tenon.

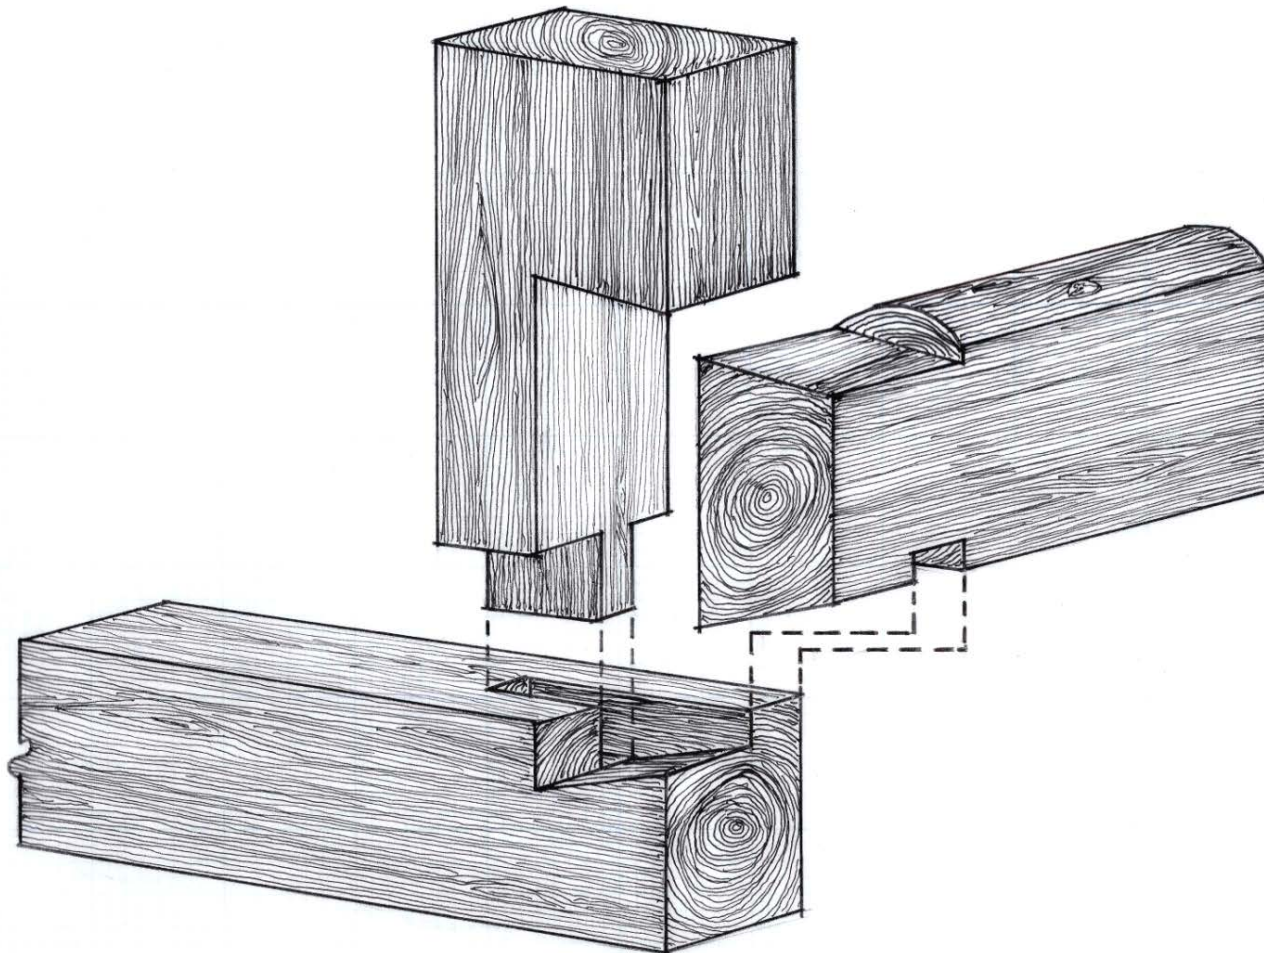
Drawing 4: Bottom post to sill joinery

- The left gable sill was placed first on the foundation. It was cut with the bottom half of a dovetail. In behind the dovetail was the mortise for the post tenon. The back side of the mortise extended out to the face of the eave sill to act as a cog. The cog locked the eave sills in place and prevented them from slipping away from the gable sill and post.

- The eave sill was placed to overlap and cut to fit the end joinery of the gable sill. The top end of the eave sill was cut to receive the upper half of the full dovetail which captured the front portion of the post.
