National Register of Historic Places Registration Form

Historic name: Schubert-Graber Log-Post Shop

Street & number: 6561 Powder Valley Road

City or town: Zionsville State: Pennsylvania County: Lehigh

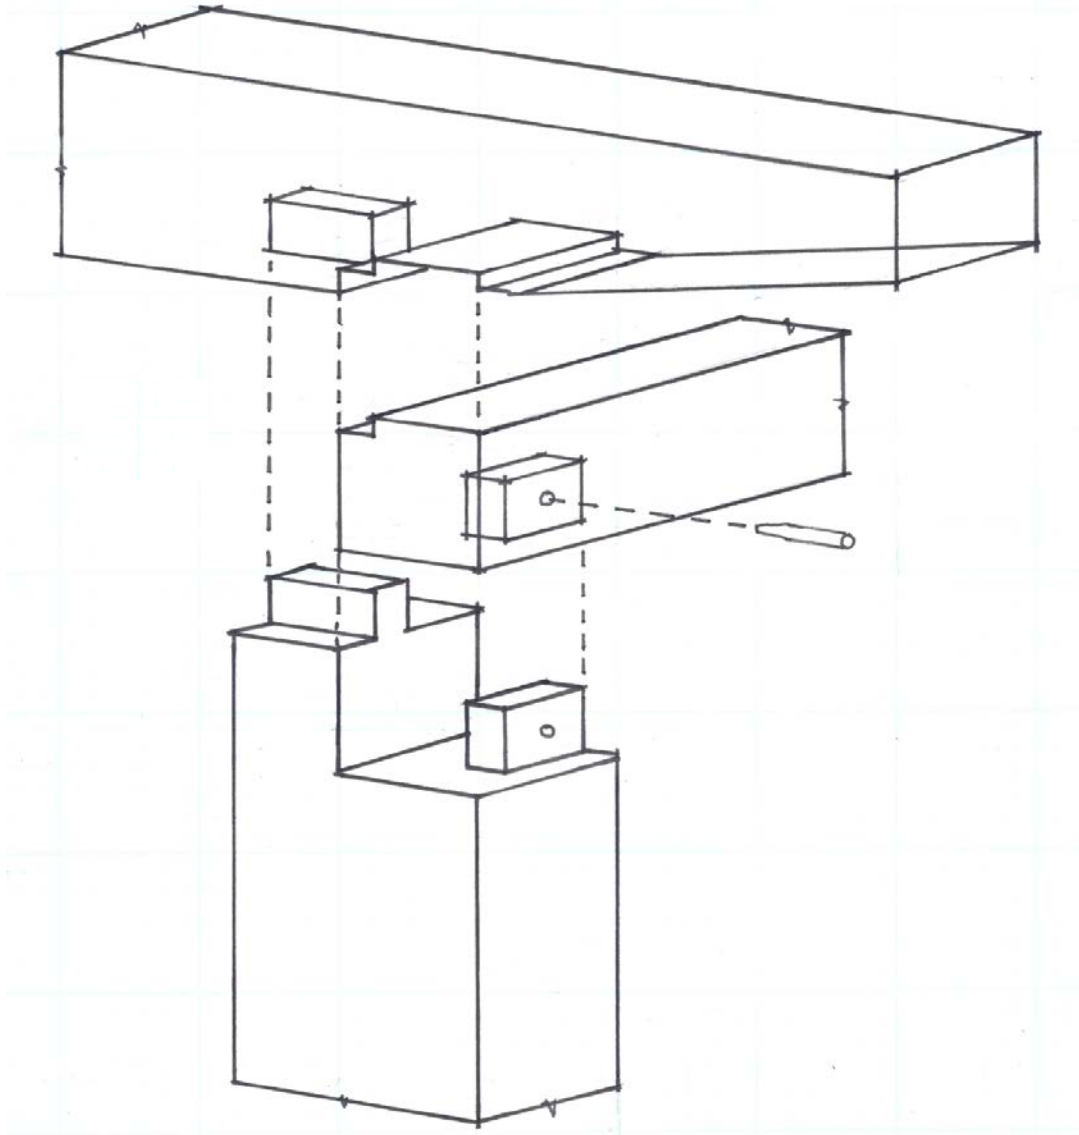
Drawing 5: Top plate to post joinery

- Gable plate laps over eave wall top plate
- Eave plate fastened to post with mortise and tenon with wood peg.
- Post steps out behind eave plate tenon, continues on to gable plate and is pegged to gable plate.
- Loft joist extension 16", bevels up to end where stub tenoned rafters were placed in mortise at end of joists without any nail or peg.

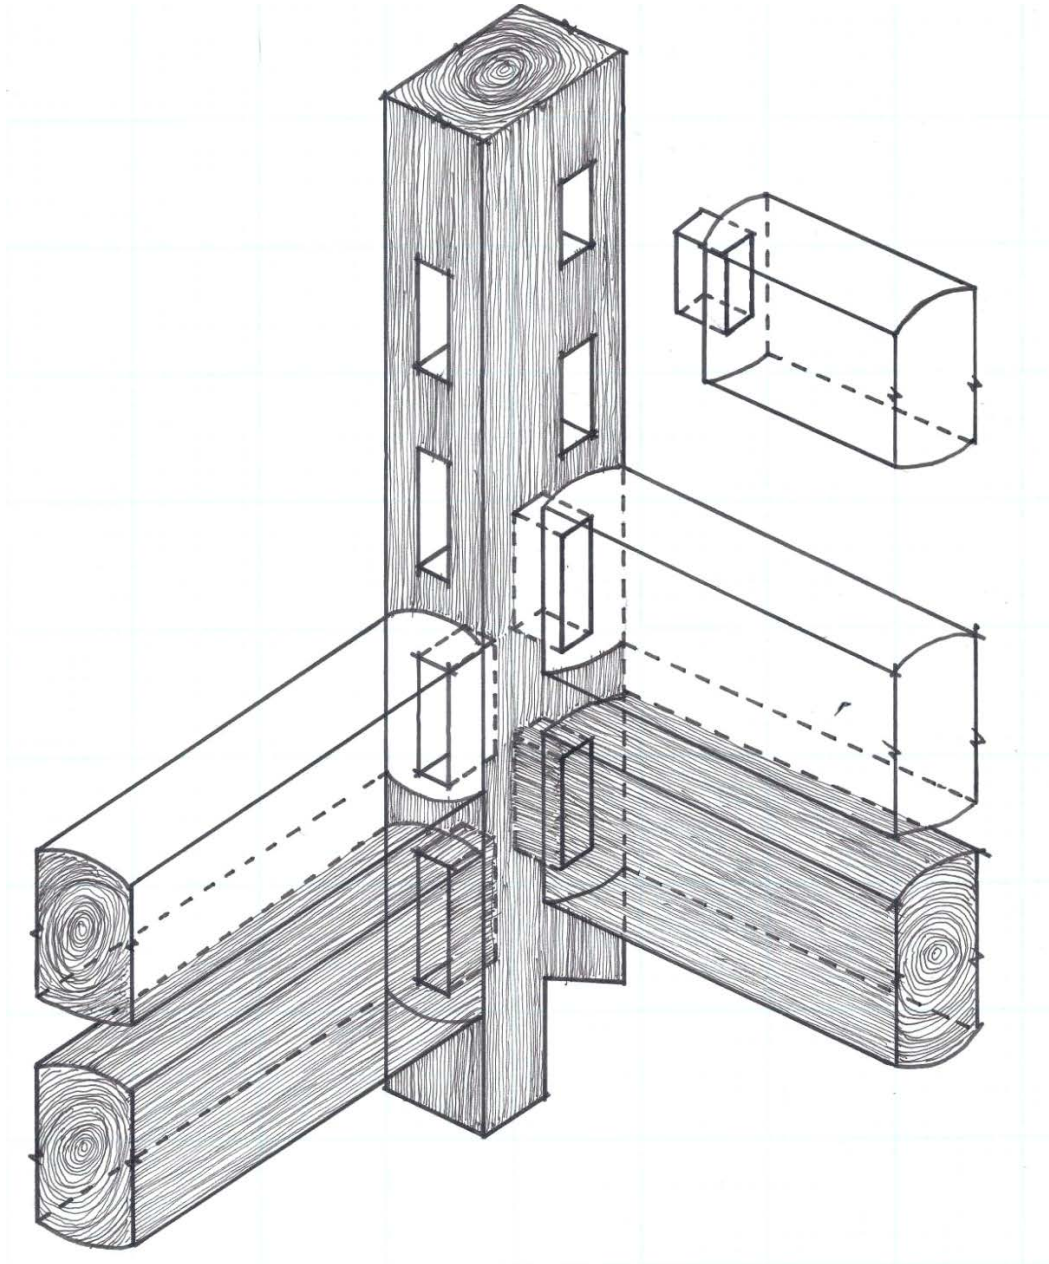
Drawing 6: Individual post mortises

- There were twelve post sides with mortises in eight posts. Ten sides had individual mortises.
- Two sides in opposing posts next to man door had trench mortises.
- Log tenons were fastened into post mortises with square head wood pegs

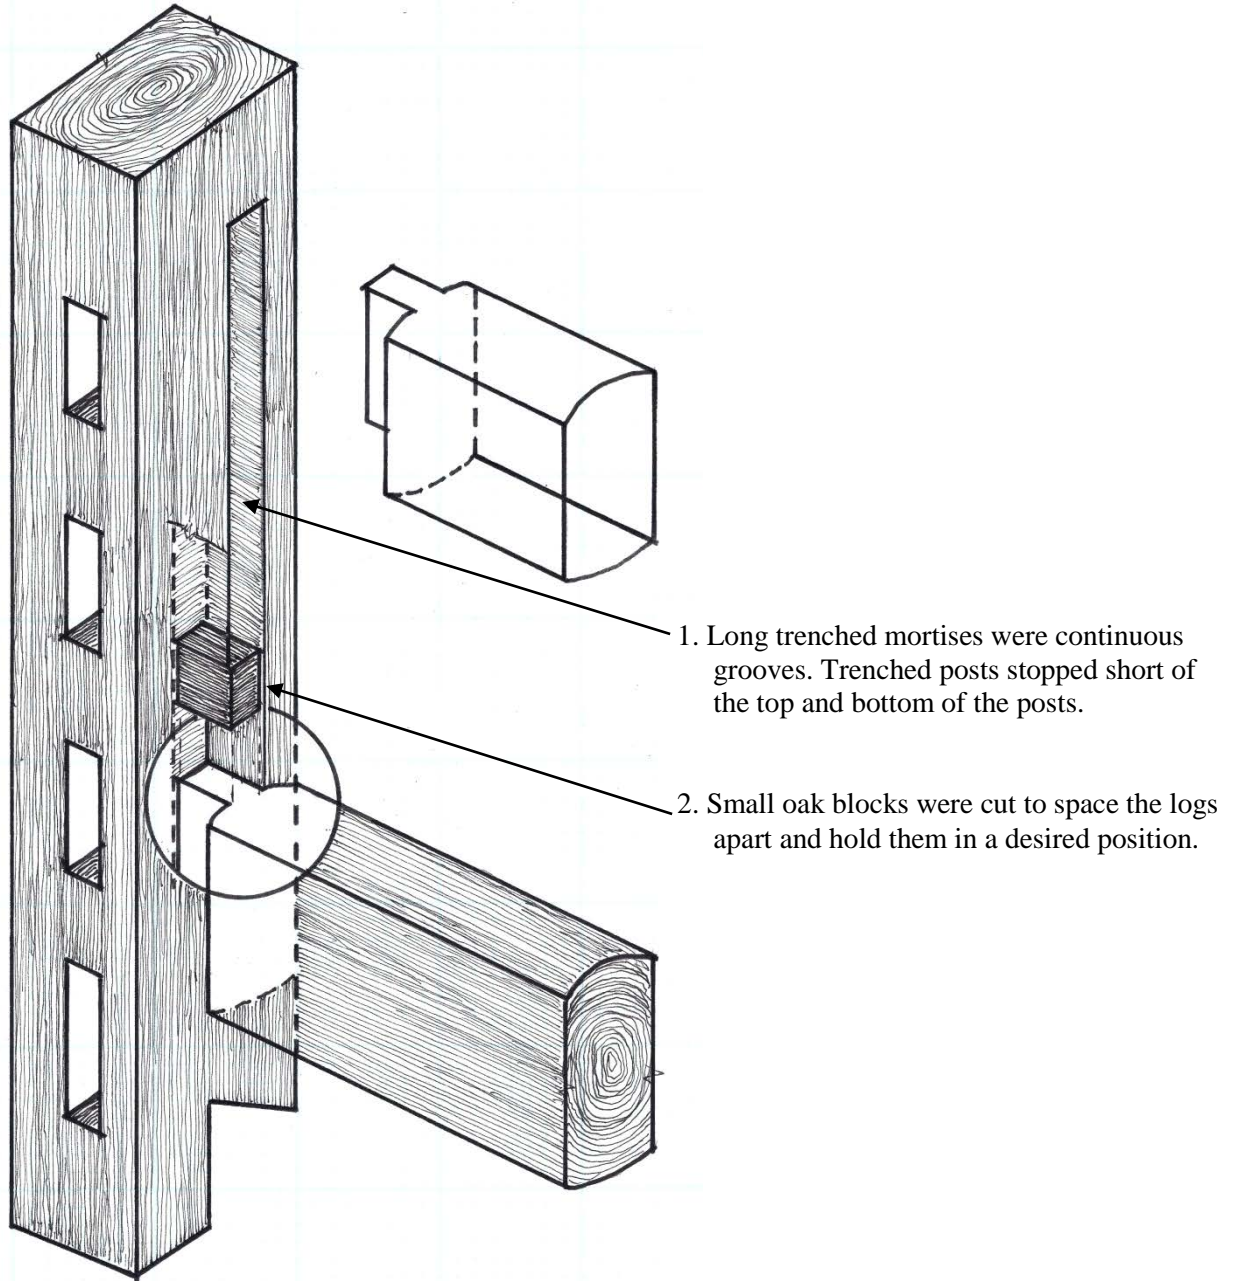
Drawing 7: Trench mortises in two posts

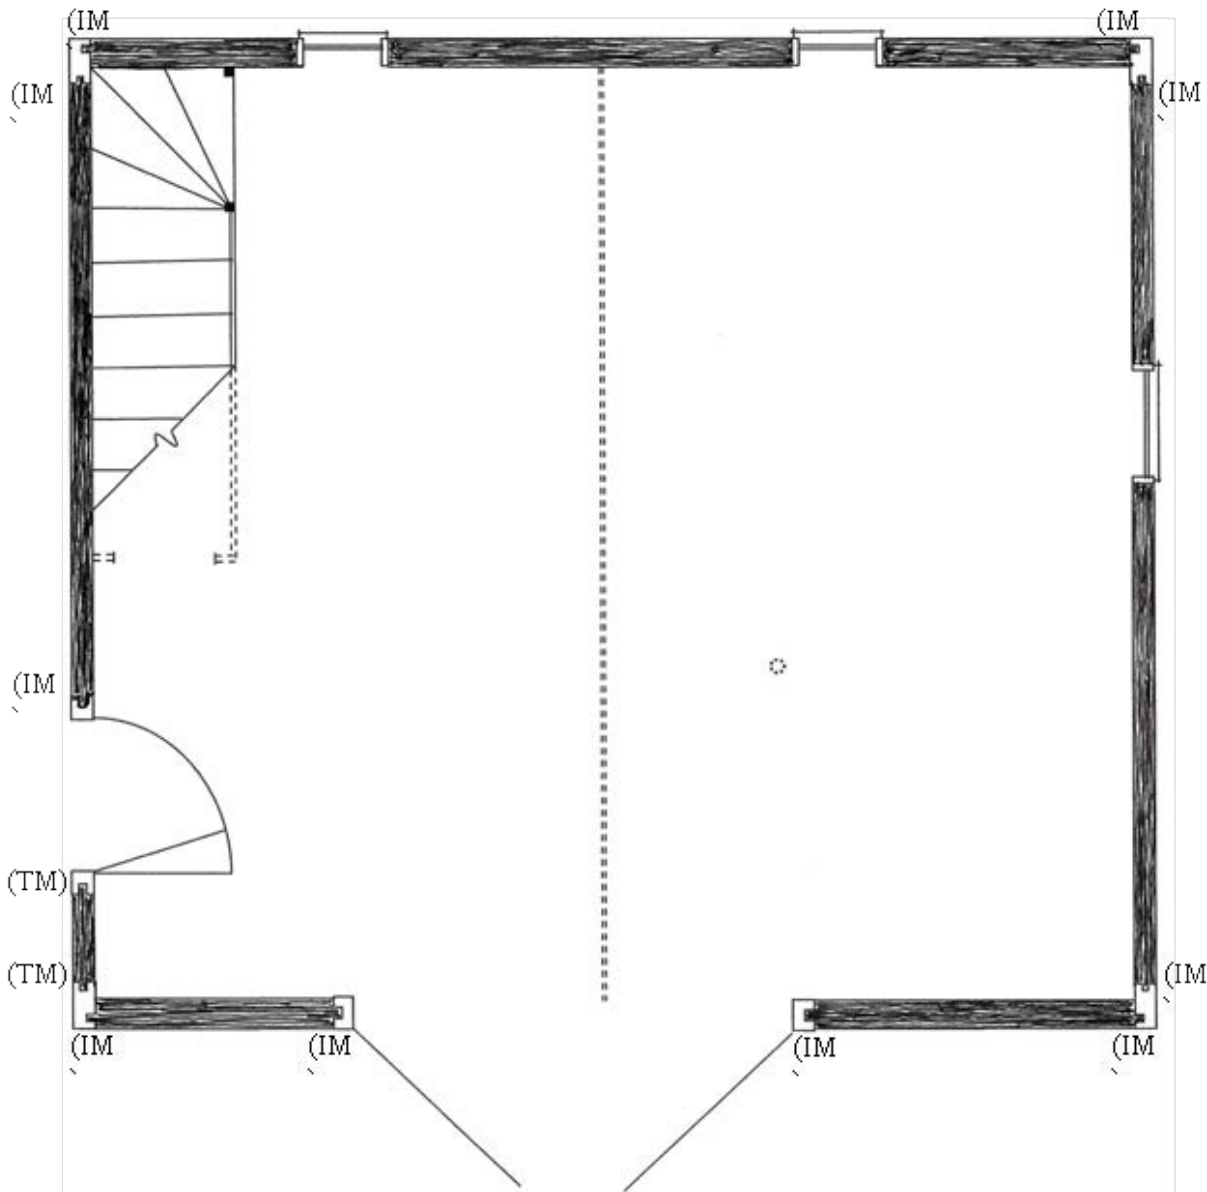
Drawing 8: Second floor plan showing Type 1 (door posts) and Type 4 corner post locations. Most of the mortises are noted as individual mortises (IM). Two posts with trench mortises are at left lower corner, noted as trench mortises TM.
