RR 1417-
Survey # 2-16

NEW JERSEY TRANSIT RAILROAD STATION SURVEY

A. Name: Common Madison station Line: Hoboken Division - Morristown
Historic (DL&W) Erie Lackawanna

FACILITY NAME: Madison

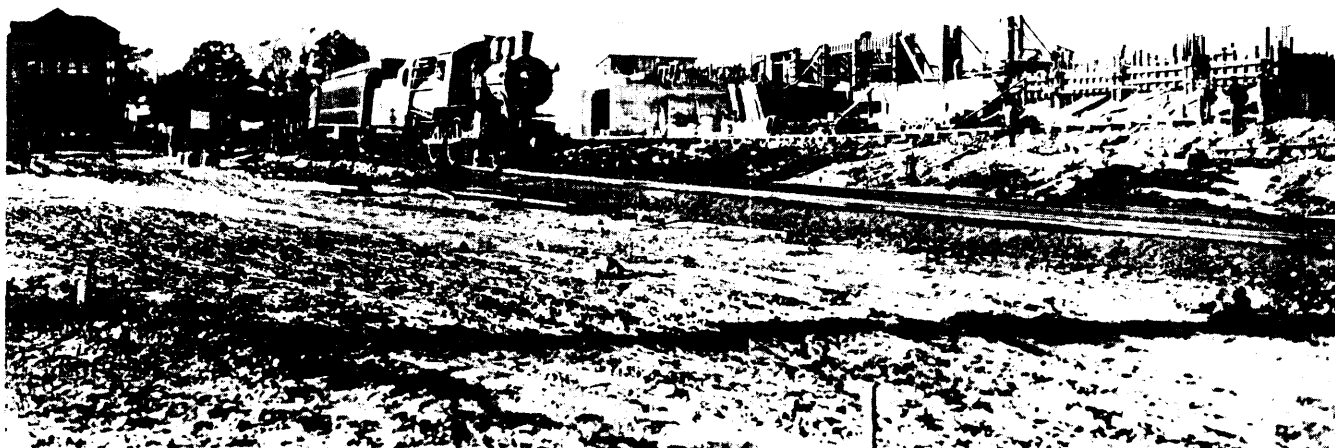
An eastbound train pauses at the temporary depot at Madison while on its way to New York. The new station will be located just east of the old. Houses, which had been located where the road and temporary track are, have been torn down or moved. Later, this area will have station parking and the front lawn of the municipal building. The picture was taken in October 1915.

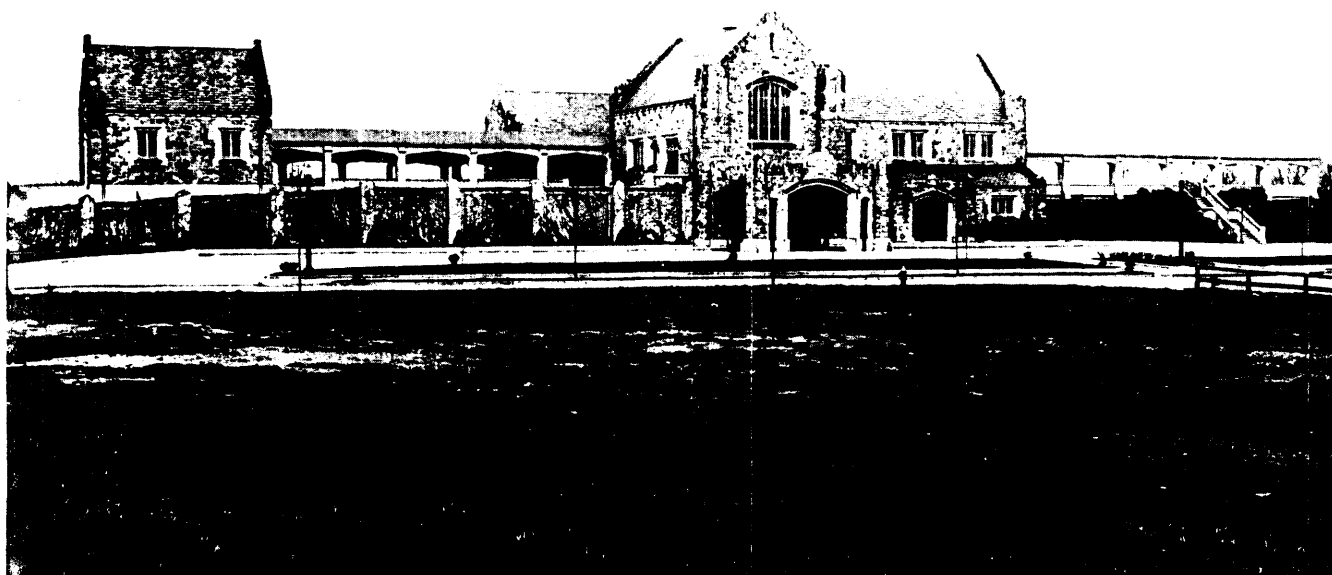
The new Madison station was opened April 17, 1916. The building at the left housed the Railway Express office. Prior to the elevation, the area in the foreground was thickly covered with homes, all of which were removed for the station. In 1976 the station was declared a historic site.
