MP 3288

National Register of Historic Places
Registration Form

historic name Selah Chamberlain Shipwreck (Bulk carrier)
other names/site number 47-SB0304

street & number 2 miles northeast of Sheboygan Point, in Lake Michigan N/A not for publication
city or town Sheboygan x vicinity
state Wisconsin code WI county Sheboygan code 117 zip code 53081

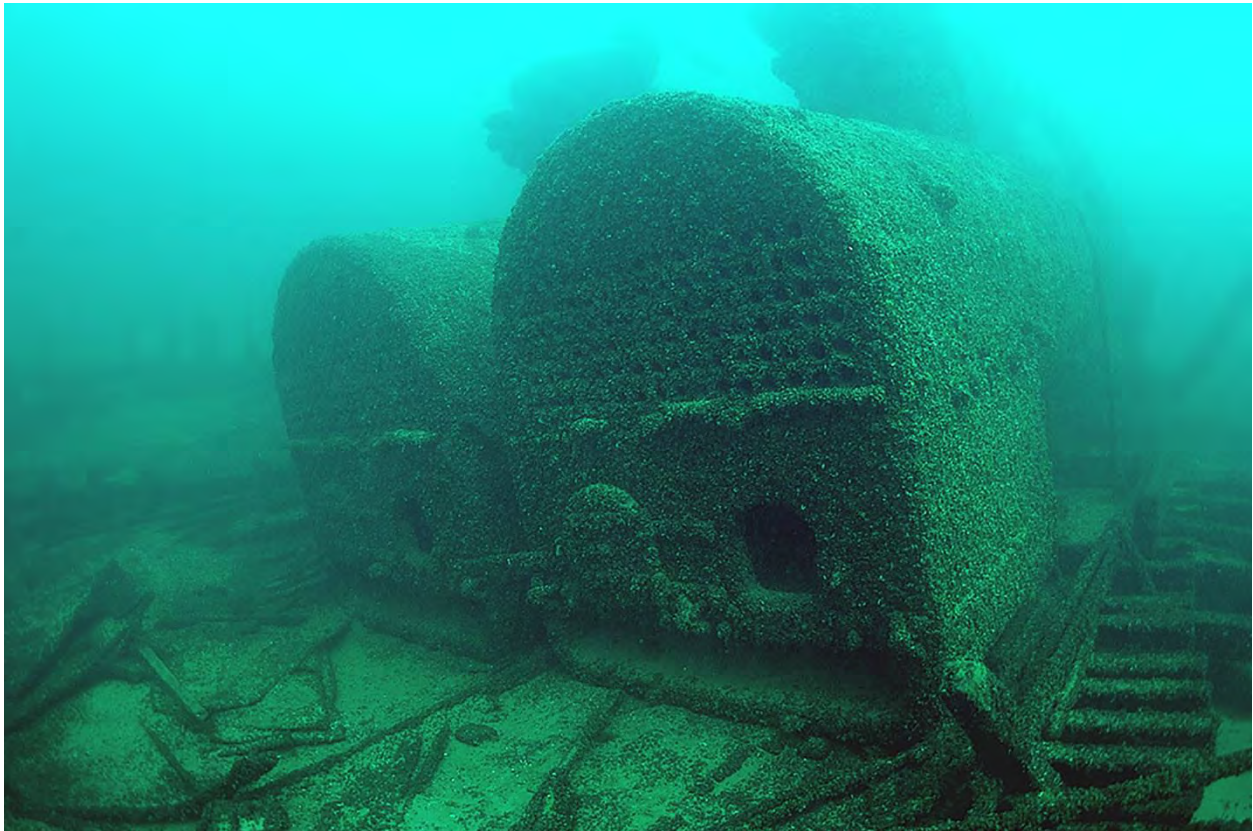
Photo #1 of 3

Selah Chamberlain Shipwreck (Bulk Carrier)
Sheboygan County, Wisconsin
Photographer Tamara Thomsen
2008
Front of *Selah Chamberlain's* firebox boilers

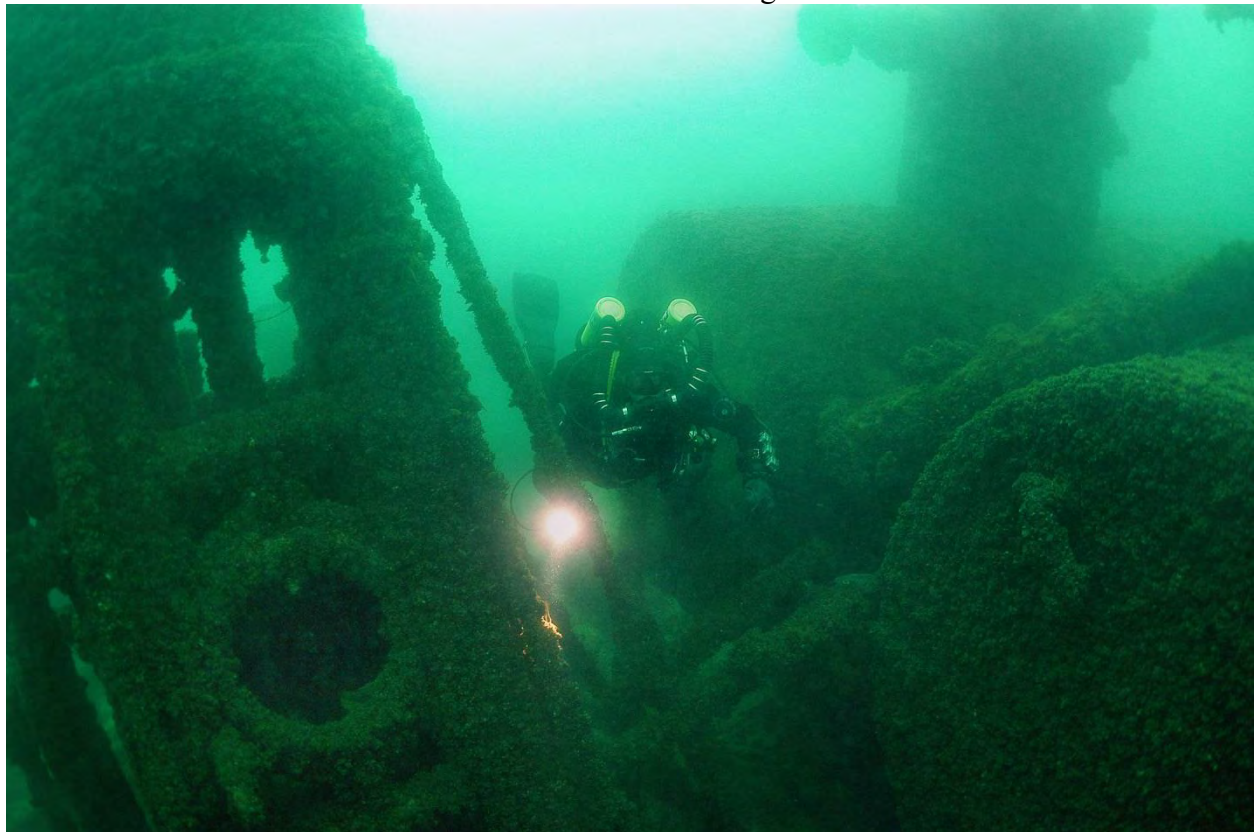
Photo #2 of 3

Diver located between *Selah Chamberlain's* boilers and engine

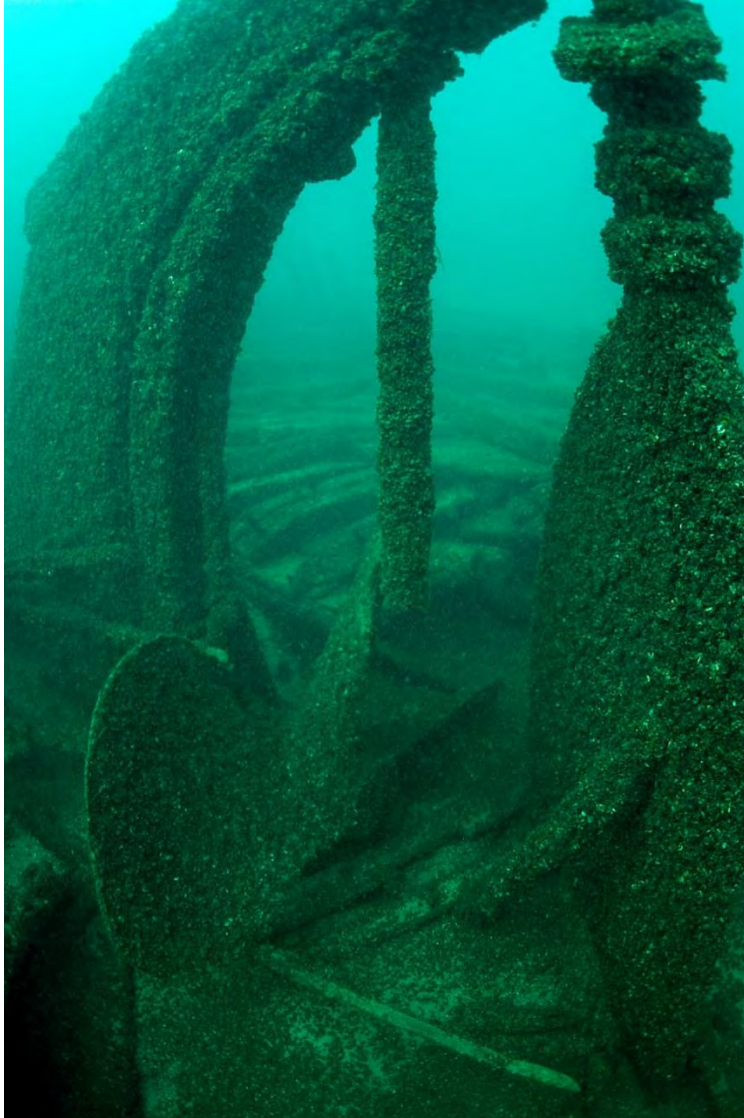
Selah Chamberlain's rudder and propeller looking starboard

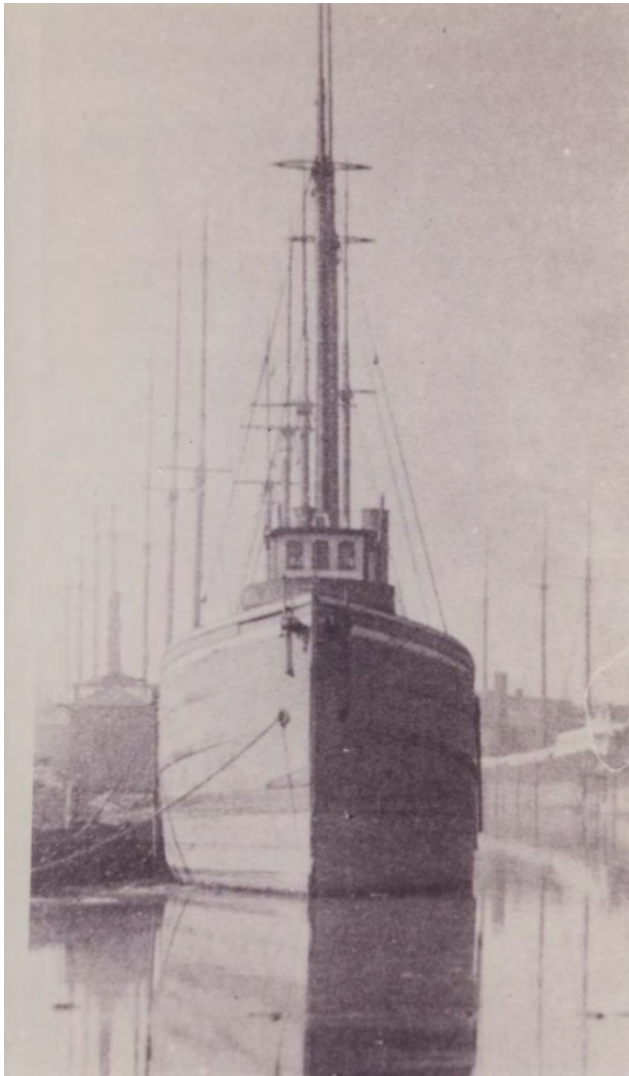
Figure #4 of 4

Selah Chamberlain Shipwreck (Bulk Carrier)
Sheboygan County, Wisconsin
Photographer Unknown
Date Unknown
Bow of the bulk carrier *Selah Chamberlain*
