National Register of Historic Places Registration Form

historic name Arizona Army National Guard Arsenal

other names/site number Arizona State Military Academy; Arizona Military Museum

street & number 5636 East McDowell Road, M5320 N/A not for publication

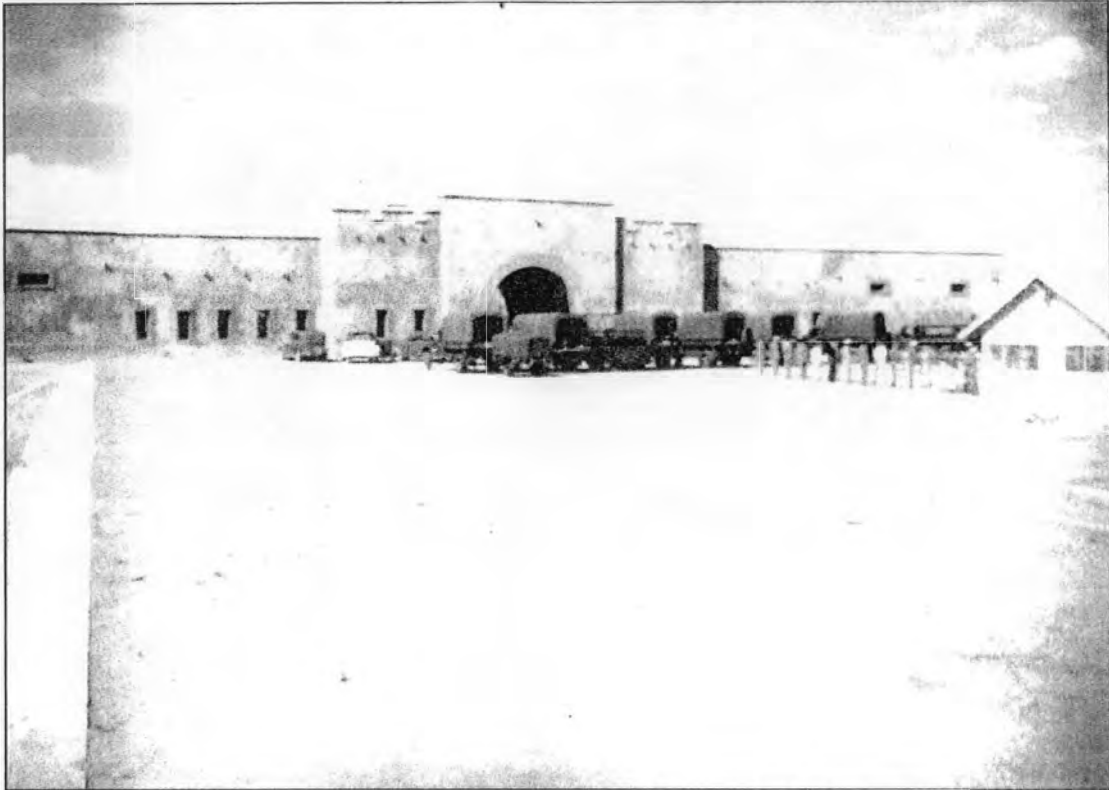
Historic Photographs 2 and 3

Front of Arsenal Circa 1940 (view north)
[Photograph courtesy of the Arizona Military Museum, PPMR, Phoenix]

- 0005. front façade of arsenal, view northwest (compare to historic photograph 1, October 1939)
- 0006. front façade of arsenal, view northeast (compare to historic photograph 2, circa 1940)
